## THE AUGUST 8, 1993 GUAM EARTHQUAKE Reconnaissance Report

### SUMMARY

*This report on the 1993 Guam earthquake summarises the earthquake and resulting damage to structures and lifelines. The particular interest in this event, which is considered to represent a serviceability limit state earthquake, was the response of relatively modern high-rise buildings.*

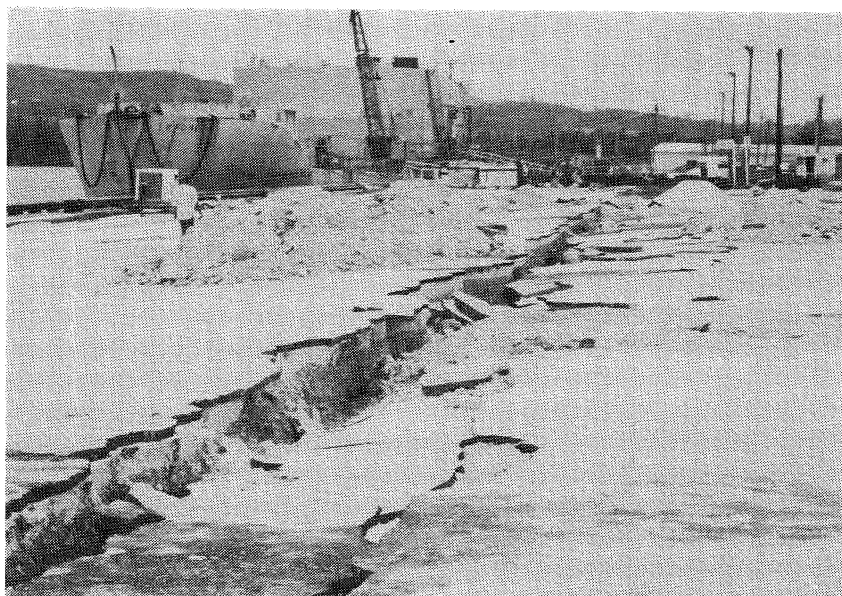
Localised slumping and lateral spreading of reclaimed waterfront material by up to 500mm and 200mm respectively was observed in the wharves of both the main port and the US Coastguard station (refer Figure 3). Similar ground displacement affected one of the main power generating facilities adjacent to the port area. It is believed that this ground damage occurred in association with some liquefaction in these areas.

*Figure 3 Lateral spreading of US Coastguard port facilities*

The port was significantly affected by the lateral spreading and slumping of its main container apron. While the container crane runway itself was supported on piles, sufficient movement-induced damage occurred to necessitate a full inspection of the pile tops, and in some cases local repairs.

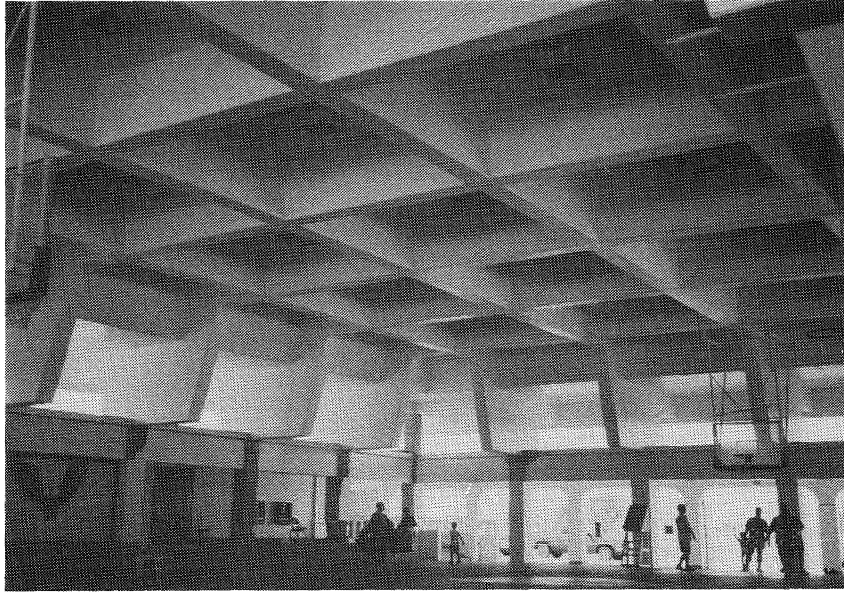
Some significant damage was sustained by low-rise structures of large mass. Buildings featuring long span concrete roofs were the worst affected in this regard, with school auditoria and grandstands being prime examples. Where these heavy mass, long period structures were supported by tall

*Figure 5 Inarajan High School - interior of gymnasium showing heavy concrete roof*

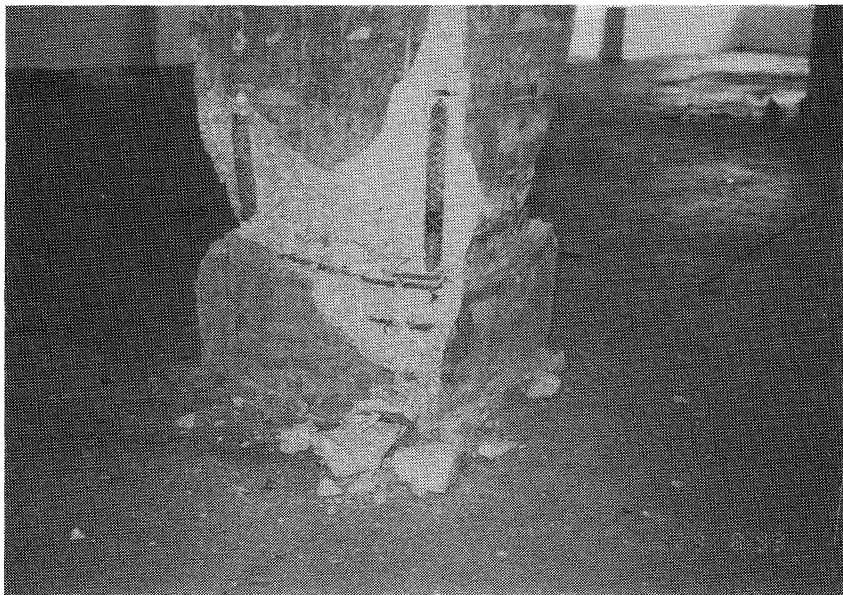
While it is clear that a measure of yielding has occurred at the base of this lightly reinforced column, this was the worst affected element of the 26 columns. The structure as a whole performed appreciably better than the porte cochere referred to above, despite having similar mass to span ratios and equally inadequate transverse reinforcement. The beneficial effect of the improved redundancy of a multi-member system, even if responding in a undesirable mode, is again illustrated.

*Figure 6 Inarajan High School - base of column supporting gymnasium roof*

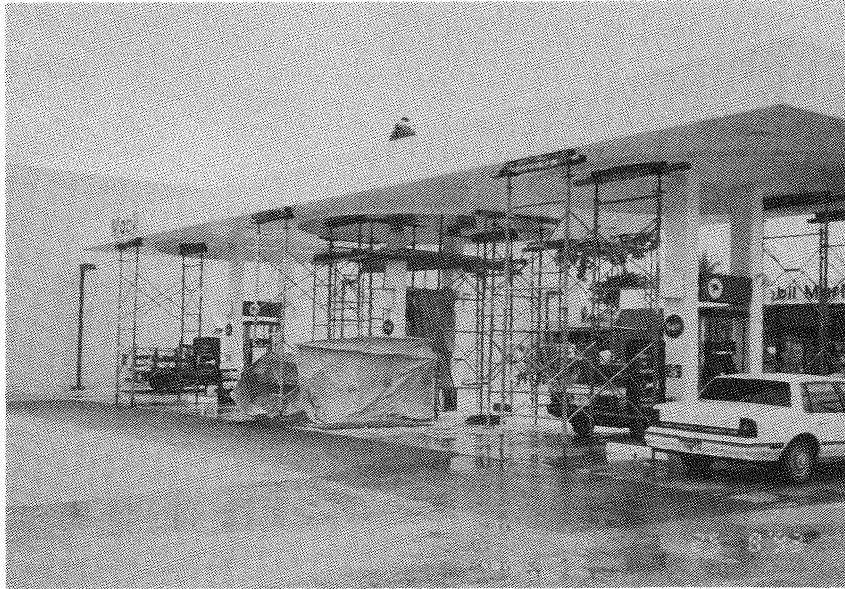
Back analysis of the canopy shown in Figure 7 indicated a period of approximately two seconds, which is broadly consistent with the taller of the high-rise buildings that sustained damage.

*Figure 7 Concrete canopy to service station*

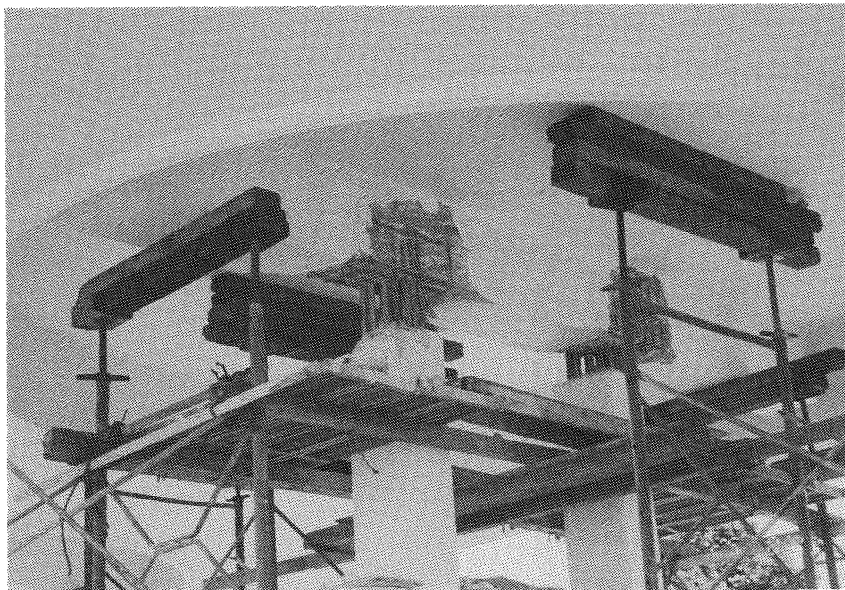
freestanding columns, significant degradation of concrete at the tops and bottoms of columns was observed. In only one case however did such a canopy collapse; it was a large porte cochere supported by four circular columns which reportedly had a clearly inadequate level of transverse reinforcement.

*Figure 8 Crushed concrete removed from tops of columns supporting the concrete canopy*

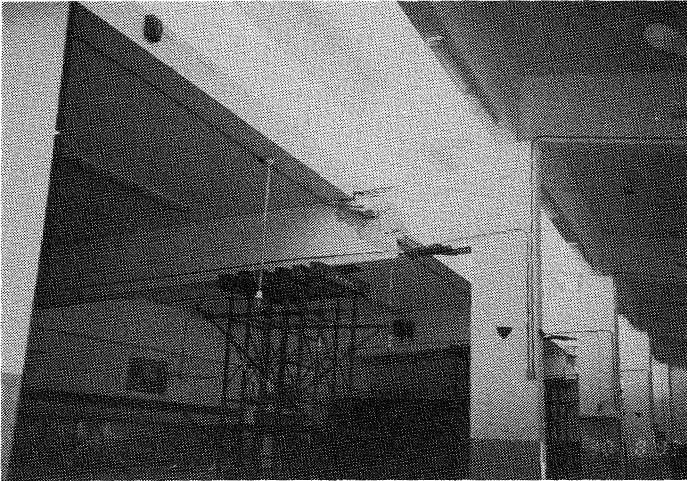
This configuration is shown in Figure 9, along with the damage that occurred to the beams due to the out-of-plane movement. There was no structure linking the two diaphragms other than the minor axis of the roof beams, and the significantly different periods of the two sections generated appreciable forces at this interface.

*Figure 9*     *Damage to beams at junction of discontinuous diaphragms to grandstand roof, Greyhound racing track*

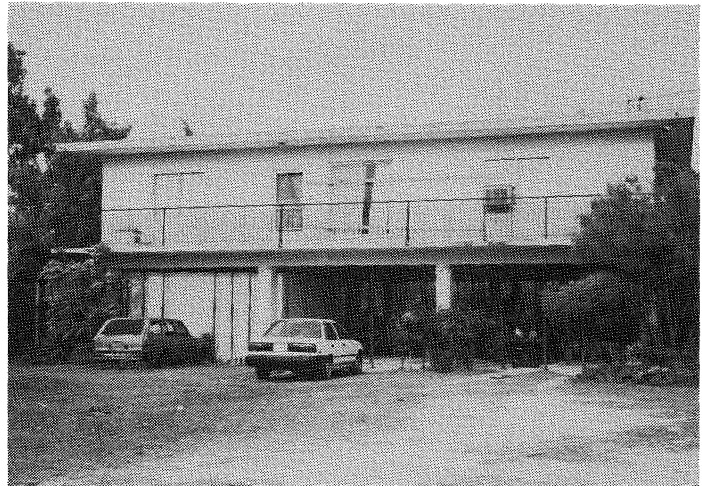
There was only one house viewed that had suffered major structural damage. This two storey house was supported

*Figure 10*     *House on free-standing columns*

on free-standing 350mm square columns with no bracing in the lower level, which is in marked contrast to the typical method of construction outlined above.

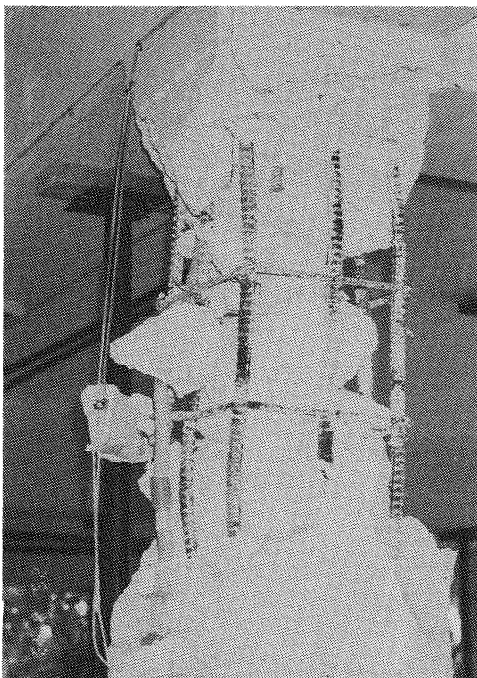
*Figure 11*     *Hinging of tops of columns to house on free-standing columns*

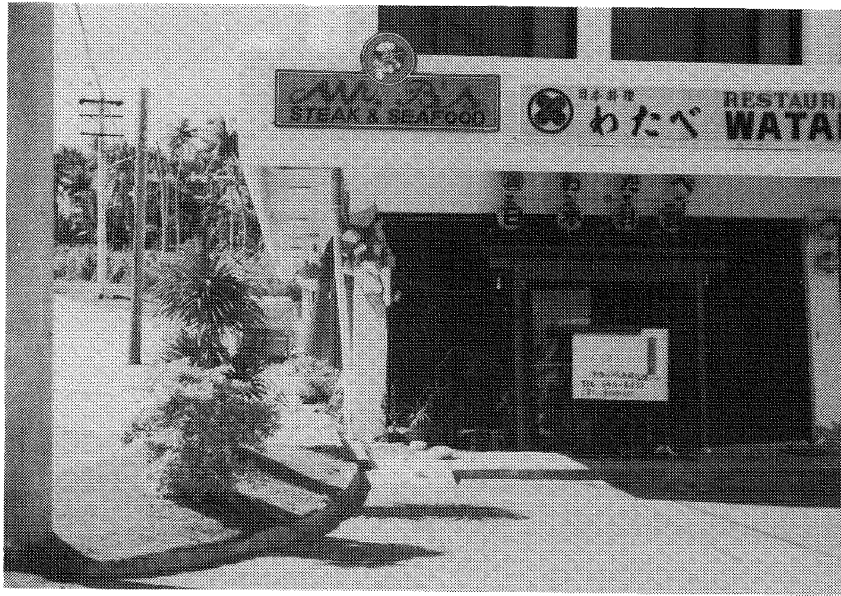
Figure 12 Front of Grand Hotel showing soft storey effects

A four-storey hotel building of 1970's vintage appeared to suffer from a ground floor soft-storey failure mechanism due to a combination of poor detailing and highly eccentric layout, and is to be demolished (refer Figure 12).

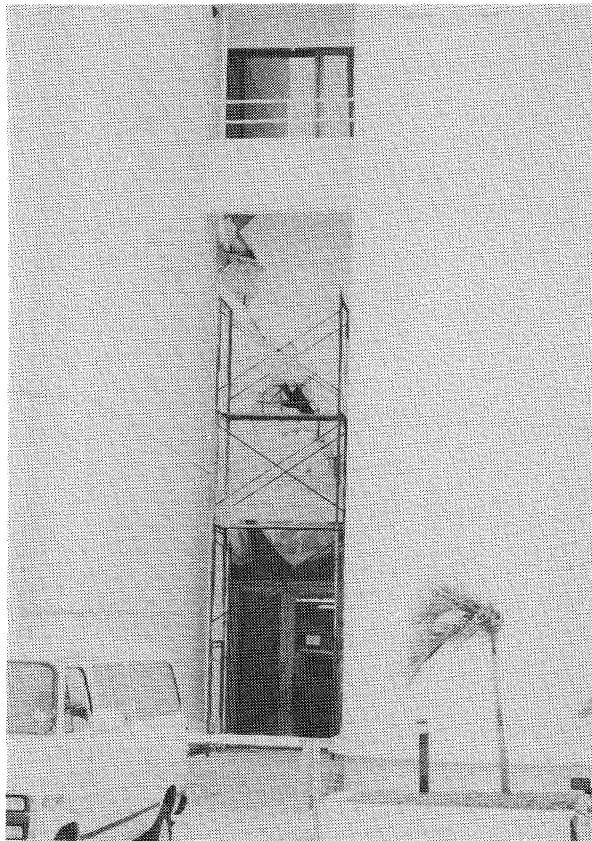
Figure 13 Severe cracking to coupling beams of Pacific Star Hotel

Cracking, and in at least two cases failure, of coupling beams between structural walls was another common damage characteristic in high-rise buildings. Two such examples are shown in Figures 13 and 14, and are taken from buildings

that are less than five years old. In both cases, it is interesting to consider what remedial measures would be most appropriate, given that both of the buildings suffered relatively minor damage otherwise.

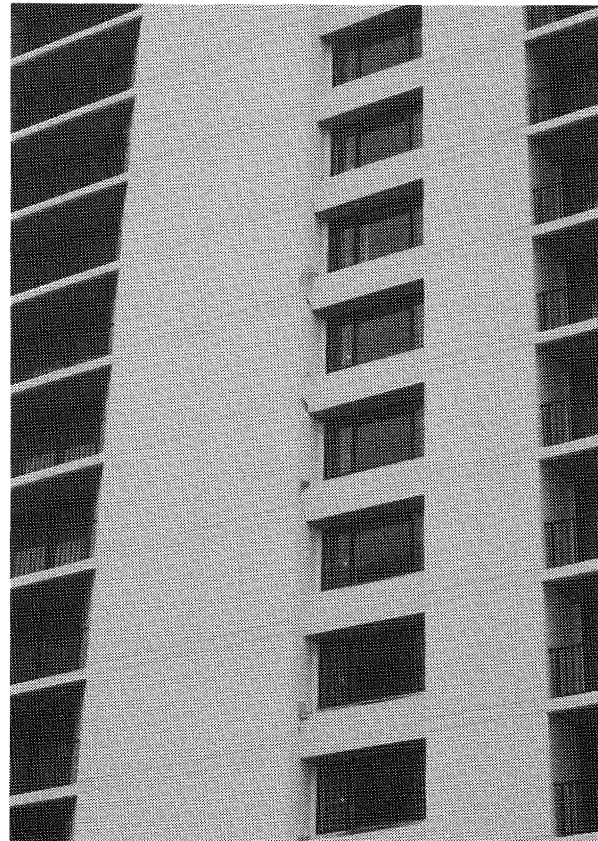
Figure 14 Minor cracking to coupling beams of the Guam Reef Hotel

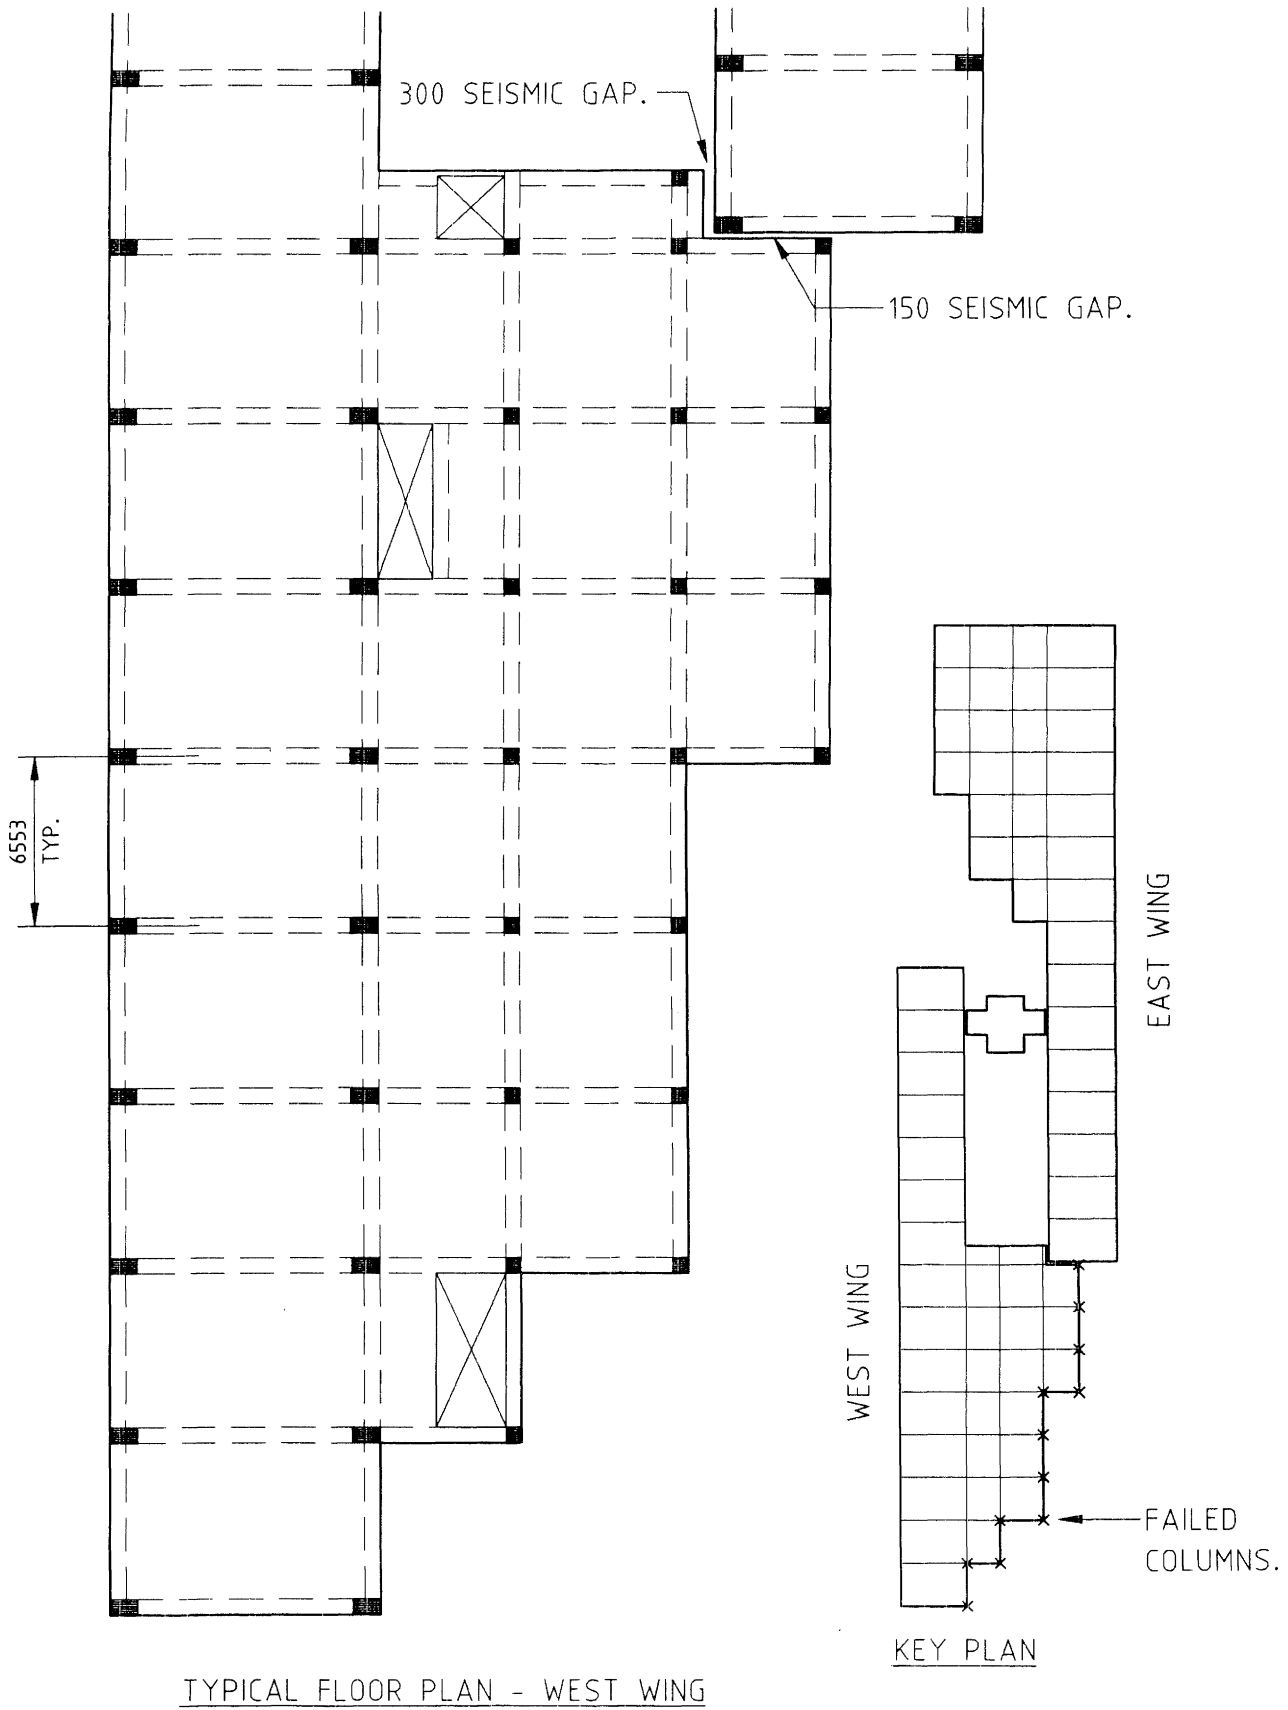
Figure 15 Plan of Royal Palm Hotel

The layout of this recently completed twelve storey moment-resisting frame building is shown in Figures 15 and 16, along with the location of columns that had failed under seismic action in the transverse direction. Inspection of the building was restricted to a brief viewing of the exterior only, and so only those columns that were observed as having failed are marked in the accompanying figures. However subsequent investigations by engineers involved in preparing the building for demolition have revealed that in excess of twenty columns on the south side have failed to varying degrees.

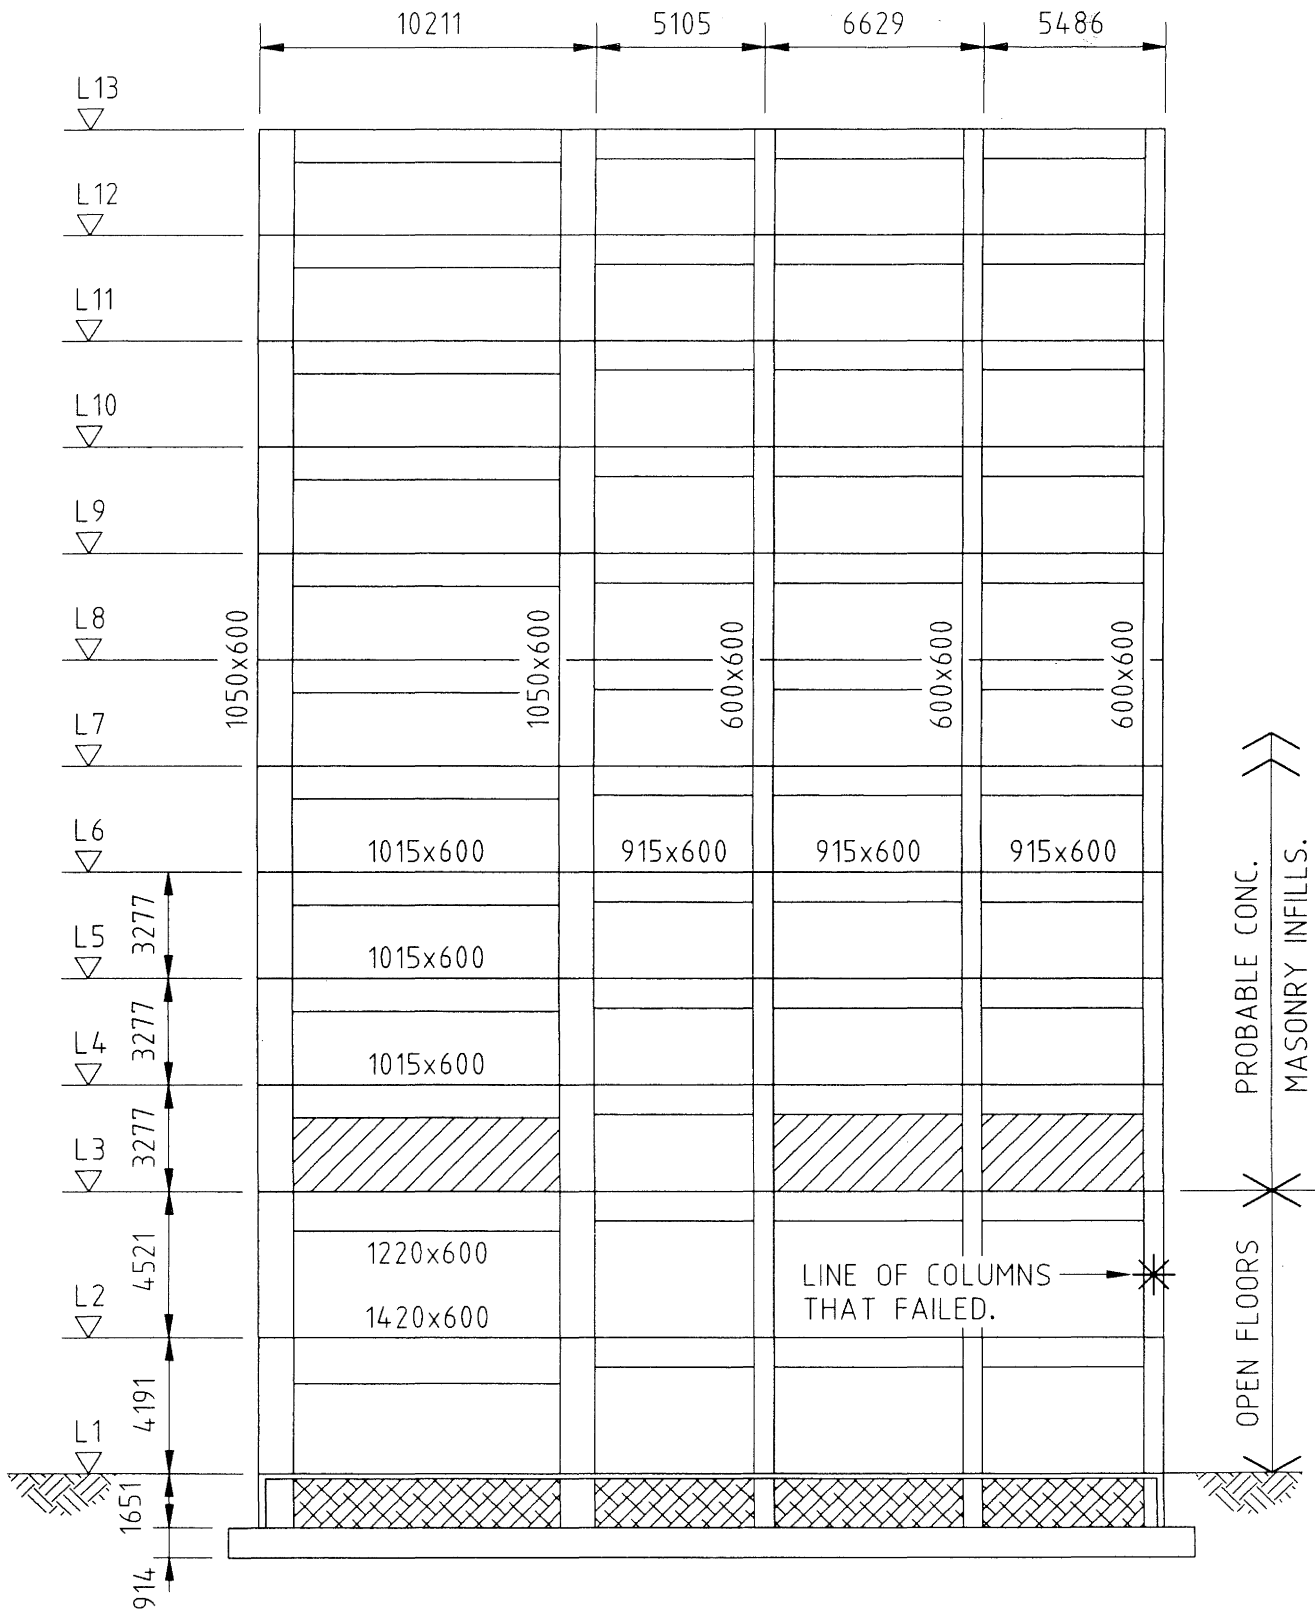
Figure 16 Elevation of typical frame, Royal Palm Hotel

Back analysis of the typical frame shown in Figure 16 indicated that there was no obvious inadequacy in the design. Relatively moderate levels of axial load were calculated to be induced in the columns that failed, even under lateral forces approaching that of the wind load case. There appears to be less transverse reinforcement in the end regions of the 600 mm x 600 mm columns than required by the UBC, and less than would be required by the New Zealand Concrete Code, NZS 3101. However, the transverse reinforcement in the mid-height regions, where failure appears to have initiated, is in accordance with the less onerous provisions for these regions of both the UBC and NZS 3101.

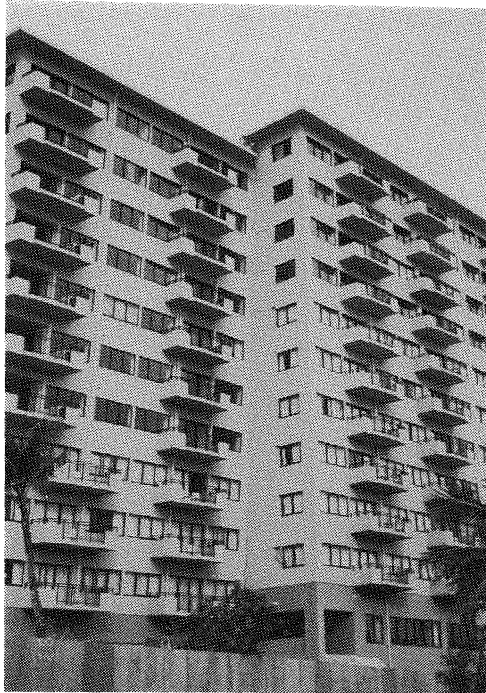
Figures 17 to 21 contain photographs showing the nature of the resulting damage. The overall displacement of the top of the west wing was of the order of 2.4m.

Figure 17    *Damage to west wing, Royal Palm Hotel*

Both wings were demolished in December. The less damaged east wing was demolished as a consequence of both the loads imposed by the west wing bearing against it and remaining concerns about the design and construction integrity of it.

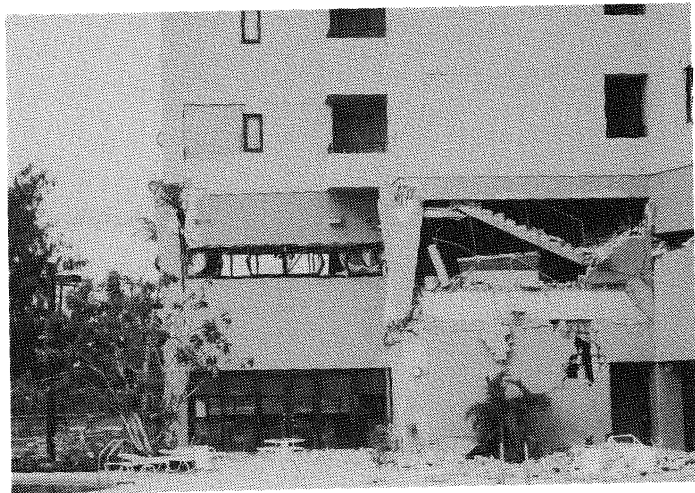
Figure 18    *Damage to west wing, Royal Palm Hotel*

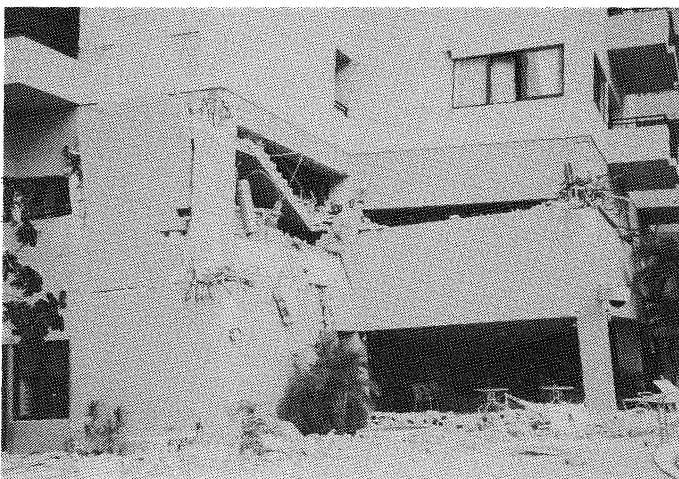
Figure 19    *Damage to west wing, Royal Palm Hotel*

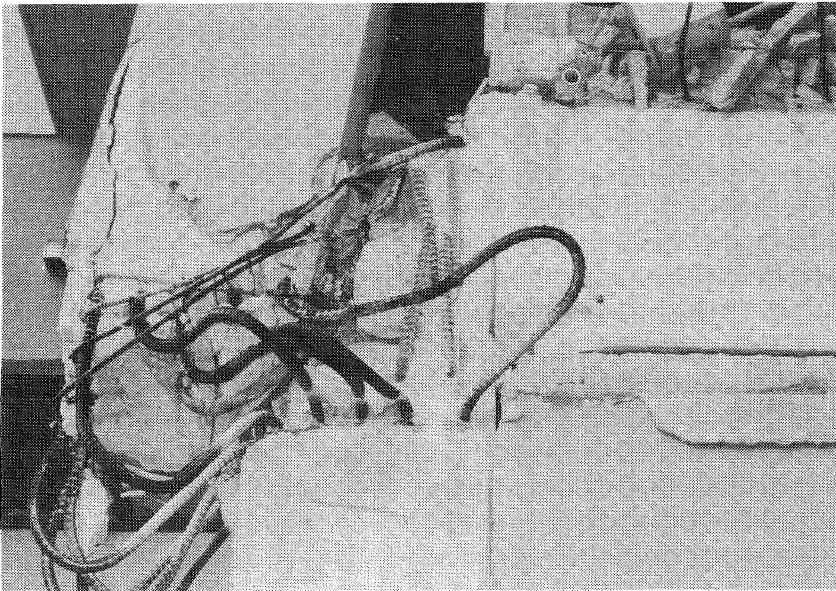
Whether all of this reinforcement was present in the columns is however less certain. The joint illustrated in Figure 20 and the middle region of the column shown in Figure 21 would appear to suggest otherwise.

*Figure 20*    *Damage to west wing, Royal Palm Hotel*

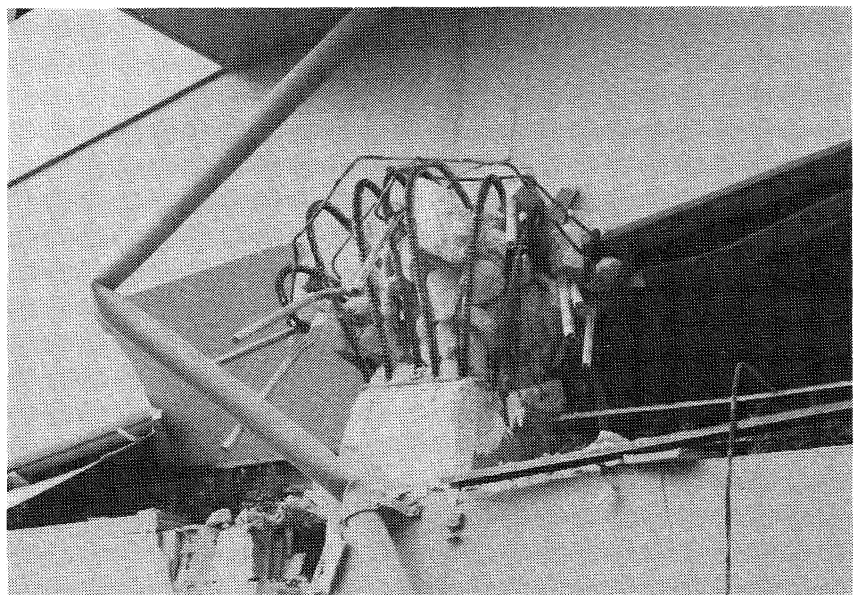
*Figure 21*    *Damage to west wing, Royal Palm Hotel*

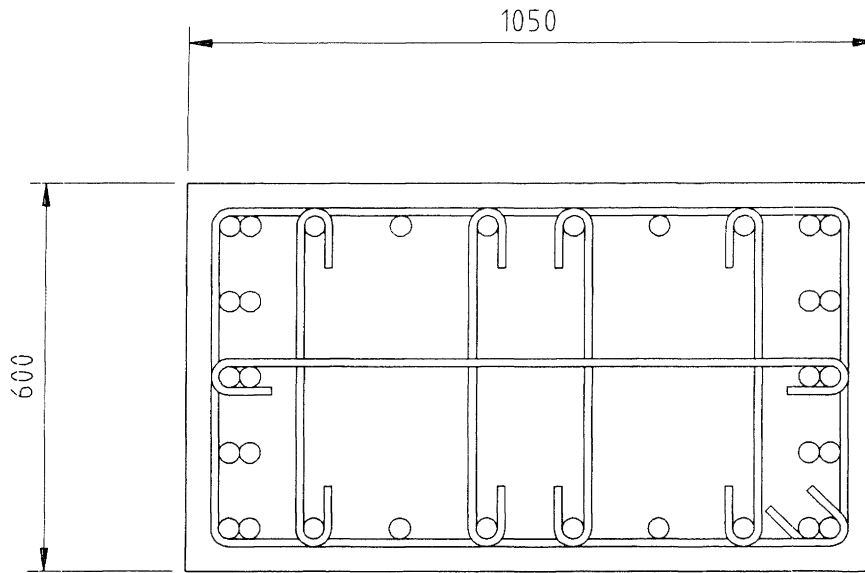
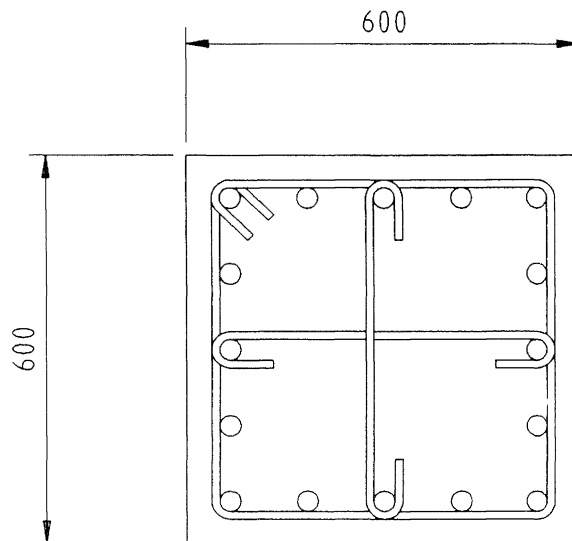
Figure 22 Reinforcement details for columns, Royal Palm Hotel

Structural drawings of the hotel were inspected, and dimensions of one of the failed frames are reproduced in Figure 16. Reinforcement details for two of the most common column types are shown in Figure 22.

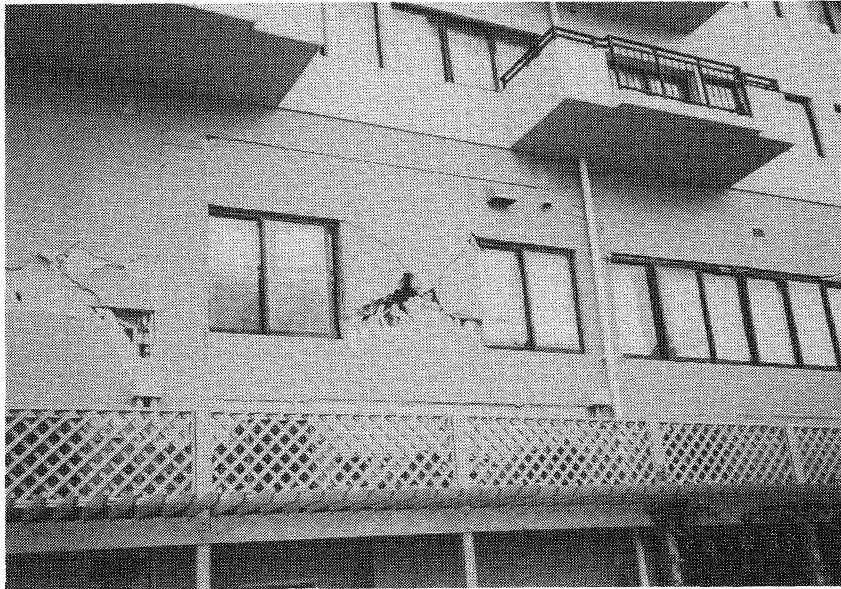
Figure 23 Damage to masonry infill panels, Royal Palm Hotel

Typical damage sustained by the non-structural masonry panels of both wings of this building are shown in Figures 23 and 24. The cracking shown in Figure 23 resulted from movement in the longitudinal direction, which in combination with the failure of the west wing due to transverse actions, illustrates the different directions of earthquake attack experienced by buildings on the island.

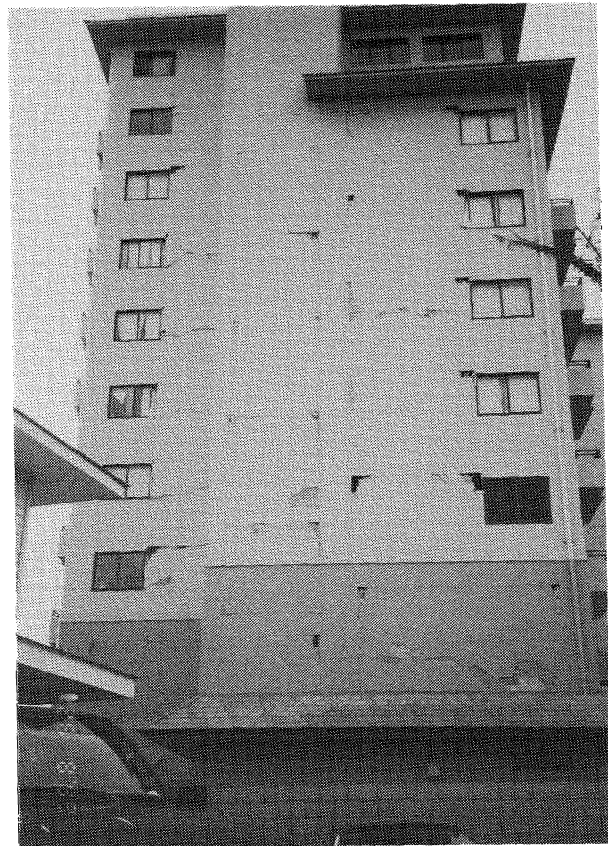
Figure 24 shows the damage to the east wall of the east wing. This type of cracking to block infill panels can be considered typical of what might occur in frame structures with inadequate separations in New Zealand in a serviceability limit state earthquake. The cost of repairing and reinstating this type of damage is not inconsiderable, particularly when due regard is given to the effect on interior finishes and fittings.

Figure 24 Damage to masonry infill panels, Royal Palm Hotel

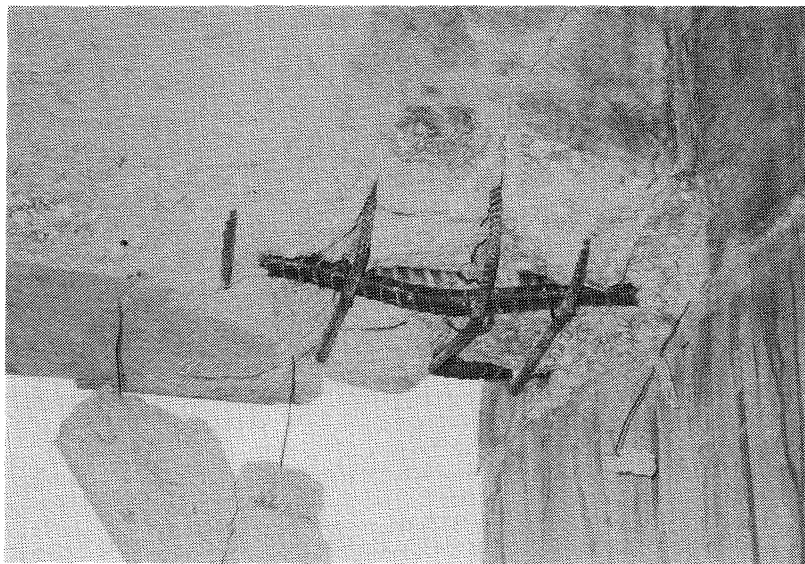
While there were few signs of movement in the main (lower) structure, the core framing had clearly been excited by the earthquake. Figure 27 shows compression bar buckling that occurred in one of the beams one level above the last full floor. Similar signs of yielding were in evidence at other locations on this level, as illustrated in Figure 28.

Figure 27 *Yielding in beam, Holiday Inn Hotel*

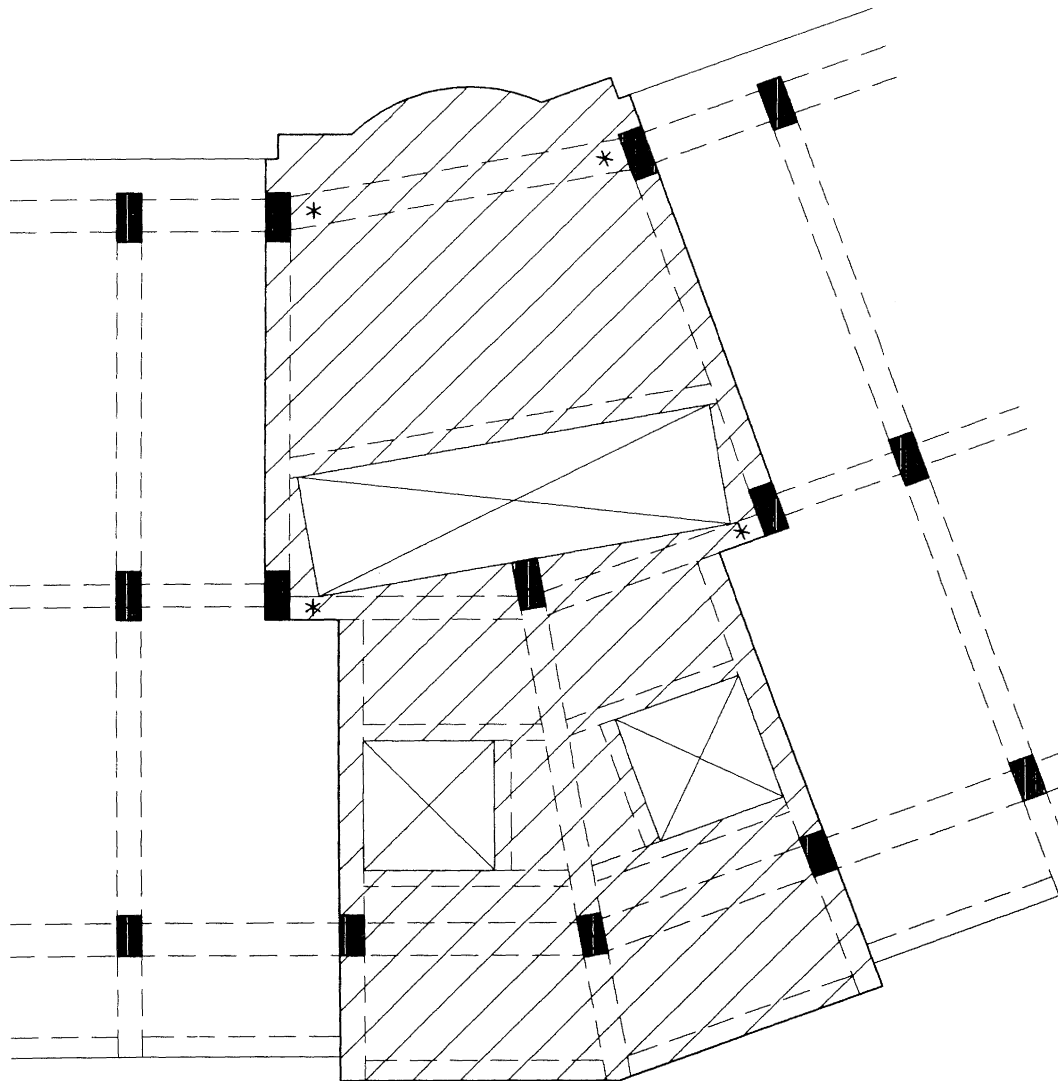
\* DENOTES LOCATIONS WHERE  
YIELDING OF BEAMS OCCURRED.
