BUILDING TYPOLOGIES AND FAILURE MODES OBSERVED IN THE 2015 GORKHA (NEPAL) EARTHQUAKE

**Dmytro Dizhur^{1,2}, Rajesh P. Dhakal³, Jitendra Bothara⁴ and
Jason M. Ingham⁵**

ABSTRACT

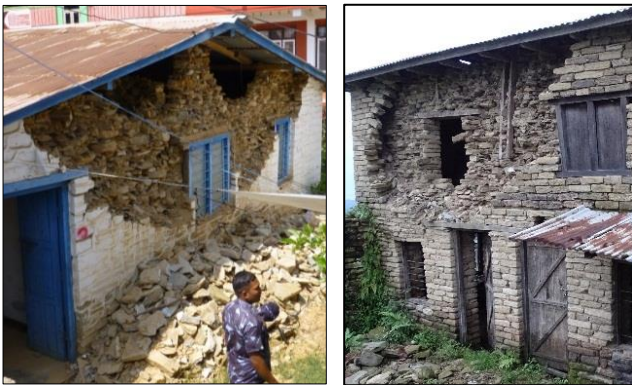
Figure 10: Examples of observed delamination of external stone leaf (provided latitude and longitude coordinates are in the WGS84 standard format).

Wall delamination: Use of weak mud mortars and poorly integrated multi-leaf stone walls frequently led to delamination of wall cross-sections and potential collapse of buildings (see Figure 10).

(a) Stone masonry building in Chautara
 27° 46' 38.48" N 85° 42' 22.91" E
 (b) Stone masonry building in rural area
 28° 12' 31.84" N 84° 4' 52.33" E

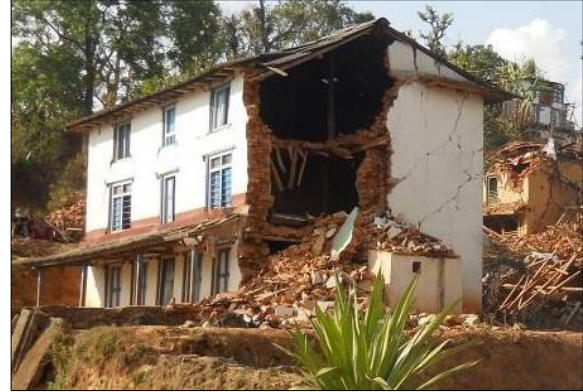
(a) Traditional stone masonry building with in-plane and corner damage

Figure 11: Corner damage to unreinforced stone masonry buildings.

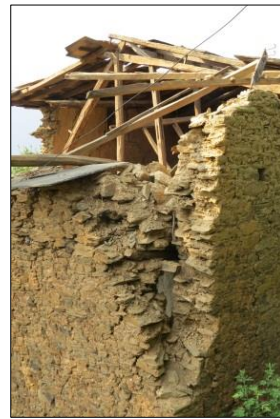
(b) Stone masonry building in Chautara

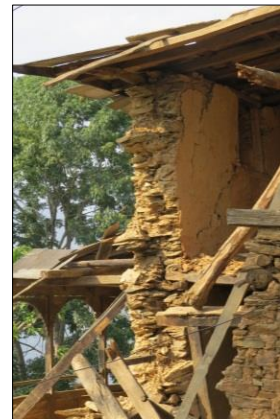
(c) Typical wall cross-section and OOP damage (Chautara)

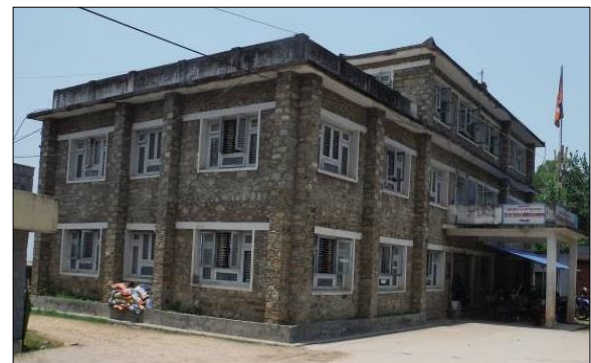
Figure 12: Unreinforced stone masonry building with cement mortar and RC floor and roof diaphragms (minor to no damage observed).

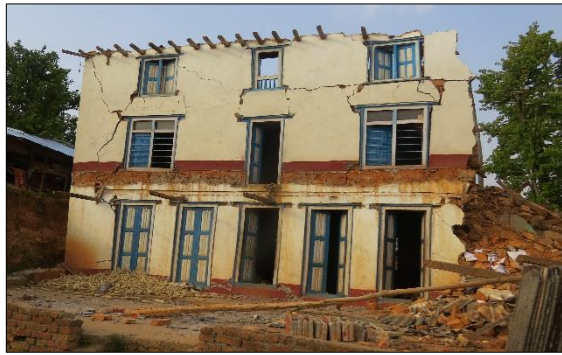
(a) Out-of-plane collapse and in-plane failures both in the piers and spandrels

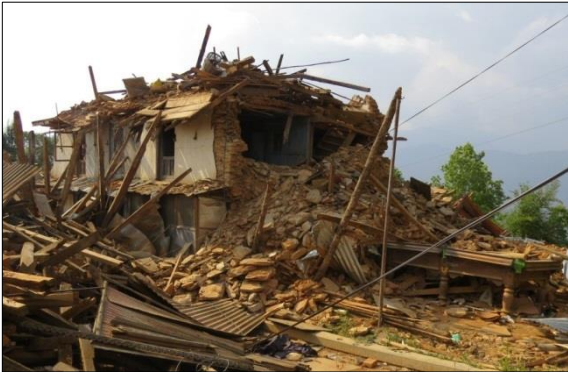
(b) Collapse due to poor quality of the masonry (Chautara)

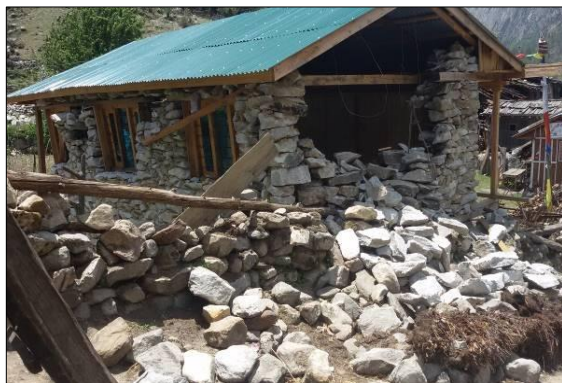
(c) Damaged dry stacked stone masonry building

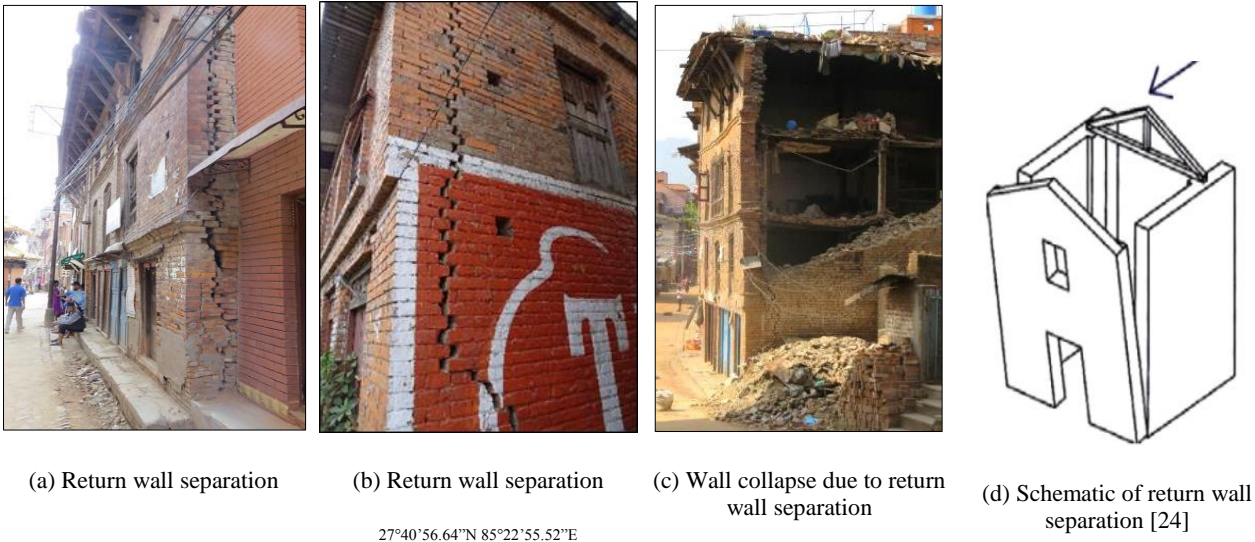
The failure mode involving separation of the front façade and return walls was commonly observed due to poor interconnection of return walls, as can be seen in the multiple examples shown in Figure 18. Façade overturning in buildings where corner connections were adequate are shown in Figure 19.

Figure 18: Observed example of return wall separation and overturning of the façade.

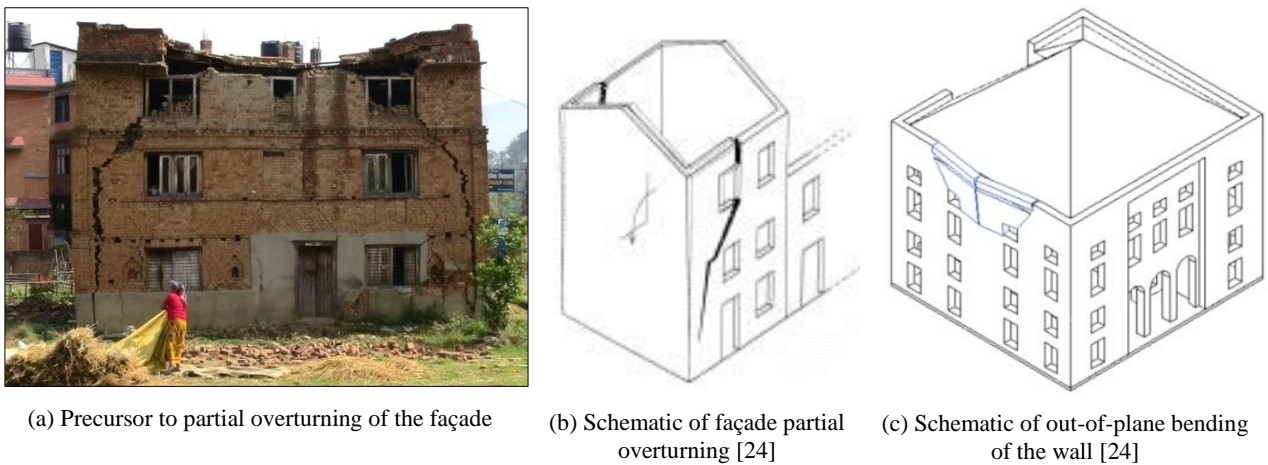
Figure 19: Example of initiation of overturning of façades where return wall separation occurred through wall penetrations adjacent to building corners.

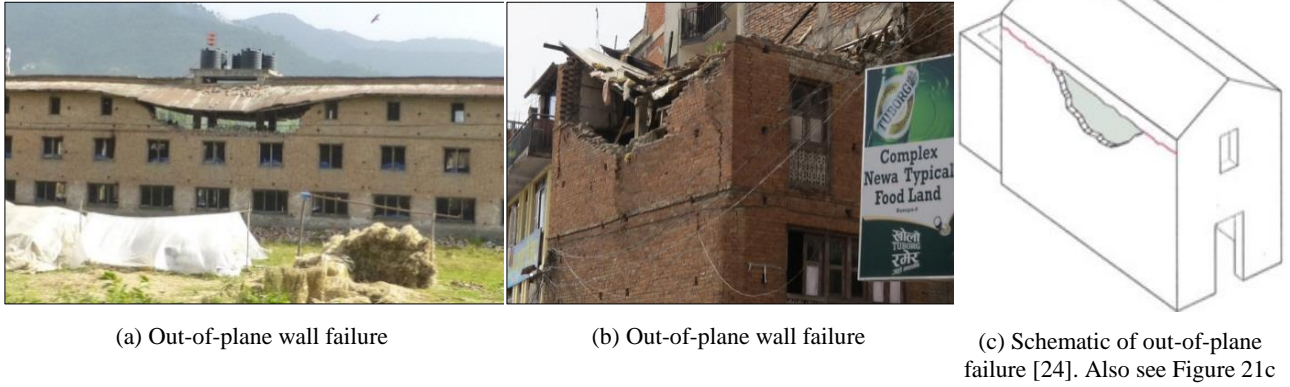
Out-of-plane wall failures due to roof diaphragm flexibility were also observed and are shown in Figure 19 and Figure 20.

Figure 20: Out-of-plane wall failure due to roof diaphragm flexibility and three-sided boundary condition.

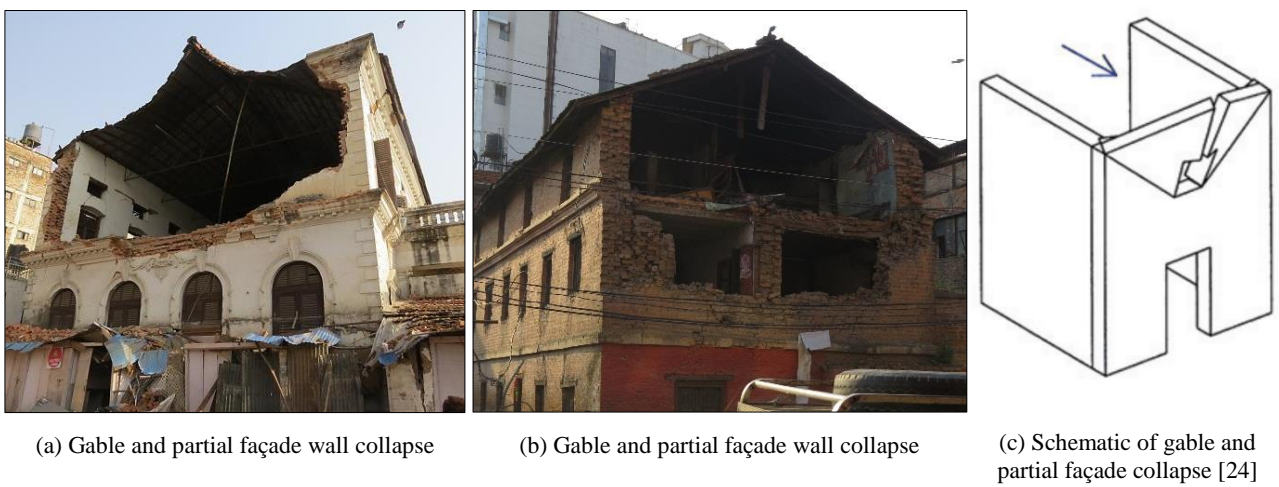
Schematics are provided to aid with visualisation of this type of failure mode. As observed in numerous other earthquakes, out-of-plane collapse of the gable end walls was widely observed throughout Kathmandu Valley (see Figure 21).

Figure 21: Out-of-plane collapse of gable end walls.

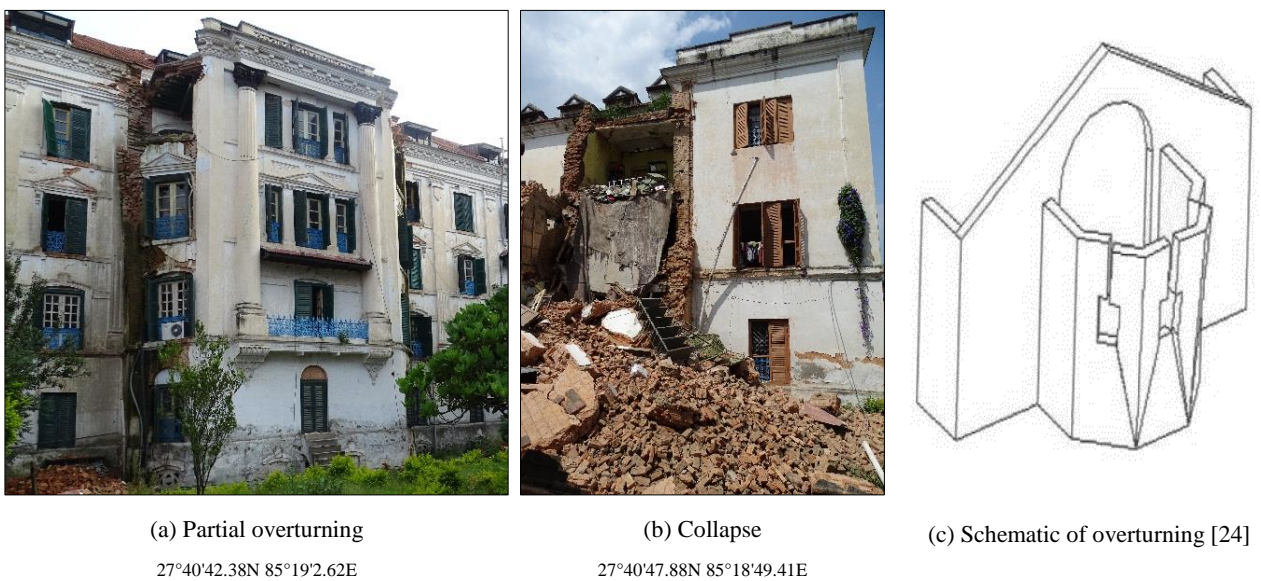
Overturning of the building plan protrusions was observed in some of the historic Palace type URM buildings (see Figure 22), similar to damage that was observed and categorised in Italian [27] and New Zealand [25] churches following recent earthquakes. Due to building plan irregularity the protrusions typically sustained more damage than the rest of the building, in some cases leading to full collapse of the building protrusions as shown in Figure 22b.

Figure 22: Overturning of the building plan protrusions.

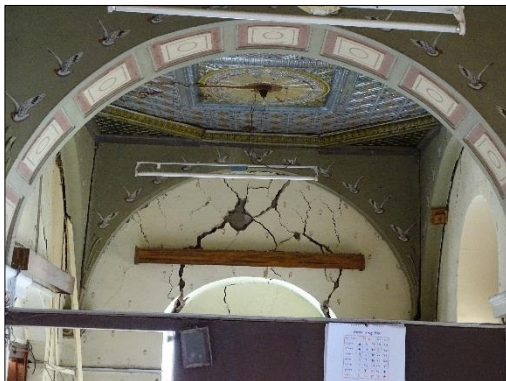
Significant in-plane damage to arches found in Victorian style Palace-type URM buildings was observed, as shown in Figure 24. In most cases the middle portion of the arch remained in place but appeared to be in a near-collapse state.

(a) Significant damage to arch

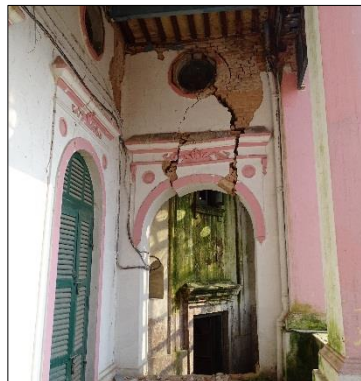
(b) Significant damage to arch

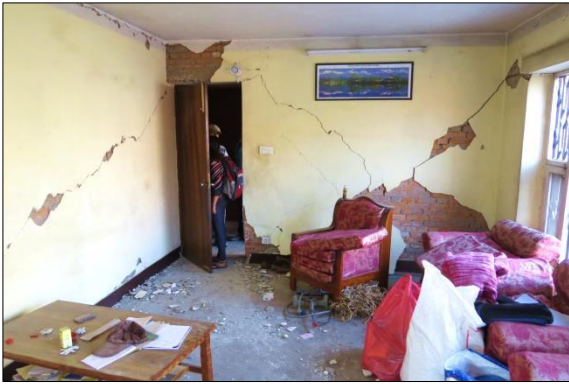
Diagonal shear cracking was observed in piers, spandrels and internal walls. Figure 25 shows shear cracking in internal walls and in piers respectively, while Figure 26 shows severe near-collapse shear failure of a clay brick external pier in a building with rigid RC floor diaphragms. In Figure 27, compression of piers and minor evidence of toe crushing is shown for a three storey URM building with RC floor and roof diaphragms. This particular building showed evidence of highly torsional response with pier compression failures occurring at the external corner piers.

(a) Diagonal shear cracking observed in internal loadbearing walls

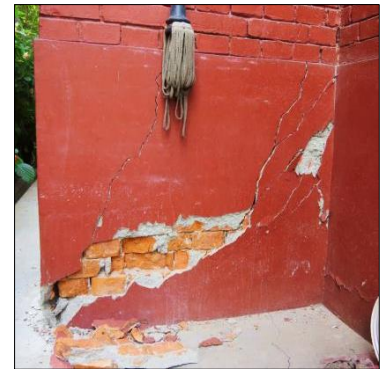
(c) Signs of toe crushing at external building corner

Figure 27: Compression damage of corner piers.

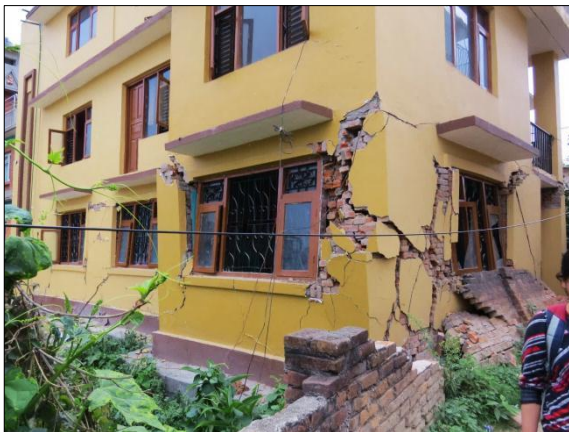
(a) Severe diagonal shear cracking of piers

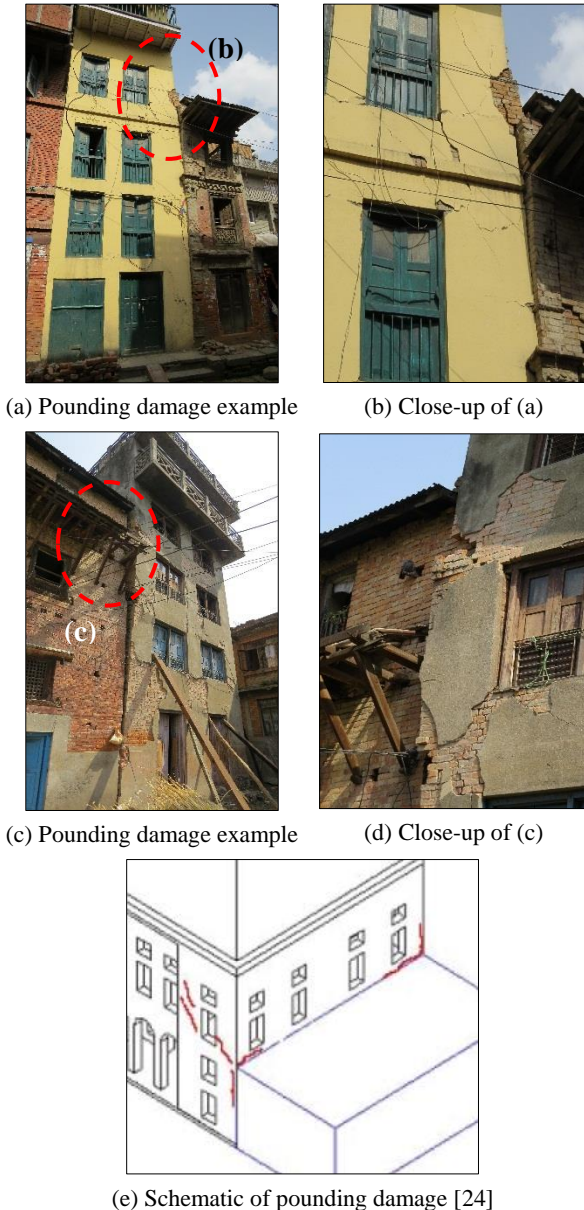
Pounding damage was observed in densely populated areas where rows of buildings with varying heights and lack of seismic separation gaps were located. Pounding induced lateral forces at the contact points that resulted in localised heavy in-plane damage of loadbearing URM piers, as shown in Figure 29, which led to a state of near collapse for many buildings [see 32].

Figure 29: Observed damage due to pounding.

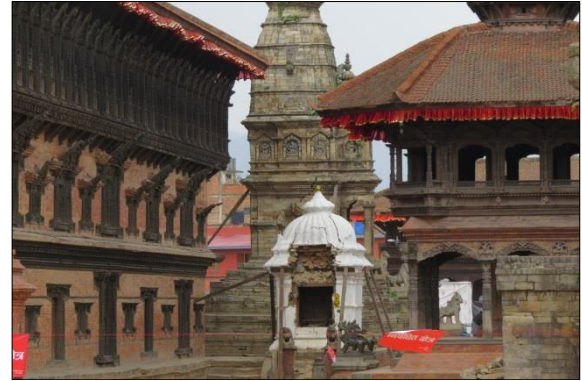
(a) Partial collapse of a small temple tower, with remaining buildings standing but with some damage

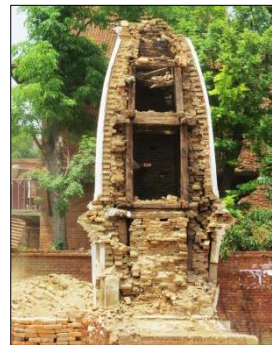
(b) Partial collapse of temple tower exposing the wall cross-section and internal construction

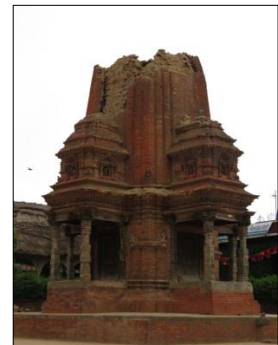
(c) Partially collapsed red-clay brick temple

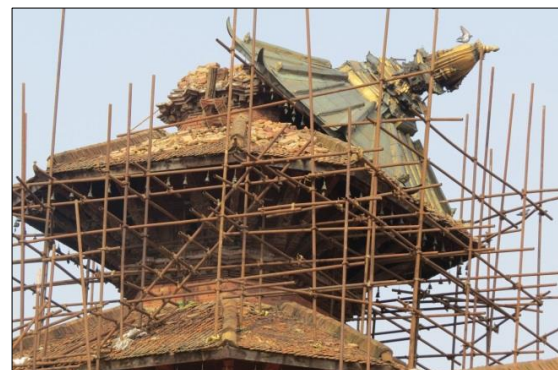
(a) Collapse of top portion of a Pagoda type temple

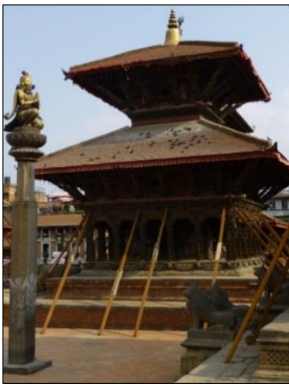
(a) Damage to smaller Pagoda temples with temporary propping to reduce further damage during aftershocks

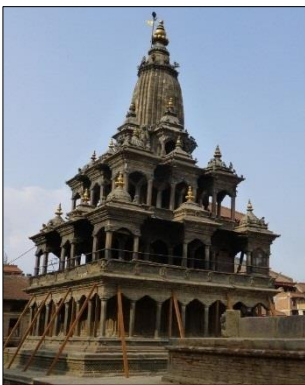
(a) Minor damage in masonry temple

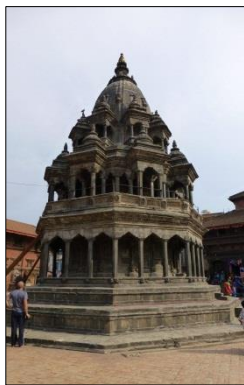
(b) Minor damage in octagonal temple built in 1637-47

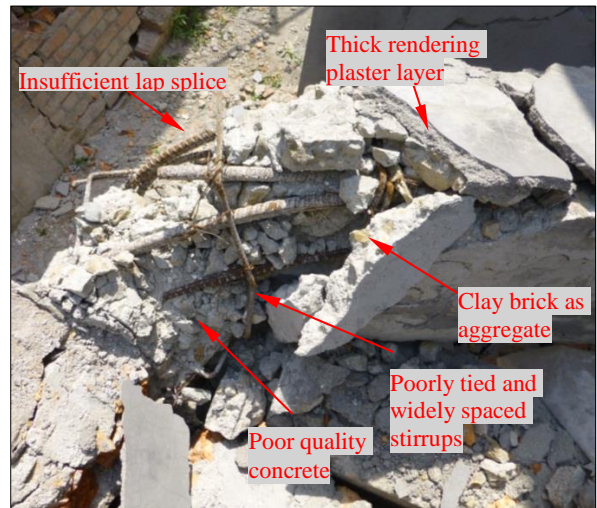
(c) Column of a collapsed RC building

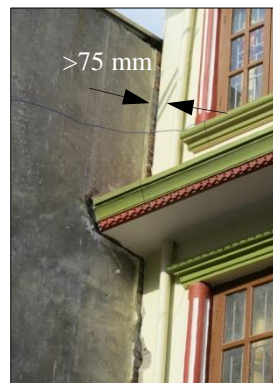
In some parts of Kathmandu Valley widespread differential settlement of buildings was observed (see Figure 39). Many observed cases were related to poor ground performance under earthquake conditions and the use of non-engineered foundations.

(a) Differential movement due to foundation rotation

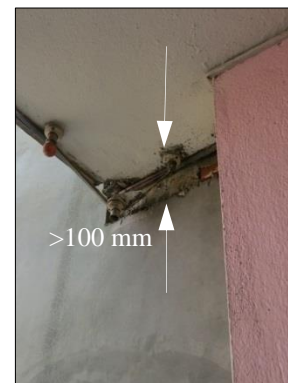
(b) Vertical differential movement due to settlement

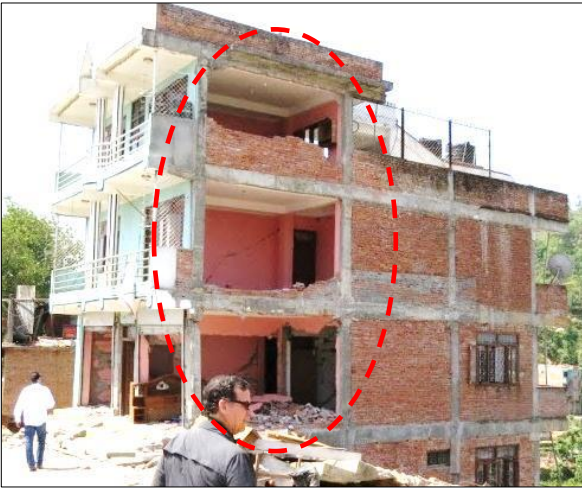
Figure 40: Out-of-plane collapse of the infill masonry walls.

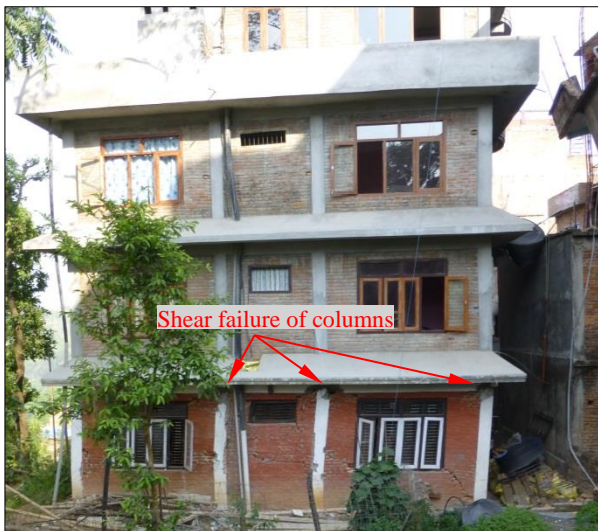
Figure 41: In-plane damage to masonry infills and significant shear failure of RC columns due to 'short-column' effect.

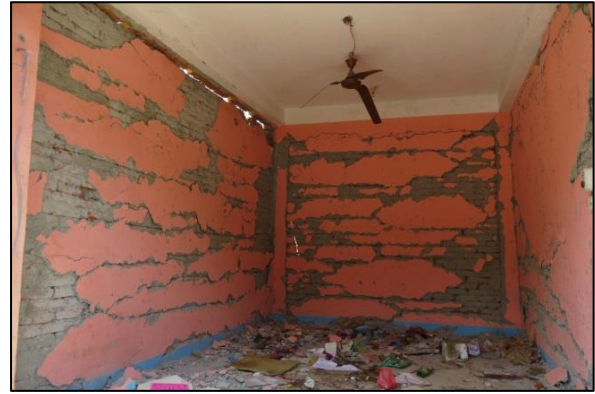
(a) Significant sliding along mortar joints and bed joint shear failures of infill masonry walls

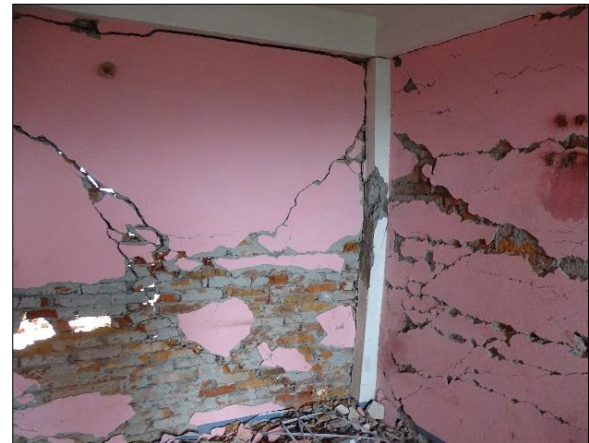
In areas where strong ground shaking occurred (i.e. Chautara near aftershock epicentre), multiple cases of significant shear dilation of infill walls was observed which led to further damage to the gravity loadbearing columns (see Figure 42b-c).

(b) Significant shear dilation of infill walls leading to damage of gravity loadbearing columns

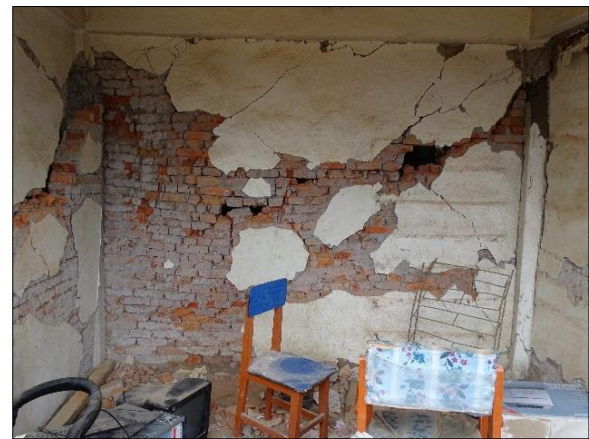
(c) Severe shear dilation of infill walls leading to failure of gravity load supporting columns

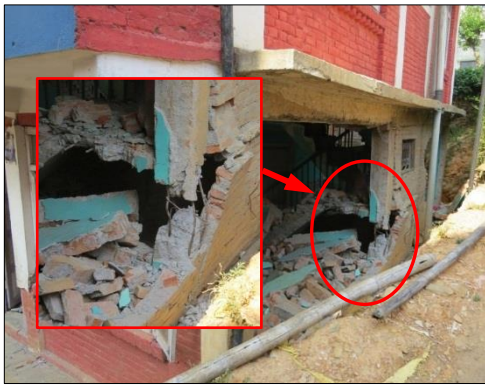
(a) Severe damage to loadbearing column in four storey building due to a staircase

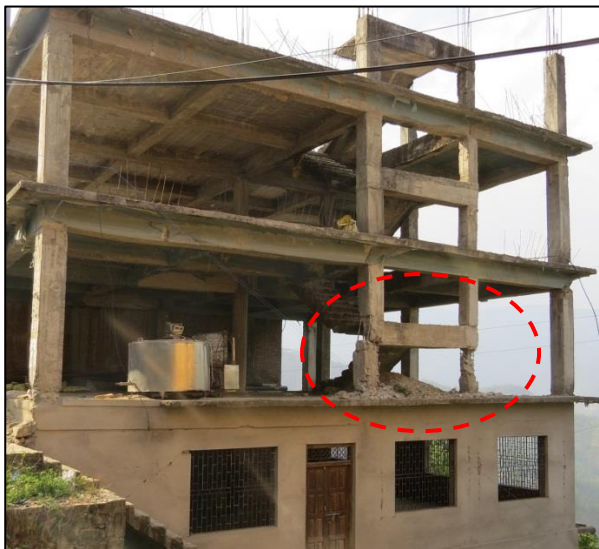
(b) Column shear failure due to stairway landing connection at column mid-height

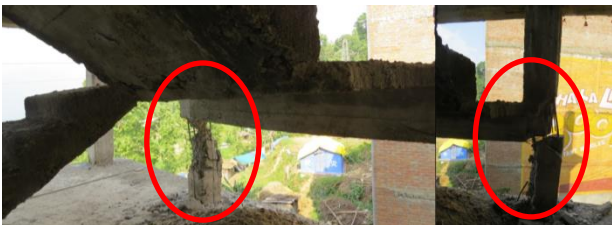
(c) Close-up of b, shear failure of columns

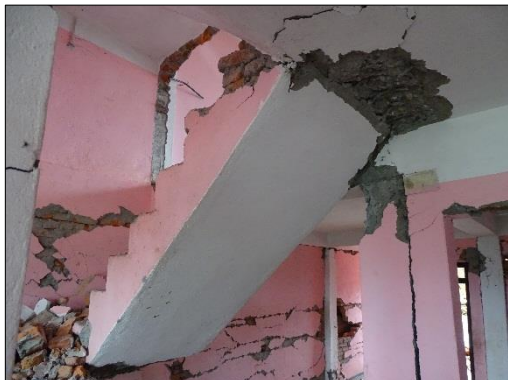
(d) Damage due to a rigid staircase

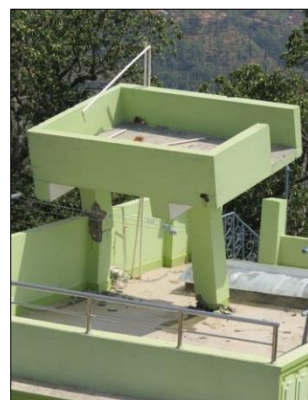
Due to amplification effects up the building height and the slender heavy cantilevered mass atop of roofs, water tank supports suffered extensive and widespread severe damage, and in some cases collapsed (see Figure 45).

(a) Plastic hinging of cantilevered RC support columns

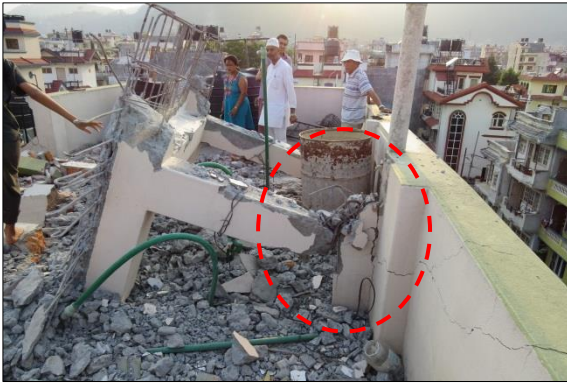
(c) Collapse of cantilevered RC support platform

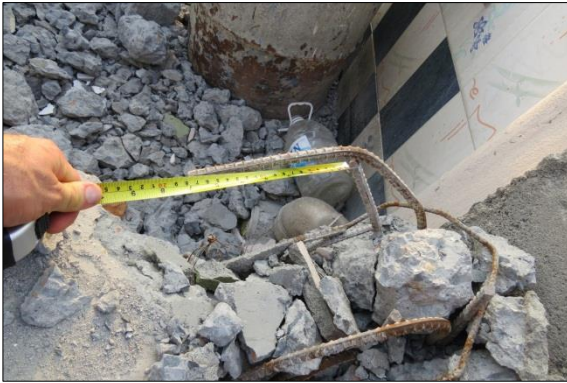
(d) Insufficient lap splice (close-up of c)

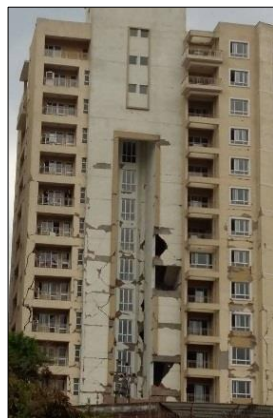
(b) Severe damage to lower floor infill walls in a multi-storey RC frame residential building

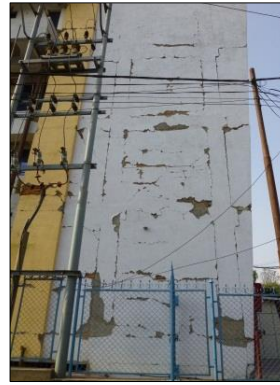
(c) Visible damage and cracking through plaster layer in masonry frame building with masonry infill walls, exposing RC frame
