THE TONGA EARTHQUAKE OF 23 JUNE, 1977

SOME INITIAL OBSERVATIONS

M. D. Campbell*, G. R. McKay*, R. L. Williams**

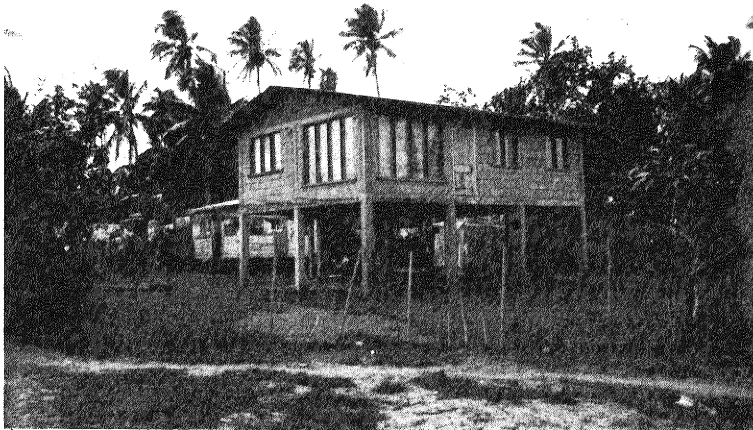
It was apparent that the ground shaking was not exceptionally severe as statues in the Royal cemetery shifted but were not toppled and numerous buildings on long piles (precast or in-situ concrete supports above the ground for domestic dwellings - fig. 2) and underground services were undamaged except in the area of the mud flats. There was no reported slipping of natural slopes but permanent ground movement occurred on filled ground, notably at Vuna Wharf, Queen Salote Wharf and around the lagoon. The fairly extensive structural damage must therefore be attributed to lack of any building codes, standards or permit requirements.

FIGURE 2: HOUSE ON LONG PILES

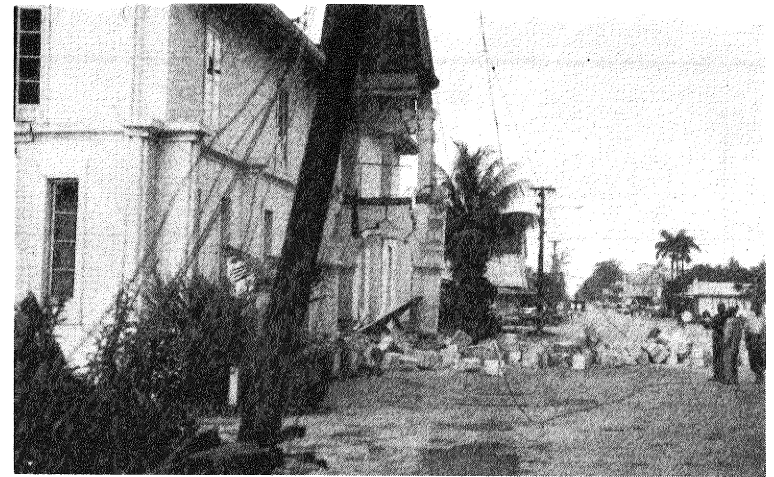
Buildings without bond beams, and particularly those made of solid coral block with little mortar e.g. Prime Minister's building, Fig. 3, and St. John's College chapel exhibited severe vertical cracking as the various parts moved in different directions. Towers on churches moving out of phase with the main building generally caused separation, with some cracking up to 75mm wide or failure of the tower, fig. 25,

FIGURE 3: PRIME MINISTER'S BUILDING, NUKU'ALOFA. NOTE POWER LINES.

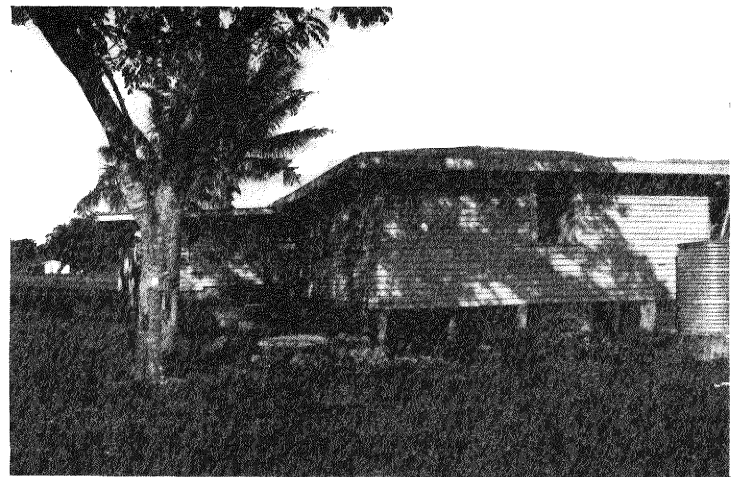
Approximately half the houses are conventional weatherboard timber dwellings with the remainder being either traditional fales (see Fig. 15) or of concrete masonry block. Timber houses suffered little damage except for a few that fell off their "piles" (short timber or pre-cast concrete piers), figs. 4, 5. Timber is mainly imported and must be treated to resist decay and insect attack. Faes are framed from saplings and covered with coconut palms and, not unexpectedly, suffered little damage.

FIGURE 4: TIMBER HOUSE ON PRECAST PILES - SAVED BY CONCRETE STEPS

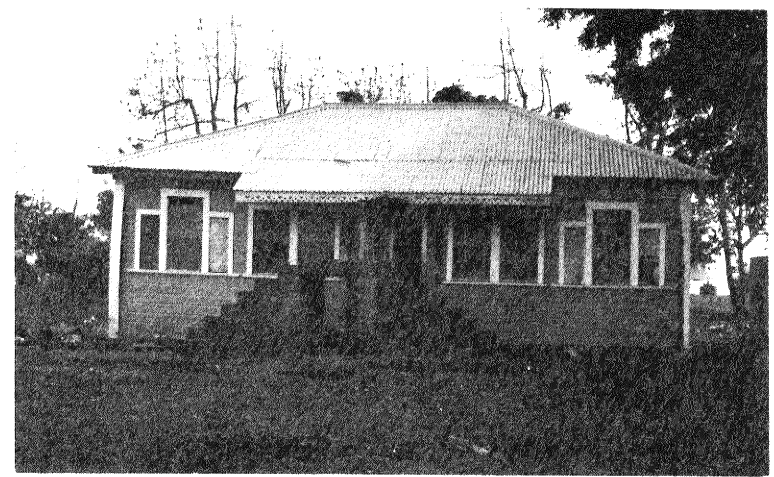
FIGURE 5: TIMBER HOUSE OFF PILES - FRONT STEPS NOW REDUNDANT

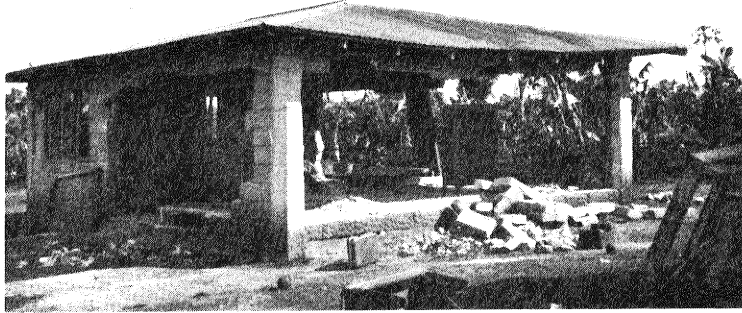
In recent years hollow blockwork has become very popular in Tonga, but the blocks are generally extremely weak, often only about 5 MPa. The use of knock-in, bond beam or other special blocks is virtually unknown. Blocks are usually 18" x 8" x 6" exclusive of mortar joint width but are also 4" and 9" thick. Mortar is variable in quality and tends to lack cohesion. Grout is usually mortar and placed as such. Consequently it is poorly compacted and fails to bond to the reinforcement (figs. 15, 16). Reinforcement is frequently poorly placed or missing altogether. Laps are often only a few inches long. The use of plain reinforcement instead of deformed compounds the poor bond characteristics of the grout (fig. 15). Joint reinforcement of the "blocklok" type is used on many government jobs and while it could not be considered to be reinforcement in the generally accepted sense of the word it appeared to have effectively acted as "basketing" and improved the performance and generally kept the walls intact. Walls of decorative screen-blocks using "blocklok" only suffered minor damage. In view of the poor construction procedures and materials for blockwork it has been recommended that except for work that is closely supervised reinforcing should not be placed in the cells of blocks but instead only in insitu structural elements, e.g. small columns, pilasters, beams, etc. and that where possible these elements be poured after and against the blockwork (see differences between figs. 6 and 7).

FIGURE 6: MASONRY HOUSE, 'EUA - RC CORNER COLUMNS PREVENTED ROOF COLLAPSE

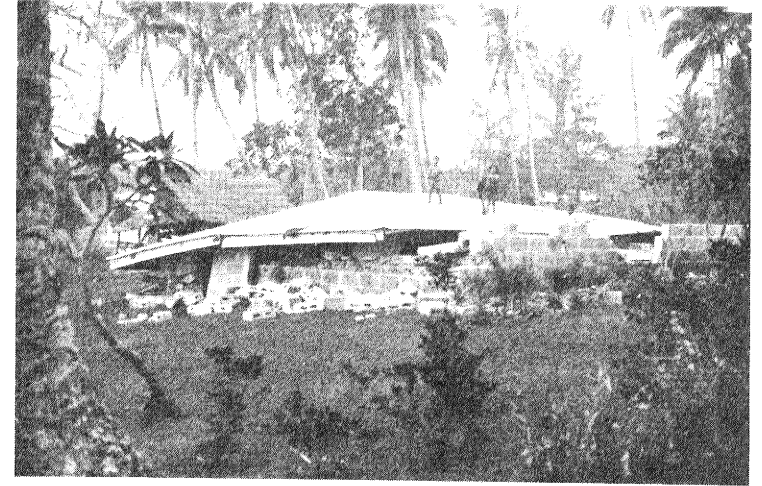
FIGURE 7: COMPLETE COLLAPSE OF MASONRY HOUSE, 'EUA

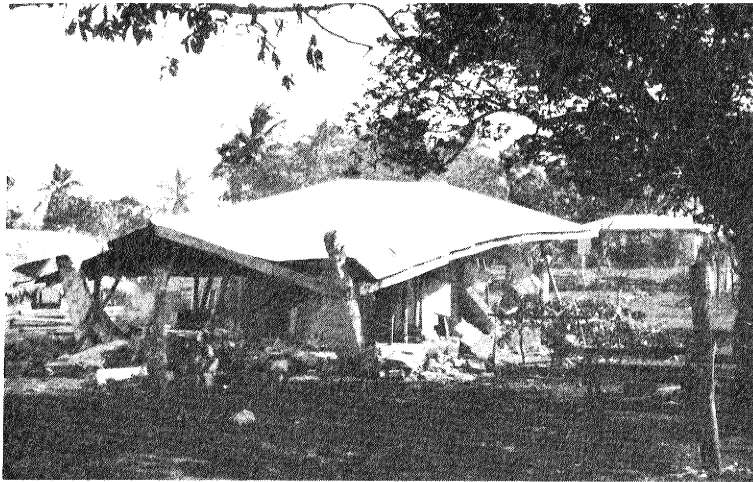
FIGURE 8: MASONRY HOUSE 'EUA - INTERNAL TIMBER PARTITIONS PREVENTED COMPLETE COLLAPSE

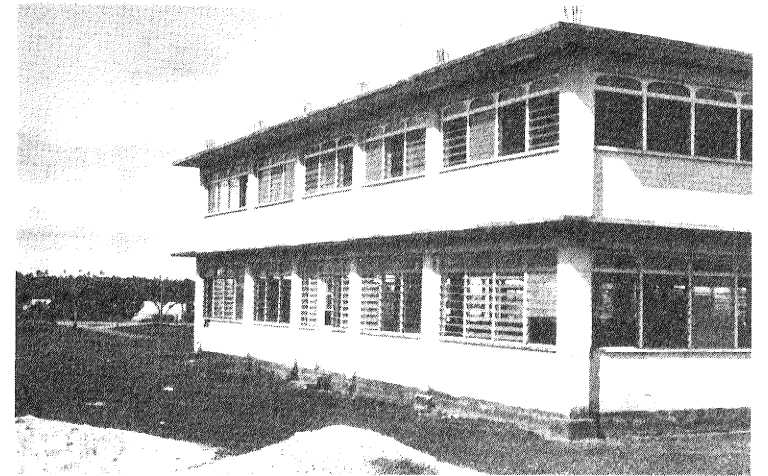
FIGURE 9: TAILULU COLLEGE, NUKU'ALOFA

There were very few reinforced concrete frame buildings which did not include at least a few block walls. However, one building without blockwalls, the Tailulu College used by 650 pupils, was damaged and left in a seriously weakened condition. This building is a two-way reinforced concrete frame eight bays by four bays each of 4.25m, being two storeys high with provision for a third storey (fig. 9). All ground floor columns showed severe cracking or spalling at the top and bottom of the windows (figs. 10, 11) and the structure was close to collapse during the earthquake. The failure mode of the 300 x 300mm columns was flexural due to the very light and poorly placed steel (fig. 12). The extent of movement was particularly apparent at the stairs which were extensively damaged where they joined the slabs but in this instance the diagonal bracing effect of these stairs was fortuitous and may well have saved the building. The recommended minimum strengthening provides for two infill concrete shear panels on each face of the building. In several other buildings the presence of non structural unreinforced blockwork or other rigid elements caused cracking away from the ends of the column (fig. 11) - a type of damage easily predicted by theoretical considerations, i.e. attracting seismic shears due to increase in frame stiffness and altered behaviour of the column itself. Examples of this cracking were also found at the Viola Hospital, the new Government Administration Building and a new classroom block at Queen Salote College. In a stronger earthquake this effect could have led to serious failures.

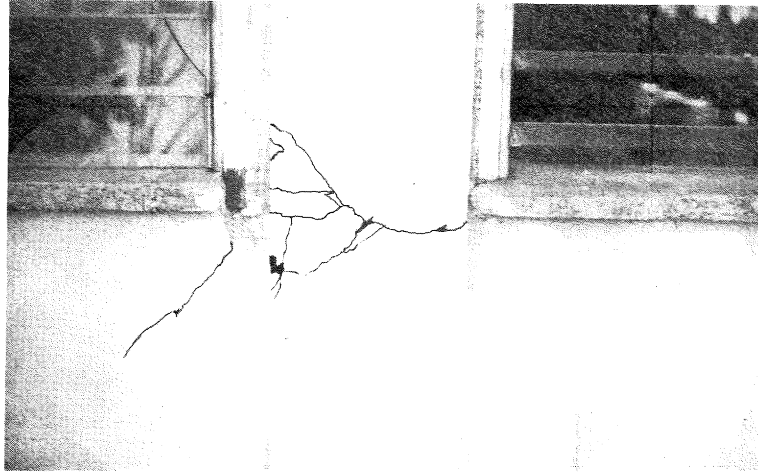
FIGURE 10: EXTERNAL COLUMN AND UNREINFORCED MASONRY INFILL - TAILULU COLLEGE

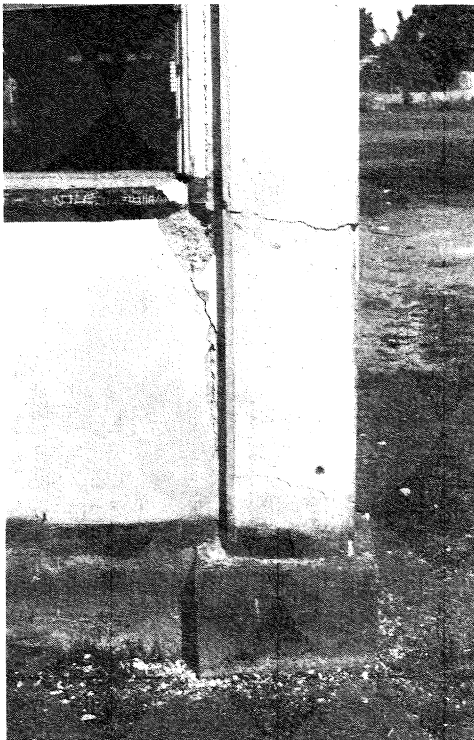
FIGURE 11: CORNER COLUMN SHOWING CRACKING AT BOTTOM AND SILL LEVEL AT TAILULU COLLEGE

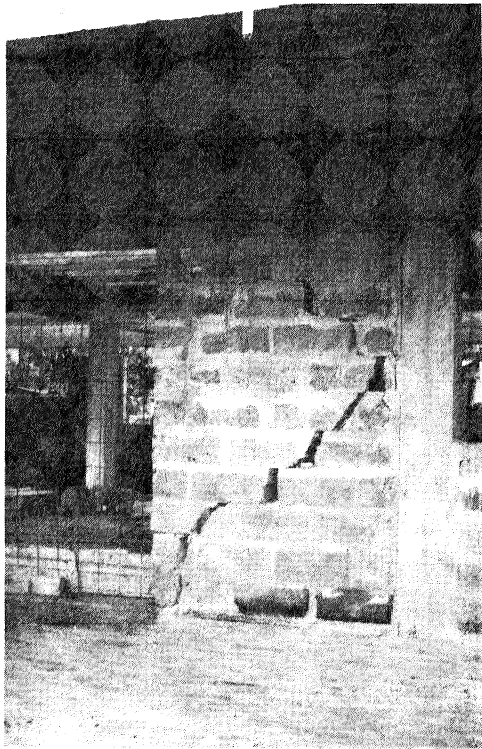
In many of these buildings, designed as frames, unreinforced or lightly reinforced walls acted as shear panels (fig. 13). A

number of these were undamaged indicating that they remained essentially elastic and this considering their weak construction confirmed that the earthquake was not intense. Where the walls were more highly stressed severe X cracking occurred. The main block of the Dateline Hotel exhibited this type of cracking in the masonry infill walls at ground level (fig. 14). It was also significant that in this case the cracking continued right through the column. Simple theoretical considerations indicate that virtually the whole seismic shear of the building was attracted to the columns at the ends of the infill walls (fig. 14). In many instances infill walls were not tied to the surrounding columns and beams. This was particularly so where the infill was constructed after the frame and many walls fell out or were left so weak that they could be swayed by hand.

FIGURE 13: UNREINFORCED SHEAR
PANEL FAILURE IN UNFINISHED
2 STOREY HOUSE, NUKUNUKU

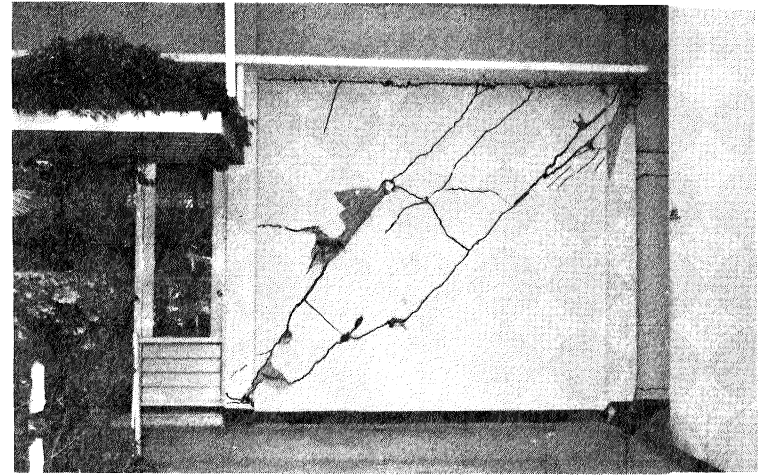
FIGURE 14: INTERNATIONAL DATELINE HOTEL -
CRACK THROUGH COLUMNS AND MASONRY
INFILL PANEL

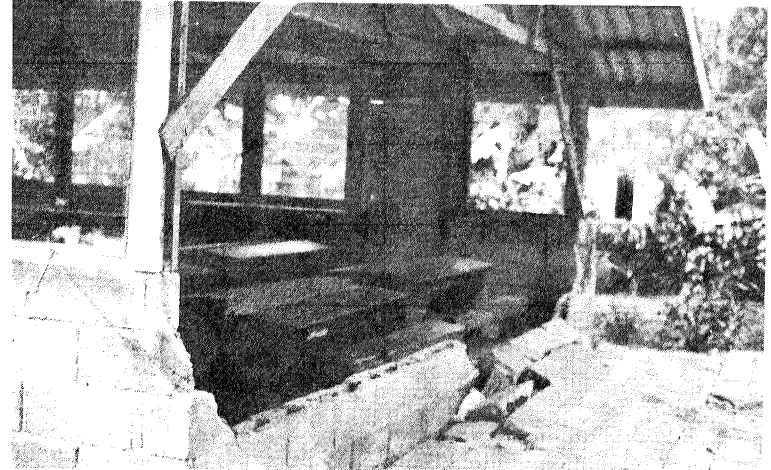
Once again an earthquake has shown the hazards created by not adequately supporting the top of masonry walls by dropping gable walls, figs. 15 and 17, and unreinforced partitions, fig. 18. Damage to stairs in relatively flexible storeys was also prevalent as no allowances had been made for interstorey drift (figs. 20 and 21).

FIGURE 15: COLLAPSED MASONRY END WALL
SHOWING LACK OF REINFORCEMENT

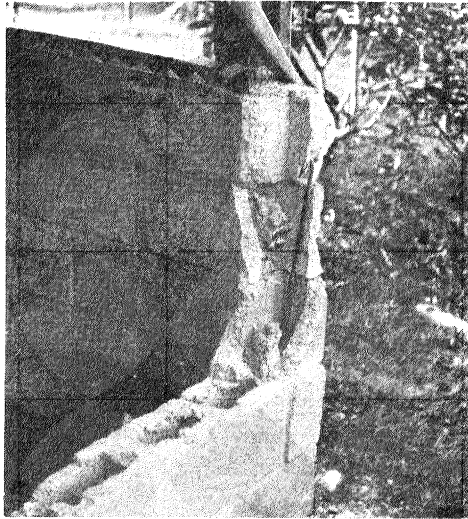
FIGURE 16: CLOSE UP OF WALL
IN FIG 14 SHOWING LACK OF
GROUT AND REINFORCEMENT

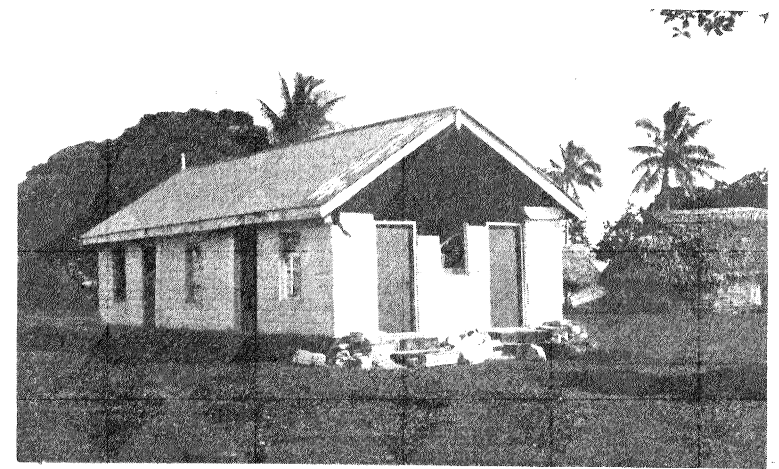
FIGURE 17: TYPICAL FAILURE OF MASONRY GABLE -
NOTE TRADITIONAL FALE ON RIGHT

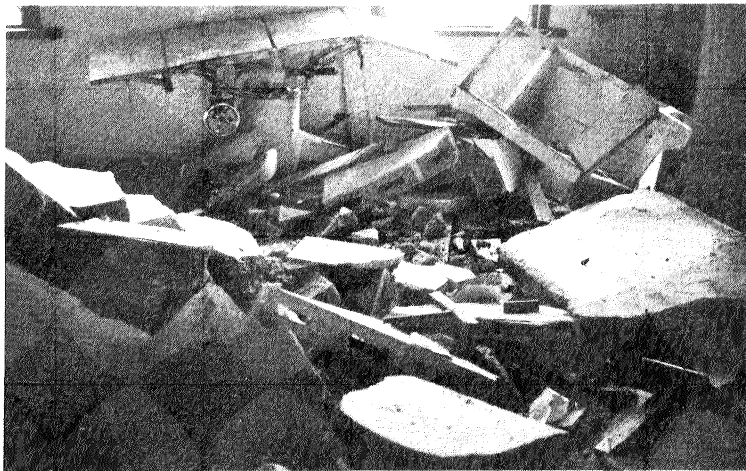
FIGURE 18: COLLAPSED UNREINFORCED
MASONRY PARTITIONS 'EUA HOSPITAL

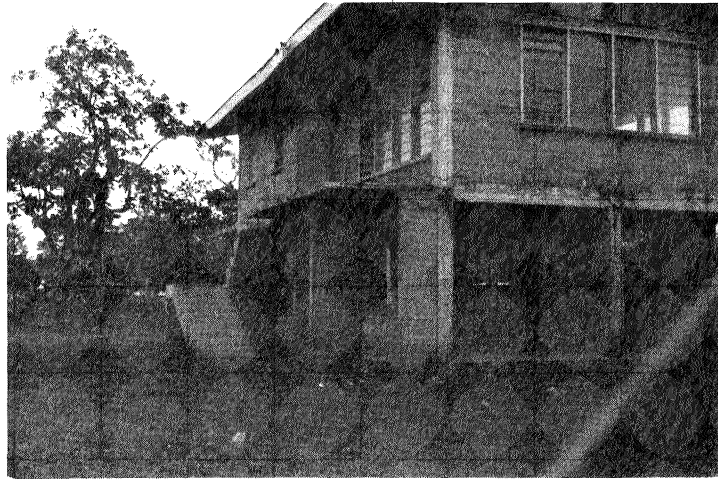
FIGURE 20: HOUSE, NUKUNUKU
SHOWING DAMAGE TO STAIRS

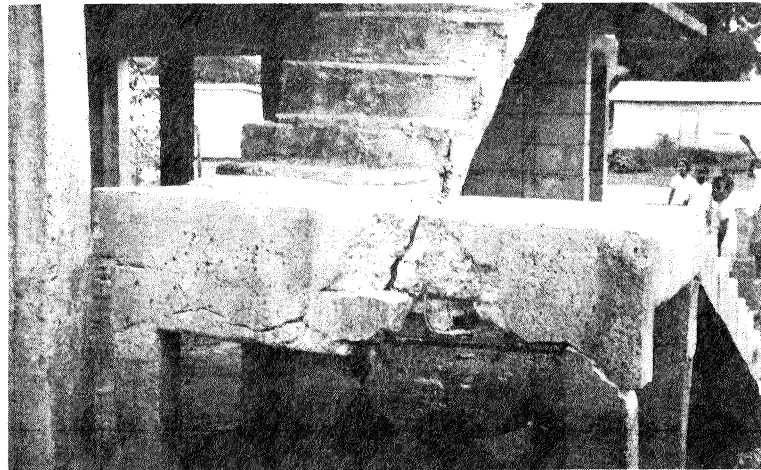
FIGURE 21: CLOSE UP OF STAIRS
SHOWN IN FIGURE 20

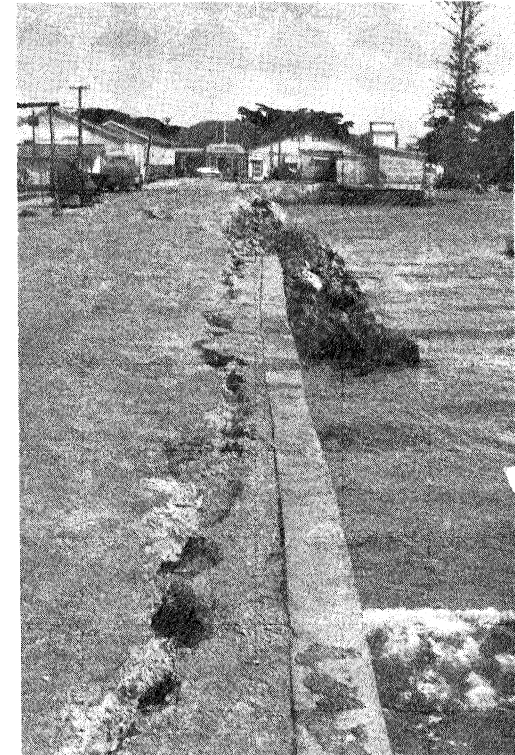
FIGURE 22: VUNA WHARF MOLE, NUKU'ALOFA

are perched on the edge of the reef and movement of the coral itself may have been a contributing factor. Slumping and spreading of the fill and overturning of rock retaining walls was particularly severe on the Vuna Wharf mole (fig. 22). There were few other civil structures on the islands.

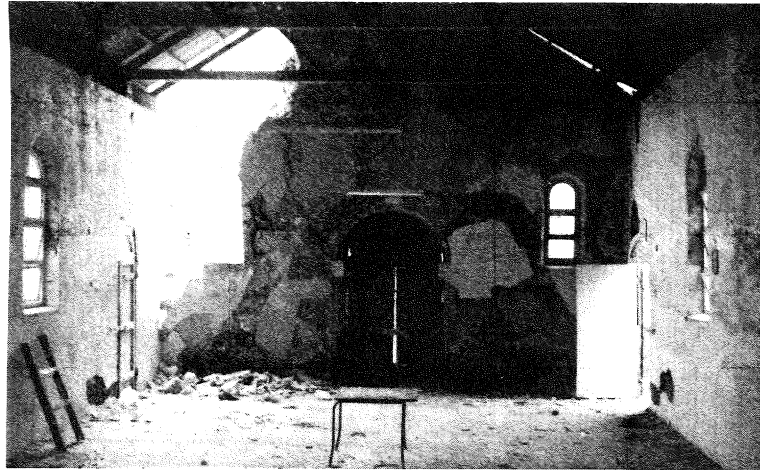
and/or collapse of the end walls, figs. 23 and 24.

FIGURE 23: END WALL SUPPORTING TOWER -
ROMAN CATHOLIC CHURCH, KOLOVAI, TONGATAPU.
WALLS OF WEAK MASS CORAL CONCRETE

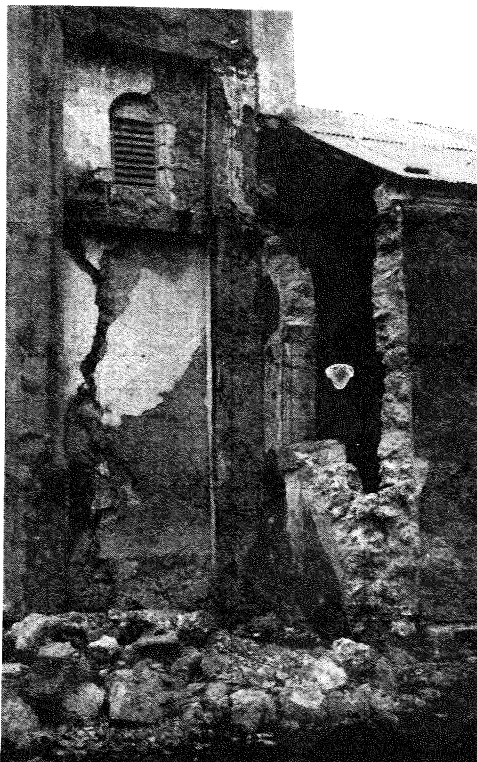
FIGURE 24: WALL COLLAPSE CAUSED
BY TOWER MOVING OUT OF PHASE WITH
CHURCH, OTHER SIDE NEAR COLLAPSE.
SEE FIGURE 23

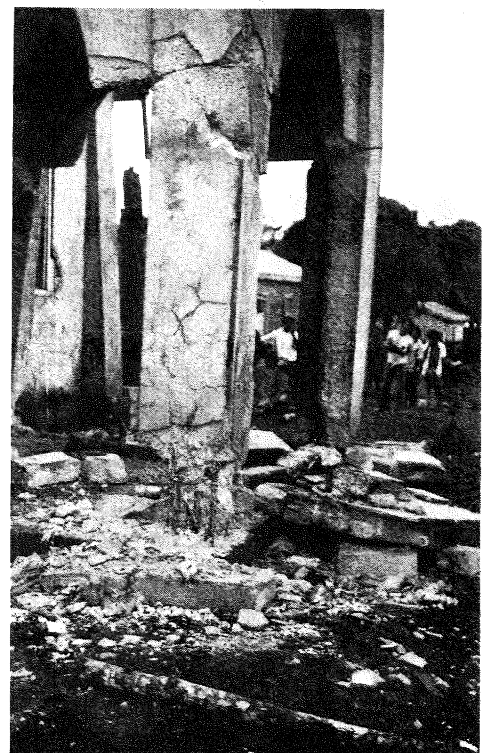
FIGURE 25:
COLUMNS SUPPORTING TOWER -
FREE WESLEYAN CHURCH,
PETANI, 'EUA
