## MASONRY PERFORMANCE IN EARTHQUAKES

O. A. Glogau\*

The original text of this paper was presented to the Structural Masonry Seminar, University of Canterbury, 3 to 5 September, 1974.

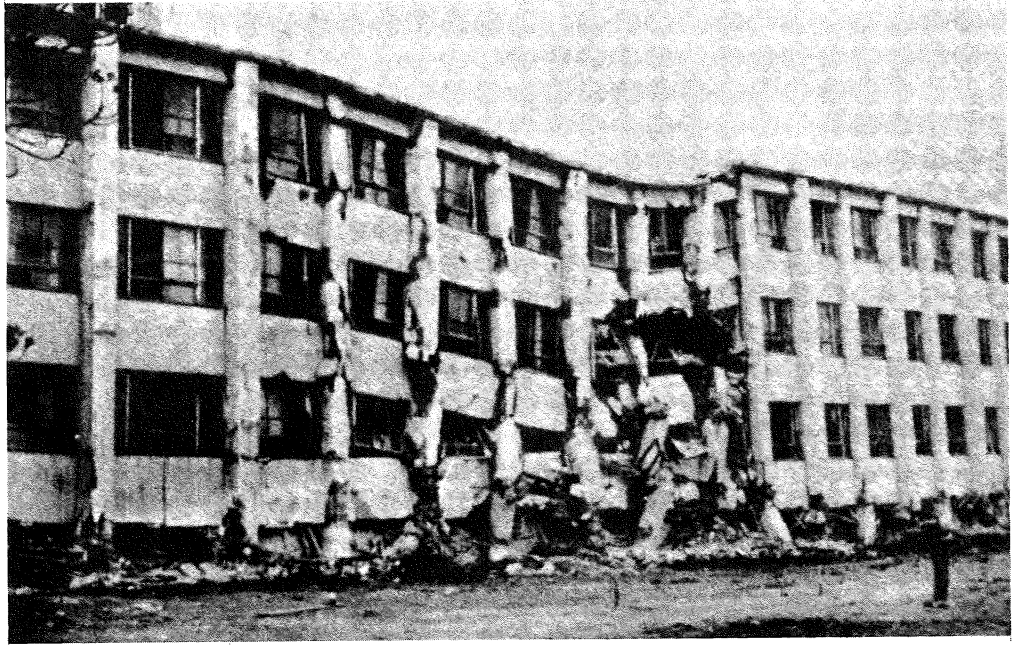
FIGURE 1:  
HAKODATE COLLEGE  
TOKACHI OKI E.Q.  
1968 (1)

It is noteworthy that the earthquake, which failed or damaged many 1 to 3 storey well built structures were conventionally designed to a level twice that of the current N.Z. Code (0.2 g working stress design), had its epicentre at a distance of some 250 km, and produced local ground accelerations of only 0.225 g (Figs. 1 and 2).

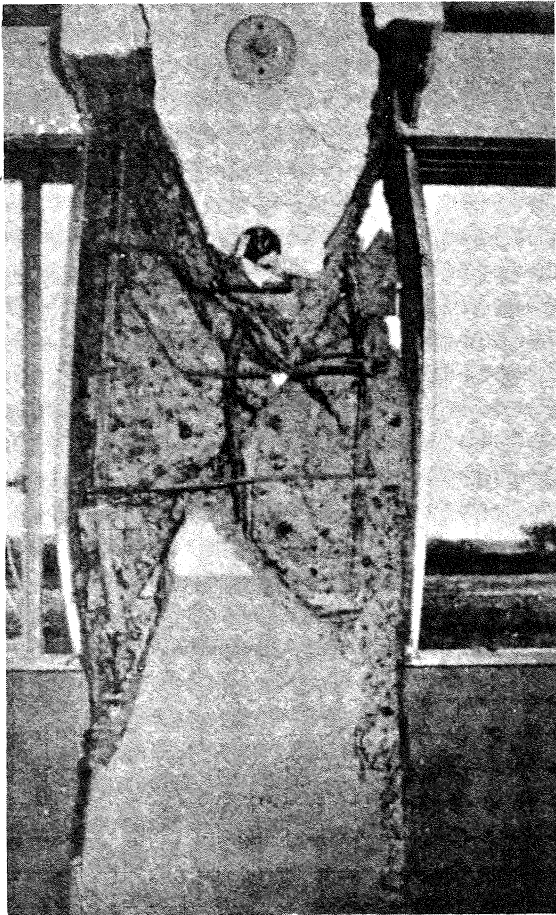
Heavily damaged short  
column ( $h_0/D=2$ )

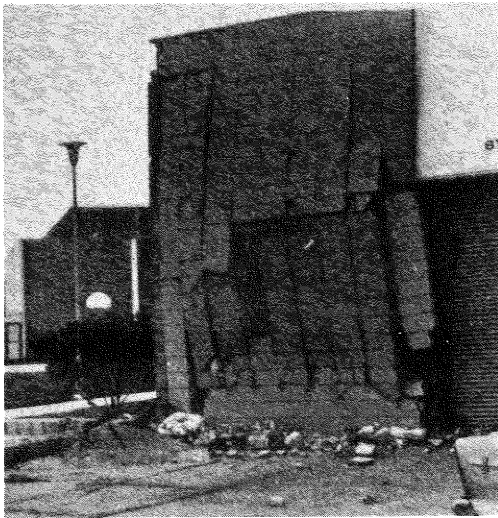
Fig 11 (6)

Figs. 11 and 12 show the poor performance of stack bonded reinforced masonry without close spaced horizontal reinforcement. The poor bond between the vertical surfaces of conventional units is well known. Mortar adhesion is frequently lost during laying as blocklayers make adjustments to obtain uniform joint widths. Fig. 10 too shows a rather unattractive mode of failure of a wall containing relatively light horizontal reinforcement. During its disintegration only small amounts of seismic energy would have been dissipated. Fig. 13 and Fig. 14 show the manner of failure of a 12" wall reinforced at 24" centres both ways. For 24" long units this is about the closest practical spacing for vertical bars. Although this wall also has little resistance left, a good deal more energy would have been dissipated in the process of its break up. A feature of all the failures that is very disturbing is the spalling of face shells which, if it had occurred some distance above the ground, would have resulted in a shower of deadly missiles. Use of an expansive grout additive may overcome this problem to a degree at least, and testing by M.W.D. is continuing to confirm this.

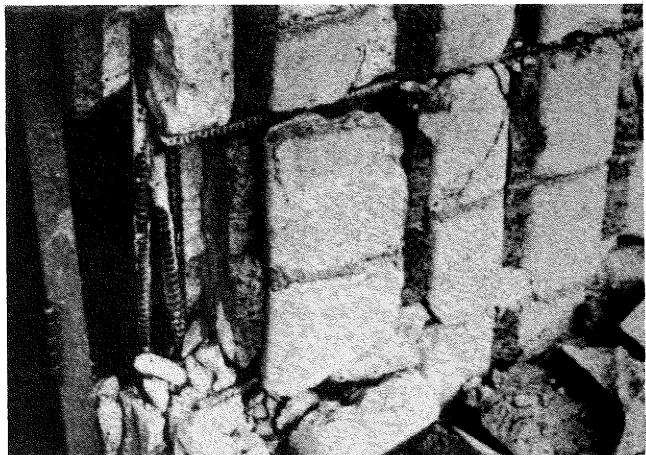
Fig 14 (6)

Fig. 14 also shows how reinforcement in the horizontal joint plane and near the surface is a contributing factor of early disintegration. The "open end bond beam" unit which is standard for all M.W.D. high lift grouting work has several features that reduce the potential for the type of failures seen in Figs. 10 to 14. The webs, lowered by 2½", allow placing horizontal reinforcement well below the level of the horizontal mortar joint plane. The open end of the units is not so much specified because of convenience in laying - in high lift construction the vertical reinforcement is generally introduced after laying of units - but because it restricts vertical mortar beds to the surfaces of the walls and ensures that grout is in contact with most of the web of adjacent units resulting in a more homogeneous wall.

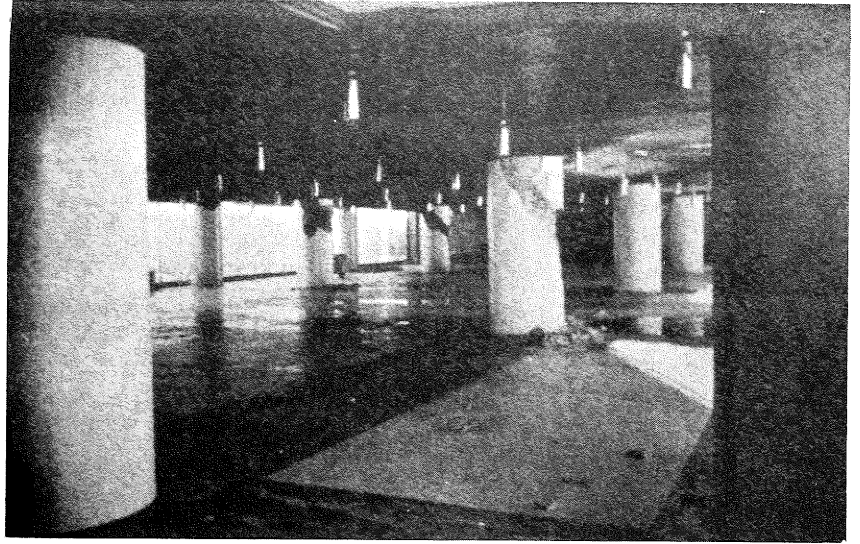
Fig 16 (3)

- (a) Formation of accidental column hinge mechanism. Figs. 15 to 17 show how very weak hollow masonry partitions in the upper stories of the Macuto Sheraton resulted in lower storey column hinge mechanisms aggravated by high axial loads.
- (b) Attracting shear to parts of the structure not designed for it and resulting in column failures. Fig. 18 shows how the infilling panels at the ends of a building

Column Failure  
in Macuto Sheraton

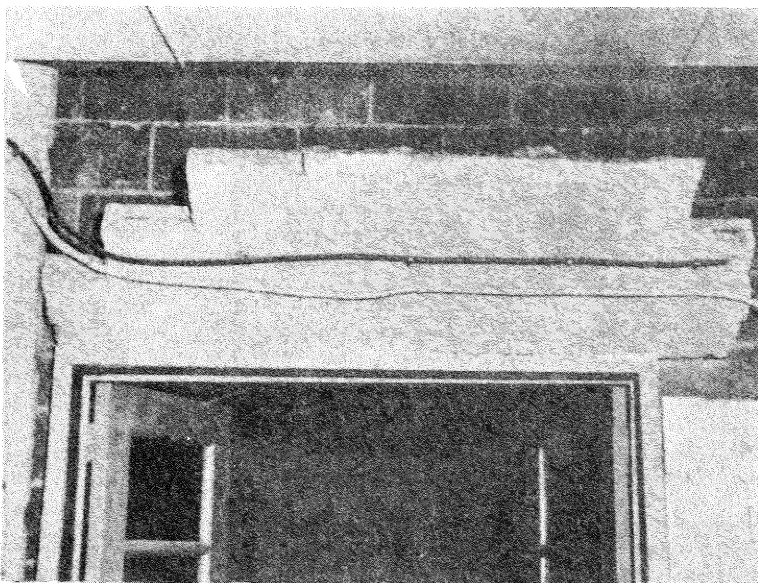
Fig 28 (8)

Fig. 28 (Anchorage) shows that electric wiring is a "must" in buildings with 4" unreinforced partitions. Note remains of 4" partition overhanging doorway. Failure of the type shown in Fig. 29 was common and resulted in loss of life. Fig. 26 shows the danger of means of egress. Fig. 29 is proof that there is nothing peculiar about overseas earthquakes. The failure occurred in 1972, Te Aroha, New Zealand.

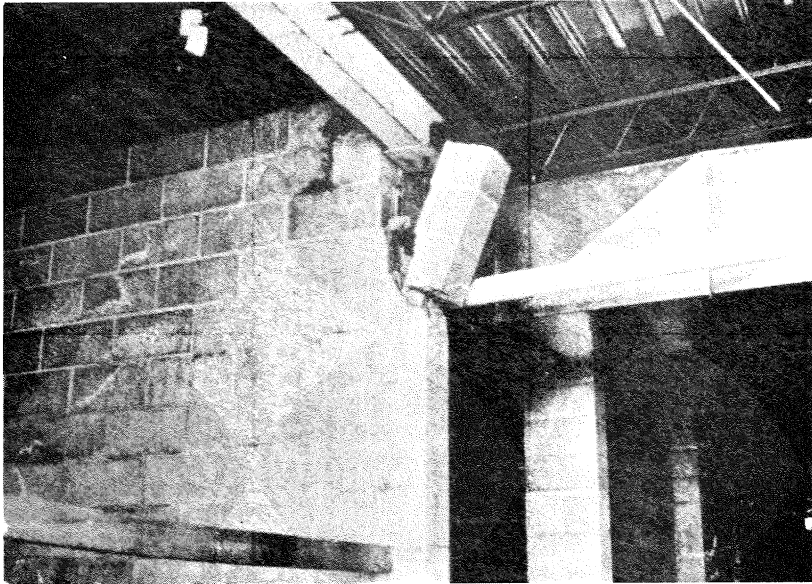
**Fig 30 (5ii)**

The lesson from the failures shown in Figs. 30 and 31 is the importance of adequate amounts of horizontal reinforcement, suitably anchored and in particular the need for supplementary reinforcement in regions where higher local stresses may occur.

-Steel beam delivered load to end of concrete block wall. Romig Junior High School.

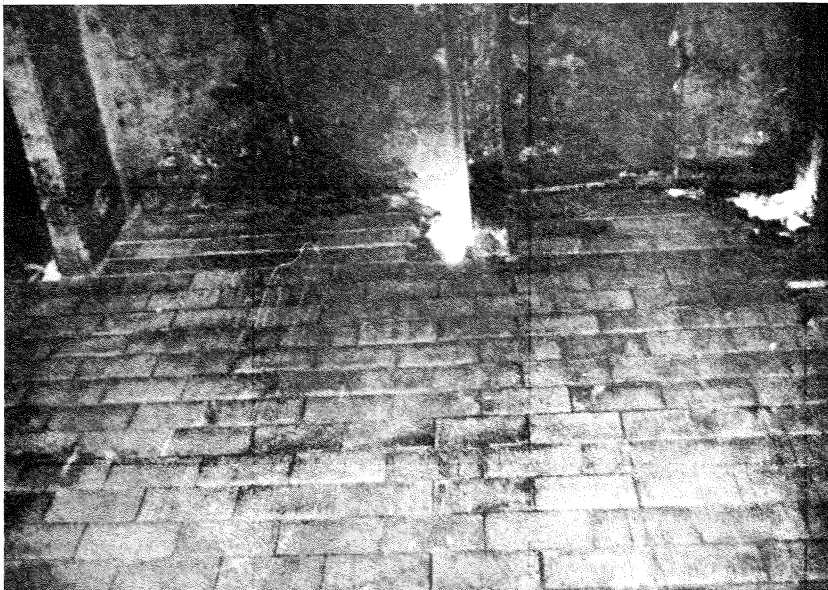
**Fig 31 (5ii)**

-View of west wall at north end of gymnasium. Note damage at beams. Romig Junior High School

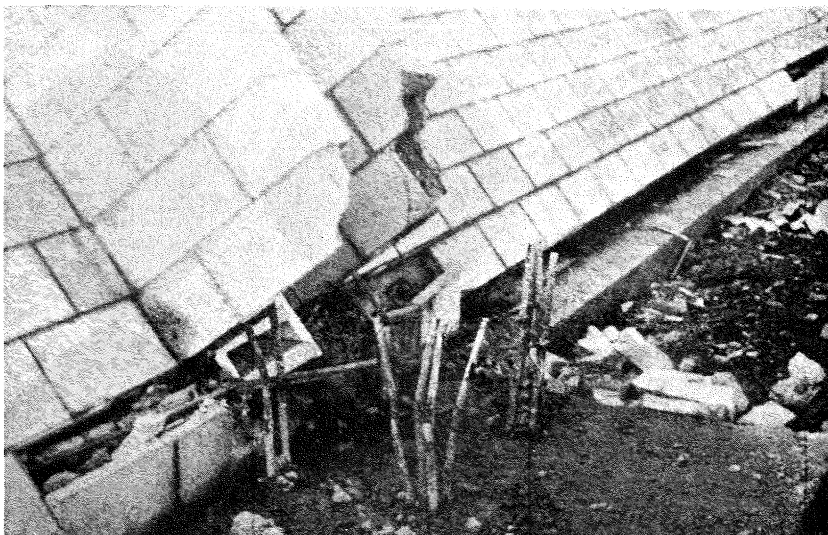
The need for close supervision of construction is evident from Fig. 33 (San Fernando) and Fig. 32 (N.Z. 1968) is shown to emphasize that "it can and does happen here too". Garden and boundary walls failed extensively at San Fernando (Fig. 34).

**Fig 32**  
**Storm Damage, N.Z. 1968**  
 Inadequate splice length  
 and excessive number of  
 bars in small cavity.

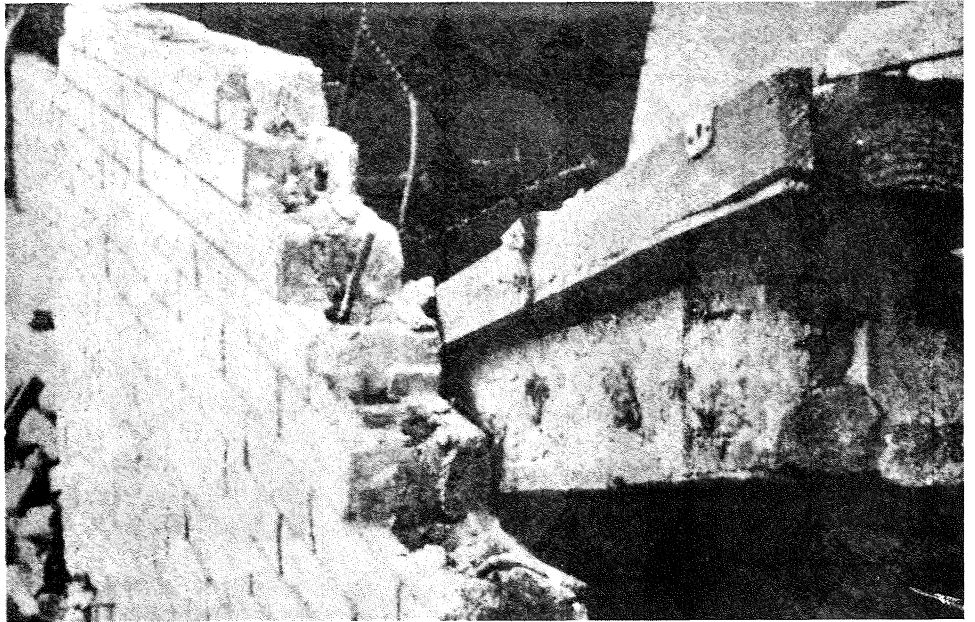
**Fig 33 (9)**  
**Liquor Store**  
**San Fernando .**  
**Discontinuous**  
**vertical reinf.**

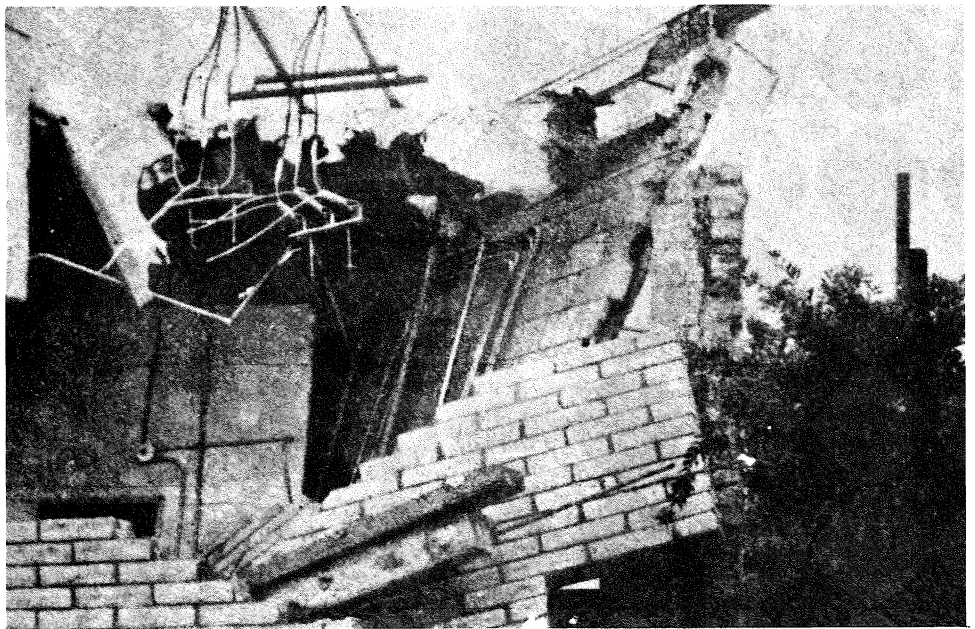
**Fig 34**  
**San Fernando**  
**Failure of**  
**boundary walls .**

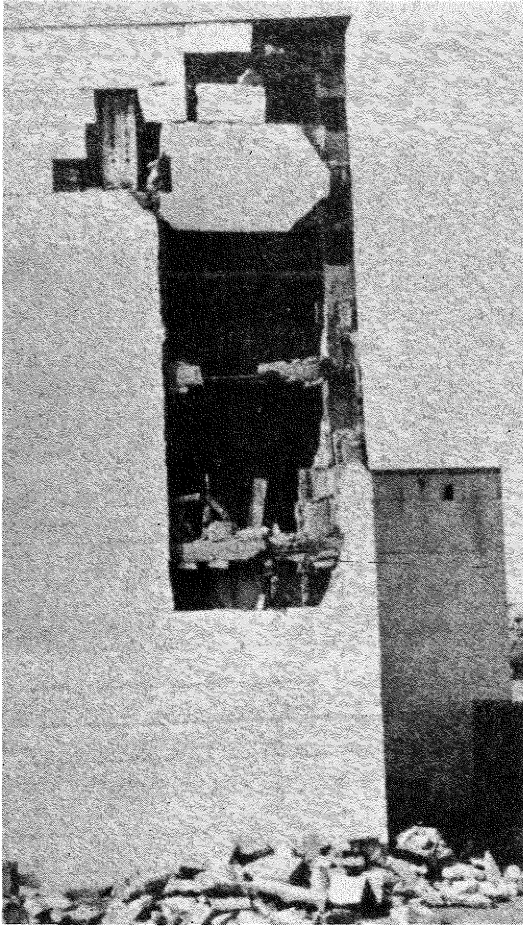
Fig 35 (5i)

Figs. 35 to 37 from Anchorage show the disturbing modes of failure of walls containing little "basketing" reinforcing. Cracks follow no particular mathematically derived stress patterns but simply the line of least resistance into regions where there are no reinforcements to impede their progress. Whether or not the failure of these walls was secondary to that of the roof diaphragm is of little importance to the lesson to be learned.

Chrysler Center. *Frank McClure photograph.*

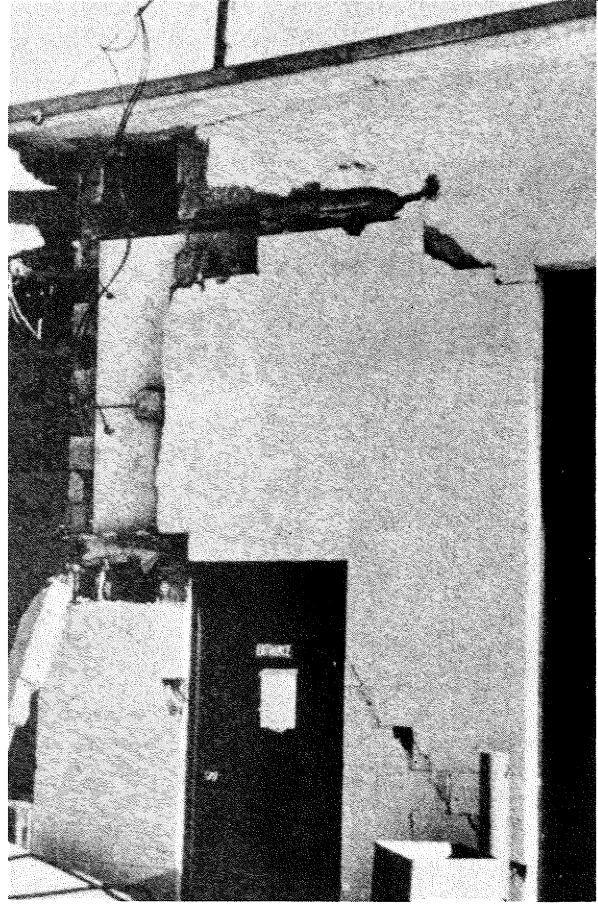
Fig 36 (5i)

—Damage at northeast corner of the Alaska Van and Storage Co. *John L. Cerruti photograph.*

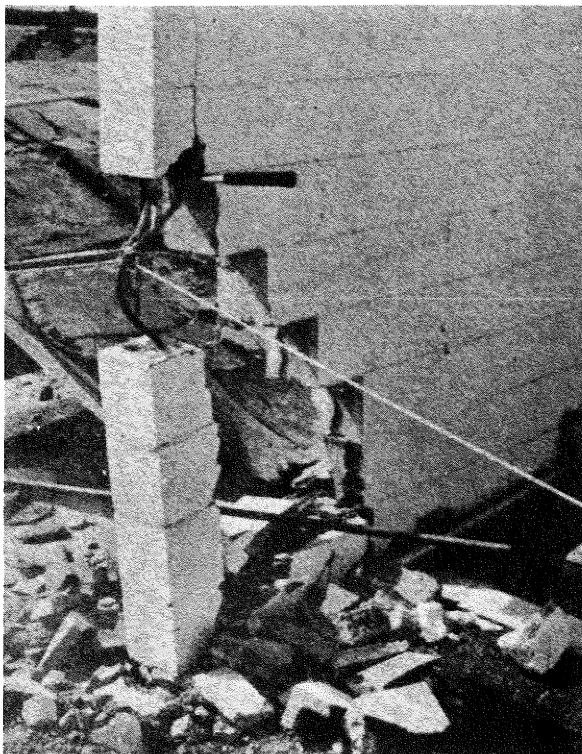
Fig 37 (5i)

FIGURE 68.—Damage at base of the east fin suggests over turning stresses. *Frank McClure photograph.*

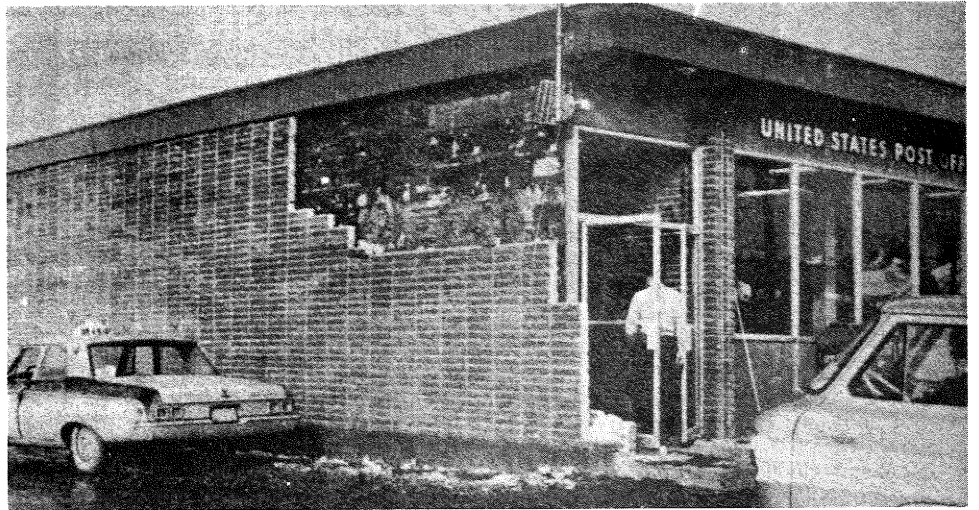
Fig 39 (5i)

The most common form of masonry veneers in N.Z. is of the tied variety. Tied veneers can fail due to a number of causes including lack of adequate ties (Fig. 38, 1935 Montana). Poor performance has, however, also occurred where apparently substantial quantities of ties were used. Fig. 39 (Anchorage), Fig. 40, shows a veneer on timber failure from Inangahua, N.Z. 1968.

-Damage to 4-inch brick veneer on a wood stud wall. Wall construction from inside to outside: Sheetrock on the interior face of the studs, 2- by 6-inch studs at 16 inches, 3/8-inch plywood on outside face of the studs, and 1 7/8-inch air gap between the plywood and the 4-inch brick veneer. Plans called for masonry veneer ties at 16 inches horizontally and 24 inches vertically.

Since veneer on timber construction is used in the first instance to reduce maintenance, its vulnerability to earthquake damage should be reduced. To achieve this, timber bearing walls must be significantly stiffened by sheathing with structural plywood or by other methods. Roof stiffness must also be improved and finally, the veneer ties themselves must be capable of withstanding very high loadings without sustaining deformations incompatible with the deformations of an unreinforced brick wall or tearing out of timber wall or veneer.

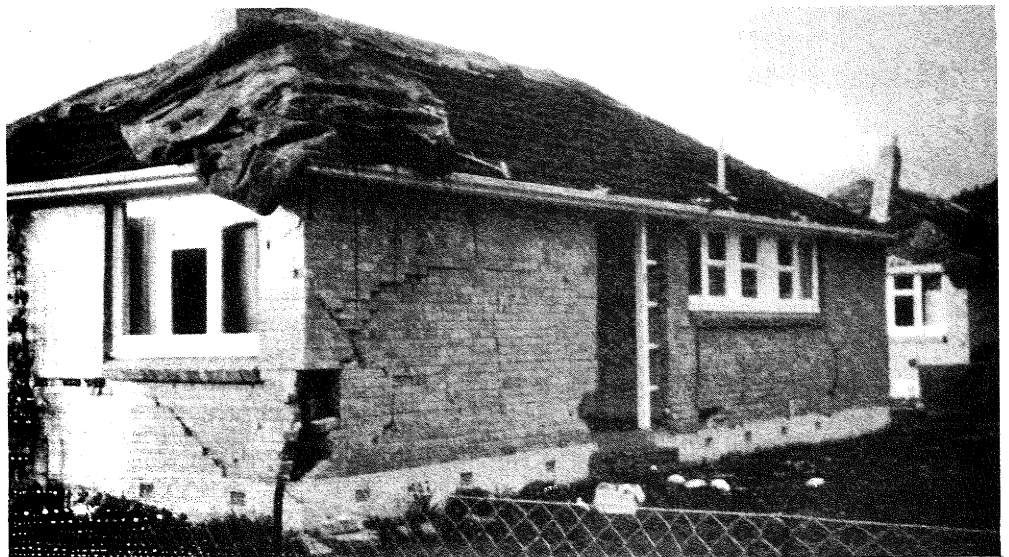
Fig 40  
Inangahua  
E.Q. N.Z. 1968

as stiff as those in a house sheathed with weatherboards. Additionally the lack of stiffness of the roof itself will introduce loadings to the top edges of the walls. The timber walls are more flexible than the veneer not only perpendicular to their plane but also in their plane and there is a tendency for the veneer to act as a kind of shear wall. The deformations of walls and partitions at right angles causes the veneer panels to be distorted, fail, and thus in turn, lose their capacity to act as shear walls.
