## THE VERACRUZ EARTHQUAKE OF 28 AUGUST 1973

H. M. Irvine\*

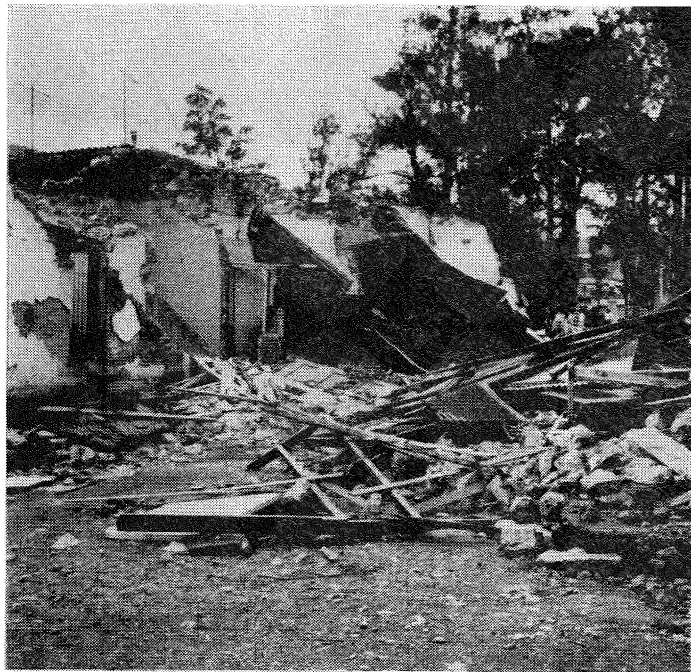
mortar. The roofs were either corrugated iron or tile. Figure 3 shows typical damage to housing.

The damage was most severe in the area nearest the hills. Possible geologic reasons that might be advanced for this are: (a) reflection of incident waves, (b) poor soil conditions (possibly). However, from discussions with residents, it appears that the houses in the most severely damaged areas were older, and, therefore, not as earthquake resistant. Also, as fate would have it, a troublesome gas main in this location had recently been removed by blasting it out of the ground. This could well have put a maze of hairline cracks in many of the buildings.

FIGURE 3: COLLAPSED HOUSES, RIO BLANCO.

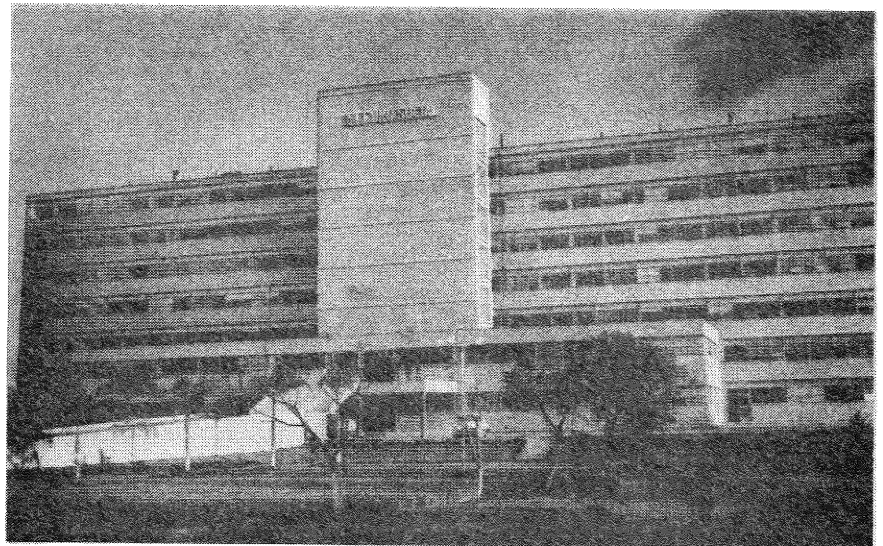
A. Social Security Hospital. - The Social Security Hospital is a modern, seven-storey structure built in 1958. The building is divided into three parts by construction joints on either side of the elevator shafts and access stairways. The main frame consists of reinforced concrete columns and floor slabs, with unreinforced brick and mortar filler walls (see Figure 5). The hospital suffered major secondary damage. In fact, the secondary damage was so severe that the top five floors were unusable. On each of these floors there was a terrific mess of broken wall tiles, reagents, hospital equipment and fractured secondary walls which, although unreinforced, had not been isolated from the main frame. Fortunately, the rest of the hospital was operational, although the staff were sorely pressed at a time when every inch of the hospital was urgently needed. The main frame of the hospital suffered little damage. The floor slabs had cracked on some floors and some of the columns had spalled. Figure 6 shows evidence of some working of the construction joints. However, plumb-line checks revealed that no permanent lateral displacement had taken place.

FIGURE 5: SOCIAL SECURITY HOSPITAL, ORIZABA.

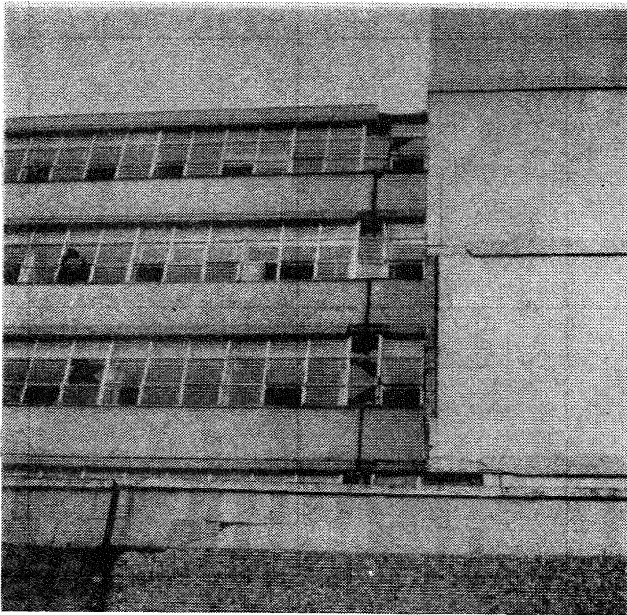
FIGURE 6: WORKING OF A CONSTRUCTION JOINT, SOCIAL SECURITY HOSPITAL.

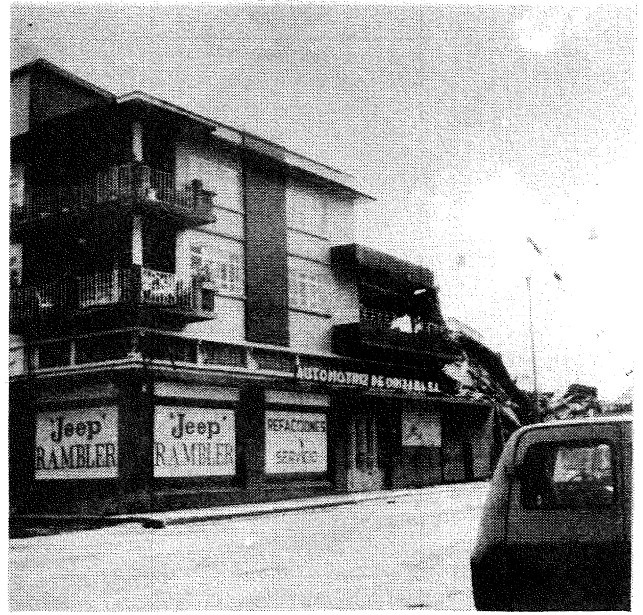
B. The "Packard" Apartment Building. - The complex consisted of three, three-storey buildings linked by terraces and stairways. Two of the buildings collapsed killing ten people, injuring 40 and crushing 20 cars parked underneath on the ground floor (see Figures 7 and 8). The end of the building, still standing, was markedly stiffer than the other part which appeared to have been supported on slender columns. Notice also, the flexural-shear failure of the short columns which provided the ventilation gap for the ground floor shops (see Figure 9). The whole complex was torsionally unbalanced because of the linking terraces and stairways which provided shear transfer between adjacent buildings.

FIGURE 7: COLLAPSE OF THE "PACKARD" APARTMENT BUILDING, ORIZABA.

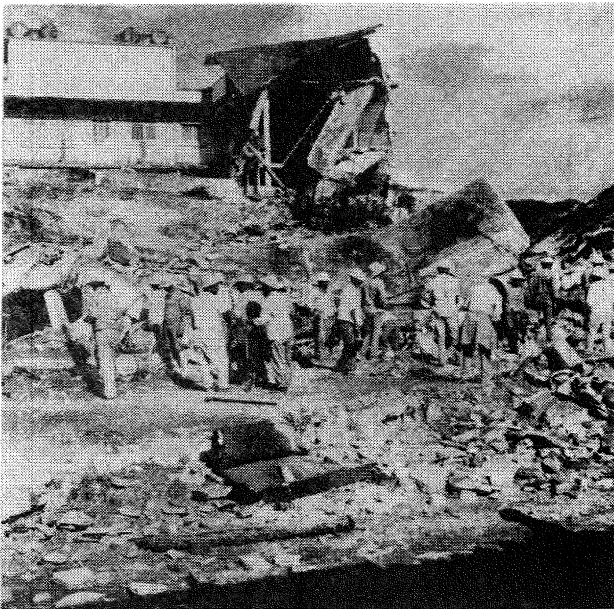
FIGURE 8: THE "PACKARD" APARTMENT BUILDING, WORKMEN ARE STANDING ON WHAT WAS THE REINFORCED CONCRETE ROOF OF THE THREE-STORY COMPLEX.

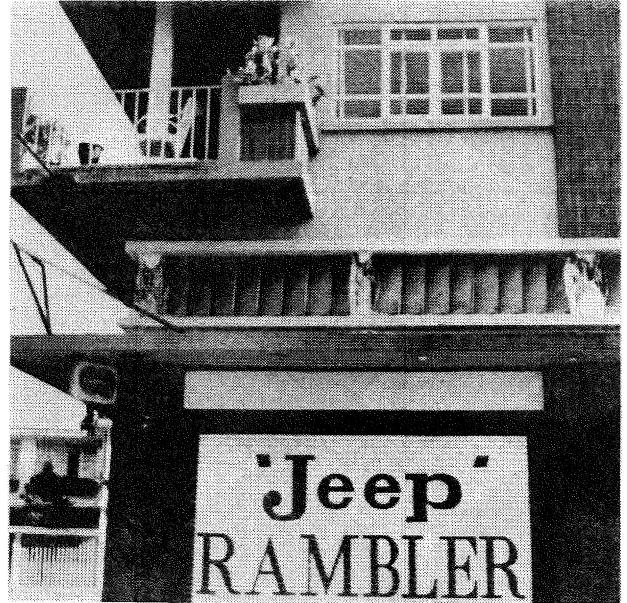
FIGURE 9: FAILURE OF SHORT COLUMNS, "PACKARD" APARTMENT BUILDING.

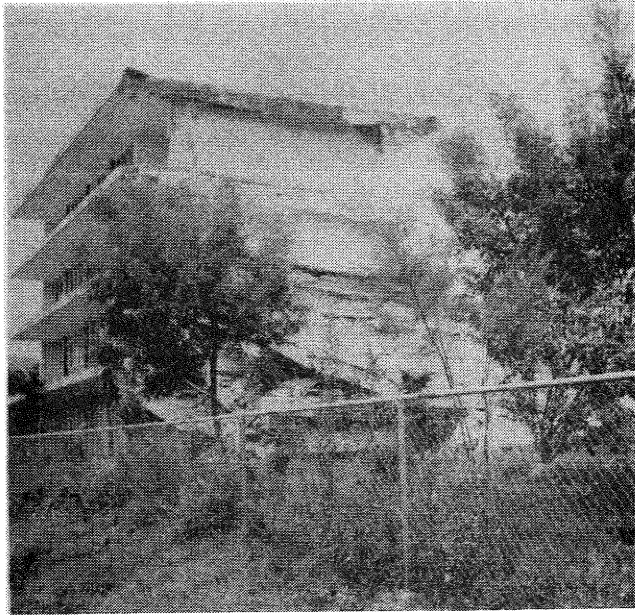
The first four-storey building (Building A) shown here consisted of two parts linked by stairways. Half of the structure collapsed completely (see Figure 10). Along the shorter sides adequate stiffness had been provided by four brick and mortar shear walls, but the building was weak along its major direction. Indeed, the rectangular columns were oriented so that their weak direction was parallel to the longer side; in plan, the column depth was approximately twice the width. Flexural-shear failure of the ground floor columns precipitated the collapse (see Figure 11). Figure 12 shows the behaviour of post-tensioned floor slabs. The hollow cardboard cylinders had been placed in the floor to save weight, but they were instrumental in the slabs losing any continuity which the prestressing cables might have provided. It is most fortunate that the earthquake occurred before school had started for the day.

FIGURE 10: COLLAPSE OF BUILDING A,  
TECNOLOGICO OF ORIZABA.

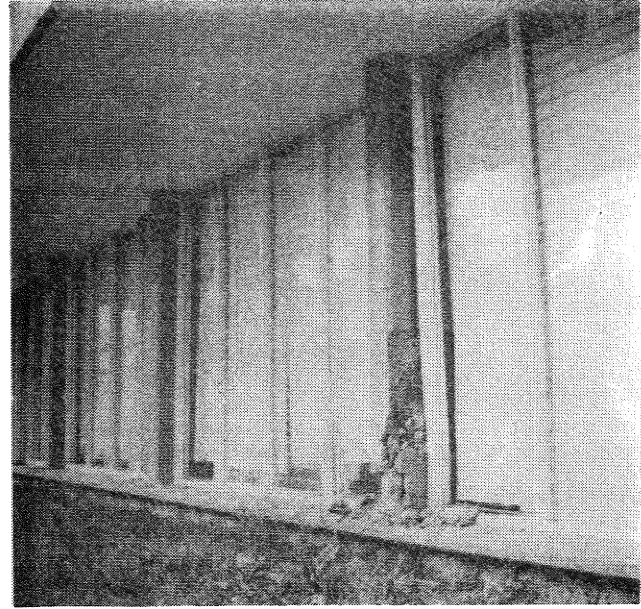
FIGURE 11: FAILURE OF GROUND-FLOOR COLUMNS,  
BUILDING A, TECNOLOGICO OF ORIZABA.

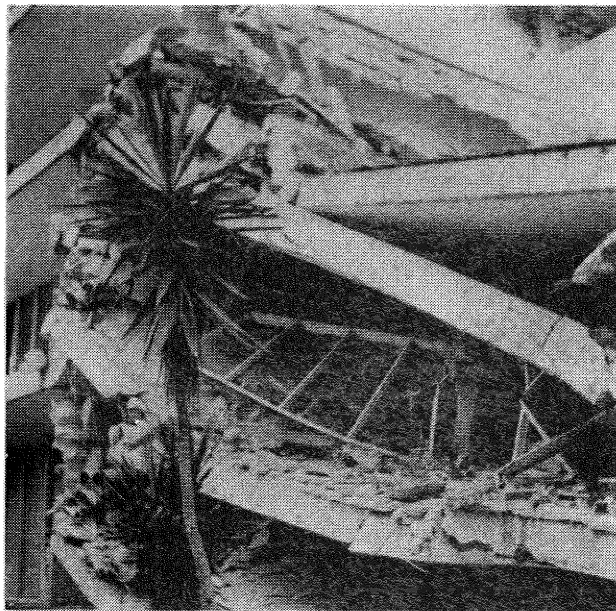
FIGURE 12: BEHAVIOUR OF FLOOR SLABS, BUILDING A,  
TECNOLOGICO OF ORIZABA.

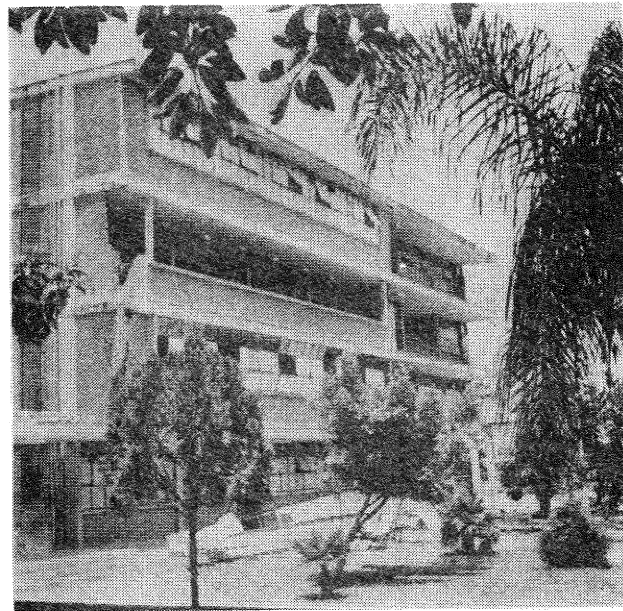
The other four-storey building (Building B) remained standing, although it is likely that it will have to be completely rebuilt (see Figure 13). Superficially, this building appeared to be similar to Building A; it was of the same height and plan area and stairways separated the building into two parts. However, closer examination revealed major structural differences. The center of mass of the building was towards the left-hand end, while the center of stiffness was nearer the stairway (see Figures 13 and 14). Hence, the building responded primarily in torsion. Good evidence of this is provided by Figure 15 which shows classical torsional cracking of a second-storey column located adjacent to the stairway.

FIGURE 13: DAMAGE TO BUILDING B,  
TECNOLOGICO OF ORIZABA.

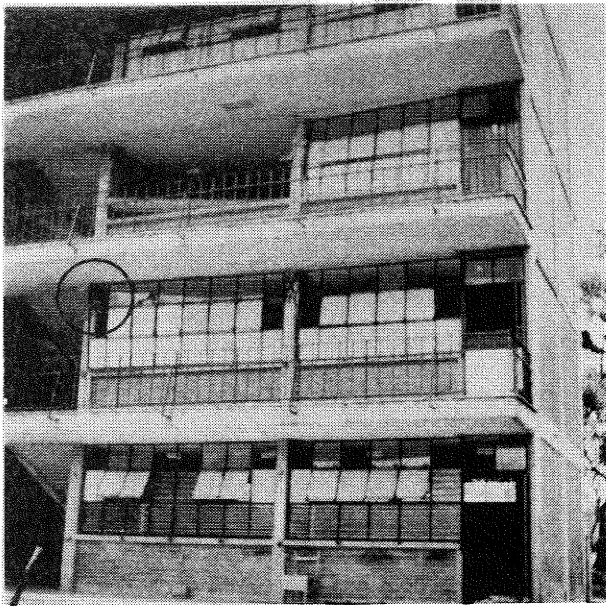
FIGURE 14: BUILDING B, TECHNOLOGICO OF ORIZABA. CIRCLE GIVES LOCATION OF FIGURE 15.

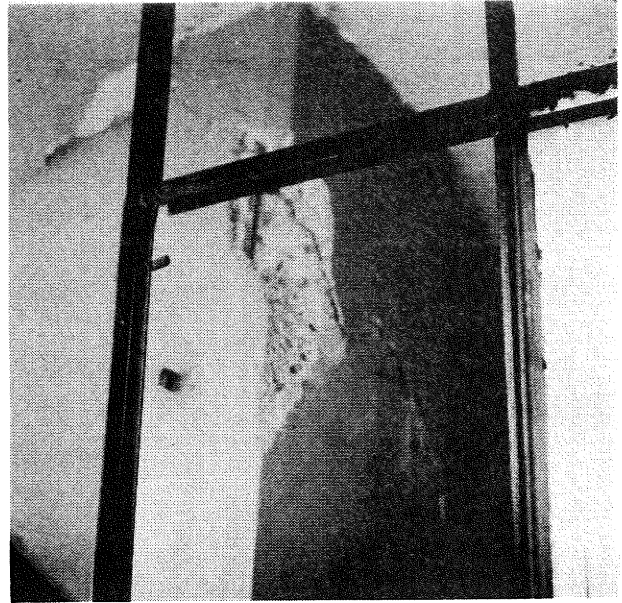
FIGURE 15: TORSIONAL CRACKING OF SECOND-STOREY COLUMN, BUILDING B, TECHNOLOGICO OF ORIZABA.

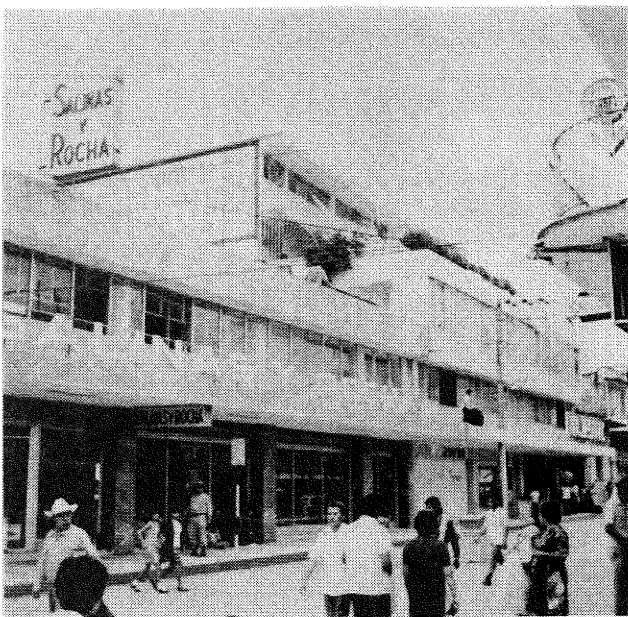
A. Five-Storey Business House. - The failure of this building was one of the most interesting, from an engineering standpoint. This building, which had a reinforced concrete frame with brick filler walls, is owned by Mr. Kushida, a Japanese businessman, and was built in 1968. The bottom three floors house shops, offices and warehouses, whereas the top two floors, which are set back (see Figure 16), are occupied by Mr. Kushida and his family. The overturning moment resulting from the motion of the top two floors caused axial compression failures of columns of the third floor (see Figure 17). The upper floors had dropped approximately 30 cm. and were severely damaged. Goods stored in this building were subsequently damaged by heavy rainfall.

FIGURE 16: FIVE-STOREY BUSINESS HOUSE, CORDOBA.

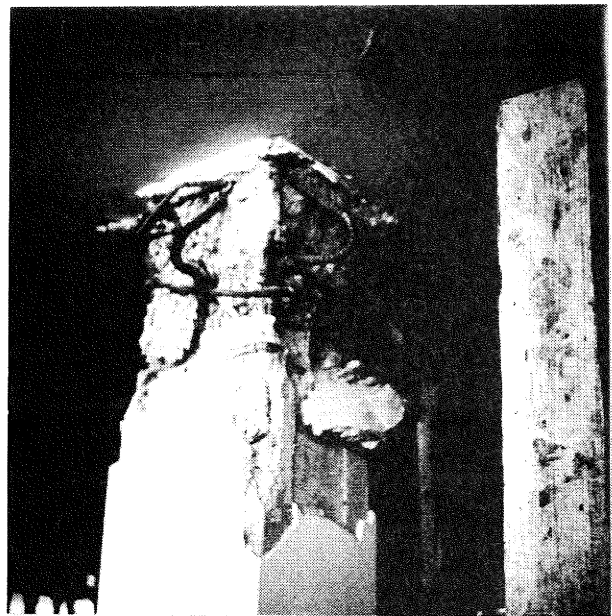
FIGURE 17: AXIAL COMPRESSION FAILURE OF A THIRD-FLOOR COLUMN, BUSINESS HOUSE, CORDOBA.

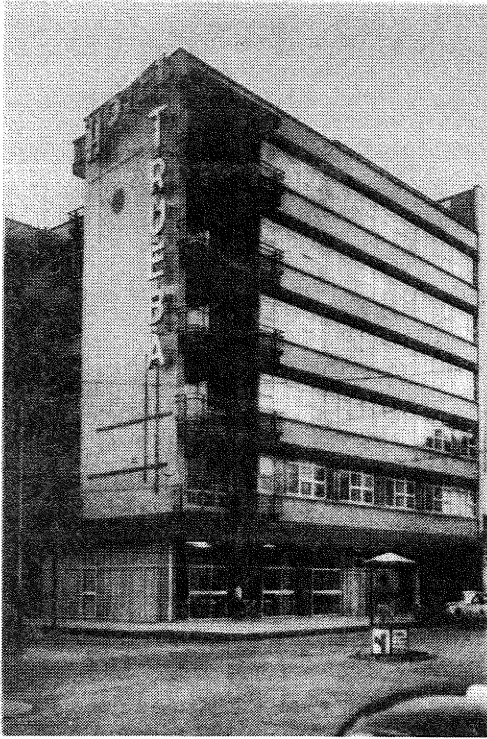
B. Hotels. - The Hotel Trueba (see Figure 18), which has a reinforced concrete frame with brick filler walls, suffered extensive secondary damage, mainly to unreinforced brick and mortar partition walls which had been made continuous with the structural frame. The six-storey shear walls showed evidence of cracking at the second and third floors (see Figure 19). This could indicate some second-mode response to the excitation. However, this seems unlikely since the participation factor for second-mode response is usually too small to be significant. The building is more likely to have responded strongly in the first mode, in which case local weaknesses in the construction at the second and third floors could have led to the cracking which occurred there. Another possibility is that the wall behaved as a coupled shear wall (the coupling between the two columns being provided by the floors and the infill walls) where, typically, laminar shear stresses attain their maximum values about one-third of the way up the shear wall.

For whatever reason, the behaviour of the wall is peculiar since Figure 18 shows an obvious zone of weakness at the level of the ground floor columns. Yet inspection showed no sign of damage to these columns. It can only be concluded that sufficient stiffness was present in the ground floor to avoid damage there.

FIGURE 18: HOTEL TRUEBA, CORDOBA,  
BEFORE THE EARTHQUAKE.

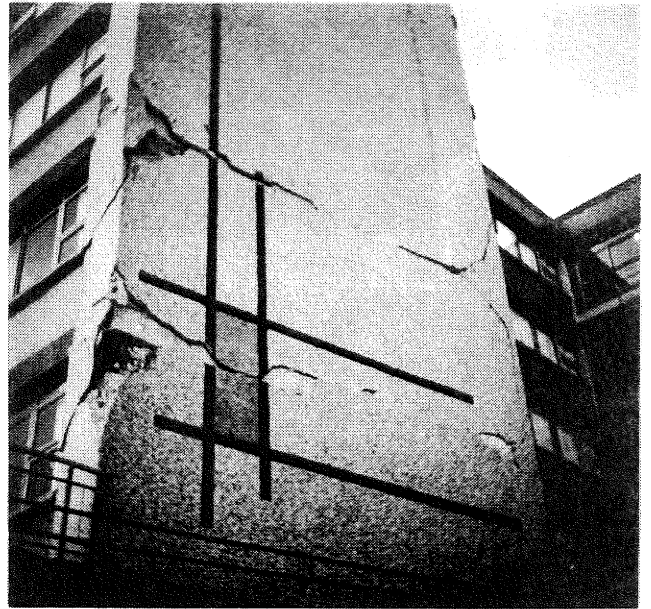
FIGURE 19: CRACKING IN SHEAR WALL, HOTEL TRUEBA.

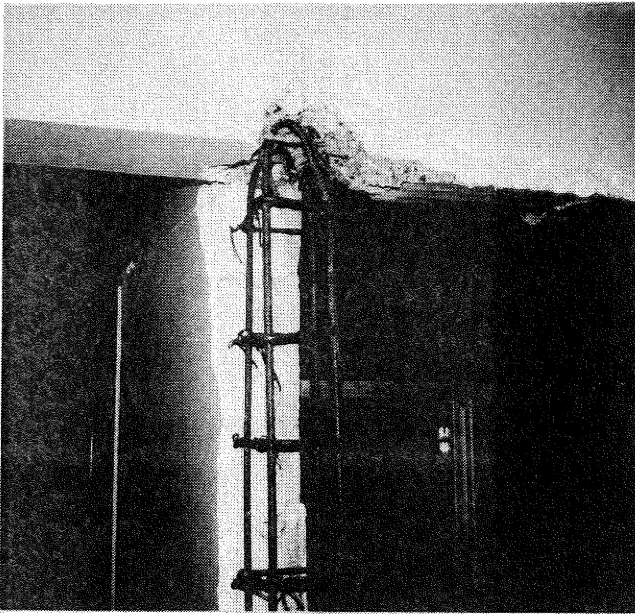
Since many of the rooms in the hotel were uninhabitable owing to broken partition walls, the owner was very keen to have repairs made as soon as possible. Unfortunately, the philosophy behind the repair scheme left much to be desired, as Figure 20 shows.

FIGURE 20: REPAIR SCHEME FOR PARTITION WALL,  
HOTEL TRUEBA.

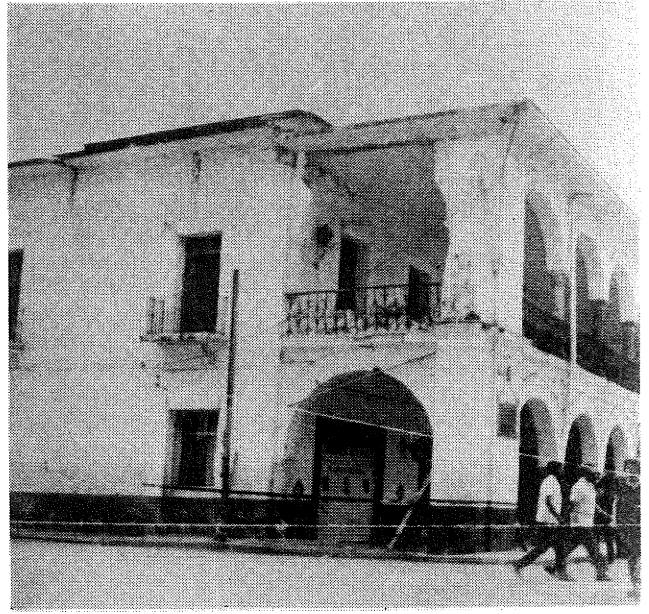
built in 1687, just 70 years after the Spaniards founded the town. Although the exterior of the building has changed somewhat (see Figure 21) and a reinforced concrete roof was placed earlier this century, the interior courtyard is substantially unaltered. The view of the all-but-failed three-way arch (see Figure 22) is taken from this courtyard. It appears that the roof slab saved the outer corner of the building from collapsing.

FIGURE 21: DAMAGE TO EXTERIOR CORNER OF THE HOTEL  
ZEVALLOS, CORDOBA.

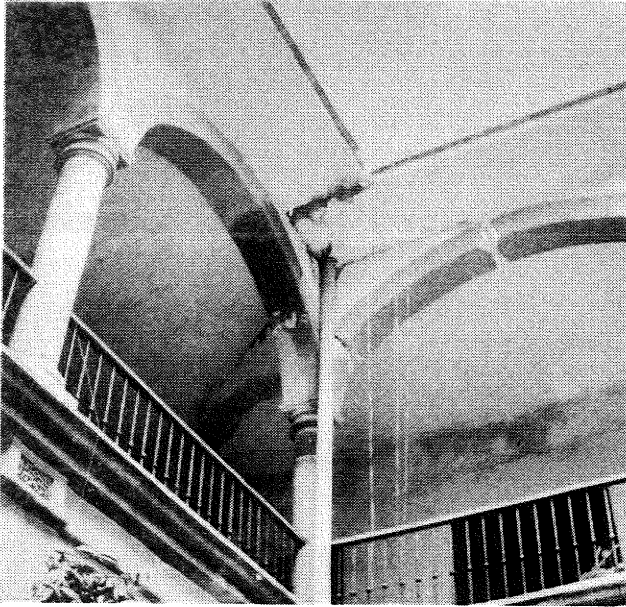
FIGURE 22: DAMAGE TO THREE-WAY ARCH, HOTEL ZEVALLOS.

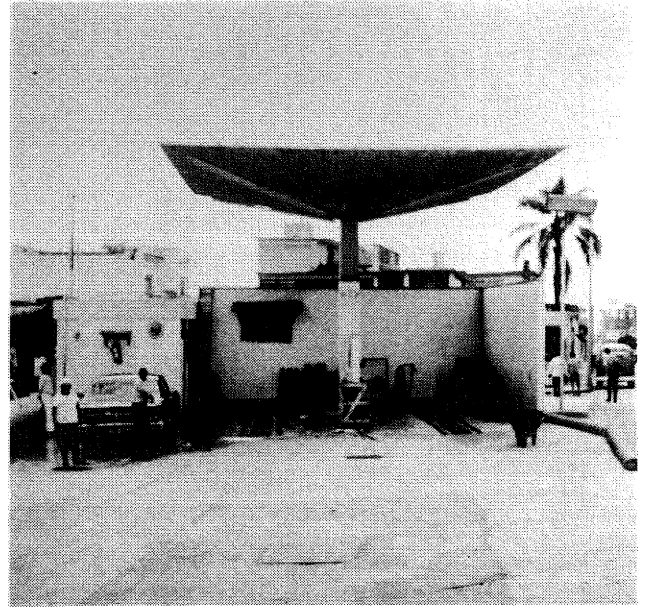
C. Service Station Shelter. - The cantilevered service station shelter shown in Figures 23 and 24 had cracked at the junction of column and roof slab, but there was no damage at the base of the column. It appears that the rotary inertia associated with the roof had been ignored in the design. The rotary inertia had two effects: firstly, under horizontal excitation the true bending moment diagram is trapezoidal, not triangular; secondly, the rotary inertia may so lower the fundamental frequency that an earthquake may cause strong excitation of what, at first, appears to be a relatively stiff single-storey structure. Punching shear may have contributed to the behaviour of the shelter, although the cracking did not extend to the other side of the column junction.

FIGURE 23: SERVICE STATION SHELTER, CORDOBA.

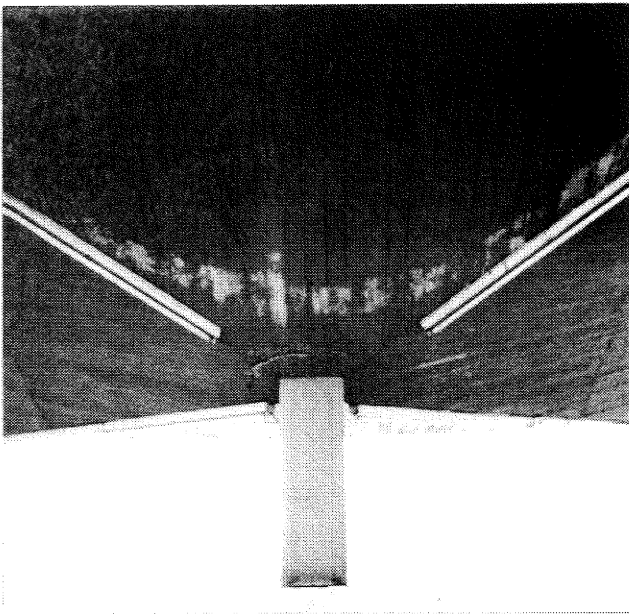
FIGURE 24: CRACKING IN ROOF OF SERVICE STATION SHELTER.

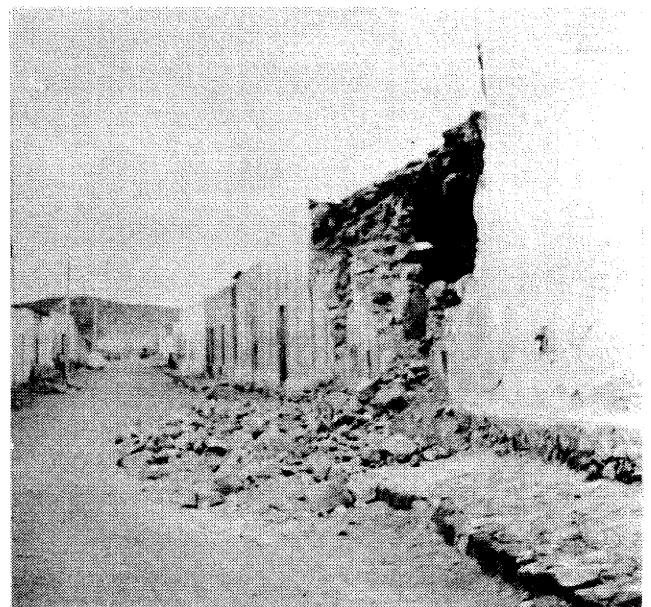
The City of Serdán (12,000 pop.) was the last visited. It was clearly the worst hit by the disaster, with perhaps 300 deaths and many of the homes were damaged or destroyed. Serdán is a very poor agricultural town, and the houses consisted of walls of stone and clay mortar and tile roofs. Figure 25 shows typical damage to such buildings. It appears that the town is too poor to finance an adequate rehousing project, and the Federal Government will have to assume responsibility for the rebuilding. In the meantime, some of the houses, which were only partially damaged, will be rebuilt using the age-old methods. Consequently, the next strong earthquake will again wreak havoc in the town. The pattern is, unfortunately, all too familiar in the country areas of Latin America.

FIGURE 25: TYPICAL VIEW OF DAMAGE TO HOUSING IN SERDAN.
