AN IMMEDIATE FIELD SURVEY OF THE SAN FERNANDO, LOS ANGELES, EARTHQUAKE, FEBRUARY 9, 1971

R. D. Adams*

Seismographic Stations, University of California,
Berkeley, California

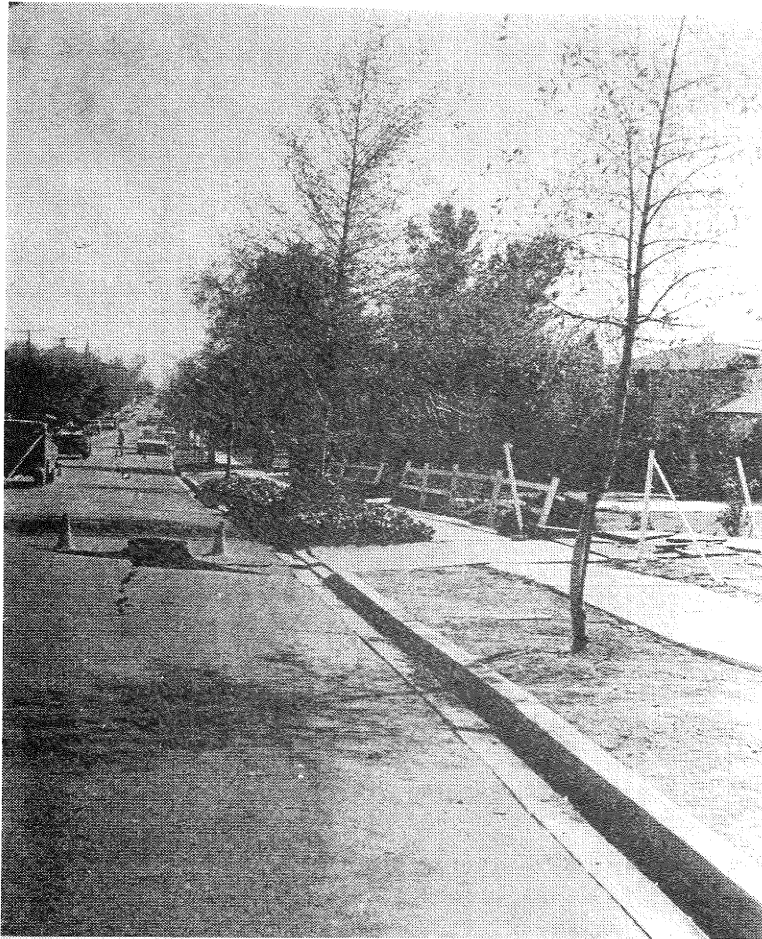
In this zone, streets were broken and curbs buckled, and in some places the roadway had slumped, damaging water and gas mains. The most conspicuous deformation effect was an offset of about five feet in a left-lateral sense that was observed over a distance of about 30 to 50 yards in streets running NW-SE, such as Knox Street, Eighth Street, Cometa Avenue, Bromont Avenue, and Foothills Boulevard (Fig. 3). In streets running NE-SW, such as Orange Grove Avenue, Fernmont Street and Harding Street, shortening of several feet was obvious, with roadways, curbs and sidewalks overthrust or buckled upwards (Fig. 4). In places, vertical steps of up to a foot were found in these streets, with the northeastern side raised. On lawns and open ground, there was also much evidence of ground compression, with the ground broken and cracked in many en echelon scarplets throughout the entire zone of deformation. There was bad cracking on the surface of Interstate Freeway 210, where the

Fig 3. Offset curb looking SE along Eighth Street. Camera is on line of curb in distant part of street.

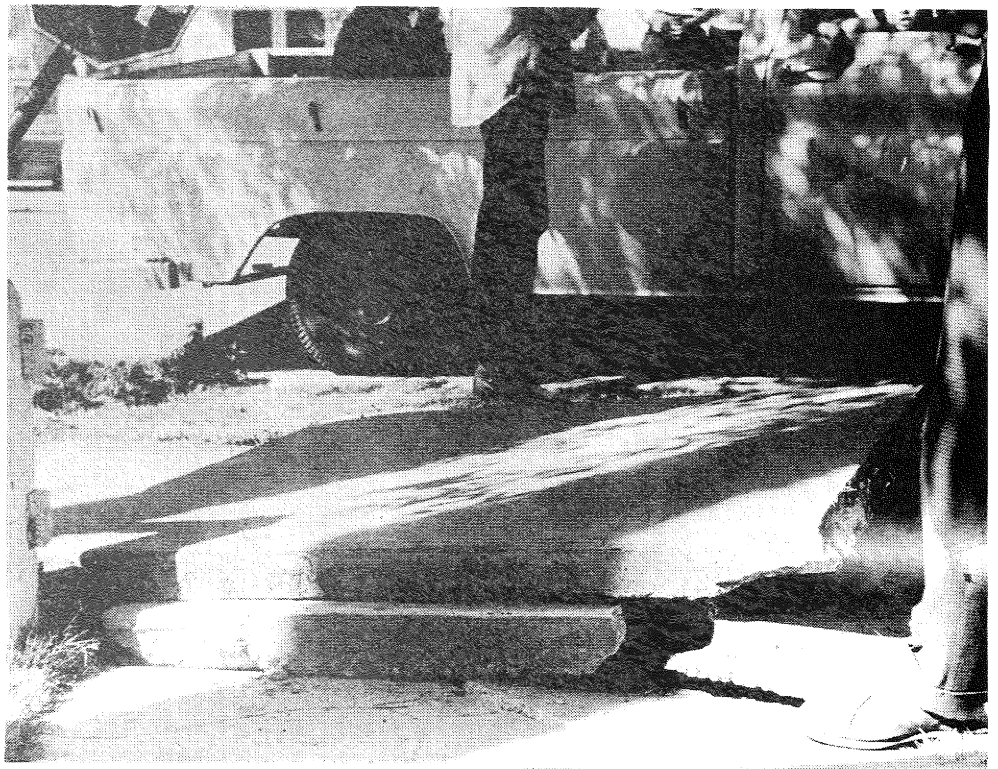
Fig 4. Overthrust sidewalk in Orange Grove Avenue. Compression of ground has forced the upper slab out of the pavement.

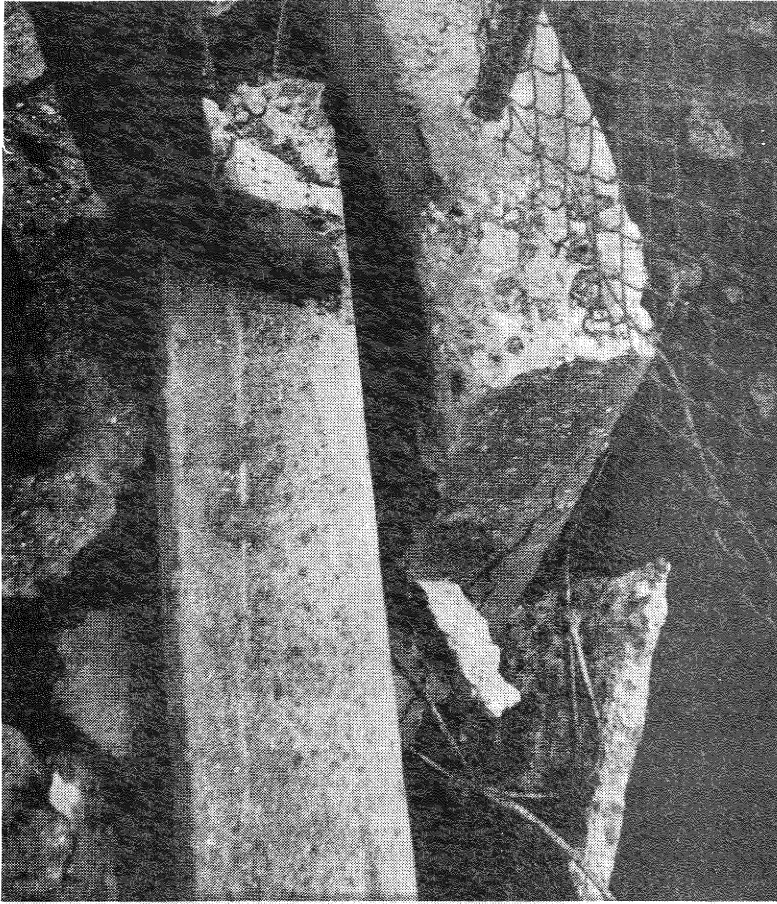
About one mile to the southeast of the junction of Maclay Avenue and Interstate 210, where Lopez Canyon emerges from the mountains, a reinforced concrete channel carrying Lopez Canyon stream was severely compressed and telescoped by several feet (Fig. 5). In the fields to the east of this point, a clear zone of thrusting, again about 20 yards wide, was found where the hills appeared to have moved out over the valley. Here we found many fresh scarplets which ran along the base of the hills. This zone crossed a dirt road above Pierce Street in five distinct breaks. At the most prominent, shown in Fig. 6, the vertical rise of the northern block appeared to be about one foot. We found obvious thrusting in Little Tujunga Canyon, two miles to the east of Lopez Canyon, where a scarp about a foot high ran across an orange grove, the road, and then the stream bed of the canyon.

Fig 5. Telescoping of reinforced concrete wall of channel leading from Lopez Canyon.

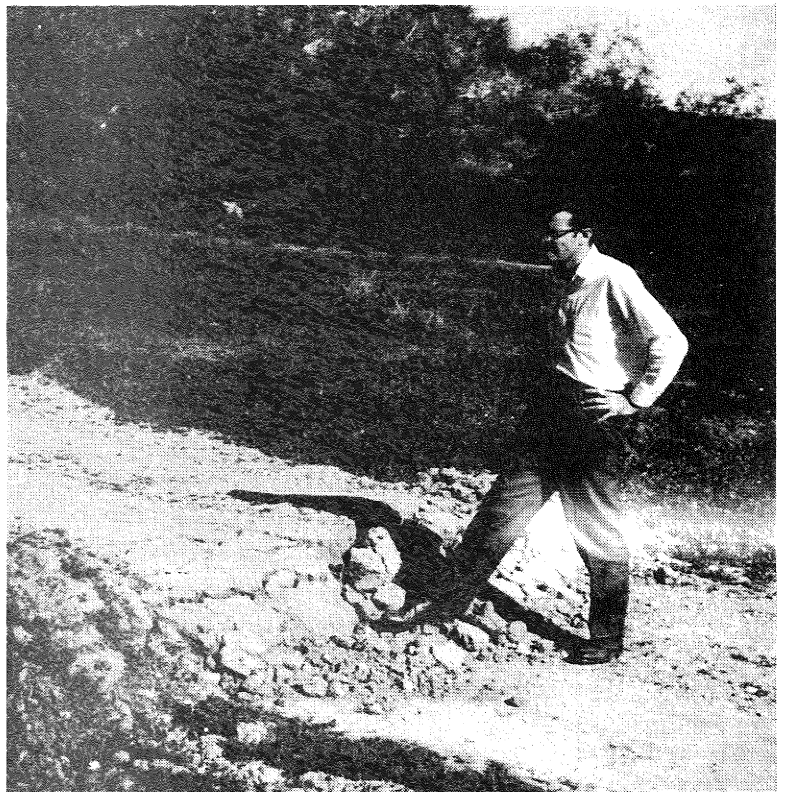
Fig 6. Thrust scarp in fields above end of Pierce Street.

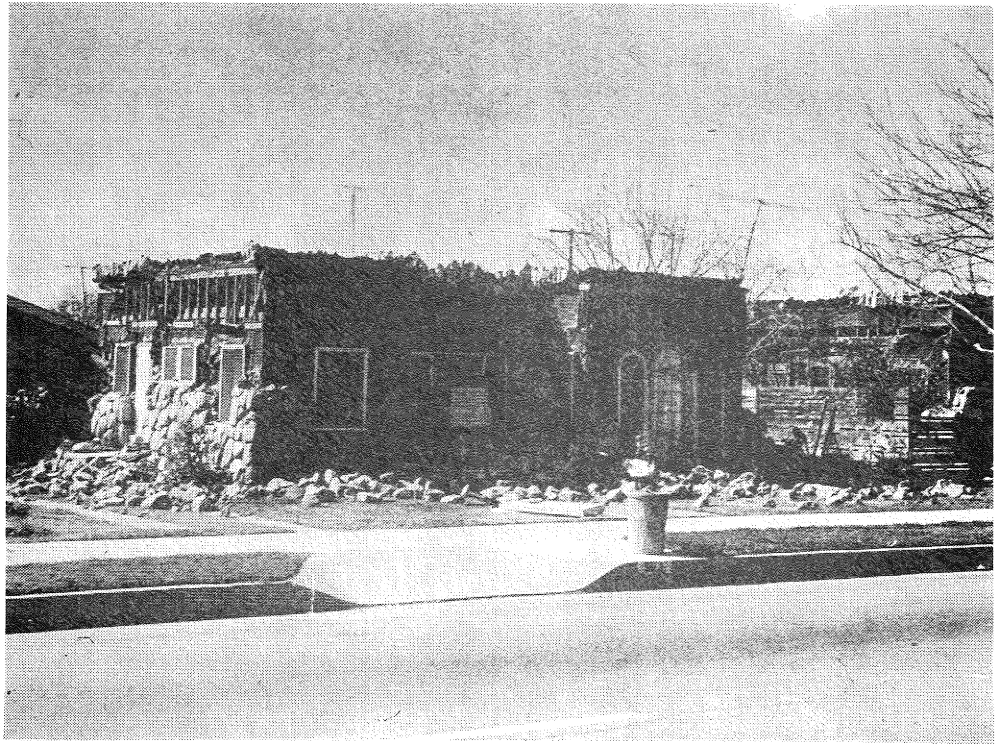
The greatest structural damage to houses occurred in the zone of ground deformation in Sylmar and San Fernando. Here, largely as a result of the ground movement, many wooden-frame houses were damaged beyond repair, although we observed none that had collapsed completely. Stone and brick veneers often fell off (Fig. 7), some houses were thrown off

Fig 7. Fall of stone veneer off house in Eighth Street.

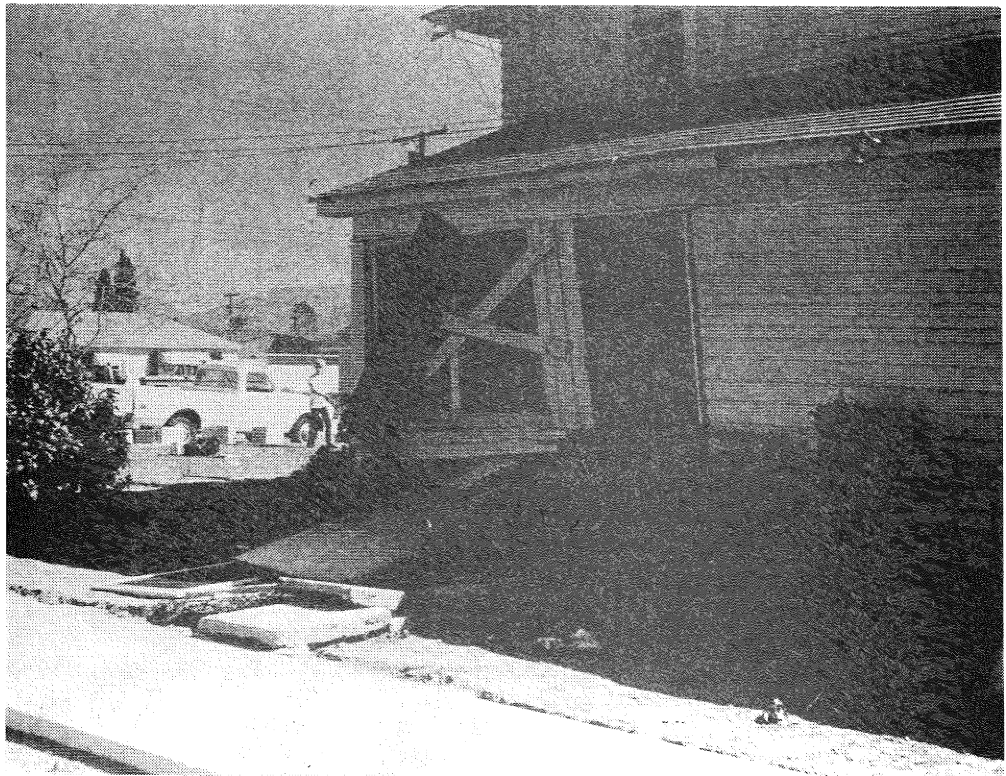
foundations (Fig. 8) and interiors were often badly damaged. The few brick houses in the neighbourhood fared worse, with partial collapse (Fig. 9). Car ports and verandahs were destroyed in many instances and most chimneys were broken. The interior of the houses was completely chaotic, with broken furniture and contents from cupboards strewn over the floor. In this area there were many breaks in the underground service mains, and I would rate the overall intensity in this central zone as about MM IX, but falling off within a hundred yards or so to MM VIII. Outside this high intensity zone, isolated instances of collapse of masonry buildings were found. The Mission Hotel in the San Fernando Mall had lost its outer brick walls, leaving the roof supported on internal walls (Fig. 10). Also in central San Fernando, in First Street, a two-storey brick building had collapsed completely, killing a boy, one of the few occupants. These buildings, however, and others that failed as far away as central Los Angeles (25 miles from the epicentre) were isolated instances of poor construction in areas that otherwise suffered only moderate to minor damage.

Fig 8. House in Orange Grove Avenue, thrown off foundation towards camera. Note door step forced upwards.

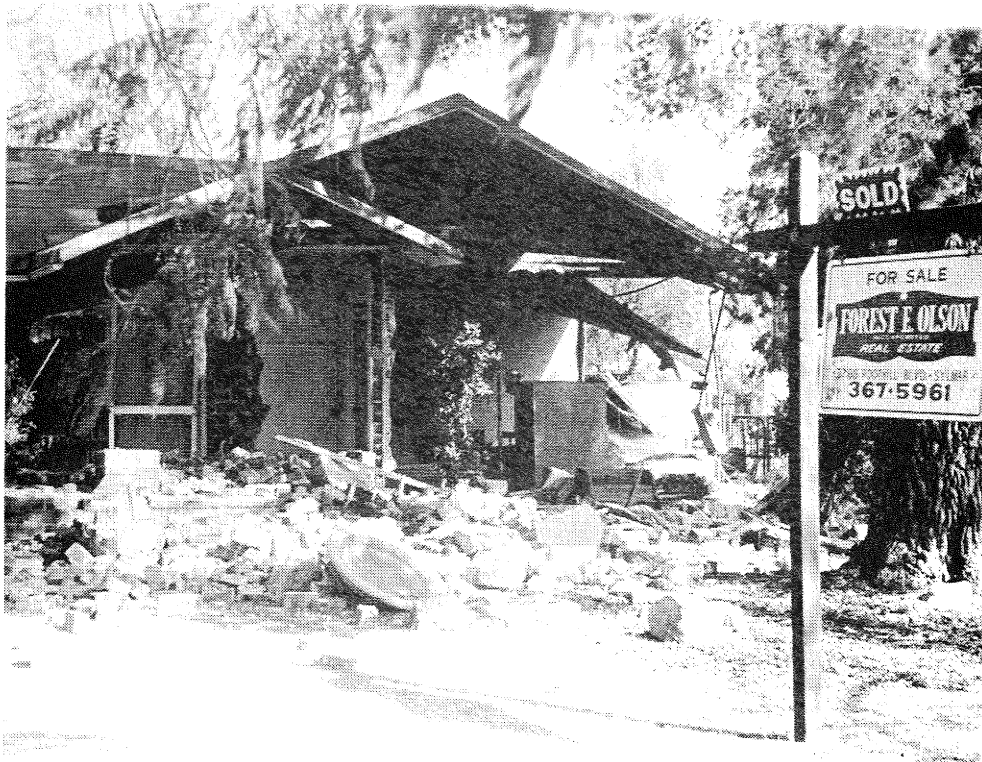
Fig 9. Collapse of brick walls of house in Eighth Street.

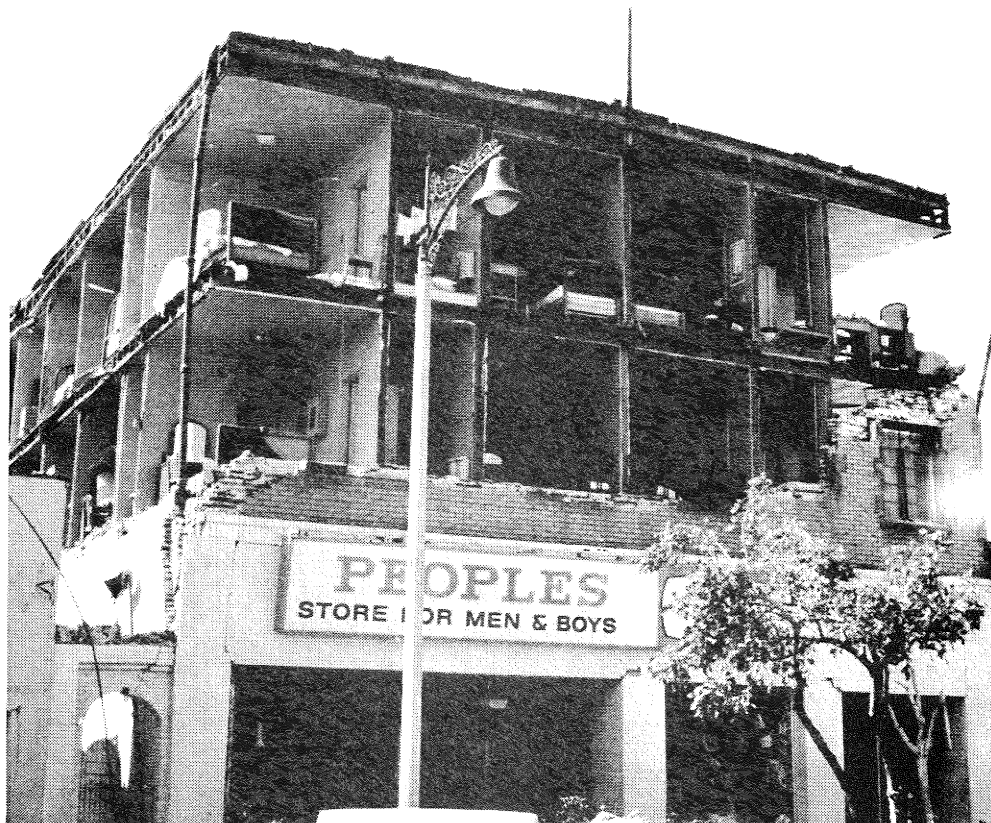
Fig 10. Mission Hotel, San Fernando Mall. Masonry walls

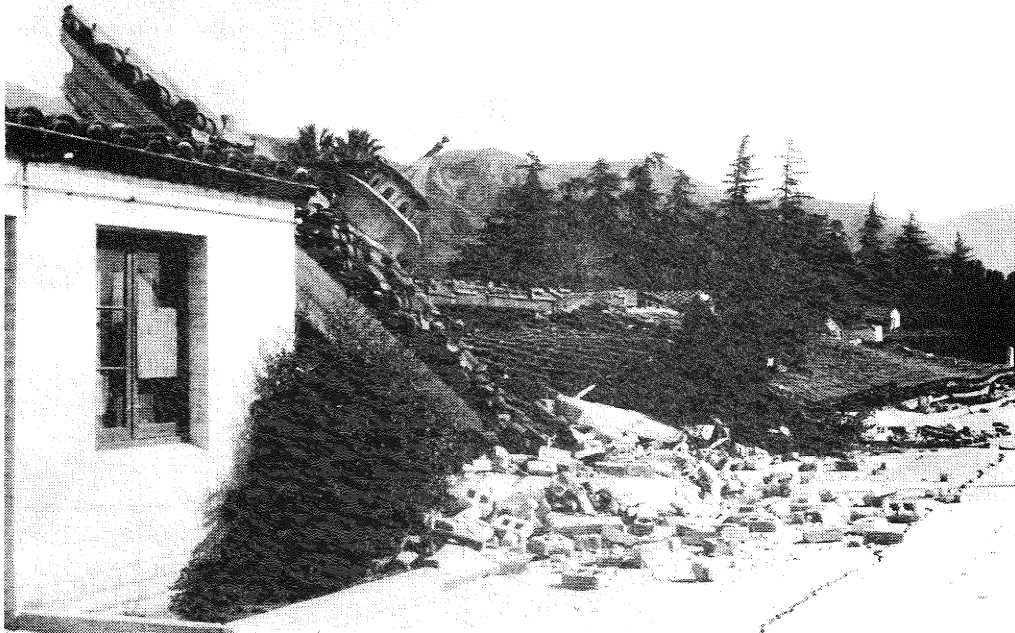
One section of the old Sanatorium building of this complex in Sylmar had collapsed completely (Fig. 11). The building appeared to be of unreinforced concrete blocks, with a heavy tile roof. The walls had failed completely, and the mortar appeared to have little cohesion. The main buildings of the Olive View Medical Centre had been dedicated only in the latter part of 1970, after being built at a cost of nearly \$25,000,000. The buildings are now totally beyond repair. The structure was built in four main wings, arranged around a central court, each with a tower block of recreation rooms and stairs at one end. Three of these towers had toppled completely and the fourth, although still standing, was leaning outwards at an angle of about 10°. Where the towers had broken away, the ends of the main block were completely clean, showing that no attempt at all had been made to tie the structure together (Fig. 12). The main blocks themselves, of reinforced concrete construction, suffered distortion of the first floor, and X-cracking of the columns at second floor level. The corner pillars at ground and first floor level had failed particularly badly, with concrete falling away to expose distorted reinforcing. The ground floor of the psychiatric wing, originally a two-storey structure separate from the main building, had failed completely with its ceiling slab now being only a foot or so above the ground. Similarly, the supports had failed under the large slab under which the hospital's ambulances were parked, causing their total destruction. It is remarkable that of the 400 to 500 people in the hospital at the time of the earthquake, only one was killed. Had the shock occurred during the day, when the recreation towers were occupied, the toll would have been much higher.

Fig 11. Collapsed wing of Olive View Sanatorium. Walls were constructed of unreinforced concrete blocks, with poor cement.

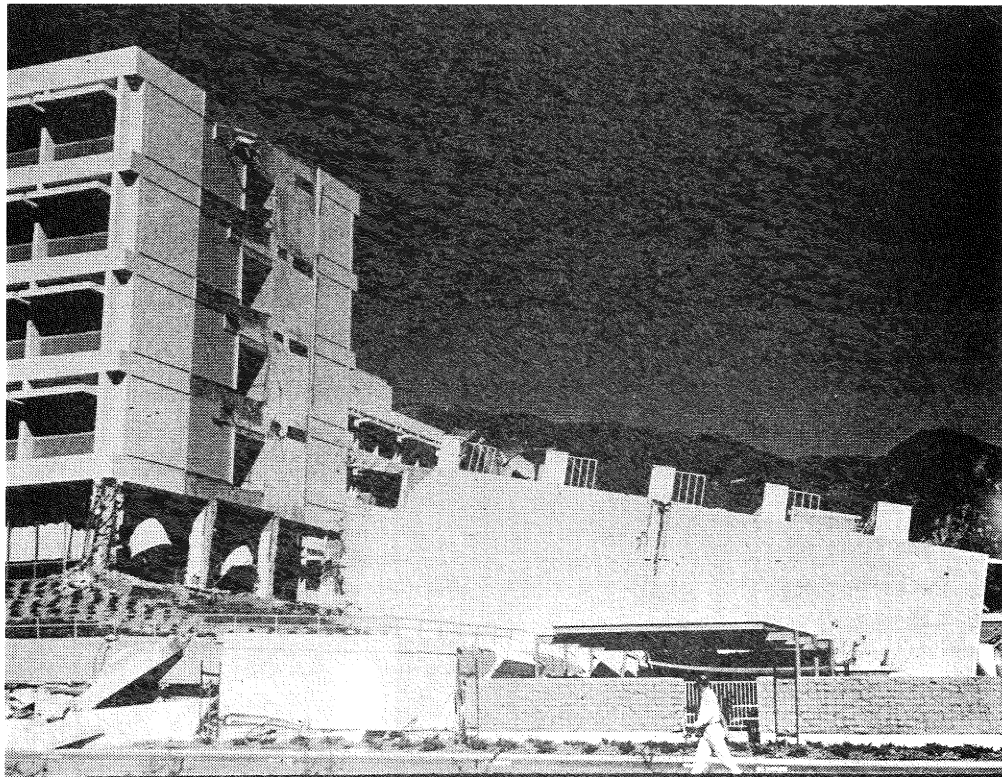
Fig 12. Overturned end tower of Olive View Medical Center, Sylmar. Note complete absence of ties between tower and main building and failed corner column of main building.

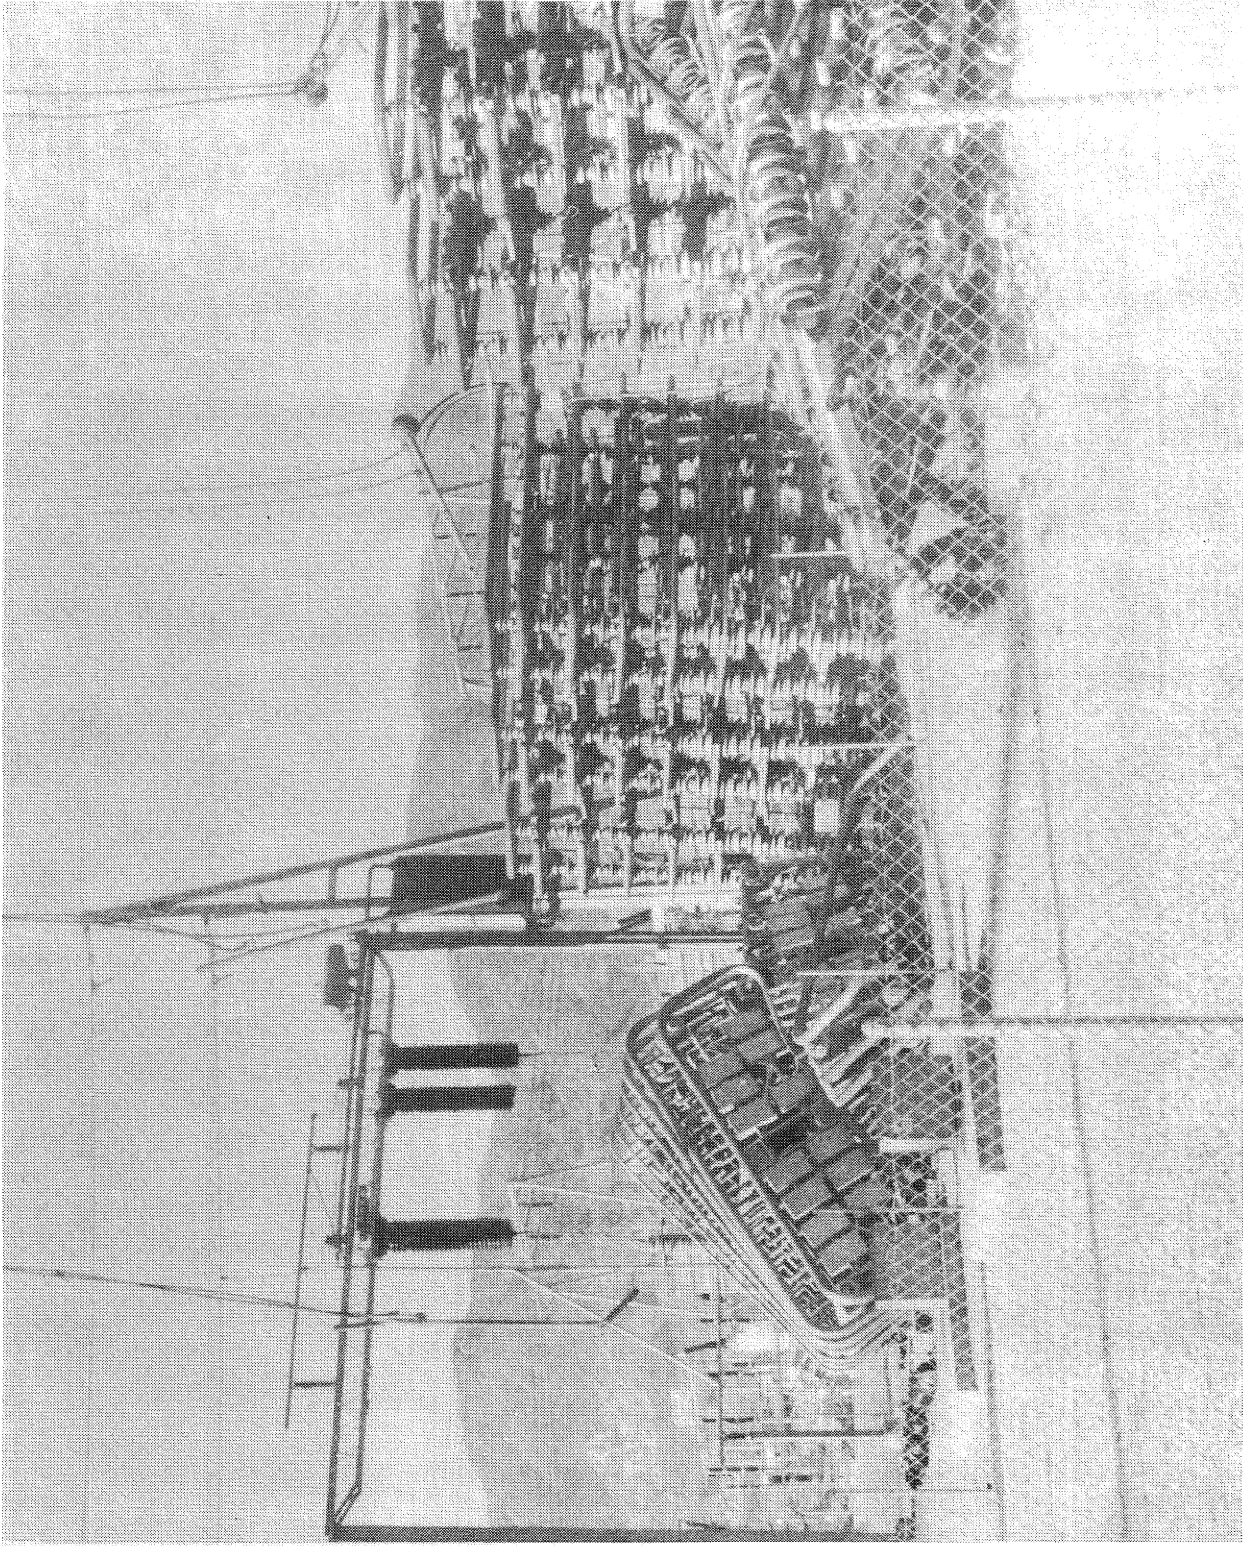
This large D.C. to A.C. Converter Station is about two miles to the west of the areas already mentioned in Sylmar, between Interstate Freeway 5, near its junction with Interstate 210, and the Upper Van Norman Reservoir. In the curbing and culverts beside the station we found evidence for a foot or so of left-lateral offset, consistent with the general pattern of overthrusting from the north, and suggestive that an expression of the main thrust fault ran through this area. The transformer and switching gear of this station were almost completely destroyed (Fig. 13). Transformers were moved up to several feet bodily from their beds. Some had toppled over completely, and other equipment had sunk up to a foot into the gravelly surface of the ground. An engineer on duty at the time of the shock told us that a computer had shut down the station in a few milliseconds, preventing serious electrical damage.

Fig 13. Collapsed outdoor equipment at Sylmar Converter Station.

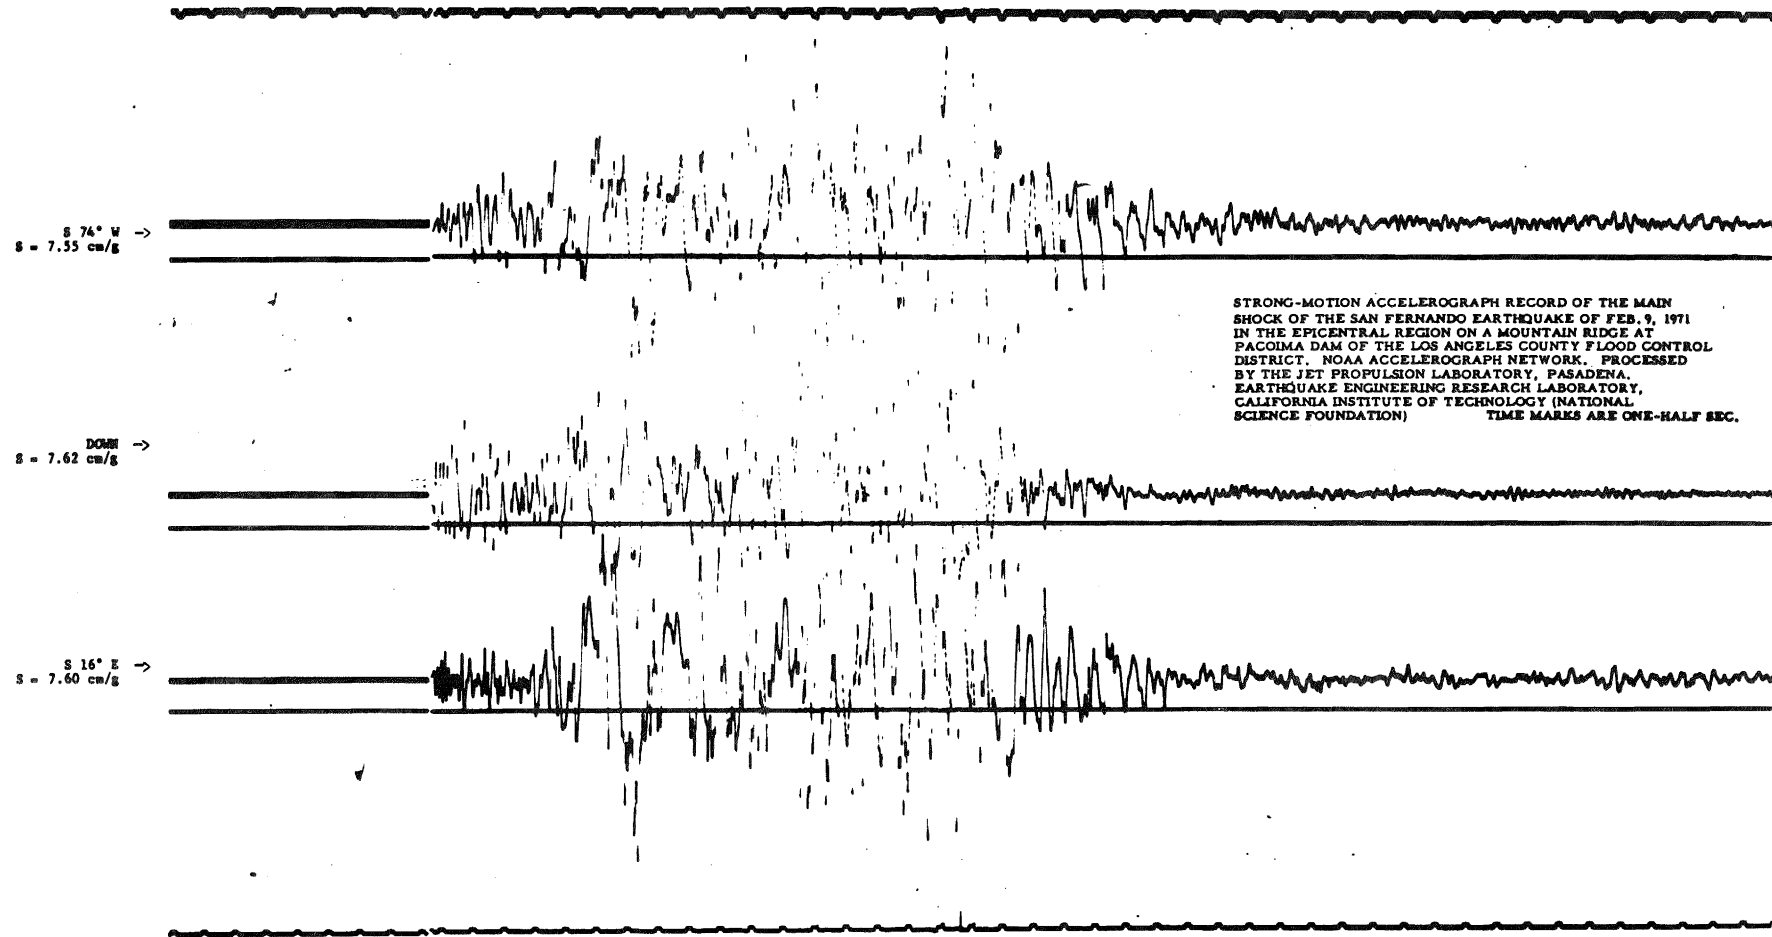
It is believed that more than 200 records of strong-motion acceleration have been obtained during this earthquake. Some instruments were close to the epicentre and high intensity regions, others were in less strongly shaken areas, and some at various levels in high-rise buildings in central Los Angeles. Mr. W. K. Cloud of the Seismological Field Survey of NOAA reports an acceleration of more than 1g recorded in the abutment of Pacoima Dam in the San Gabriel Mountains, about 5 miles from the epicentre and about one mile to the east of the Veterans' Administration Hospital. Here, accelerations of between 0.5 and 0.75g lasted approximately 7 seconds. This is the highest acceleration ever recorded and considerably higher than that thought possible by some earthquake engineers. This record is reproduced in Fig. 14.

Fig 14. Strong-motion accelerogram recorded at Pacoima Dam. Maximum acceleration greater than $1g$. Reproduced by permission of Mr W.K. Cloud, Seismological Field Survey, N.O.A.A.
