DAMAGE TO FREEWAY STRUCTURES IN THE SAN FERNANDO EARTHQUAKE

J. H. Wood* and P. C. Jennings**

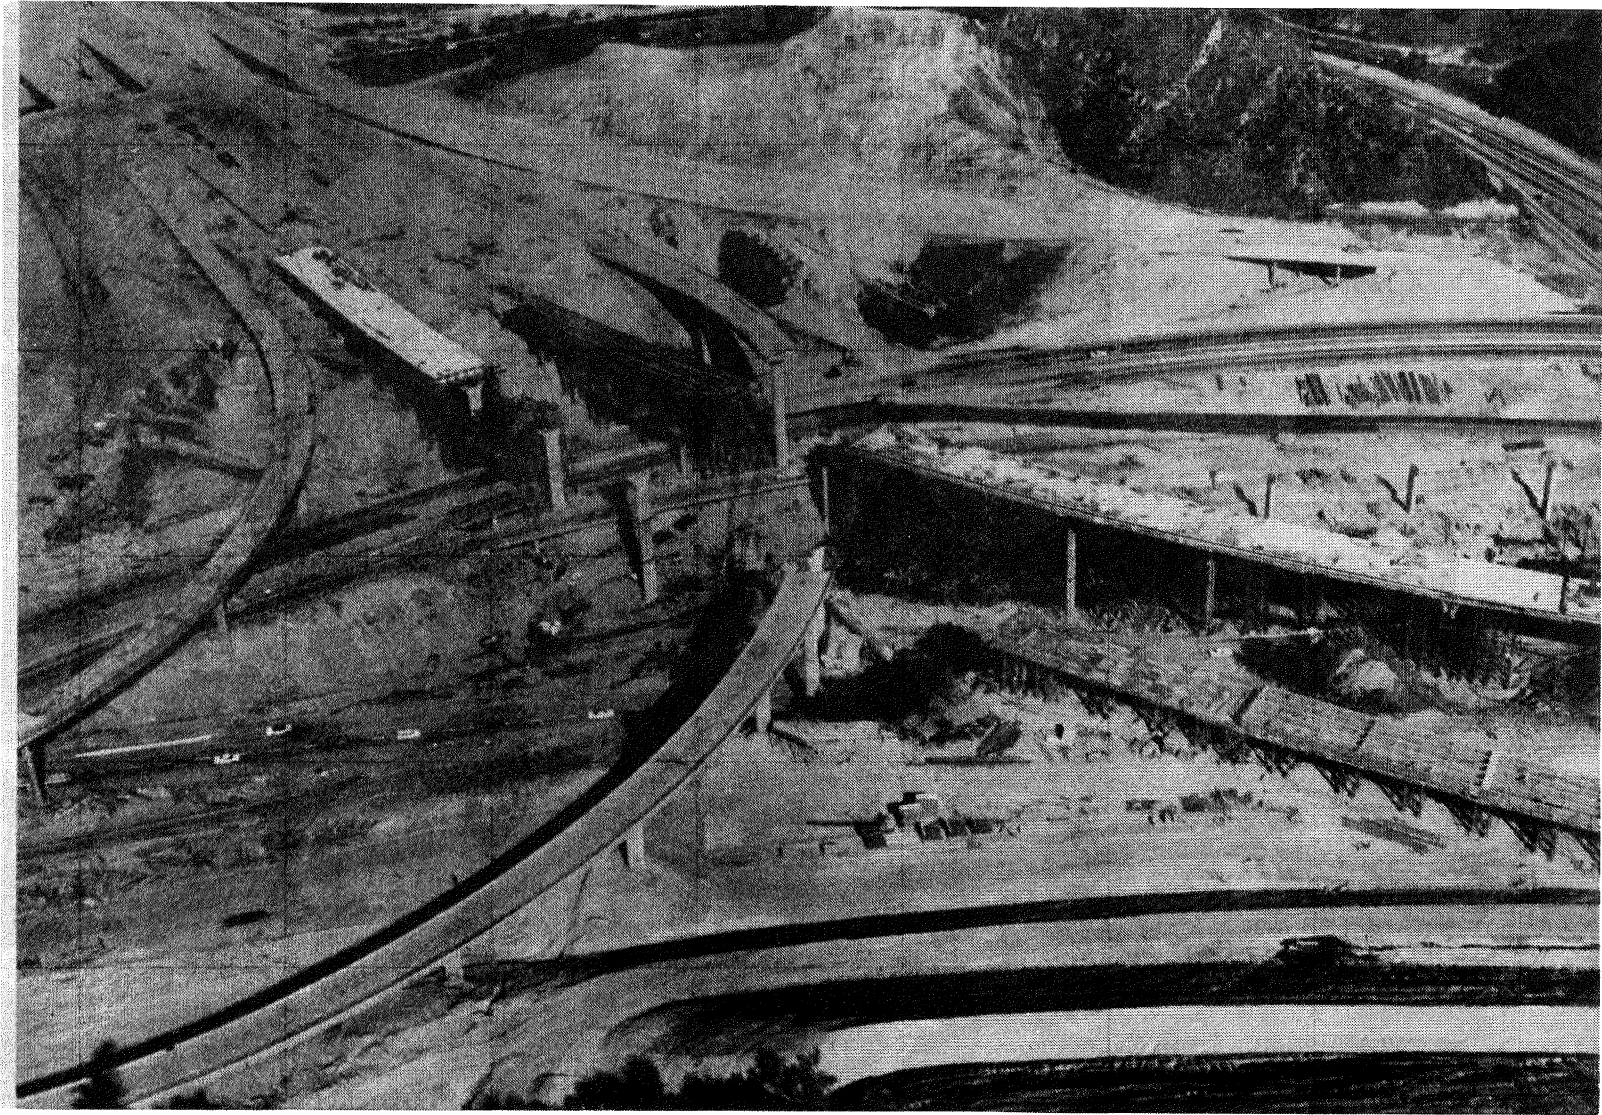
Fig. 2 The Golden State - Antelope Valley freeway interchange, looking east. The South Connector Overcrossing curves from lower left and the missing spans which collapsed can be seen in the center of the photograph. Other bridges were damaged by falling debris and settlement of falsework.

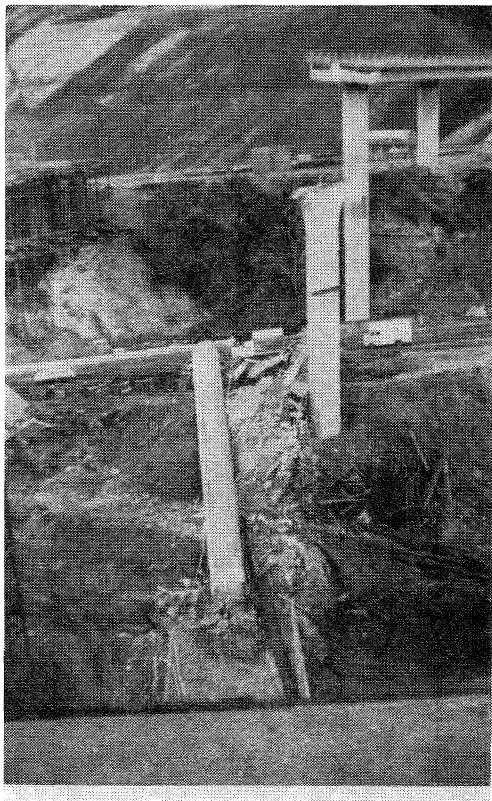
Fig. 5 The collapsed pier and superstructure of the South Connector Overcrossing. This view was taken from the remaining eastern section of the bridge looking towards the western section. The pier standing between the two sections is for an overcrossing under construction.

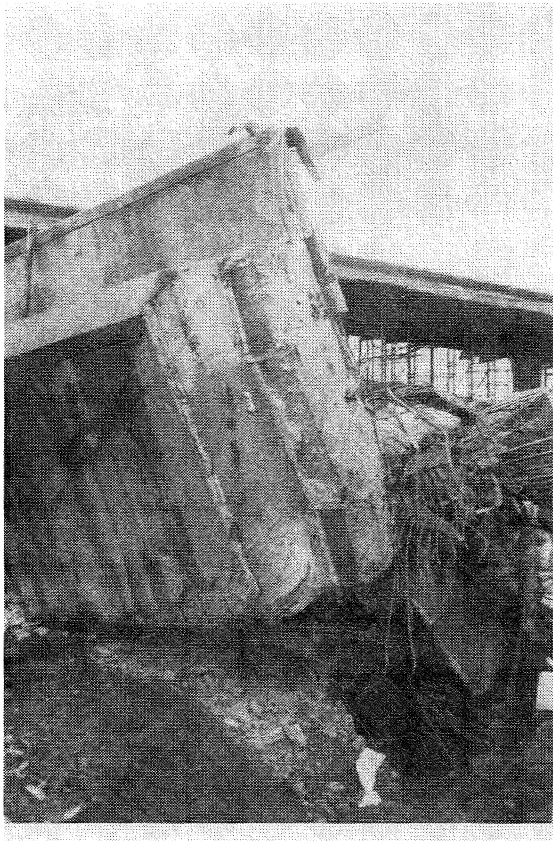
It is conceivable that combined transverse and longitudinal vibrations were sufficient to allow one of the hinge joints to open sufficiently for the girder end to fall. The 14 in seating width appears small in relation to the 190 ft long spans. The two joints in the remaining western section of the bridge showed evidence of pounding but it was not possible to determine whether these joints had separated appreciably during the earthquake. Although the monolithic connections between the superstructure and abutments showed signs of overstressing no large relative displacement between the superstructure and abutments, or abutments and the ground, appeared to have occurred.

Fig. 6 The western end of the collapsed superstructure of the South Connector Overcrossing. An elastomeric hinge-joint was constructed at both ends of the collapsed section. Details of the 14 in wide notch used at the joints can be seen in this view.

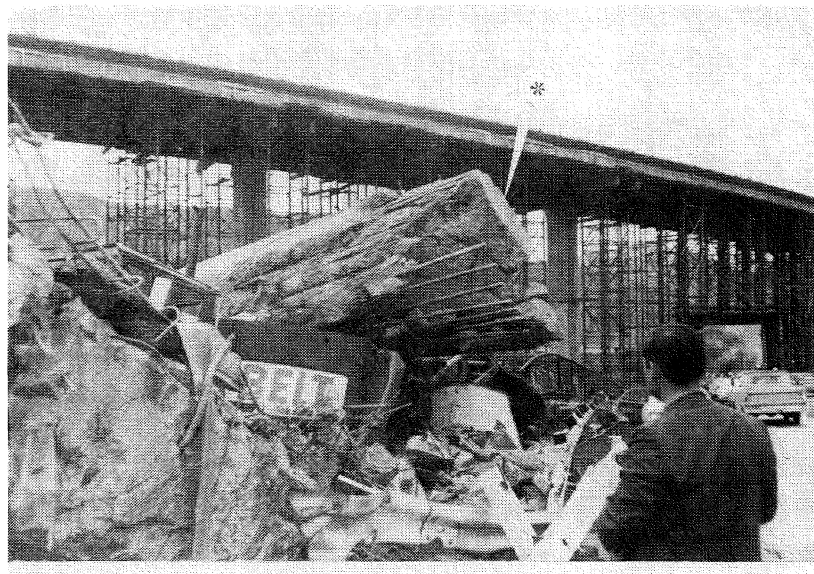
Fig. 7 Top of the collapsed column of the South Connector Overcrossing. Apparently the deck was cast on top of the flat surface at the column end.* Remains of the capping beam were not visible and must have stripped from the column during failure.

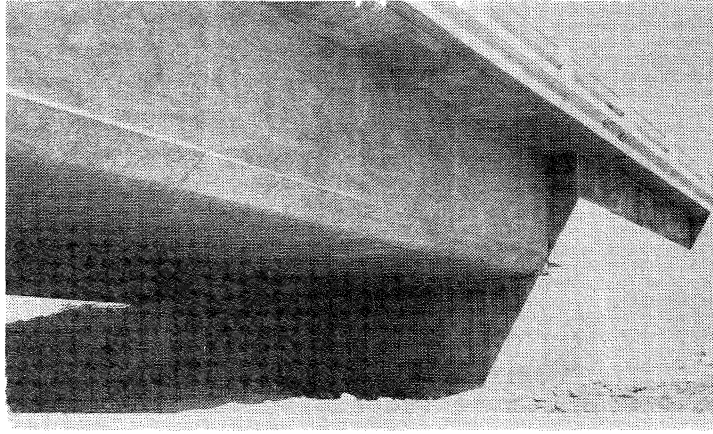
Fig. 8 Abutment of the remaining eastern section of the South Connector Overcrossing. Spalling occurred at the monolithic joint between superstructure and abutment but there was no evidence of appreciable displacement.

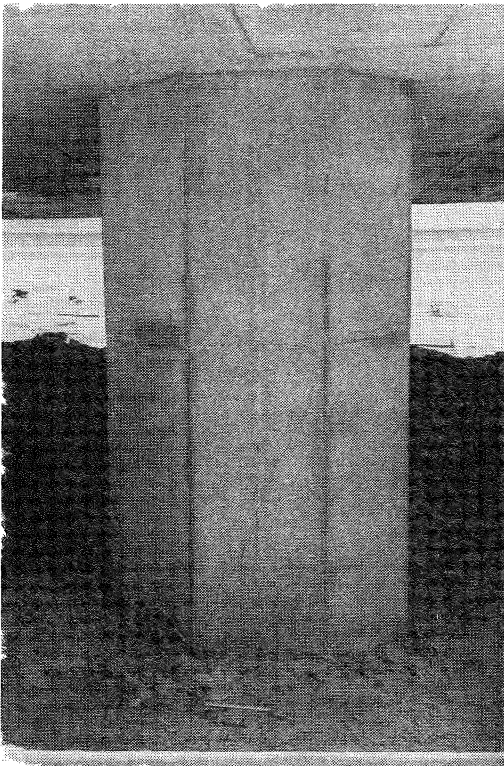
Fig. 9 Shear cracking in Column 9, the shortest column (7 ft) supporting the South Connector Overcrossing. Other remaining columns were undamaged.

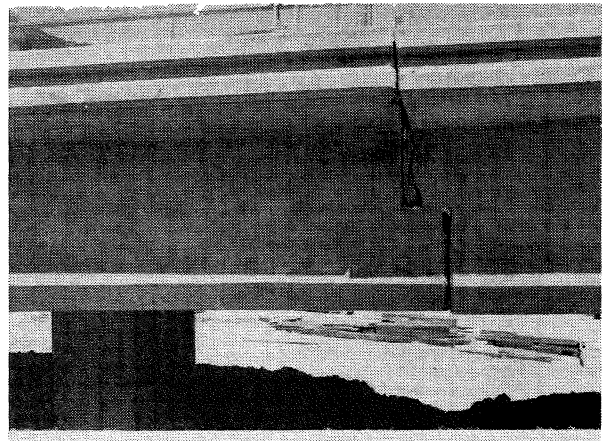
Fig. 10 The hinge-joint near Column 9, South Connector Overcrossing. Both joints on the remaining western section were damaged by pounding.

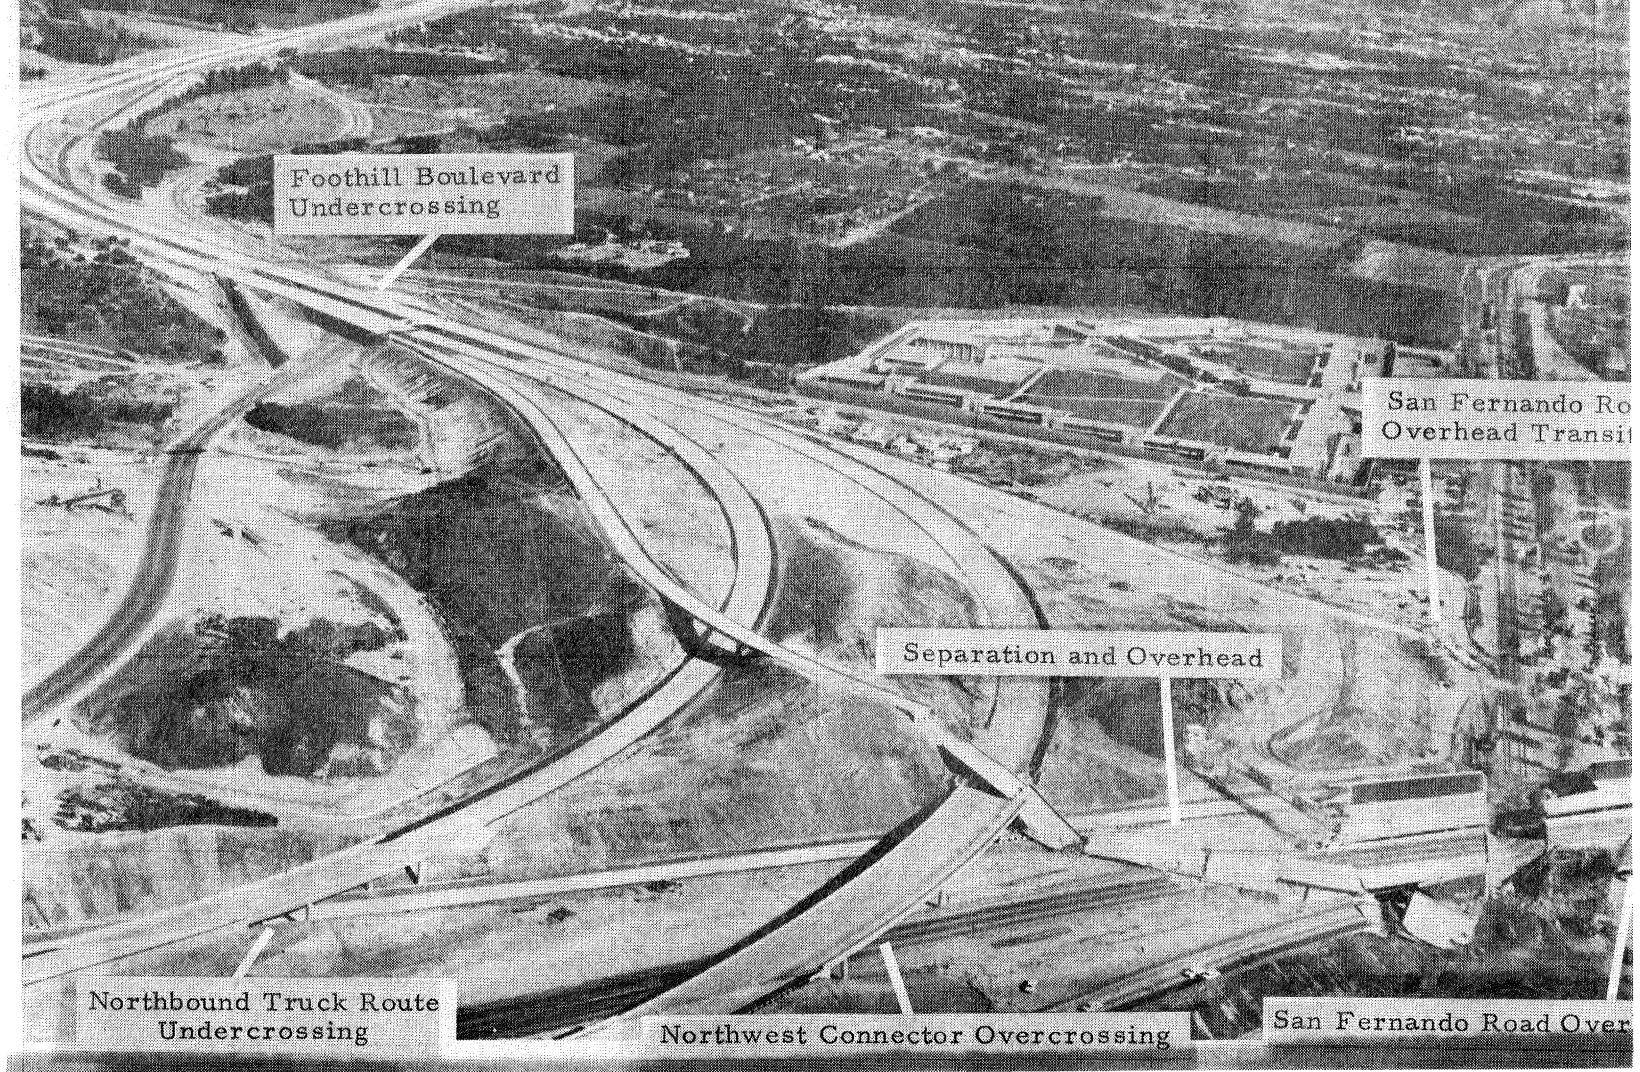
Fig. 11 The Golden State - Foothill freeway interchange, looking southeast. This view was taken several days after the earthquake and considerable demolition work had been carried out in the vicinity of the San Fernando Road overhead bridges.

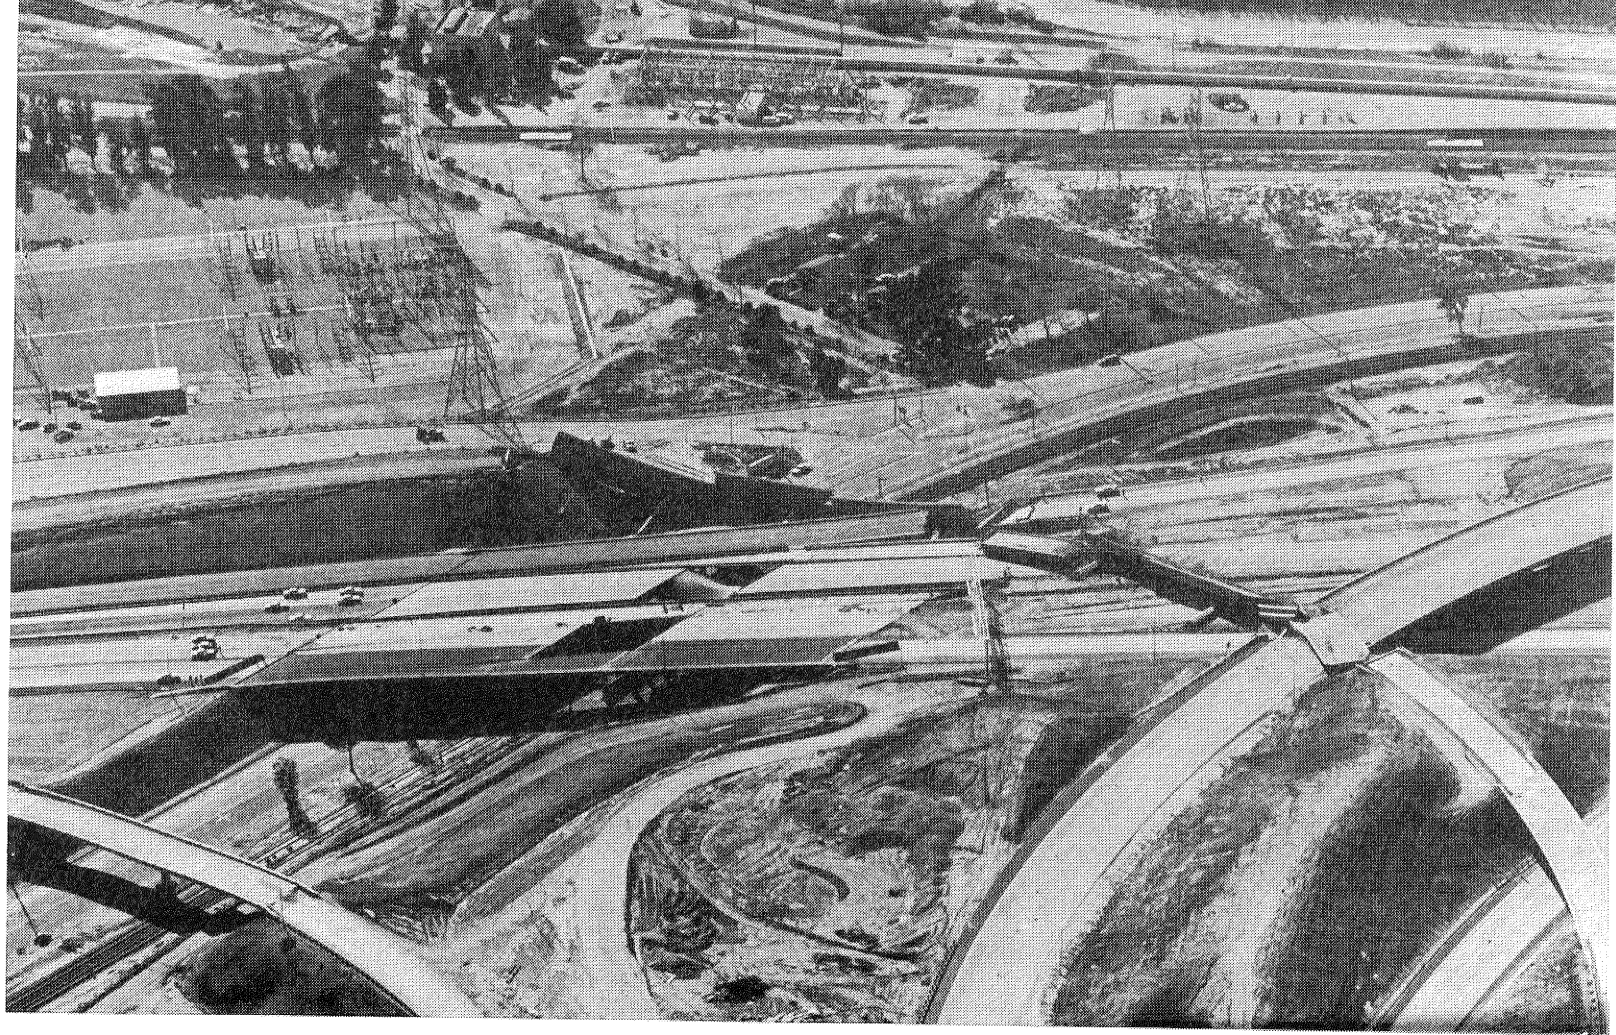
Severe damage occurred at the base of the central column (Fig. 12) but unfortunately the bridge was quickly demolished before an inspection could be made. Photographs that were unavailable for this report indicated that the failure in the column was basically from overstress in bending. The relative simplicity of this particular structure would make it suitable for a detailed analysis.

Fig. 12 The Golden State - Foothill freeway interchange, looking west. This view was taken several hours after the earthquake. The San Fernando Road transition bridge, lower left, was still intact at this stage but note the vertical sag produced by a failure at the column base.

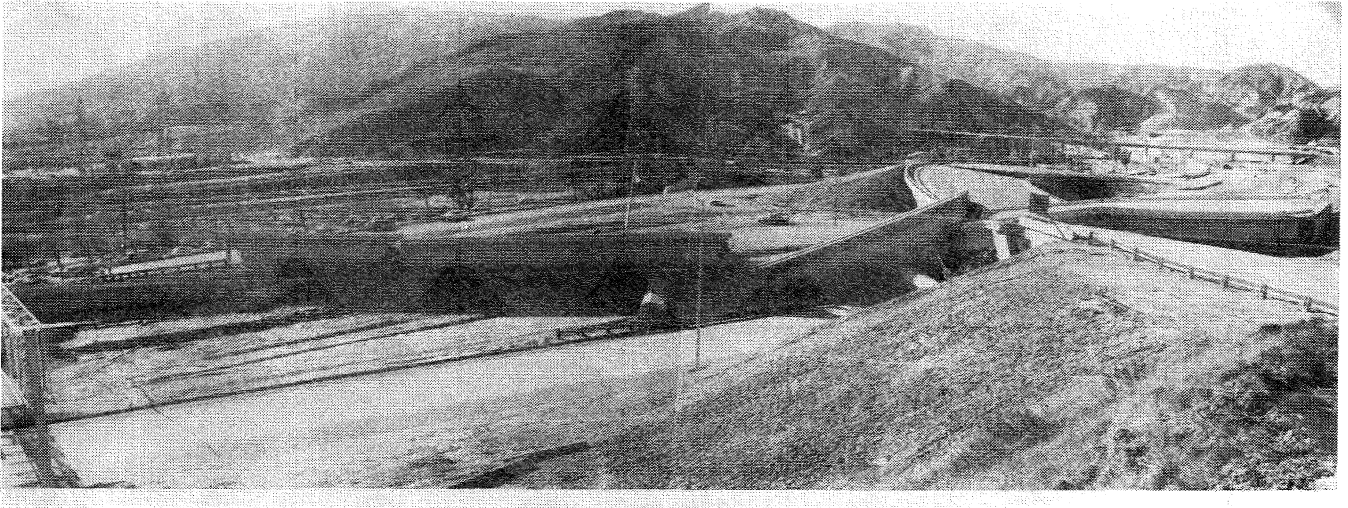
Fig. 14 Collapse of the Separation and Overhead bridge at the Golden State - Foothill freeway interchange. The northernmost end of the superstructure is visible at the far right. The bridge was a 770 ft R. C. box with a single hinge-joint.

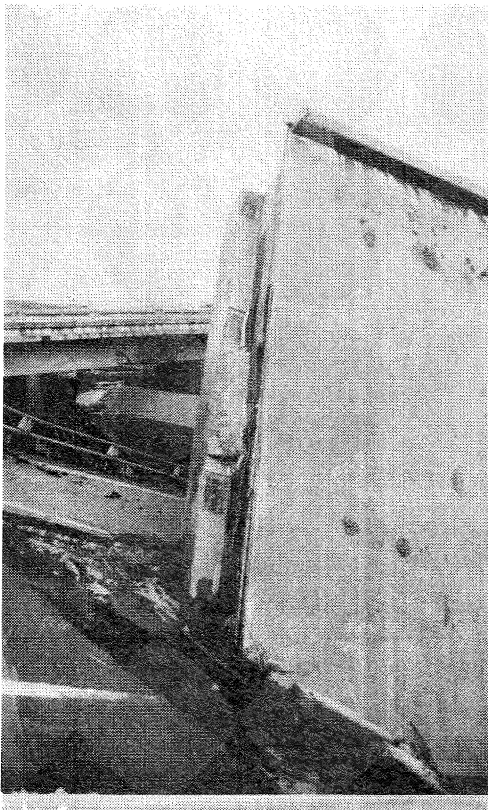
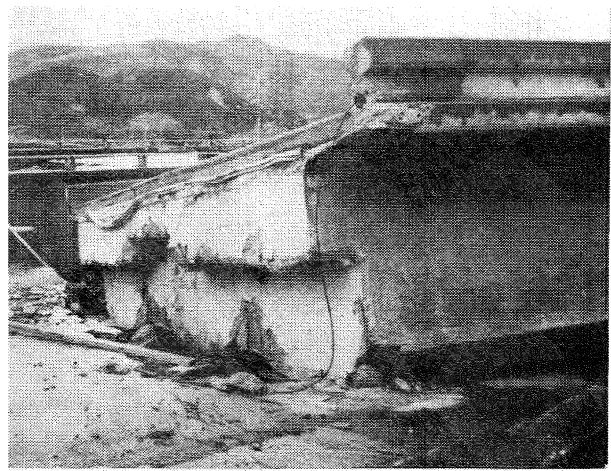
The combined influence of permanent ground movements and the severe vibrations of the long bridge essentially unrestrained at its abutments could have caused separation of the 14 in hinge joint with subsequent collapse of the bridge spans.

The two views show the separated sections at the hinge-joint of the Separation and Overhead bridge. A standard 14 in wide elastomeric hinge was used. Note the shear-key and the absence of hold-down or linkage bolts.

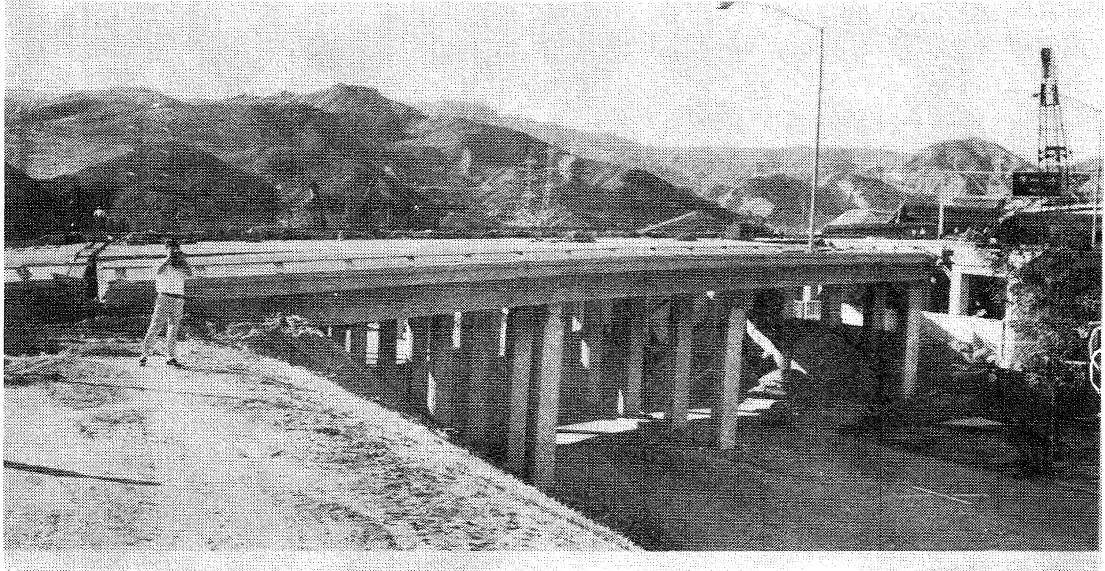
Fig. 16 The San Fernando Road Overhead bridges, Golden State - Foothill freeway interchange, looking northwest. Sections of the central span of the seven-span bridges collapsed. Note the separation at the abutment joint and the column failures.

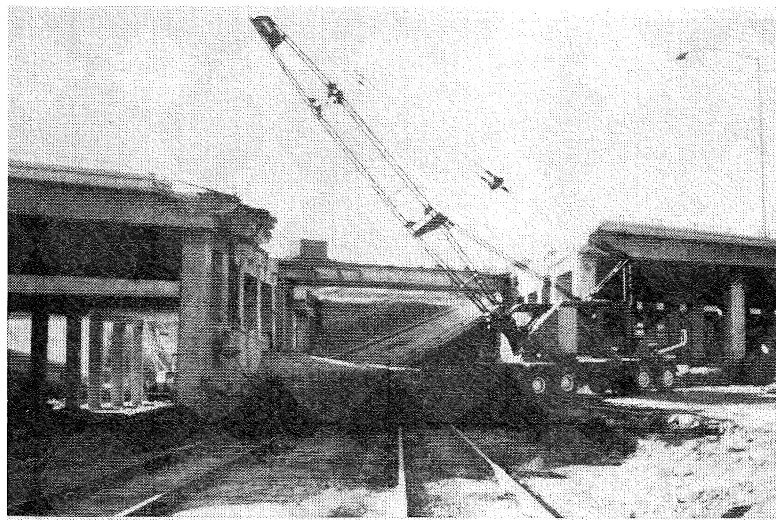
Fig. 17 Collapse of the simply-supported steel girder spans of the San Fernando Road overhead. The newer widening sections of prestressed girder construction remained intact. This view, the day following the earthquake, shows demolition work in progress to open the railway.

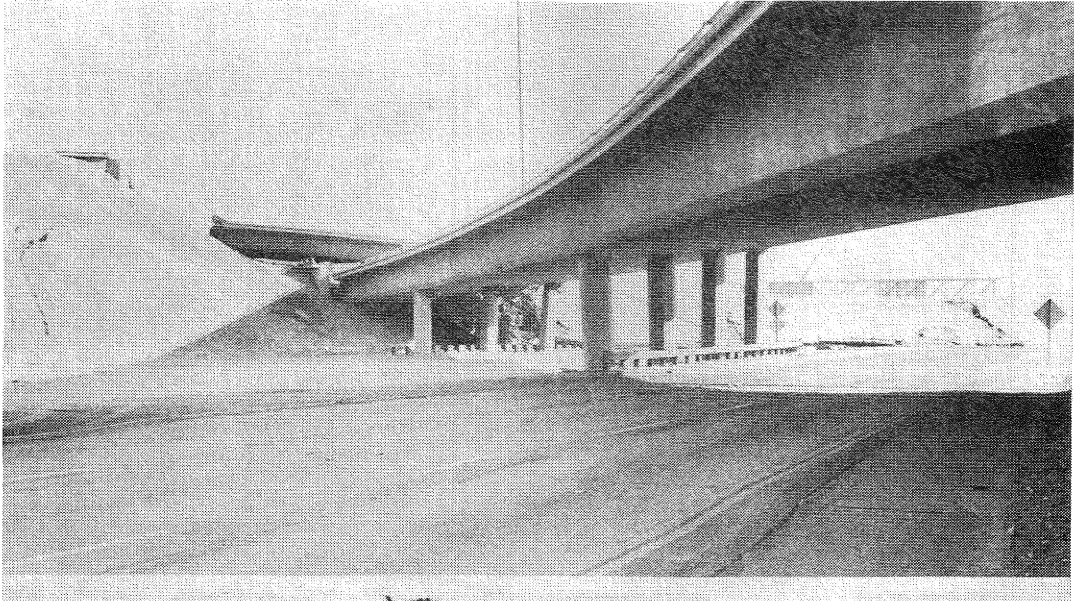
Fig. 19 The Northwest Connector Overcrossing, Golden State - Foothill freeway interchange, looking east. The Separation and Overhead bridge fell on the span adjacent to the eastern abutment of this bridge.

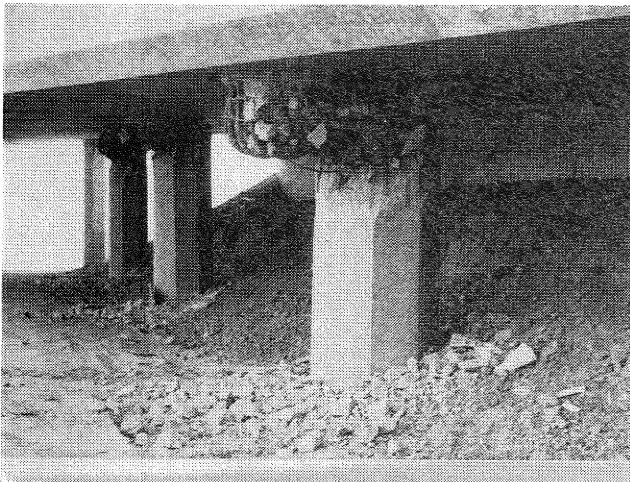
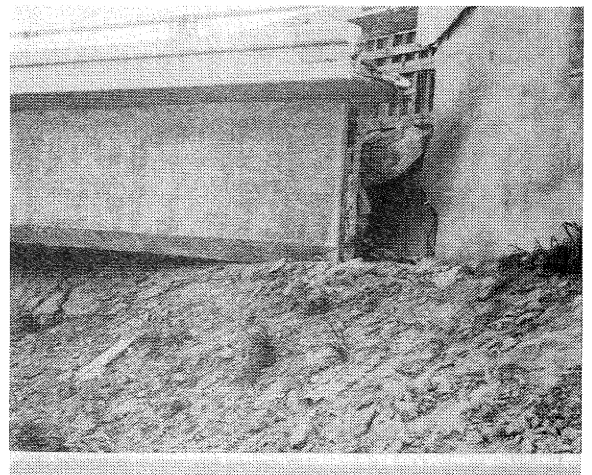
Pier and abutment failures at the western end of the Northwest Connector Overcrossing. The failures may have resulted from the combined influence of ground shaking, permanent displacement and the impact at the eastern end of the bridge.

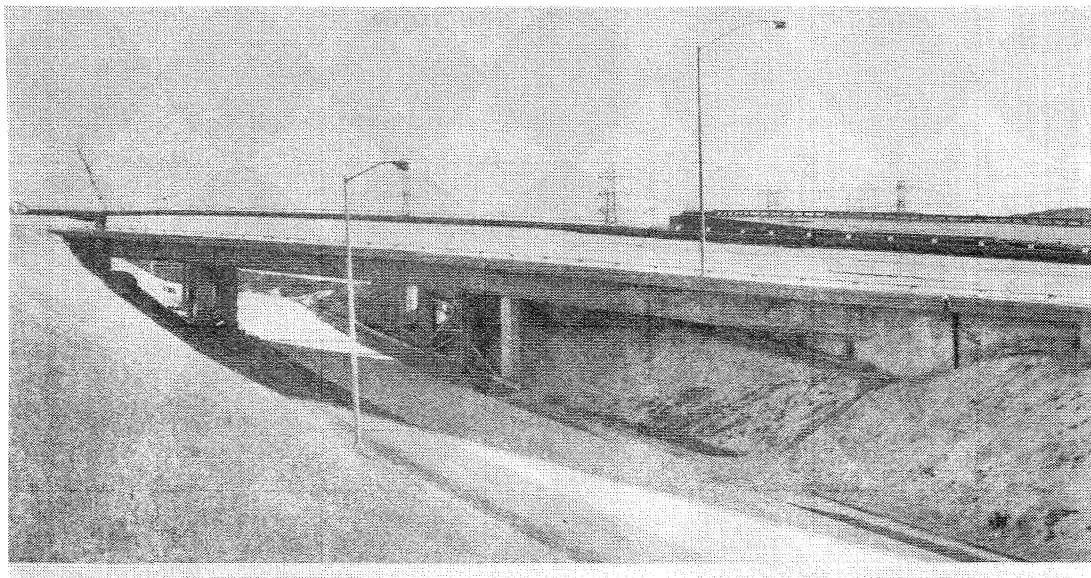
Fig. 21 The Northbound Truck Route Undercrossing, Golden State - Foothill freeway interchange, looking south. The eastern abutment has a skew of 55° and the western abutment is approximately 70° skew.

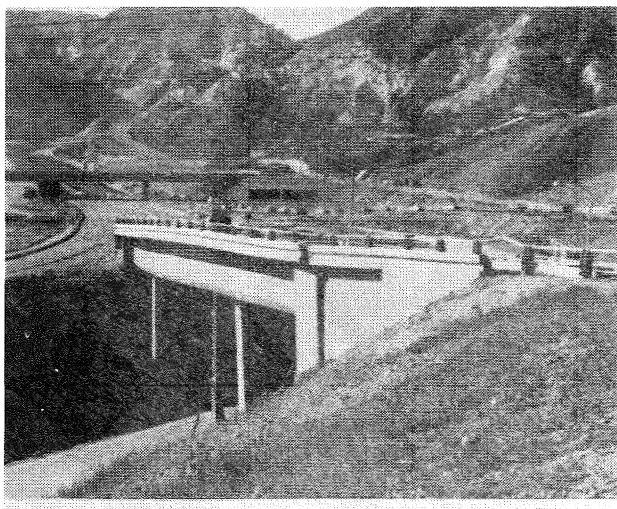
Fig. 22 The eastern abutment Northbound Truck Route Undercrossing. The bridge tended to rotate in a horizontal plane resulting in a 4 in displacement of the superstructure relative to the abutment wingwalls.

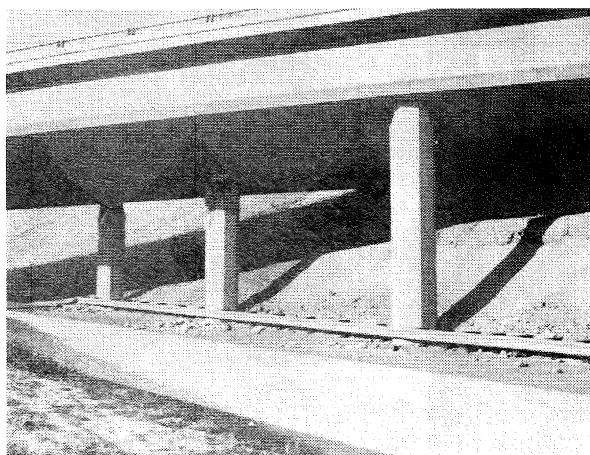
Fig. 23 Bending failures in the columns of the eastern pier of the Northbound Truck Route Undercrossing. The columns are on spread footings.

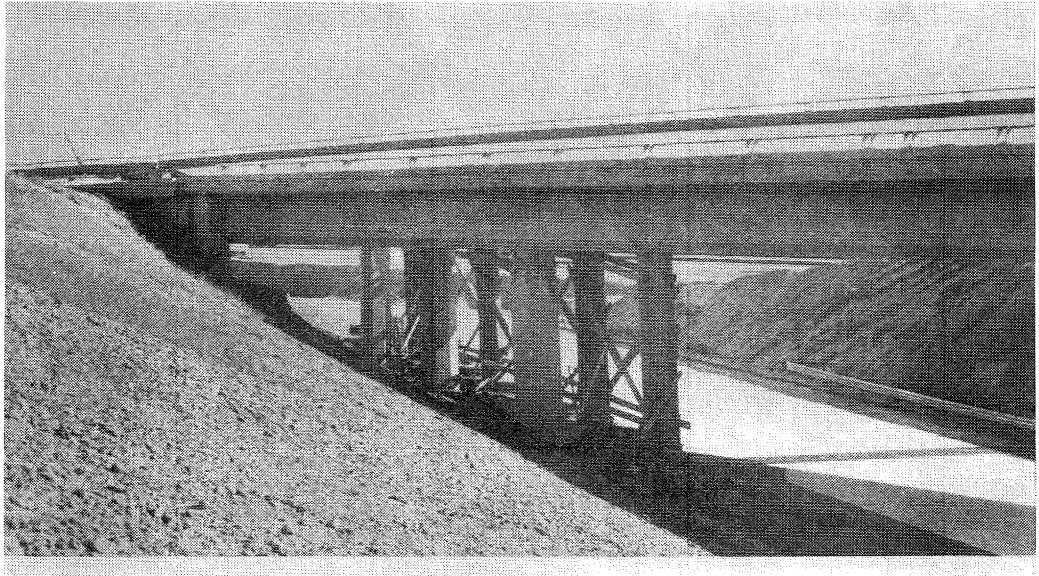
Fig. 24 Pier and abutment damage at the eastern end of the Northbound Truck Route Undercrossing. The continuous R. C. box bridge tended to rotate about the western end producing large displacements at the eastern end.

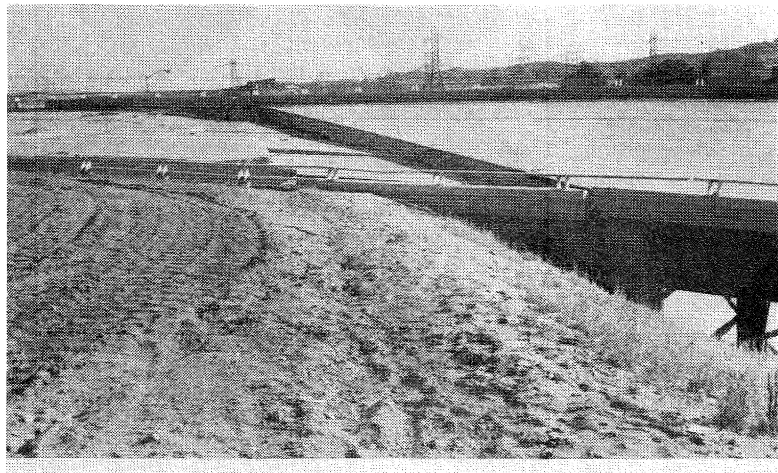
Fig. 25 Backfilling settlement and pavement failure at the eastern abutment of the Northbound Truck Route Undercrossing. Note the separation of the pavement from the abutment recess resulting in a potential barrier for emergency vehicles.

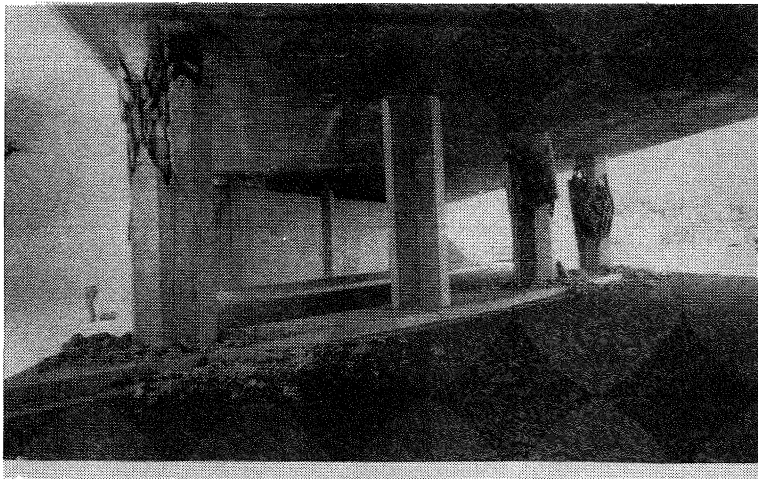
A number of factors probably contributed to the overloading of the central pier of the southeastern bridge. The abutments and piers have spread footing foundations and possibly differential settlements occurred producing an increase in vertical loading on some of the columns. The bridge rotated in the horizontal plane and a permanent offset of about 4 in in the direction of increasing skewness was observed at the abutments. Rotation would effectively increase the lateral load carried by the outer columns at the central pier but it is not apparent why the columns at the other piers were not damaged by this displacement.

Fig. 27 Foothill Boulevard Undercrossing, southeastern bridge, Foothill freeway. Failures were severe in three of the central columns but the columns located between the walls at either end of this bridge were undamaged.

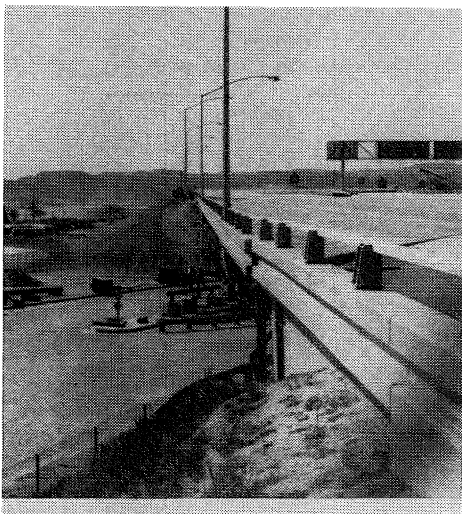
Fig. 28 The skew bridges of the Foothill Boulevard Undercrossing tended to rotate producing displacements of the superstructures relative to the abutment wingwalls of about 4 in.

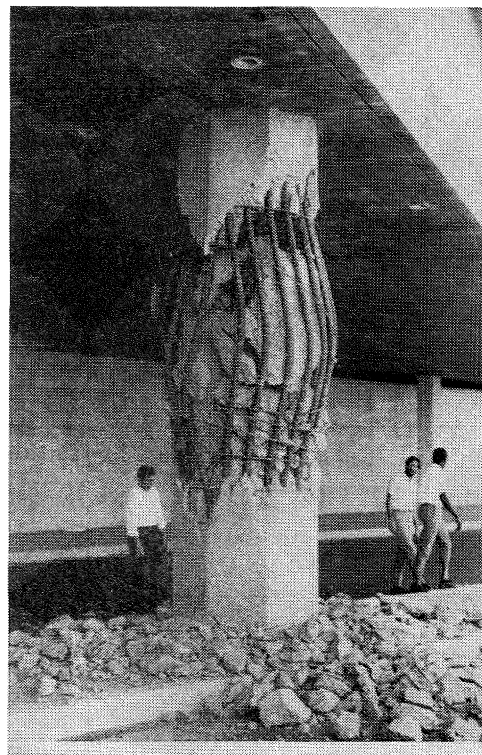
It is clear that the extent of the column failures in the southeastern bridge was aggravated by inadequate ties. The use of 1/2 in diameter lapped ties at 12 in spacing does not appear adequate for large bridge columns. Laps are unsatisfactory because spalling of the outer concrete shell renders the ties ineffective.

Fig. 29 Details of a central column failure, Foothill Boulevard Undercrossing. The No. 18 bars were tied with No. 4 bars spaced at 12 in.

The ties on the damaged columns were lapped and with the spalling of the outer concrete shell they became ineffective. A more positive anchorage of ties, such as a 135° bend and an extension into the central region of the column, is required.

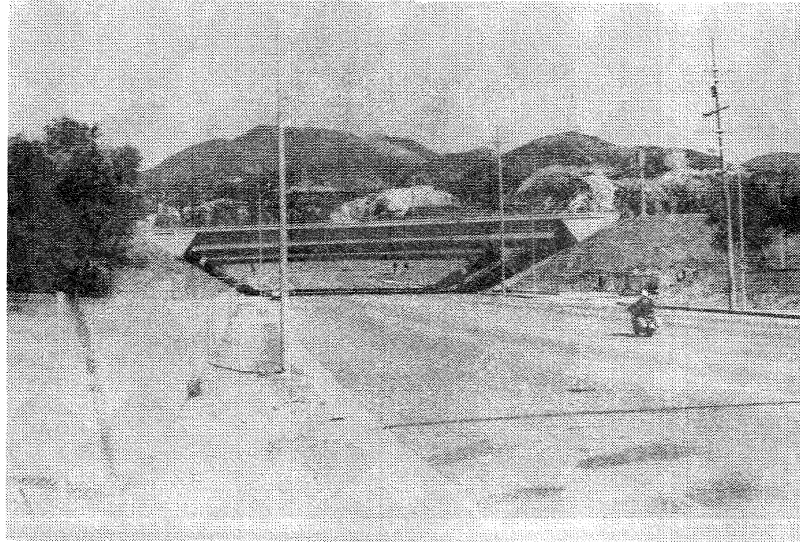
Fig. 31 The Roxford Street Undercrossing, Foothill freeway. Twin 151 ft long prestressed box girder bridges. Horizontal load pile failures occurred on both bridges.

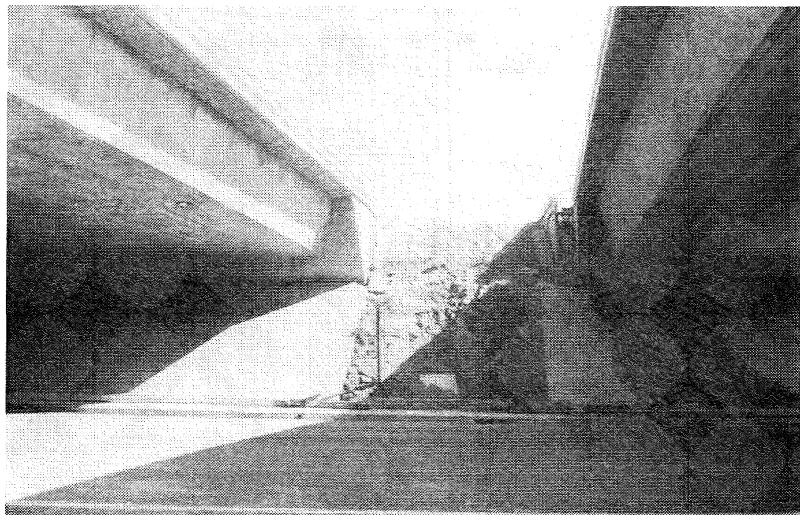
Fig. 32 Eastern abutments of the Roxford Street Undercrossing. At this end the southern bridge displaced transversely 2 ft 6 in and the other bridge moved about 1 ft.

On a number of bridges a concrete apron was used to pave the slope under the bridge between the city street level and the bridge abutment (Fig. 32). The aprons were not connected to the bridge abutments and many slipped down the slope damaging the apron and the sidewalk. This damage, although minor, would probably have been largely avoided by tying the aprons to the abutments.

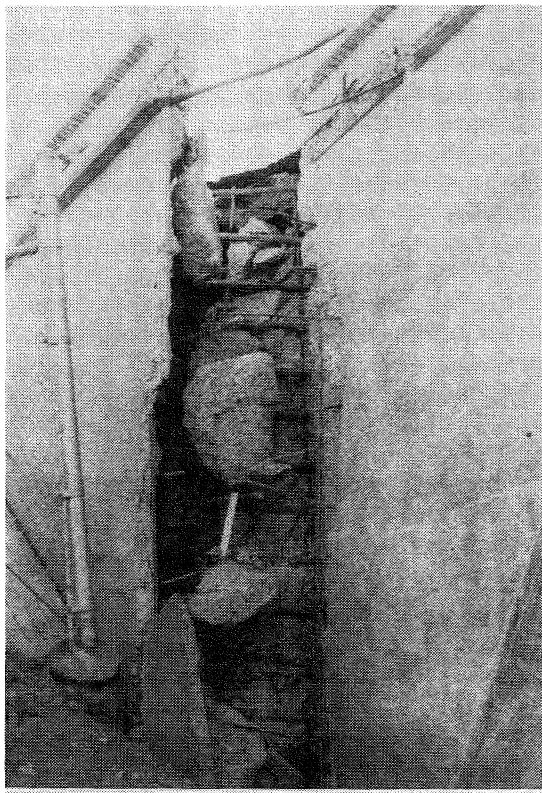
Fig. 33 Fracture of the wing-wall at the eastern abutment of the southern bridge, Roxford Street Undercrossing. A severe lateral failure of the piles at this abutment resulted in a 2 ft 6 in horizontal displacement.

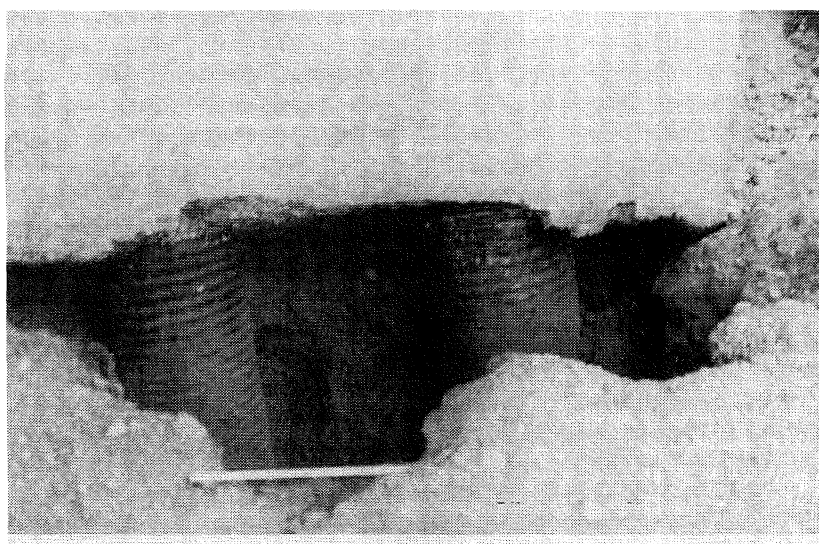
Fig. 34 15 in diameter corrugated steel casing concrete piles at the western abutment of the southern bridge, Roxford Street Undercrossing. Permanent displacement at this abutment was about 6 in. Apparently the piles failed by hinging at their tops and shearing through the soil.

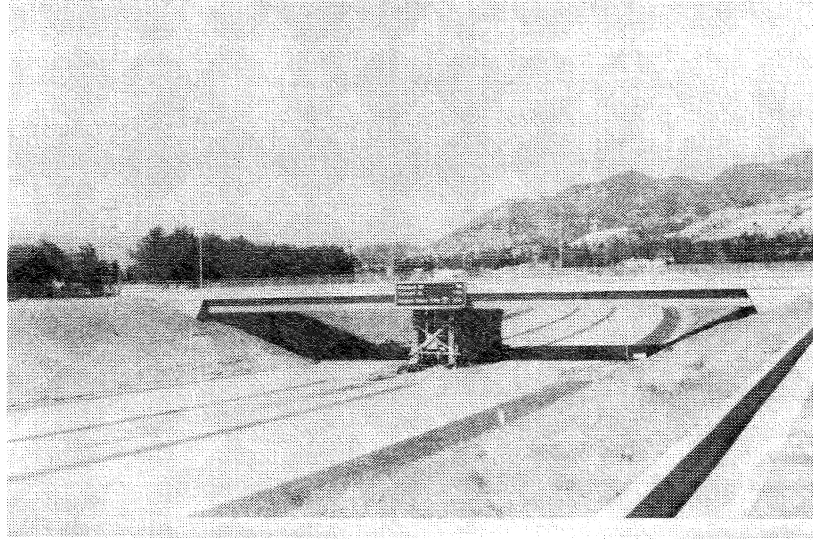
Fig. 36 Bledsoe Street Overcrossing, Foothill freeway. A continuous R. C. box bridge with spread footing foundations. The abutments settled relative to the central pier cracking the superstructure deck.

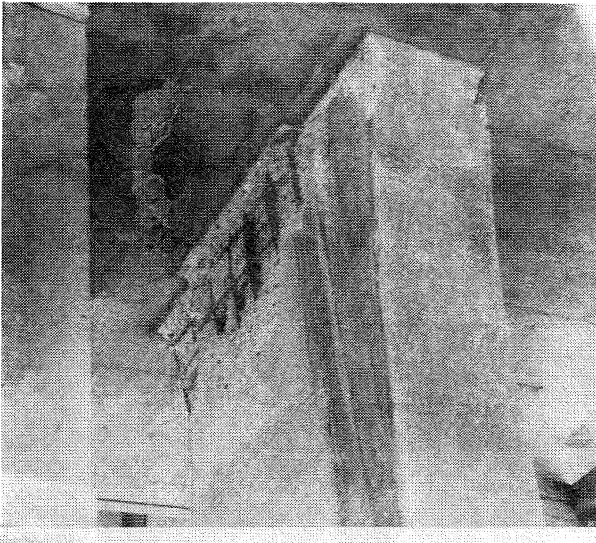
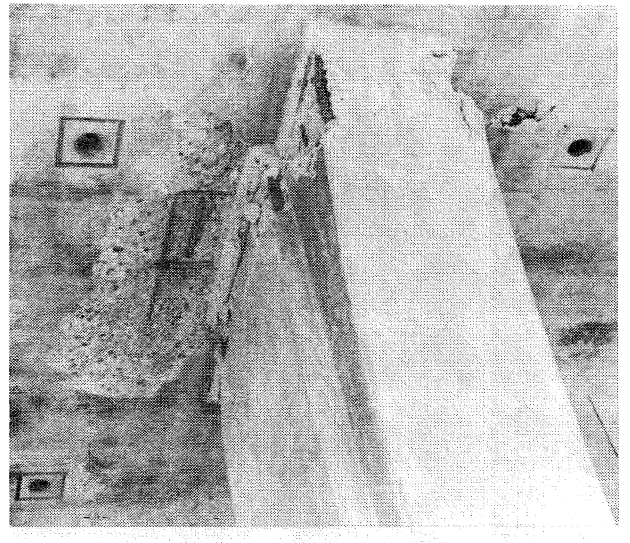
Spalling damage at the tops of the twin central columns of the Bledsoe Street Overcrossing. The damage was probably caused by excessive longitudinal vibrations and aggravated by the increase in axial load due to the differential settlement.

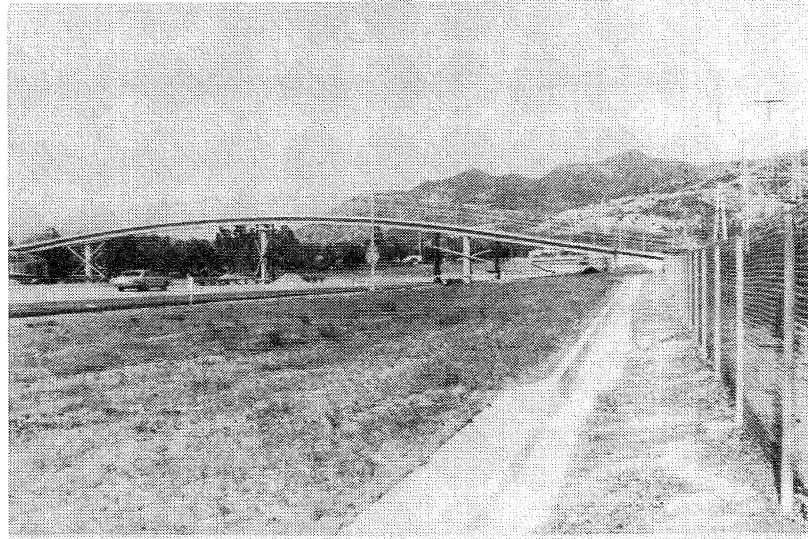
Fig. 38 Tyler Street Pedestrian Overcrossing, Foothill freeway. Longitudinal movements caused bending failures at the column tops and separation at the abutments.

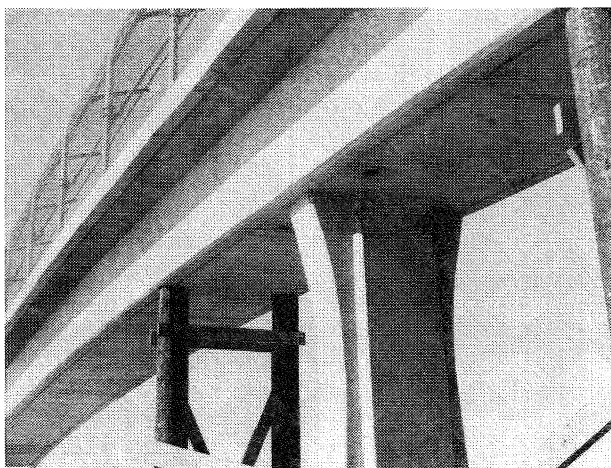
Fig. 39 Spalling of the top of the tallest column. Tyler Street Pedestrian Overcrossing

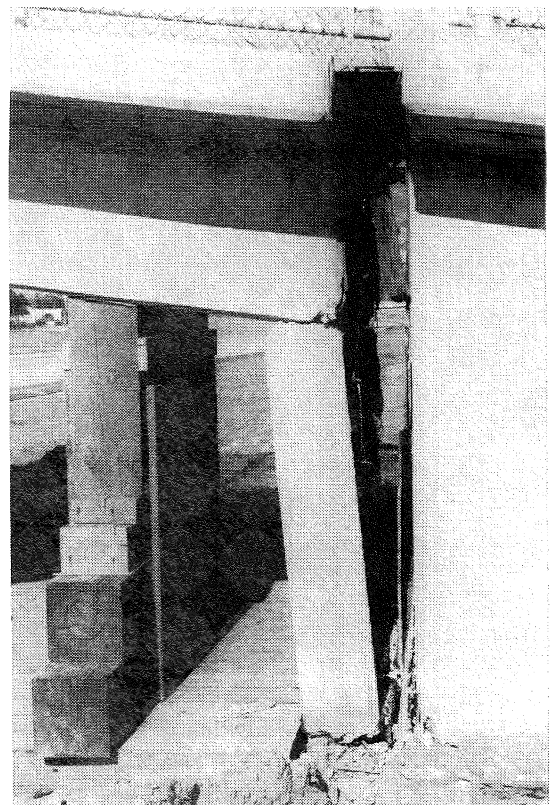
Fig. 40 Separation of the seating from the abutment structure at the northern end of the Tyler Street Pedestrian Overcrossing.

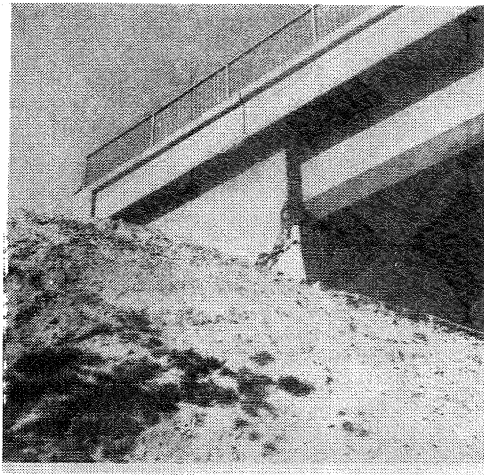
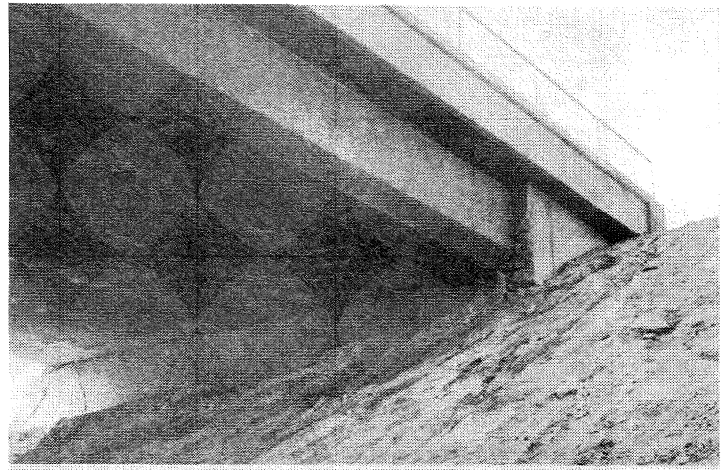
Abutment damage at the western end of the Balboa Boulevard Overcrossing, Golden State freeway. The 674 ft long R. C. box superstructure was cast monolithically with the spread footing abutment structure.

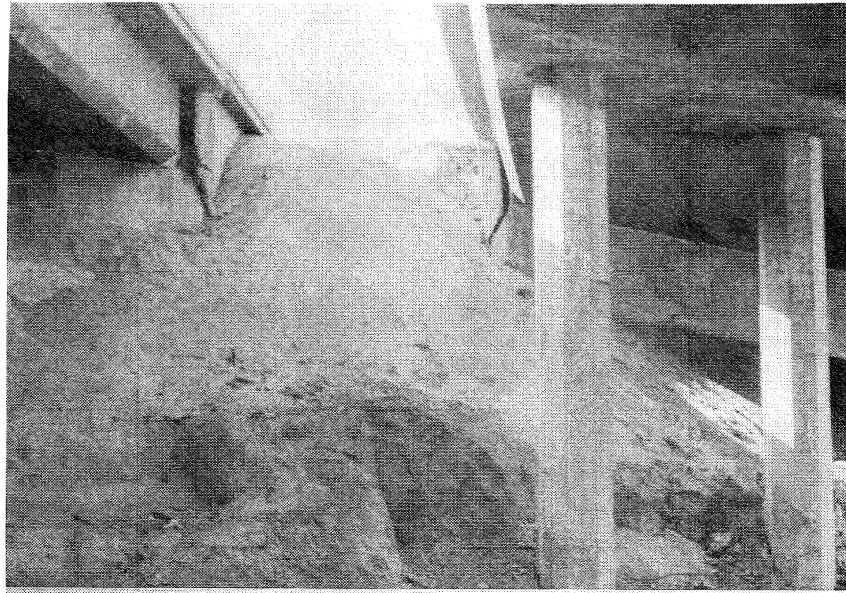
Fig. 42 Abutment damage at the northern end of the west Sylmar Overhead bridges, Golden State freeway. Apparently the skew superstructures were structurally separated from the abutments and seated on elastomeric pads. The abutment wingwalls failed at both ends of the bridges.

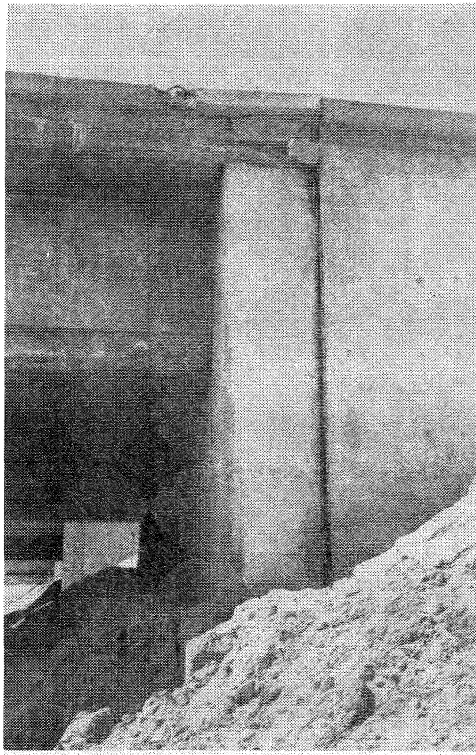
Fig. 43 Pounding damage at the joint between the abutment structure and wingwall at the eastern end of the Sierra Highway undercrossing, Angelope Valley freeway.

Pounding damage at superstructure and abutment joints was a relatively common form of damage. Some examples are shown in Fig. 43 and Fig. 44. Elimination of this damage could probably be achieved by using thicker elastomeric pads to increase the separations at the joints and by the use of more positive tying between the components.
