DAMAGE TO FREEWAY STRUCTURES IN THE SAN FERNANDO EARTHQUAKE

J. H. Wood* and P. C. Jennings**

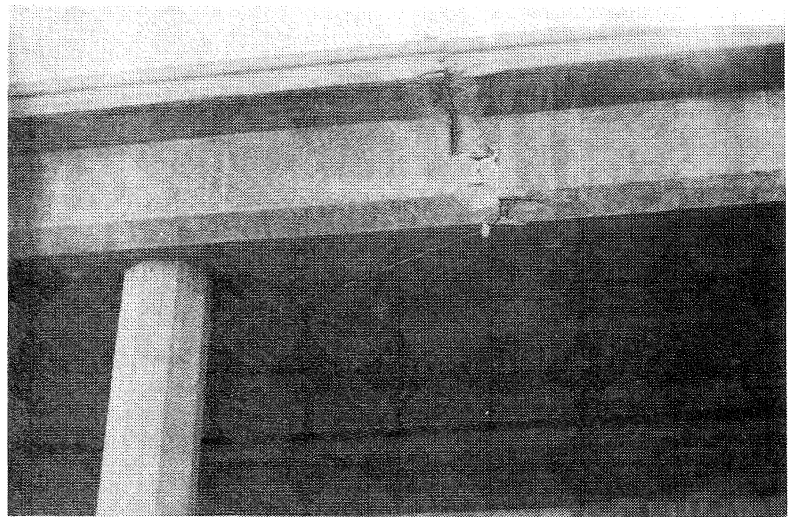
Fig. 44 Pounding damage at a skew joint in the superstructure of the West Sylmar Overhead, Golden State freeway.

Pounding damage at superstructure and abutment joints was a relatively common form of damage. Some examples are shown in Fig. 43 and Fig. 44. Elimination of this damage could probably be achieved by using thicker elastomeric pads to increase the separations at the joints and by the use of more positive tying between the components.
