DESIGN LESSONS FROM RECENT DESTRUCTIVE EARTHQUAKES

R. I. Skinner*

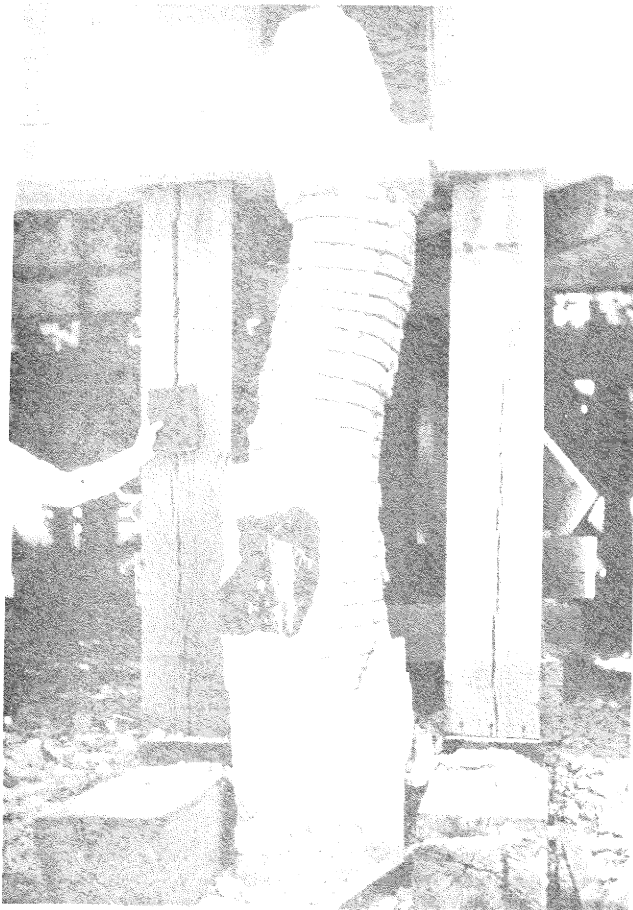
FIGURE 1

Inadequate ties have been an important factor in the observed failures of a large number of columns. Cases of damage under forces which were predominantly bending or shearing or crushing have been observed and also cases with combinations of these forces. Instances of tie steel failure in tension have been very rare. In almost every case the ties have unwrapped. A common error is excessive spacing between ties. There have been a number of instances of very irregularly placed ties with some spaces more than twice the design value. The effectiveness of properly placed spiral reinforcing was demonstrated in the case of some greatly overloaded columns in the P.B.A. building, Manila, Fig. 1.

Column D4, P.B.A. Building. A spirally reinforced column under a severe overload.

Photo V-3 Column D4, P.B.A. Building;
compare photograph 11, 1968 report

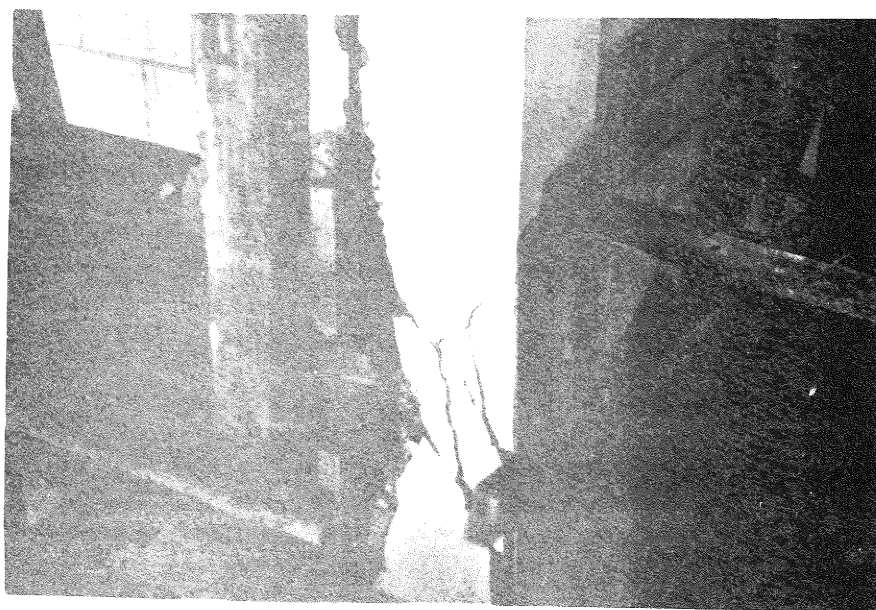
FIGURE 2

Photo V-24 Column shear damage by panel,
Agoncillo Elementary School

Column shear damage from an unreinforced concrete hollow block panel to $2/3$ of the column height.

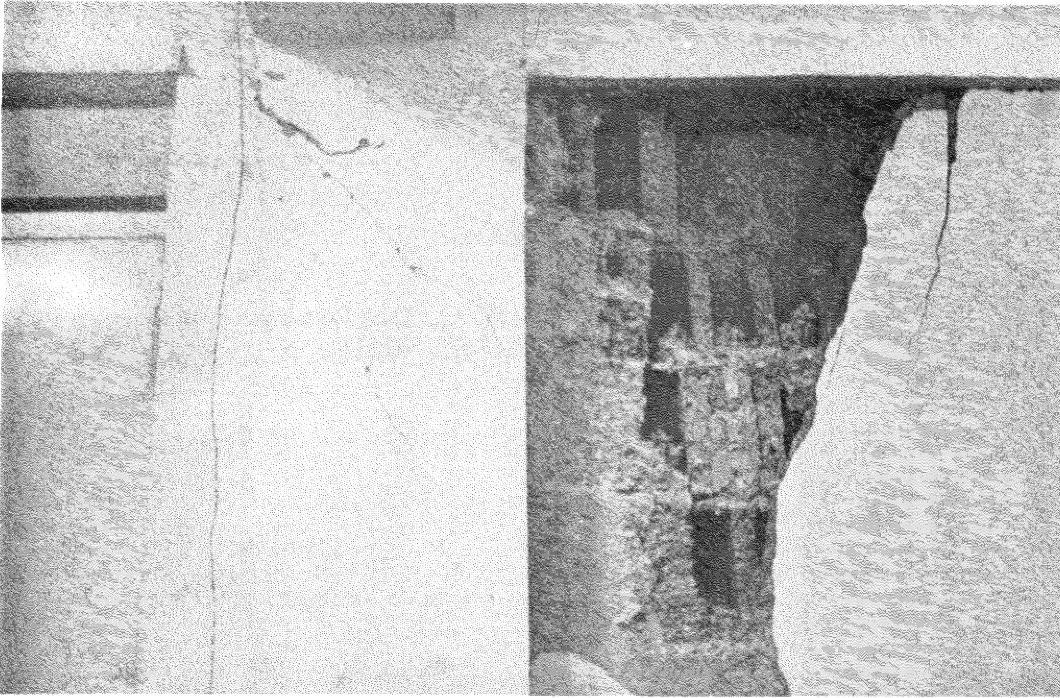
Figure 3

Diagonal tension cracks resulting from a damaged panel in Diamond Tower.

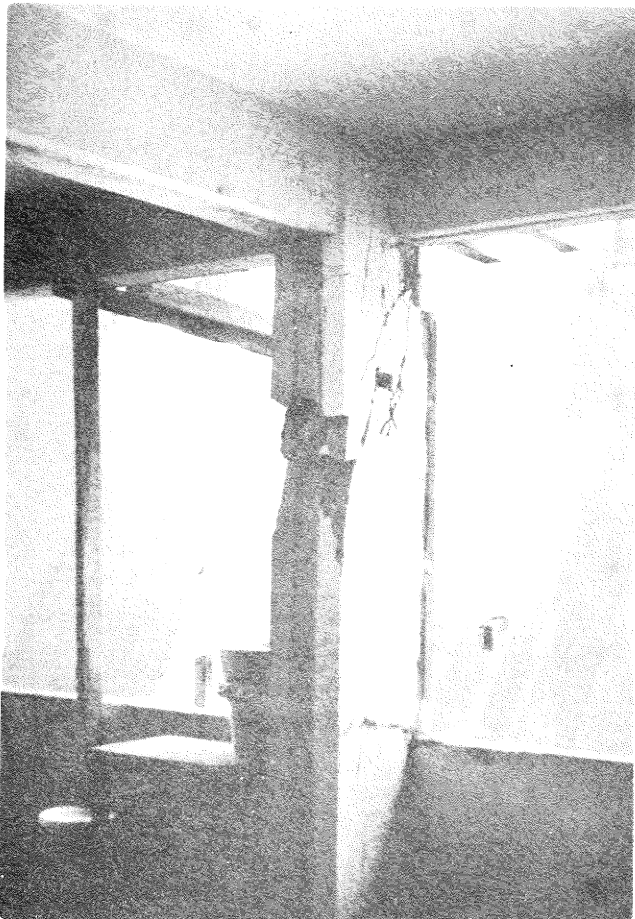
Figure 4

Panels which extend part way up columns are most likely to cause direct column damage. However even complete panels can cause shear failure in columns, after first separating along their top edge and then failing at their upper corner. The panel then supports the column over only part of its height and column failure in diagonal tension may occur once more. During the 1968 earthquake columns at the upper levels of the 11-storey Diamond Tower suffered moderate damage by concrete hollow block panels, Fig. 3. During the 1970 earthquake the 8-storey United Building had several columns severely damaged by panel forces, Figs. 4 and 5. As a result the building was close to total collapse.

Diagonal tension cracks from a damaged panel in the United Building.

Photo V-32 Diagonal tension cracks in second-storey exterior column, G7, of United Building

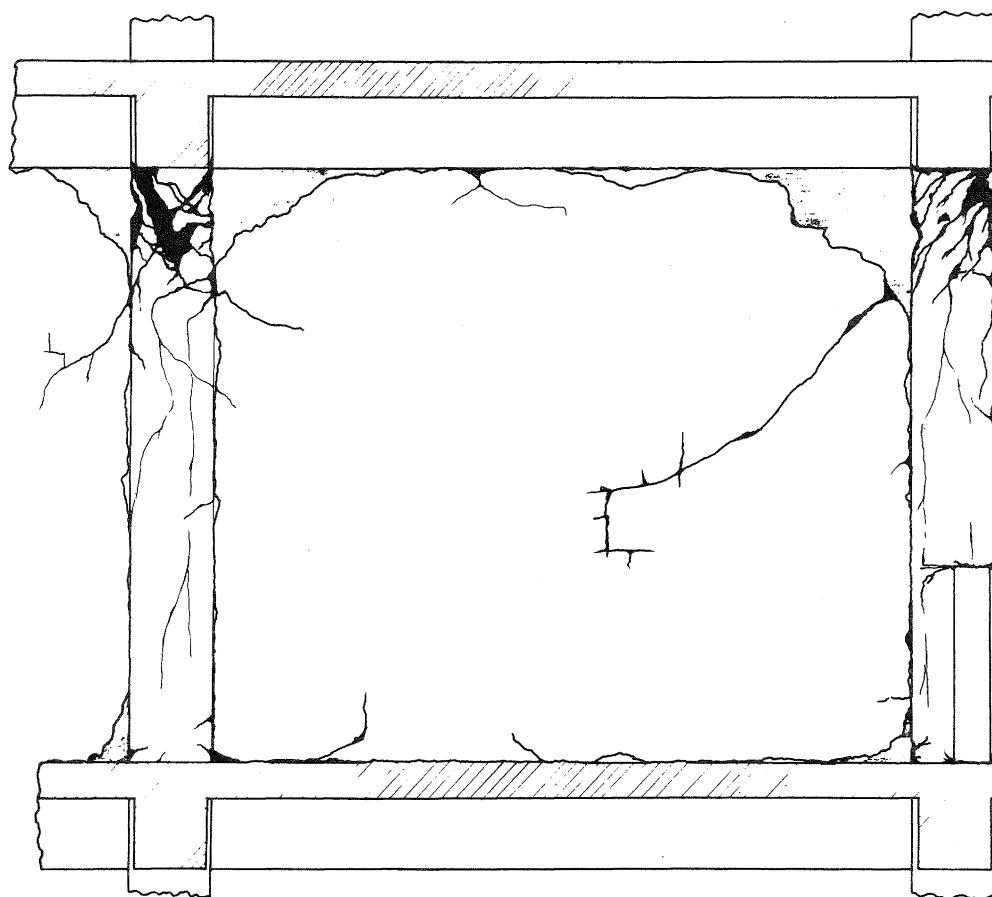
Figure 5

Composite drawing based on unrelated components showing assumed mechanism of column damage in the United Building.

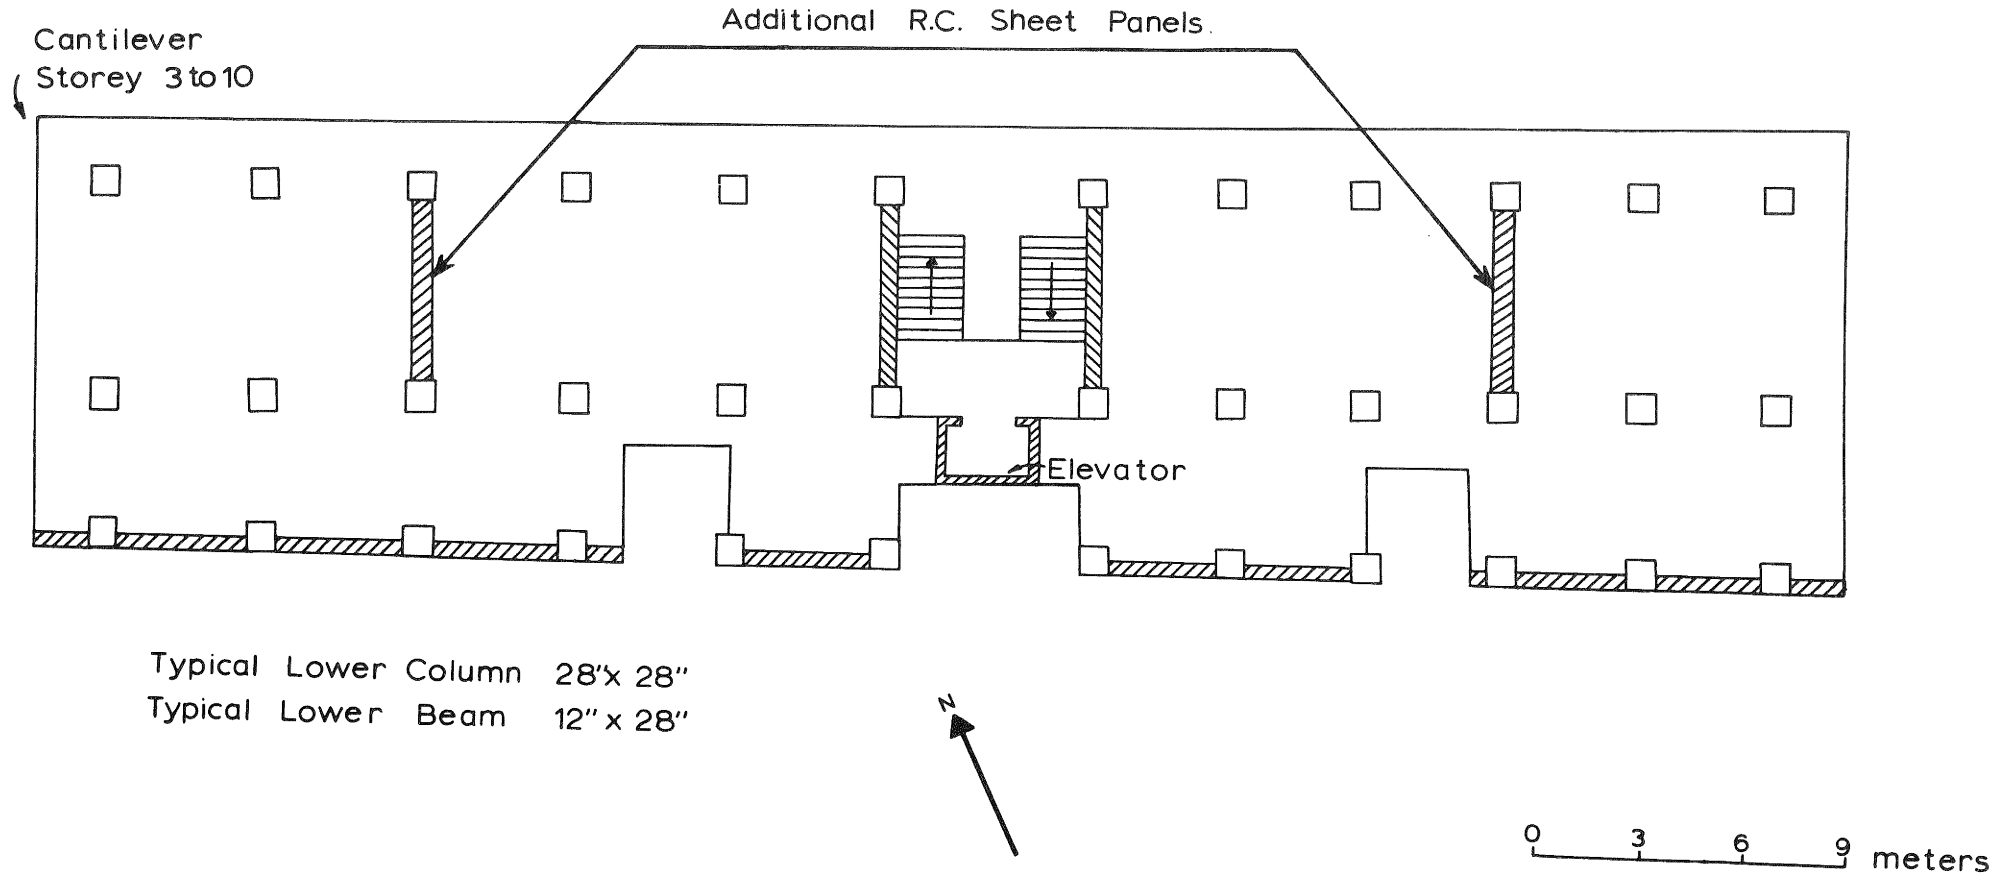
Figure 6

During the 1970 earthquake the Pearl Tower and the Diamond Tower suffered no significant structural damage and little non-structural damage. The Gocheco suffered moderate structural and non-structural damage and this was distributed over a substantial part of its height. The moderate damage and the large margin of safety against collapse were due in large measure to the strengthening shear walls.

Diamond Tower showing the two bays with added R.C. panels.

Near the ends of the long Diamond Tower building, Fig. 6, and of the long section of the Pearl Tower building short transverse shear walls were provided to complement the longitudinal fire walls. Transverse shear walls were also introduced in single bays of the more nearly square Pearl Tower block. The Gocheco building is in the form of a large hollow square and contains no fire walls. Five single-bay shear walls were added, and also 2 U-shaped shear walls which were associated with stairways and lift shafts. In introducing the single-bay shear walls great pains were taken in an attempt to ensure that they were integral with the building frame and floor diaphragms. This integral action was certainly achieved during the moderately severe 1970 earthquake.

One method of introducing shear walls was to remove all the non-structural panels in a single bay. The surface concrete was then chipped off the beams and columns to expose the main longitudinal steel on all sides of each opening. These openings were then filled with substantial reinforced concrete panels which contained vertical, horizontal, and diagonal steel. A substantial fraction of this panel steel was welded to the exposed main steel in the surrounding columns and beams. An attempt was made to give these shear walls a substantial footing but this was difficult to achieve in the existing buildings.
