AN INVENTORY OF UNREINFORCED MASONRY CHURCHES IN NEW ZEALAND

**Alessandra Marotta¹, Tatiana Goded², Sonia Giovinazzi³,
Sergio Lagomarsino⁴, Domenico Liberatore⁵,
Luigi Sorrentino⁶ and Jason M. Ingham^{7*}**

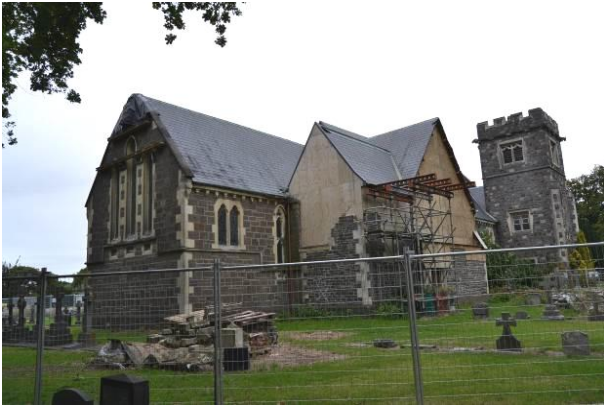
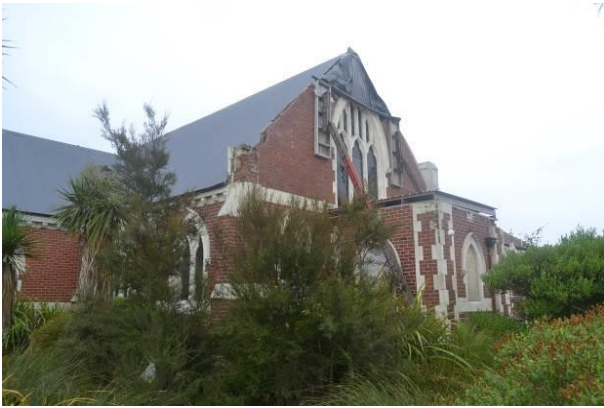
(a) St Peter's Church (1875), Christchurch

(b) St Joseph's Church (1921), Christchurch

Figure 1: Examples of damage caused by the 2010-2011 Canterbury earthquakes.

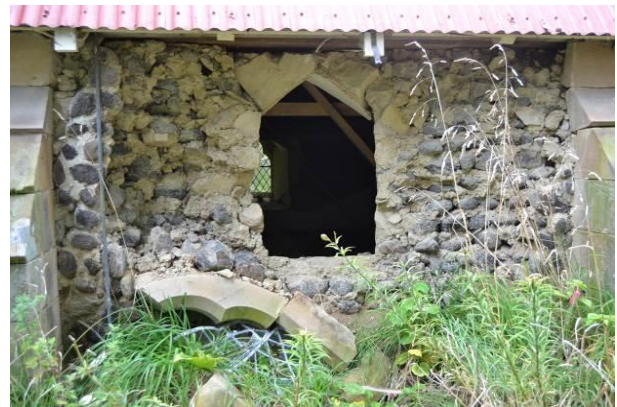
St Cuthbert's Church (1860), Governors Bay

Figure 25: Example of bad masonry quality.

Field observations have shown a rather high seismic vulnerability of non-solid walls, which are prone to failure of one or more leaves. Nonetheless, solid walls can also display inadequate performance, when the wythes are not properly connected and undressed units are used.

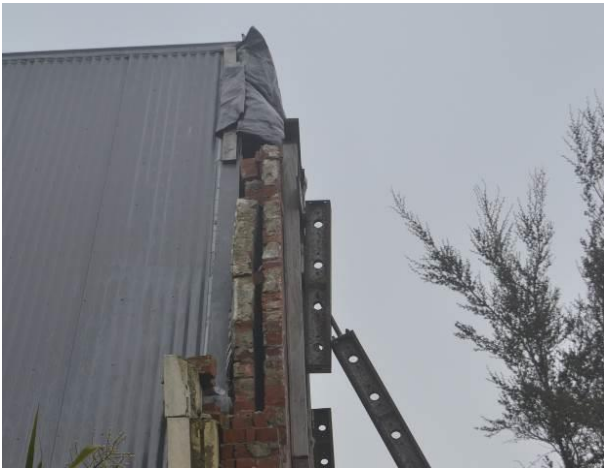
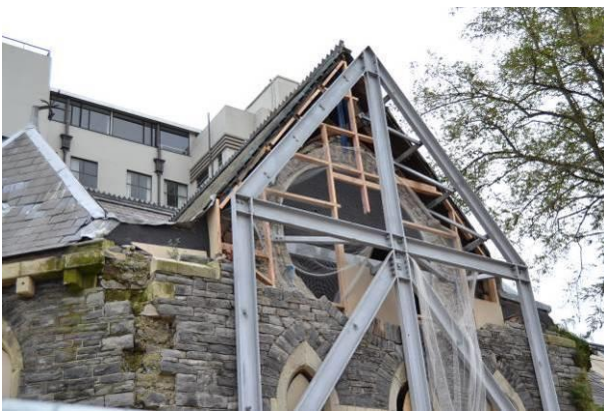
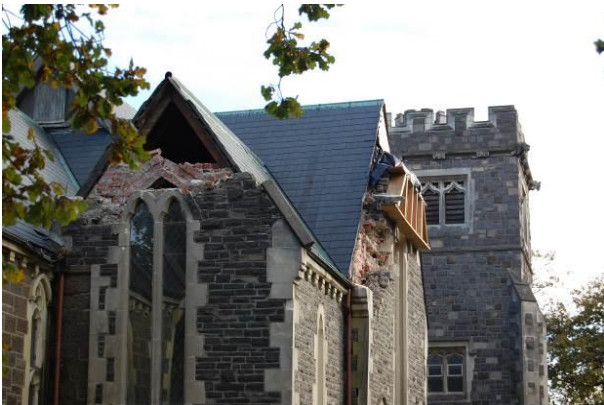
(a) St Joseph's Church (1921), Christchurch – Clay-brick cavity wall

(b) Trinity Congregational Church (1873), Christchurch – Natural-stone cavity wall

(c) St Peter's Church (1875), Christchurch (Photo courtesy of Joao Leite) - Two-layer wall
