## A NOTE ON THE EARTHQUAKE PERFORMANCE OF REINFORCED CONCRETE SHEAR WALLS

Karl V. Steinbrugge,\* Henry J. Degenkolb\*\*

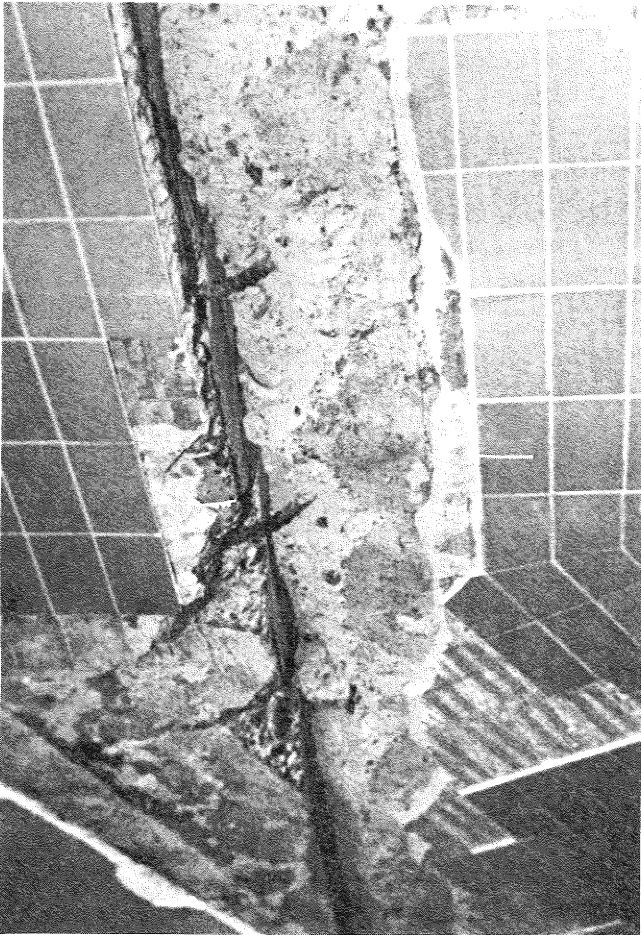
Figures 1 and 2 show construction joint movement in a major shear wall in the two story West Anchorage High School during the 1964 Alaskan earthquake. The joint was so smooth that some persons called it a "troweled joint". Figure 3 shows the movement in a poorly built construction joint in the rear of the Cordova Building after the 1964 Alaskan earthquake. The aggregate in this instance acted as "ball bearings". Figure 4 clearly indicates the construction joint slippage that occurred in a wall of the Penney Building during the same shock. The authors' files contain similar examples from many other earthquakes.

- Fig. 1 Construction joint movement in a shear wall in the West Anchorage High School during the 1964 Alaskan earthquake. Other structural damage was severe throughout much of this building.
- Fig. 2 Detail of Figure 1. Bent bars indicate the amount of lateral movement between the upper portion of the wall and its lower portion. Note the smoothness of the construction joint which provided an excellent slippage plane. Dowel action was inadequate.
- Fig. 3 Rear wall of the Cordova Building in Anchorage, Alaska after the 1964 Alaskan earthquake. The concrete was

In the authors' opinion, best current practice in California requires the use of mechanical bond through serrated shear keys plus the best possible contact between the freshly roughened surface of previously poured concrete using grout on the contact plane. Theoretically, if a freshly roughened surface with adequate grout can be furnished in the field, the mechanical bond should not be necessary. However, the almost universal experience is that workmanship is too lax to rely on adequate adhesion at the contact surface, so the mechanical key, such as illustrated in Figure 5 (or the equivalent), must be provided as an insurance factor.
