ENGINEERING SEISMOLOGY

W. R. Stephenson*

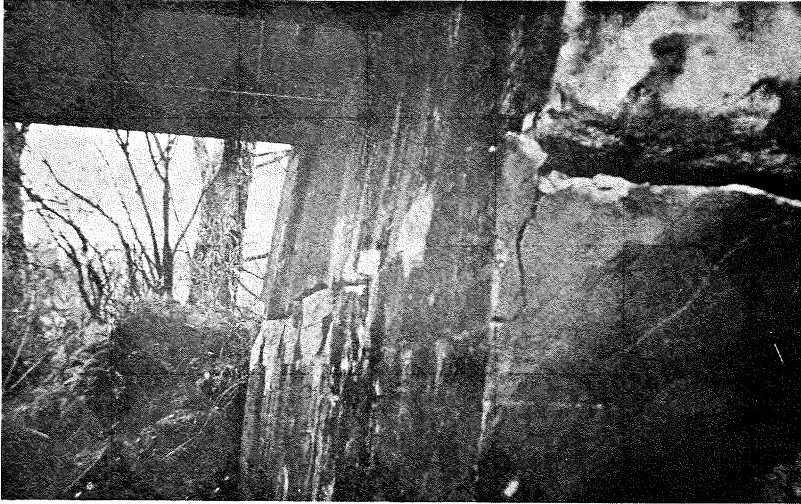
Fig. 2 Reefton buttress of the Inangahua road-rail bridge, looking upstream. Soil has thrust the buttress towards the river, causing the fracture shown.

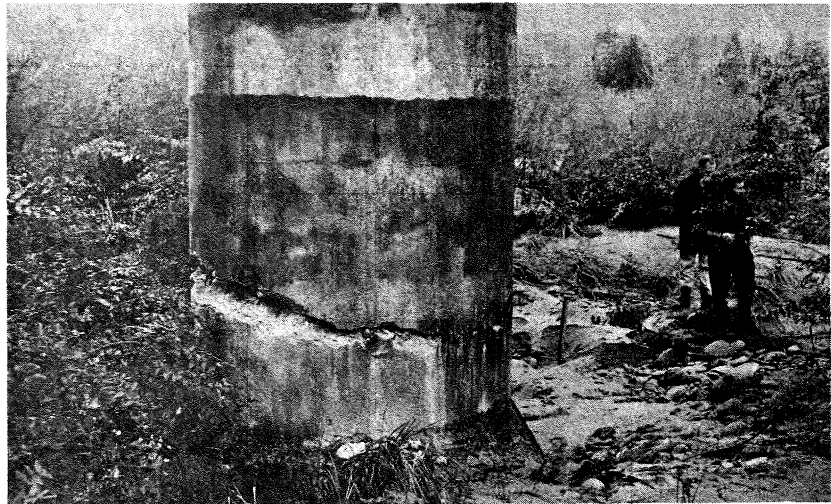
Fig. 4 Northernmost pier of the Buller rail bridge showing extension of the crack in Fig. 3 into the web. This damage to the web was characteristic of all the piers.
