THE 2014 SOUTH NAPA EARTHQUAKE AND ITS RELEVANCE FOR NEW ZEALAND

Bruce Galloway¹ and Jason M. Ingham²

ABSTRACT

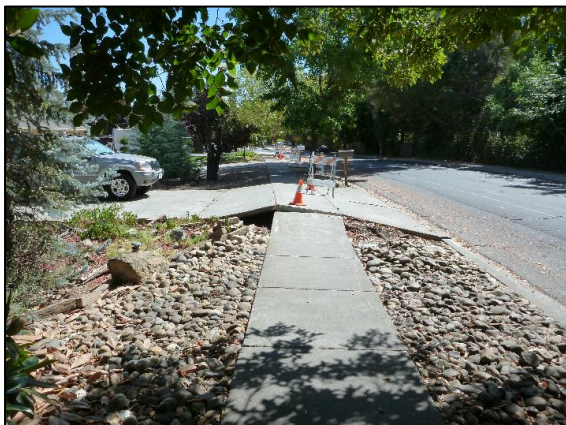
Figure 7: Buckling of pavement on Patrick Road, Napa.

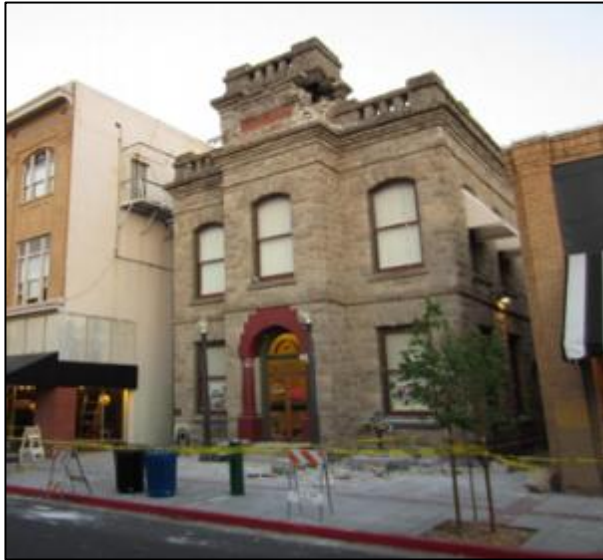
The Goodman Library displayed significant damage to the feature on top of the front elevation (see Figure 11(a)), which at first viewing could have had the potential for full collapse of this wall. Hazard tape was initially used to barricade off the footpath (well inside 1.5 times the height of the building), and fences were subsequently erected at the edge of the roadway in lieu of the hazard tape. By 18 September, more was presumably known about the global stability of the front elevation and the fences had been moved back to the inside of the sidewalk (Figure 11(b)). This reduction in barricade and associated erection of a light scaffold over the sidewalk indicates that the building officials expected only minor fall hazards (ie a brick or two) rather than a partial collapse of the feature atop the facade. The purpose and effectiveness of the scaffold walkway was unclear.

(a) Barricading of Goodman Library on 24 August
(Source: Bill Tremayne)

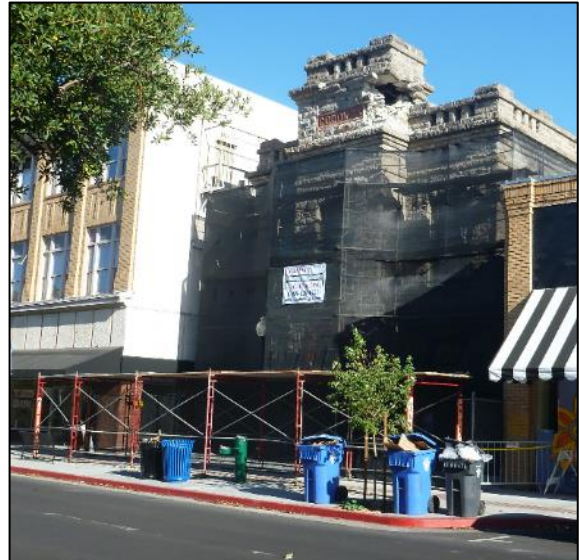
(b) Barricading of Goodman Library on 18 September

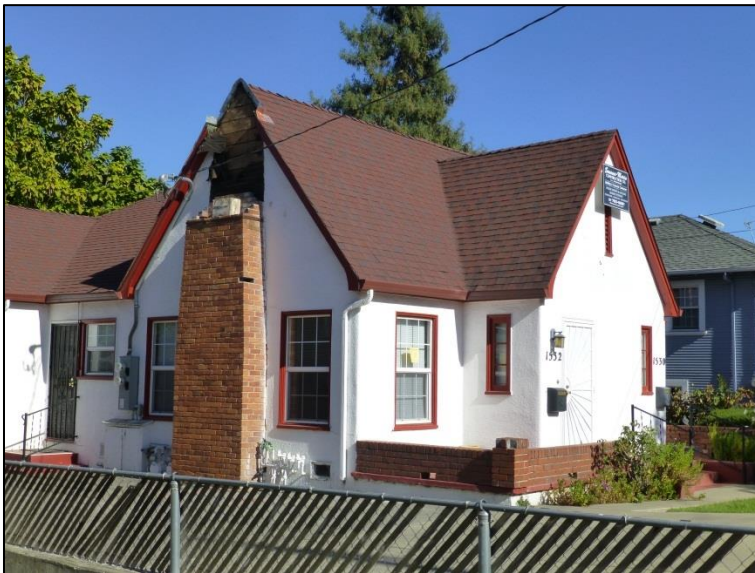
(a) Chimney damage in Napa

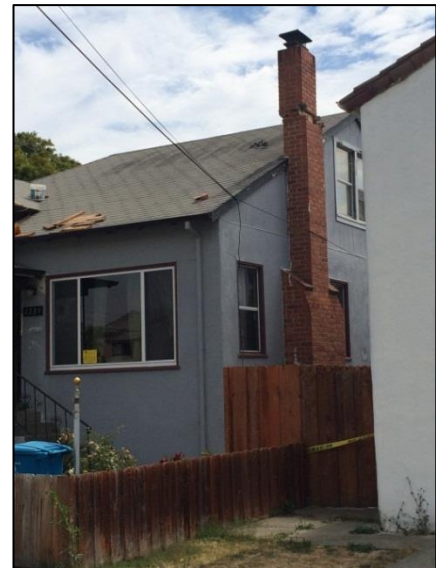
(b) Chimney damage in Vallejo (Source: Laura Whitehurst)

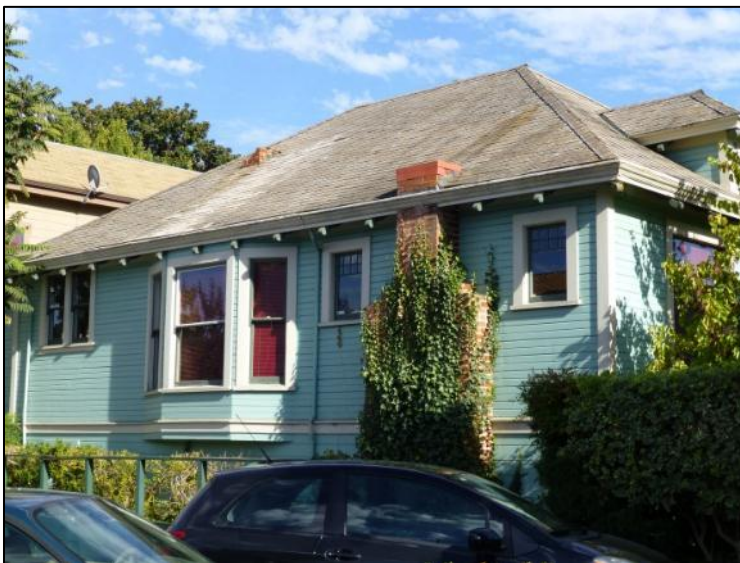
(c) Chimneys in Napa removed to roof level

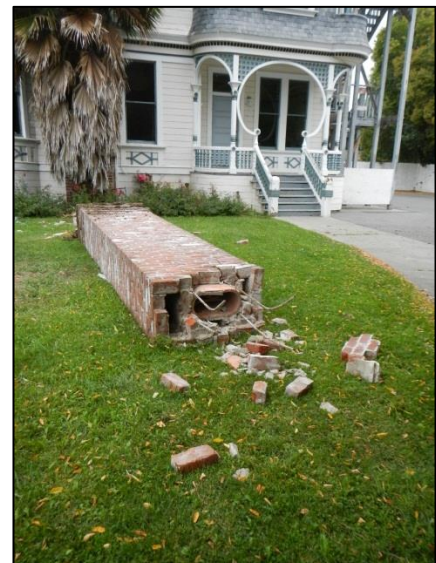
(d) Chimney completely removed (CA EQ Clearinghouse / Source: David McCormick)

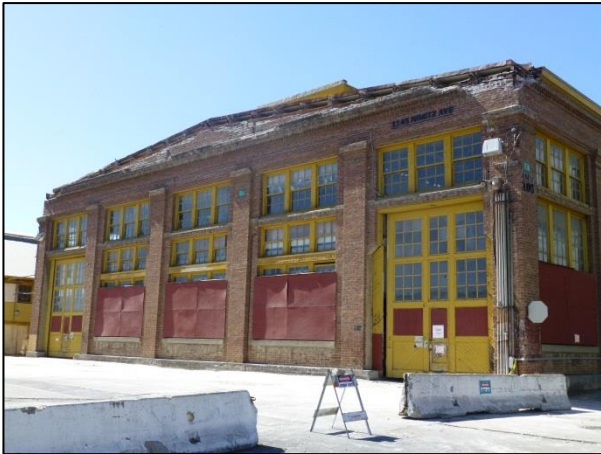
(a) Loss of parapet at the Mare Island shipyard

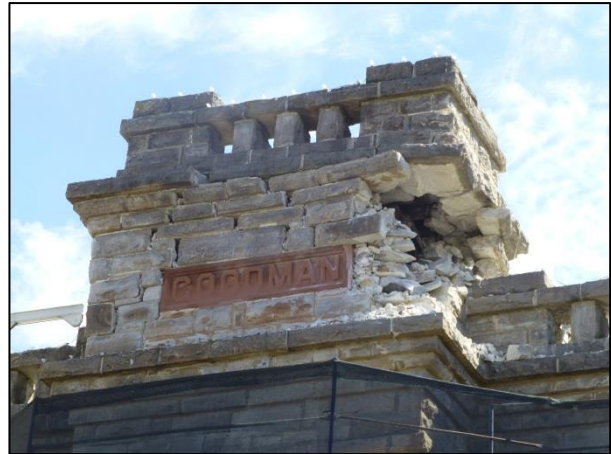
(b) Damage to the ornamental feature atop the Goodman Library in Napa

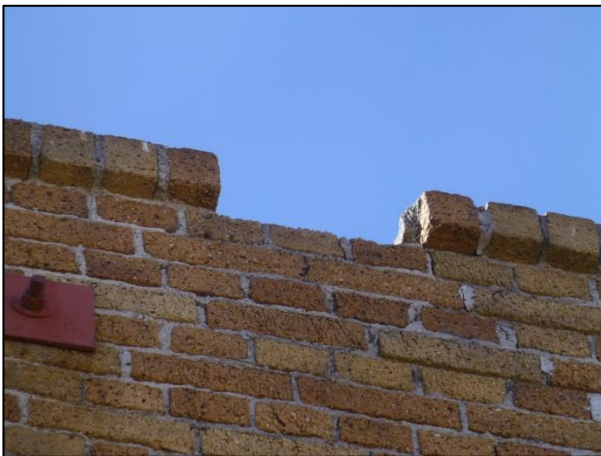
(c) Loss of capping bricks to a building in Vallejo

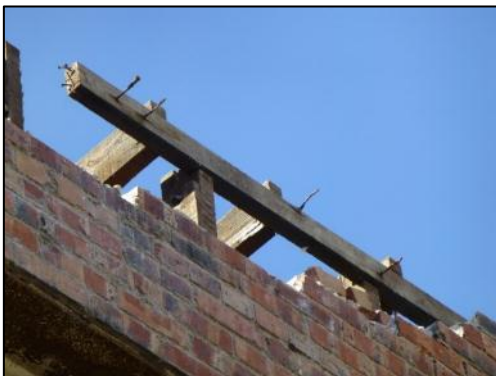
On the few occasions where parapet failure was observed, it was generally noted that securing was either absent or had been reliant upon original or historic sub-standard securing.

(a) Parapet failure in Vallejo

Figure 16: Examples where parapet failure was attributed to sub-standard (original or historic) securing.

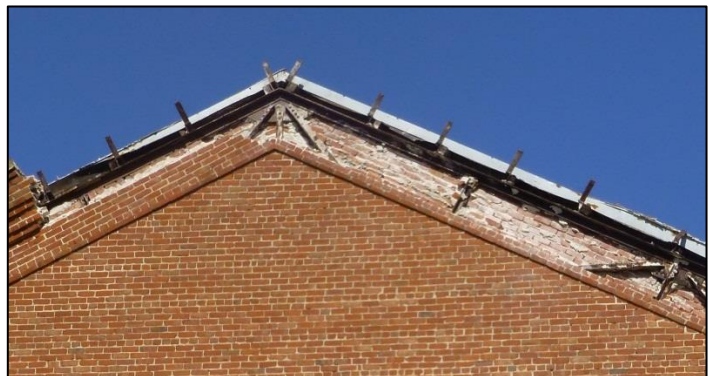
(b) Parapet failure at Mare Island

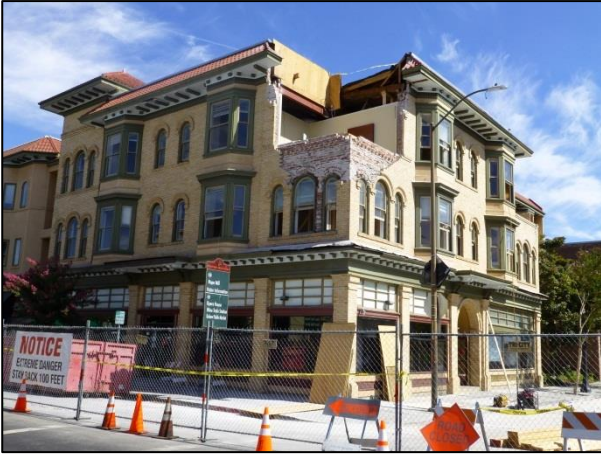
(a) Alexandria Hotel

The corners of URM buildings frequently attract greater damage than do other parts of the building due to the confluence of in-plane and out-of-plane load actions and possible torsional building response. Two such examples are shown in Figure 17.

Figure 17: Examples of corners of URM buildings having poor anchorage and attracting significant damage.

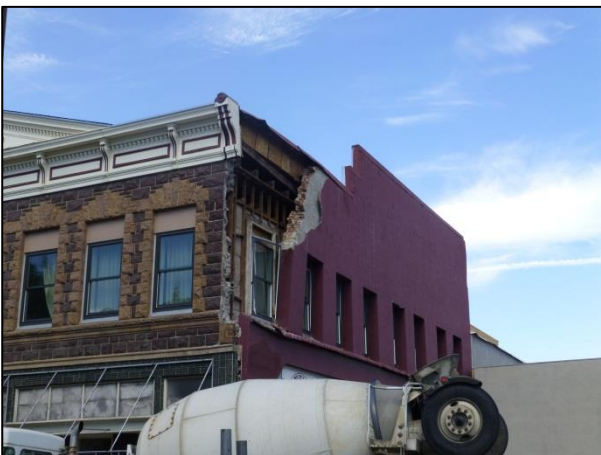
(a) Out-of-plane failure including end-wall separation

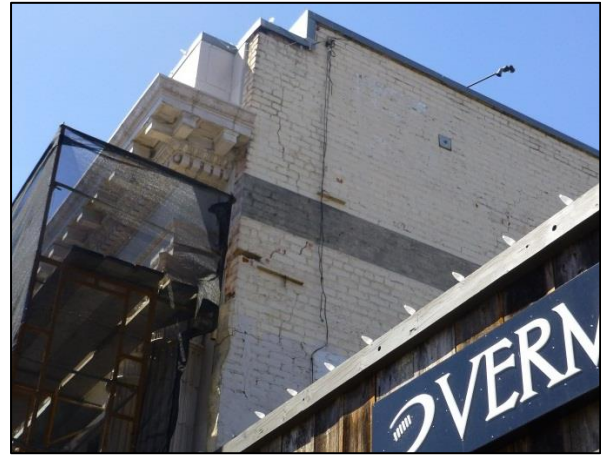
(b) Impending end-wall separation

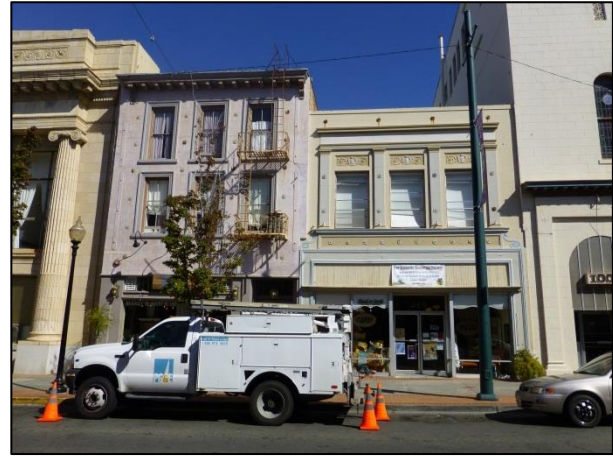
(b) Shops in central Vallejo

Figure 19: Examples where the bolting philosophy appeared to have worked well, other than the loss of individual bricks. Note that none of these buildings comply with the specific restrictions of the bolts-plus ordinance.

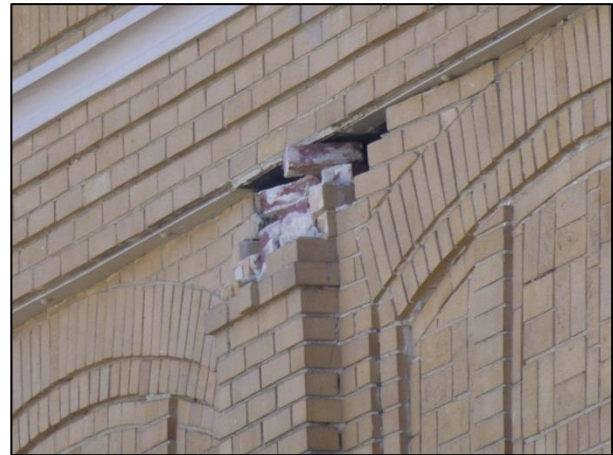
(d) Loss of brickwork above one pier, resulting in a falling hazard

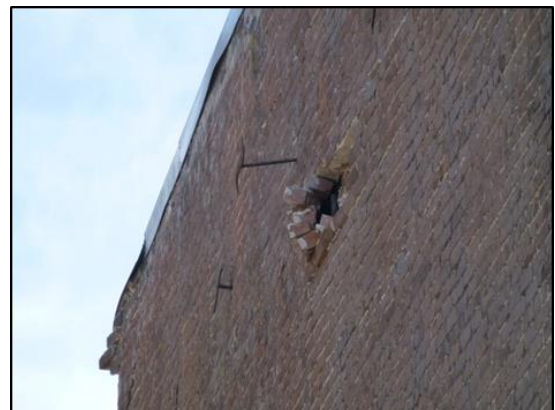
As observed in the recent Canterbury earthquakes, there were cases where it was evident that wall diaphragm anchorages had been placed under severe load and in some places failed, emphasising that it is preferable to replace any aged anchorages or undertake a proper load testing regime to confirm their adequacy if a decision is made to rely upon existing anchorages as part of a strengthening scheme. Two such examples are shown in Figure 20.

(a) Apparent rupture of the anchor rod or failure at the diaphragm connection

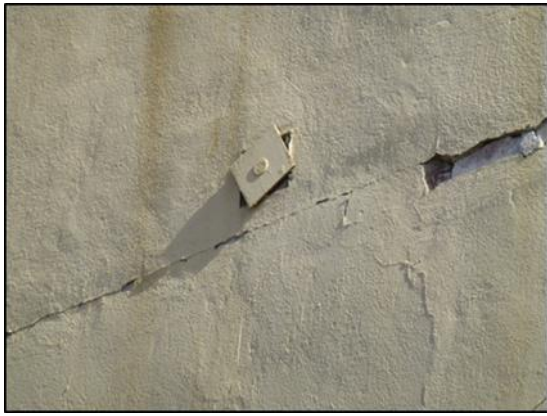
(b) Example of anchorage shift during wall movement

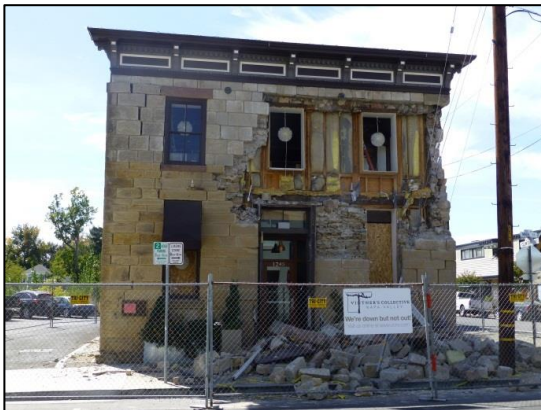
(c) View of damaged front face

Figure 21: Damage to the Pfeiffer building in Napa.

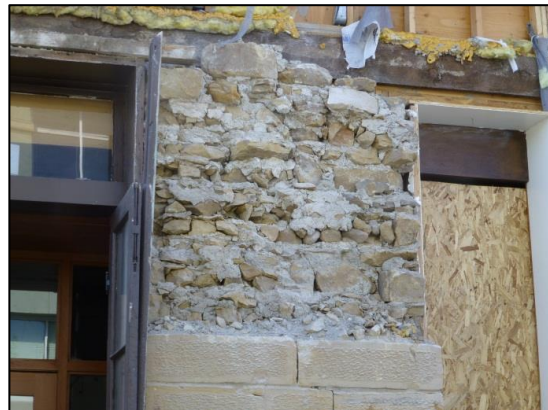
(d) Close up of rubble fill

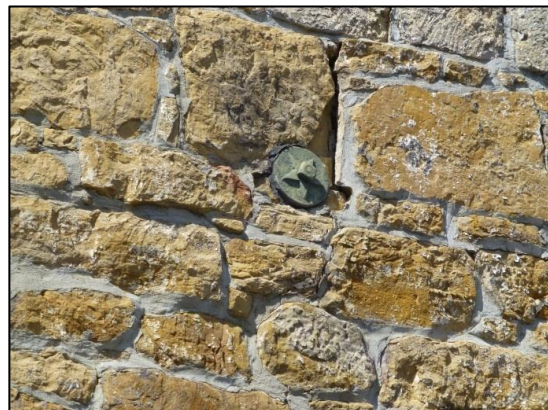
(f) Distressed stonework around the anchor plate of side-wall anchorage

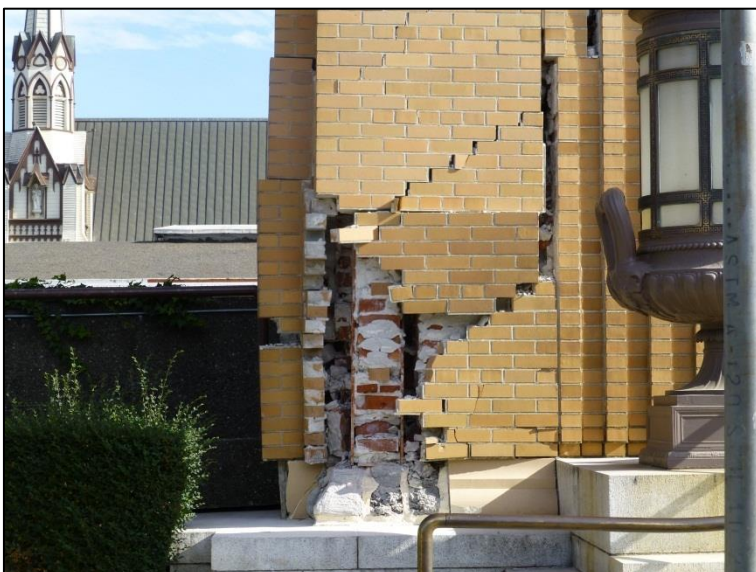
(c) Close-up of left pier

Figure 22: Prominent diagonal pier cracking in Napa Post Office.

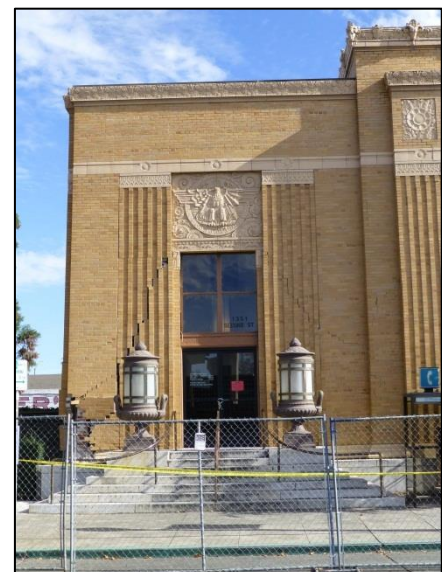
(d) Left pier

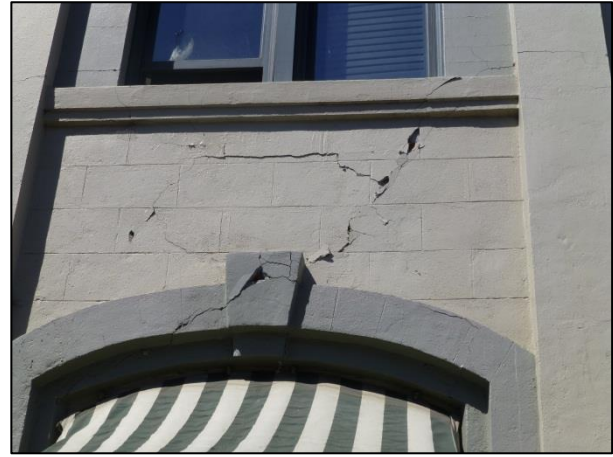
(b) Close-up view of distinct spandrel failure

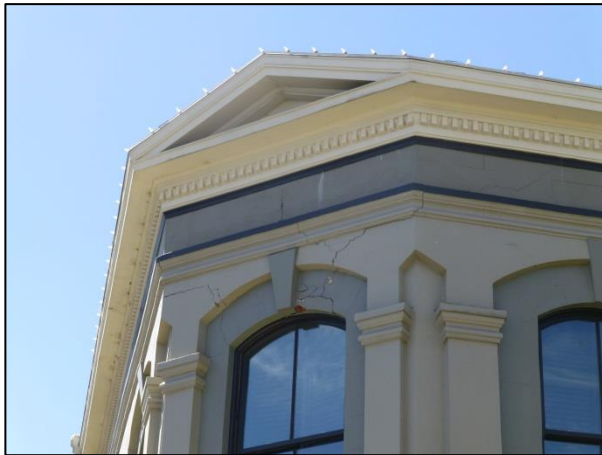
(c) Spandrel failure wrapping around corner of building

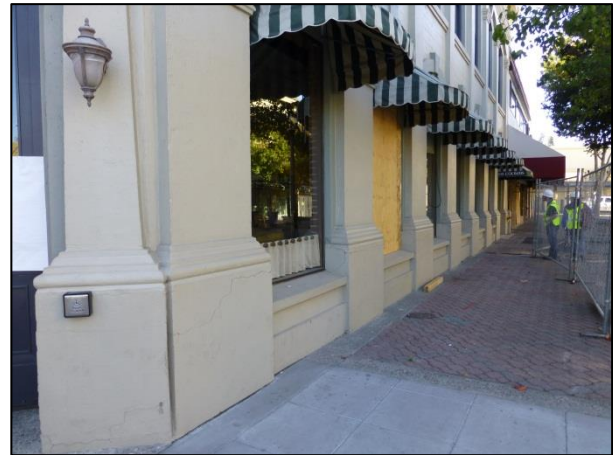
(d) Cracking at base of piers, suggesting pier rocking

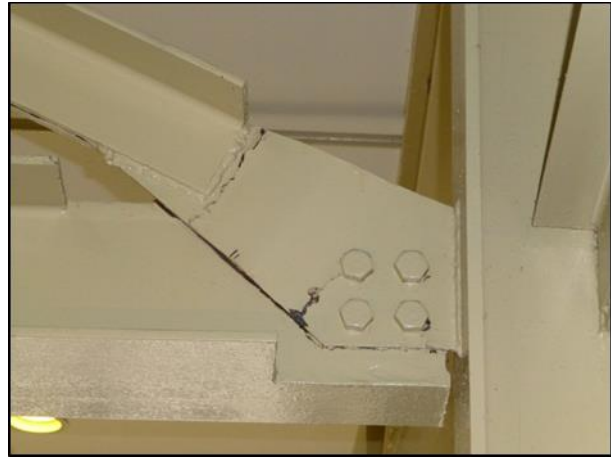
(d) Distress at bolted connection

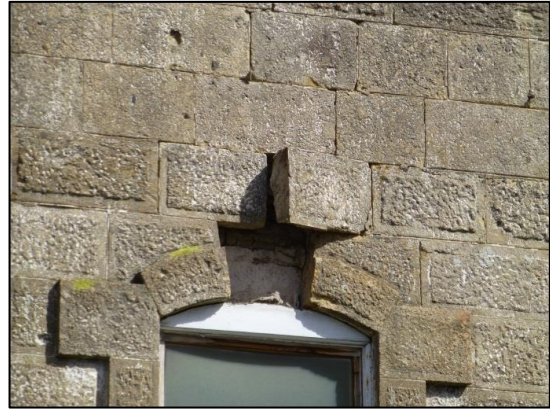
(b) Loose stones above window opening

Figure 26: Limited earthquake damage to the Borreo building.

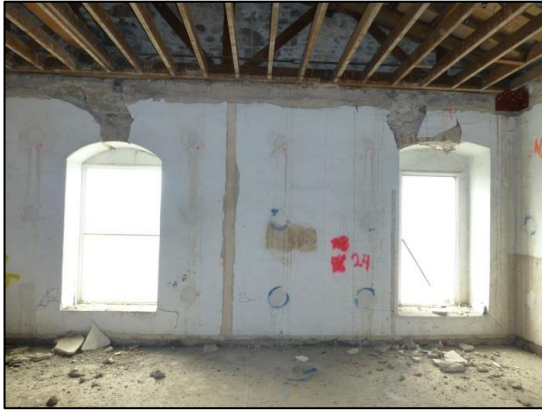
(c) Internal spandrel damage

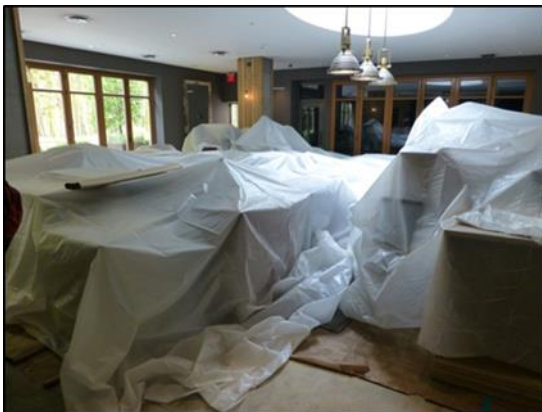
(c) Hotel furnishing covered while non-structural damage was attended to

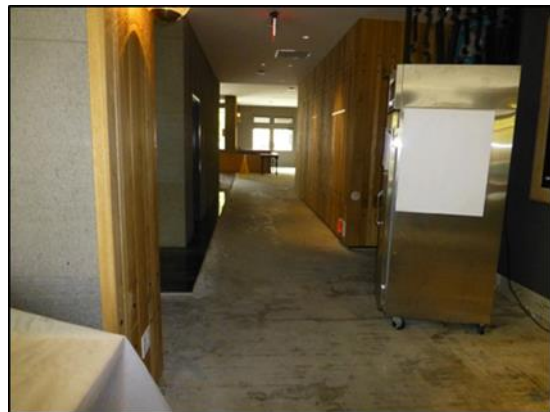
(d) Removed floor linings due to water damage

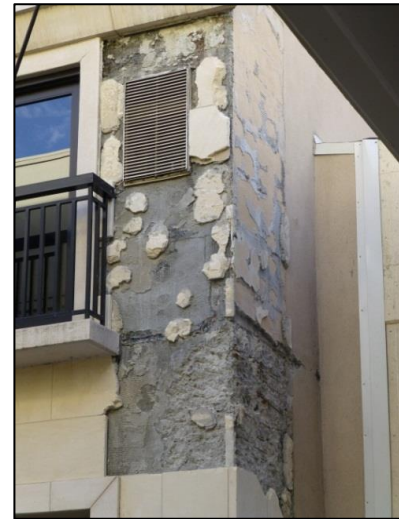
(b) Loss of exterior cladding

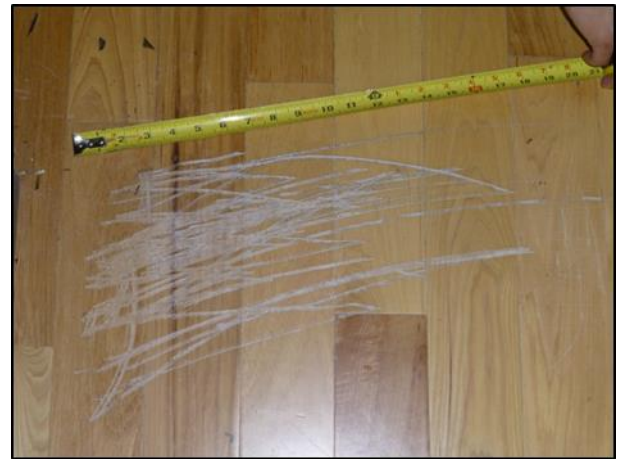
(a) Scratch marks due to cabinet motion

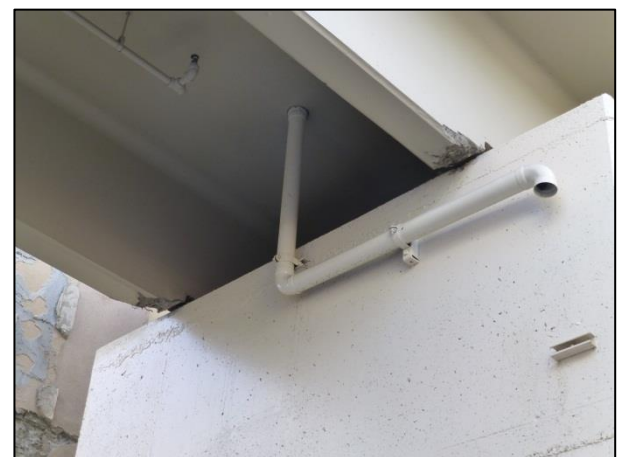
(b) Pounding damage for a pedestrian overpass

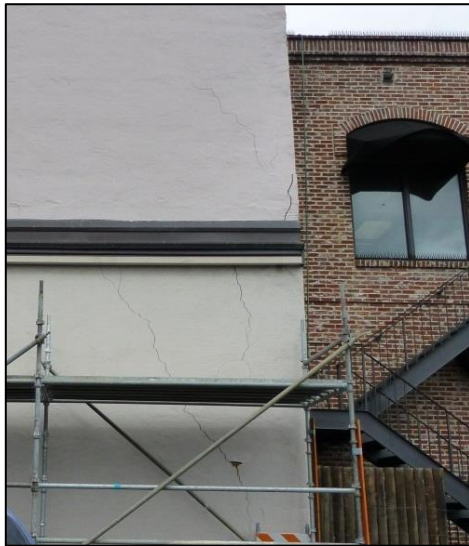
In a complex of historic URM buildings it was observed that an exterior access staircase at the rear of one building (see Figure 30(a)) had stiffened a perpendicular wall, resulting in punching damage as shown in Figure 30(b).

(a) Exterior stairs

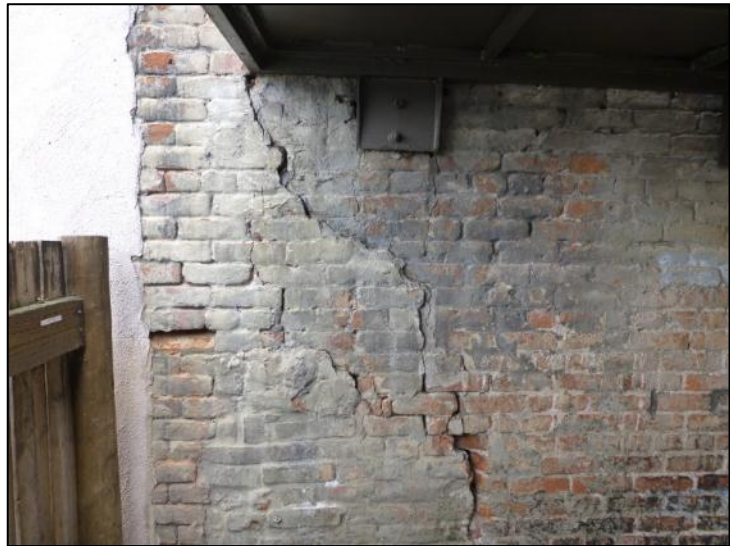
(b) Punching of walls

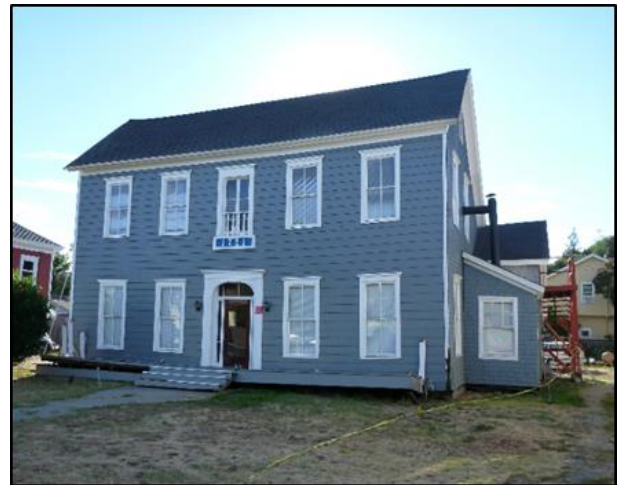
(a) Cripple wall failure in Napa

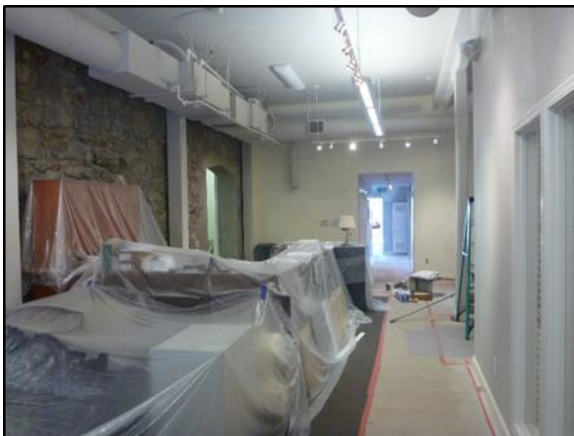
One shortfall of repairing quickly to resume business is that some repairs appeared to be ill-conceived. Figure 35 shows the internal repairs to a badly damaged unreinforced masonry building being largely complete, while the exterior walls still pose a collapse hazard.

(a) Status of internal repairs

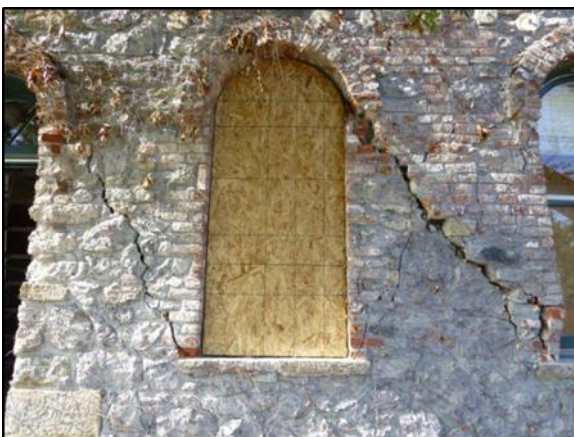
(b) Status of external repairs

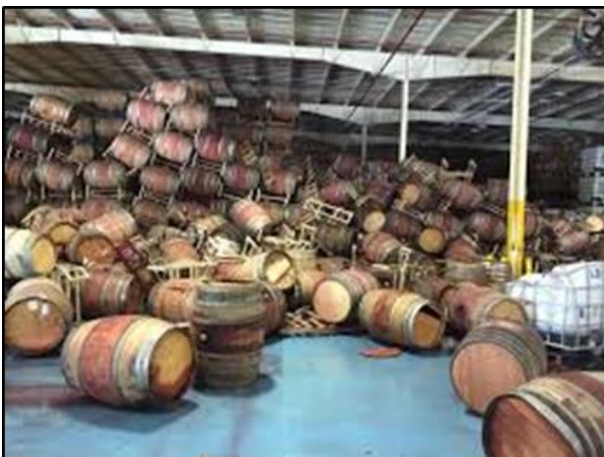
Wine barrels are typically stacked in two barrel racks which were observed to perform poorly in the earthquake (Figure 37b). In one storage facility alone, 20% of their 12,000 barrels were lost, with an estimated 5-6 weeks work required to salvage the barrels. With some of the wine barrels valued in

(b) Collapse of two barrel racks [64]

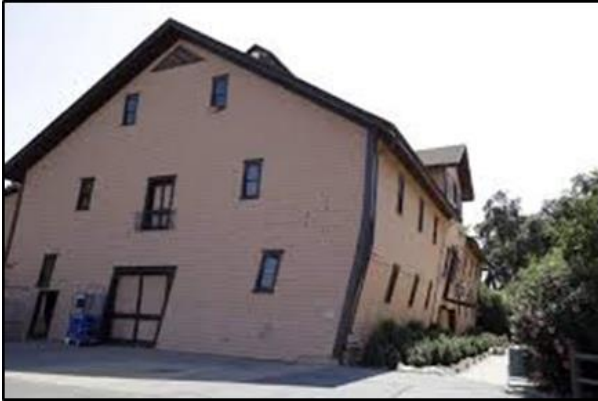
A heavy timber barn-type structure used for barrel storage at the Trefethen Winery was full with barrel stacks at ground and first floor levels. The mass of full barrels stored at first floor level resulted in a permanent lean of the building due to significant displacement of the first floor (Figure 38). This issue was also identified following the 2000 Yountville earthquake, where deformation of the first floor structure was observed to a lesser extent.

Figure 38: Timber barn at Trefethen family vineyard [65].
