IMMEDIATE FIELD DAMAGE RECONNAISSANCE

B. H. Falconer* and G. J. Lensen**

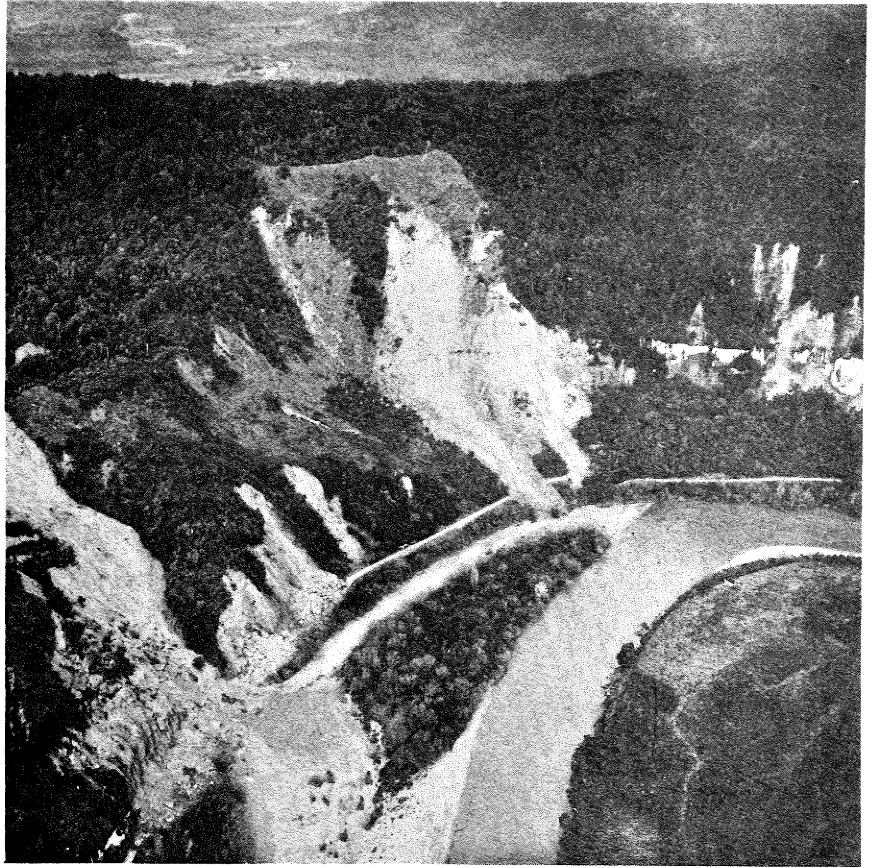
Further down the Buller River to Inangahua (Inangahua Junction is 22 miles west-south-west from Murchison) slips were visible continuously; and ranged from rock falls in the Tertiary limestone, rock slides in the jointed granite, rotational landslides in the Tertiary mudstone, to mudflows in Tertiary sediments. Increasingly, roads became blocked by slips either on to the roadway (fig. 1) or by slump of fill (fig. 2).

Fig. 1. Slip in Tertiary sediments blocking Inangahua to Westport Highway. photo N.Z.G.S. L. Homer

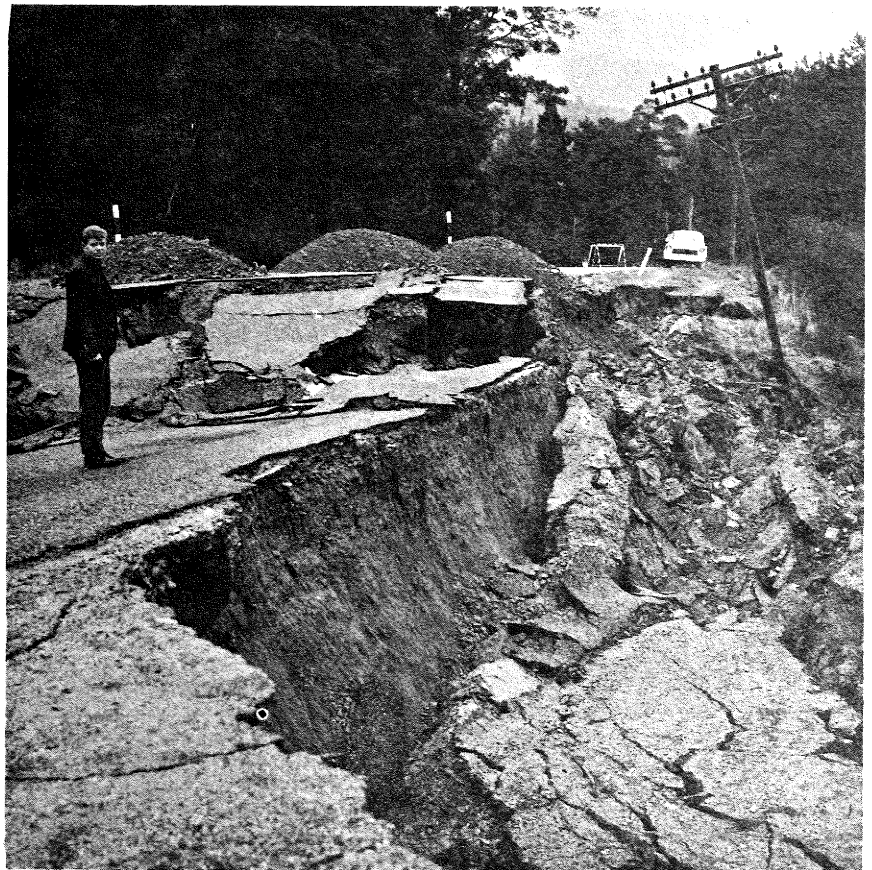
Fig. 2. Failure of roadbed on fill along Inangahua to Murchison Highway. photo N.Z.G.S. L. Homer

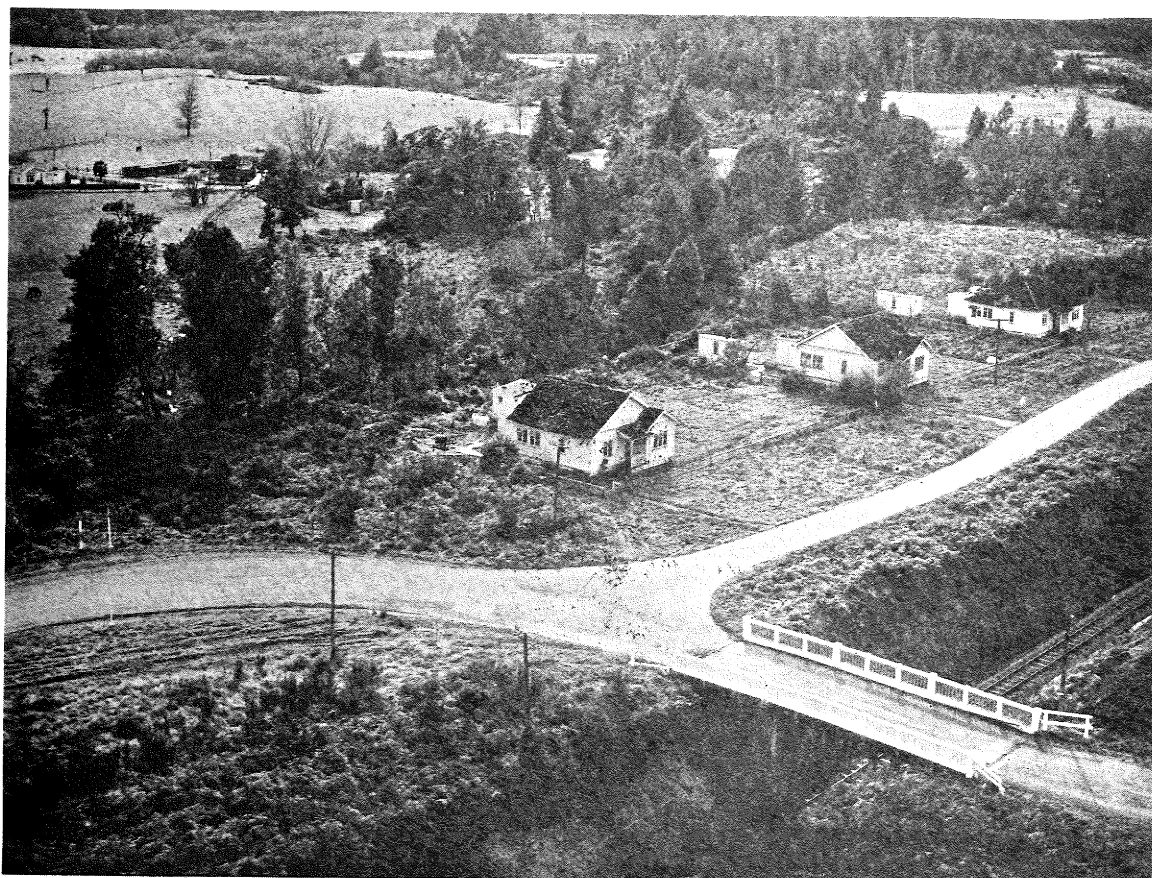
Whilst at Lyell and New Creek, several but by no means all, chimneys had collapsed, in Inangahua Junction severe damage was evident also to tiled roofs, and a few brick veneer walls. Houses in several cases were either seen to be distorted, moved off piles, or suspected to be damaged because of proximity to ground fissures or earth slumps.

Fig. 3. Aerial view of part of Inangahua Camp showing damage to chimneys and tile roofs. photo NZGS L. Homer

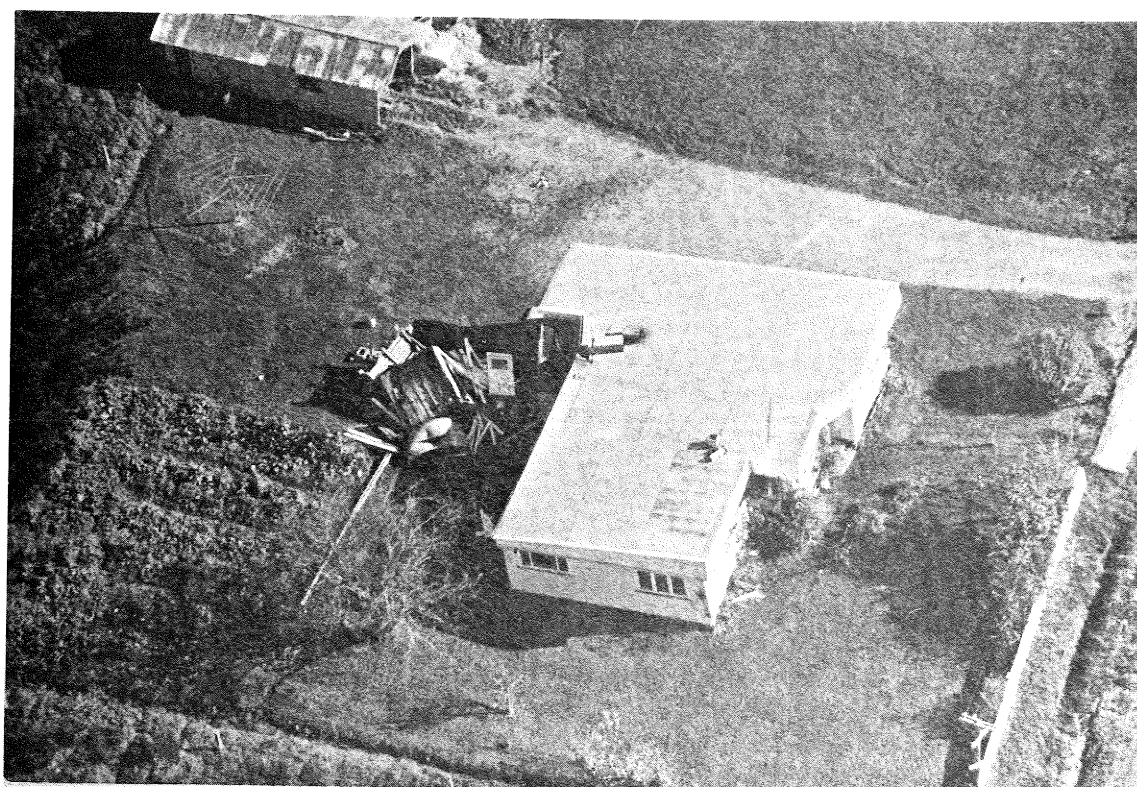
Fig. 4. Aerial view of damaged dwelling, showing the collapsed chimneys and tank stand. photo B.H. Falconer
