DAMAGE TO CIVIL ENGINEERING WORKS AND RESULTING CIVIL DEFENCE PROBLEMS

G. L. Evans*

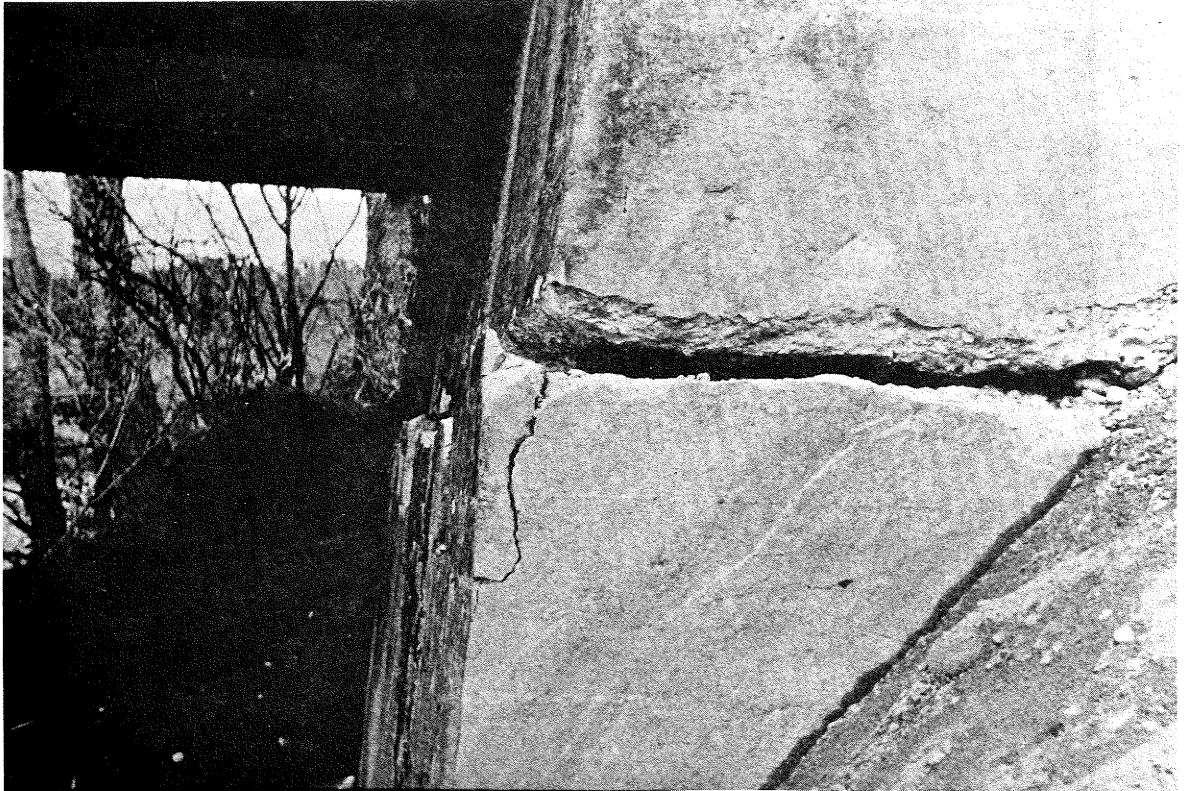
Concrete bridges with steel girders suffered sheared or bent holding down bolts and in some cases spans were displaced laterally because of orientation relative to the maximum impulse direction. Some abutments cracked badly because of earth pressure impulse causing movement towards the river, with the top of the abutment restrained by the superstructure. (Fig 2)

Fig 2. Combined rail and road bridge, Inangahua Junction.
Three inch relative movement, horizontally and
vertically, at fracture through mass concrete abutment.
photo G.L. Evans

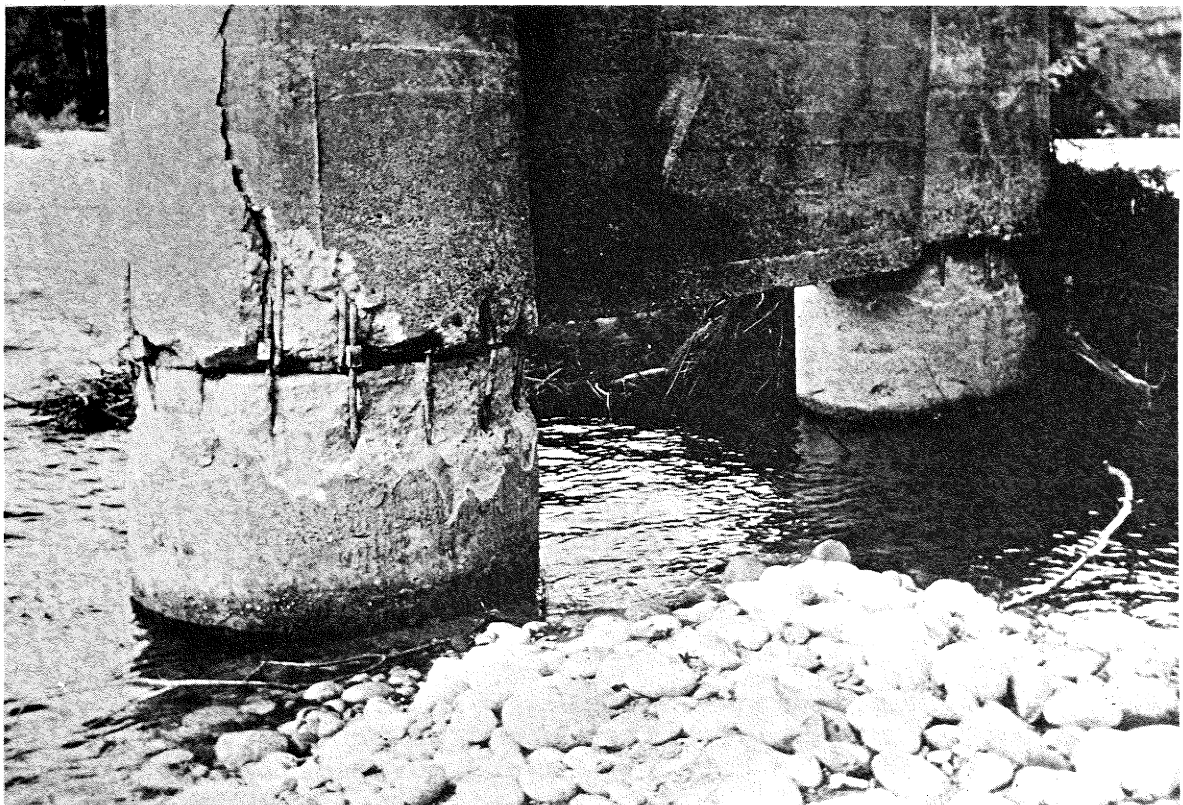
Foundation cylinders of 4 ft and 6 ft diameter and heavily reinforced were sheared by horizontal movement. (Fig 3)

Fig 3. Combined rail and road bridge, Inangahua Junction.
Fracture at construction joint of 6 ft diameter
reinforced concrete pier cylinders
photo G.L. Evans

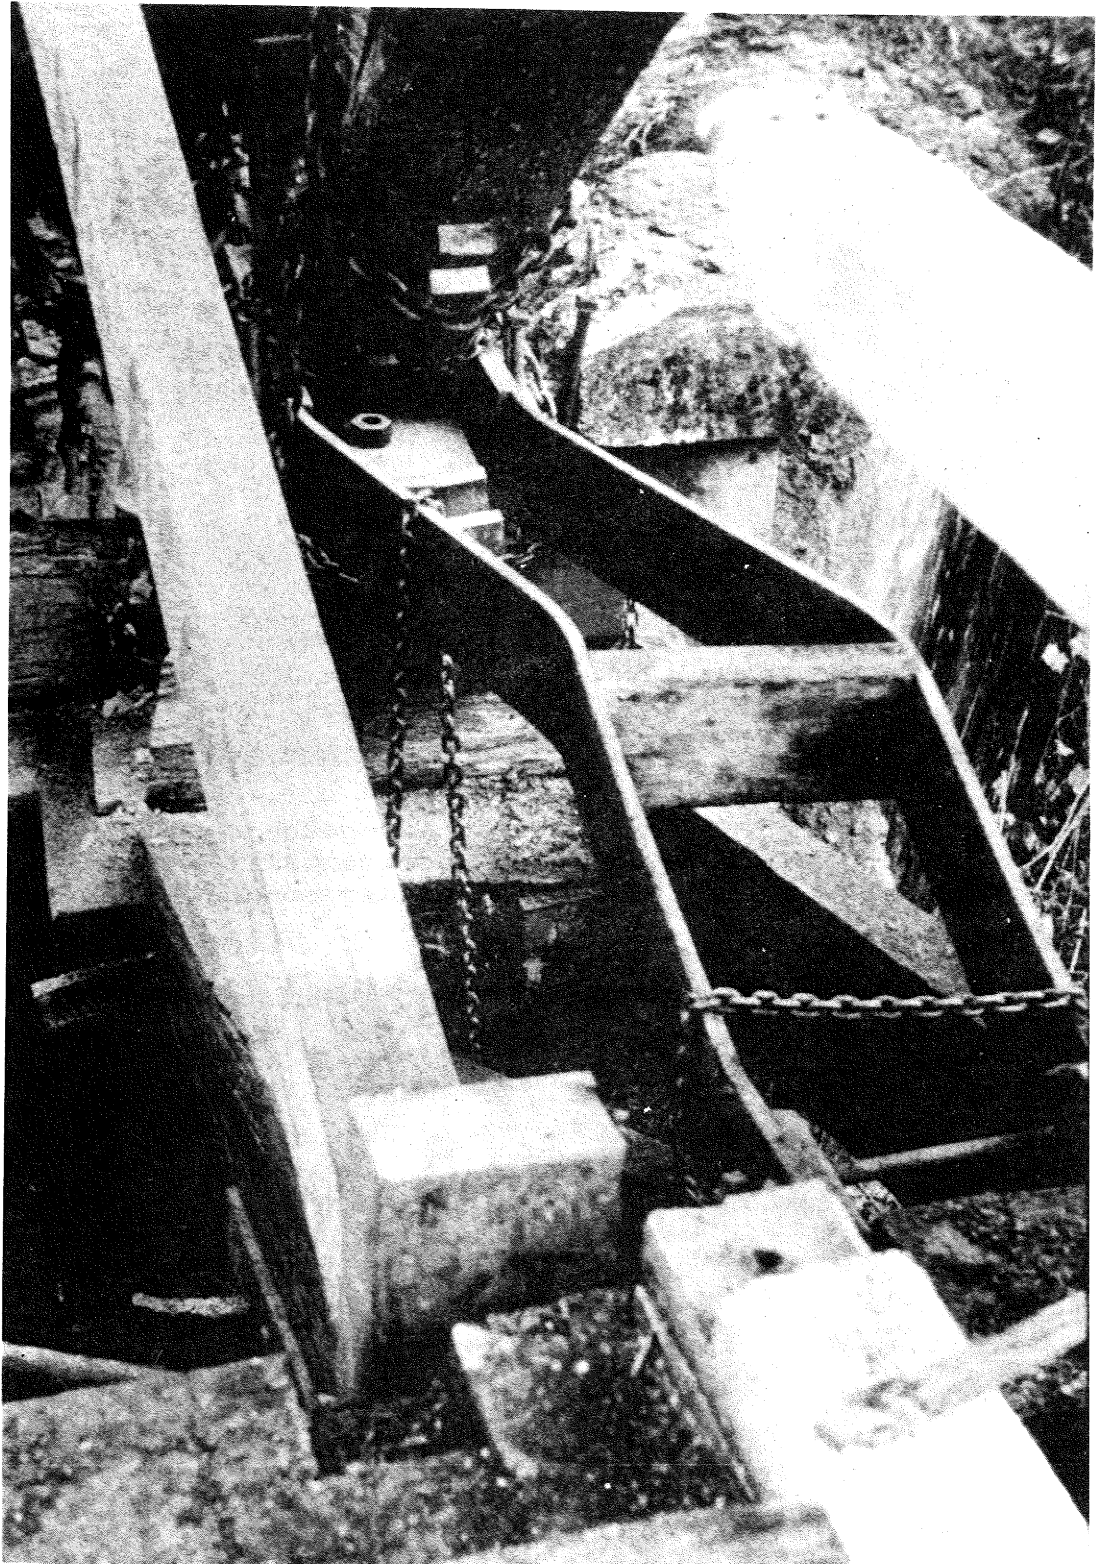
Fig 4. Combined rail and road bridge, Inangahua Landing.
Buckling of end of bottom chord of truss, caused
at both ends by relative inward movement of abutments.
photo G.L. Evans
