BUILDING DAMAGE IN THE REEFTON AREA

D. I. D. Bird**, S. C. Gentry*, J. P. Hollings*

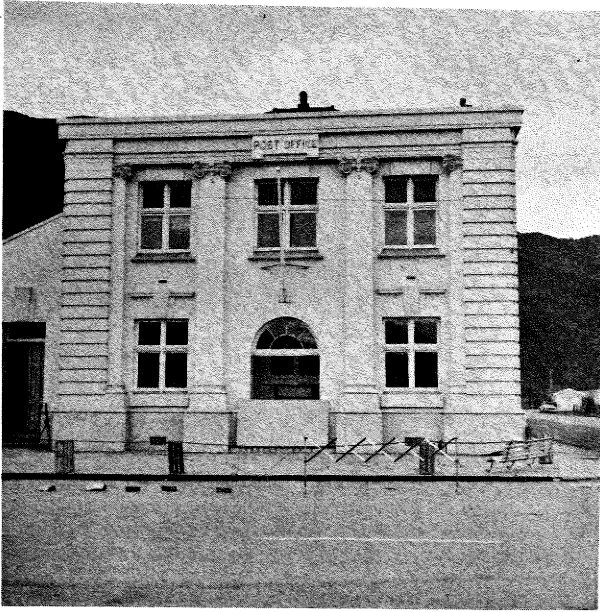
There were no total collapses of any structures of size. Damage was generally limited to separation of masonry and timberwork and to masonry cracking. Typical examples of the former were a store where mass concrete partition walls separated up to 1" from the adjoining timber work. Masonry cracking was severe in the solid brick Post Office (Photos 1 and 2).

Fig. 1. Reefton Post Office building, with unreinforced brick masonry walls

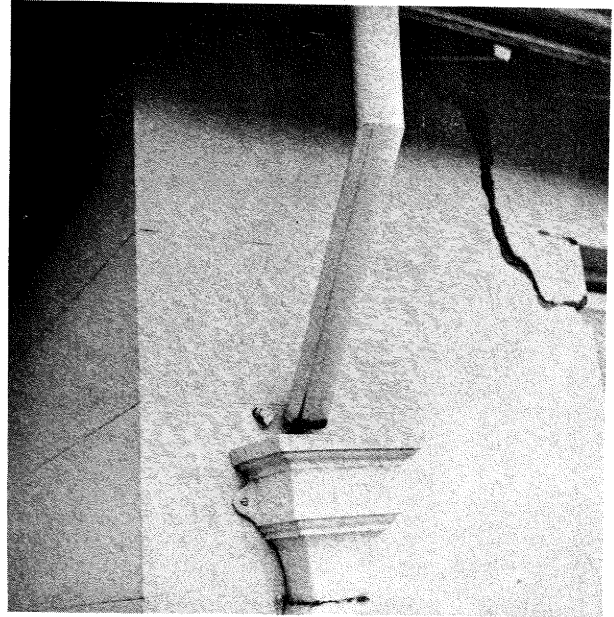
Fig. 2. Reefton Post Office, heavy cracking at a window head

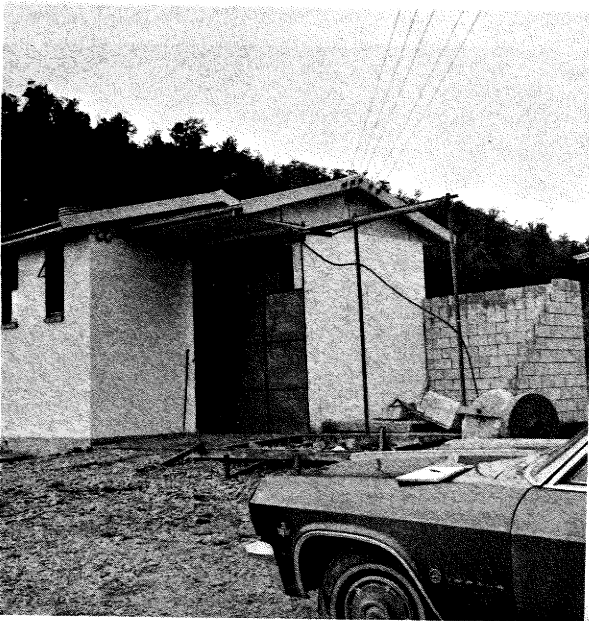
At Cronadun, 7 miles north of Reefton, an Abattoir built on an alluvial flat with a high water table suffered collapse of an unreinforced blockwork lean-to in course of construction (see photos 4 and 5). This structure had been founded on a reinforced concrete footing which was not continued across two doorways. Complete separation of the structure occurred across a line joining the two doors and the two halves moved apart bodily some 2". This was notwithstanding concrete bands provided over the doors and at eaves level. No part of the structure actually collapsed but much of it will require rebuilding.

Fig. 4. Abattoir near Cronadun

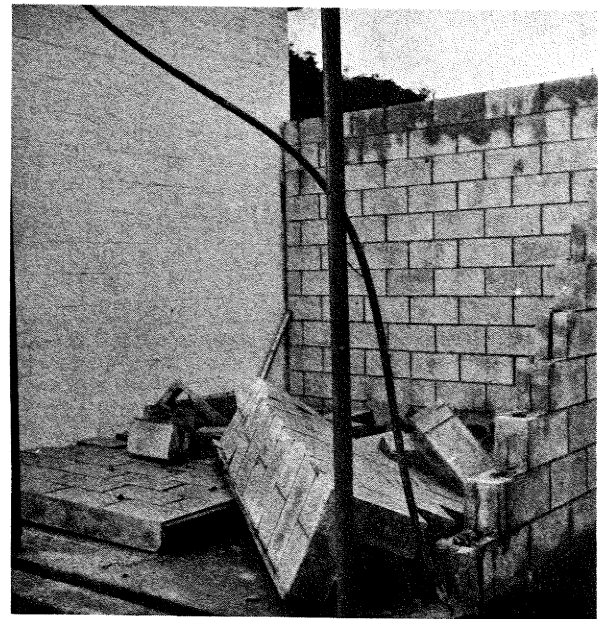
Fig. 5. Abattoir near Cronadun, partial collapse of unreinforced concrete blockwork lean to structure

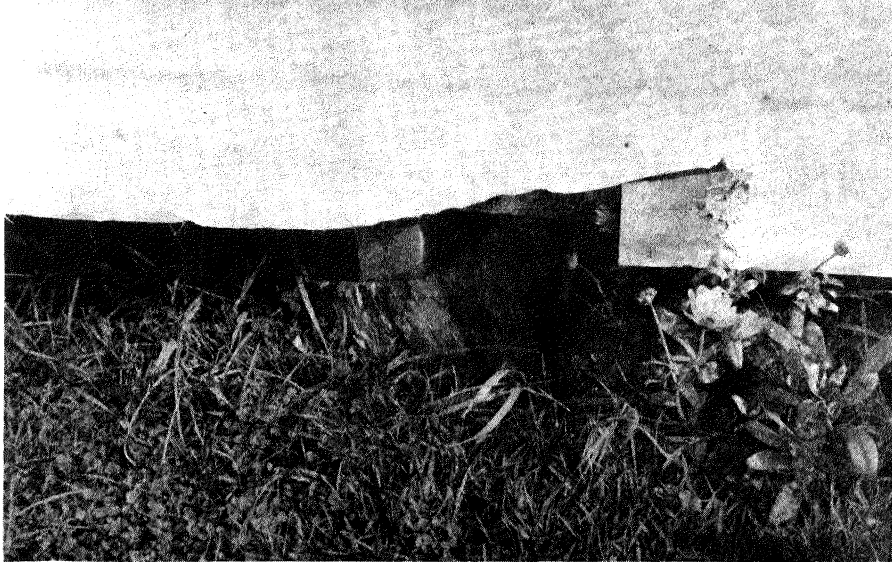
The Cronadun Hotel, an old 2 storey timber frame structure, some 8 miles north of Reefton, suffered structural damage. The building has 2 later single storey additions, one on continuous concrete footings and one on concrete piles. The 2 storey portion on old wooden piles moved

relative to the single storey portions up to 3". The timber piles show evidence of rocking some 3" one way and the other, but they were practically non-existent 3" - 6" below ground level (Photo 3). Surprisingly there was little evidence of settlement in a wet alluvial soil.

Fig. 3. Cronadun Hotel. Pile rocked some 3" to 4" leaving a gap in the ground, evident at the right side of the pile

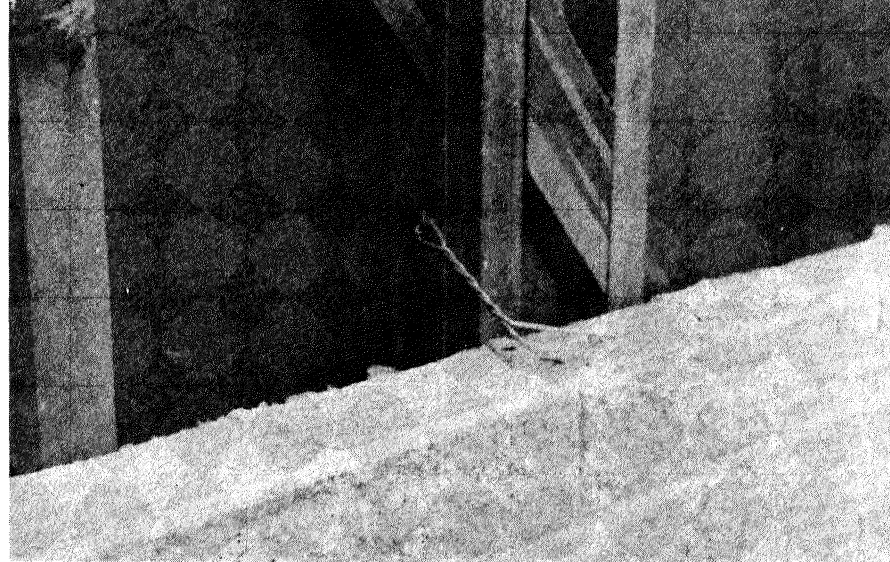
At the Reefton Secondary School concrete block veneer panels (in recent timber frame additions of substantial area) suffered minor cracking and offsets. (The remaining timber sheathed portions of this structure were unmarked). Some concrete block veneer actually fell off a motel unit and inspection revealed that although there were the correct number of ties, these were only held to the framing with 14g staples which had pulled out (Photo 6).

Fig. 6. Motel in Reefton. Staples of 14 gauge pulled out allowing blockwork veneer to separate from the structure

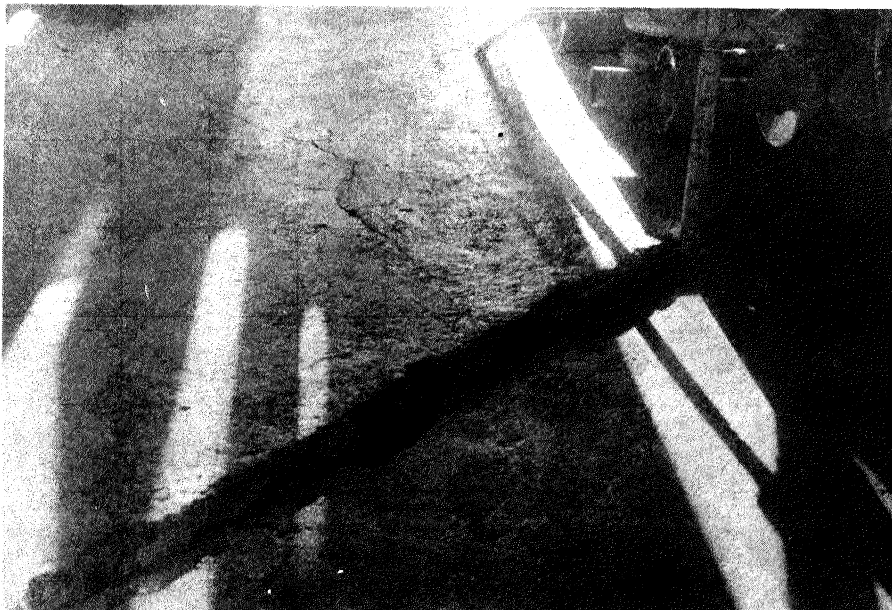
A relatively new floor in a motor car sales showroom showed considerable damage due to movements in the underlying gravel soils. The slab was badly cracked, and at construction joints differential movements of $1\frac{1}{2}$ " had taken place (Photo 7).

Fig. 7. Motor garage building in Reefton. Differential movement of floor slab at construction joint, in shw
