DAMAGE BETWEEN WESTPORT AND GREYMOUTH

A. D. Smith*

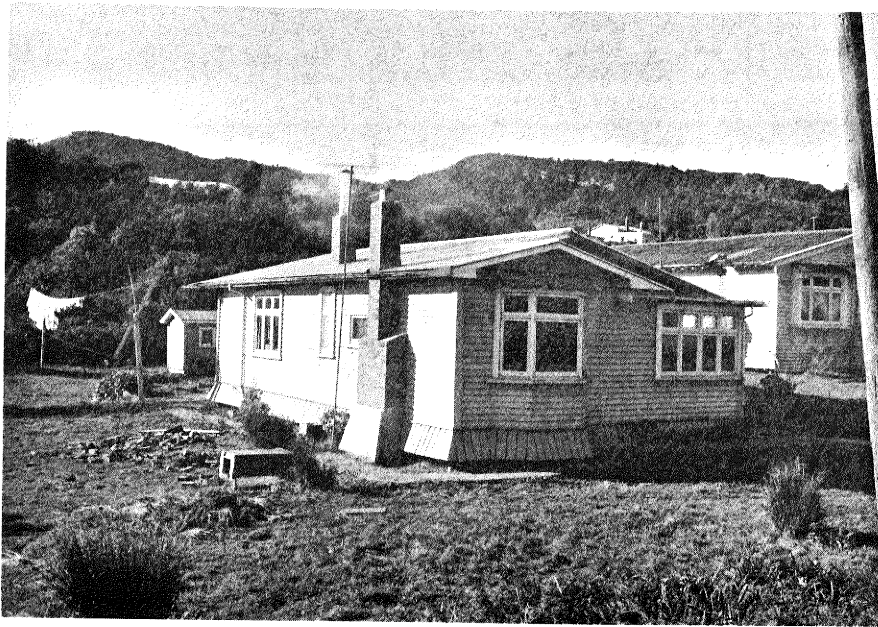
Fig. 1. House with repaired chimneys, debris still on ground

In the Runanga and Dunollie area, the Runanga Borough Council undertook the immediate organisation of the repair or rebuilding of chimneys, except for the few owners who chose to plan their own repairs. The Council arranged for the supplies of bricks and other materials, and for the availability of men, both council employees and private bricklayers. A schedule of urgent cases was prepared, with priorities for the elderly, widows and retired miners. The Council also undertook to assist, within its powers, in any way possible, the residents adversely affected by the earthquake. This resulted in a most economic and efficient method of dealing with the disaster, stabilized repair costs, ensured that the most urgent cases were completed first, and also ensured a high standard of workmanship. The Runanga Borough Council can not be too highly praised for the fine example which they set on the West Coast in the organisation and repair of disaster damage and the exceptional service given to the people in the area at the time of the earthquake.

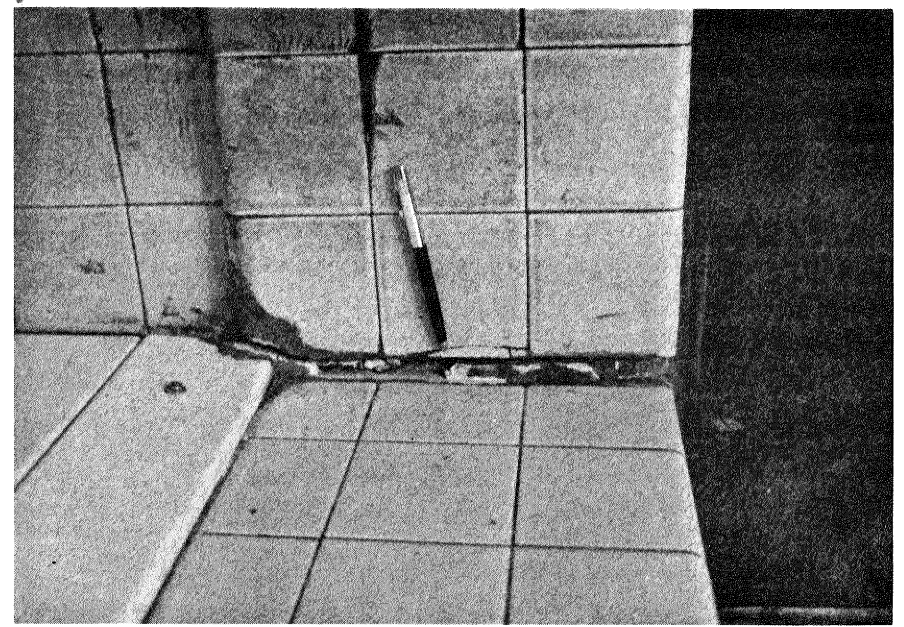
Fig. 3. Old movement & prior evident repair at fire surround

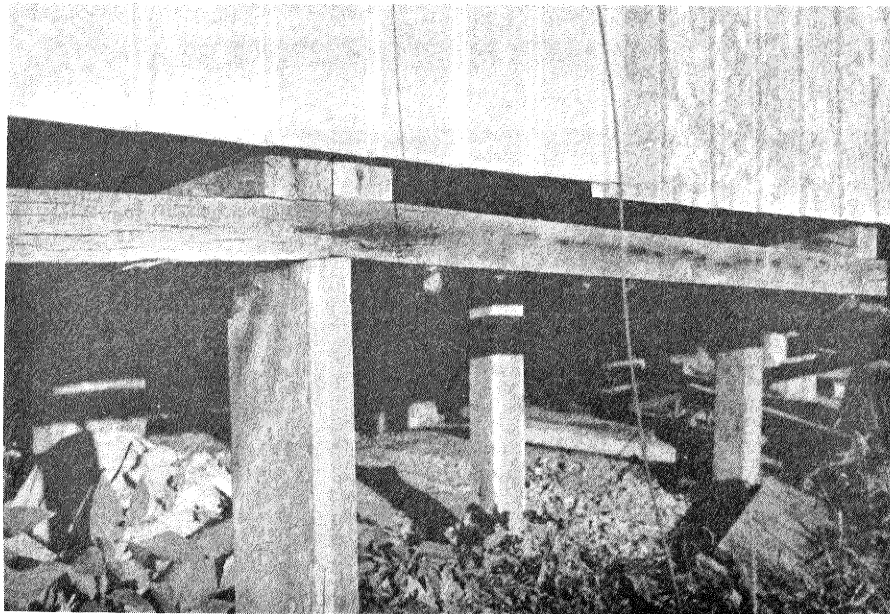
Fig. 2. Foundation and under structure of a "coastal" house

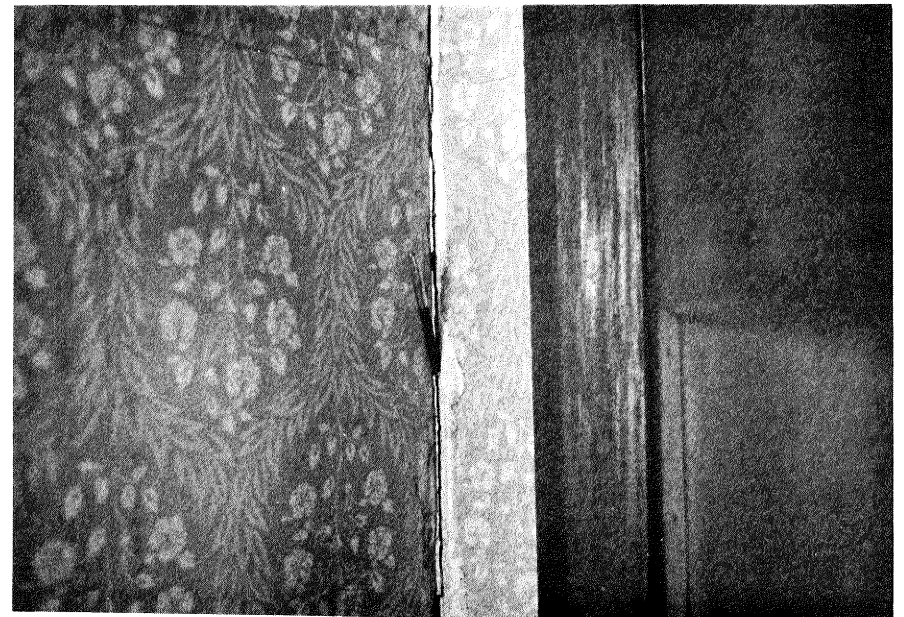
Fig. 4. Old movement and prior filling at wall junction

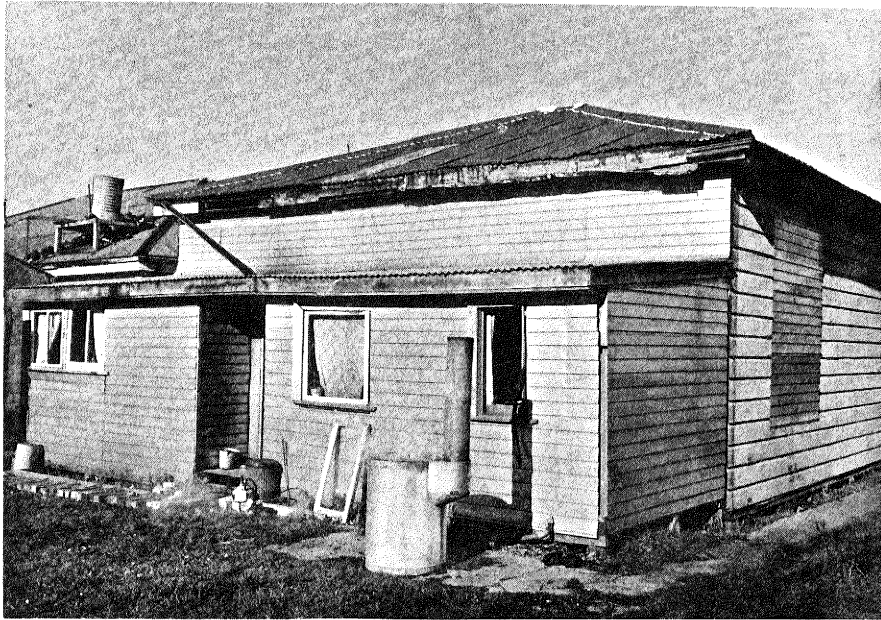
Fig. 5. Rear of dwelling, lack of maintenance, old subsidence

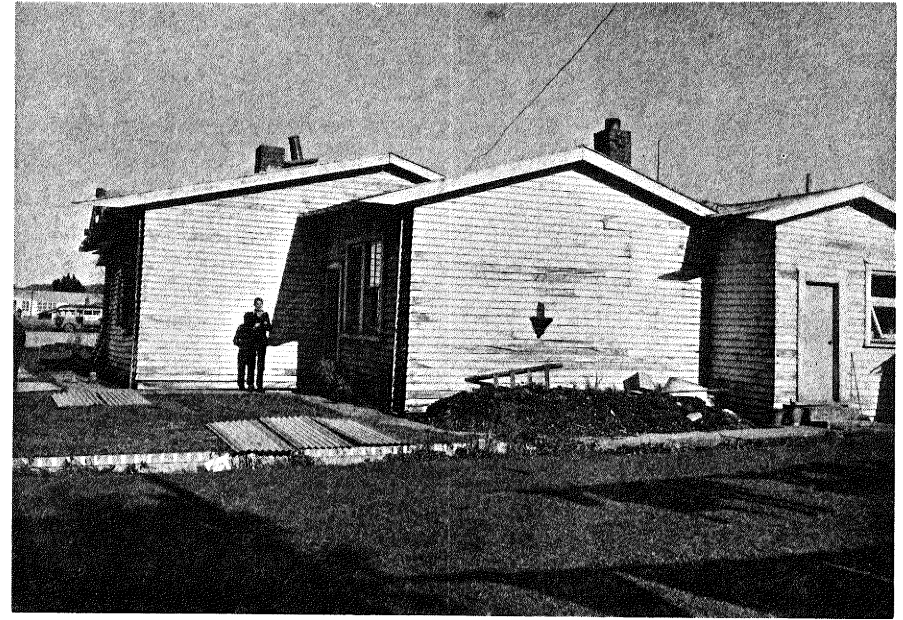
Fig. 7. Dwelling with irregular plan, having old settlements

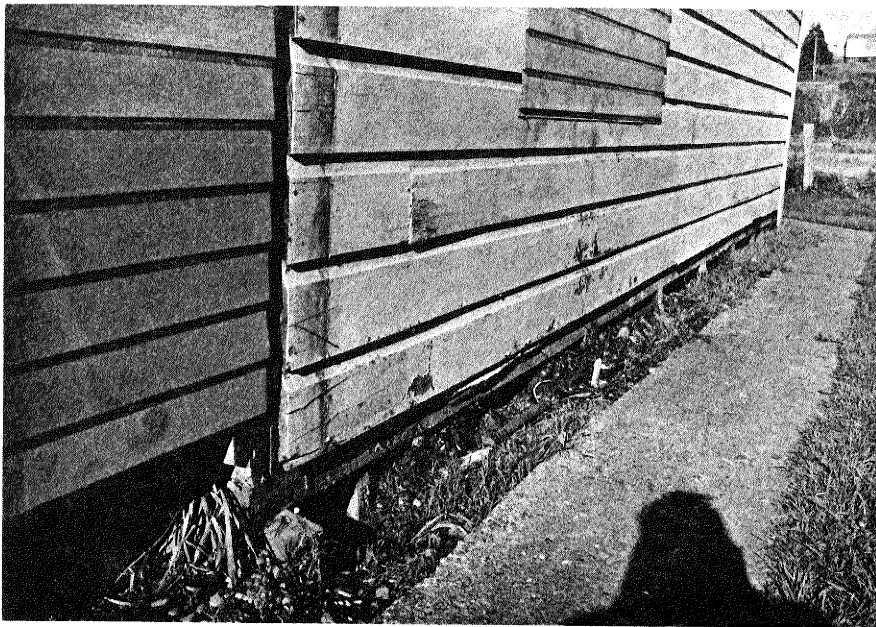
Fig. 6. Detail of view 5, showing short piles in damp soil

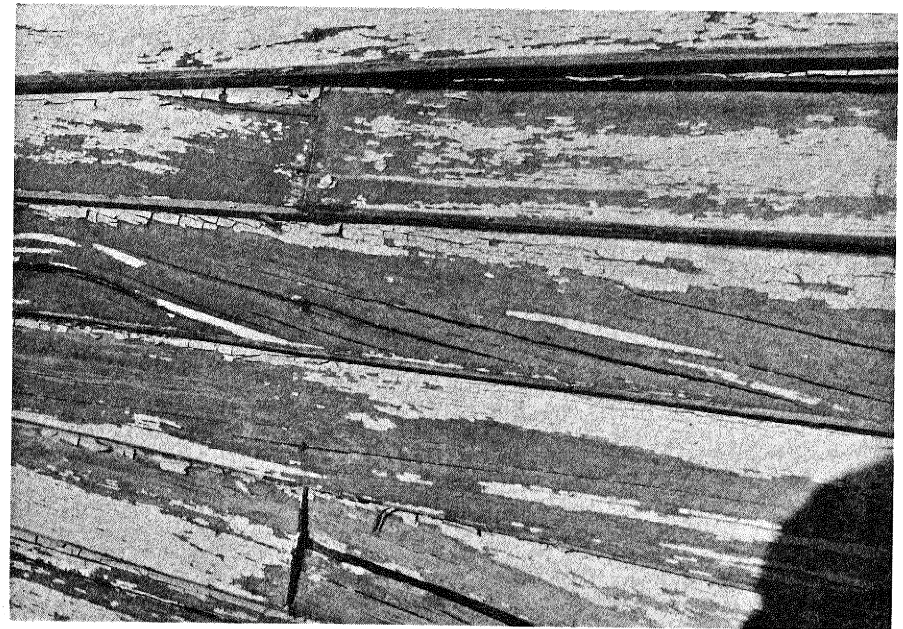
Fig. 8. Detail of view 7 at arrow, showing weather boards
