DAMAGE IN THE GREYMOUTH AREA

P. D. Anderson* F. R. Smith* F. Quinn**

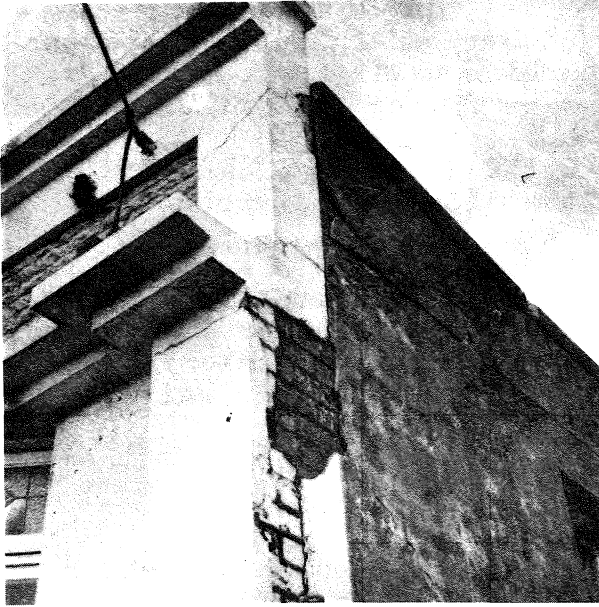
Brickwork parapets on the north-south walls collapsed in many cases, and in most cases suffered some lateral displacement.

Fig. 1. Typical Damage to
Brickwork parapets.

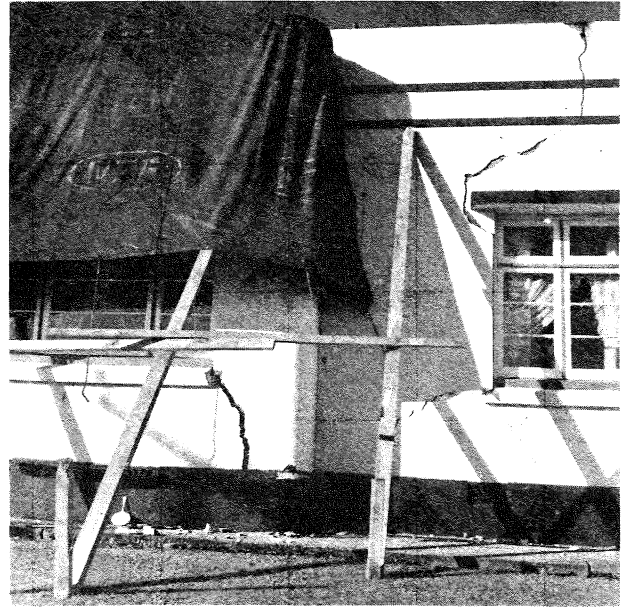
One notable example of amplification of ground motion due to poor subsoil was observed. One of a row of houses built on an alluvial terrace was constructed over a gulley which had been filled with silt sluicings. The house was apparently well constructed, of timber frame with plastered brickwork veneer. The vibrations were sufficiently intense to move large sections of the veneer bodily by up to two inches. The foundation beam was undamaged and there was **no** foundation settlement. Repairs would involve the rebuilding of most of the veneer and the redecoration of the interior. Other houses of similar construction on the same terrace were virtually unmarked.

Fig. 2. Timber framed brick veneer
house built on poor subsoil.

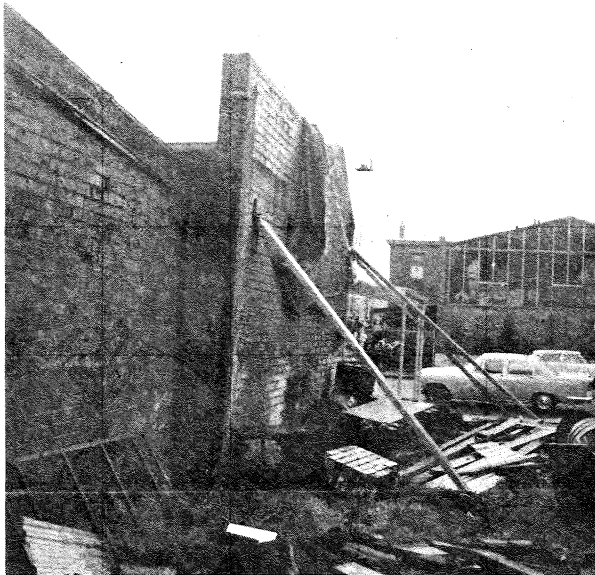
W.C. 739

Fig. 3. Boundary wall not tied to
remainder of structure.

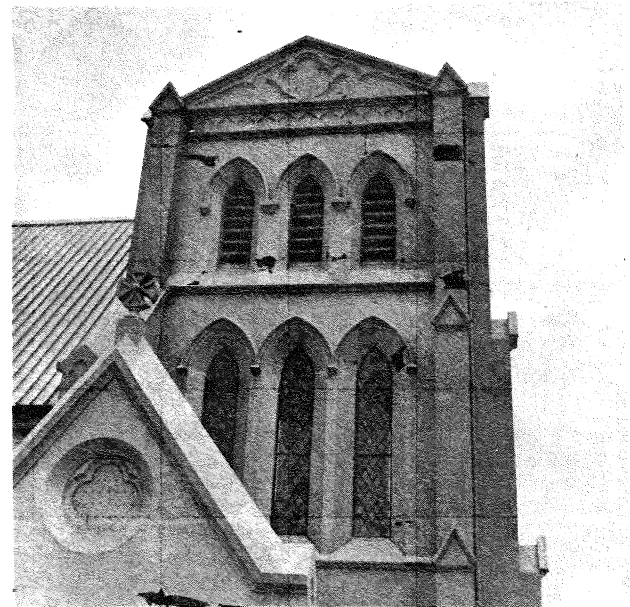
Fig. 4. Cracking to unreinforced
brickwork of bell-tower.
