# DAMAGE IN CHRISTCHURCH AND CANTERBURY

P. J. Moss\*

## DAMAGE FROM GREYMOUTH TO HOKITIKA

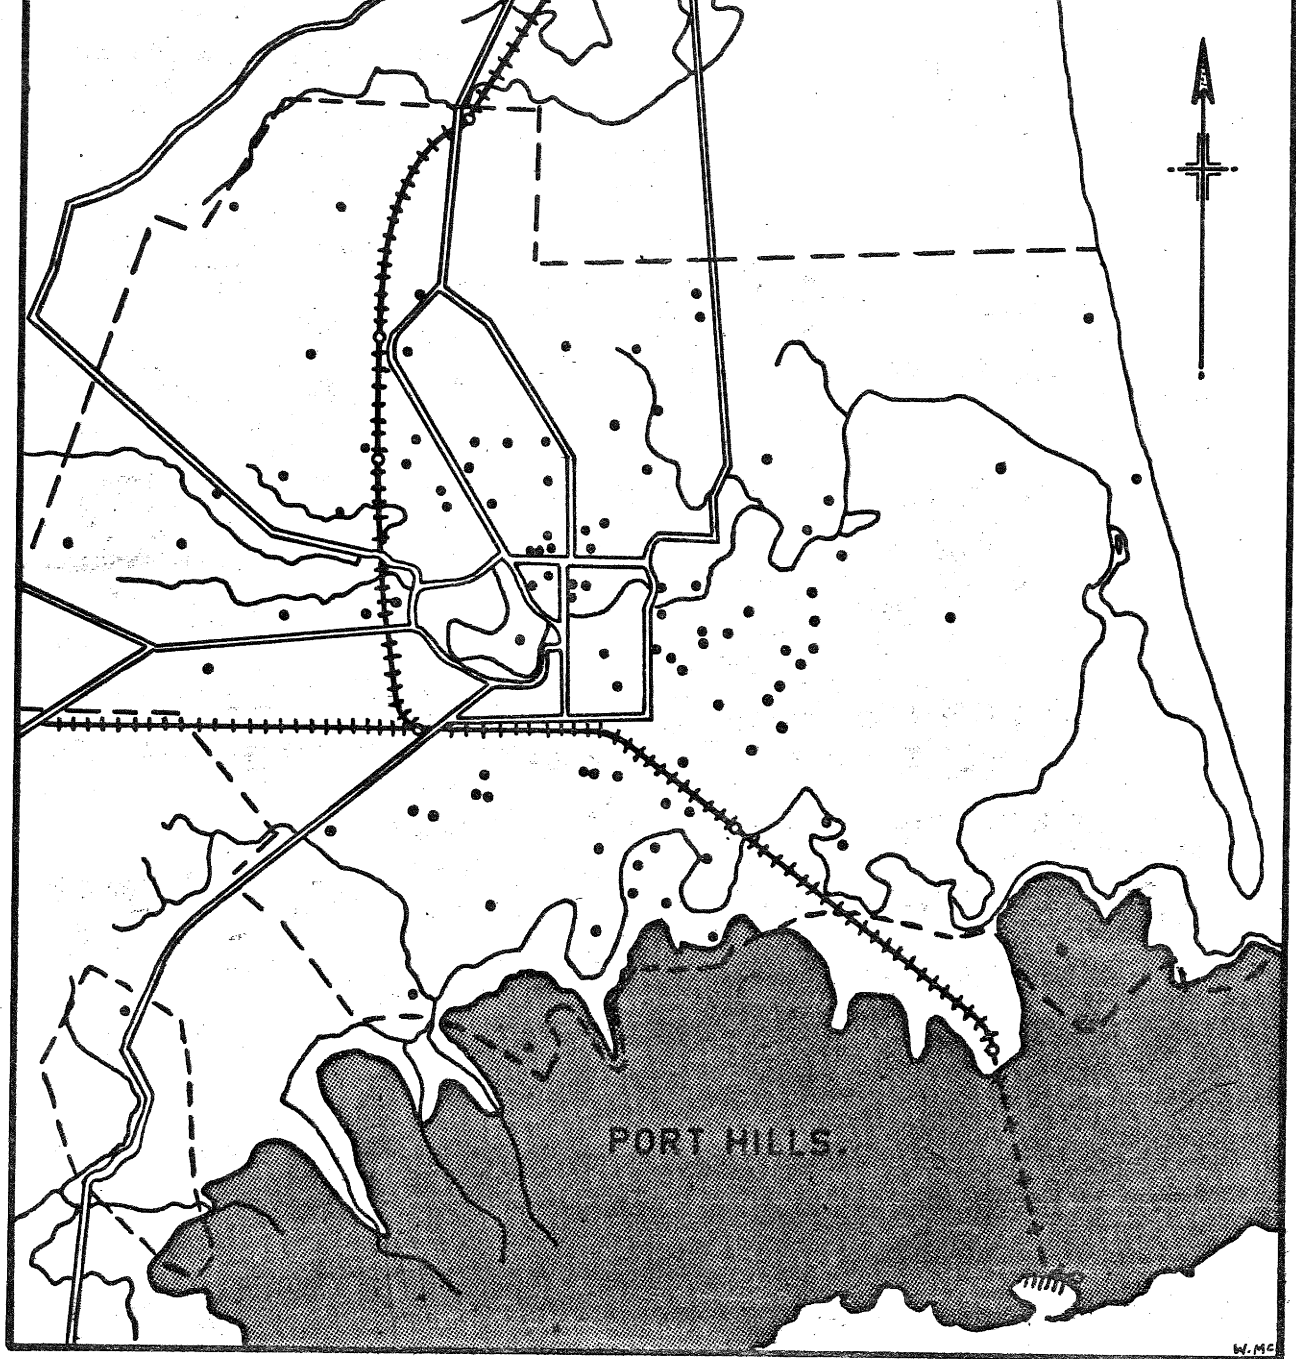
the built-up area and does not appear to predominate in any one area. Fig. 2 shows the scatter of damage to chimneys in Christchurch. No cases were reported of stock being thrown off shelves in shops.

The distribution of chimney damage throughout the area is shown in fig. 2. Damage of other types followed a similar pattern with no apparent preponderance in any one part of the built-up area.

**FIGURE 2.** Distribution of chimney damage in the Christchurch area. (Dots indicate damaged chimneys.) (Dash line indicates extent of urban area.)
