# THE 1968 INANGAHUA EARTHQUAKE AND ELECTRICITY SERVICES

H. C. Hitchcock, B.E. (Hons.) M.N.Z.I.E. M.I.E.E.

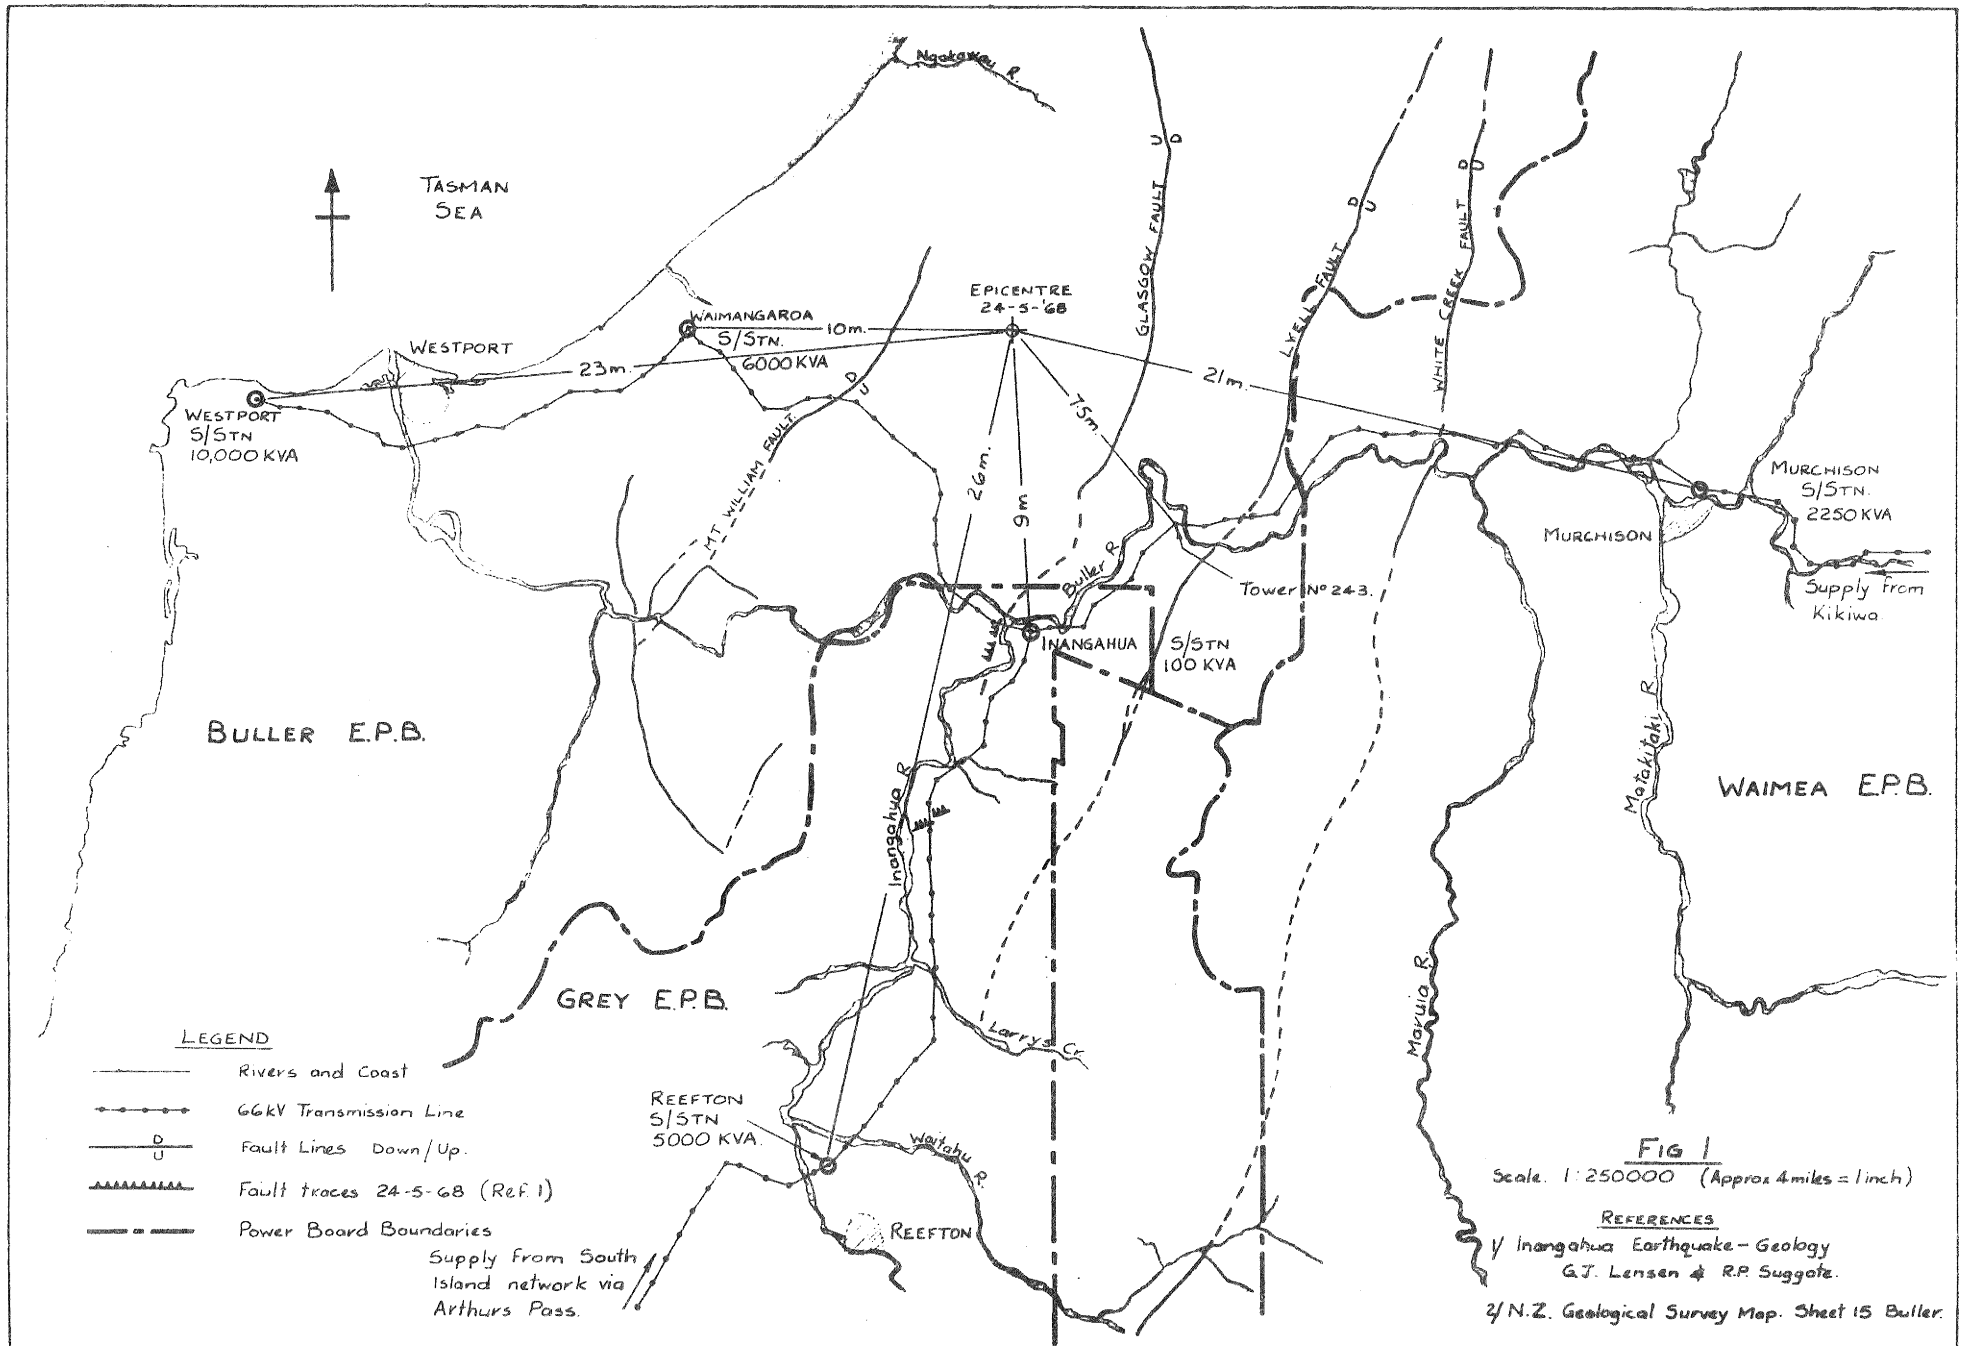
Earthquake loads on such structures are insignificant and the only real risk of failure is from disturbance to foundations. Fig. 2 shows how nearly this occurred in the Upper Buller Gorge near Lyell - at a point only 7.5 miles from the epicentre. The worse damage to towers themselves was on top of a ridge of poorly consolidated alluvial material near Dee Creek 2 miles north of Inangahua. The upper levels of the ridge were disintegrated with the violence of the shaking and the disturbance of the grillage footings was so great that an angle leg was fractured. Many towers were distorted to a lesser degree but none failed in service.

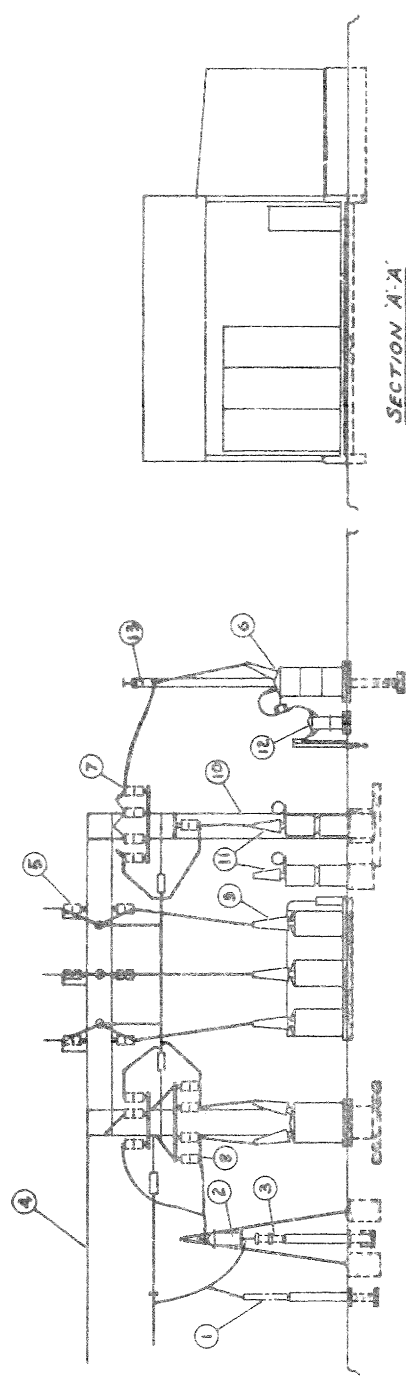
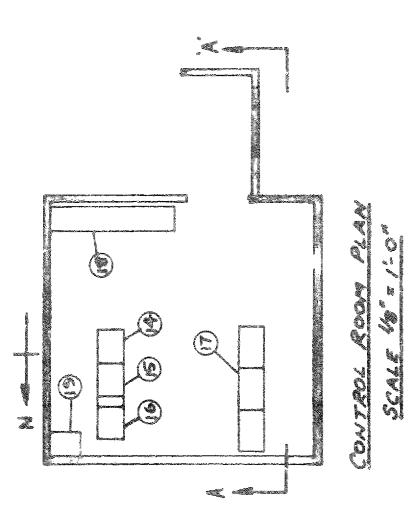
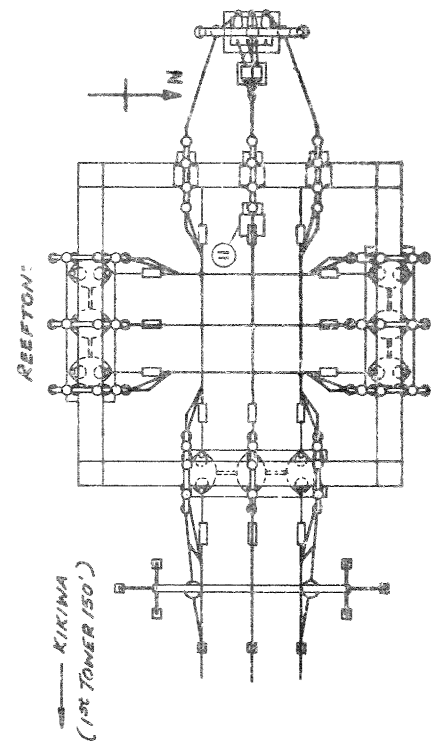
**SWITCHING GEAR & STRUCTURE PLAN**  
SCALE 3/8" = 1'-0"

Inangahua Substation (Fig.3) was 9 miles from the epicentre but was in the zone of maximum ground damage and shaking.

In the small control building the station battery and control, relay and communications panels were overturned because of inadequate fastening.

In the outdoor switching station the lattice steel switch structure was undamaged and its foundations undisturbed as were the bulk oil type circuit breakers and their foundation slabs. Some of the 66 kV insulator stacks in the airbreak switches were broken off because jumpers did not have enough slack to allow for movement between the steel structure and adjacent equipment. Broken insulator stacks swung down on the ends of the jumpers and damaged the transformer neutral bushing and the support insulators for the power line carrier coupling capacitors.

The small permanent staff at the substation were however able to carry out sufficient repair work to bypass the inoperative circuit breakers and allow through transmission of power to resume about three hours after the main shock.
