INANGAHUA EARTHQUAKE DAMAGE ON RAILWAYS

* W. J. H. Duckworth, B.E., M.N.Z.I.E., D.P.A.

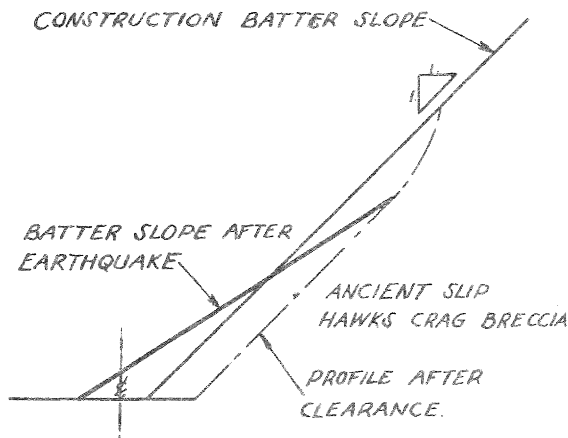
FIG. 2.
SLIP AT 73M.

The material in this area was largely a massive hard conglomeratic rock composed of granite and greywacke set in a matrix of sand and silt. The boulder size was up to 50 tons. The site was an ancient slip and the earthquake merely reactivated it. The batter slopes were approximately 1 to 1.

Clearing and stabilization of this slip (Fig. 2) presented a problem. Removal of the spoil from the toe merely triggered off further slips, and gradually the exposed face got wider and higher. The solution eventually was to crib log the toe.

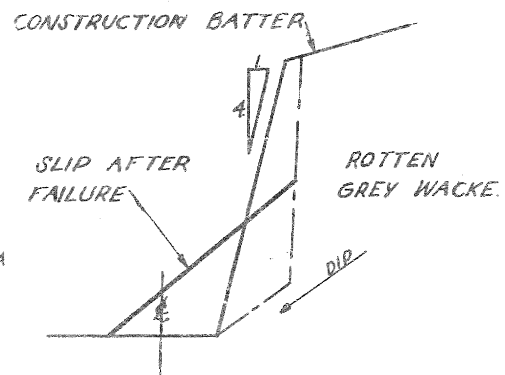
FIG. 3.
SLIP AT 67M 40ch.

In a number of instances the sidlings were composed of large shattered rock mainly of mudstone origin. The batters were steep, some nearly vertical. The earthquake merely destroyed (Fig. 3) the bonding between the rock and slides developed.

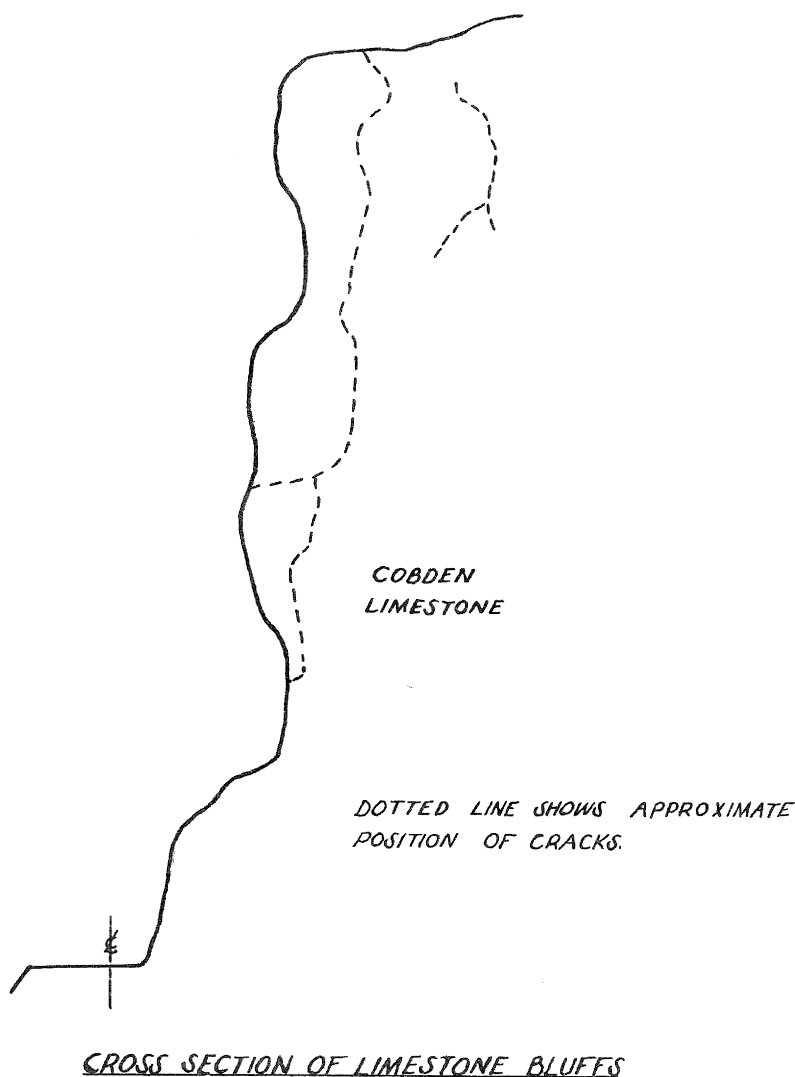
FIG. 4

Prior to the earthquake this bluff (Fig. 4) had almost a vertical face. It stood 275 feet high and the track was within 15 feet of the base. The earthquake caused deep seated vertical cracks in the face. Besides this permanent damage, large sections of the face in block form 100 tons or larger in size were dislodged onto the ground below.

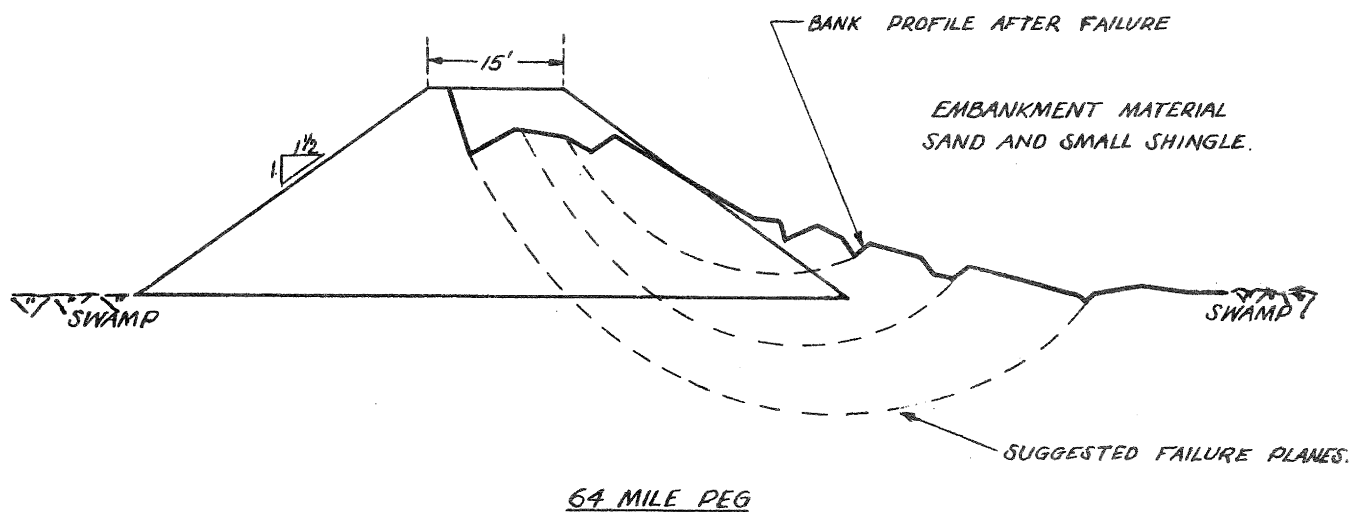
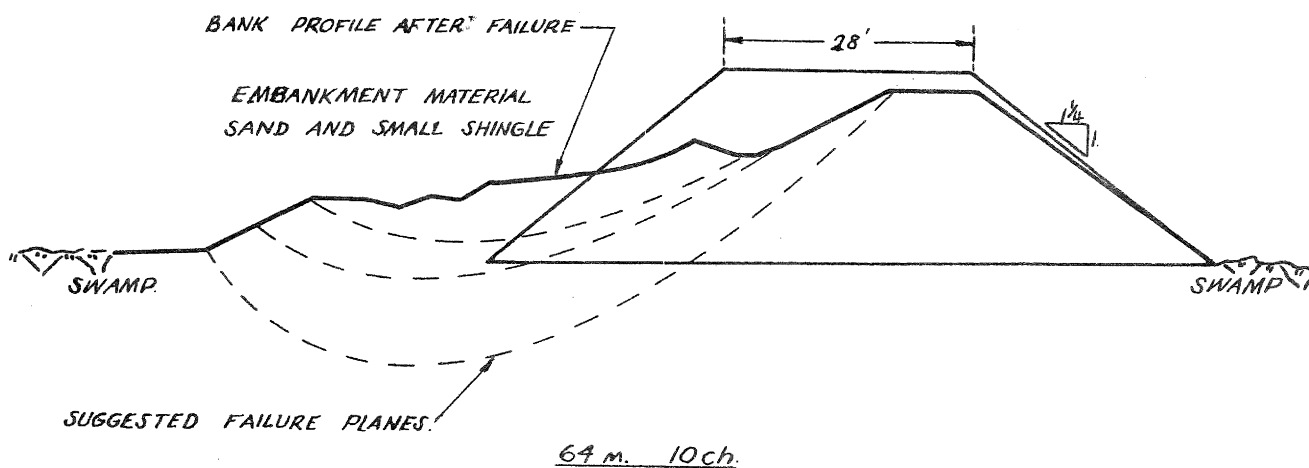
FIG 5

The characteristic failure pattern was a downward movement to the lowest unconfined level. In some cases the failure was of the slip circle type (Fig. 5).

SLIP CIRCLE EMBANKMENT FAILURES NEAR RAHUI.

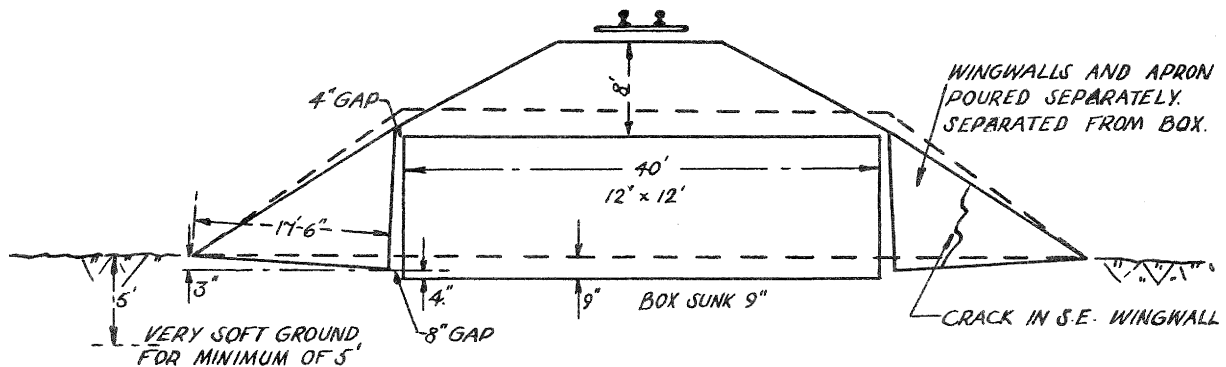
Culverts laid in firm dry natural ground stood up best. Those that were laid in soft and wet ground displayed the tendency to settle. In some instances the settlement was uneven - the culverts bowed in the middle. The largest recorded uniform settlement was 9" (Fig. 6).

FIG 6: CULVERT SETTLEMENT
BRIDGE 88 57m. 27ch.
