EARTHQUAKE DAMAGE TO THREE RAILWAY BRIDGES 1968 INANGAHAU EARTHQUAKE

+ J. P. Hollings, B.E., D.I.C. M.I.C.E. M.N.Z.I.E.

1.0 Synopsis

This report describes in detail the measured deformations and damage suffered by two combined road-rail and one rail bridge in the 24.5.68 Inangahua earthquake. The measured deformations are plotted in diagram form for each bridge and photographs of all typical damage are presented. No interpretive or analytical material has been included.

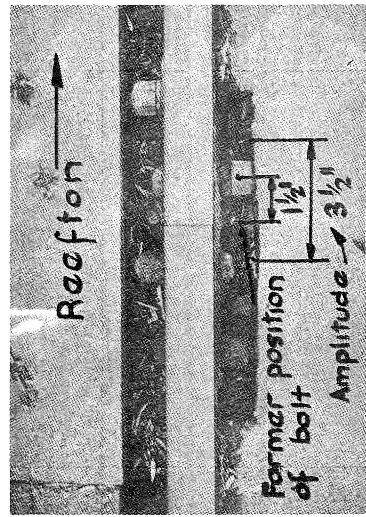
4. Relative to this moving rail system the bridge deck had an amplitude (north-south movements, i.e. parallel to the track) of $3\frac{1}{2}$ " and a permanent displacement northwards of $1\frac{1}{2}$ " (Figure 1.1).

1.1 Movement of deck system relative to rails. The projecting end of the fish-plate bolt chafing on the timber deck clearly showed $1\frac{1}{2}$ " of permanent displacement.

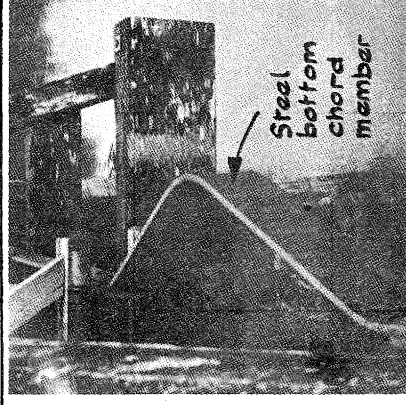
1.2 Buckling of truss bottom chord giving measured reduction in chord length of 6" (Pier 5)

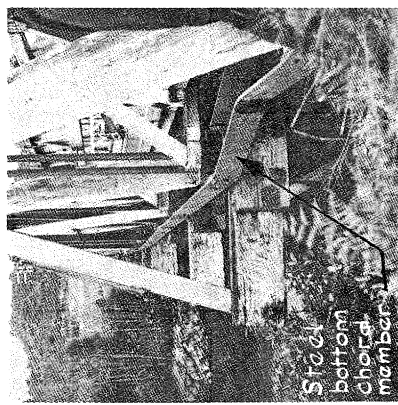
On the downstream side at Pier 5 similar effects have occurred. The 4" northwards movement of the deck has produced a 2" buckling in the lower chord panel of the truss. The reason for the 2" discrepancy in these measurements is obscure but may be partly explained by the general lengthening required in the whole of the downstream trusses due to the substantial downstream movement of the top of Pier 4 (Figure 3.2).

1.4 Buckling of truss bottom chord giving measured reduction in chord length of 2" (Pier 5)

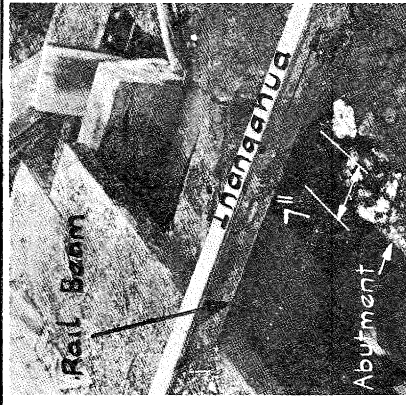
- Pier 3 has not moved
 - Pier 4 has moved north $1\frac{3}{8}$ to $4\frac{3}{4}$ "
8. At Pier 5 which, according to the original plans, was built with a vertical front face, there is now on the upstream side a 2" forward lean (Figure 3.1). This, when taken with the known 4" northward movement (see above) of the entire bridge deck, means a shortening of 6" in the end panel of the bridge on the upstream side. This checks with the measured 6" shown in Figure 1.2 where the truss base has remained firmly bolted to the concrete abutment so that the 6" movement has been concentrated in buckling of the steel lower chord of the truss. It also checks with the measured 7" shown in Figure 1.3 where the rail beam has sheared the through bolts attaching it to the corbel and ridden forward over the concrete abutment a distance of 7".

1.3 Photo with deck removed at Pier 5. The rail beam and therefore the deck system was moved 7" relative to the abutments.

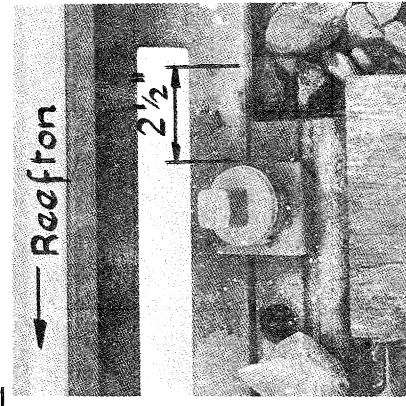
2. The amplitude of this movement was at least 4" (Figure 1.6) and the rail system finished with a permanent displacement of $2\frac{1}{2}$ " northwards relative to the base rock. (Figure 1.5).

1.5 Movement of rail relative to sleeper of $2\frac{1}{2}$ " (shown by scraping of clip on rail) sleeper is fixed to cattle stop which is built into rock.

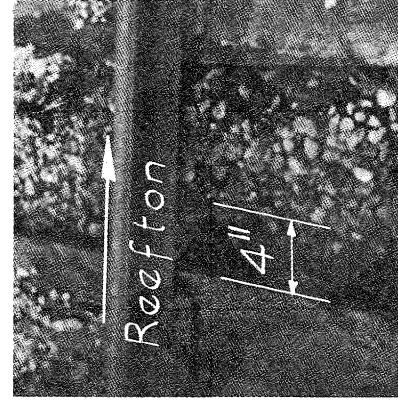
1.6 Ballast gap shows amplitude of track movements was not less than 4"

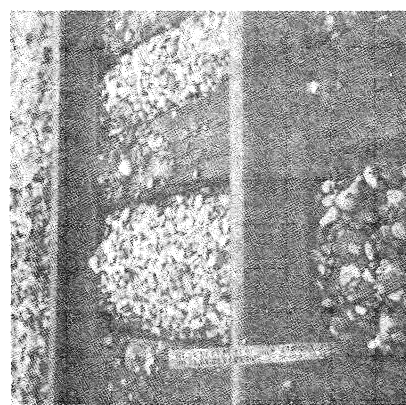
2.1 Heaping of ballast between sleepers was general for several chains south of the bridge.

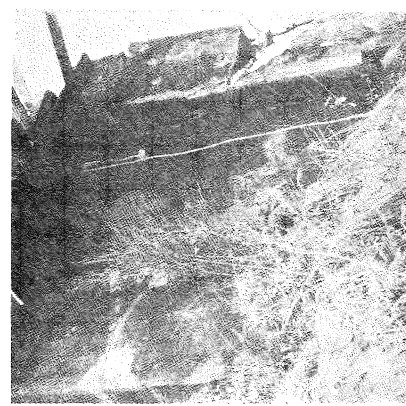
The pilaster under the downstream truss and its attached wing wall survived these movements without apparent rupture. About halfway up this pilaster, however, a crack (appears on lefthand side of Figure 2.2) about $\frac{1}{16}$ " wide ran horizontally across the pilaster face. A vertical section through this pilaster parallel to the bridge longitudinal axis would now appear curved out (northwards) about halfway down.

2.2 Damage at Pier 1 due to longitudinal movement.

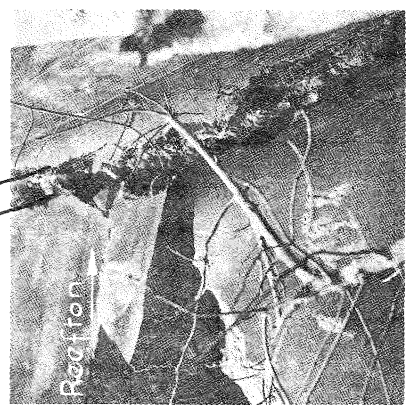
The pilaster under the upstream truss was wrenched away from the general mass of the pier (Figures 2 and 2.3) and in addition the abutment separated from its wing wall: the broken abutment moved forward (north) 6" (Figure 2.4) and the wing wall tilted out (Figure 2.3) one foot approximately (measured at the top of the wall), the base remaining fixed.

2.4 View from upstream of pileaster E.H.S. in photo 2.2. Shows forward movement of pileaster.

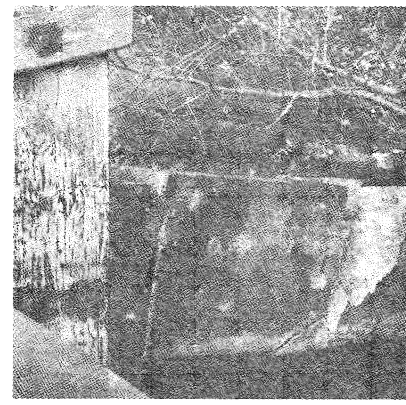
2.3 View from bridge deck of right hand plaster in photo 2.2 Note outward movement of winnow.

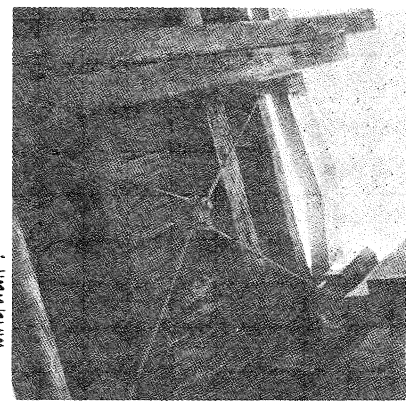
2.5 View under deck shows shortening of pier in upstream chord adjacent Pier 1 (1 1/2" only measured on downstream chord).

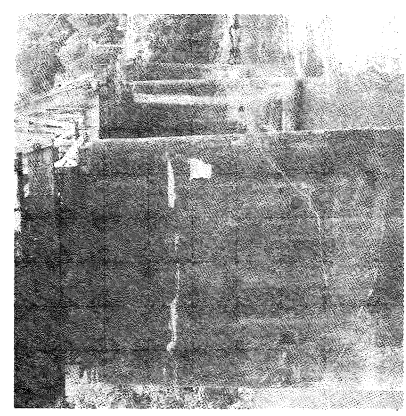
2.6 Spalling near top of Pier 2 due to longitudinal movement.

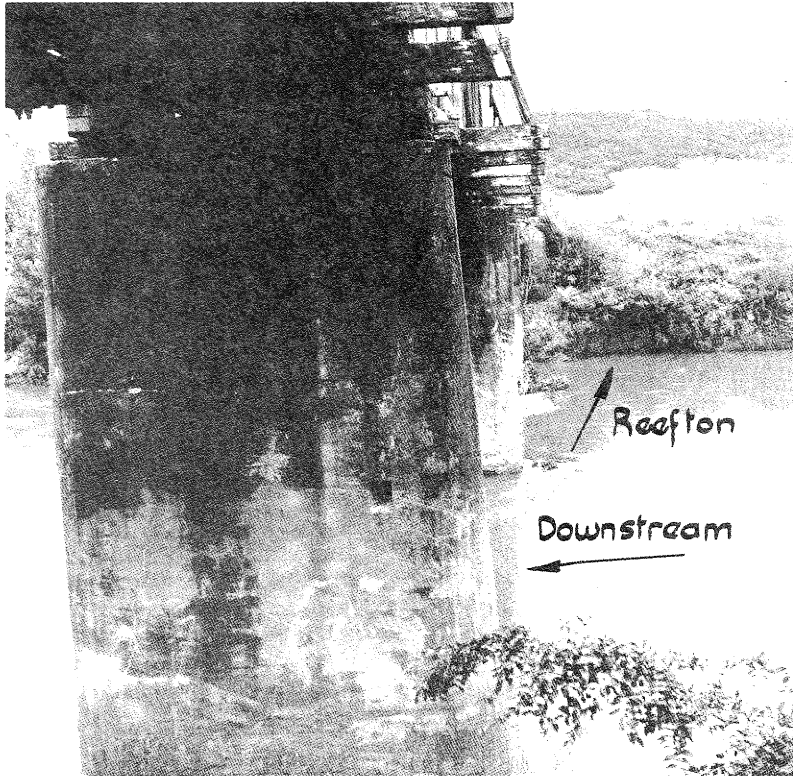
In this case the pier moved sideways (downstream) $18\frac{3}{4}$ " at rail level, is out of level 5" across the deck surface and the cylinder bases have lifted or sunk $6\frac{3}{4}$ " relative to each other.

4.2 Showing lateral displacement of pier 4

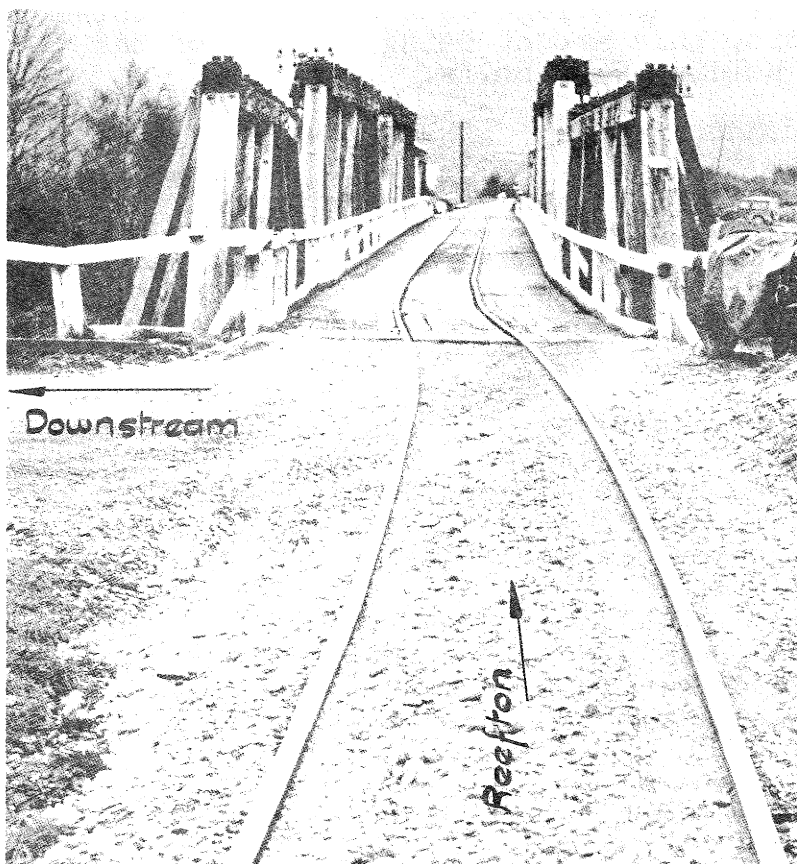
4.1 Showing lateral displacement of rails at pier 4

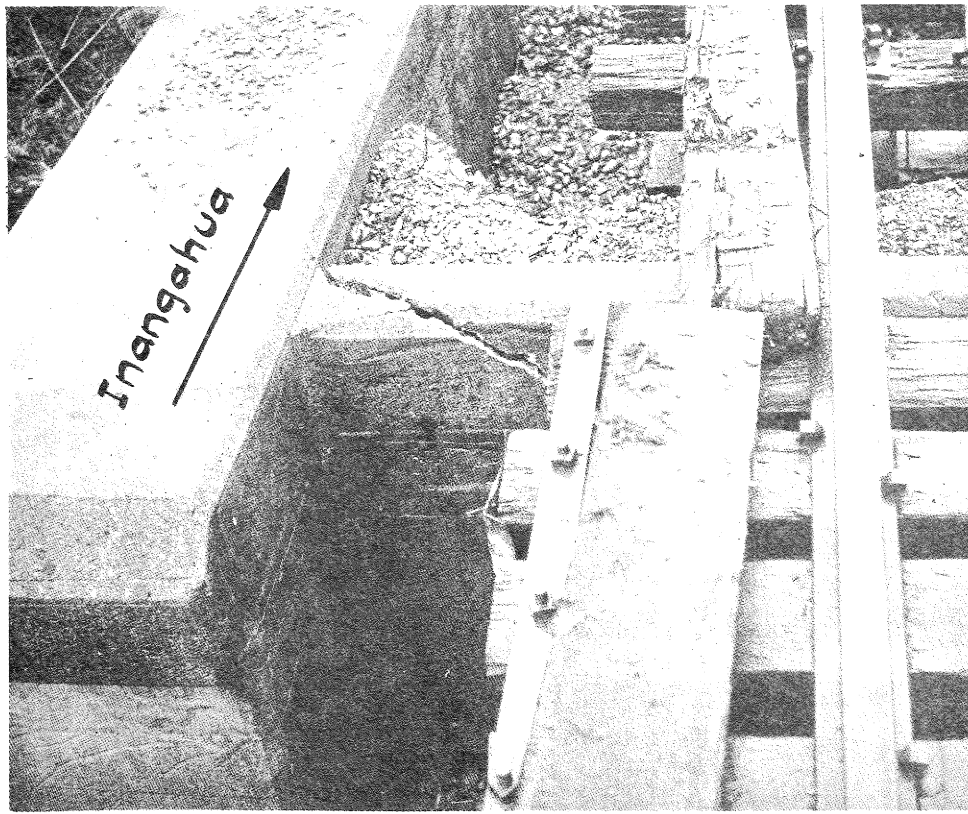
Photo 7.1 : Abutment 1
 (South) Note cracked wall and settled ballast behind abutment

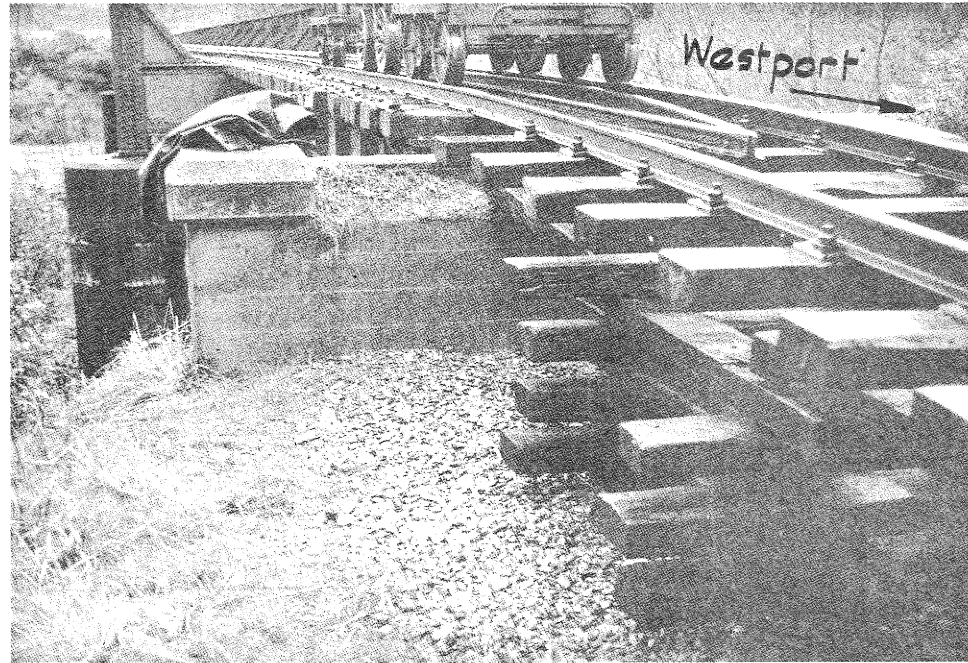
Photo 7.2 : Abutment 9
 (North) Whole embankment has settled 4'-6" for 100 ft past the abutment which itself settled 9"

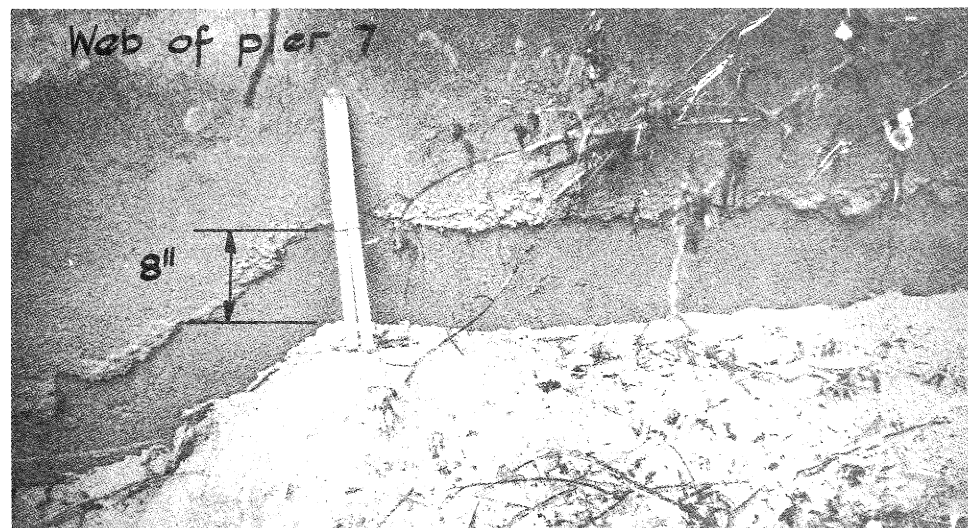
All piers, except No. 7, have diagonal tension cracks at ground level, passing from the bottom centre of the web running at 30° to 45° through both columns, - see photos 9.1 and 9.3. These are probably due to sideways oscillations of the pier tops when there exists a condition of horizontal and vertical tension above one of the piers. In the web of Pier 6 there is also a vertical crack which runs nearly the full height of the pier, starting 3 inches from the edge of the east column and finishing at the top web centre. Pier 7 is the only pier with no visible cracking above ground level, in spite of major failure at the base of Piers 6 and 8. Rail level also appears to have fallen about one inch over this pier (Figure 6.4) and the ground around the base of the pier appears to have settled about 9", - see photo 7.3.

Photo 7.3 : Base of Pier 7
 The surrounding ground has settled 8". Bedrock (papa) is overlain by 70 ft of river gravel at this point.

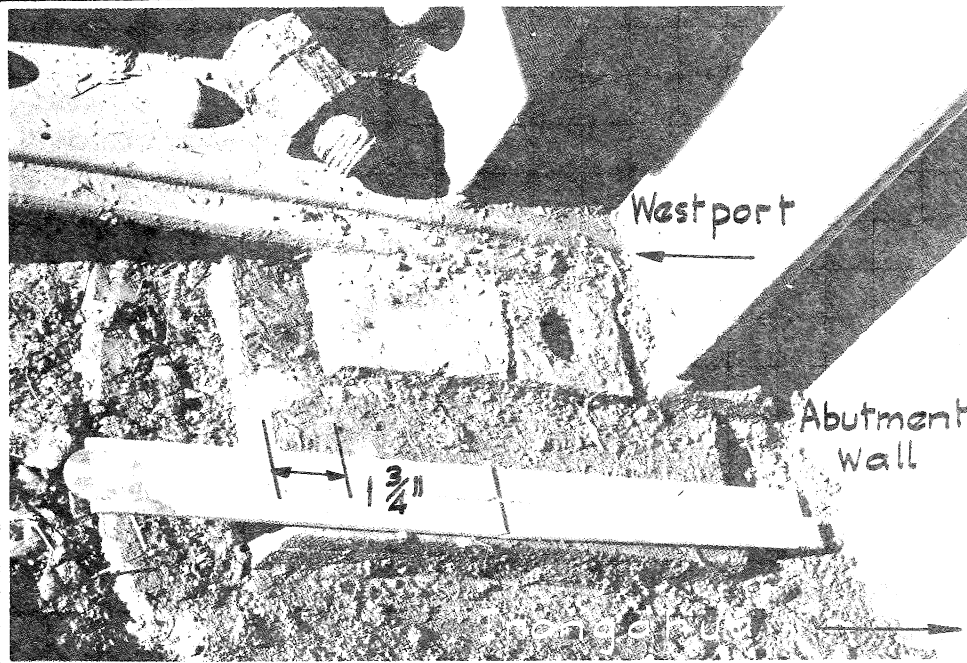
Photo 8-1: Abutment 1
Holding-down bolt
has sheared and the
girder thrust against
the abutment wall.

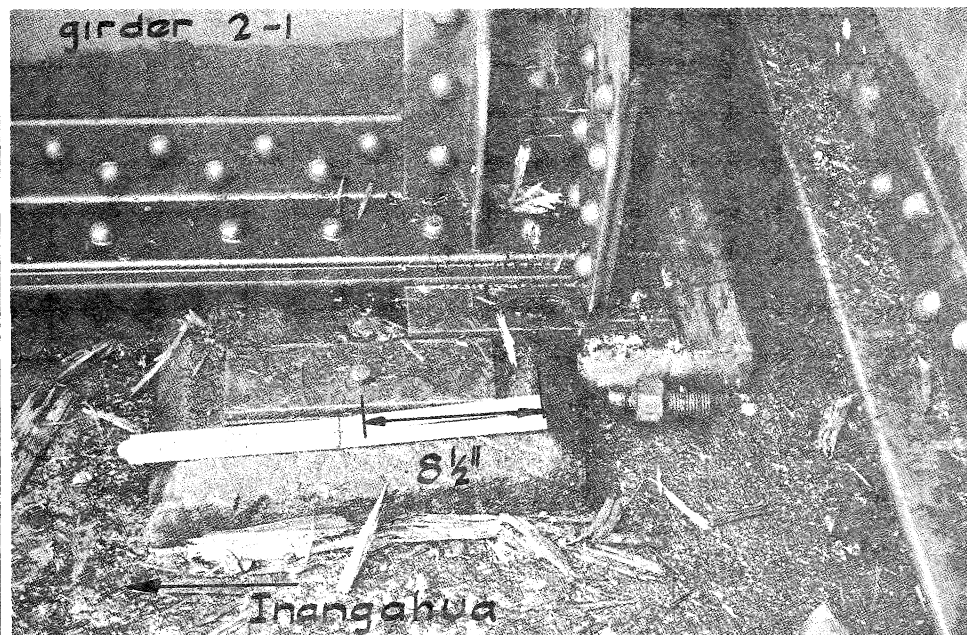
Photo 8-2: Girder 2-1
at pier 2.
Holding-down bolt
has sheared and the
girder slipped $8\frac{1}{2}$ ".
Note the elongated
hole for a "sliding"
joint.

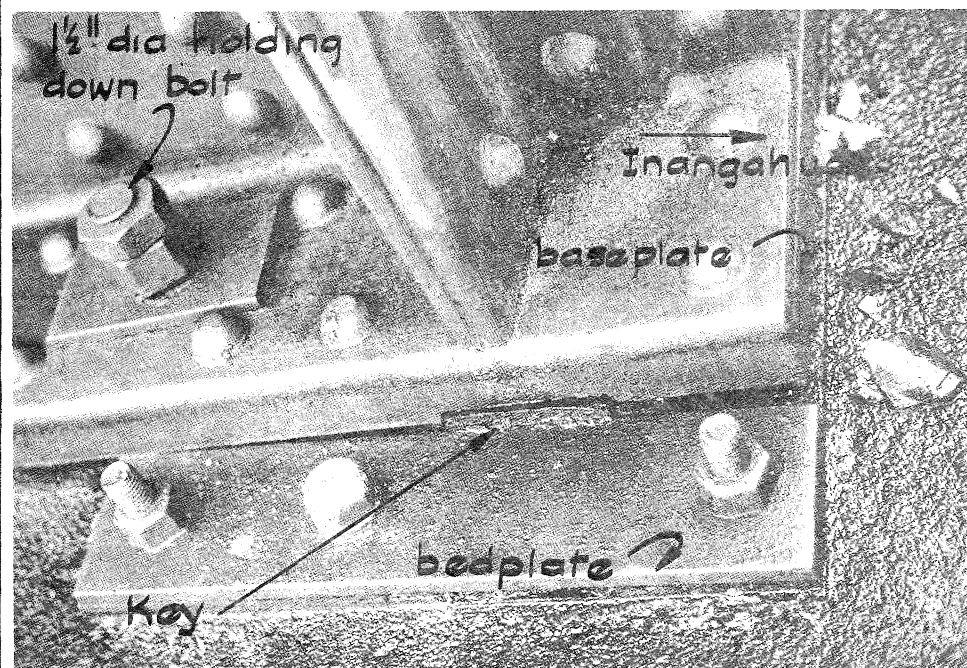
Photo 8-3: Girder 2-3
at pier 2
Typical "fixed"
connection of 100 ft
girders to pier. Note
key and slope due
to lean on pier 2.

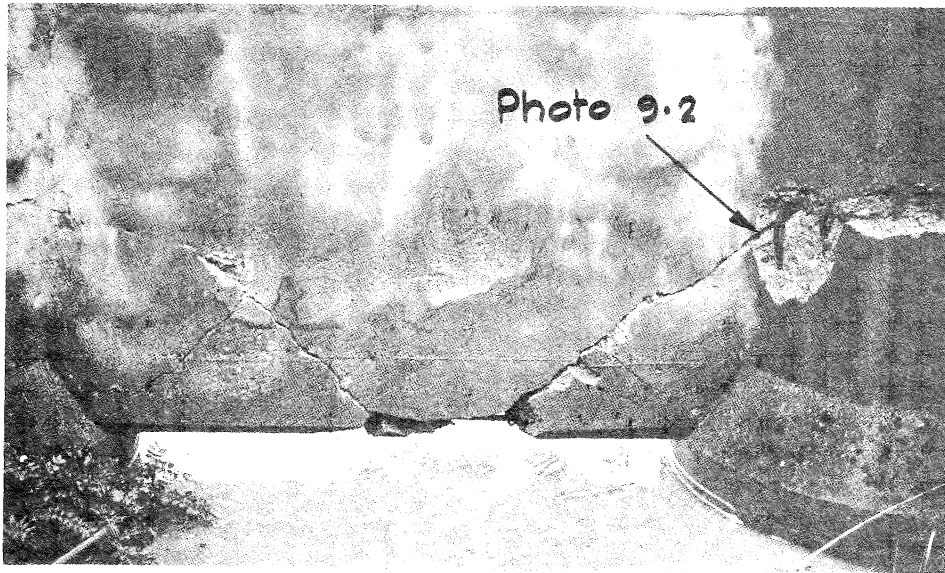
Photo 9.1: Pier 6
 Failure at ground level north face, south face similar. Note the diagonal tension cracks and the reinforcing bars which have buckled after yielding.

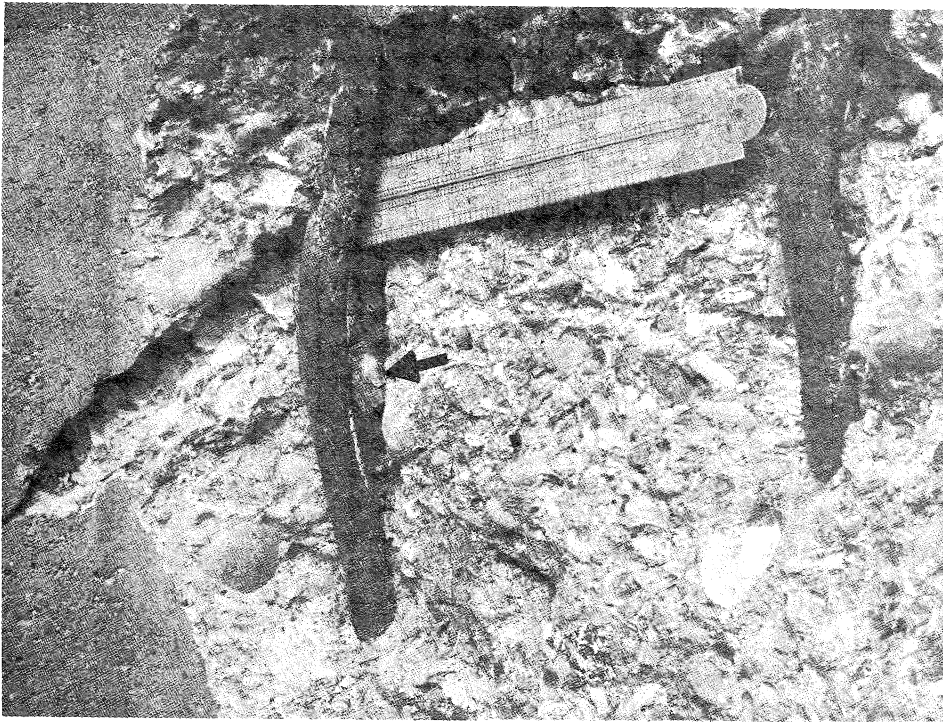
Pier 6 shows evidence of at least $1\frac{1}{2}$ cycles of oscillation which could have been lateral or longitudinal or probably both - see photo 9.2.

Photo 9.2: Pier 6
 Detail from photo 9.1
 Note the marked piece of aggregate behind the left bar. This stone fell behind the bar when it buckled and was later crushed by bar tension. The bar has since buckled again.

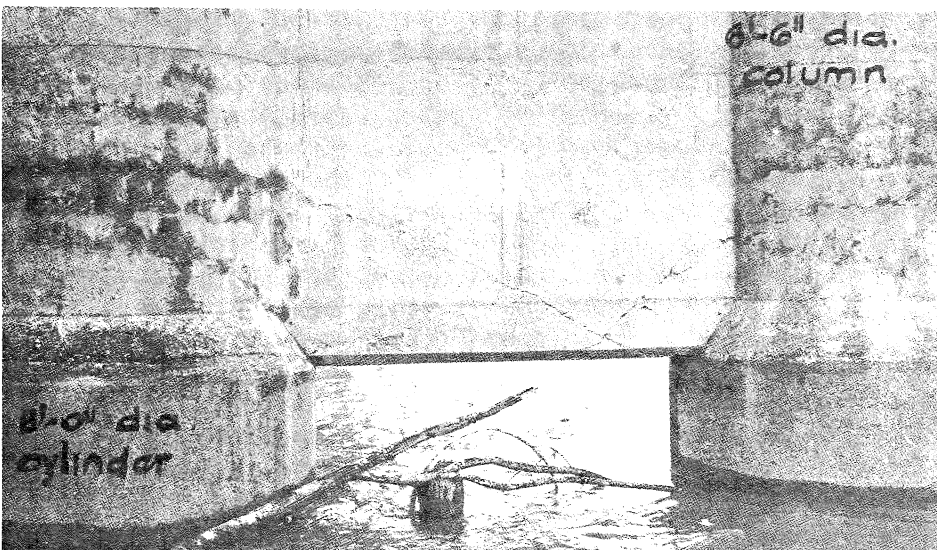
Photo 9.3: Pier 5
 Failure at ground level north face, south face similar. Diagonal tension crack extends through web and columns. Piers 3 and 4 are similar

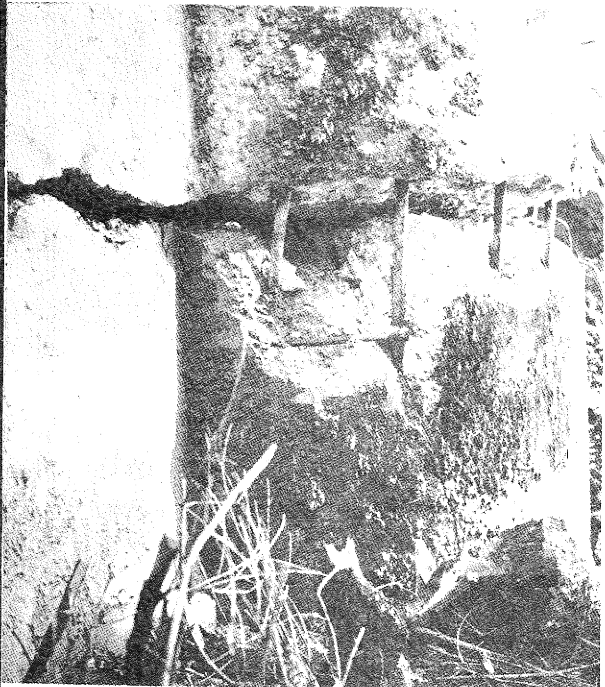
Photo 10.3: Pier 2 failure at ground level, northern face, west side. Note size of crack.

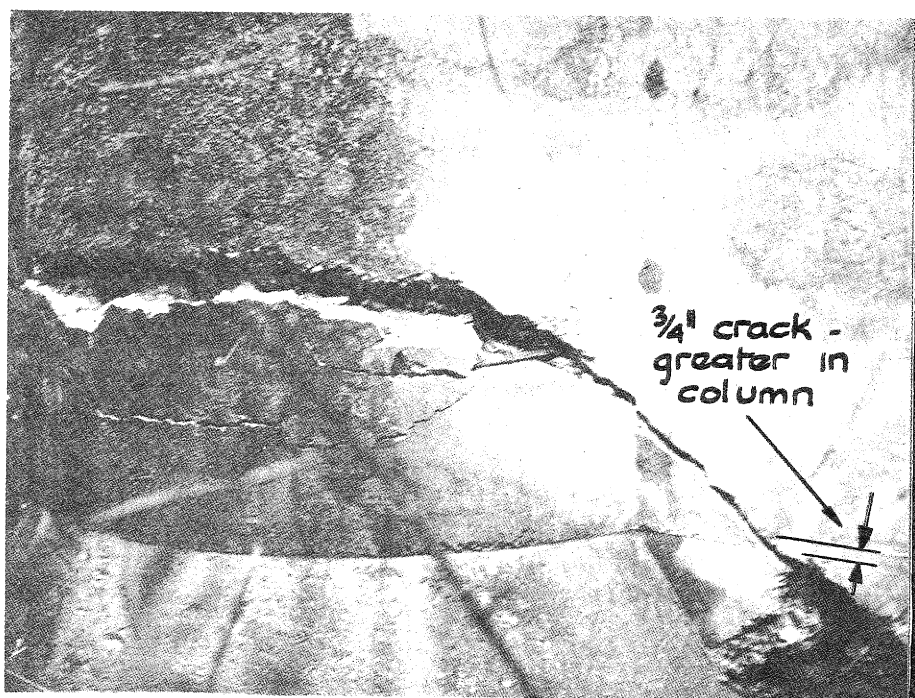
3/4" crack - greater in column

Photo 10.4: Pier 8 failure at ground level southern face, west side. East side is similar

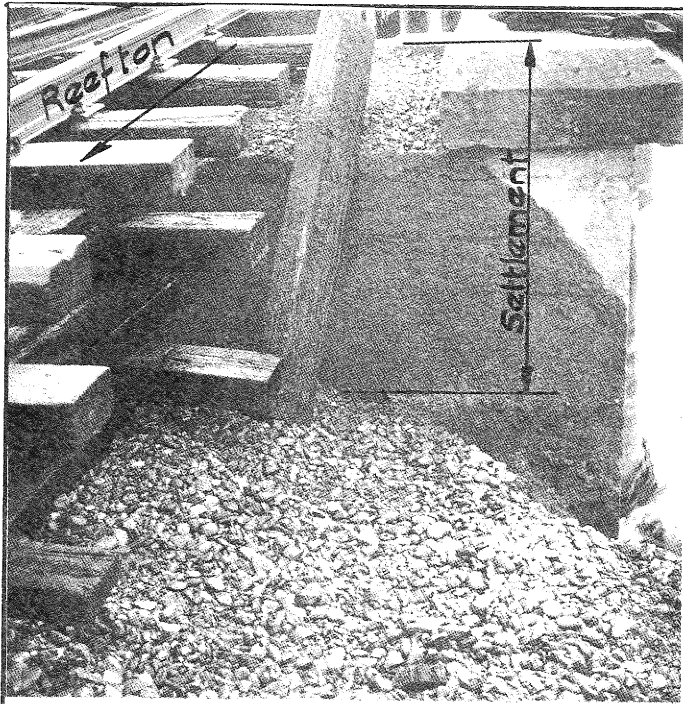
This movement of the abutment has probably been caused by settlement of the railway embankment to the south of the bridge, see photo 13.1, and by debris falling behind the abutment during longitudinal oscillations of the bridge deck. The southern piers, being connected to the abutment by deck girders, have therefore been pushed northward, which is opposite to the direction of the 1929 earthquake displacements. Holding down bolts did not shear off anywhere except at abutment 1. Except for the end spans, the north end of each girder appeared to be "fixed" by bolting through round holes in the baseplates and bedplates (no shear key), and the south end "sliding" having elongated bolt holes in the baseplate. This is not the arrangement of "fixed" and "sliding" joints shown on the working drawings but it is consistent with current practice on other plate girder bridges of similar construction (e.g. Buller Rail Bridge at Inangahua). The end spans are "fixed" at the abutment and sliding at the pier.

Photo 13.1: Abutment 1 (south) Note settled embankment.

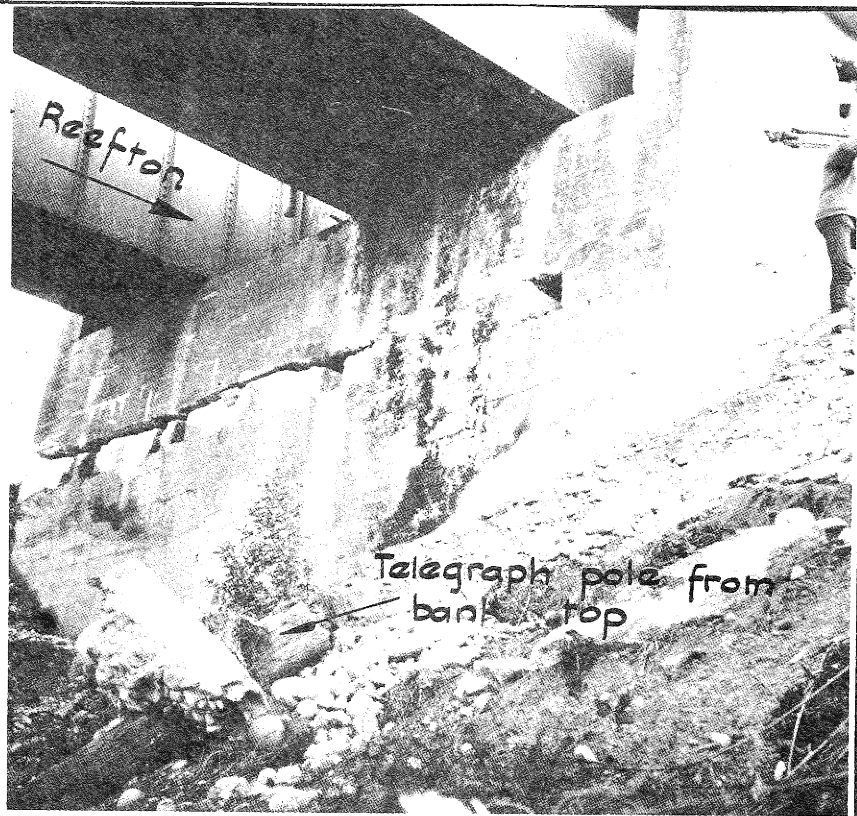
Both abutments, which are unreinforced mass concrete, cracked horizontally through the holes left for access to holding down bolts see photos 13.2 and 13.4. Abutment 1, which was in a region of considerable embankment settlement, had a crack width of 3 inches and a shear displacement at the crack of 3".

Photo 13.2: Abutment 1 Horizontal crack through holes for access to holding-down bolts in mass concrete abutment. Note debris sliding down bank

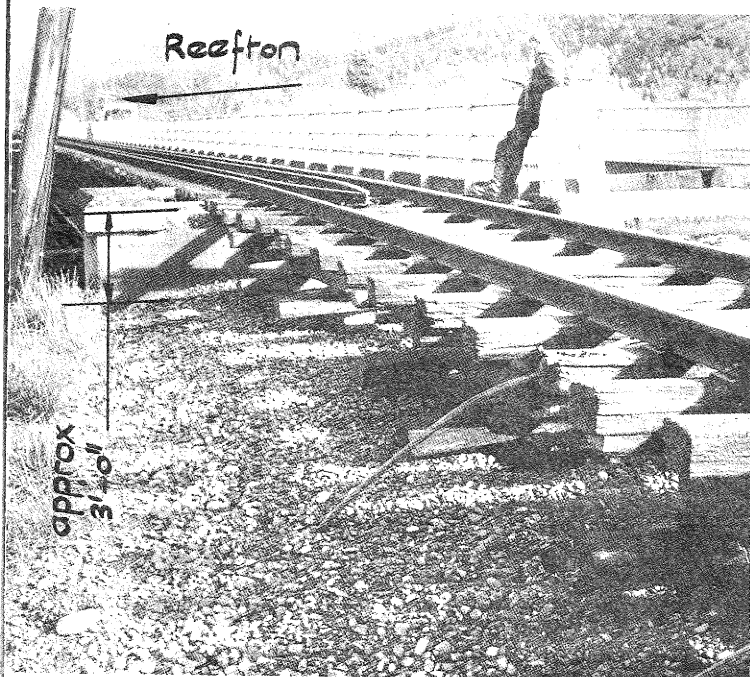
Photo 13.3: Abutment 10 Embankment has settled approximately 3'-0"

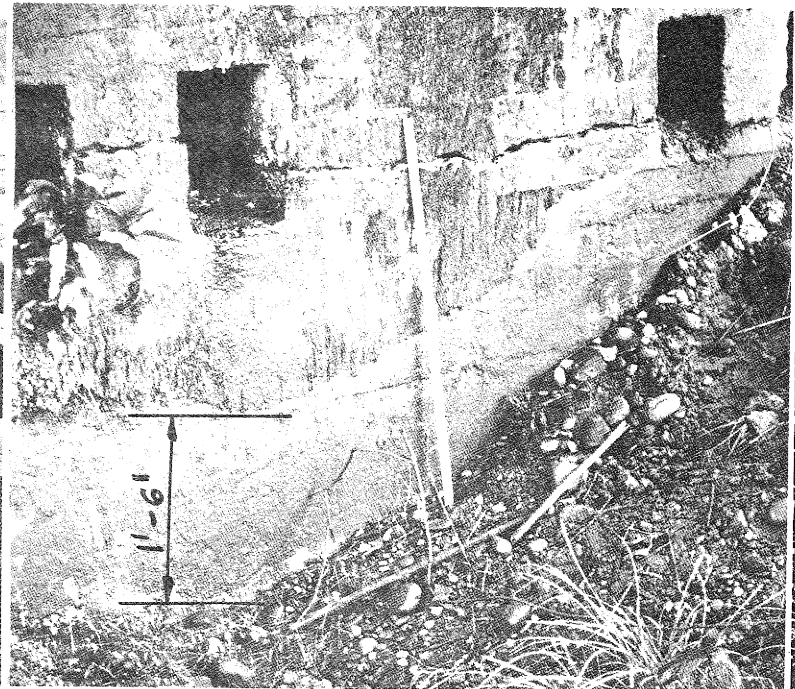
Photo 13.4: Abutment 10 Horizontal crack through holes for access to holding-down bolts. Note ground settlement

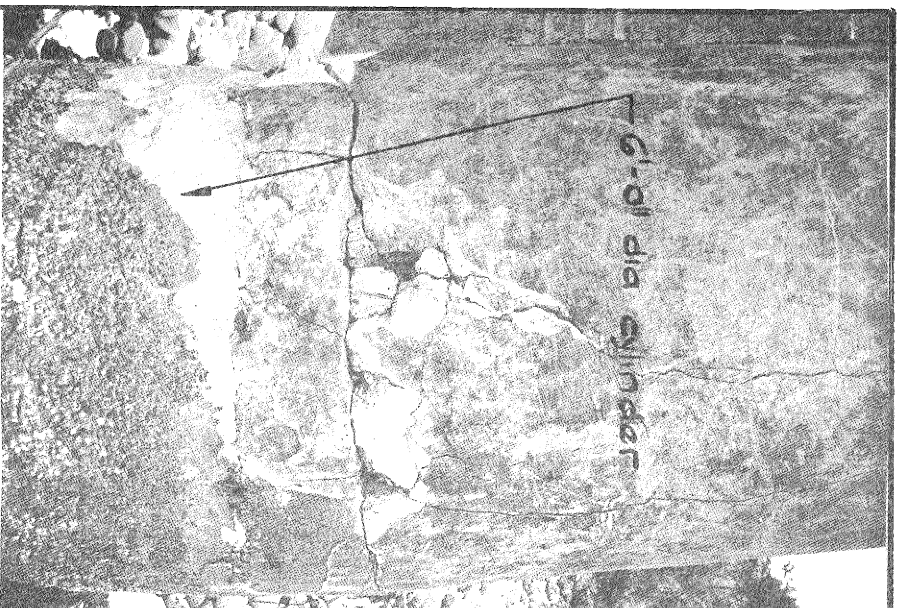
Piers 2, 3, 4, 5 and 6 all failed just above ground level at the construction joint in line with the bottom of the web, see Figure 15 and photos 14.1, 14.2 and 14.3. This is a definite weak point, being the bottom of the web and the cut off point of the hooked bars in the cylinders; the reinforcing bars that are continuous through this joint have threaded splices further reducing the area of reinforcing steel. Many bars buckled at this threaded portion (photos 15.2 and 15.3) and some broke (left bar in photo 15.2). It is possible that there have been concrete cracks in this area for some time, or the bars were not properly covered with concrete after the 1929 earthquake, as some bars appeared to be corroded - see photo 15.3.

Photo 14.1 : Pier 5 south face east column. Failure at construction joint

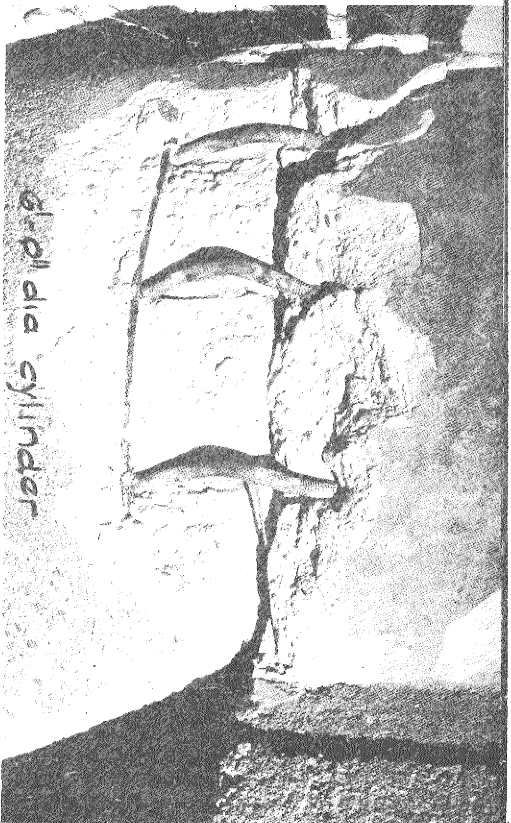
Photo 14.2 : Pier 5 north face east column, failure at construction joint.

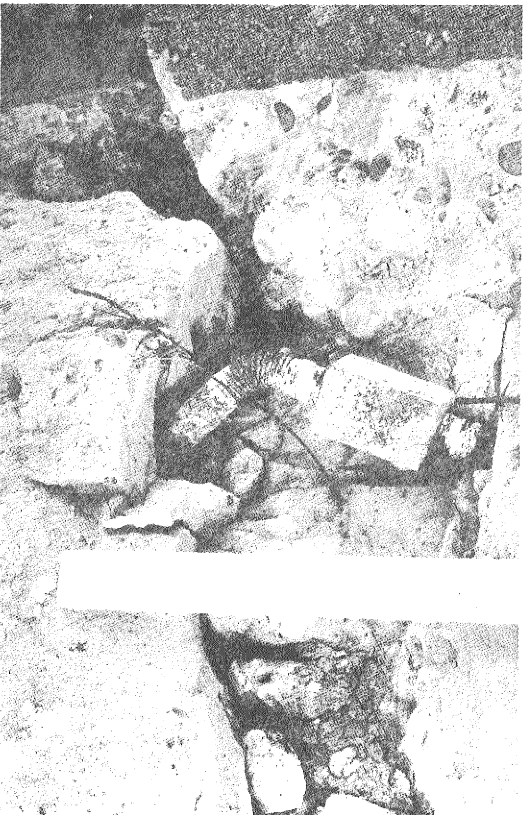
Photo 14.3 : Pier 5 northeast face west column. Failure at construction joint

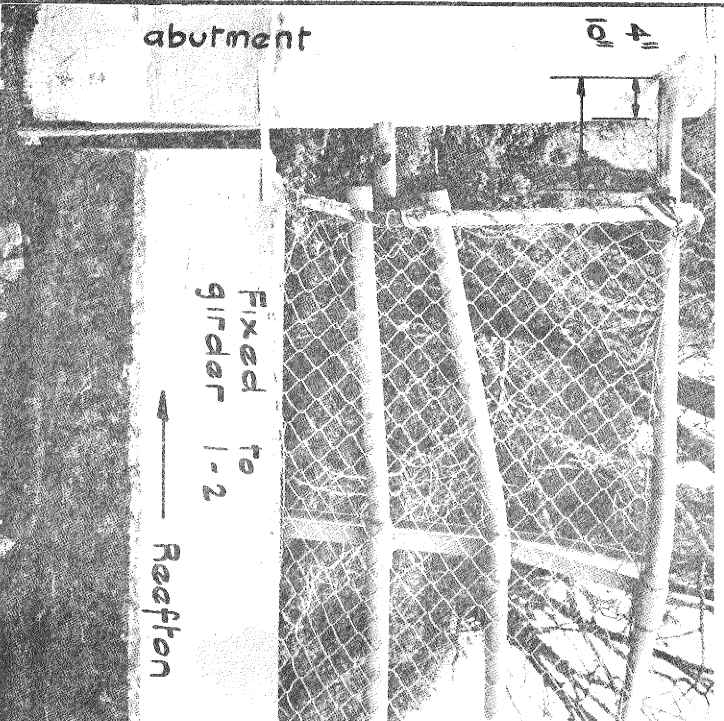
The top handrail was embedded 8 inches in the abutment wall, allowing for the piece of concrete broken off the top of the wall. This rail was pulled fully out of the wall and later buckled just to the north of photo 14.4.

Photo 14.4 : Southwest end of handrail to roadway, showing evidence of differential movement of

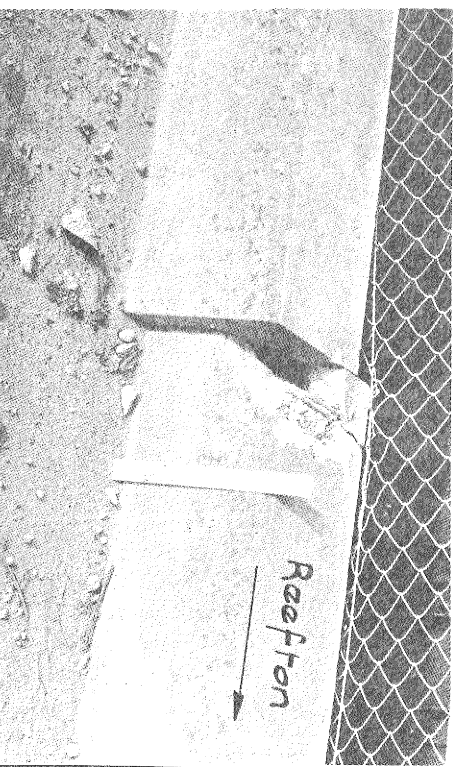
The road deck shows evidence of considerable longitudinal oscillations by spalling at the joints between precast deck slabs and failure and buckling of the handrails, see photos 14.4 and 14.5.

Photo 14.5 : Road deck, east side, over pier 8, showing evidence of violent longitudinal motion. West

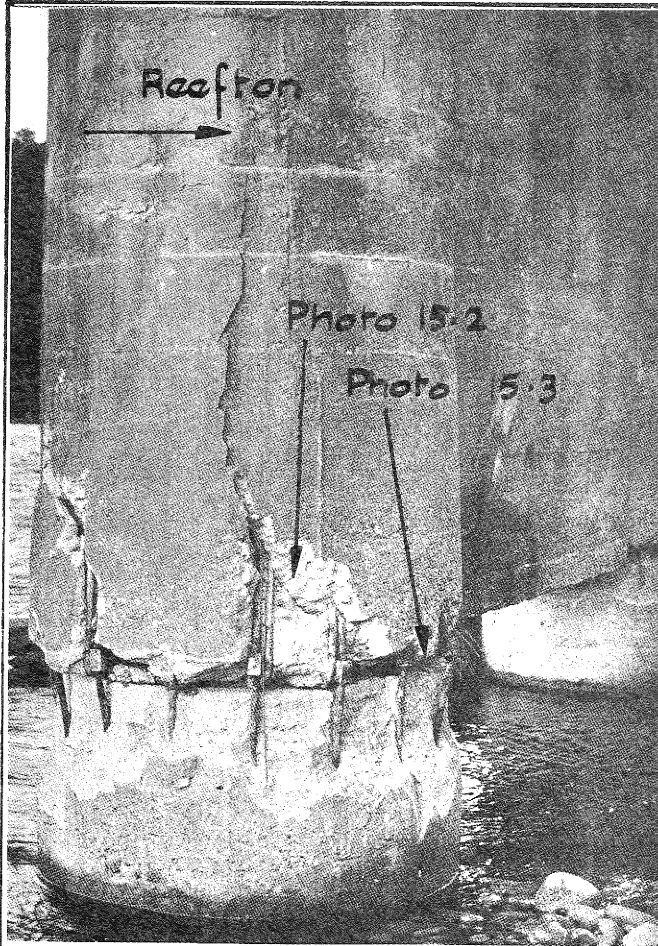
Photo 15.1: Pier 2 east side. Failure at construction joint.

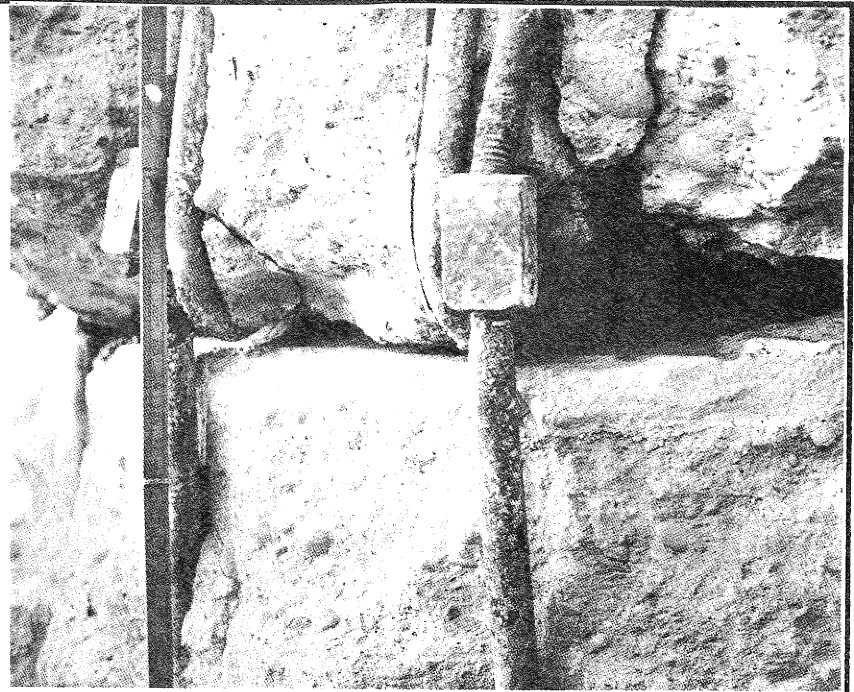
Photo 15.2: Close up of photo 15.1 construction joint. Note hooked and threaded bars

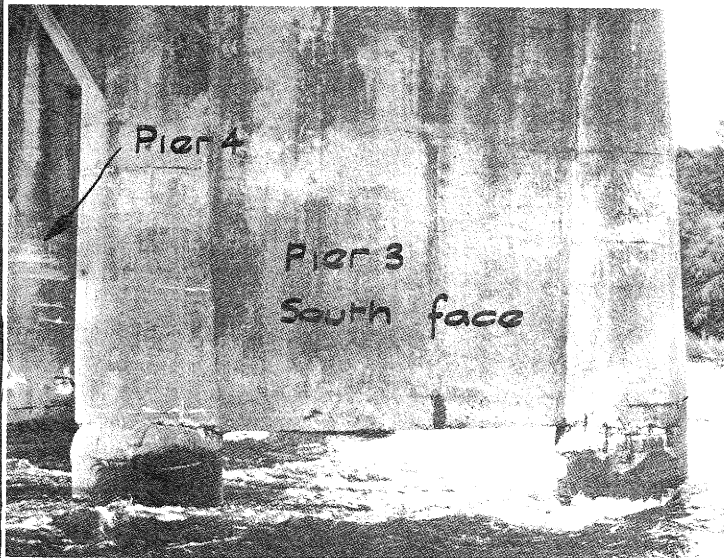
Photo 15.4: Pier 3 south side. Failure at construction joint at cylinder top. Piers 4 and 6 similar.

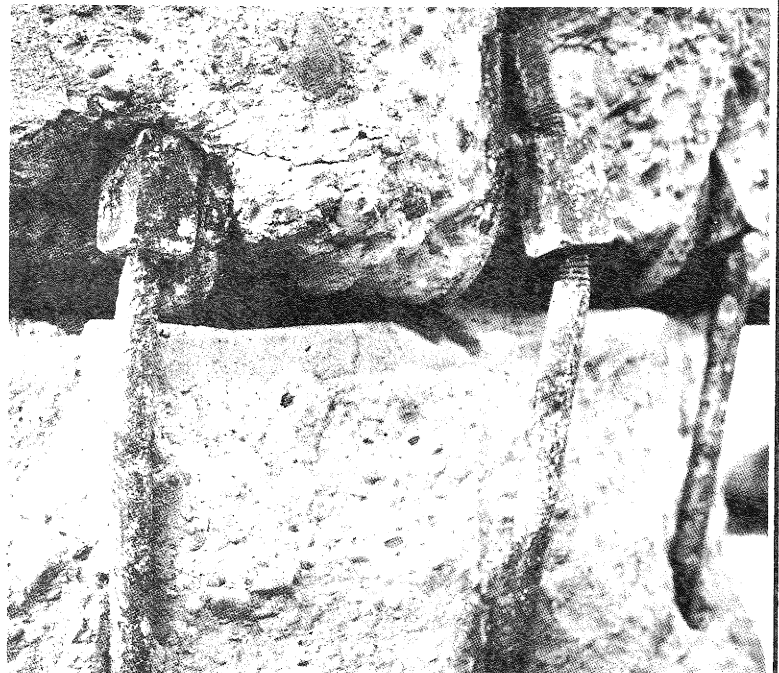
Photo 15.3: Pier 2 west column south face. Note pitted left bar and buckling
