INANGAHUA EARTHQUAKE 1968

DAMAGE TO STATE HIGHWAYS

J. S. Douglas, A.M.I.C.E.*

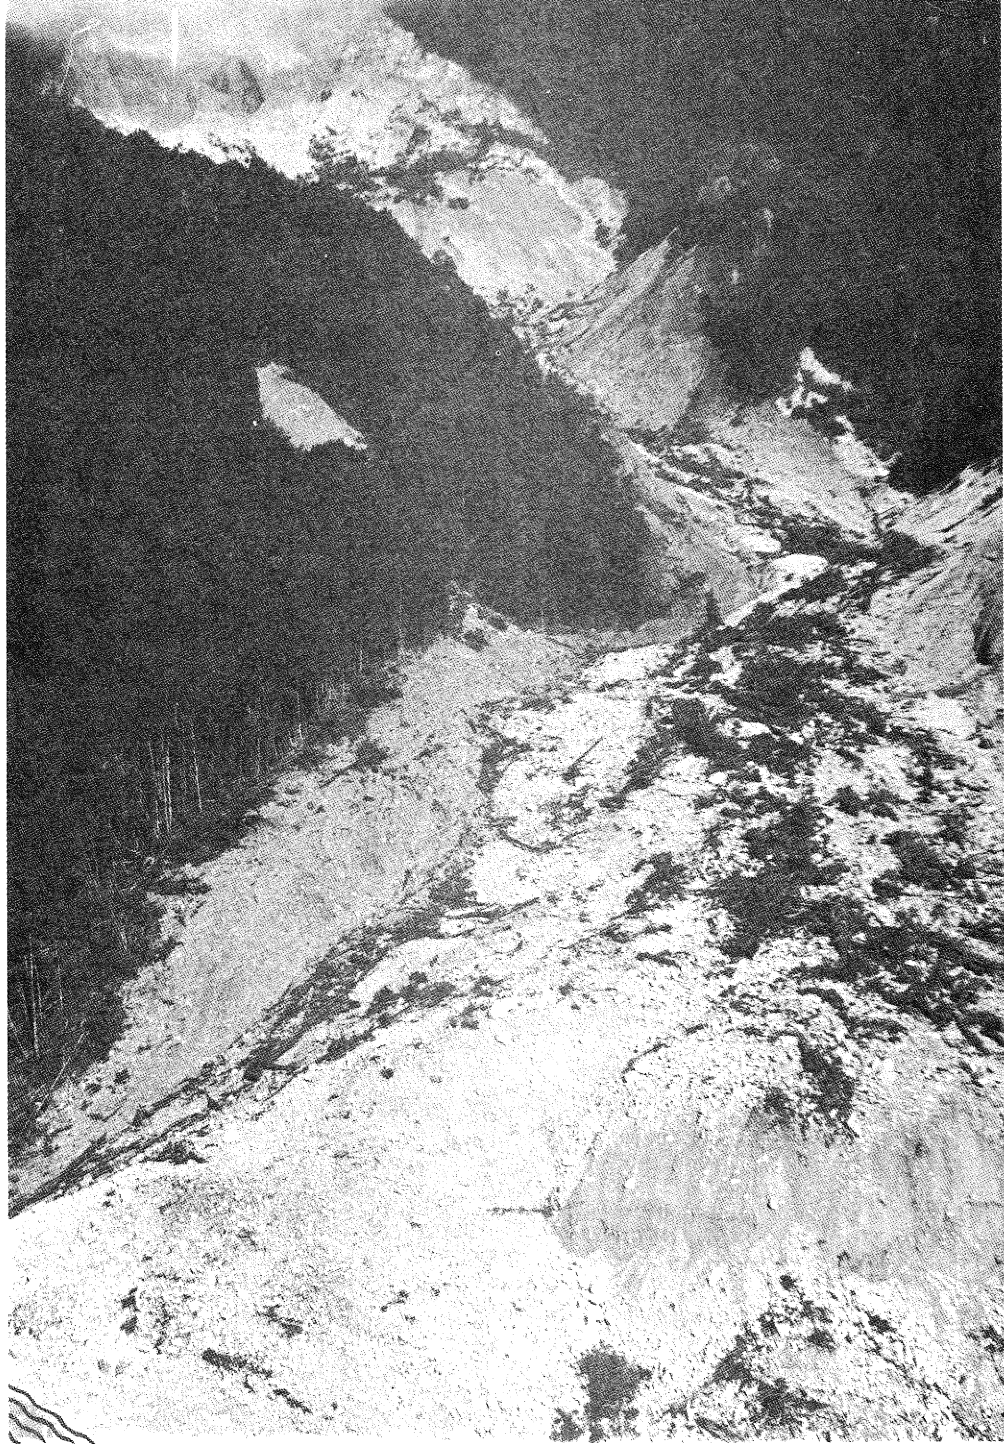
S.H.6 R.M. 173.00 M

Avalanche opposite Dublin Terrace.
- Dammed Buller River

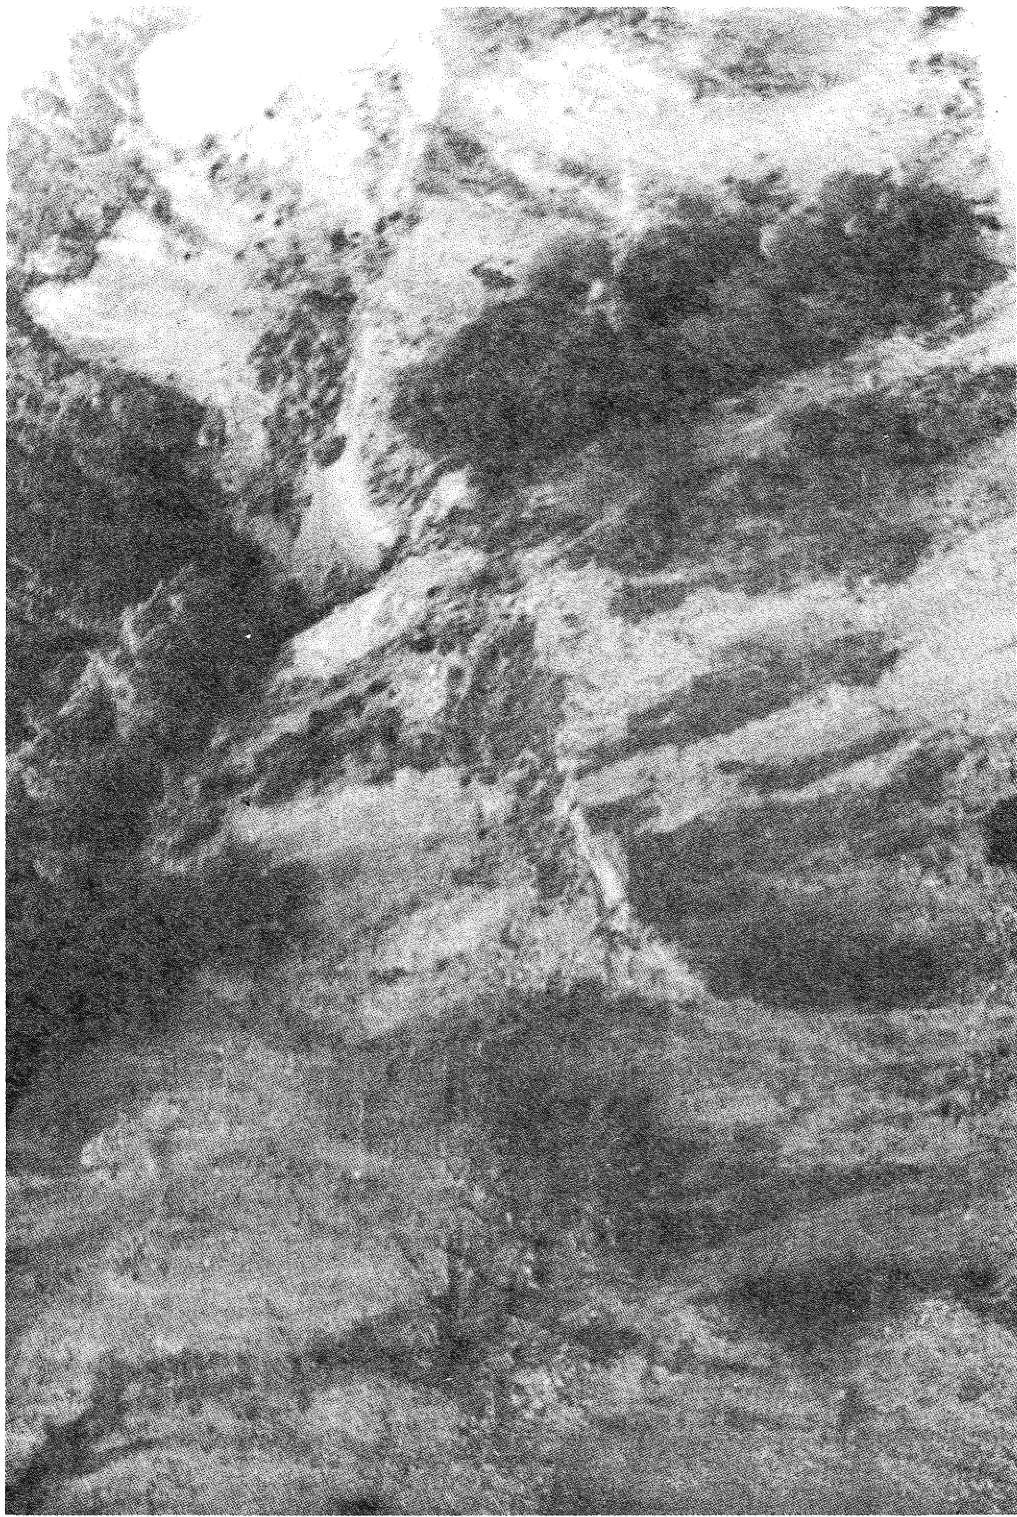
S.H.G R.M. 175.00 M.

Typical slips : Eight Mile Ck. - Lyell Ck. Section

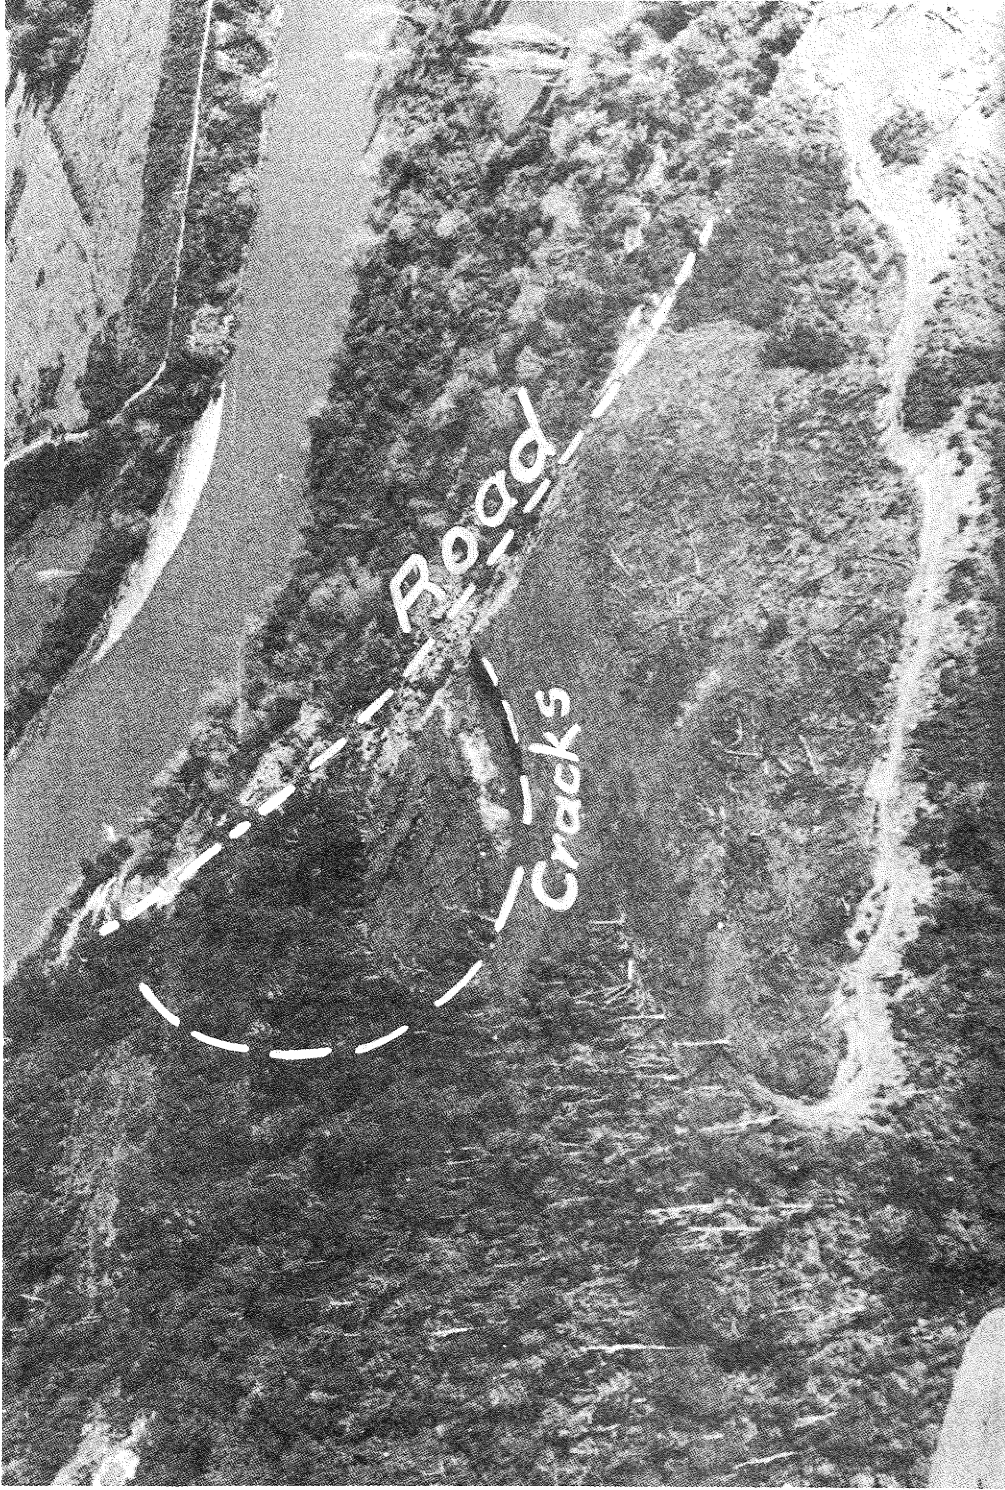
S.H.G. R.M. 178.80 M

Slip at Van Vugh's showing cracks in terrain

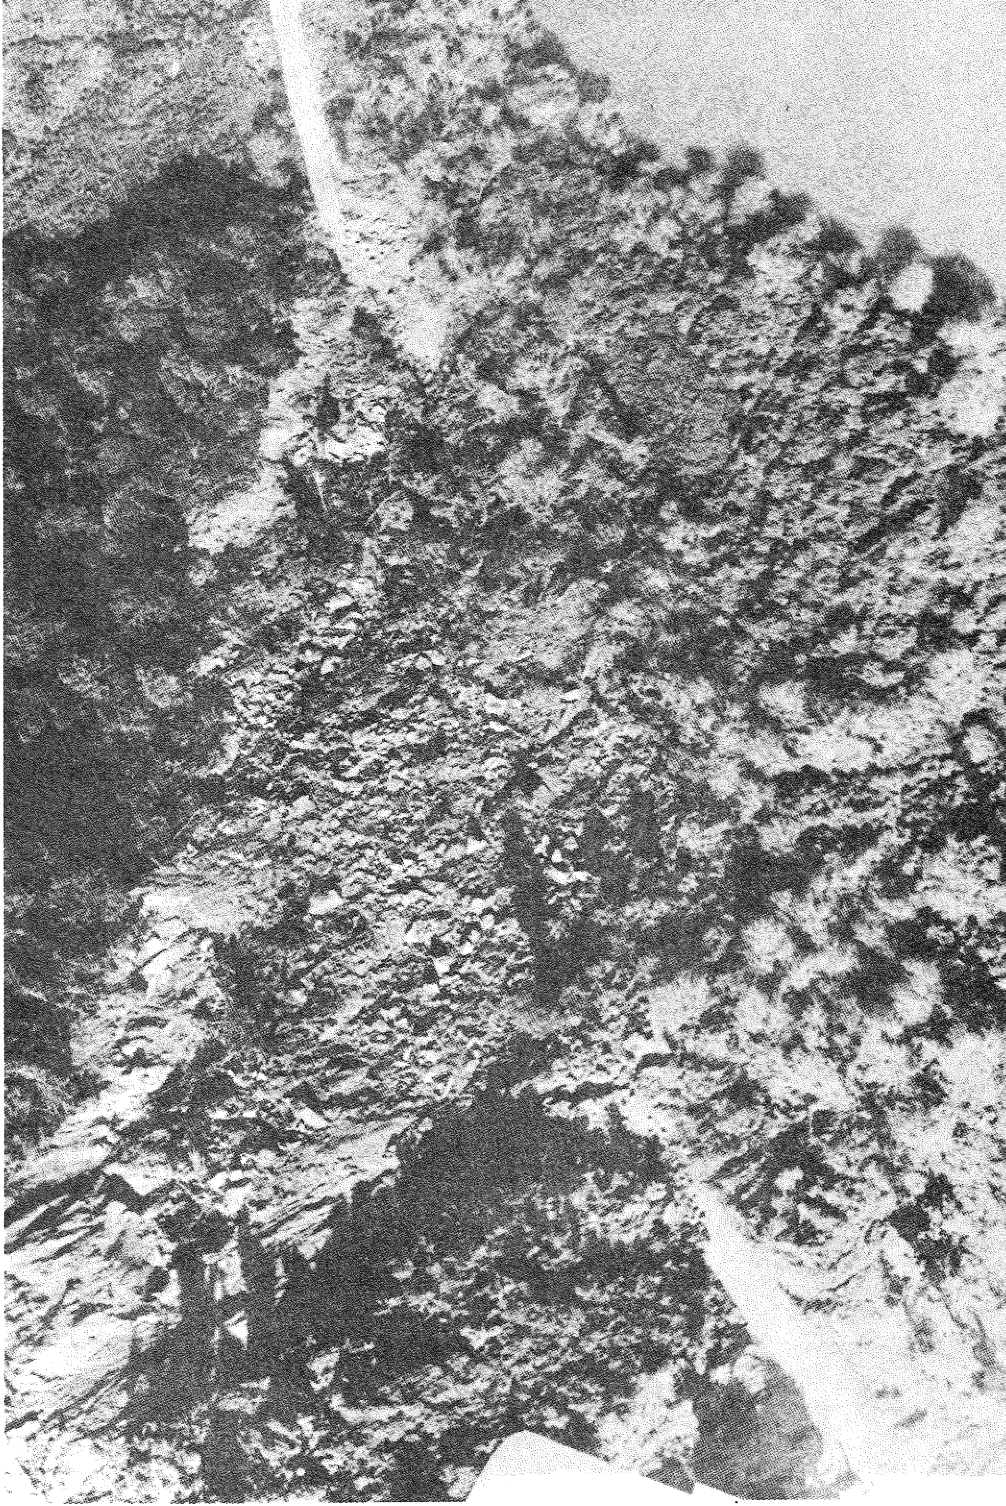
*S.H.G. R.M. 178.80M
Rotational slide in papa near Van Vughs*

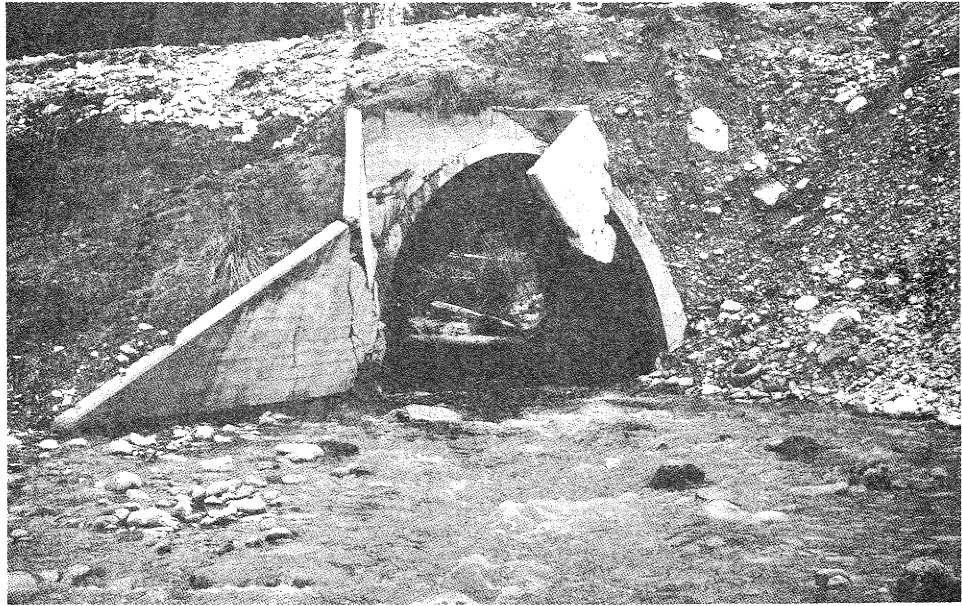
*S.H.G R.M. 182.55
De Filippi Culvert damage*

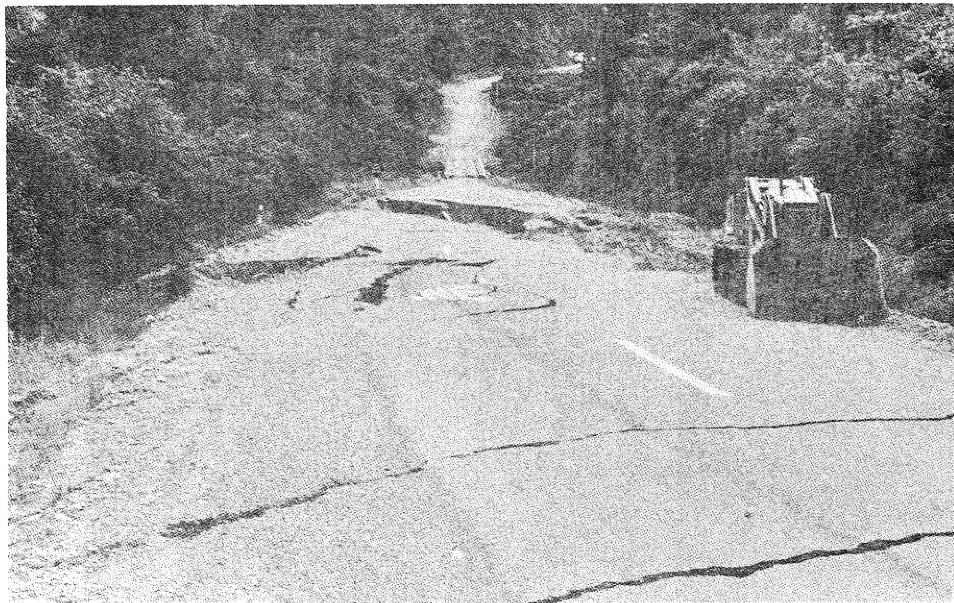
*S.H.G R.M. 193.80^{M.}
Coal Creek approaches : Road subsidence*

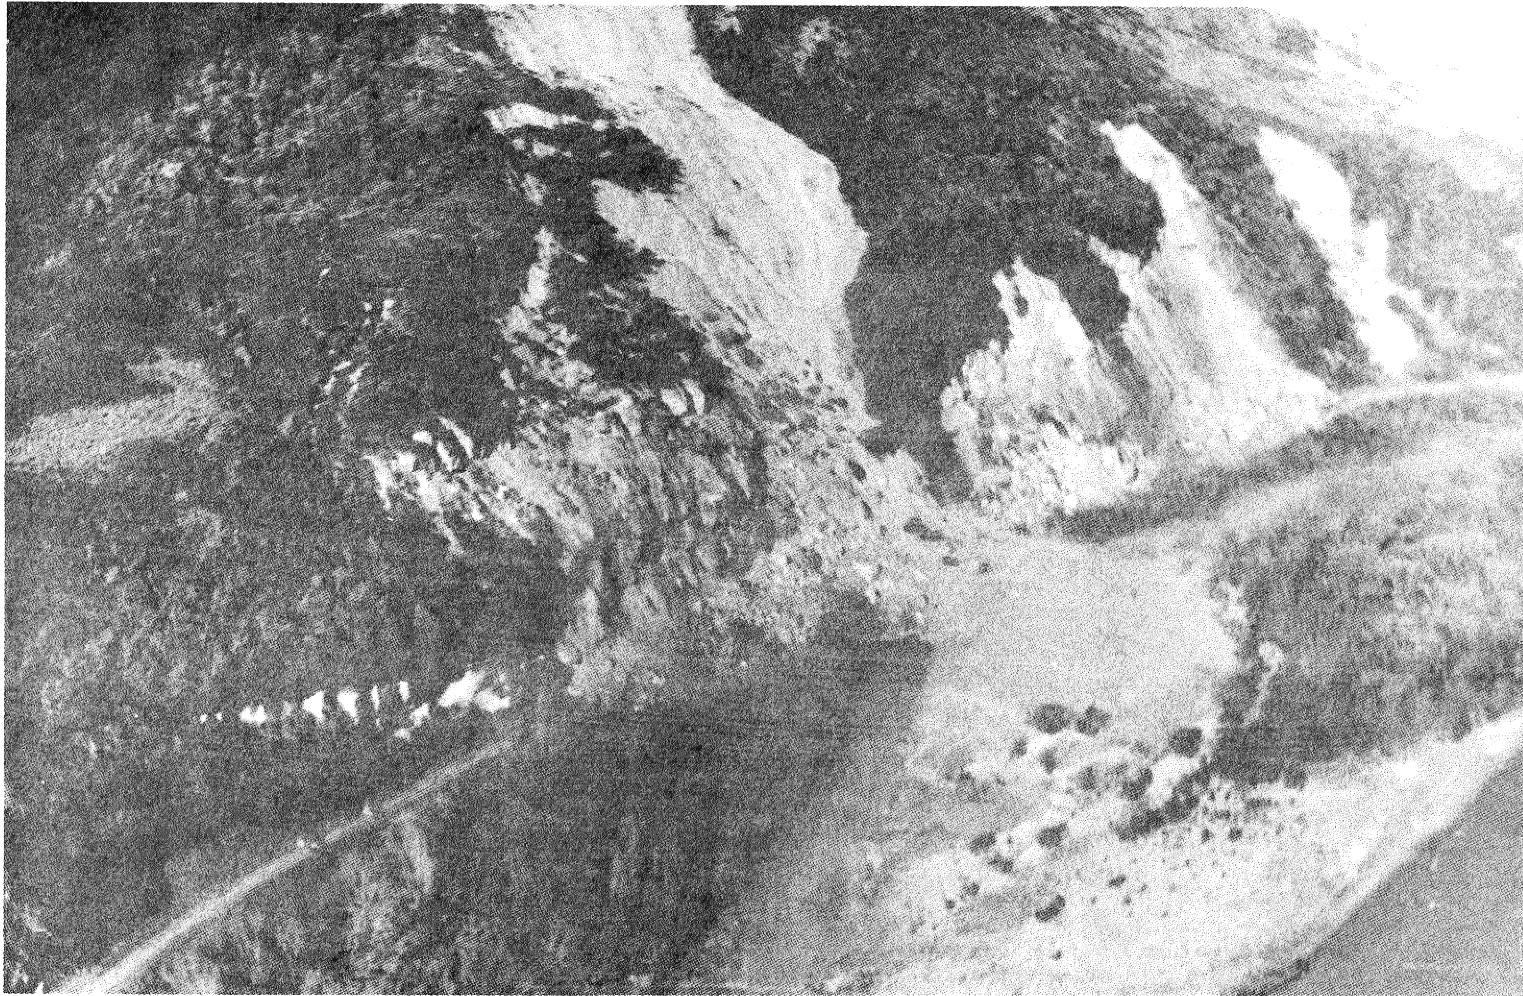
S.H.G. R.M. 190.00M.

Rockfalls and landslides at Whitecliffs.

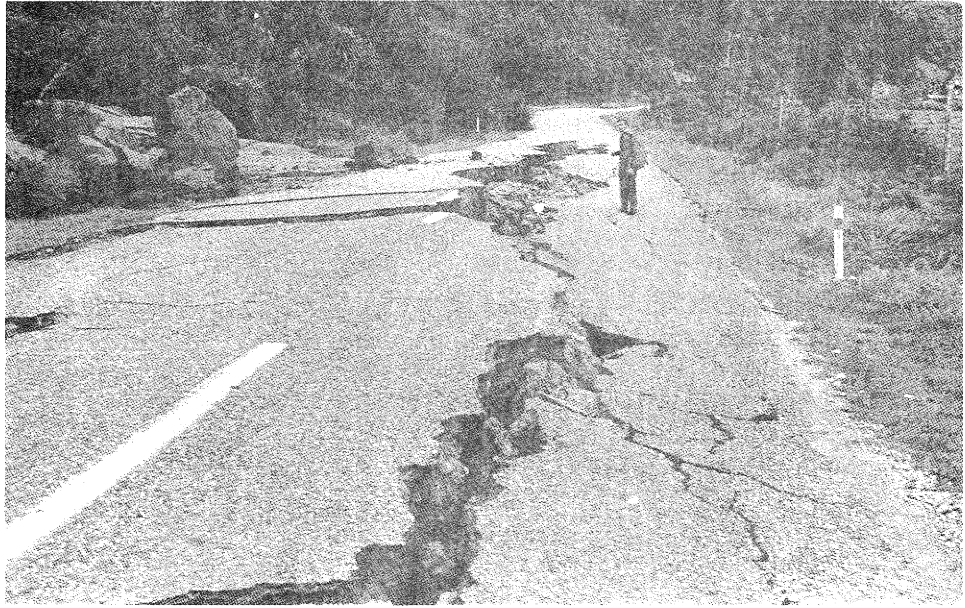
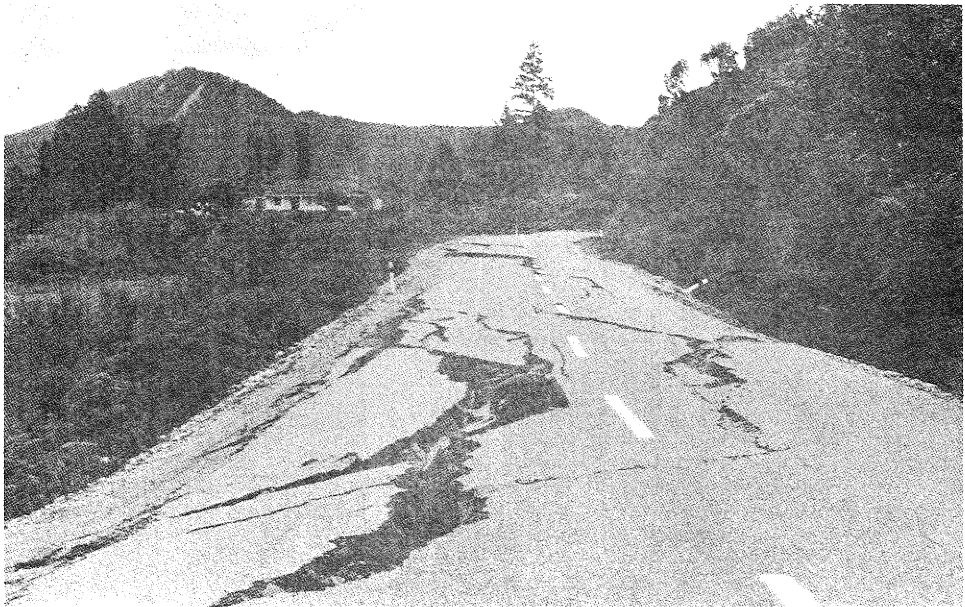
S.H.6 R.M. 192.00^M.

Typical highway damage at Rocklands.

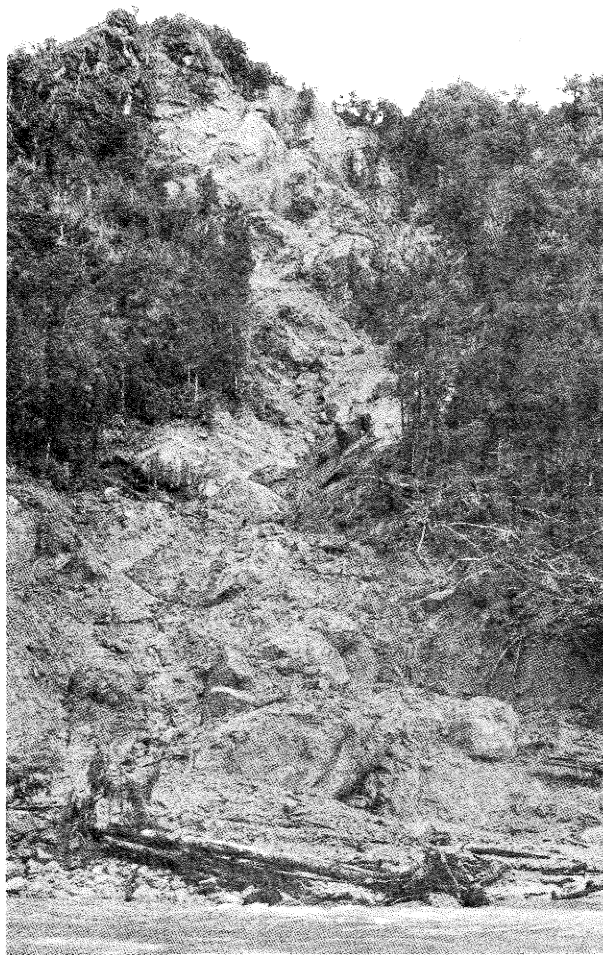
S.H.6 R.M. 196-90^m.

Rock and clay slip at Stitt's Bluff.
