PRELIMINARY COMMENT ON DAMAGE TO BUILDINGS IN THE INANGAHUA EARTHQUAKE

Bruce H. Falconer*

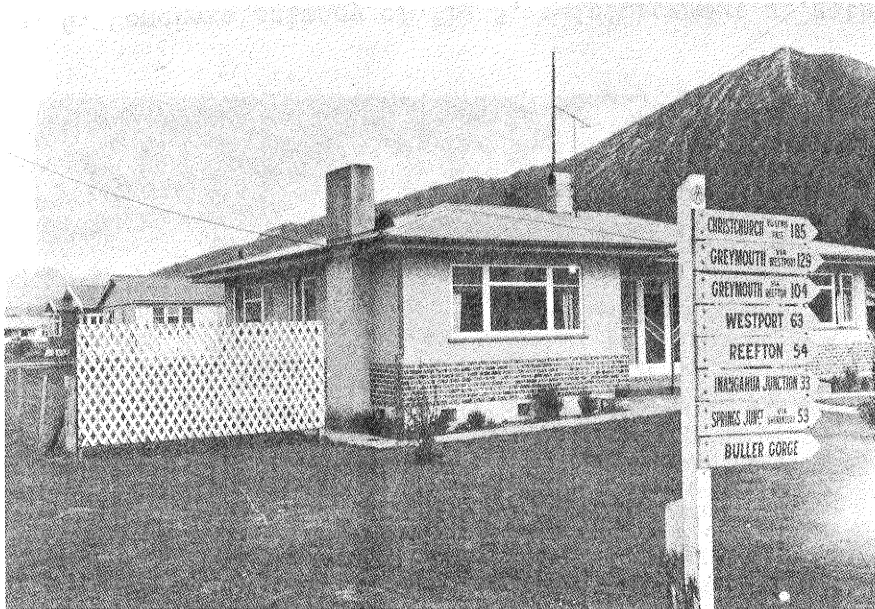
Fig 1. House in Murchison (August 1968)

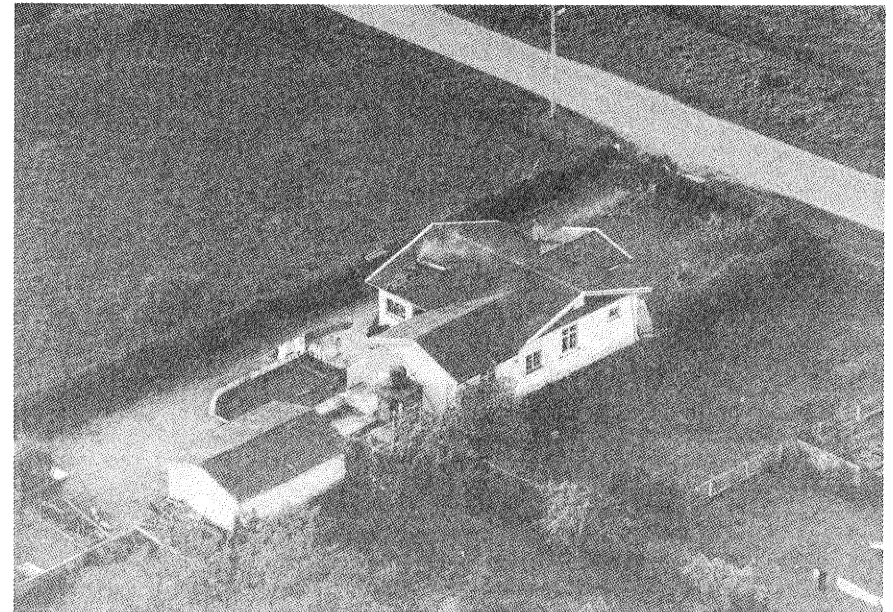
Fig. 3. Dwelling, collapsed chimney, May 24, 1968

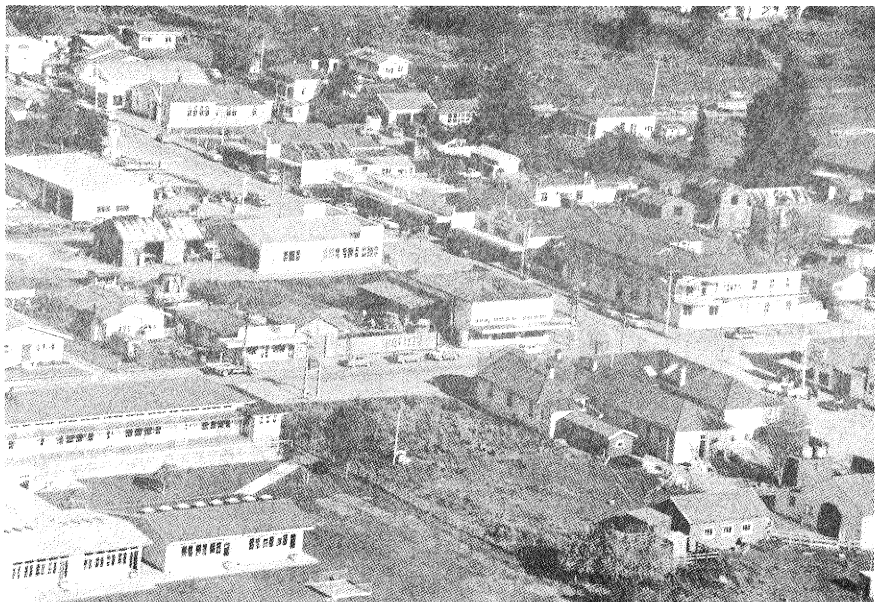
Fig 2. Centre of Murchison, May 24, 1968

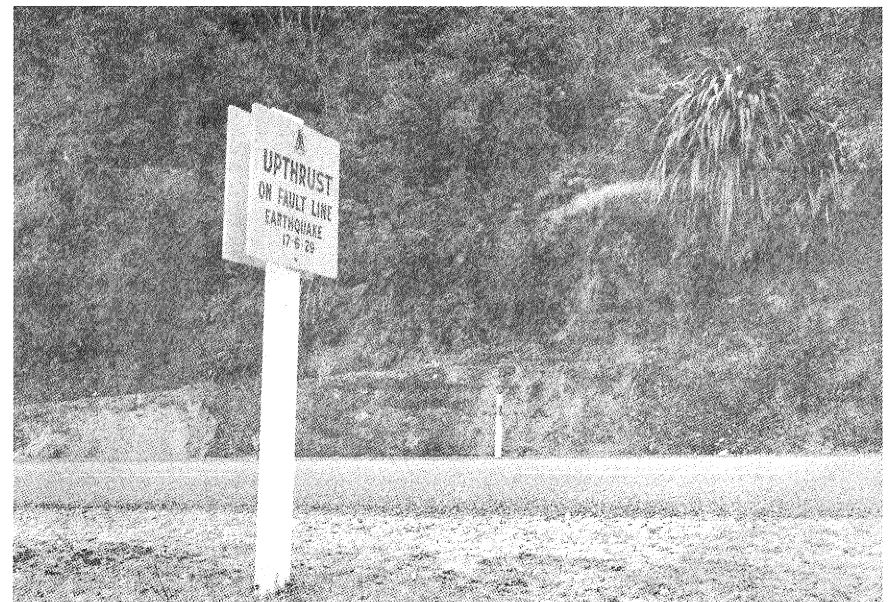
Fig 4. White Creek Fault, (1929 earthquake)

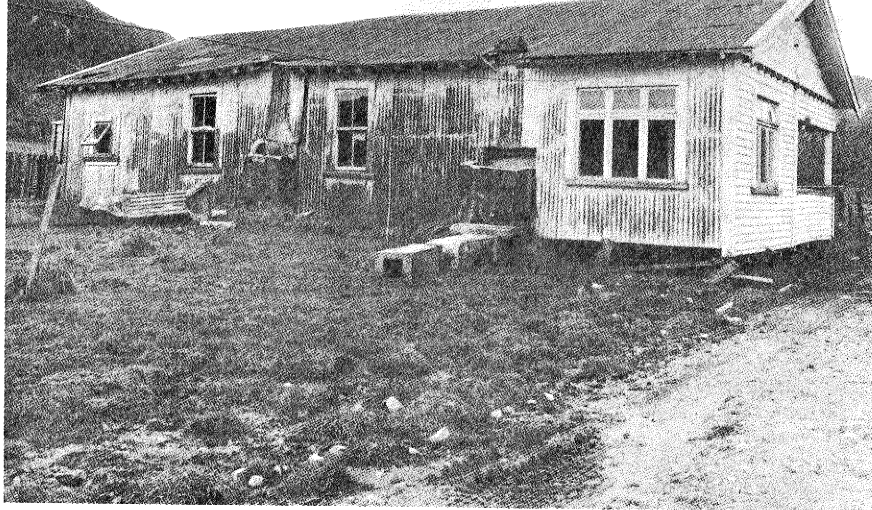
Fig. 5. Dwelling, off piles, chimneys down, 3 km n.w. of Lyell

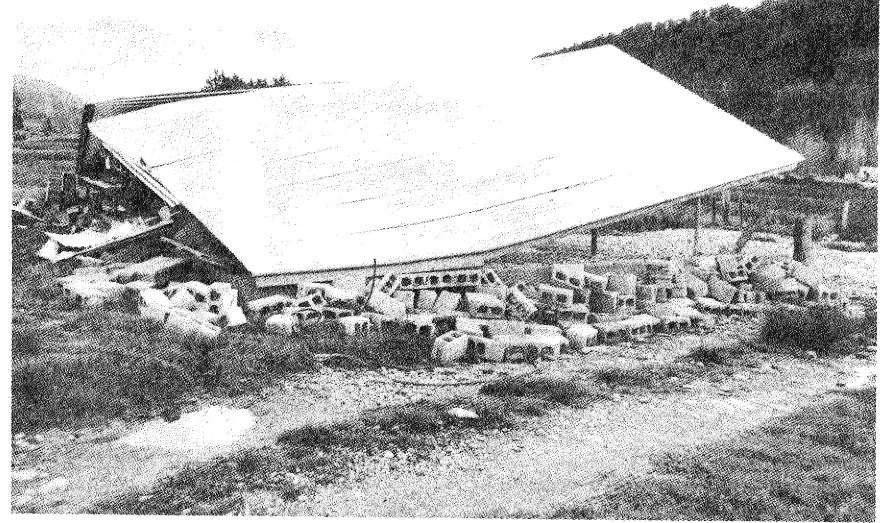
Fig 7. Farm shed, weak unreinforced concrete block walls

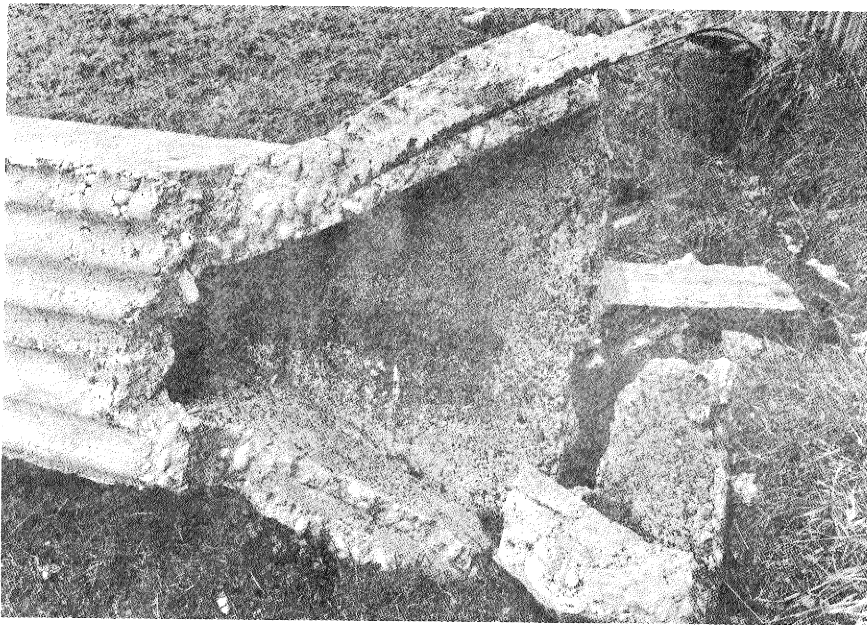
Fig. 6. Concrete chimney of fig 5, reinforcement at gathering

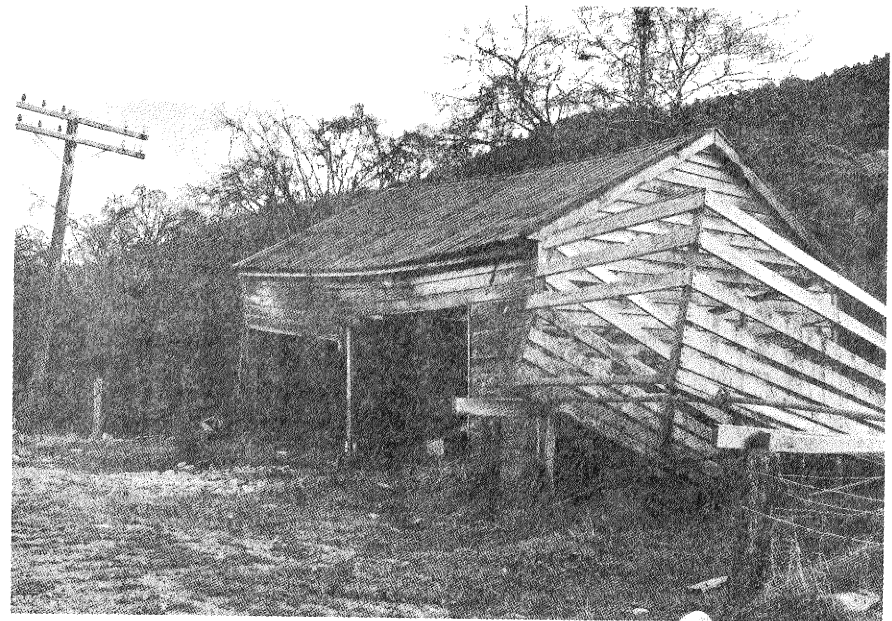
Fig. 8. Undamaged timber farm shed, derelict, near fig. 7

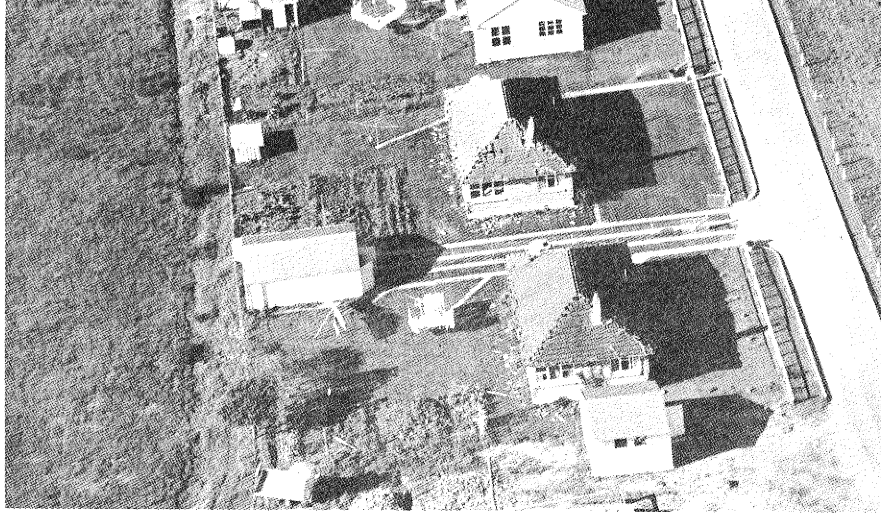
Fig 9. Dwellings 2, Inangahua Camp, tiles & brick veneer

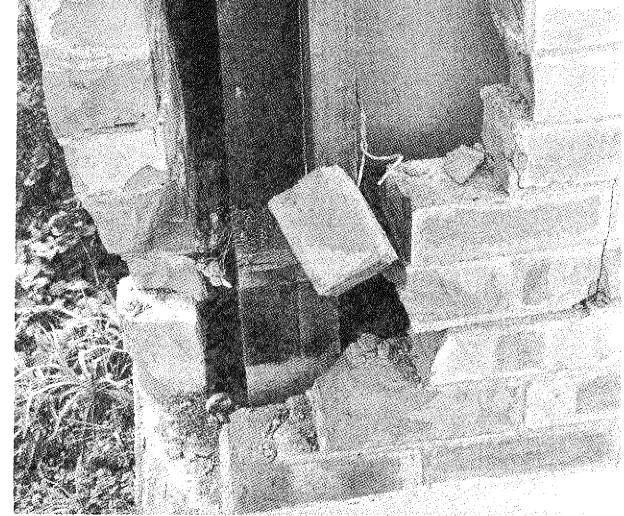
Fig. 11. Detail at bottom of fig. 10, one brick moved

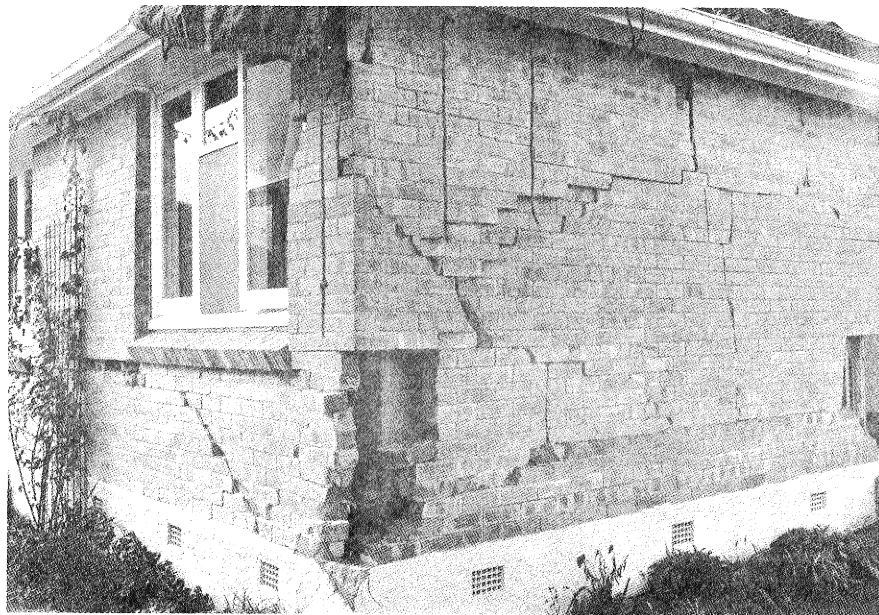
Fig. 10. Shattered veneer, 1st dwelling, fig 9

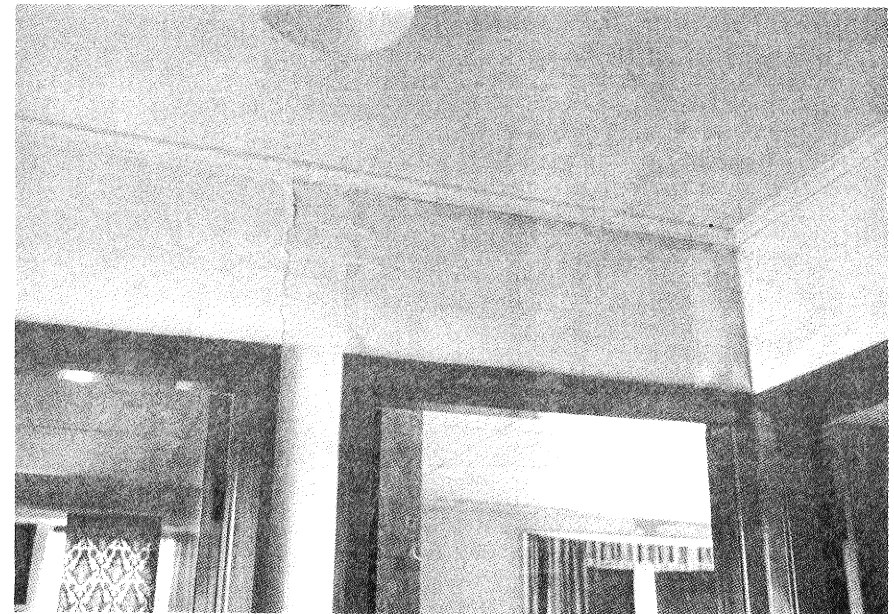
Fig. 12. Interior of fig. 10, moderate damage to lining

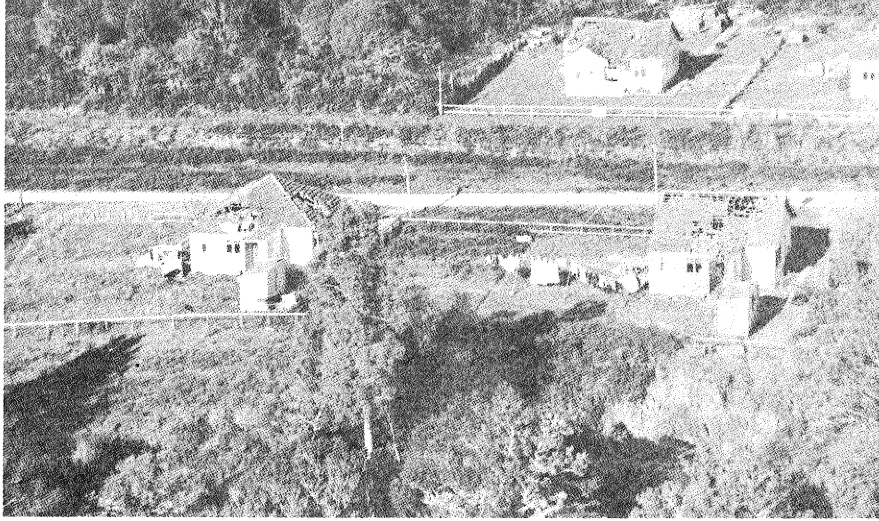
Fig. 13. Dwellings, Inangahua Camp,

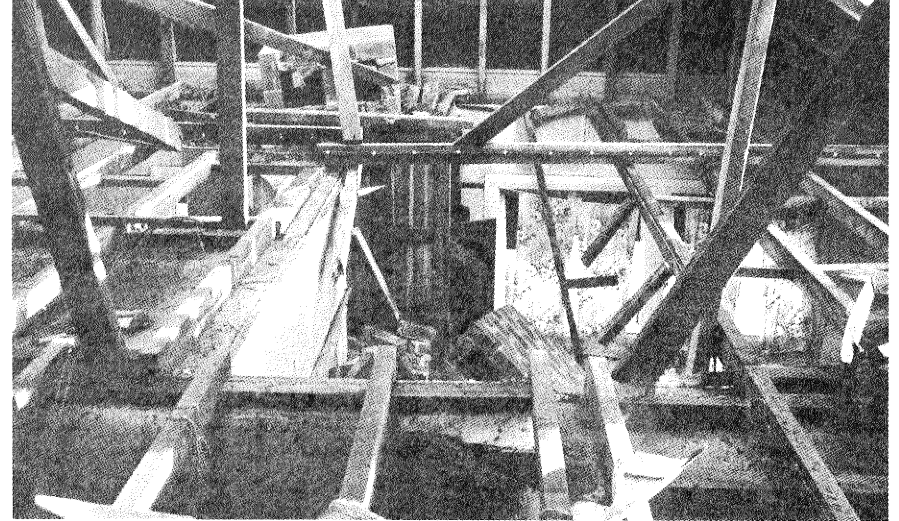
tiles & weather board Fig. 15. View inside ceiling of fig 14, full collapse chimney

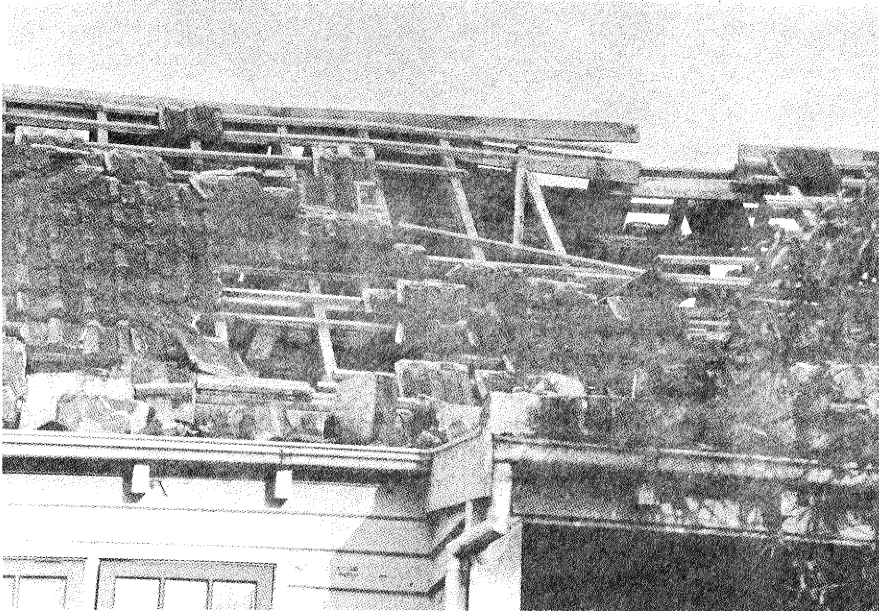
Fig. 14. dwelling lower right fig. 13, close up view of roof

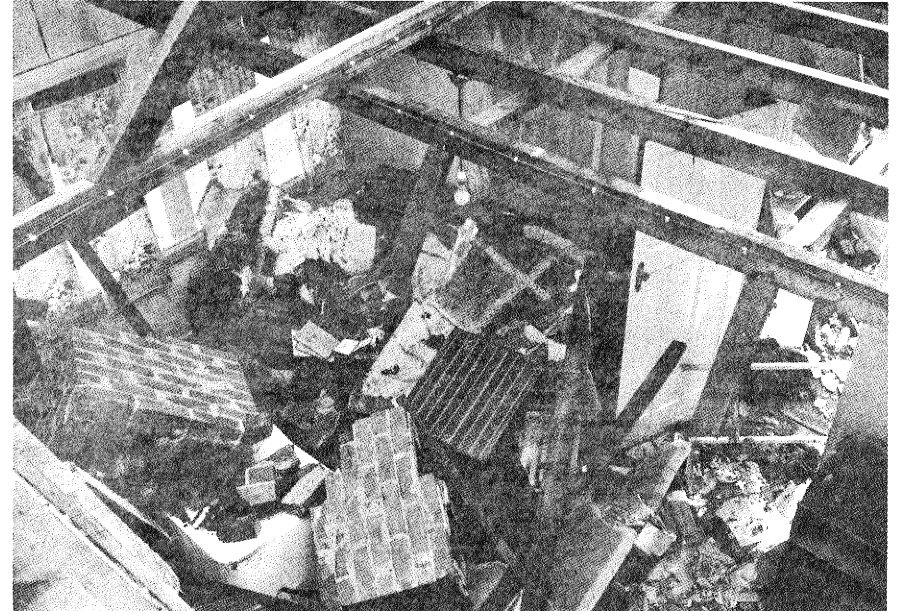
Fig. 16. Debris of tiles and chimney on living room furniture

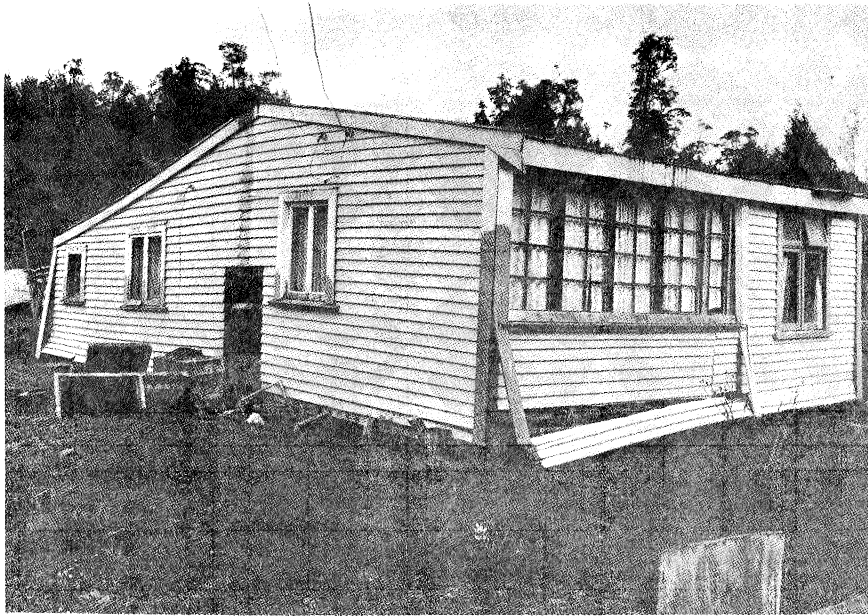
Fig 17. Dwelling, Inangahua Camp, off piles, chimney down

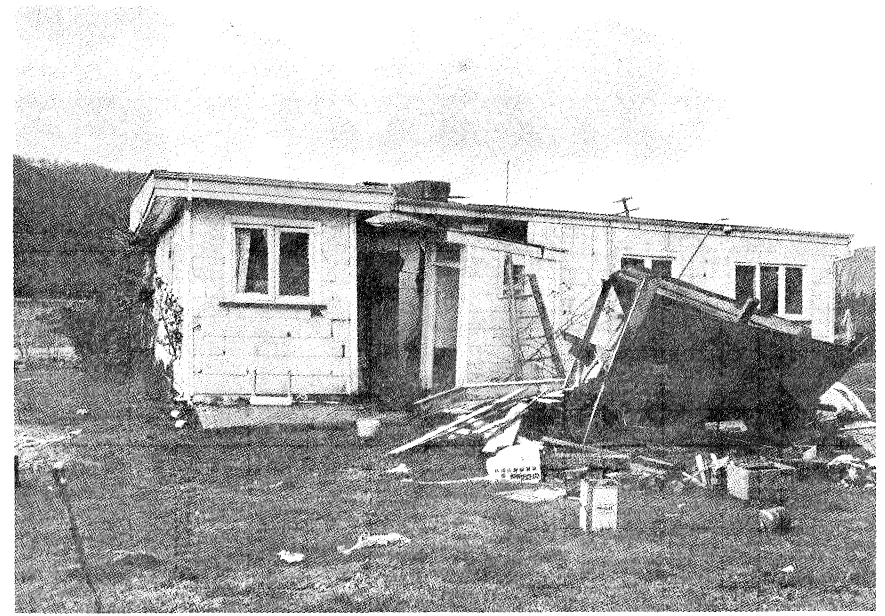
Fig. 19. Dwelling, moved, chimney collapsed, shed collapsed

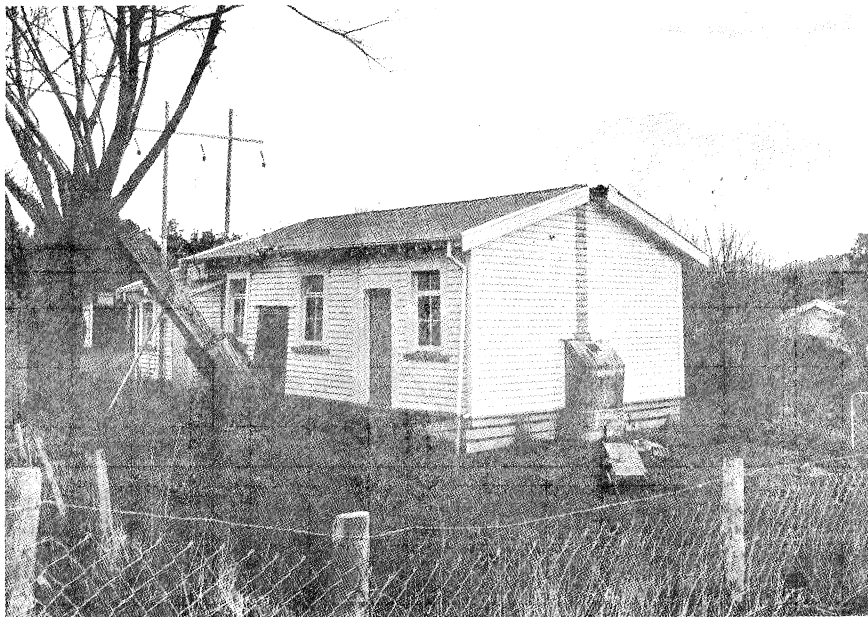
Fig. 18. Dwelling, one chimney folded out, another collapsed

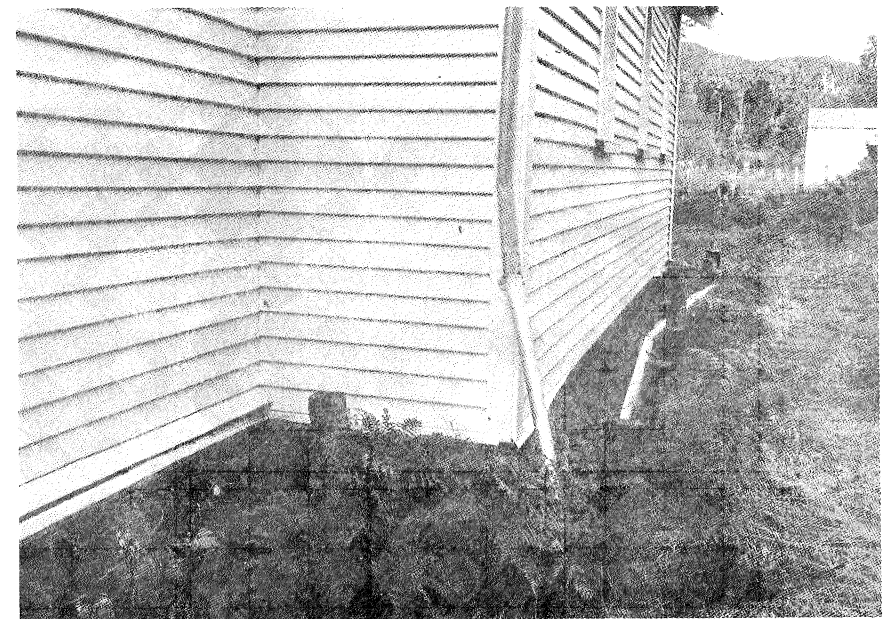
Fig. 20. Church, moved off its timber foundation piles

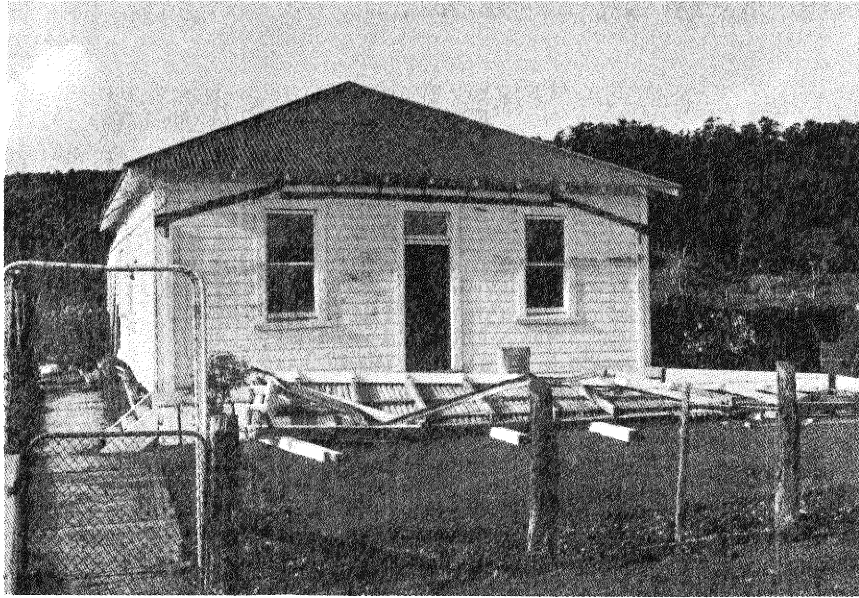
Fig. 21. Dwelling off piles, 1 km south of Inangahua Camp

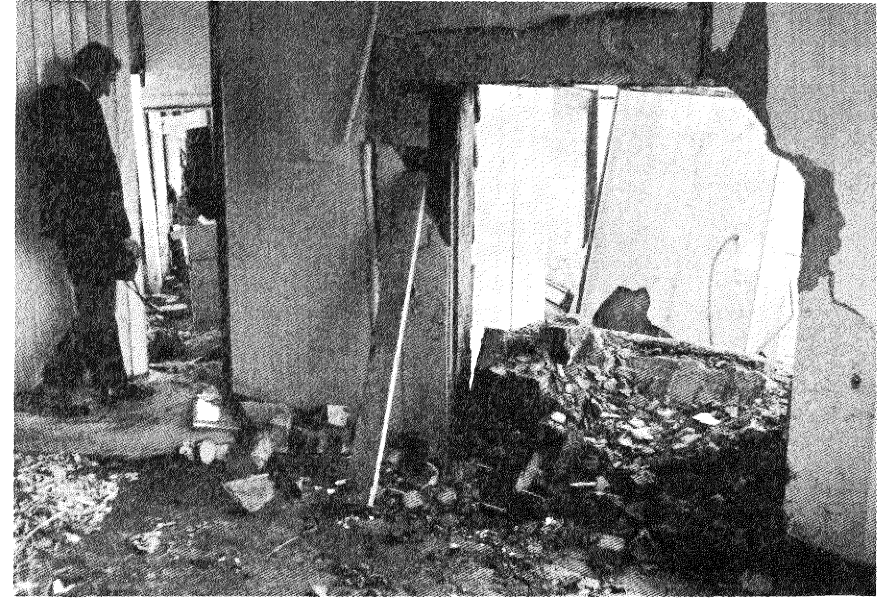
Fig. 23. Collapsed chimney and fireplace, fig. 21

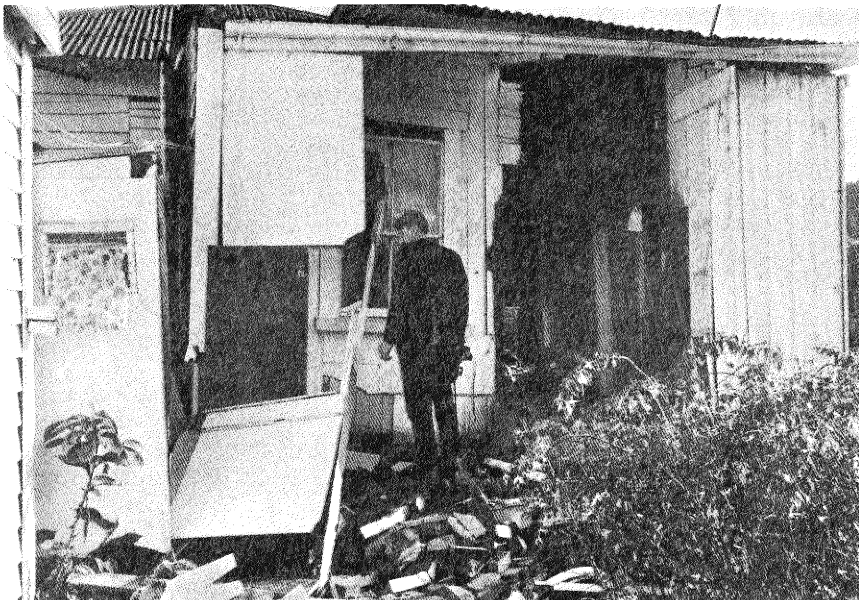
Fig. 22. rear of dwelling, fig 21

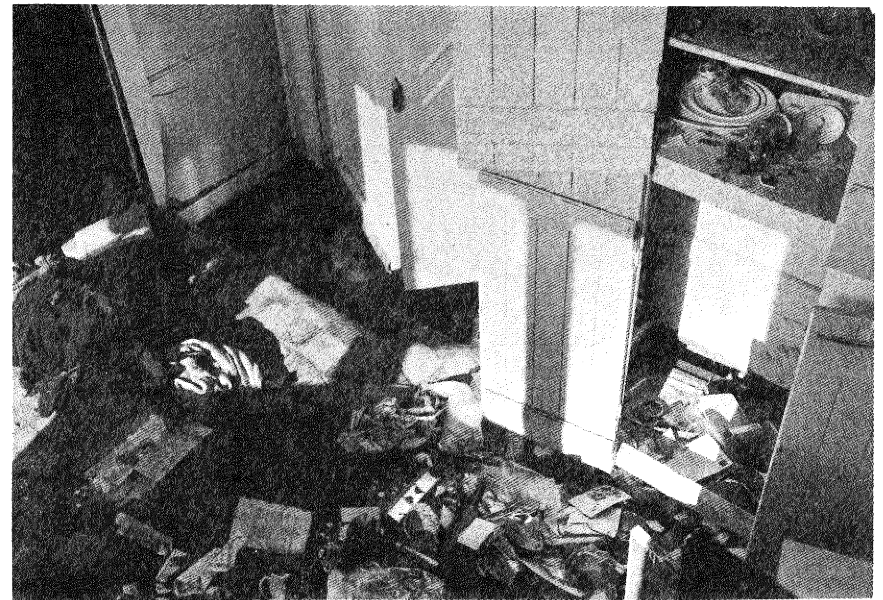
Fig. 24. Debris in pantry of dwelling of fig 21

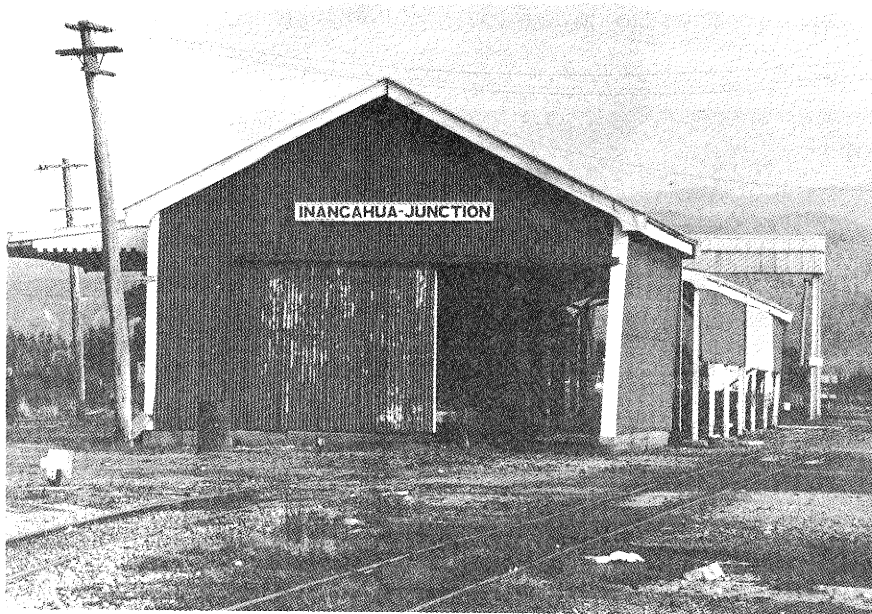
Fig. 25. Inangahua Junction railway station building

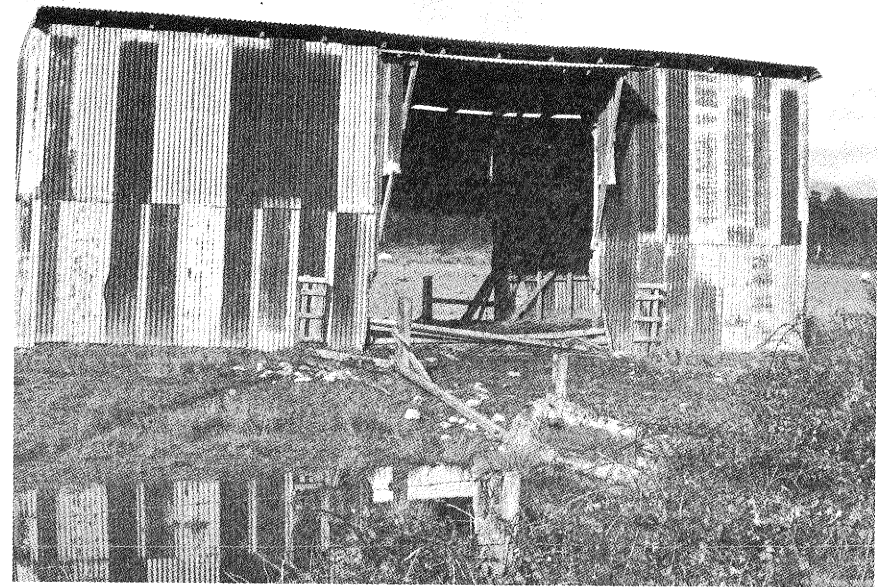
Fig. 27. Inangahua Junction. Shed on line of fault movement

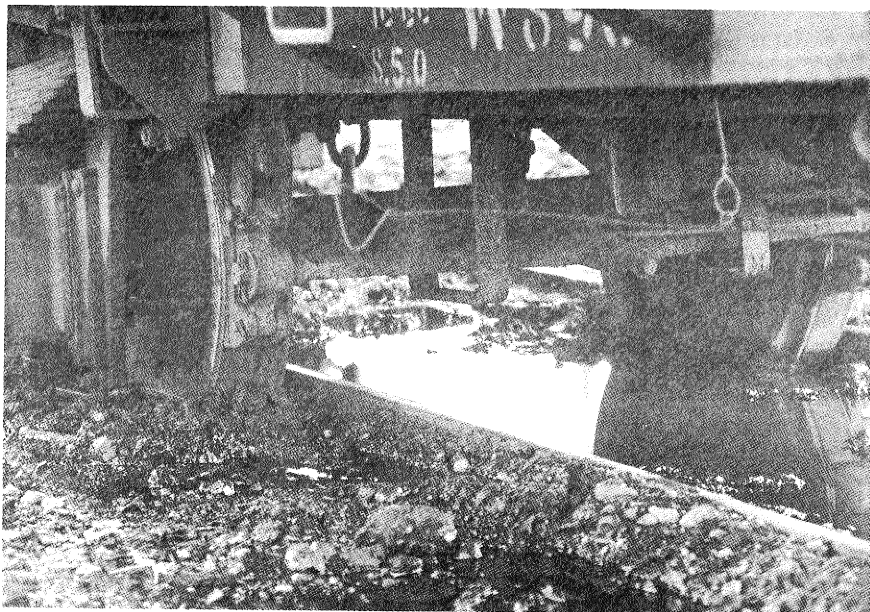
Fig. 26. Railway wagon displaced off rails

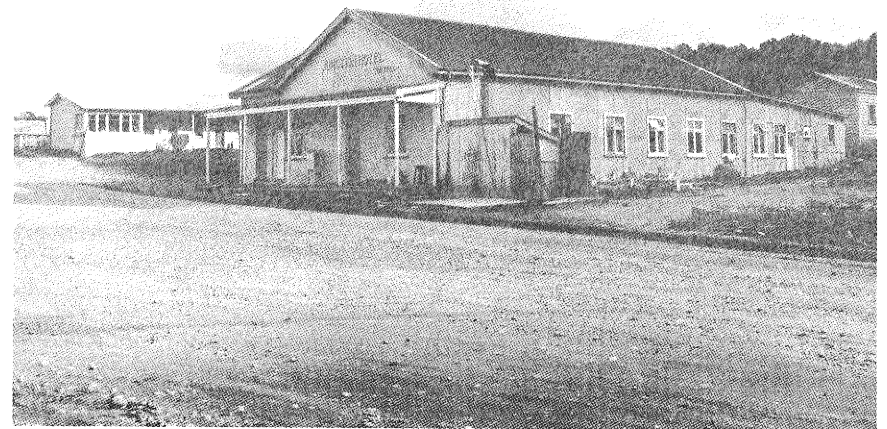
Fig. 28. Building at base of landslide and on fault line

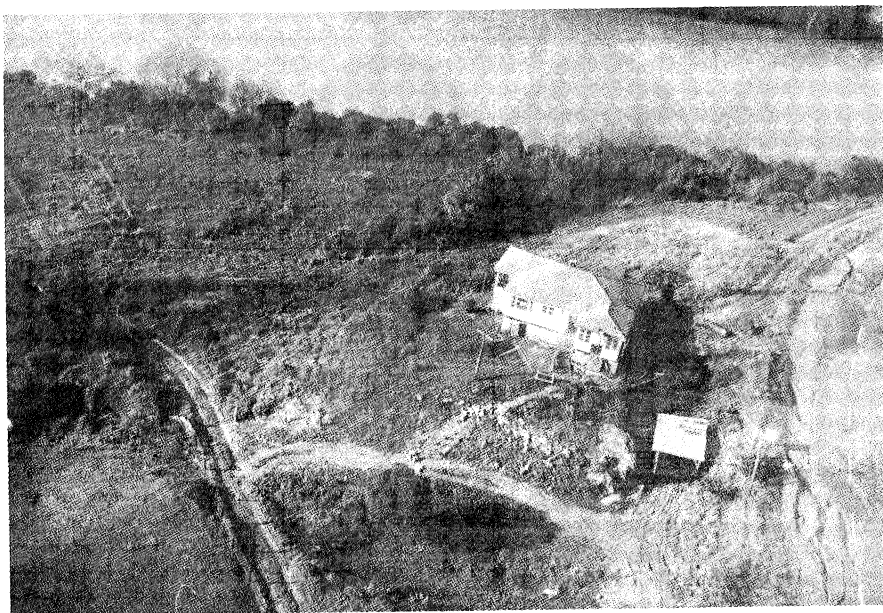
Fig. 29. Dwelling on earth movement, 4 km w.n.w. of Ing' Camp

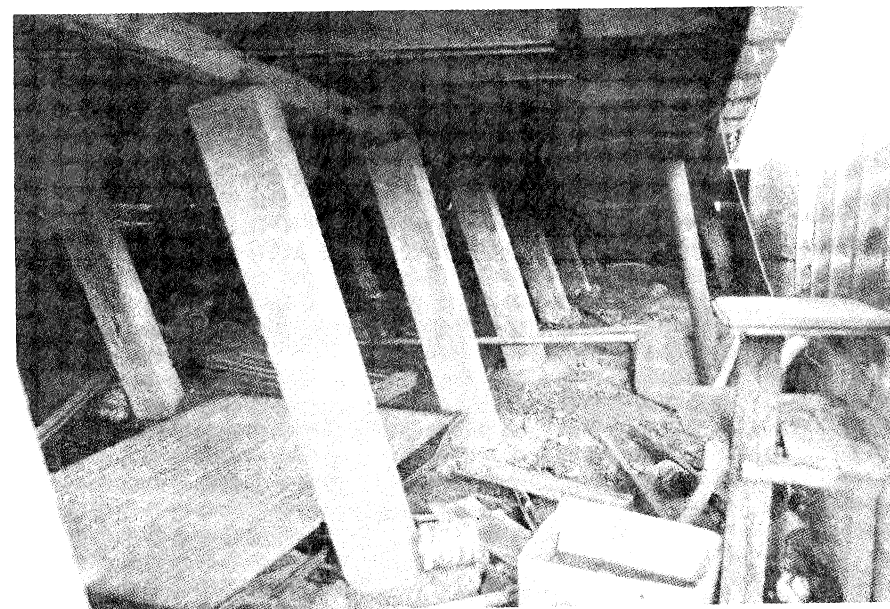
Fig. 31. Foundation piles leaning, dwelling, fig. 29

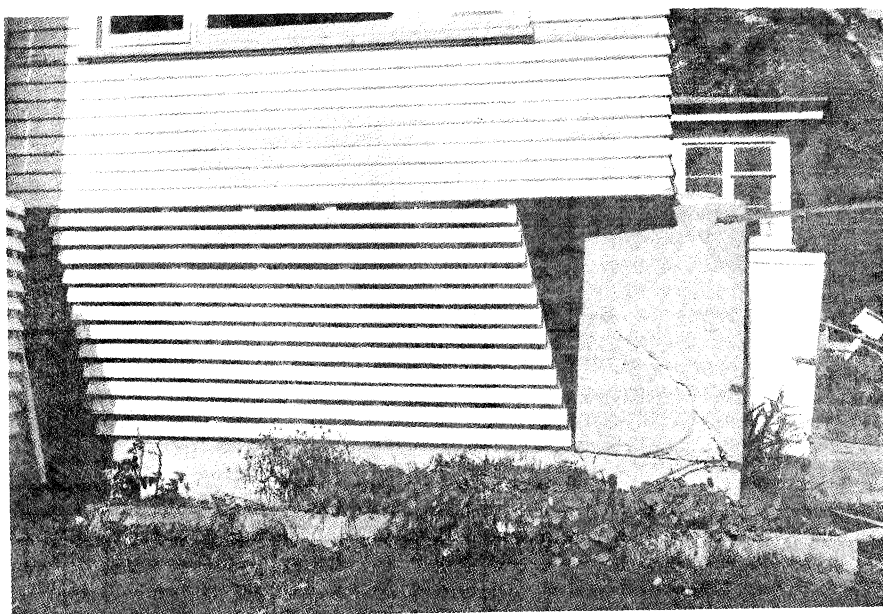
Fig. 30. Dwelling of fig. 29. movement at foundations

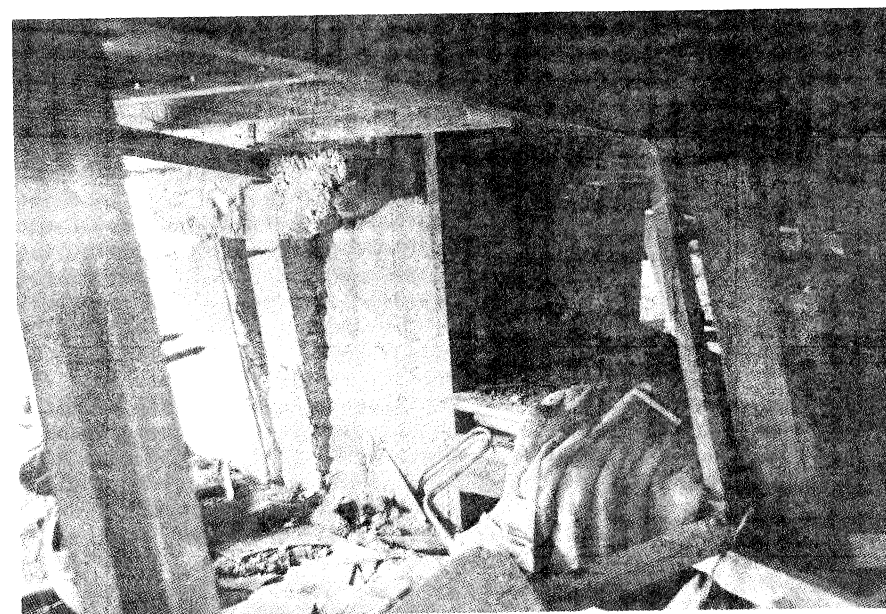
Fig. 32. Damage to chimney base, fig. 29

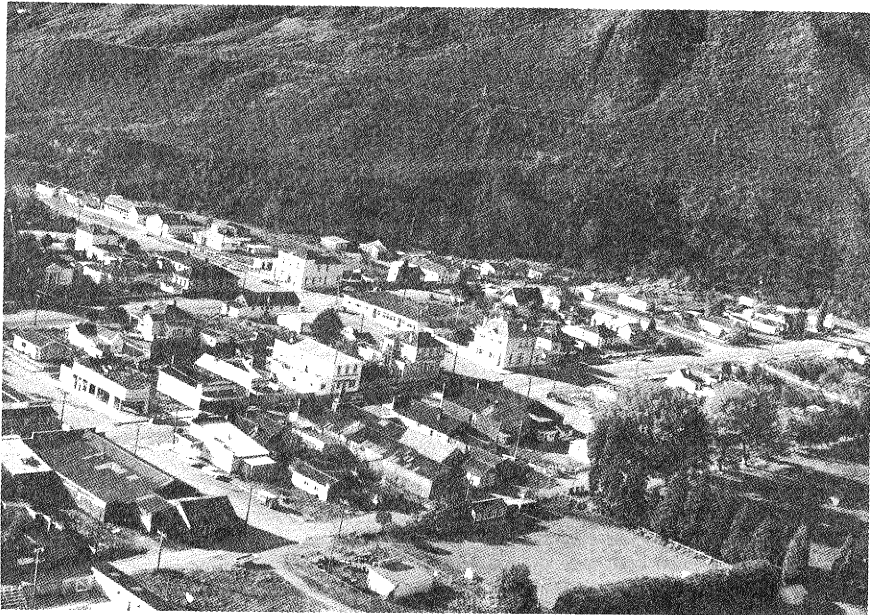
Fig. 33. View of Reefton, May 24, 1968

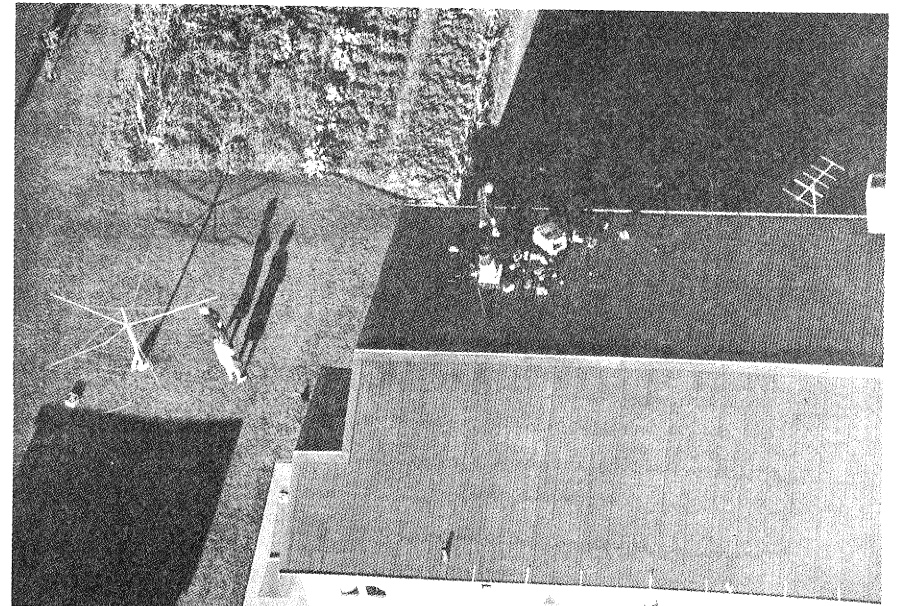
Fig. 35. A chimney collapse in Reefton

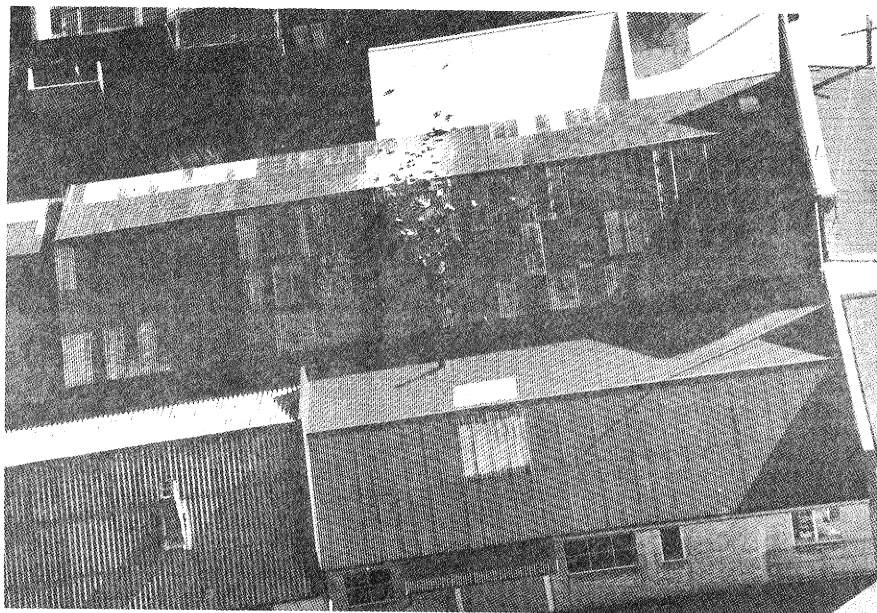
Fig. 34. Collapsed chimney, Reefton

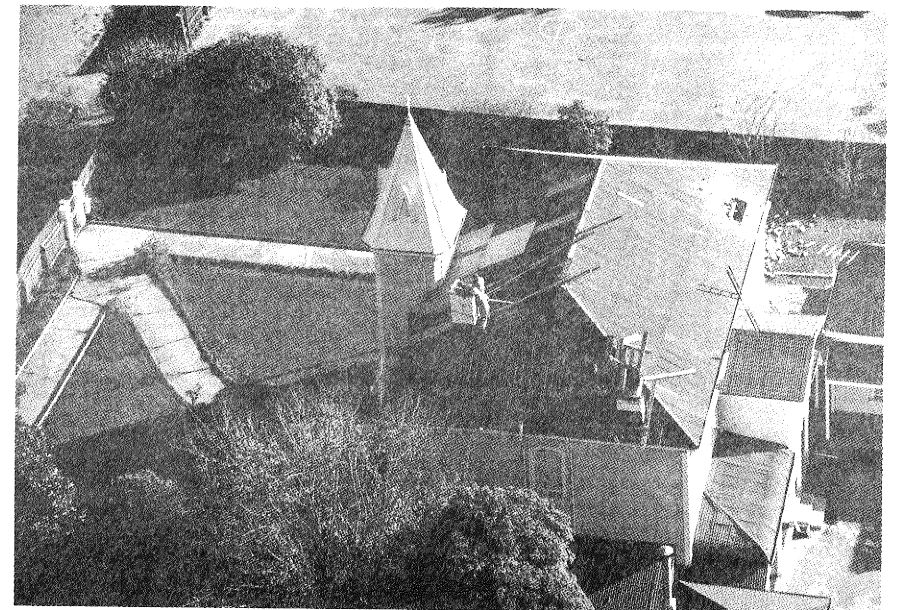
Fig. 36. Reefton, May 24, 1968, immediate work
