AGADIR, MOROCCO, RECONSTRUCTION WORK SIX YEARS AFTER THE EARTHQUAKE OF FEBRUARY 1960

Bruce H. Falconer*

This paper is based upon enquiries and observations made by the writer during three weeks spent in Agadir in January 1966; and upon a manuscript he wrote at that time, xerox copies of which were given a limited circulation.

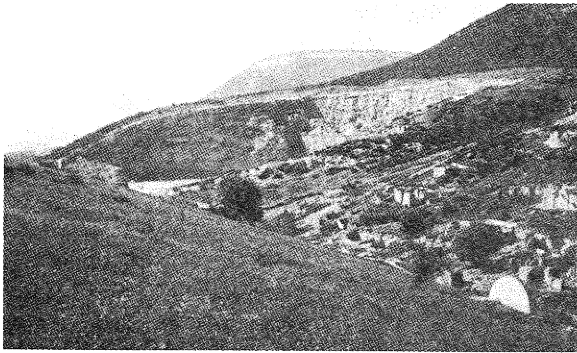
Yachech ruins, quarry and Kasbah hill

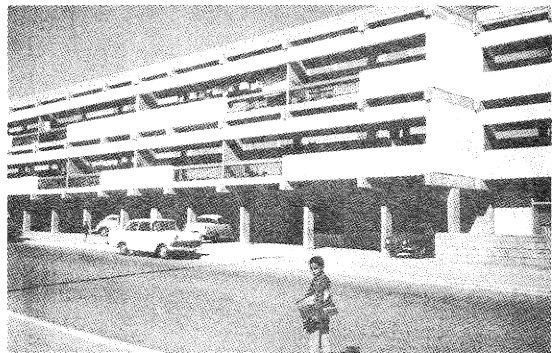
Construction to new building code

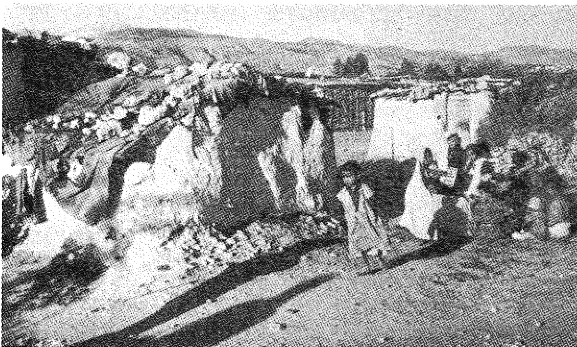
Meanwhile the bulk of the claimants, after passage of six years, still remain housed provisionally in the buildings, whether of temporary or permanent construction, erected during the emergency period, or else reside in Inezgane, or in an encampment which has grown up north-west of the industrial quarter of the city. Regrettably, many of the dwellings which have sprung up in the encampment, it appears, are no less hazardous than the old traditional houses.

Refugees at outskirts of Agadir

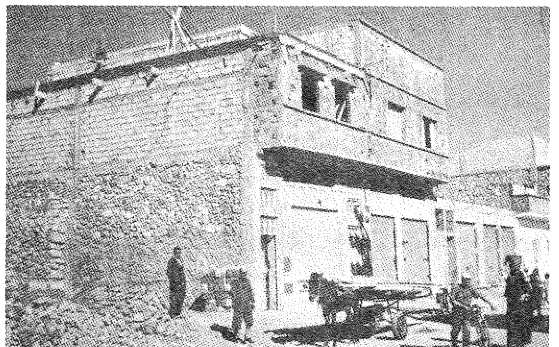
The lack of consideration of the chance of earthquake forces in buildings beyond the city is readily apparent in viewing the buildings erected since 1960 elsewhere in the plain of Souss. Nevertheless there have been some significant changes for the better. Use of traditional masonry of weak rubble masonry, or even of mud walls is being displaced by the use of concrete blocks (though often of feeble strength) set in mortar with some cement, inset in concrete "chainages". The chainages are generally reinforced, on occasions with quantities of reinforcing steel somewhat similar to that now compulsorily required within the city. However, in such things as concept of structure, manner of use of the materials, disposition of elements and continuity of connections, there are often serious deficiencies. In the village of Inezgane, and its cluster of six neighbouring settlements, spaced in a grouping extending from 8 km to 13 km (5 to 8 miles) distance from the new centre of Agadir, one can see a full range of the pre-1960 construction and the newer variants.

In Inezgane - no Agadir building code
