## SEISMIC PERFORMANCE OF SCHOOL BUILDINGS IN 2017 EZGELEH EARTHQUAKE, IRAN

Mehdi Kahrizi<sup>1</sup> and Mehrzad TahamouliRoudsari<sup>2</sup>

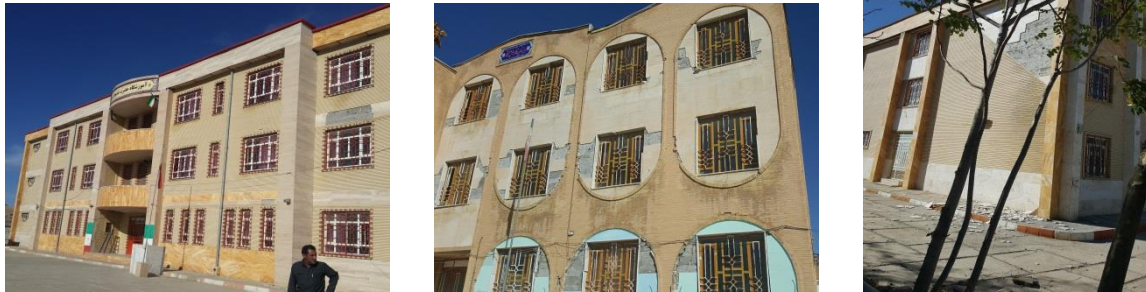
There are guidelines in Iranian design standards explaining how the façade layer should be connected to the main wall. Among the methods introduced are the use of L shaped rebars or galvanized steel mesh between the brick rows of the main wall, to which the façade layer is attached. The façade layers in the new school buildings built in recent years have been implemented based on these guidelines. Field observations after the 2017 Ezgeleh earthquake revealed that in new school buildings, where the façade layers were properly implemented, damage were inconsiderable (Figure 7).

Figure 7: Damage caused by the earthquake in schools with brick facades.

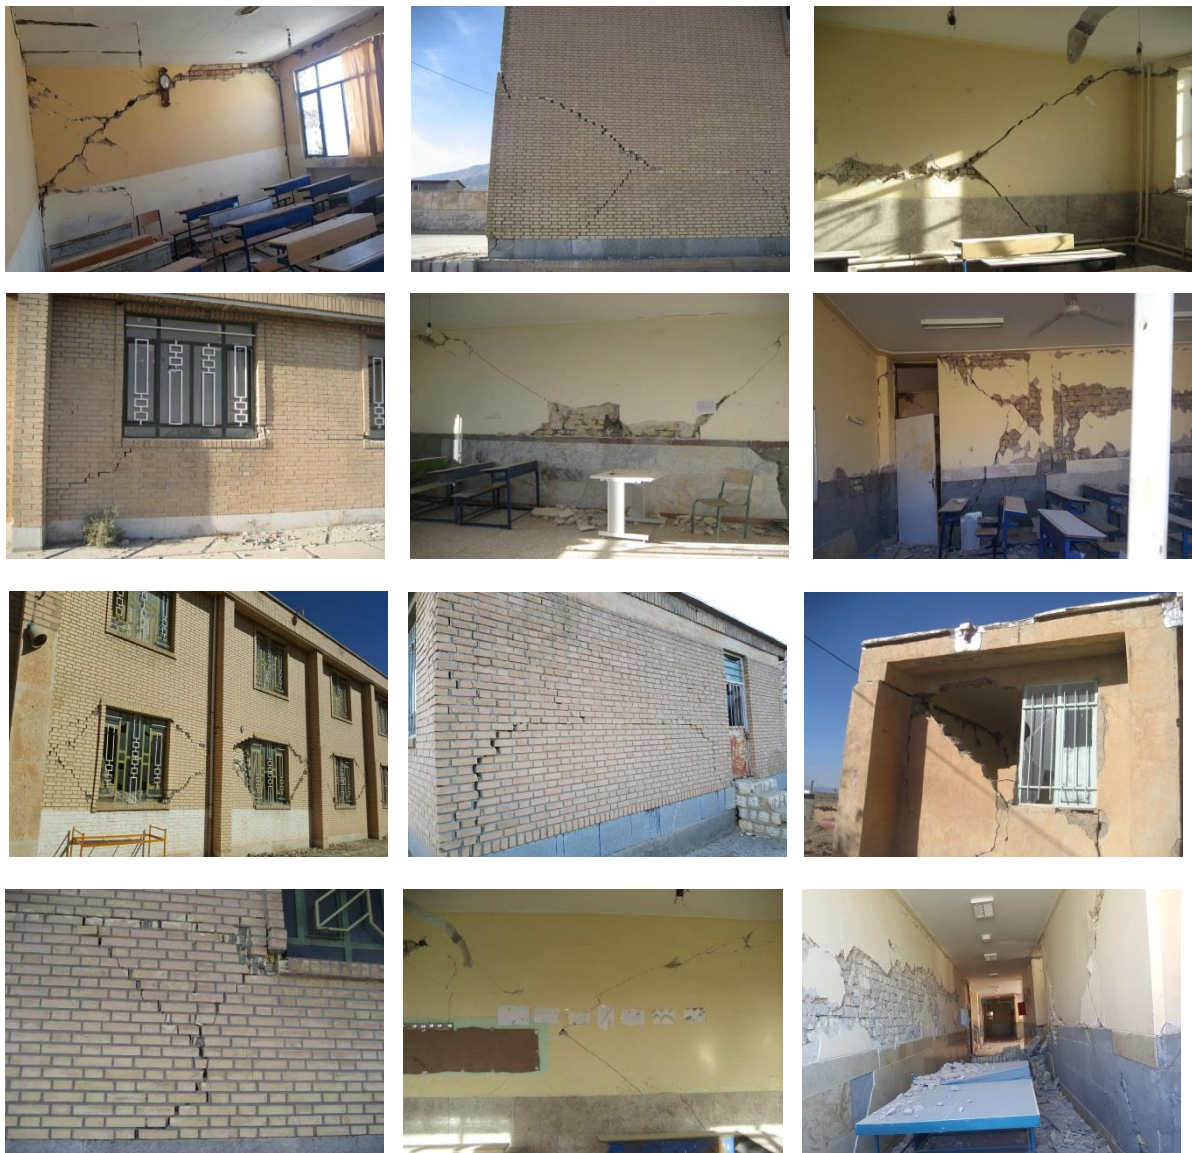
**Figure 9: Damage sustained by unconfined schools located within 10 km radius of the epicentre.**

the unconfined bearing wall structural system and also unconfined surrounding walls (Figure 9).

Most of the damage in unconfined school buildings located in the near field of the earthquake include diagonal cracks in the walls, separation of the brick rows and horizontal cracks in the walls, failure of the piers around the openings due to the short column phenomenon, slippage of the ceiling, and the separation of the ceiling from the walls.

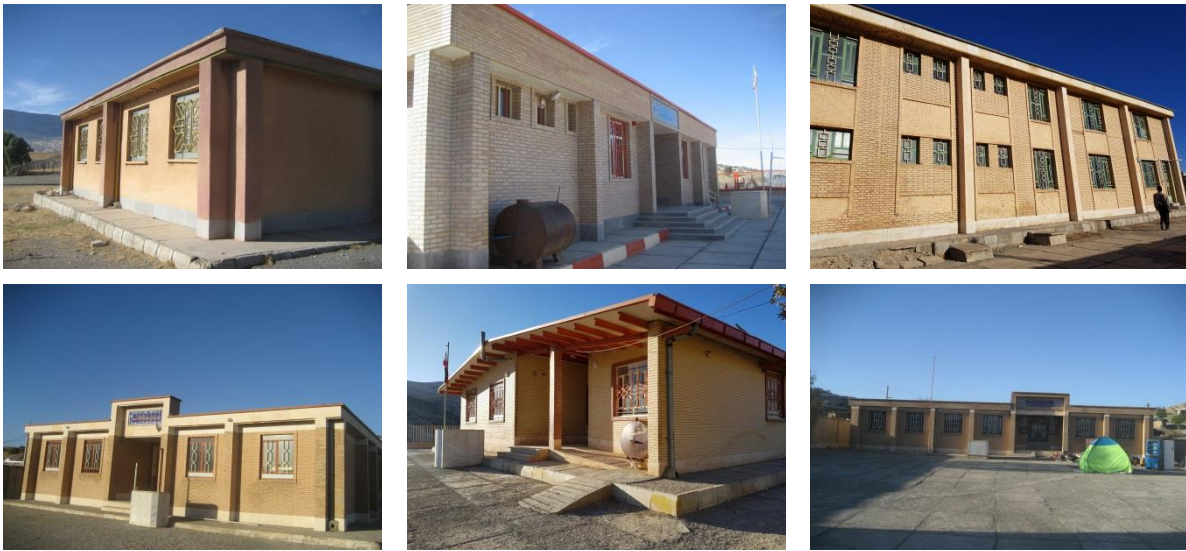
Investigations carried out on the schools in the region have revealed that old school buildings (schools with the age of more than 25 years) that were horizontally confined and employed the load-bearing wall structural system, had sustained far less damage compared to unconfined masonry buildings. Schools with horizontal and vertical ties were either without or with little structural damage. In new schools built according to the latest design codes, the use of reinforcing steel bars in between the rows in the masonry wall, in conjunction with tie columns and tie beams fully connected to the walls, almost no damage was seen. Schools with steel structures and proper lateral anchorage and slightly-sloped ceilings satisfied the Immediate Occupancy performance level and had desirable performances during the earthquake, so much so that even the infill walls of these school buildings did not sustain any kind of cracking or damage (Figure 10).

Figure 10: Undamaged newly-built schools located within 10 km radius of the epicenter.

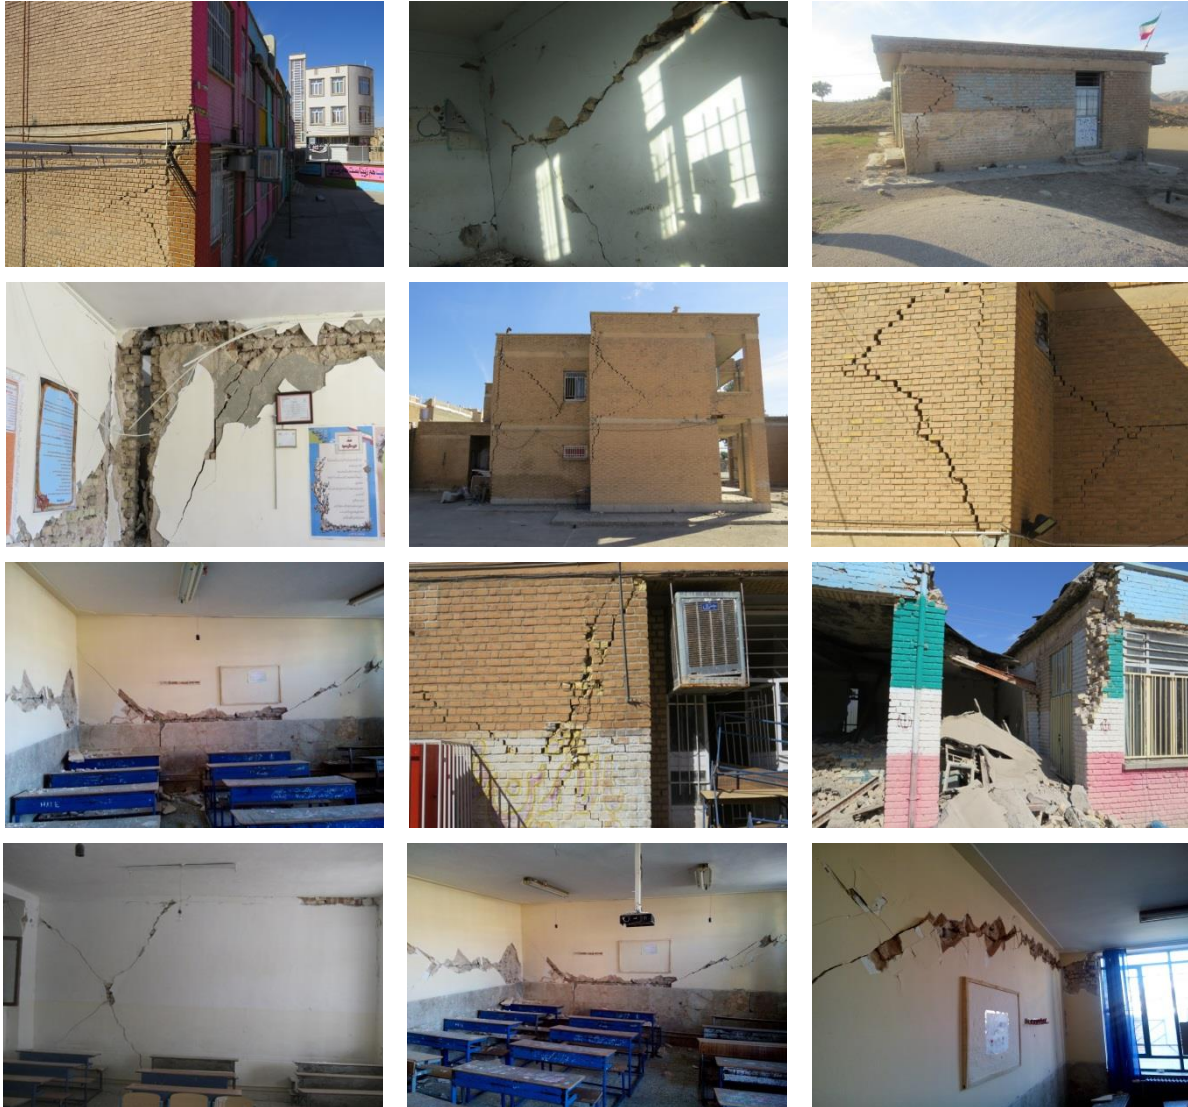
Among the most prevalent observed damage were shear failures, development of diagonal cracks in the corners of

buildings without tie columns, the combination of extended diagonal cracks and horizontal cracks in the wall's mid-height, and the separation of the wall from the other walls. These failure states are because of the stress concentrations in the upper and lower corners of the wall's panel. The poorest performance of these types of buildings was seen in regions for the weak soil, alluvium, and riverbanks (Figure 12).

*Figure 12: Damage suffered by schools located between 10 and 40 km from the epicenter of the earthquake.*

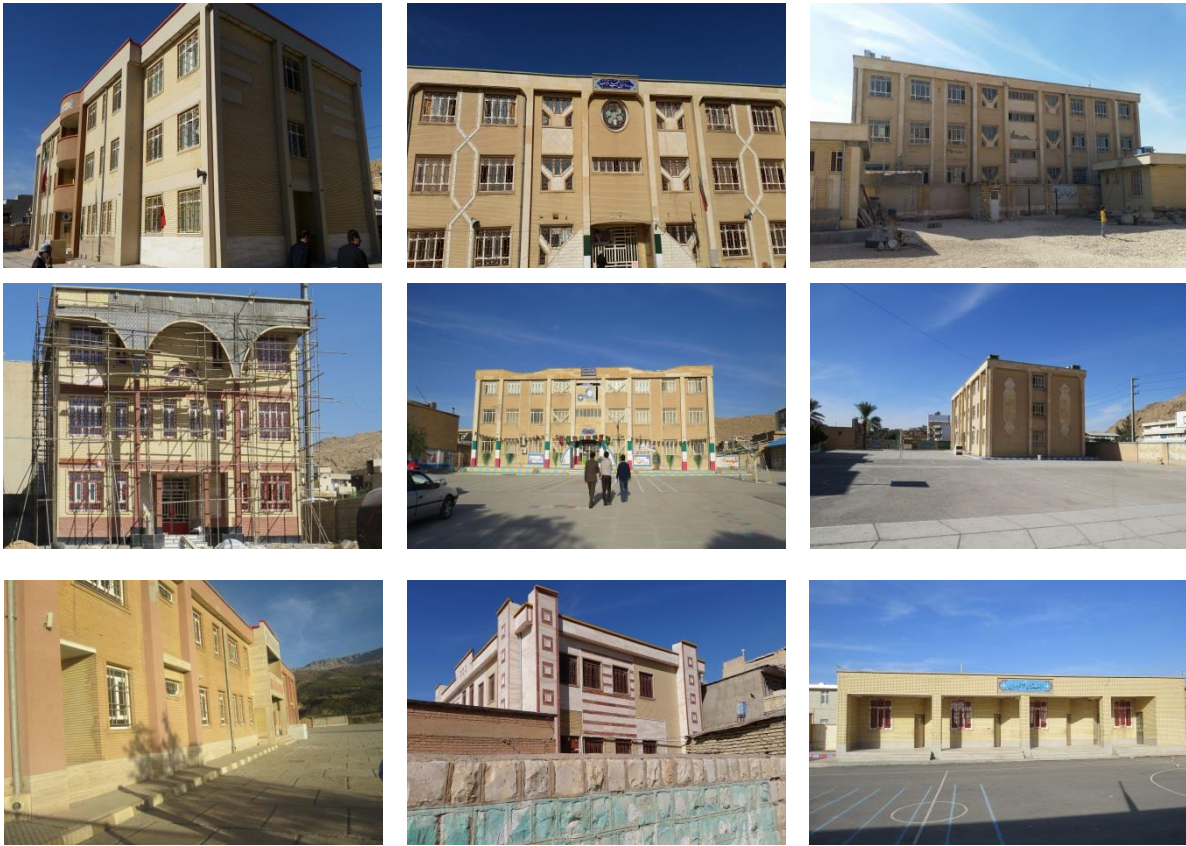
In most of the schools with this structural system, despite the intensity of the earthquake, the infill walls either have remained intact or contain a few surface cracks, with some small parts having fallen off. However, no total cracking or collapse of the infill walls was observed. In addition, in schools under construction where sandwich panels (3D panels) were used with sufficient anchorage, almost no damage was seen (Figure 13).

*Figure 13: Steel and reinforced concrete school buildings with anchored infill walls located 10 to 40 km away from the epicenter of the earthquake.*

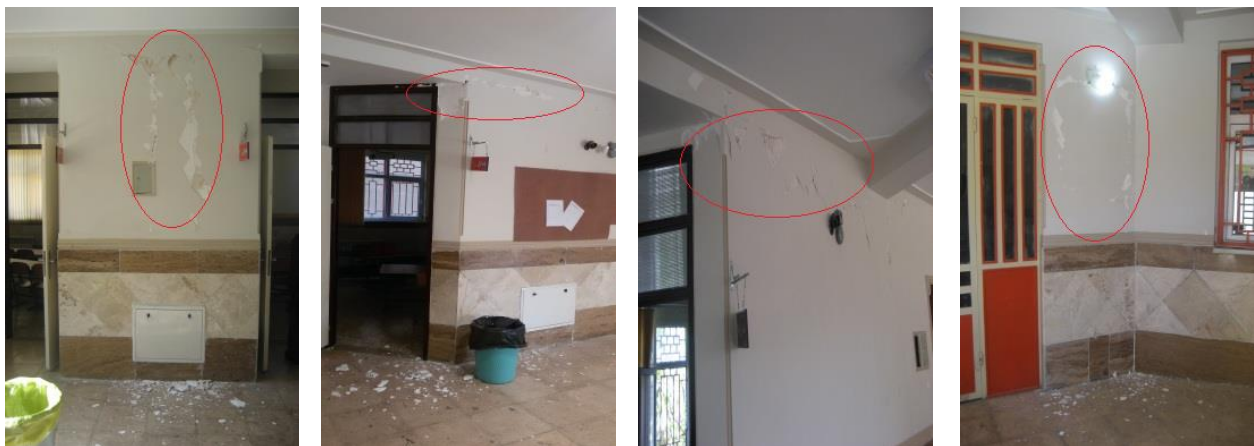
Assessing the failure modes of the wall and the cracking pattern of the infill walls show that anchored infill walls, especially continuous infills such as sandwich panels (3D panels), due to their proper and complete connection to the frame, experience no separation from the surrounding structure and only contain surface cracks along the vertical, horizontal, and diagonal directions, which results only in the plaster covering to peel off (Figure 14).

*Figure 14: Surface cracks on the anchored infill walls of schools 10 to 40 km away from the epicenter.*
