THE SEPTEMBER 19TH, 2017 PUEBLA, MEXICO EARTHQUAKE: FINAL REPORT OF THE NEW ZEALAND RECONNAISSANCE TEAM

**Samuel Roeslin¹, Hugón Juárez-García², Kenneth J. Elwood³,
Rajesh P. Dhakal⁴ and Alonso Gómez-Bernal⁵**

ABSTRACT

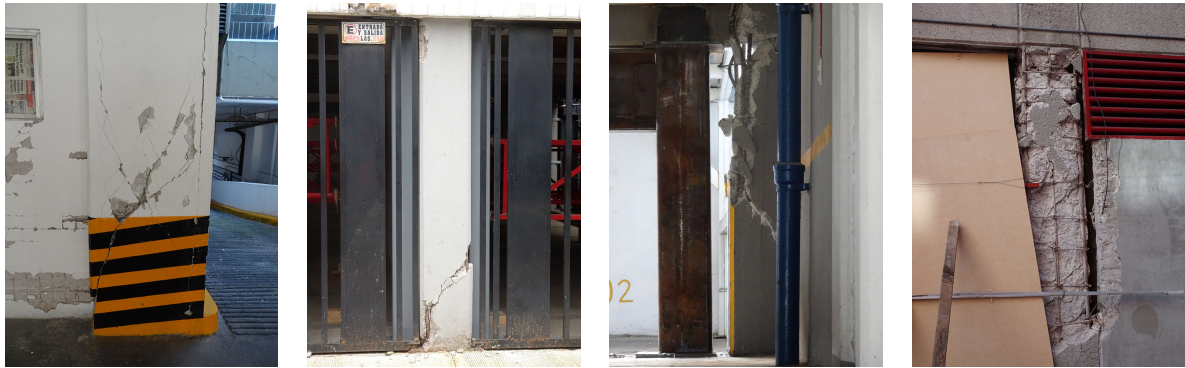
Figure 9a and Figure 9b show examples of column shear failure observed in residential buildings. Figure 9c shows an example of insufficient confinement (and anti-buckling) stirrups which led to buckling of reinforcement bars. Figure 9d shows a column where damage was triggered by the interaction with a partial height infill. Figure 9e shows splitting cracks in the lap splice zone, which led to concrete debonding and the exposure of the longitudinal reinforcement.

(a) Shear failure in a column.

(b) Shear failure at the base of a column.

(d) Spalling of concrete cover exposing large stirrup spacing.

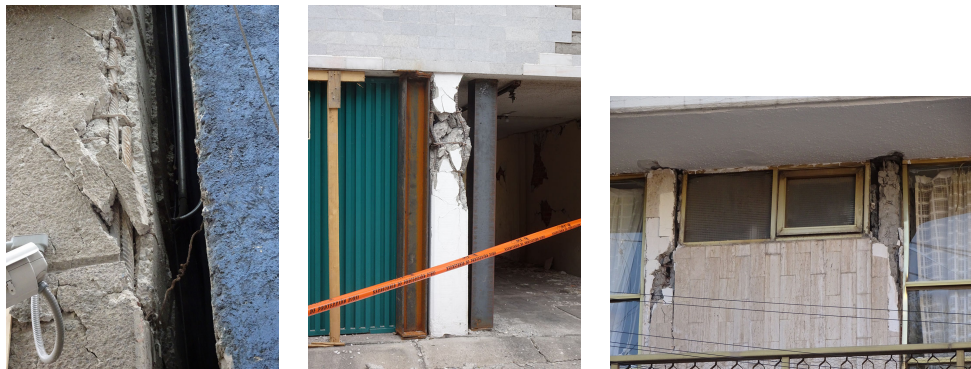
Figure 9f shows concrete spalling, followed by bar buckling at the top of a column. The buckling of the longitudinal rebar at the top of the column in this picture appears to be a secondary outcome of shear-axial failure caused by the combination of high compression and shear demand in a deteriorated plastic hinge zone. Figure 9g shows the typical case of a short column failure caused by a partial height infill wall.

(e) Lap-splice with insufficient length and confinement leading to debonding of concrete.

(f) Buckling of reinforcing bars in a concrete column.

(g) Column failure triggered by partial infill.

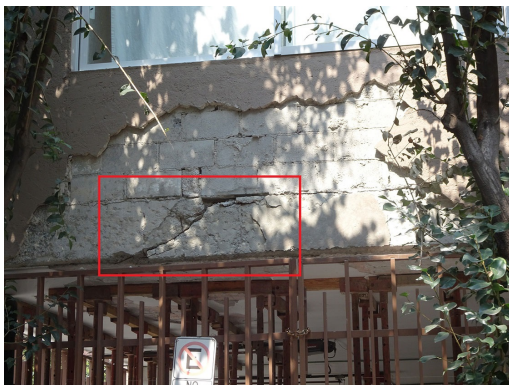
Figure 10: Slab failure.

While flat-slab systems were very popular in Mexico before 1985, after their brittle failure evident in the 1985 Michoacán earthquake, this configuration was not used after 1985. However, many buildings that suffered damage in the 2017 earthquake were built before 1985 and had this type of floor system. The waffle slab and precast beam-block floor systems were extensively used in Mexico [36]. Commonly, the thickness of a waffle slab ranged from 25 to 45 cm. Flat slab systems are flexible and prone to punching and shear failure the slab-column connections. Figure 10 shows an example of typical shear cracks observed in flat slabs.

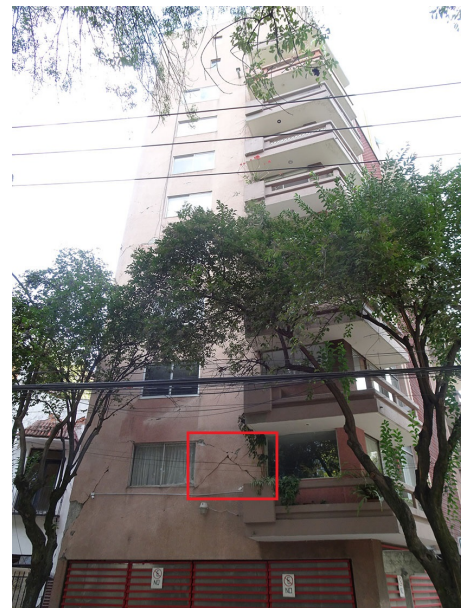
Figure 11: Failure in masonry wall.

In Mexico, residential buildings typically have a significant number of infill walls of either brick or hollow clay tile. In several buildings, masonry infills between columns were observed to have failed. Infills are typically not considered in the design of RC frames in Mexico, and they are treated as non-structural walls. As is well-known, infill walls can significantly reduce structural drifts and the team suspects they may have protected many flexible flat slab buildings from exhibiting nonlinear response. If the seismic demands exceeded the strength of the infills, however, they would have failed in a brittle manner and concentrated damage to the frame would be expected. For the moderate demands of the 2017 Puebla earthquake, it is believed the infills may have helped reduce damage in many RC buildings, but for a larger earthquake the opposite may be true. In some cases though, X-shaped shear cracks were observed in masonry wall panels, as shown in Figure 11.

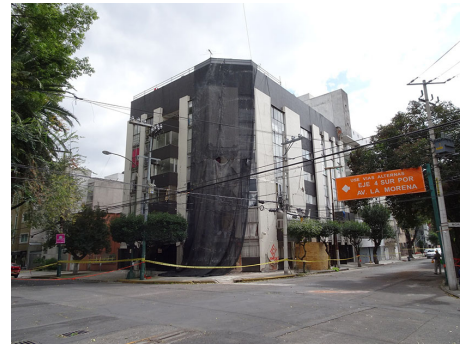
Buildings located at the end of a block (or “corner buildings”) have unique characteristics which increase their vulnerability. It is typical to have frames facing the streets and walls toward the rear of the building. This difference in stiffness leads to significant eccentricity between the centre of mass and the centre of resistance. Figure 14 shows two of the many corner buildings that suffered damage during this earthquake. The earthquake ground motion induced horizontal forces which generated torsion in these irregular buildings, causing extensive cracking in infill walls and severe damage to the non-structural claddings and columns.

(a) Corner building heavily damaged.

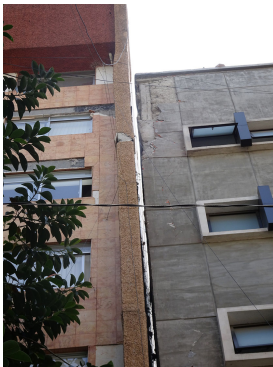
(a) Damage due to pounding between two buildings.

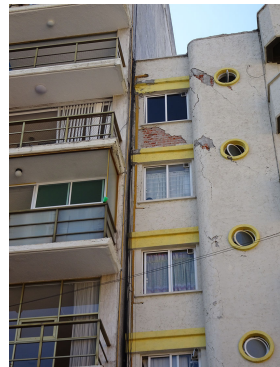
under the same ground motion. The roof of the shorter building may collide with the exterior wall (or columns) of the taller one leading to severe damage. Figure 13b shows an example of observed pounding damage, where the shorter building suffered spalling and column damage due to a collision with the neighbouring taller building. Similarly, Figure 13b shows facade and infill masonry damage in the shorter building caused by the interaction with the taller building.

(b) Tilting of the left building leading to pounding.

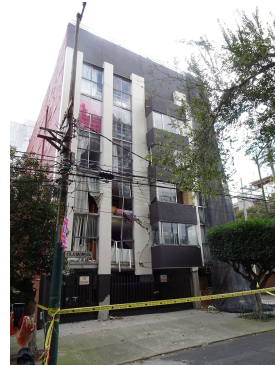
(b) Damage on the North facade.

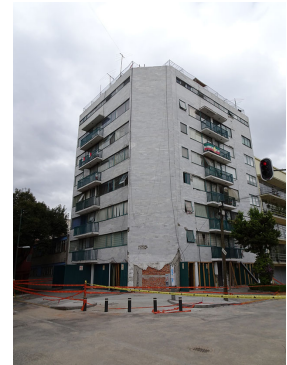
(c) Corner building to the point of collapse.

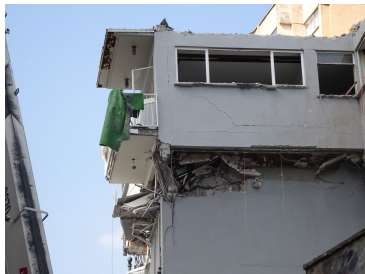
In some cases, two adjacent buildings were found to have restricted the motion of a taller building located in between. As shown in Figure 13c, the fifth floor of a seven storey building collapsed potentially due to interaction with the shorter adjacent buildings. The upper flexible part of the taller building oscillated while the lower part was more restricted from movement. Larger drifts in the upper storeys likely led to a concentration of inelastic demands at the fifth floor just above the roof of the smaller buildings.

(c) Storey collapse of level 5.

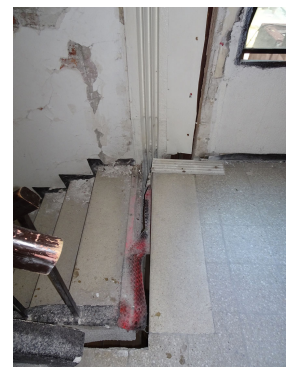
Because of the limited internal inspection, drawing generic conclusions on the performance of non-structural elements was not possible. However, internal inspections were useful to check the performance of structural elements, partition walls and stairs. As shown in Figure 15 stairs and stairwells experienced damage due to the displacement of adjacent elements. Figure 15a and Figure 15b shows prefabricated stairs that fell off their support.

A gap formed between the supporting slab and the prefabricated concrete stairs. This mode of stair damage was also observed in flexible RC buildings in Christchurch during the 2010-11 Canterbury earthquake sequence.

(b) Stairs failure (side view).

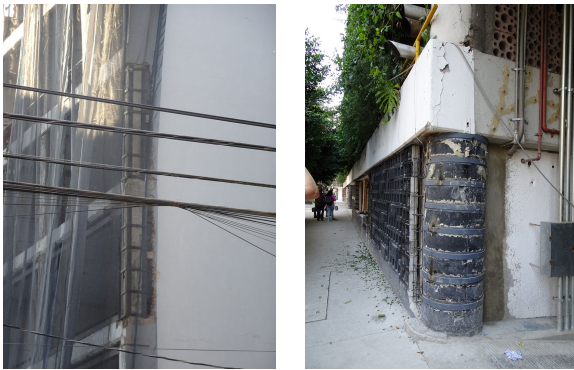
(a) Steel jacketing of box concrete columns.

(b) Steel jacketing of circular concrete columns.

The upgrading of critical structural elements with steel strapping and/or concrete jacketing was a typical retrofit or repair used to add deformation capacity to the critical elements. In addition to retrofits after 1985, the NZ team observed several buildings where steel strapping was being installed in October 2017. Steel straps are intended to provide concrete confinement to improve their ductility and shear strength without changing the lateral force-resisting mechanism of a building [42]. Steel strapping is flexible and adaptable to different shapes of columns (Figure 16). Epoxy resin ensures the connection at the interface between the steel strap and the concrete column. The case studies show more examples of steel column jacketing from after the 1985 earthquake.

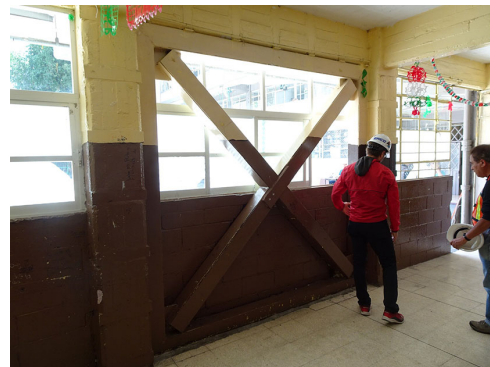
the government initiated widespread retrofit of school buildings. The retrofit measure implemented in one of the visited schools is shown in Figure 18a. The braces added stiffness and strength to the structural frame. Although they were able to prevent collapse of the building and ensured life safety during the 2017 earthquake, they were not able to avoid damage to infill walls. Figure 18b shows an out-of-plane failure of a masonry infill wall in the same school, emphasising the importance of bracing out-of-plane walls.

(a) Internal bracing of a frame.

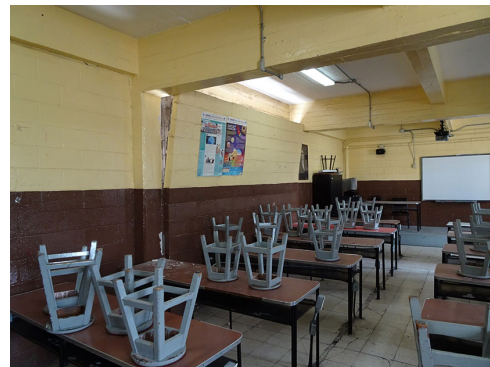
(b) Out of plane failure of the masonry wall in a school building.

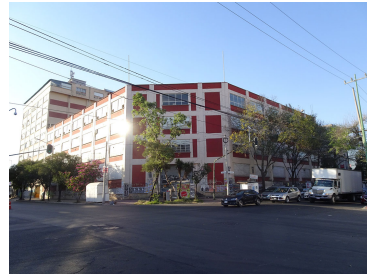
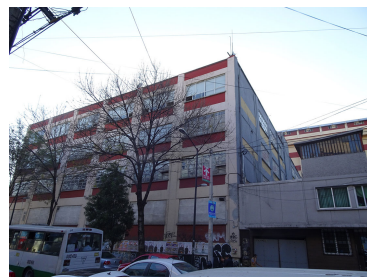
Figure 20: Building A.

At the date of inspection, doors were closed, and it was not possible to enter the building to check the retrofitted columns. The outside facade showed no apparent damage. As can be seen in Figure 20, the building seemed to have performed well during the 2017 Puebla earthquake.

This four-storey tall warehouse is located in seismic zone III c (lake bed zone). The reinforced concrete frame building was built in 1959. The building suffered damage to beams and columns during the 1985 earthquake. Columns and beams were retrofitted with reinforced concrete jacketing.

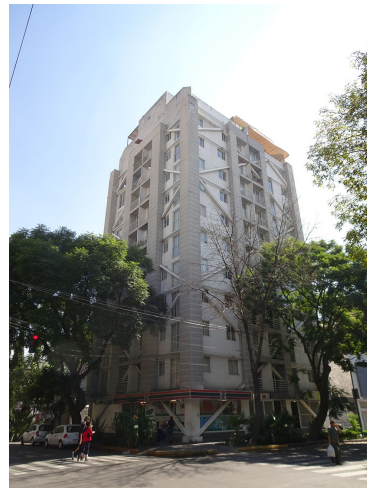
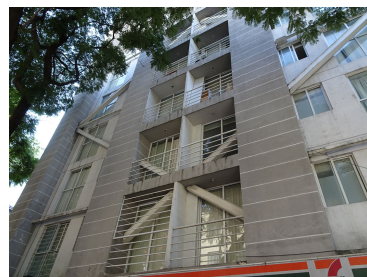
Figure 21: Building B.

As the first floor is used for commercial purposes, it was possible to do an internal inspection of some parts of the first floor. The building did not suffer internal or external damage during the

2017 earthquake. A discussion with a shop owner from the first floor confirmed that non-structural elements did not experience any damage during the 2017 earthquake. The retrofit solution performed as expected leading to low overall displacement of the structure and protection of the internal elements.

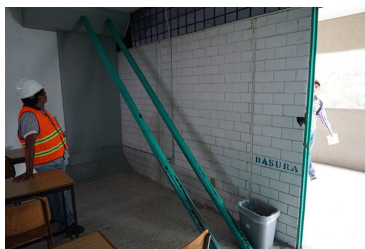
Cable braces and steel beams performed well during the 2017 earthquake. No damage occurred in the braces and structural elements or in the non-structural walls.

Figure 23: Building D - Cable bracing and connection through slab-column joint.

the Metropolitan Autonomous University (UAM). In the 1985 earthquake captive columns experienced diagonal cracks wider than 1 mm. As a retrofit solution, engineers decided to add cable braces acting in tension, as shown in Figure 23. The cable braces were designed such that the cables and the original RC frame reached their maximum lateral resistance at approximately the same horizontal displacement. Columns were strengthened to withstand the added loads due to the cable bracing. New steel beams were used to strengthen the diaphragm at the stairwell openings. Reinforced masonry walls located in the stairway areas were also reinforced with wire mesh and shotcrete.

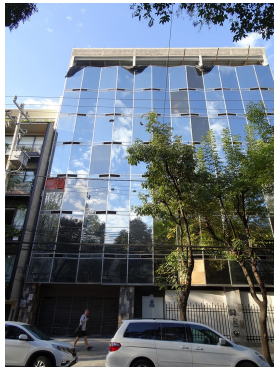
retrofitted. Nevertheless, as shown on Figure 26, no damage occurred in the glass cladding suggesting that the building performed well during the Puebla earthquake.

Figure 26: Building H - Glass cladding on the main facade.

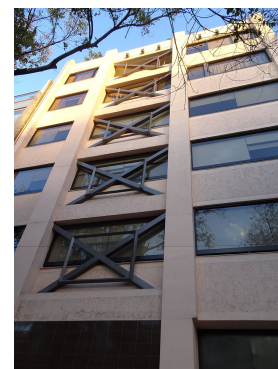
After the 2017 earthquake, only an exterior inspection was possible. Damage on the façade or in braces were not observable. The building seemed to have performed well.

Figure 28: Building J - External bracing on the facade.

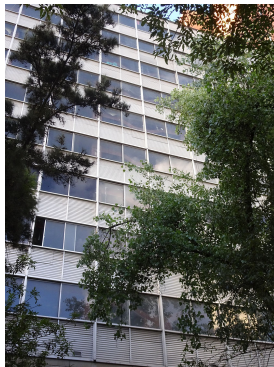
In the 2017 earthquake, the external inspection revealed no damage to the facade. Steel bracing was only observable through the windows (Figure 29). No internal access allowing a closer look at the braces was granted.

Figure 29: Steel bracing in upper levels behind the facade (building L).

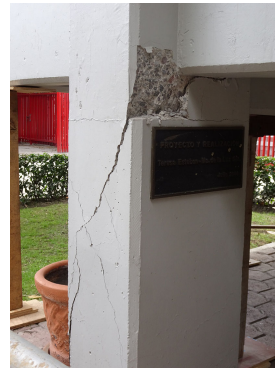
(a) Shear crack in a column of administration building.

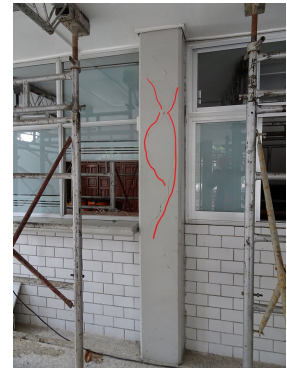
(b) Shear crack in a column of administration building.

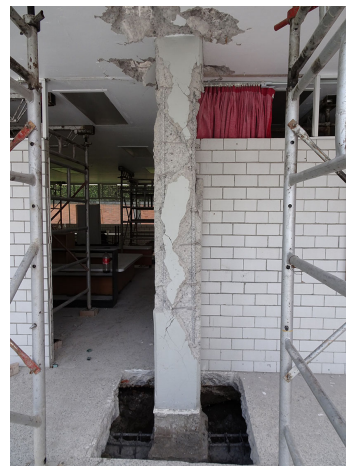
(c) Damage to a column in the Kindergarten.
