# SEISMIC PERFORMANCE OF PRECAST HOLLOW-CORE FLOORS: EXPERIMENTAL FINDINGS AND UPDATES TO C5

## ABSTRACT

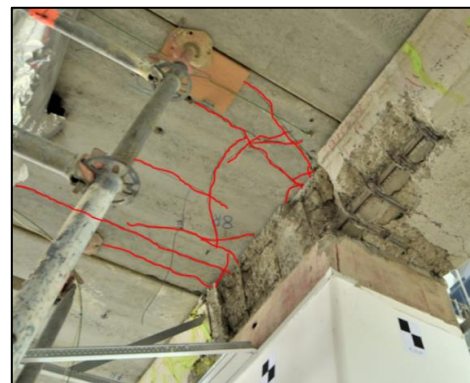
**Figure 2: Soffit damage in a ‘beta unit’ recorded following the 2016 Kaikōura earthquake [29].**

Several important damage observations from the 2016 Kaikōura earthquake remained unaccounted for in the Assessment Guidelines C5 [25]. Mostafa et al. [24] reported that hollow-core units supported on or close to intermediate columns were, in some instances, heavily damaged, while adjacent units remained largely undamaged (Figure 2). These hollow-core units have come to be referred to as ‘beta’ units and differ from alpha units in that there is no parallel beam or wall running adjacent to the hollow-core unit. Another key issue that was emphasised by observations from the 2016 Kaikōura earthquake and previous experiments was the susceptibility of hollow-core floors to cracking in the webs. Cracks in the webs

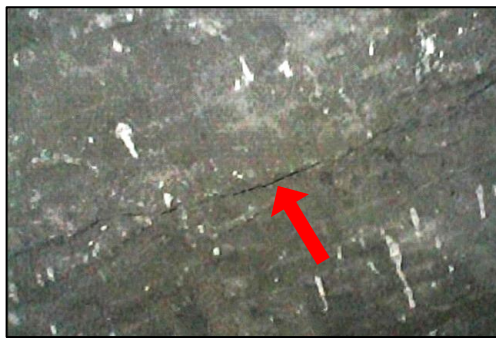
The first web cracks were recorded with a borescope camera at  $-0.42\%$  ( $\parallel$ ) drift at the north end of units U7 and U8 (Figure 6a). While these web cracks extended from the previously mentioned negative moment crack, the low drift at which they formed underscored the damageability of the unreinforced webs.

(a) First web crack at the south end of unit U8 at  $-0.42\%$  ( $\parallel$ ) drift.

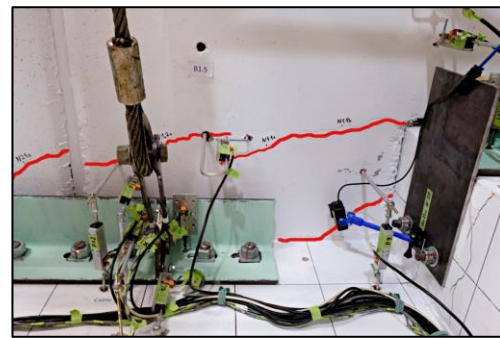
(b) Transverse crack in the north end of alpha unit U1 shown at  $-0.87\%$  ( $\parallel$ ) drift.

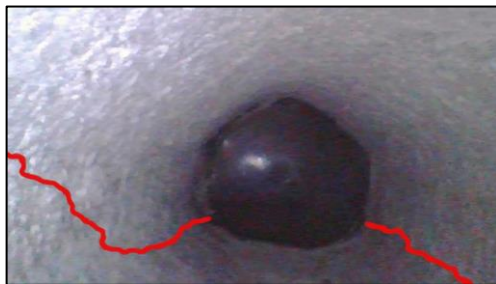
At  $-0.87\%$  ( $\parallel$ ) drift, the beta unit, U5, had dropped by 1.3 mm across the soffit crack at the north support. Following loading to  $-1.34\%$  ( $\parallel$ ) drift, the vertical offset had doubled to 2.6 mm across the now 3 mm wide transverse soffit crack. This measurement surpassed the vertical offset benchmark of 2 mm, which is deemed to be an indicator of the loss of a reliable load path [27]. Even more substantial was the 3.7 mm vertical offset recorded across a soffit crack in beta unit U4 (north end). This transverse soffit crack formed about 100 mm from the seating ledge of the support beam and propagated internally as a shallow web crack over approximately 400 to 500 mm toward mid-span (Figure 6c).

(c) Web cracking in beta unit U4 (North support) at  $-1.34\%$  ( $\parallel$ ) drift.

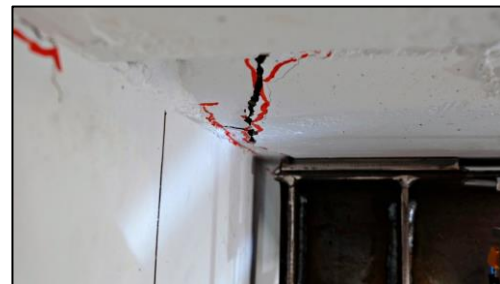
(d) Vertical offset in soffit crack of beta unit U5 (North support) at  $-1.84\%$  ( $\parallel$ ) drift.

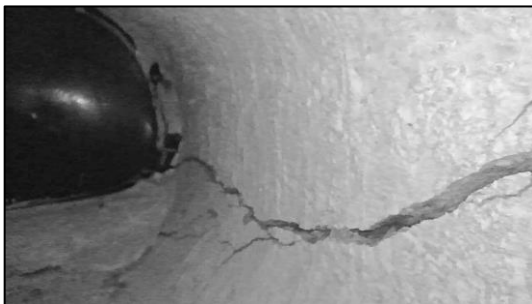
As peak displacements increased, the web cracks expanded considerably, as illustrated in Figure 7a at -2.42% (||) drift. The gravity load paths in the hollow-core units at the support ends became severely compromised. Beta unit U4 experienced a substantial vertical drop of up to 25 mm at -2.92% (||) drift, while the alpha unit U1 only incurred a 10 mm vertical offset despite heavy damage in its support region. The smaller vertical offset in the alpha unit was likely due to load sharing between the adjacent beam A1-A2, alpha unit U1, and unit U2. Although this load path could not be considered structurally reliable, it evidently helped reduce the vertical drop of the alpha unit at this stage of the test. The retrofit underneath unit U2 engaged at the subsequent loading to +2.87% (||) drift.

(a) Web cracking at the north end of unit U8 at -2.42% (||) drift.

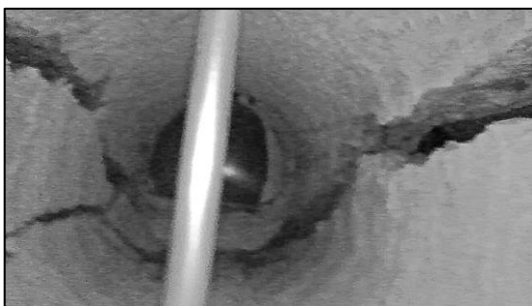
(a) Web cracking at the south end of beta unit U4 at +3.44% (||) drift.

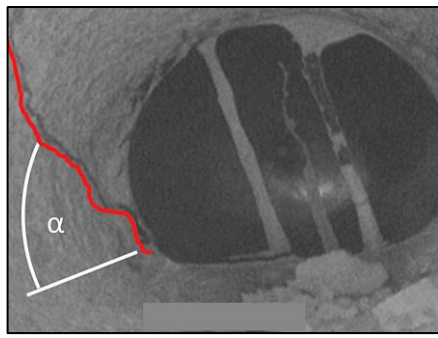
(a) Steeper crack  
(Alpha unit U8 south at 1.91% ( $\parallel$ ) in Test 1)

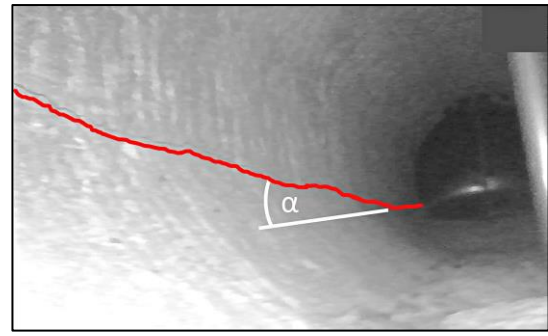
(b) Shallower crack  
(Beta unit U4 south at 1.38% ( $\parallel$ ) in Test 2)

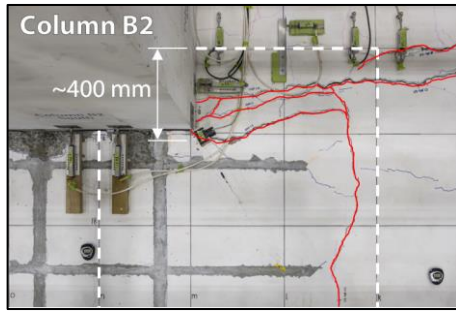
The damage in the tested beta units was extensive (Figure 12). The support region of these units incurred substantial transverse topping cracking up to 400 mm away from the support (Figure 12a). Such cracking away from the support is particularly unexpected for this support because it lacked starter bars and only comprised 665 mesh as continuity reinforcement. The predicted behaviour was the formation of a single crack along the cold joint at the floor-to-beam interface. The crack formation away from the support could be attributed to the discontinuity in the flooring unit created by the notches in the end region of the beta units around the inter-mediate columns (Figure 4). At the bottom of this hollow-core floor, the damage was concentrated in a single transverse crack 50 mm away at the seating ledge (Figure 12b). Internally, the top and bottom cracks joined via a shallow diagonal web crack (Figure 12c).

(a) Topping – dashed line indicating the perimeter of the flooring unit (+1.89% (||)).

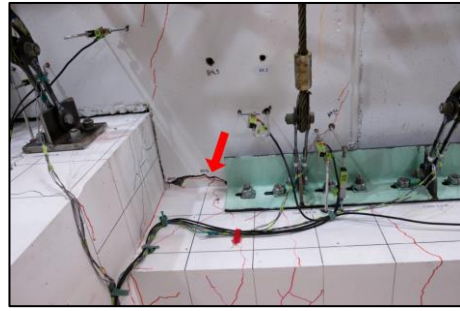
(b) Soffit (-1.92% (||)).

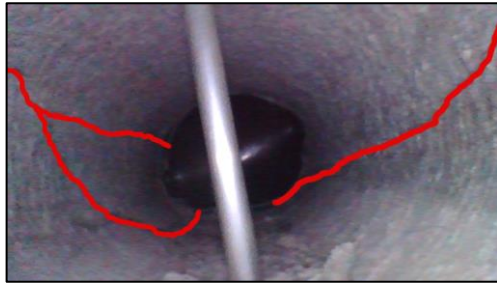
(c) Internal damage shown at residual after cycle 5 with -1.92% (||) peak drift (vertical element in the foreground is part of an instrumentation assembly).

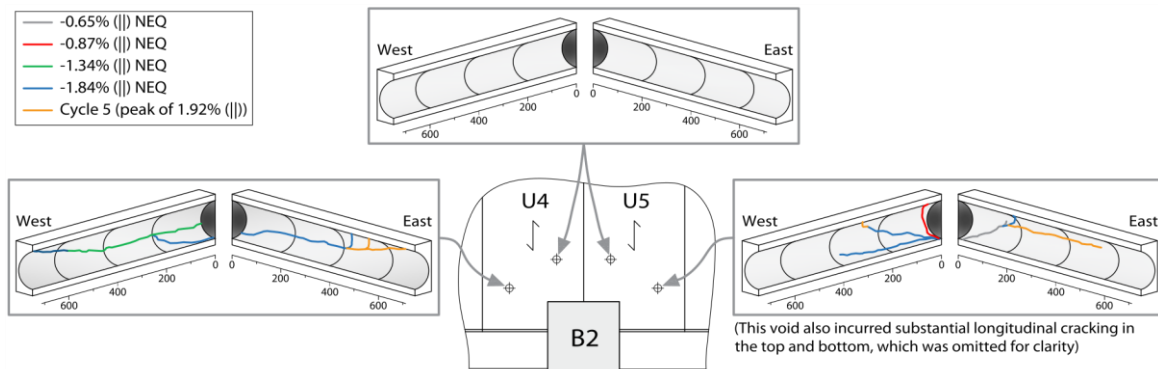
The web cracking was limited to the reduced floor section beside the notch. This section is particularly vulnerable due to its lower flexural and shear capacity as well as the limited prestress force within the transfer length of the strands. As indicated in the web crack drawings in Figure 12e, no internal damage was found in the webs along the width of the column. It should be noted that screw anchors (Figure 12d) were installed vertically through the hollow-core unit one meter away from the seating ledge as part of the cable catch retrofit. Borescope inspection indicated that these screw anchors helped to prevent the further propagation of the web cracks towards midspan of the floor.

(d) Web cracking in beta units U4 and U5 at the north support. (Dimensions in millimetres).

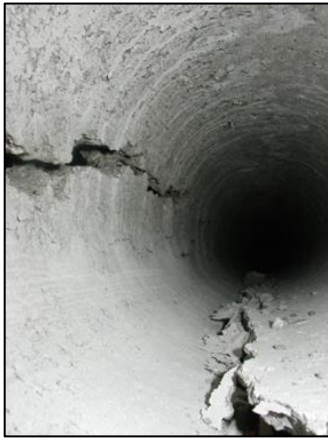
the Matthews test sustained horizontal splitting in the webs (Figure 13a), which resulted in partial floor collapse of the alpha unit at 2.5% drift (Figure 13a). The splitting was due to the displacement incompatibilities between the alpha unit and the adjacent beam. Alpha units in the Matthews test spanned past an intermediate column and, therefore, had 4 locations along the length of the units where large relative vertical displacement demands were imposed (Figure 13c). In contrast, the alpha units in this new test did not span across an intermediate column and only had high relative displacement demands close to the support. In addition, hollow-core units that span multiple bays tend to span longer distances and require deeper units. In Matthews's case, the hollow-core units were 300 mm deep and had fewer more slender webs compared to the hollow-core units in the herein-described tests. Based on this evidence, it can be concluded that alpha units spanning multiple bays and past a vertical element tend to be more vulnerable to premature collapse.

(a) Internal damage recorded at 2% drift [8].

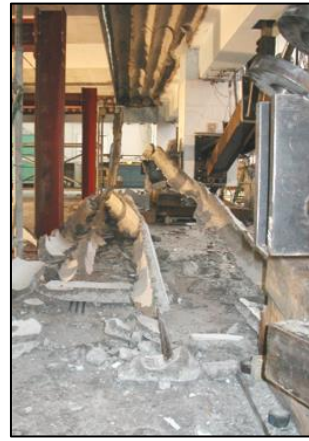
(b) Collapse of the bottom part of the alpha unit at 2.5% drift [8].
