FUNCTIONAL RECOVERY OF BUILDINGS FOR SEISMIC RESILIENCE OF COMMUNITIES: LESSONS FROM THE 2024 HUALIEN, TAIWAN EARTHQUAKE

**Alice Chang-Richards¹, Ke Jiang², Julian Rincon³,
Alex Shegay⁴, Julian Benito⁵, Bo-yao Lee⁶, Tomomi Suzuki⁷,
Jonathan Monical⁸, Tsung-Chih Chiou⁹, Lucas Hogan¹⁰
and Joe Byrne¹¹**

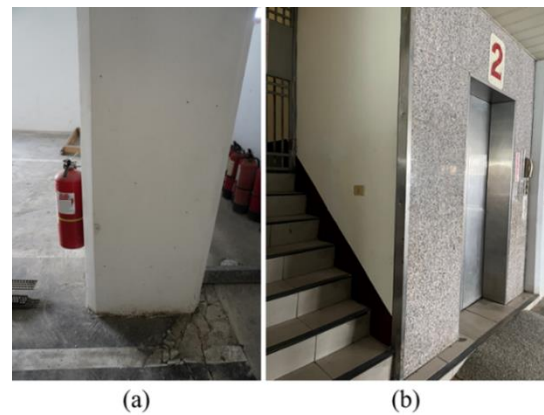
Figure 8: (a) manual fire extinguishers and (b) functional elevator post-earthquake in Building S03.

Such predictions were produced based on the default assumption of non-structural elements in SP3. Those defaults assumed that the building had non-anchored non-structural components that were not seismically pre-qualified. In addition to the fire system reported above, the elevator in this building sustained little damage and remained functional after the earthquake (see Figure 8b).

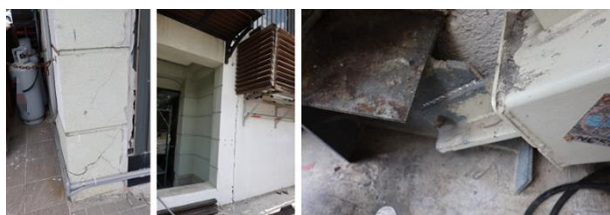
The PGA experienced at the building's location was recorded as 0.44g. The building showed relatively good performance following the earthquake and had no placard (i.e., green placard for the purpose of this paper). However, minor structural damage was observed. As shown in Figure 12, some welds connecting the BRB to the steel gusset frames fractured during the earthquake. There was also minor damage at the seismic gap between Buildings A11-1 and A11-2. Minor cracking was observed in the cladding surrounding the concrete columns at the base of the exterior columns.

Figure 12: Observed damage to Building A11.

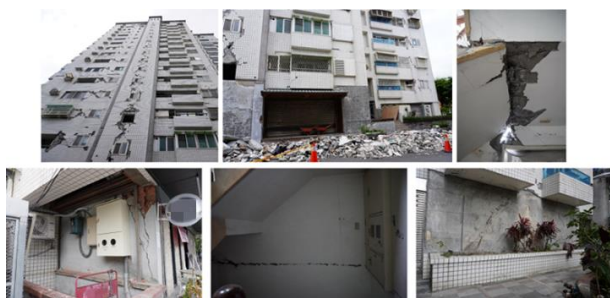
Damage to the building was extensive but seemed repairable. Distributed shear failures were observed in walls and columns between the ground floor and the floor above. Shear failure was observed in the exterior concrete partition walls at all levels of the building. Sliding failures were also observed in the shear walls of some stairwells, making egress difficult. Moreover, large cracks were seen in the diaphragm at locations where walls terminated on the second floor due to the transfer of forces to the columns.

Non-structural damage was also observed. There was damage to URM partitions around the openings on the ground floor. Falling hazards from exterior tiles were a major concern for households and foot traffic. Shear failure was also observed on the masonry infill walls at the ground floor. Three of four elevators were damaged and inoperable. Water pipes were broken, and there were water leaks. Figure 14 shows instances of the observed damage to the building. Several other tall residential buildings nearby sustained only minor damage compared to Building D13; however, the explanation for this has not been established.

Figure 14: Observed damage to Building D13.

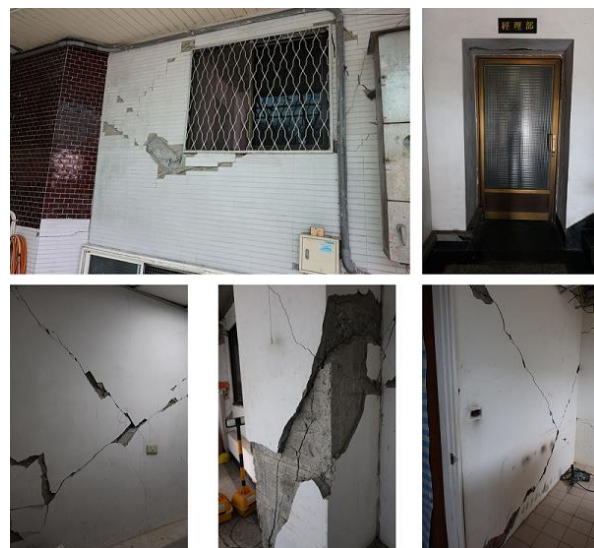
The PGA experienced at the building's location was recorded as 0.44g. The building was occupied after the earthquake, and at the time of reconnaissance, despite slight to moderate structural damage being observed. The building was officially assigned a yellow placard. As shown in Figure 16, shear failure of one column was observed. There were visible cracks in the masonry infill walls, especially around the south corner of the building. There were also visible cracks at the base of columns around openings of the RC shear walls along the y-axis.

Utilities functioned continuously after the earthquake. However, several non-structural elements suffered some damage: URM partitions, doors, and concrete infill walls. Water pipes were damaged in the aftershocks, leading to water leaks. One elevator was damaged. However, the damage observed did not affect the continued use of the building. After the earthquake, the building owner decided to strengthen the building by adding shear walls and expanding the ground-floor columns. The building remained operational while undergoing staged strengthening.

Figure 16: Observed damage to Building D10.

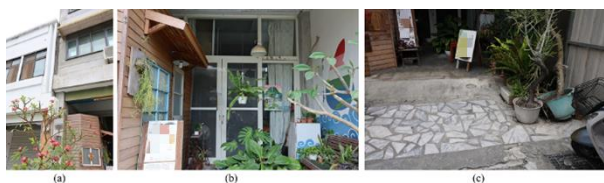
The PGA experienced at the building's location was recorded as 0.44g. The reconnaissance records indicate that building C04 sustained moderate damage. The building was assigned a yellow placard. Figure 18a–c presents various types of damage observed. The building was safe for occupancy following the earthquake, but it tilted towards the adjacent eight-storey building due to foundation damage caused by ground settlement beneath the eight-storey building, as shown in Figure 17d. There was also minor pounding damage to a similar height building on the opposite side, as shown in Figure 17a. Permanent building rotation was observed with a 50mm permanent roof drift. As shown in Figure 18b, the front door was jammed, which suggests storey drifts in addition to overall rotation of the building. Furthermore, damage to the rooftop water tank was reported.

Repair of the building will require re-levelling. However, access to the tilted side of the building would be extremely difficult, as shown in Figure 18a. The building owner had covered the yellow placard on the front door to address concerns expressed by shop customers about the building's safety. It was reported that the building would be righted after the Mid-Autumn Festival on October 6, 2024, 6 months after the earthquake, due to the time required to mobilise engineers and contractors.

Figure 18: (a) pounding damage to the adjacent building, (b) door jamming, and (c) pavement cracks and content damage.

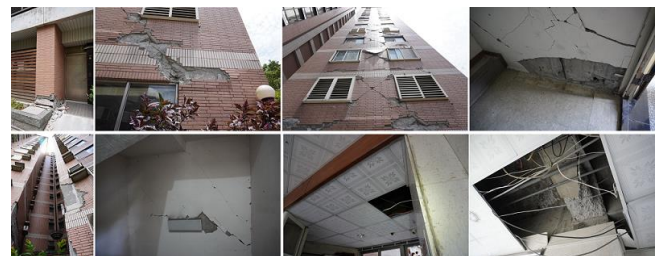
The PGA experienced at the building's location was recorded as 0.41g. Building O67 showed a poor seismic performance following the earthquake. It was assigned a red placard. All 118 households had vacated the building. As shown in Figure 20, structural damage included shear failure of an RC wall in the staircase, shear failure of beams, shear failure of RC exterior partition infill walls above the second floor, and shear failure of hanging walls with a horizontal reinforcement fracture. Damage to several non-structural elements included damage to interior suspended ceiling panels. There were large diagonal cracks in the exterior tiles due to damage to the exterior concrete infills, creating a considerable falling hazard. The building manager had shut down power and water, but there was no reported disruption to the utility supply.

Figure 20: Observed damage to Building O67.
