PERFORMANCE EVALUATION AND COST ASSESSMENT OF WEAK-STORY RETROFITS IN RC BUILDINGS SURVEYED AFTER THE 2024 HUALIEN EARTHQUAKE

Jonathan Monical¹, Alex Shegay², Tomomi Suzuki³,
Tsung Chih Chiou⁴, H. Huseyin Aydoğdu⁵, Lucas S. Hogan⁶,
Zhuoran Yi⁷, Julian Benito⁸, Julian Rincon⁹ and Min Lang Lin¹⁰

ABSTRACT

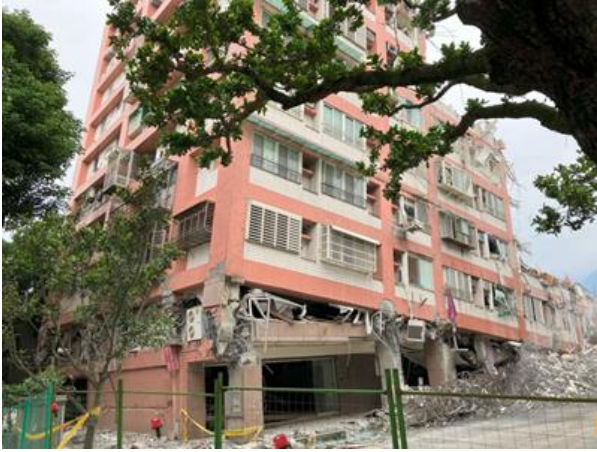
Figure 1: Demolition of a partially collapsed residential building in Hualien City.

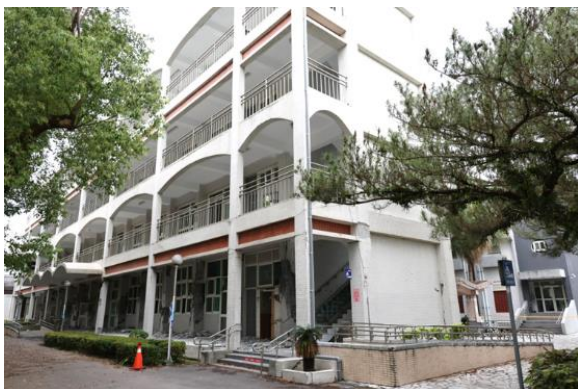
Figure 11: Building S01 without retrofitting.
Note: Figure is taken from Shegay [10].

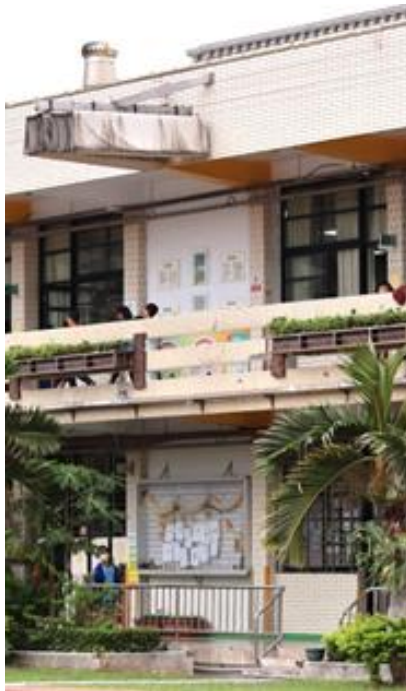
Figure 16: RC shear walls added to Building C43.

Retrofitting applied to Building C43 consisted of six 25 cm-thick, 3-m long RC shear walls added to bays running along the x-axis in first and second stories and eight RC shear walls with the same dimensions added to bays along x-axis in basement (Figure 16). Walls increased lateral stiffness and lateral strength in x-direction to become more comparable to y-direction.

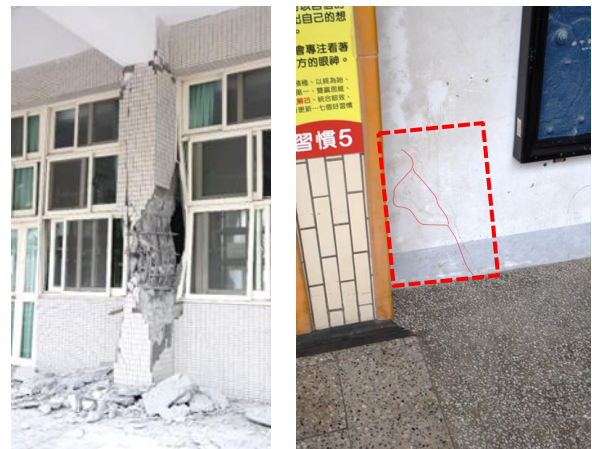
Building S01 suffered severe earthquake damage while Building C43 suffered only minor damage. Building S01 had shear failures with subsequent axial failures in most columns located next to windows (captive columns) as seen in Figure 20. Building C43 was observed to have much less damage consisting of small, inclined cracking in RC shear walls (Figure 21).

Figure 20: Shear and axial failure of typical column in Building S01. (Source: Shegay [10])

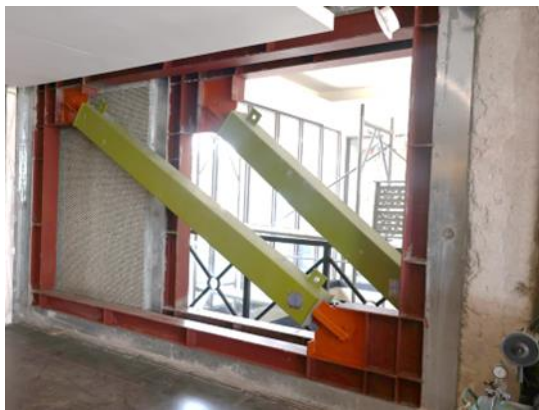
Figure 26: Steel braces added to Buildings A11-1 and A11-2.

Retrofitting applied to Building A11 consisted of installing steel frames with buckling-restrained braces along both building directions to first story only (Figure 26). One bay had braces added to stories 1-4. Steel frames with braces mitigated seismic vulnerability by reducing torsional response and increasing lateral strength and stiffness.

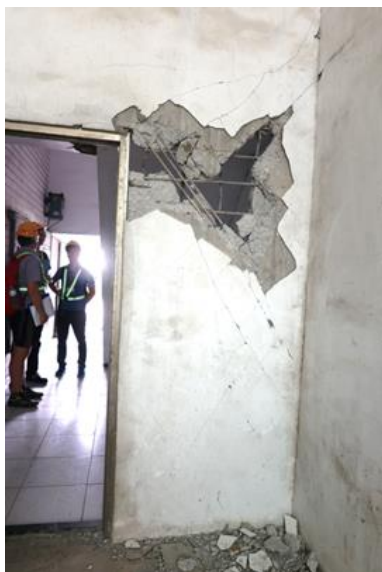
In the weaker and more flexible x-direction of Building C05, shear failure occurred in the single RC shear wall (Figure 28). This wall was located adjacent to a door opening increasing its vulnerability. In the stronger y-direction of the building, small, inclined cracks were observed in RC shear walls and minor concrete spalling occurred at joints of stairs. Masonry infill walls in the y-direction had moderate to severe damage but did not collapse (Figure 29).

Figure 28: Shear failure in RC shear wall of Building C05.

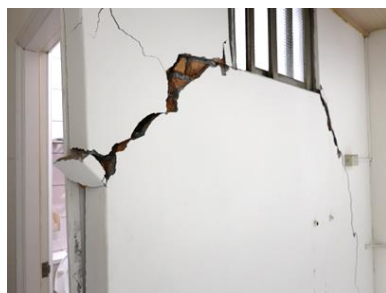
Figure 29: Large inclined cracks in masonry walls of Building C05.

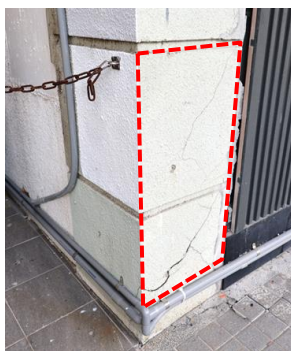
Building A11 was observed to have minor damage consisting of small, inclined cracking on exterior columns (Figure 30). Additional cracking and damage at the seismic joint may have been caused by pounding between Buildings A11-1 and A11-2 (Figure 31).

Figure 30: Inclined cracks at base of exterior column of Building A11-1.

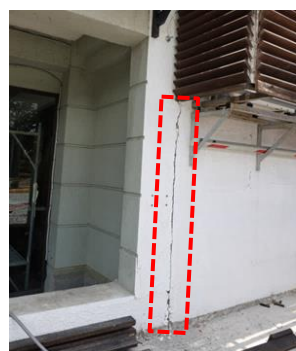
Figure 31: Cracking at seismic joint between Buildings A11-1, A11-2.

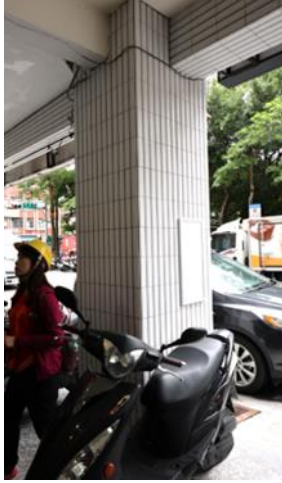
Figure 37: Exterior column with RC jacketing.

stiffness and strength consisted of RC shear walls and RC column jacketing. Wall retrofits included a 30 cm-thick, 2.4 m-long RC shear wall added to the first story and 12 cm-thick, 2.4 m-long RC shear walls added to stories 2-4 oriented along the x-axis. Column retrofits included RC column jacketing applied to boundary columns of the additional shear wall added to first story (Figure 37) and exterior columns of stories 1-2.

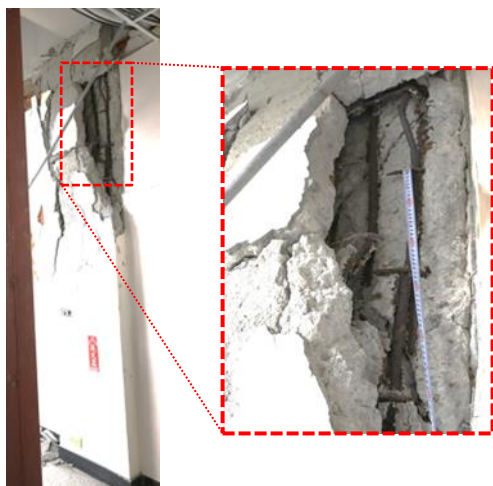
After the earthquake, Building E35 had one column with axial failure and two columns with shear failures (Figure 41). Steel columns were used to shore the soffit of the second level floor slab around the column with axial failure which showed signs of severe corrosion and significant section loss for both longitudinal and transverse reinforcement. Masonry infill walls were observed to have inclined cracks wider than 1 mm. The building was evacuated except for the bank located on the first floor which operated one hour in the morning and one hour in the afternoon.

Figure 41: Axial failure of column consisting of buckling of longitudinal reinforcing bars in Building E35.

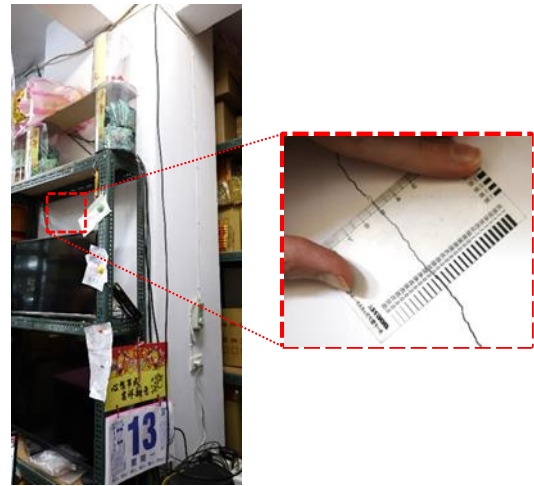
Building E36 was observed to have minor damage consisting of 0.5-mm wide inclined cracks observed in columns with RC jacketing serving as boundary columns for the retrofitted shear wall in the first story (Figure 42). No disruption to commercial or residential units was observed or reported.

Figure 42: Boundary column of added shear wall with RC jacketing and 0.5-mm wide shear cracks in Building E36.
