IMPACTS OF SURFACE FAULT RUPTURE ON RESIDENTIAL STRUCTURES DURING THE 2016 M_w 7.8 KAIKŌURA EARTHQUAKE, NEW ZEALAND

Russ J. Van Dissen¹, Timothy Stahl², Andrew King³, Jarg R. Pettinga⁴, Clark Fenton⁵, Timothy A. Little⁶, Nicola J. Litchfield⁷, Mark W. Stirling⁸, Robert M. Langridge⁹, Andrew Nicol¹⁰, Jesse Kears¹¹, David J. A. Barrell¹² and Pillar Villamor¹³

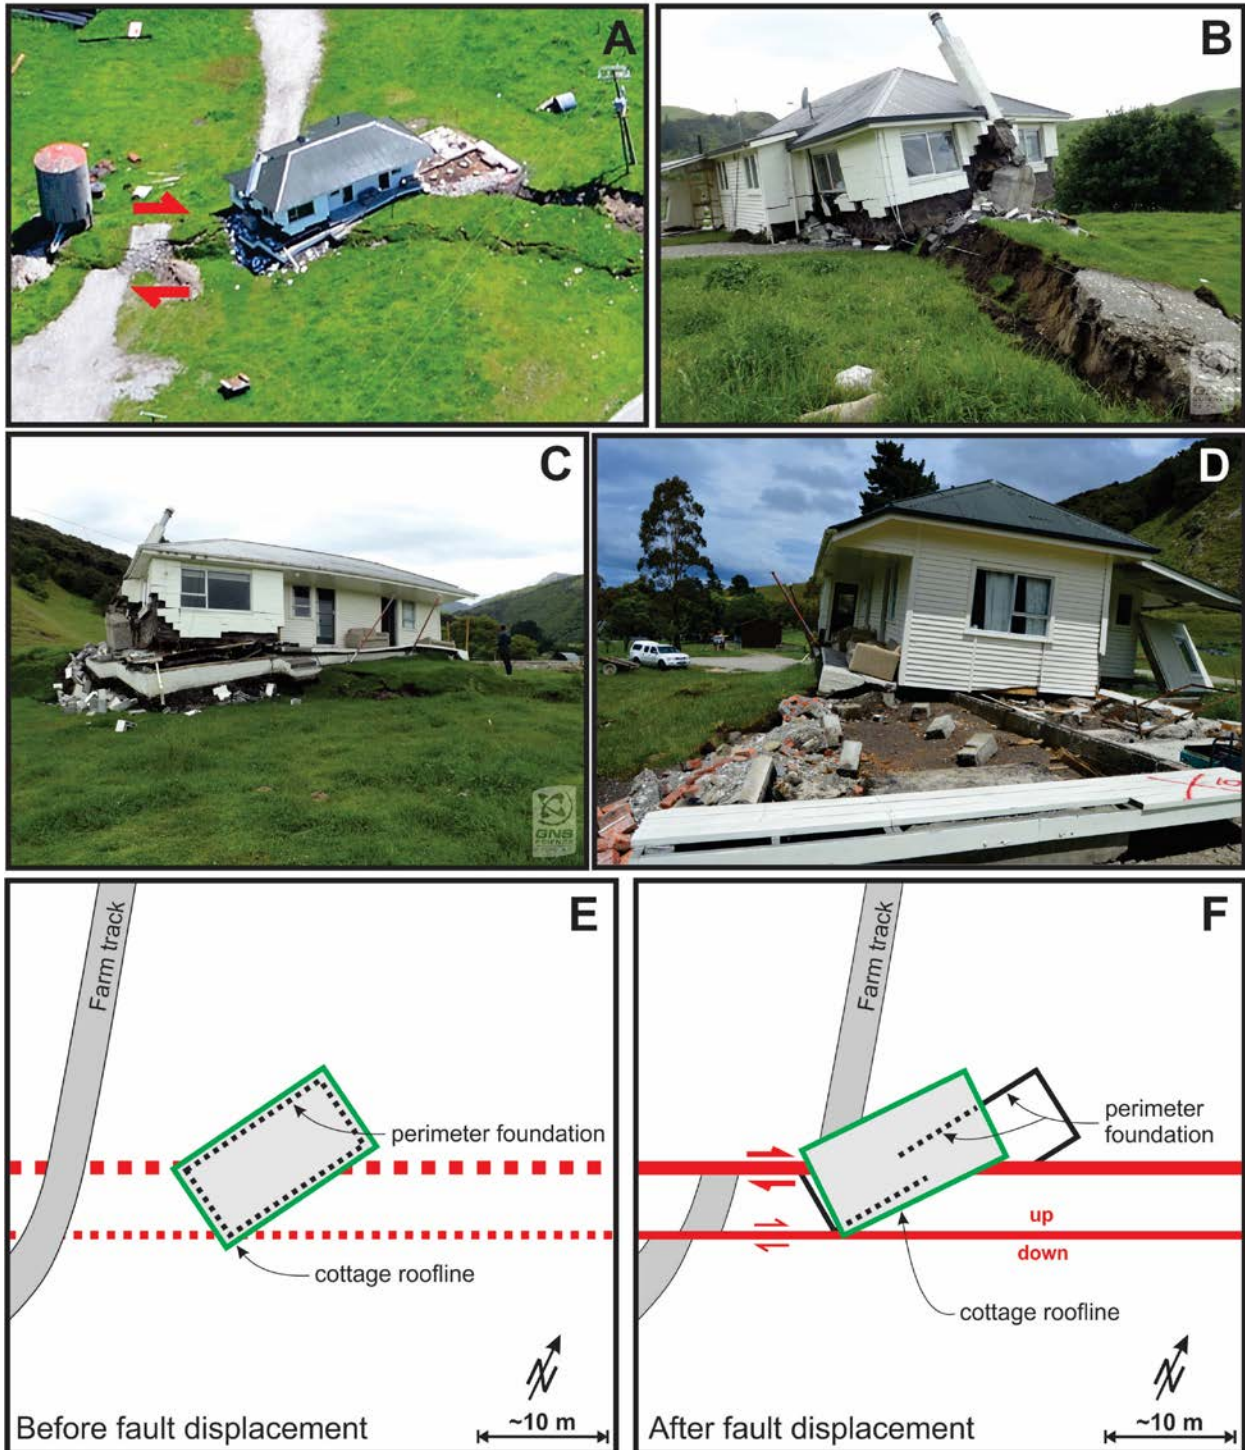
Approximately 10 m of discrete (i.e., concentrated – as opposed to distributed) horizontal and 1-2 m vertical surface fault rupture displacement extended through the foot-print of Bluff Cottage on the Kekerengu Fault (Figure 3) [18]. Offset fence lines within ~450 m either side of the cottage also document lateral displacements of ~10-11 m and narrow fault deformation zone widths (Figures 2 & 4). The foundation of Bluff Cottage was cut in half and displaced by fault rupture. The superstructure of the house was low mass, flexible, regular in shape, timber floored and relatively weakly attached to the foundation. These properties allowed the superstructure to detach from the mainly laterally displacing foundation, and to isolate it from the extreme ground deformation taking place beneath. The house suffered severe structural damage, but it did not collapse. From a life-safety perspective, and considering the large displacement and small fault zone width at this site (i.e., metre-scale strike-slip displacements and shear strains in the order of 10⁰; Table 2), this house performed admirably.

Figure 3: Bluff Cottage and Kekerengu Fault surface rupture; see Figure 1 for location (Lat: -41.9796, Long: 173.9976). (A) Oblique aerial view looking northwest. Red arrows show the sense of slip of the Kekerengu Fault that generated ~10 m of right-lateral surface rupture displacement at this locality. Photo by Dougal Townsend taken in November 2016. (B) View of Bluff Cottage looking northeast along the strike of the surface rupture of the Kekerengu Fault. Right-laterally offset farm track to left of cottage in Figure 3A is the same farm track visible in lower right and middle left of Figure 3B. Photo by Nicola Litchfield taken in November 2016. (C) View looking northwest. Photo by Nicola Litchfield taken in November 2016. (D) View looking southwest. Note that the concrete perimeter foundation and piles that were once under the cottage have now been torn from the superstructure of the cottage and laterally displaced towards the viewer relative to the cottage. Photo by Robert Zinke taken in November 2016. (E) Schematic map of Bluff Cottage and farm track prior to surface rupture of the Kekerengu Fault. (F) Schematic map of Bluff Cottage and farm track after fault displacement.

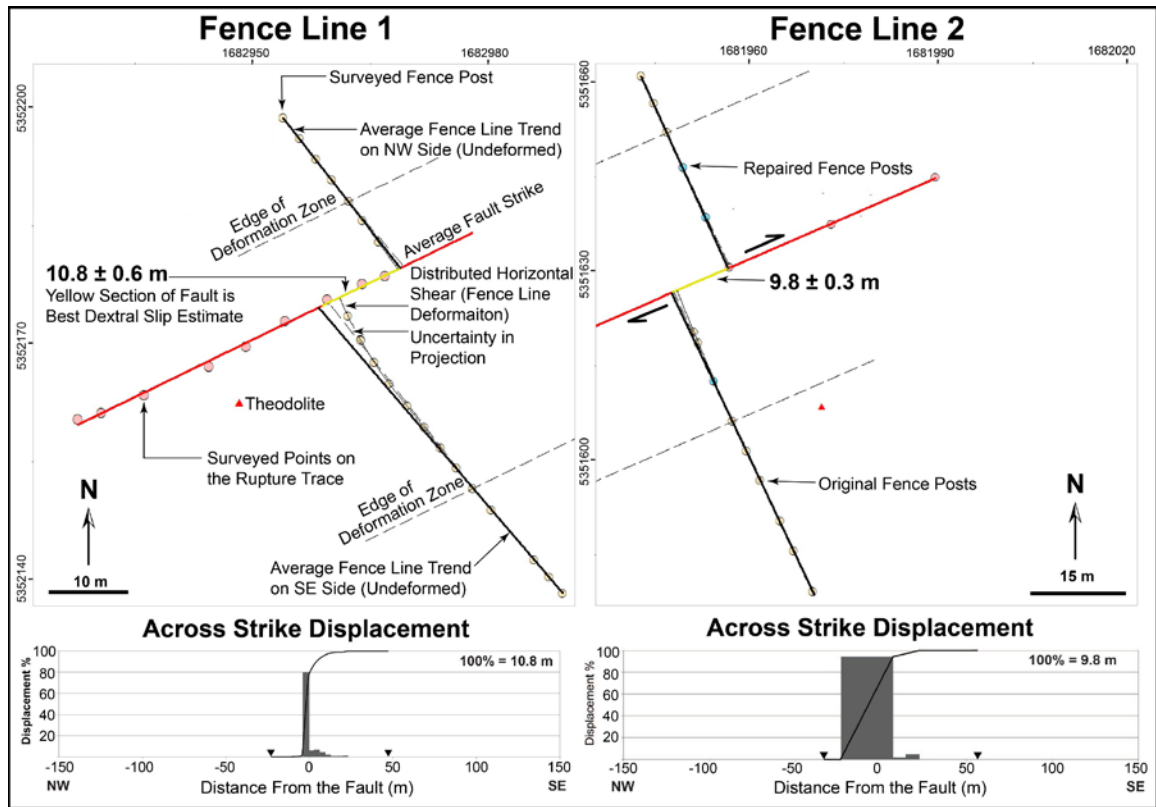
Figure 4: Examples of fence line displacements along the Kekerengu Fault near Bluff Cottage documenting both the amount of right-lateral displacement, and how that displacement is distributed as a function of distance perpendicular to fault strike (see Kearse et al. [18] for more detail). See Figure 2 for locations. Coordinates are New Zealand Transvers Mercator 2000.

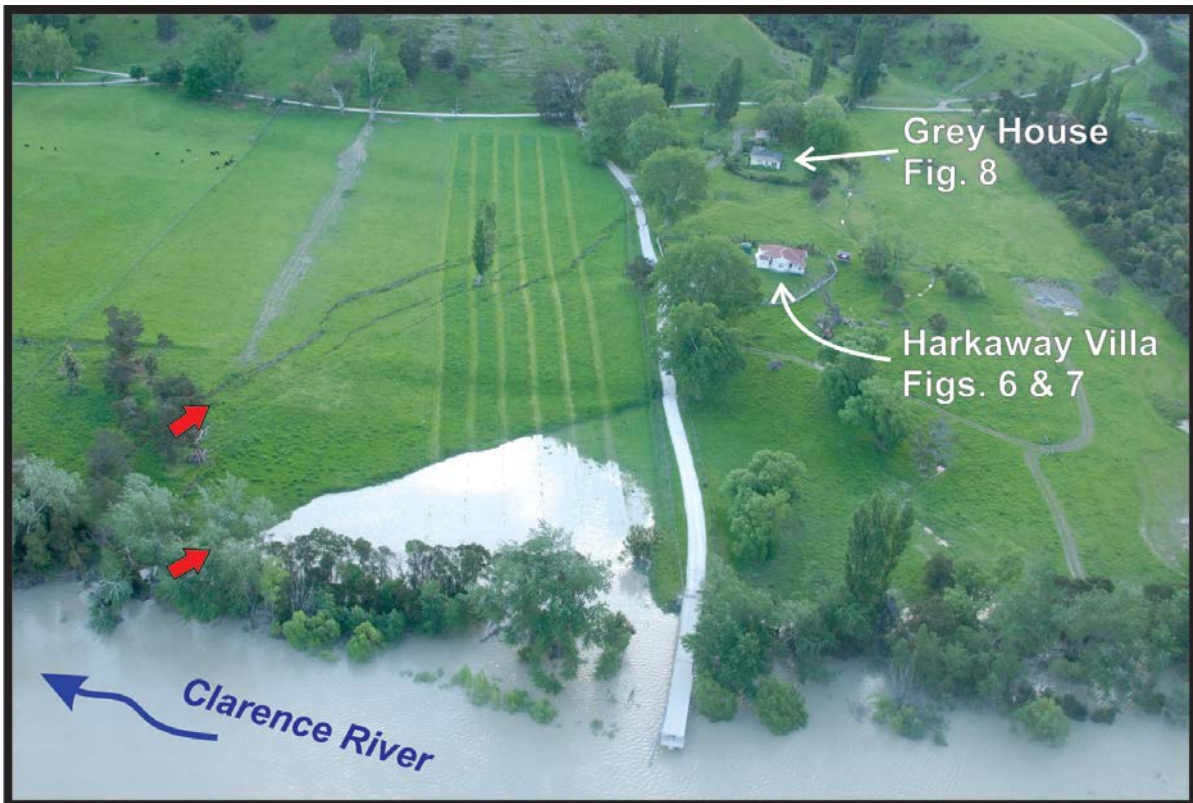
Figure 5: Harkaway Villa (Lat: -42.1105, Long: 173.8384), Grey House (Lat: -42.1105, Long: 173.8372), and the Papatea Fault surface rupture; see Figure 1 for location. Oblique aerial view looking west with red arrows denoting position of prominent discrete ruptures in the surface rupture deformation zone of the Papatea Fault. Photo by Will Ries taken in November 2016.

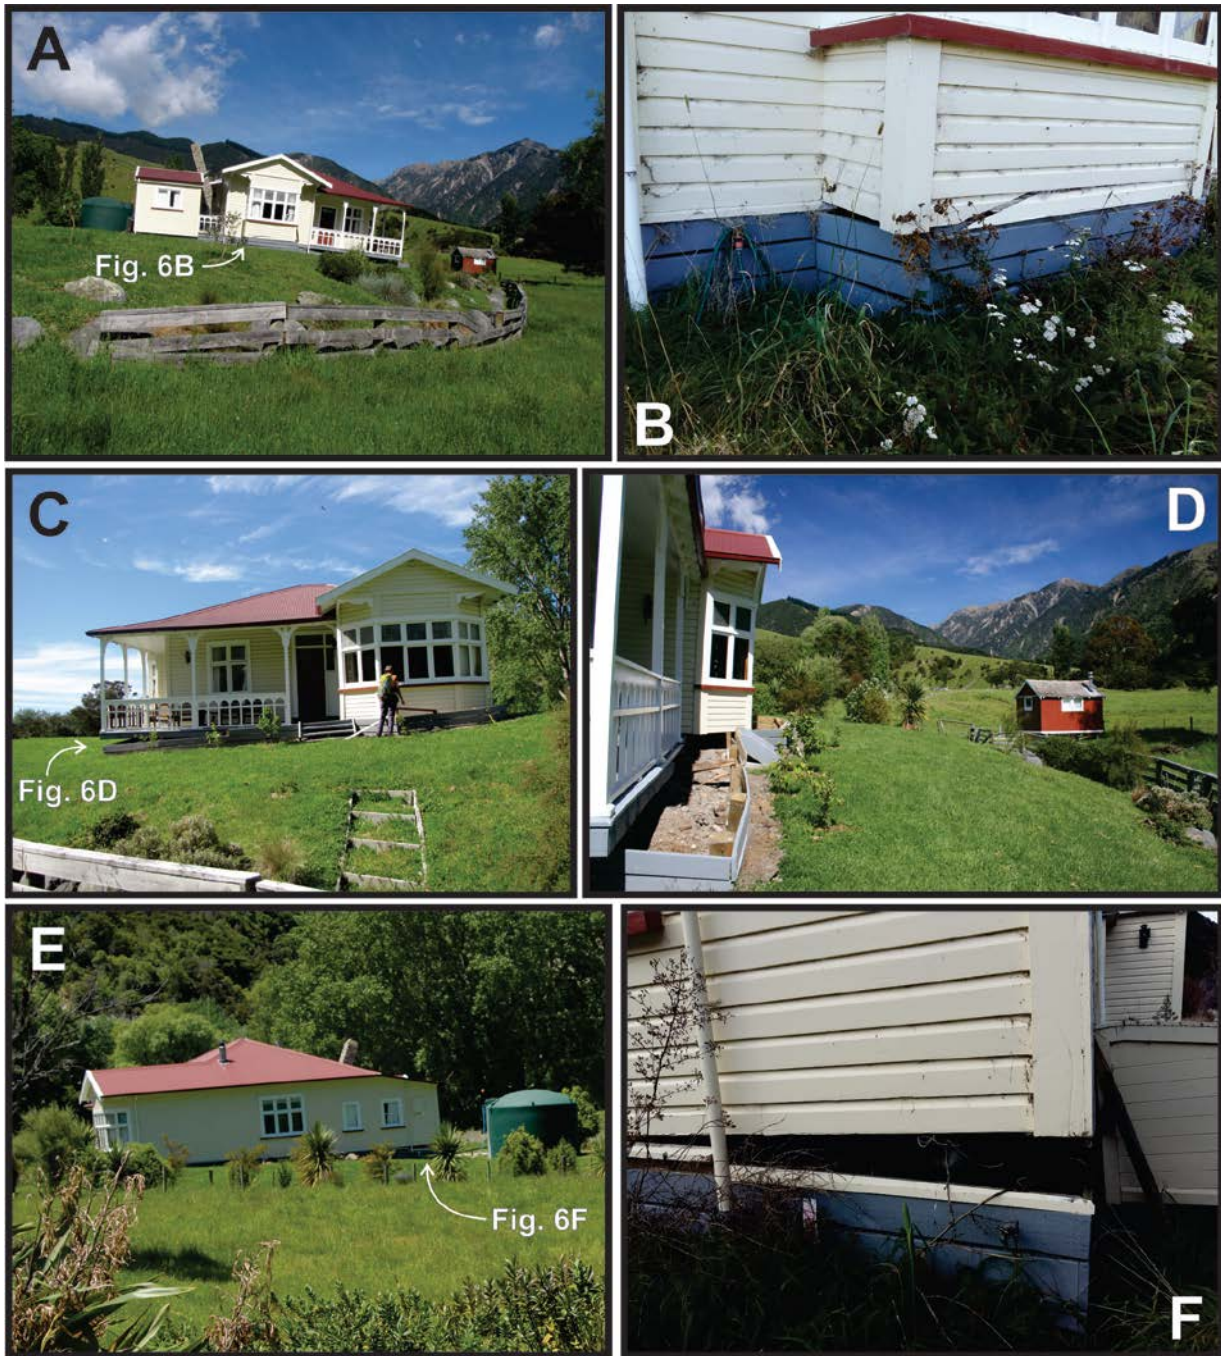
Harkaway Villa is located within the surface rupture deformation zone of the Papatea Fault which, at this site, is ~90 m wide, comprising both discrete fault rupture and distributed deformation, and accommodating ~5 m of vertical deformation (reverse, SW side up) and a comparable (or lesser) amount of left-lateral horizontal slip (Figures 5-7) [19]. The villa is situated ~200 m west from the true-right bank of the Clarence River on the hanging-wall side (SW side) of the Papatea Fault in the hinge zone between the higher vertical displacement gradient fold/fault scarp to the NE and the lower vertical displacement gradient “back limb” to the SW (Figure 7). The ground encompassed by the foot-print of the structure experienced decimetre-scale folding, horizontal sinistral flexure (i.e., fault drag), and up to ~80 cm of distributed N-S oriented extension (Figures 6 & 7). The villa was also tilted ~5° in a down to the NE sense. Fortunately, the superstructure of the house is low mass, flexible, regular in shape, timber floored and relatively weakly attached to the pile foundation, all of which allowed the superstructure to detach from the foundation thus isolating much of the ground extension from the superstructure. Despite this house suffering damage significant enough to be “red tagged”, it - from a life-safety perspective - performed commendably. It experienced very strong ground shaking, local decimetre-scale surface fault rupture deformation and is located within the hinge zone of a reverse fault scarp that has been classified in other earthquakes as a zone of ‘severe building damage’ [20], yet the villa did not collapse. And, not only did the villa not collapse, it appears that it could potentially be re-piled and re-levelled, suggesting the possibility of post-event reinstatement (as opposed to demolition and reconstruction).

Figure 6: Harkaway Villa and Papatea Fault surface rupture. (A) View looking west showing northeastward tilt of the villa on the upthrown (hanging-wall) side of the Papatea Fault. Photo by Julie Rowland taken in November 2016. (B) View looking northwest showing detail of damage to the east-side of the villa. Photo by Julian Garcia-Mayordomo taken about 18 months after the 2016 Kaikōura earthquake. (C) View looking south of the north-side of the villa. Photo by Rob Langridge taken in November 2016. (D) View looking west of the north-side of the villa showing offset of the foundation piles from the superstructure. Photo by Julie Rowland taken in November 2016. (E) View looking east of the west-side of Harkaway Villa. Photo by Rob Langridge taken in November 2016. (F) View looking east showing detail of damage to the west-side of the villa. Photo by Julian Garcia-Mayordomo taken in May 2018.

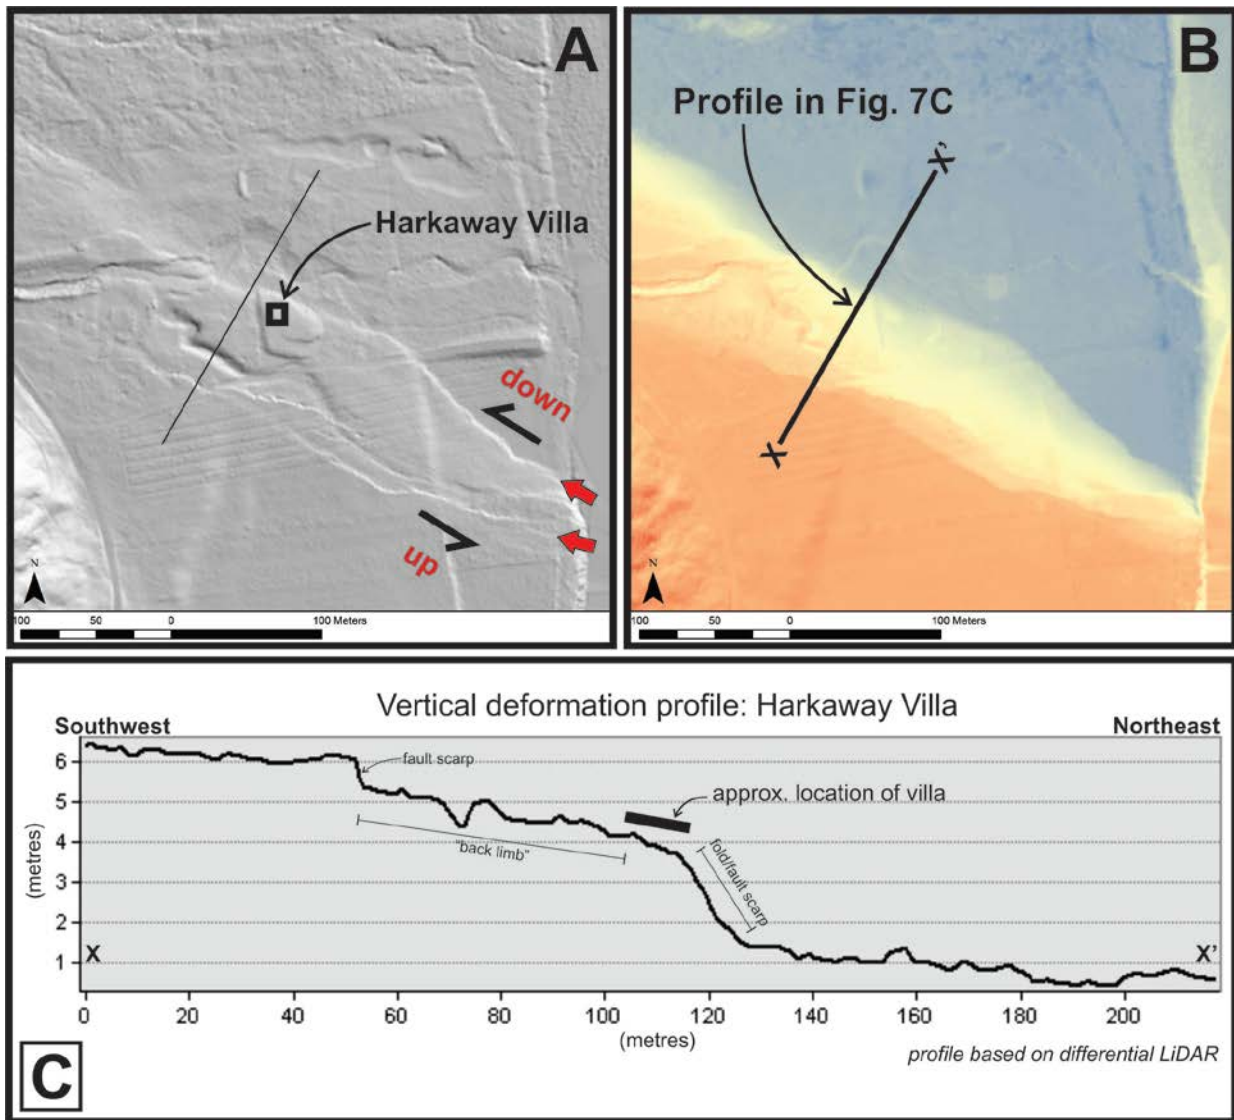
As stated above, and illustrated in Figure 7, Harkaway Villa is located in the transition zone between the higher strain fold/fault scarp to the NE and the lower strain “back limb” to the SW. Utilising a combination of field observations, a differential Light Detecting and Ranging (LiDAR) digital elevation model (DEM; 2013 LiDAR subtracted from post-earthquake 2016 LiDAR) at the site (Figures 7B & 7C), and assuming simple shear, ground strains at the villa site can be approximated.

At the steepest portion of the fold/fault scarp region to the NE of the villa, dip-slip shear strains of ~ 0.2 - 0.4 can be derived

based on ~ 1.5 m of elevation gain over 7 m of fault-perpendicular horizontal distance (Figure 7C), an estimated/observed fault dip of 45° - 90° [19], and assuming simple shear. Strike-slip shear strains of ≤ 0.2 can be estimated based on an observed horizontal to vertical ratio of displacement of ≤ 1 [19], ~ 1.5 m of elevation gain over 7 m of fault-perpendicular horizontal distance, and assuming simple shear. Based on the above dip-slip and strike-slip shear strain considerations, net shear strains oriented parallel to the plane of the fault of ~ 0.2 - 0.4 (rounded to 10^{-1}) are approximated in the region of the fold/fault scarp.

Figure 7: Harkaway Villa and Papatea Fault surface rupture. (A) 2016 post-earthquake LiDAR hill shade DEM with black square denoting villa's location, and red arrows showing location of prominent discrete ground surface ruptures. (B) Differential LiDAR DEM with blue colours denoting little vertical change and red colours denoting significant positive vertical change (see Figure 7C for more detail regarding scale). (C) Vertical deformation profile derived from the differential LiDAR DEM. Vertical exaggeration = 7.5.

In the “back limb” area, dip-slip shear strains of ~ 0.02 - 0.04 can be estimated based on ~ 1 m of elevation gain over 50 m of fault-perpendicular horizontal distance (Figure 7C), an estimated/observed fault dip of 45° - 90° [19], and assuming simple shear. Strike-slip shear strains of ≤ 0.02 can be estimated based on an observed horizontal to vertical ratio of displacement of ≤ 1 [19], ~ 1 m of elevation gain over 50 m of fault-perpendicular horizontal distance, and assuming simple shear. In the “back limb” area, and based on the above dip-slip and strike-slip shear strain considerations, net shear strains oriented parallel to the fault plane of approximately 0.02 - 0.04 (rounded to 10^{-2}) are estimated.

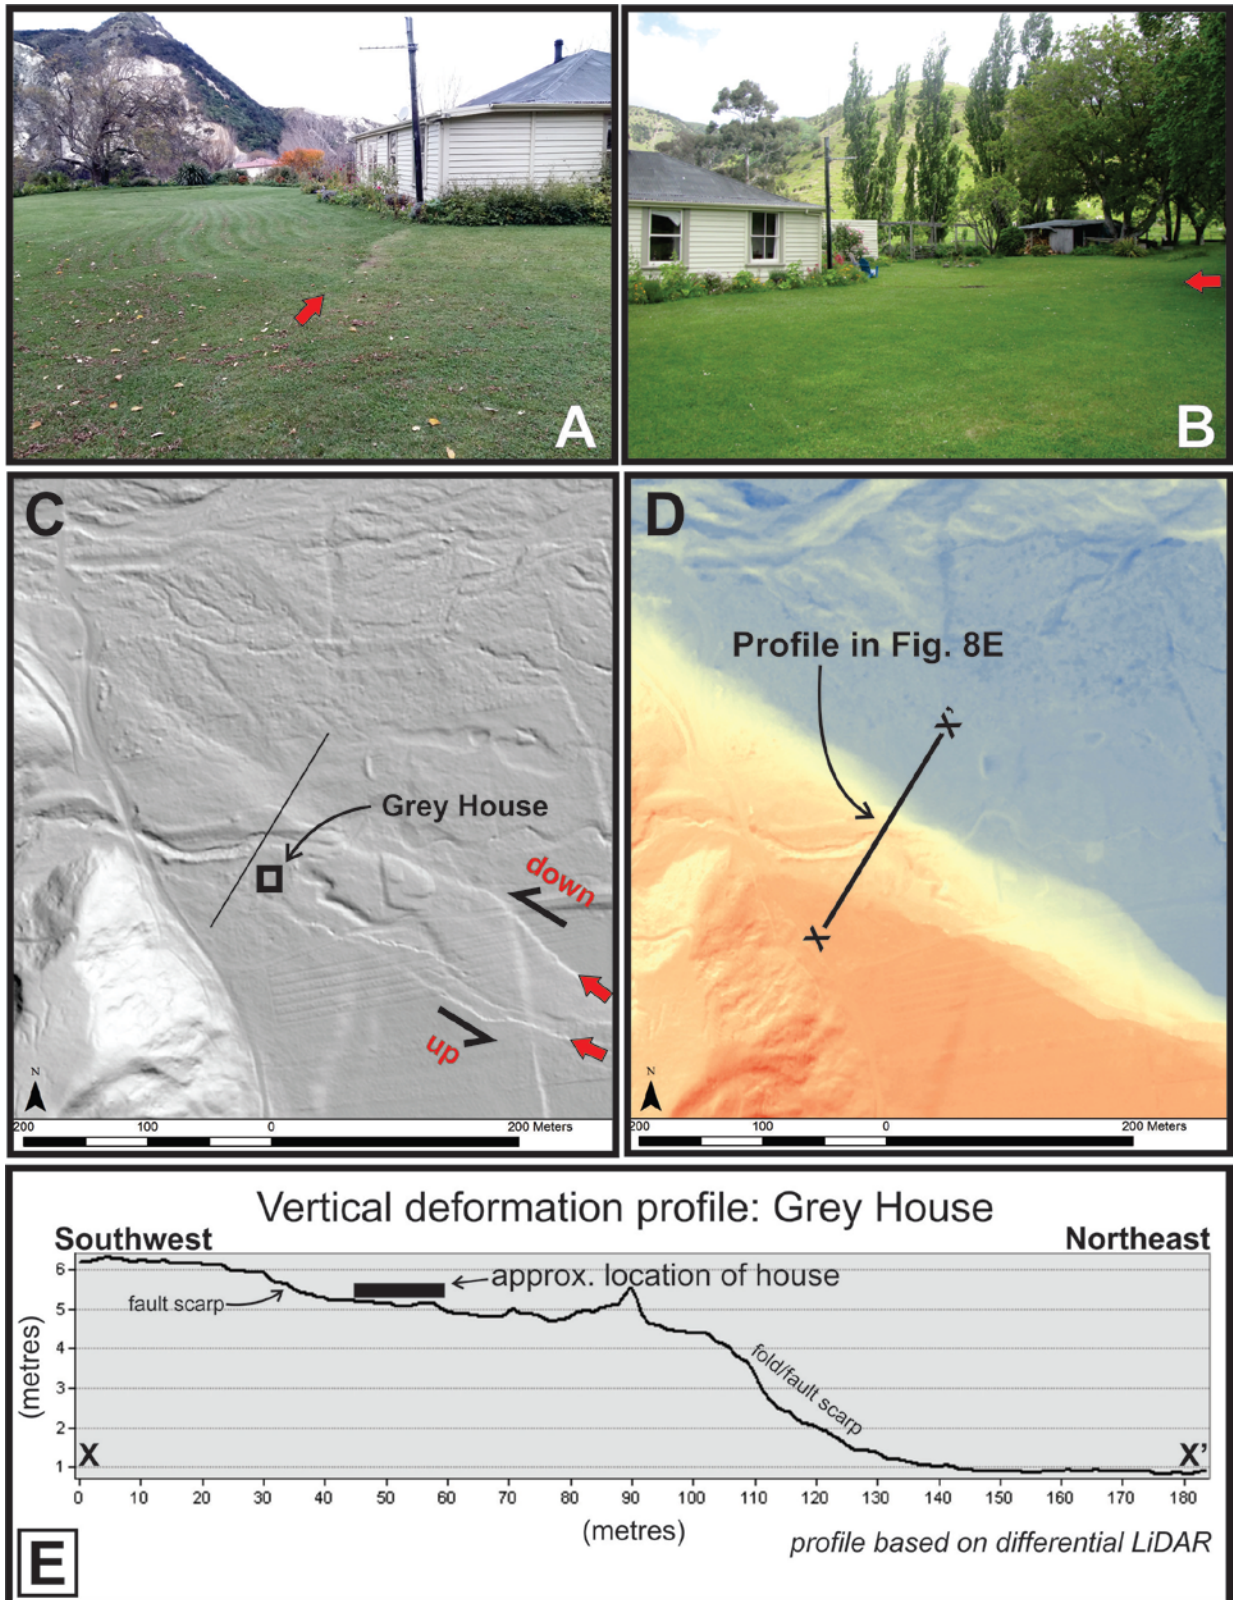
Figure 8: Grey House and Papatea Fault surface rupture. (A) View looking east-southeast with red arrow showing location of centimetre-scale discrete rupture that intersects northwest corner of the house. Harkaway Villa (Figures 5 & 6) is visible in the middle distance. Photo by Julia Garcia-Dayomo taken about 18 months after the 2016 Kaikōura earthquake. (B) View looking southwest. Red arrow denotes the location of centimetre-scale discrete rupture that intersects the northwest corner of the house. (C) 2016 post-earthquake LiDAR hill shade DEM with the black square denoting the house's location, and red arrows showing the location of prominent discrete ground surface ruptures. (D) Differential LiDAR DEM with blue colours denoting little vertical change and red colours denoting significant positive vertical change (see Figure 8E for more detail regarding scale). (E) Vertical deformation profile derived from the differential LiDAR DEM. Vertical exaggeration = 6.4.

Fault. At this locality, the Papatea Fault accommodates approximately 6 m of vertical deformation (reverse, SW side up), and a comparable (or lesser) amount of left-lateral horizontal slip [19], and defines an ~100+ m wide surface fault rupture deformation zone comprising both discrete fault rupture and distributed deformation (Figure 8). The house is located on the hanging-wall side (SW side) of the Papatea Fault with metre-scale surface fault rupture passing within ~45 m NE of the house, metre- to decimetre-scale surface fault rupture passing within ~10 m SW of the house, and centimetre-scale surface fault rupture intersecting the foot-print of the house (Figures 8A & 8B). Nevertheless, the house came through the earthquake in good shape. It did not suffer significant structural damage, and following the earthquake it was adjudged suitable for habitation, and is currently occupied. In addition, the house is located within a portion of the surface rupture deformation zone that experienced minimal tilt, and this too no doubt facilitated post-event occupation.

Utilising a combination of field observations, a differential LiDAR DEM at the site (Figures 8D & 8E), and assuming simple shear, ground strains at the Grey House site can be approximated. At the location of the house, dip-slip shear strains of ~0.02-0.03 can be estimated based on ~0.5 m of elevation gain over 25 m of fault-perpendicular horizontal distance (Figure 8E), an estimated/observed fault dip of 45°-90° [19], and assuming simple shear. Strike-slip shear strains of ≤ 0.02 can be estimated based on an observed horizontal to vertical ratio of displacement of ≤ 1 [19], ~0.5 m of elevation gain over 25 m of fault-perpendicular horizontal distance, and assuming simple shear. Based on the above dip-slip and strike-slip shear strain considerations, net shear strains oriented parallel to the fault plane of ~0.03-0.04 (rounded to 10^{-2} ; Table 2) are approximated at the Grey House site.

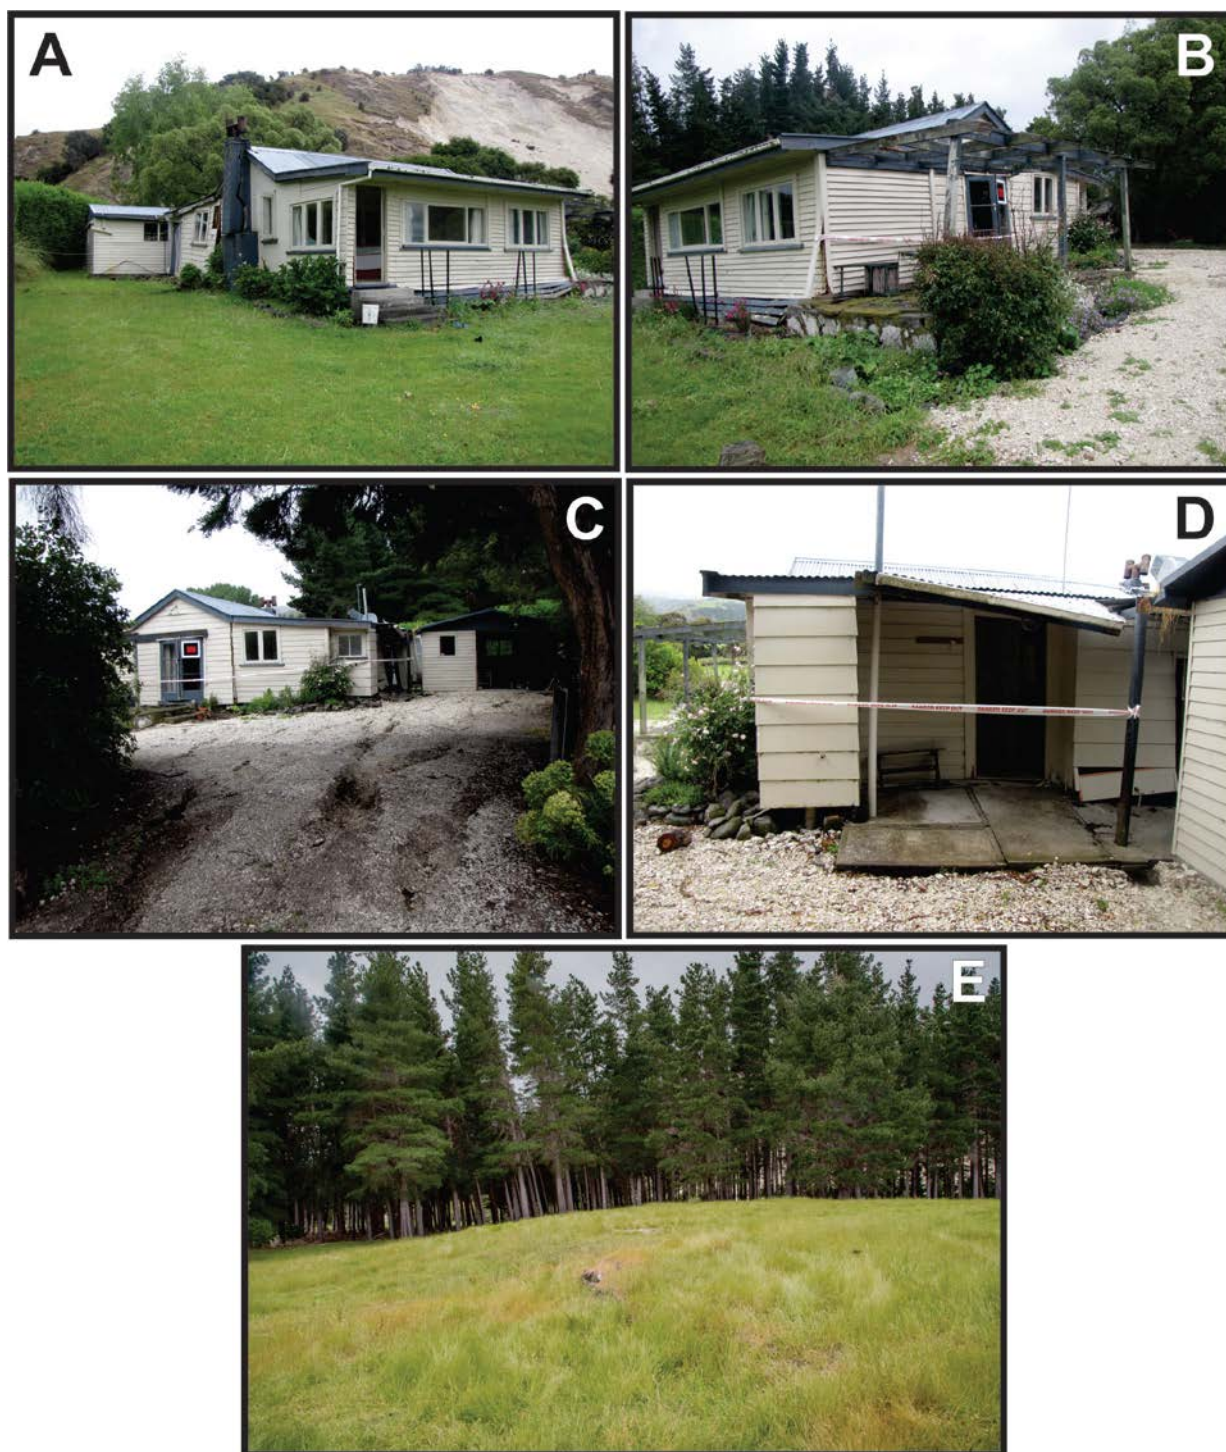
Middle Hill Cottage was located within the surface rupture deformation zone of the Papatea Fault which, at this site, is ~100 m wide, comprising both discrete fault rupture and distributed deformation, and accommodating ~7.5 m of vertical deformation (reverse, W side up) and a comparable (or lesser) amount of left-lateral horizontal slip (Figures 9 & 10) [19]. The Cottage was located on the hanging-wall side of the Papatea Fault, close to the crest of the broad fold/fault scarp that is cut by extensional fissures (Figure 9C). The ground encompassed by the foot-print of the structure experienced decimetre-scale folding, horizontal sinistral flexure (i.e., fault drag), tilting, and distributed E-W oriented extension. As a result of the Kaikōura earthquake, this house suffered damage significant enough to be “red tagged”, and it has since been demolished. However, from a life-safety perspective, this house performed creditably - it experienced very strong ground shaking, tilting and decimetre-scale surface fault rupture deformation, but it did not collapse.

Figure 9: Middle Hill Cottage and Papatea Fault surface rupture; see Figure 1 for location (Lat: -42.1536, Long: 173.8667).

(A) View looking west. Photo by Rob Langridge taken in December 2016. View looking south-southwest. Photo by Rob Langridge, December 2016. (C) View looking southeast along the strike of extensional fissures located in the crestal region of the primary fold/fault scarp that extend towards, and intersect, the cottage. Photo by Rob Langridge, December 2016. (D) View looking northeast. Photo by Rob Langridge, December 2016. (E) View from the cottage looking south-southeast along strike of the Papatea Fault's surface rupture deformation zone. Prior to the 2016 rupture of the Papatea Fault, the ground surface in this photograph was approximately flat and horizontal, and the trunks of the pine trees were all sub-vertical. Photo taken about a year after the earthquake by Stefano Pucci.

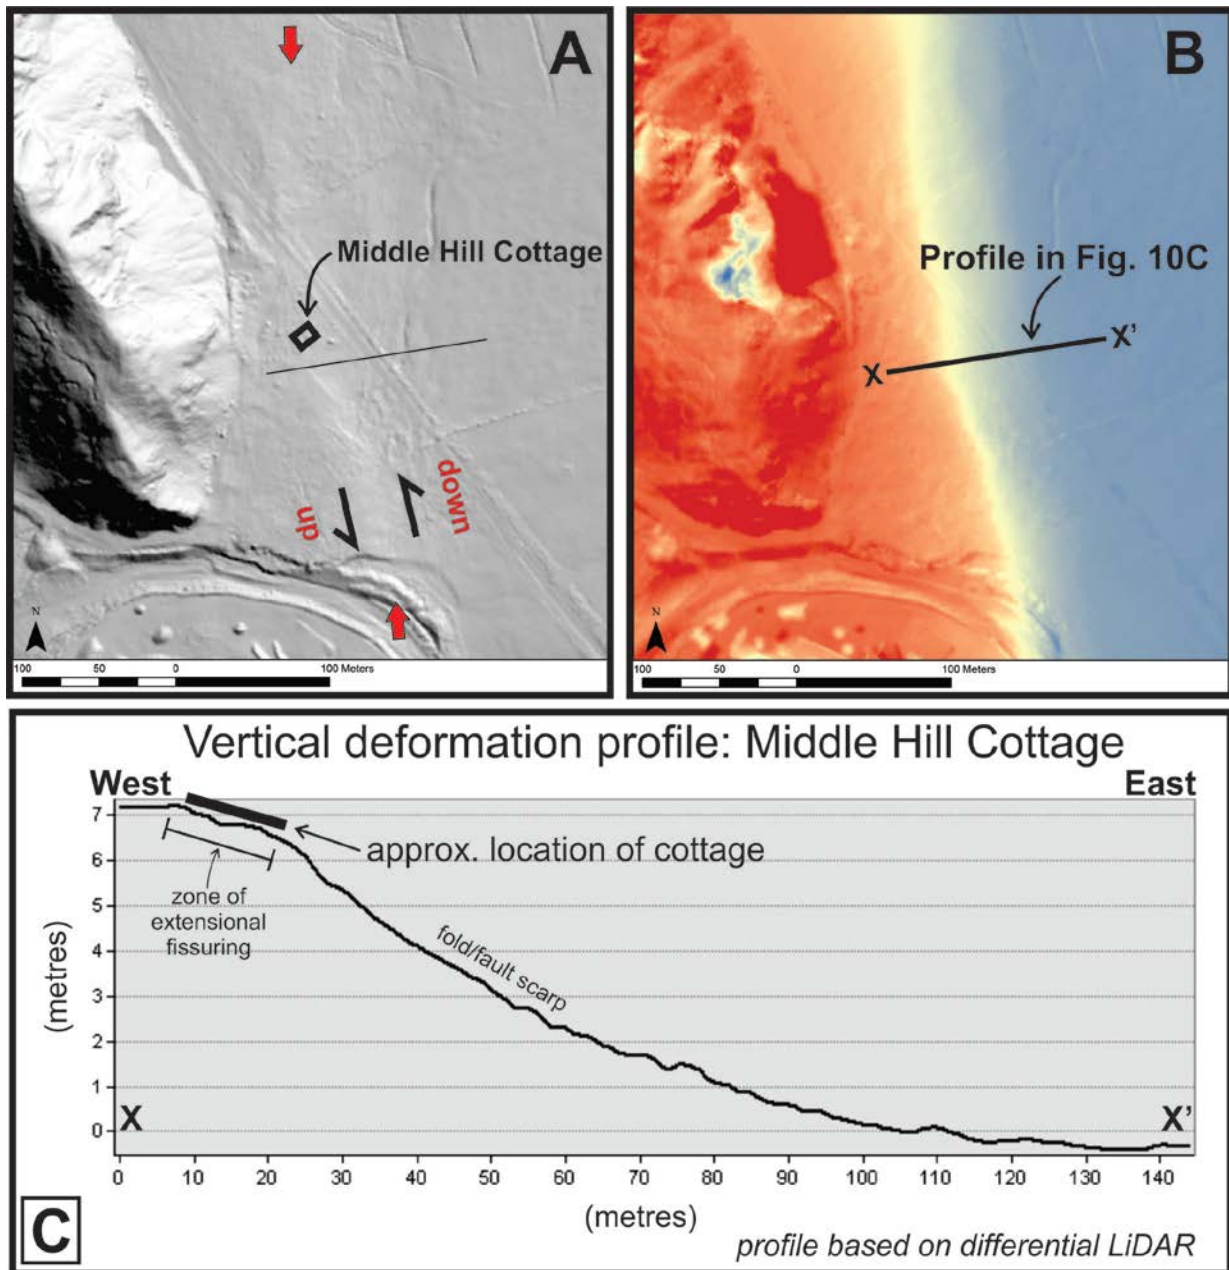
Figure 10: Middle Hill Cottage and Papatea Fault surface rupture. (A) 2016 post-earthquake LiDAR hill shade DEM with the black square denoting cottage's location, and red arrows showing the location the surface fault rupture scarp. (B) Differential LiDAR DEM with blue colours denoting little vertical change and red colours denoting significant positive vertical change (see Figure 10C for more detail regarding scale). (C) Vertical deformation profile derived from the differential LiDAR DEM. Vertical exaggeration = 6.1.

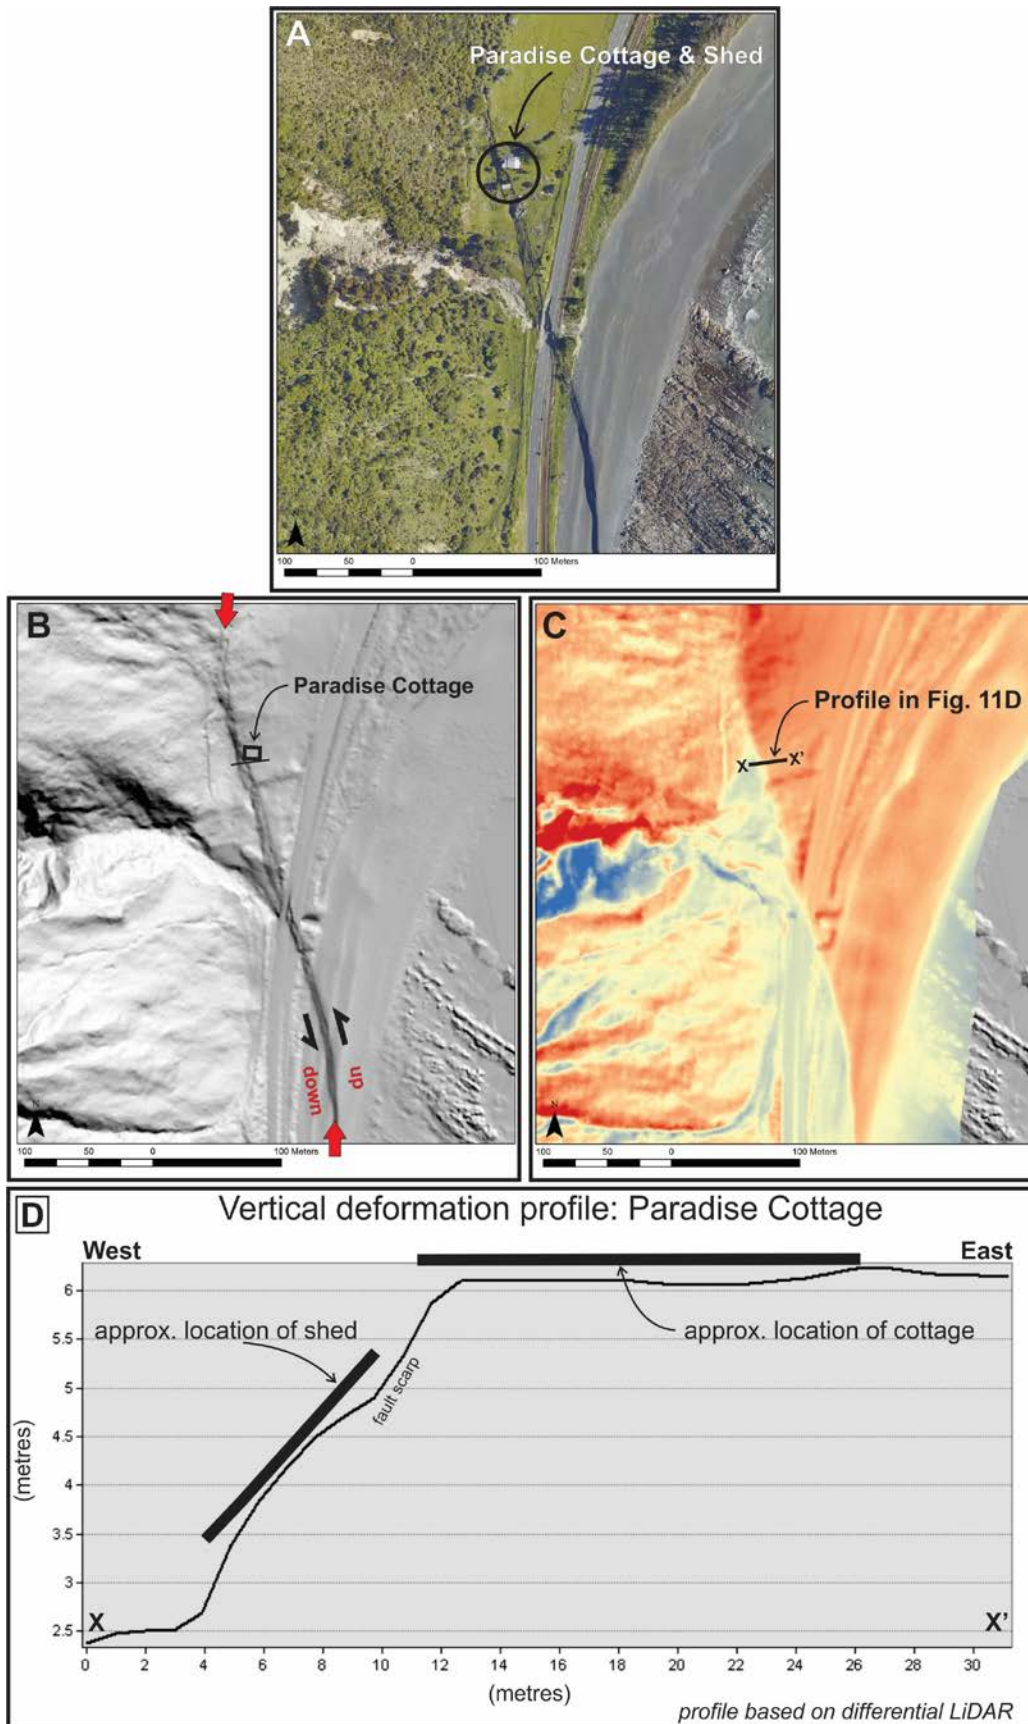
At the coast, where Paradise Cottage is located, the Papatea Fault comprises several main strands; the cottage is located across and immediately adjacent to the western most of these [19]. Here, the western strand of the Papatea Fault accommodates approximately 3.5 m of vertical deformation (E side up) (Figure 11D), a subordinate amount of left-lateral horizontal slip [19], and defines an 8-10 m wide surface fault rupture deformation zone primarily comprising discrete fault rupture. The cottage is located on the upthrown side of the fault, at the eastern edge of the surface rupture deformation zone, and has had its back-side ripped out by surface fault rupture. The nearby timber shed is located entirely within the fault scarp, and has been severely tiled and deformed. Neither the house nor the shed collapsed.

Figure 11: Paradise Cottage and Papatea Fault surface rupture; see Figure 1 for location (Lat: -42.2010, Long: 173.8753). (A) 2016 post-earthquake vertical aerial orthophotograph. Black circle denotes location of cottage and shed to the south. (B) 2016 post-earthquake LiDAR hill shade DEM showing location of cottage (black square) and prominent discrete ground surface ruptures (red arrows). (C) Differential LiDAR DEM with blue colours denoting little vertical change and red colours denoting significant positive vertical change (see Figure 11D for more detail regarding scale). (D) Vertical deformation profile derived from differential LiDAR DEM located half-way between the cottage and the shed. Vertical exaggeration = 3.3.

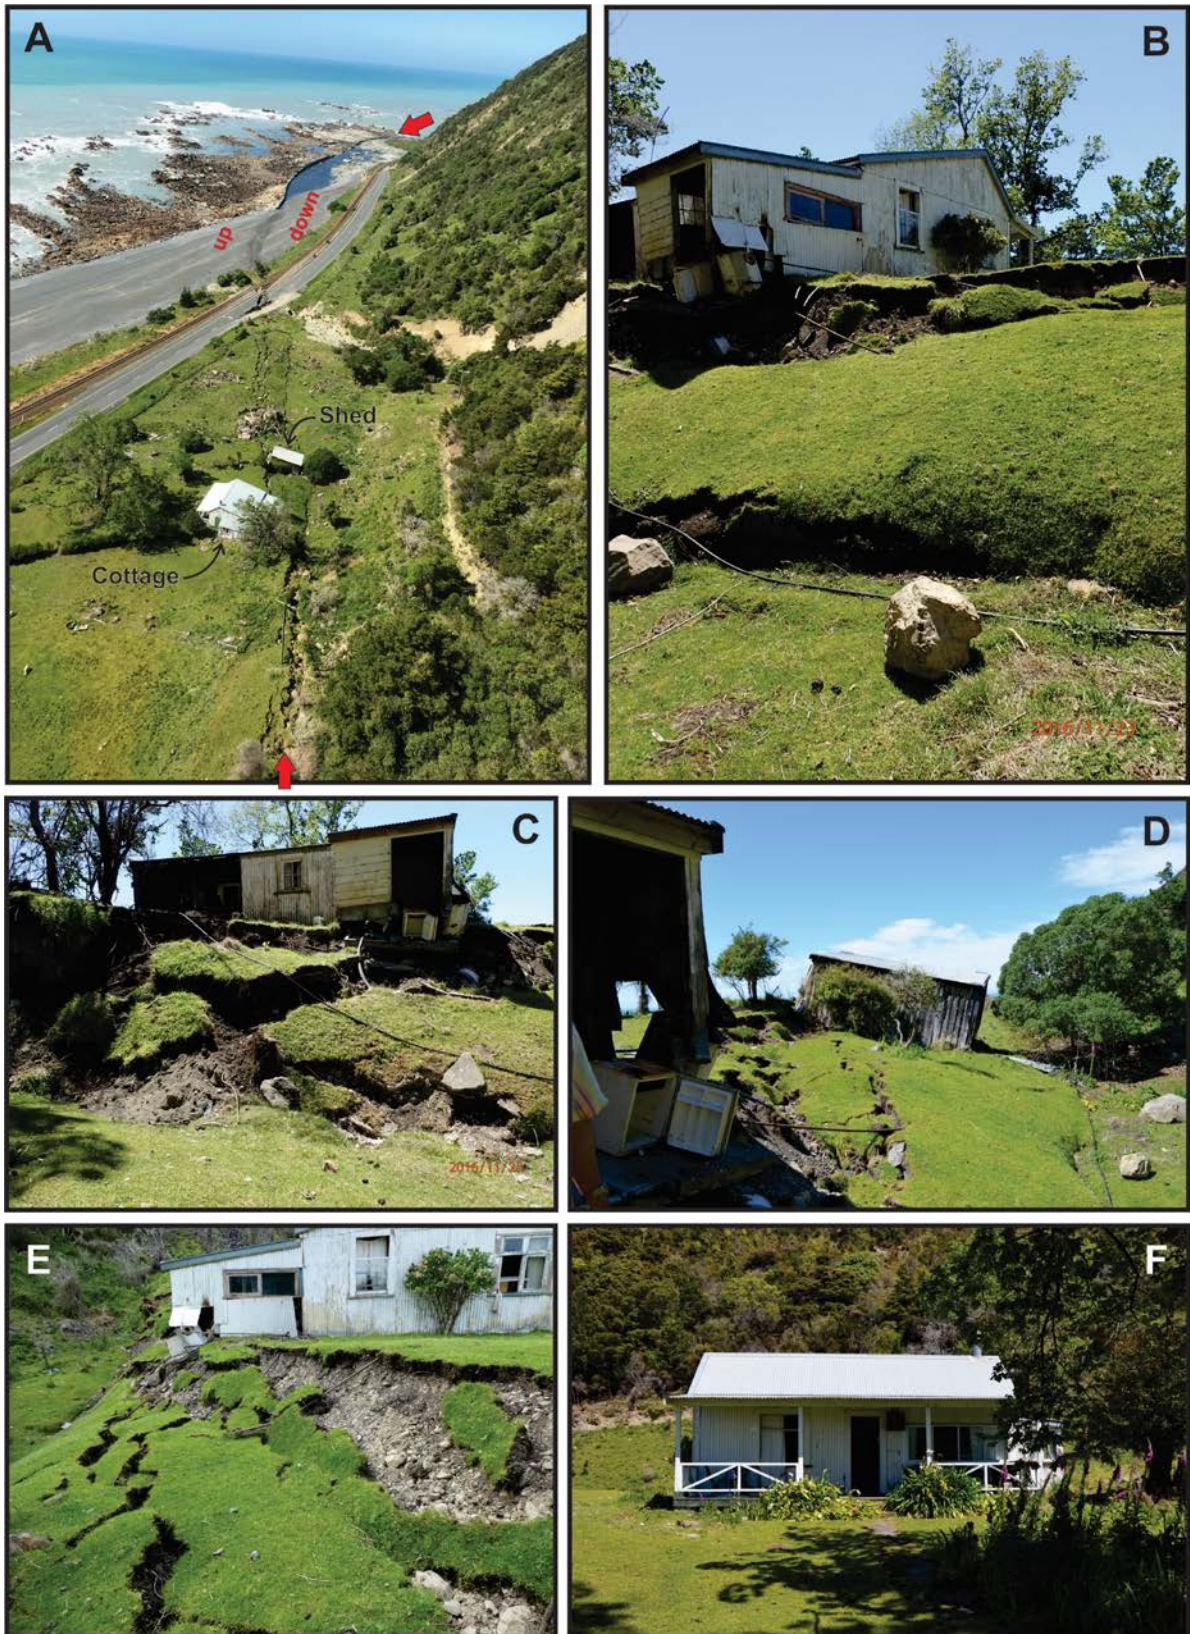
Figure 12: Paradise Cottage and Papatea Fault surface rupture; see Figure 1 for location. (A) Oblique aerial view looking south-southeast along the strike of the western strand of the Papatea Fault. Red arrows denote the position of prominent discrete rupture. Photo by Will Ries taken in November 2016. (B) View looking northeast. Photo by Alex Hatem taken in November 2016. (C) View looking east. Photo by Alex Hatem taken in November 2016. (D) View looking south-southeast towards the shed. Photo by Robert Zinke taken in November 2016. (E) View looking north-northwest along strike of the surface fault rupture. Photo by Tim Little taken in November 2016. (F) View looking east towards the front-side of the cottage. The front of the cottage appears to be little damaged and belies the havoc out back. Photo by Robert Zinke taken in November 2016.

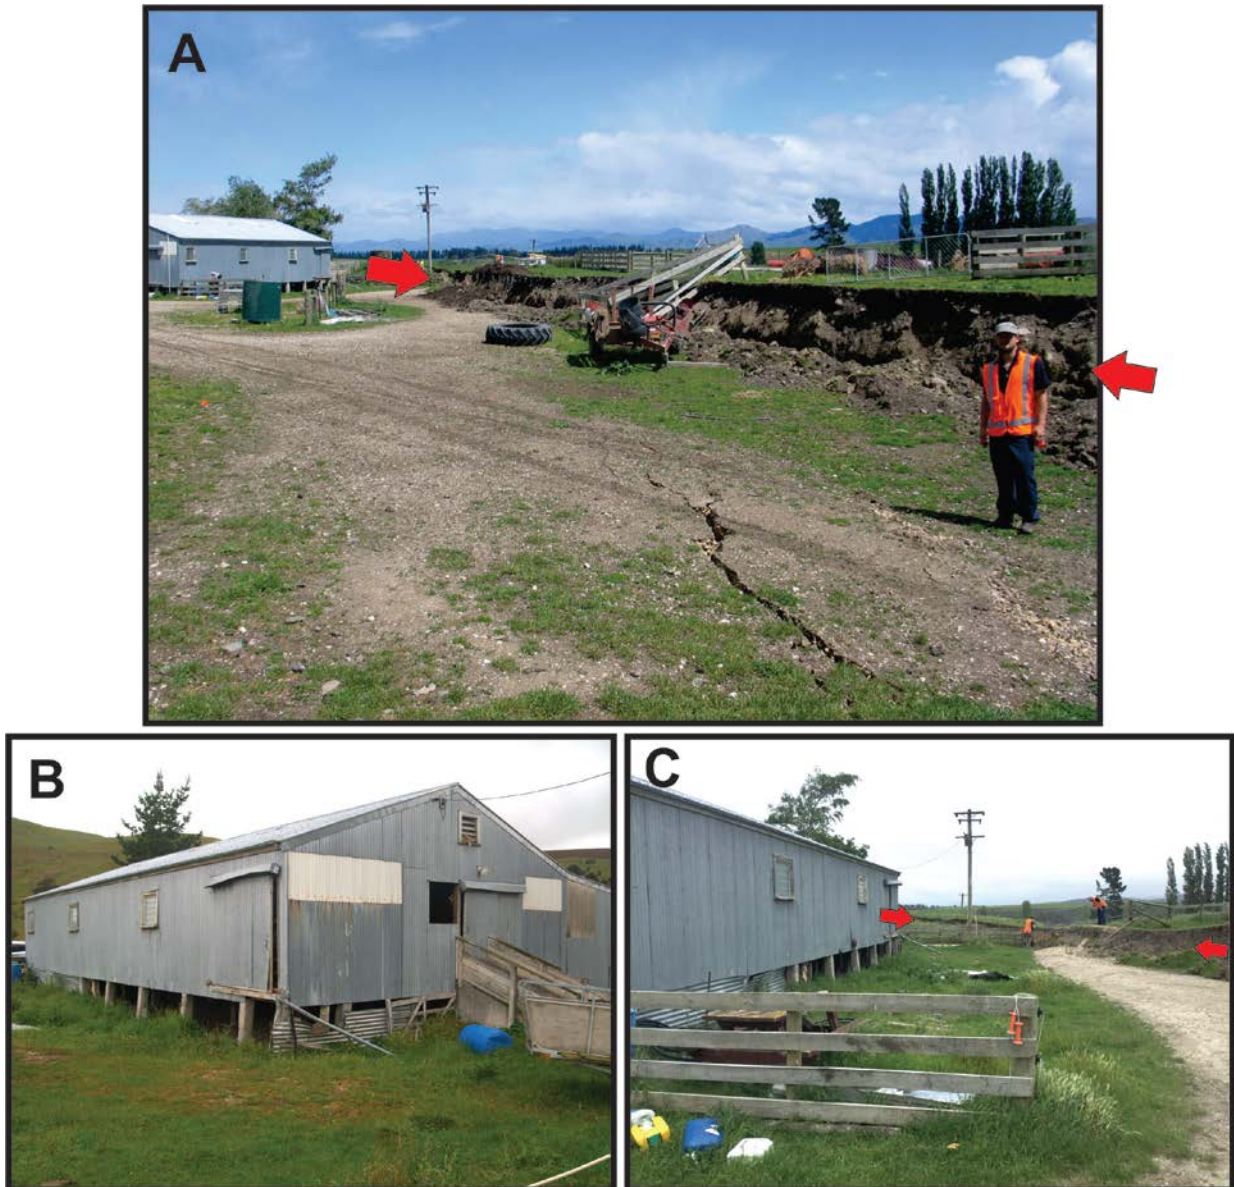
20 m wide zone of decimetre-scale ground subsidence that encompasses minor fracturing and small faults with vertical displacements of 1-10 cm (Figure 13A). This zone of ground subsidence extends from the stockyard adjacent to, and southwest of, the woolshed to the northeast for over 50 m. Fault rupture induced damage to the Glenbourne woolshed appears to be limited to rotation of some of the shallow-seated concrete piles (Figure 13B). The super structure itself is relatively undamaged and intact. We suspect that rotation of the piles isolated the super structure from the decimetre-scale fault rupture ground deformation underneath. It is pertinent to note that a similarly constructed, and piled, woolshed sited across the 2010 surface rupture of the Greendale Fault displayed similar performance with rotation of shallow-seated piles isolating, to a large extent, the super structure from the underlying fault rupture ground deformation [21].

Figure 13: Glenbourne Woolshed and The Humps Fault surface rupture; see Figures 1 & 14 for location (Lat: -42.6152, Long: 173.1058). (A) View looking southwest along the fault rupture towards the woolshed. Note distributed centimetre-scale cracking in the foreground (in front of the high-vis geologist), adjacent to the main trace (red arrow, and behind the high-vis geologist). The distributed centimetre-scale cracking persists along strike for many tens of metres. Photo by Jarg Pettinga taken in November 2016. (B) View looking south at the woolshed (main fault scarp is behind the camera). Tilt and rotation of the shallow-seated concrete piles is the only recognisable damage. Photo by Clark Fenton taken in December 2016. (C) View looking southwest along the side of the woolshed and towards the main fault scarp at this site. Photo by Tim Stahl taken in November 2016.
