IMPACTS OF SURFACE FAULT RUPTURE ON RESIDENTIAL STRUCTURES DURING THE 2016 M_w 7.8 KAIKŌURA EARTHQUAKE, NEW ZEALAND

Russ J. Van Dissen¹, Timothy Stahl², Andrew King³, Jarg R. Pettinga⁴, Clark Fenton⁵, Timothy A. Little⁶, Nicola J. Litchfield⁷, Mark W. Stirling⁸, Robert M. Langridge⁹, Andrew Nicol¹⁰, Jesse Kears¹¹, David J. A. Barrell¹² and Pillar Villamor¹³

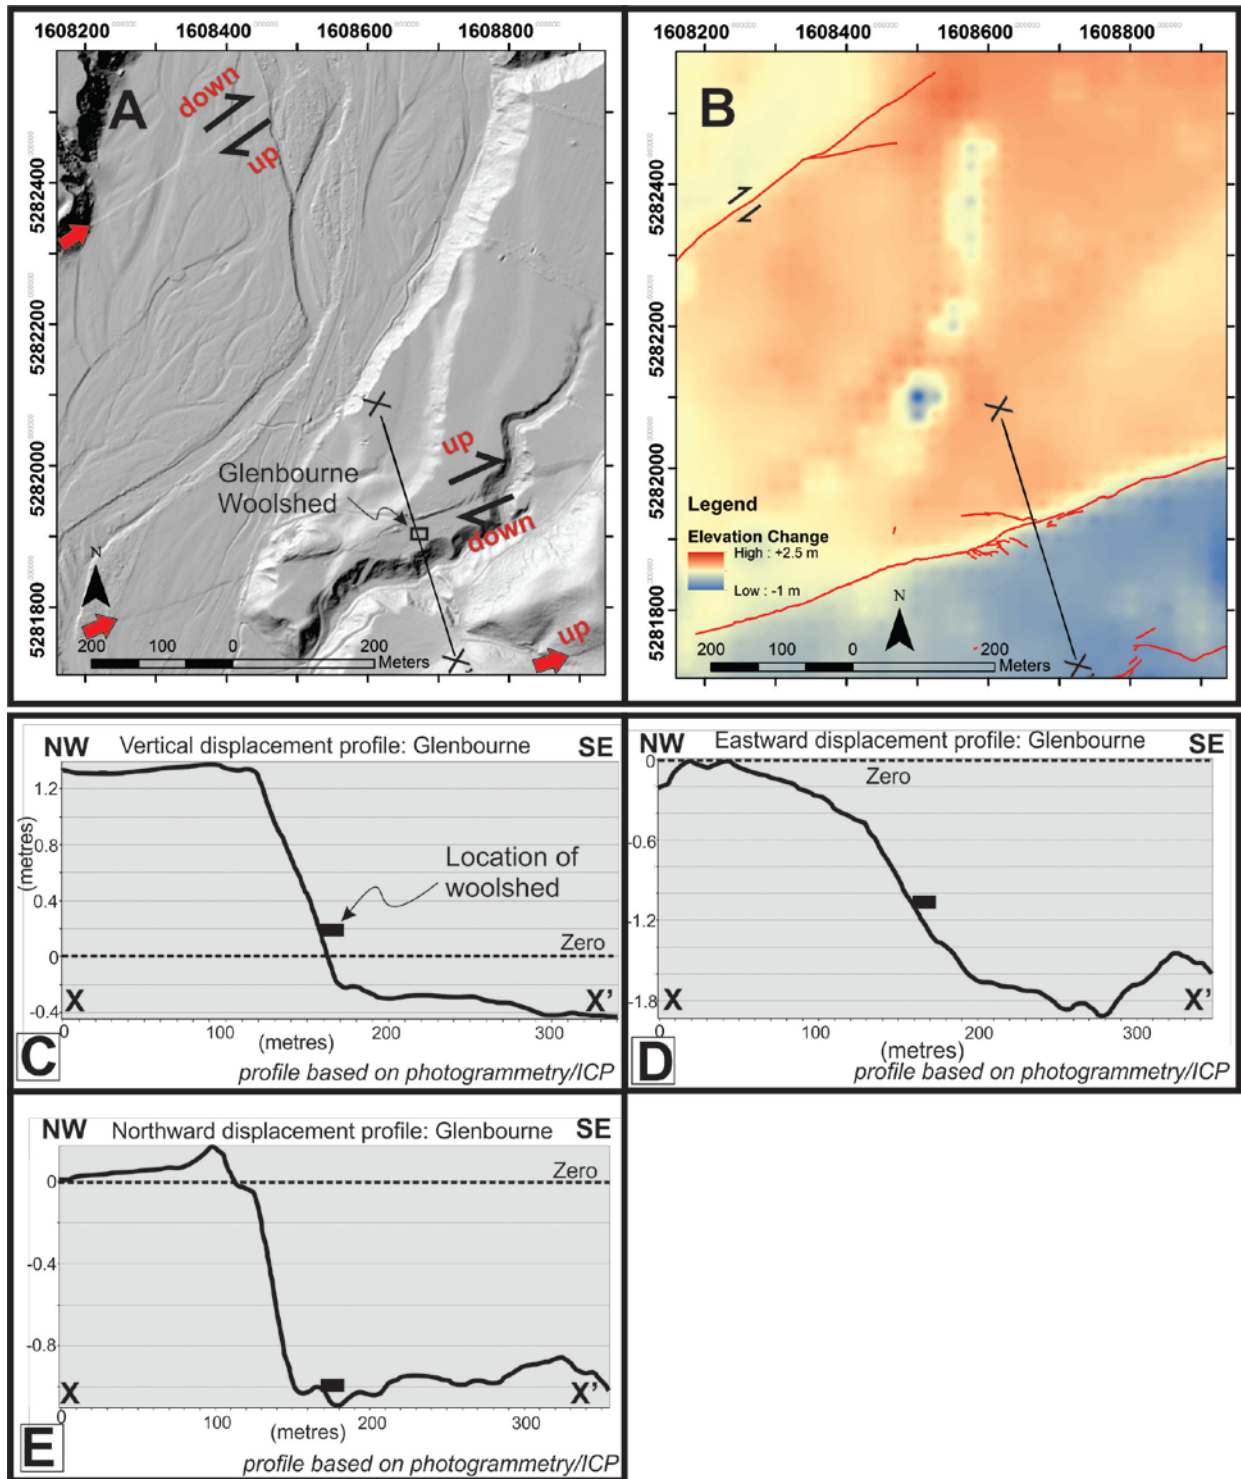
Figure 14: Glenbourne Woolshed and surface rupture of The Humps Fault. (A) LiDAR hill shade DEM showing location of the woolshed and two prominent discrete fault traces (red arrows), one of which is within ~5 m of the woolshed (see Figures 13A & 13C). **(B)** Raster of vertical displacements in the same area as (A), using ICP method outlined in the text. **(C), (D), and (E)** are the vertical, eastward, and northward displacement profiles from X to X' on the top two images. The location of the woolshed is shown on each profile. Note that while relative motions were mapped in the field, the absolute sense of displacement is more complex, with the downthrown side of the fault moving southwestward and the up-thrown side of the fault remaining relatively stable except in the vertical direction. Y-axis exaggeration in (C) & (D) = 85. Y-axis exaggeration in (E) = 130.

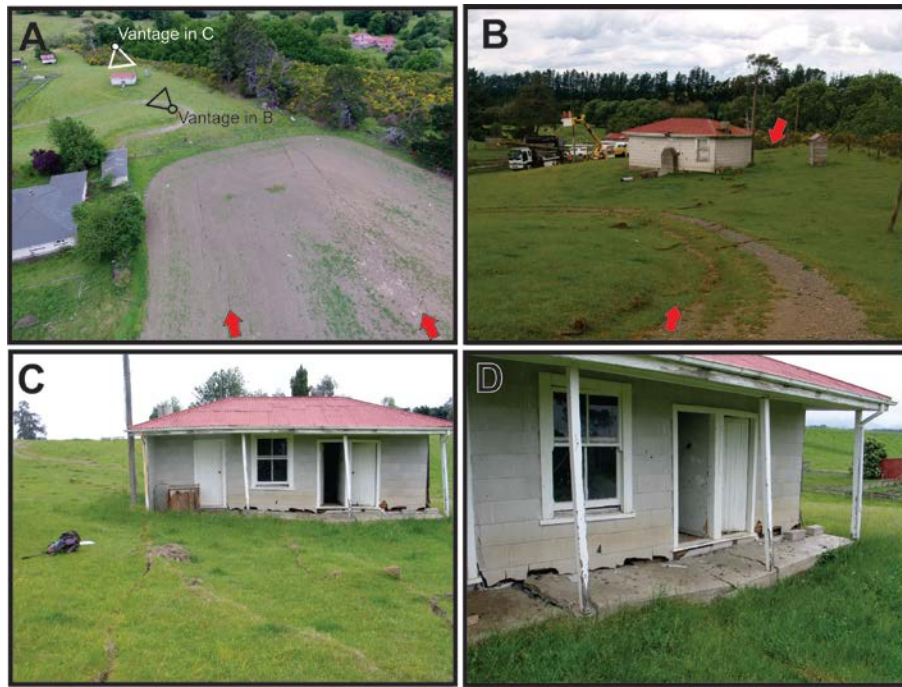
depression that transitions to the east into a narrow zone of Riedel shears and tension fractures (Figures 15 & 16A). In the field, an adjacent fault-offset fence yielded RTK-derived offset measurements of 0.9 m dextral and 0.5 m vertical [4]. The cottage experienced a chimney collapse (Figure 15B), and multiple fractures to the concrete foundation (Figures 15C & 15D). Timber supports for the roof/veranda at the front the

cottage experienced minor amounts of shear, and were deformed out-of-plumb (Figures 15C & 15D). Several cladding planks at the base of the exterior of the cottage were broken (Figure 15D). Although surface rupture caused structural damage to the cottage, the cottage appears to be far from collapse. Using a combination of the ICP-based analysis (see

Figure 15: Hillview Cottage and surface rupture of The Humps Fault; see Figures 1 & 16 for location (Lat: -42.6287, Long: 173.0154). (A) Oblique aerial view looking east towards the cottage, along discrete dextral-normal surface fault ruptures (red arrows). Photo courtesy of Sam McColl taken from a drone in November 2016. (B) View looking northeast. At this location, the cottage is impacted by decimetre-scale discrete fault rupture (in this case Riedel shears) and centimetres to decimetres of distributed deformation between the shears. Note the collapsed chimney. Photo taken by Clark Fenton in November 2016. (C) & (D) Details of damage to the cottage caused by decimetre-scale surface fault rupture. Photos taken by Jarg Pettinga in November 2016.

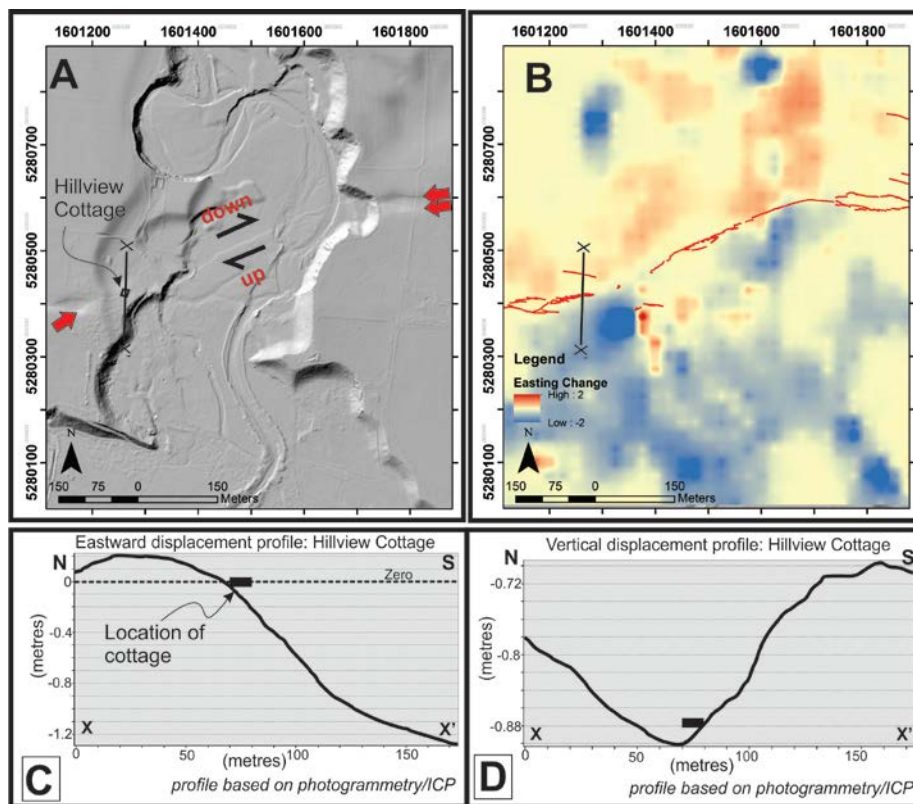
Figure 16: Hillview Cottage and The Humps Fault surface rupture. (A) LiDAR hill shade DEM showing location of the cottage within a relatively narrow fault rupture deformation zone (red arrows). (B) Raster of displacement in the east direction (positive is east, negative is west) calculated using ICP method described in text. Some anomalies and artefacts of the grid exist within the dataset but the overall pattern is one of predominantly dextral displacement. West of the cottage is a small pull-apart, while the 100 m-scale fault geometry is that of a restraining bend. (C) & (D) The eastward and vertical deformation profiles from X to X', respectively. Y-axis exaggeration in (C) = 60. Y-axis exaggeration in (D) = 385.

Glenbourne section), and field observations, we estimate centimetre-scale vertical and decimetre-scale dextral displacement at the site of the cottage. Assuming simple shear and a sub-vertical fault plane, we estimate a net shear strain across the foot print of the structure of $\sim 10^{-2}$.

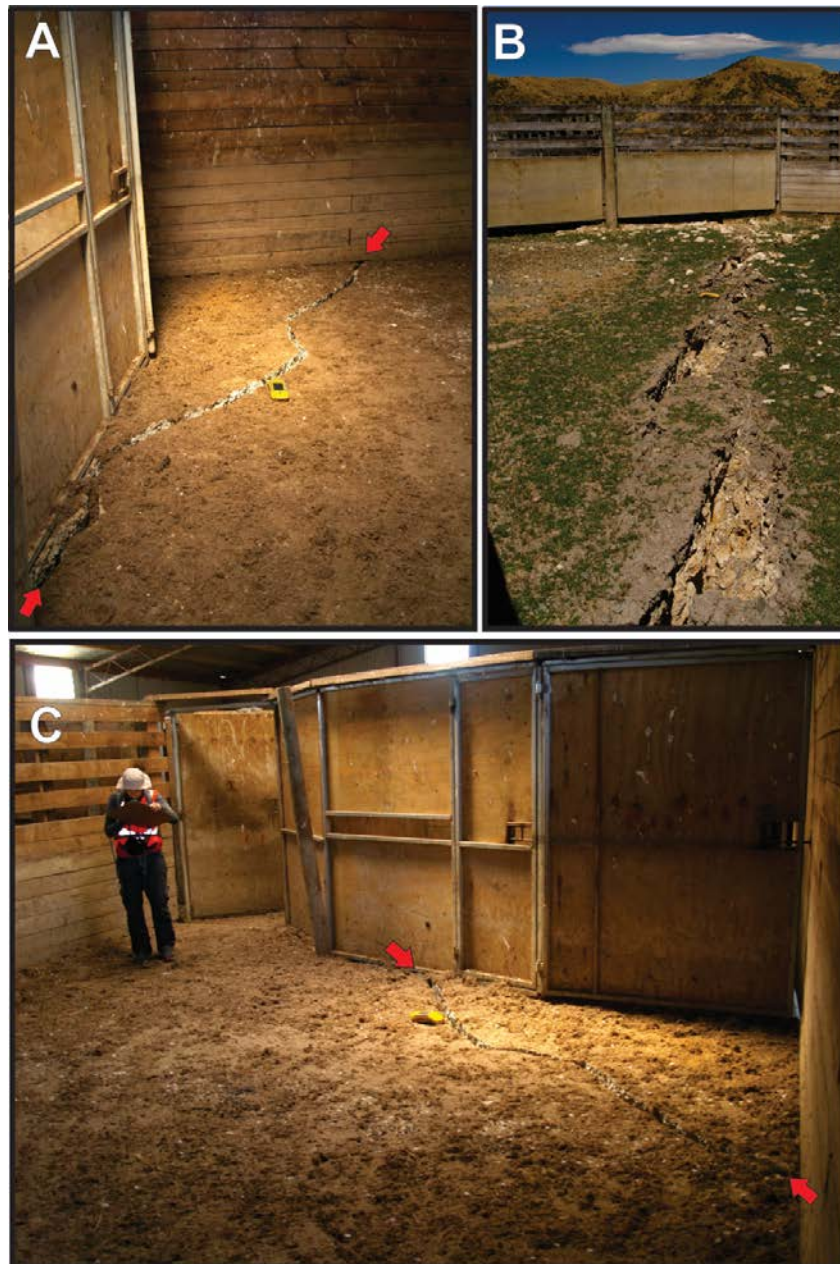
Figure 17: Mendip deer shed and northern Leader Fault surface rupture; see Figures 1 & 18 for location (Lat: -42.5740 , Long: 173.2825). (A), (B), & (C) Field photographs of normal faulting running through the deer shed. (B) is looking to the southeast, across the stock yard and towards the intersection of the two fault sets (see text for discussion). Photos taken by Clark Fenton in January 2017.

faults were tracked through the deer shed floor and into the adjacent stock yards (Figure 17).

Damage to the deer shed was relatively minor and limited to some cracking of the concrete floor, and separation of the walls from the floor (Figure 17). Most of the damage is linked to the relatively minor, discrete displacements on the northwest trending secondary faults, as distributed deformation from the main thrust (~25 m to the southeast) is limited. This does,

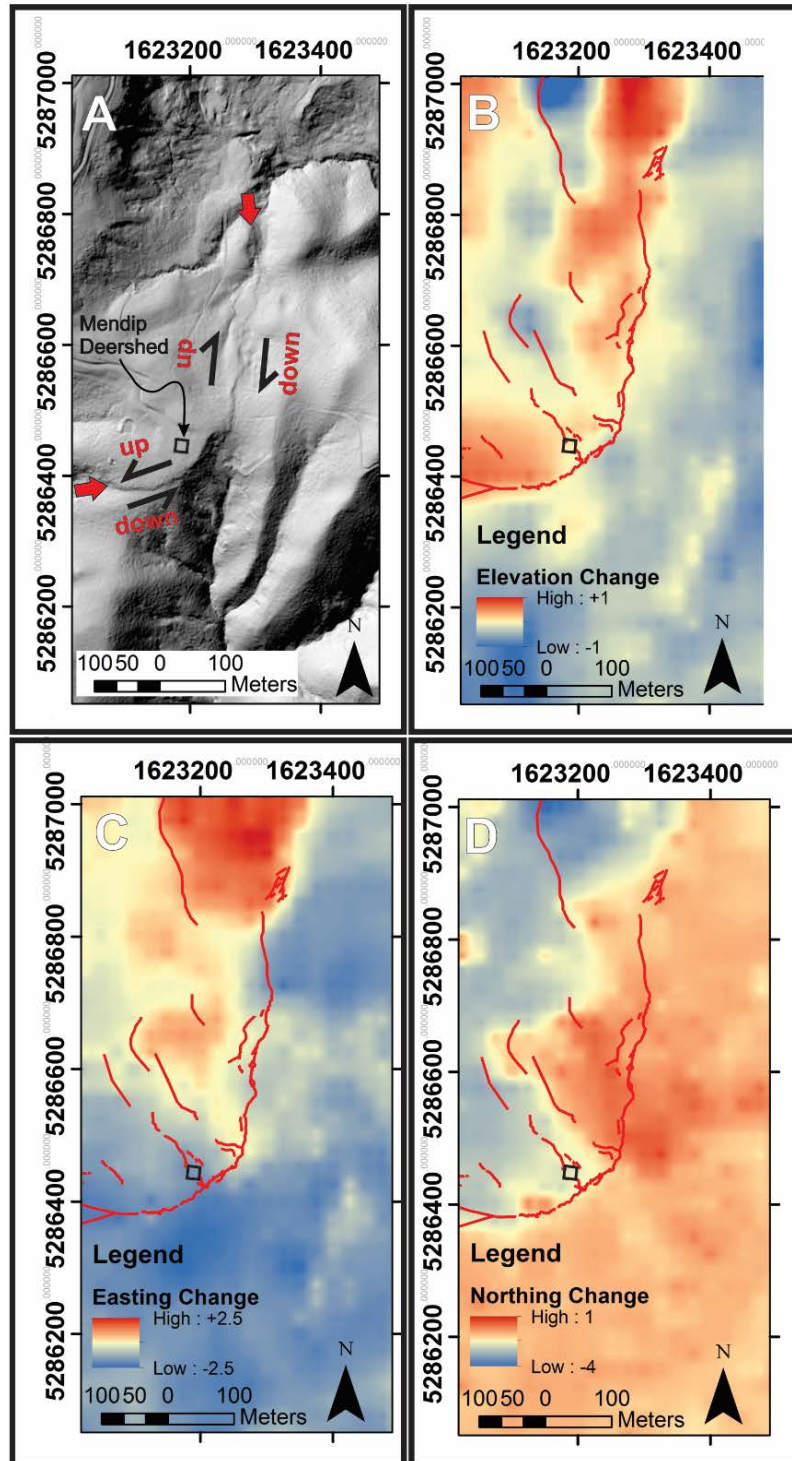
however, highlight the fact that complex fault kinematics can result in secondary faulting that can directly impact engineered structures. These secondary features may not be evident in the landscape over geologic timescales due their relatively small scale and commensurate poor preservation potential, but might be anticipated with detailed mapping and documentation of the primary fault trace geometry and kinematics. Shear strain estimates are complicated by the intersecting set of faults at this location, but we estimate strains on the order of $10^{-1} - 10^{-2}$.

Figure 18: The Mendip deer shed and surface rupture along the northern Leader Fault. (A) LiDAR hill shade with location of the deer shed indicated. The primary fault trace (red arrows) and sense of slip are indicated. (B) The fault traces with elevation change raster determined using ICP method described in text. (C) Same as (B), but for easting change (positive values moved east). (D) Same as in (B), but for northing change (positive values moved north). Note that compression and associated reverse faulting predominates, with components of sinistral and dextral sense west and north of the deer shed, respectively. However, discrete faulting on secondary NW-SE striking faults was the main contributor to deer shed damage.
