PERFORMANCE OF HOUSES DURING THE CHRISTCHURCH EARTHQUAKE OF 22 FEBRUARY 2011

Andrew Buchanan¹, David Carradine², Graeme Beattie³ and Hugh Morris⁴

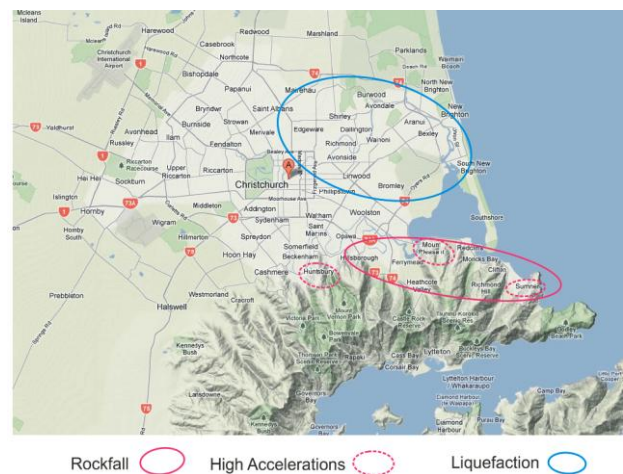
Figure 1: Approximate location of the worst types of damage.

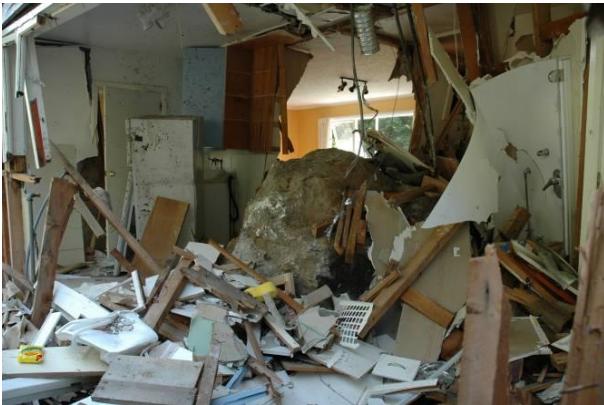
Figure 2: *House damage in Heathcote due to rockfall (Carradine).*

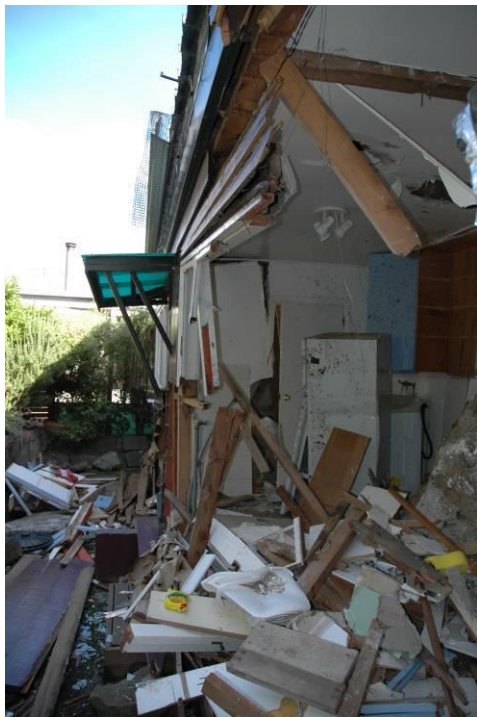
Figure 3: *House damage in Heathcote due to rockfall (Carradine).*

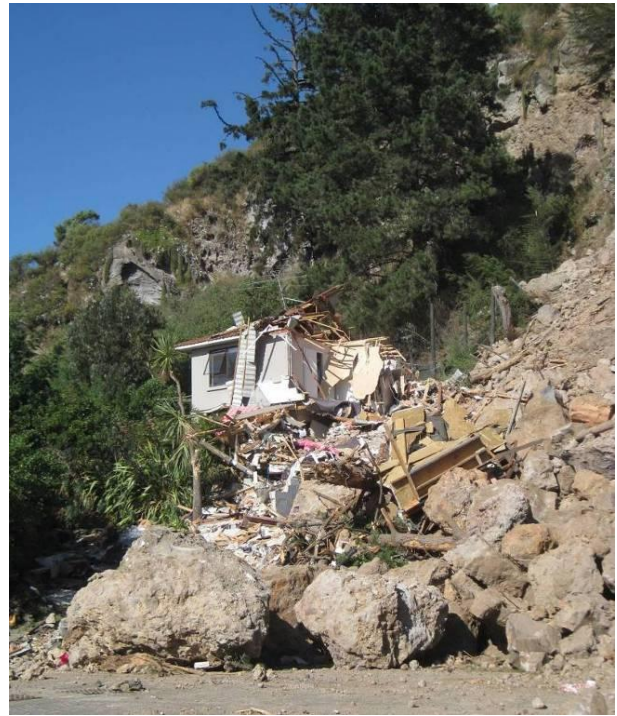
Figure 4: *House destroyed by landslide in Redcliffs (Beattie).*

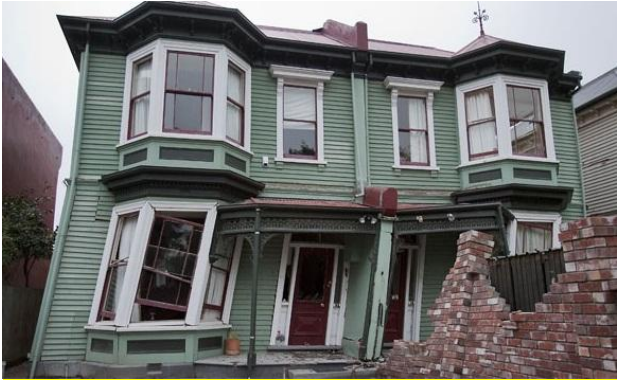
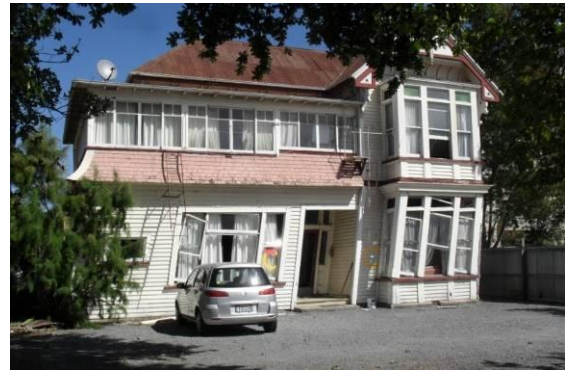
Figure 5: *Examples of soft storey failures of timber framed houses not resulting in collapse.*

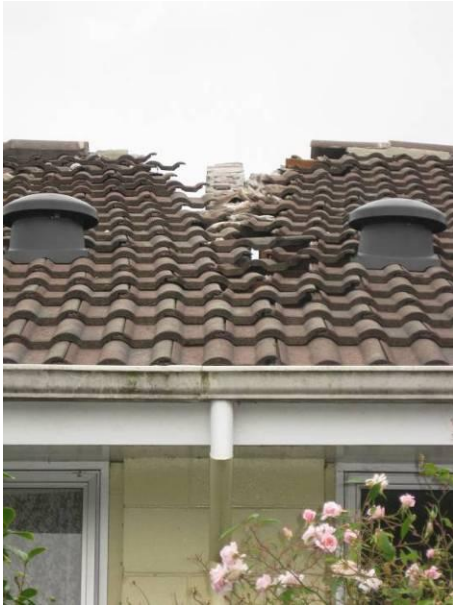
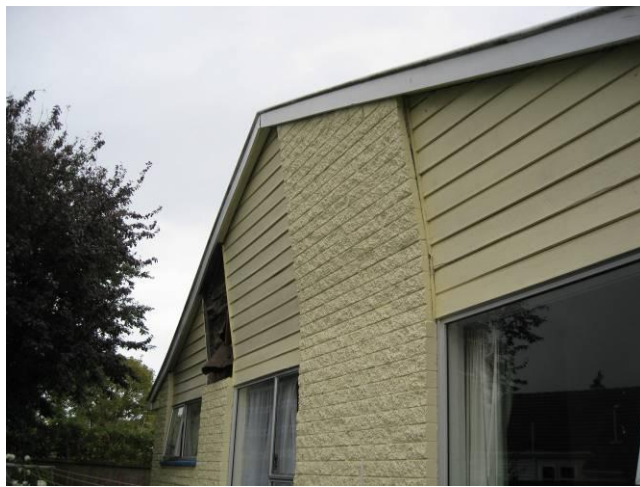
Figure 6: *Roof separation (left) at masonry party wall in St. Martins, and deflection of gable end (right) due to roof bracing failure on same house (Carradine).*

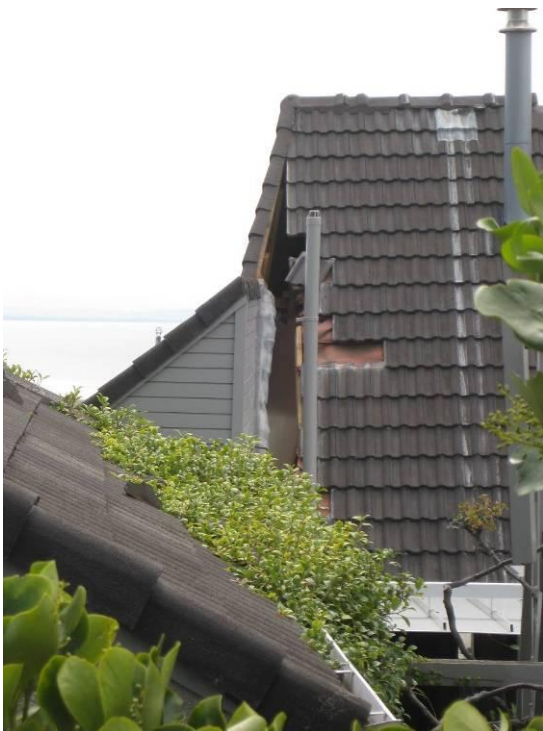
Figure 7: *Superstructure distress caused by foundation failure on sloping ground (Beattie).*

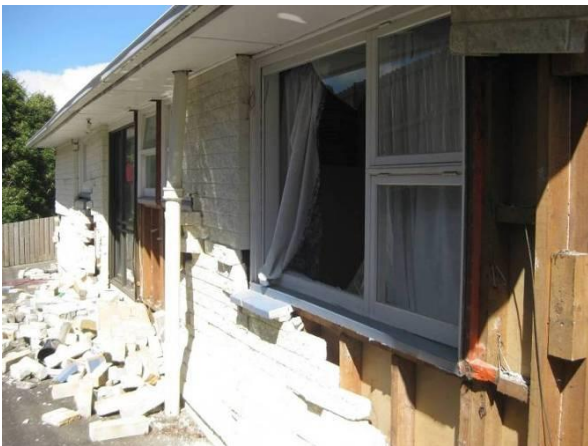
Figure 8: Collapsed brick veneer (Beattie).

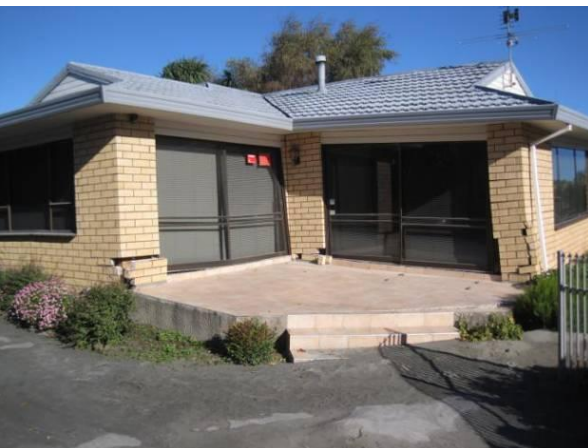
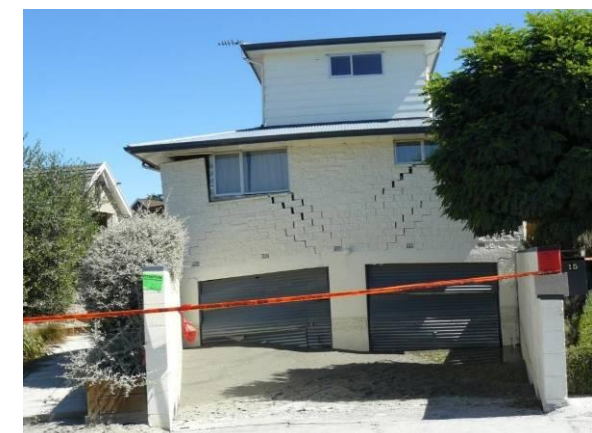
Figure 9. Veneer damage due to lateral spreading and differential settlement (Buchanan) and due to differential settlement (Morris).

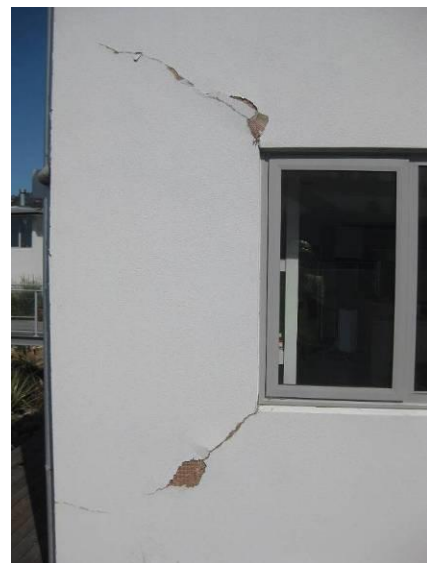
Figure 10: Typical cracking of an EIFS system (Beattie).

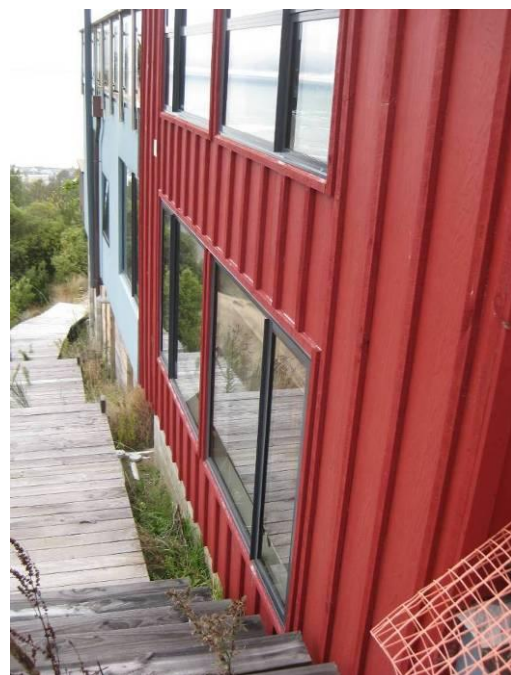
Figure 11: Plywood sheet cladding with timber battens (Beattie).

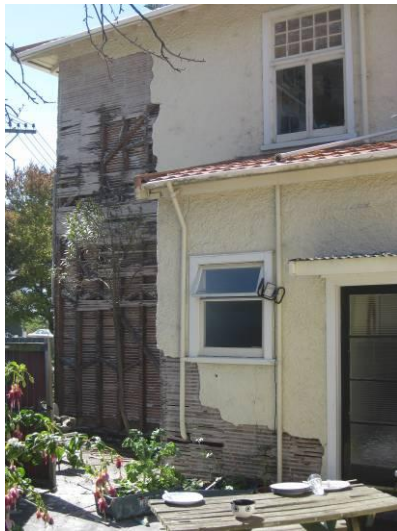
Figure 12: Detached lath and plaster from an exterior lath and plaster system (Beattie).

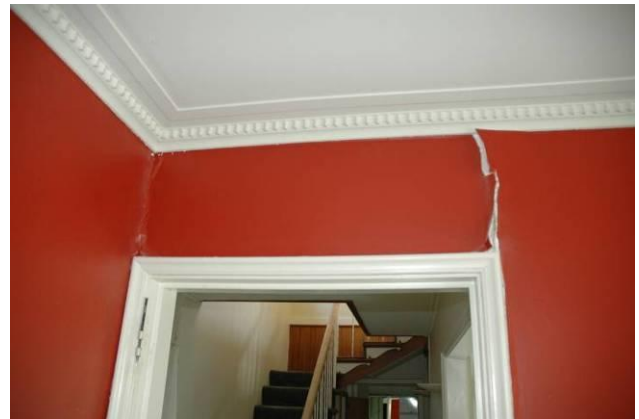
Figure 13: Buckled plasterboard in house in Heathcote Valley (Carradine).

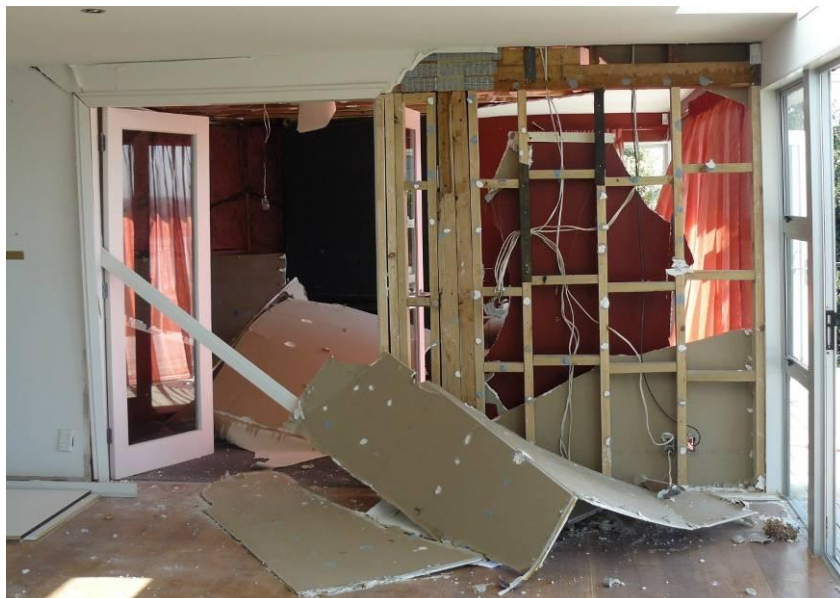
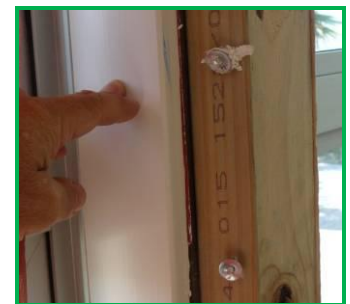
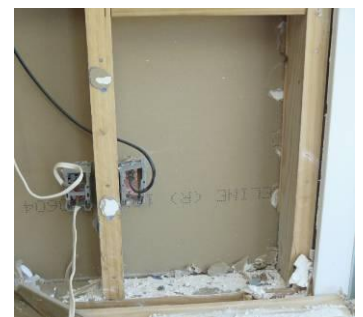
Figure 14: Severe failure of high grade plasterboard internal linings (Morris).

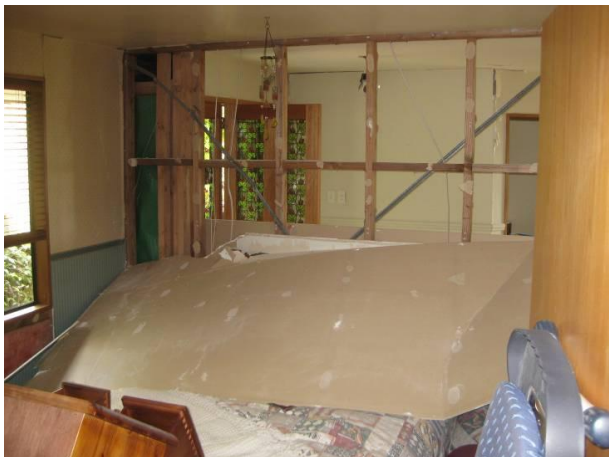
Figure 15: Failure of a generic plasterboard/metal brace combination (Beattie).

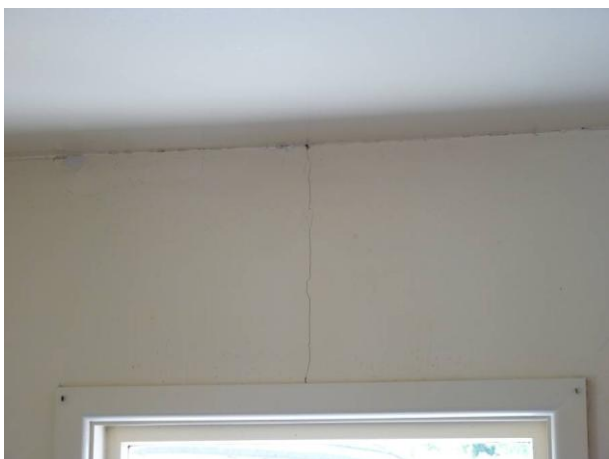
Figure 16. Cracking of a joint between fibrous plaster wall lining sheets (Beattie).

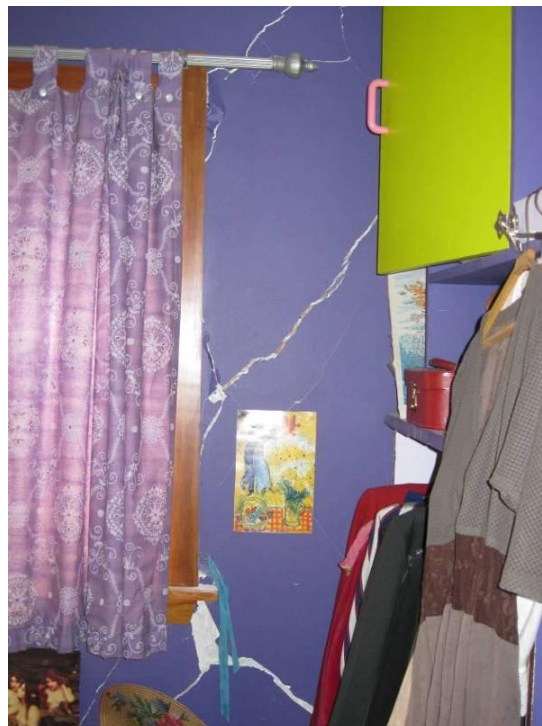
Figure 17: Damage to plaster on lath lining in Waltham (Carradine).

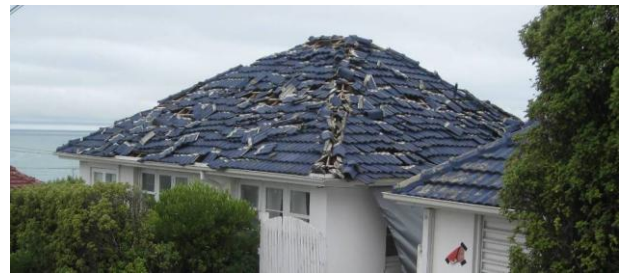
Figure 21: Dislodged heavy roof tiles on a hillside property (Beattie).

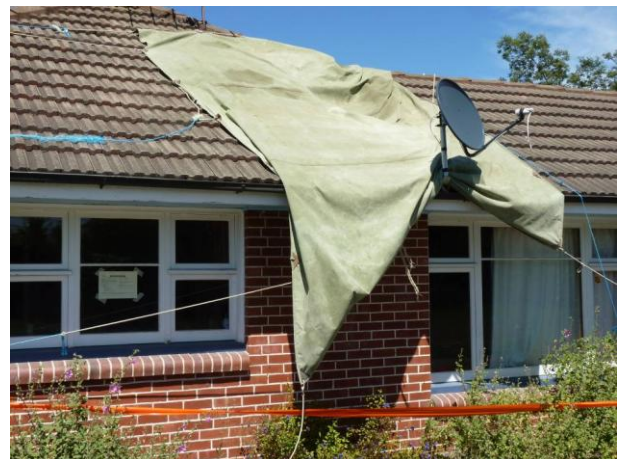
Figure 22: A case where roof tiles were not able to support falling bricks from a collapsing chimney (Beattie)

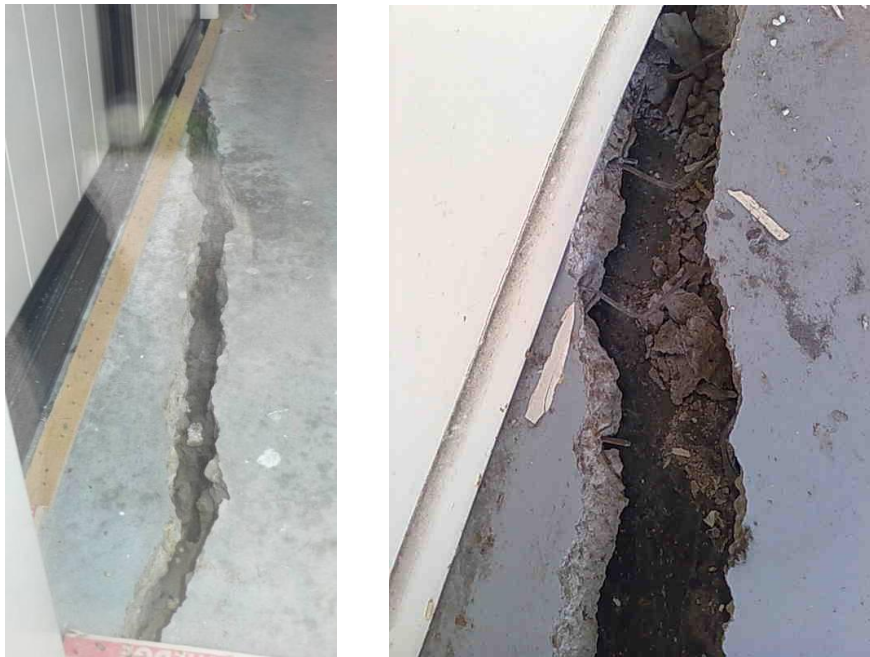
Figure 23: (Left) An unreinforced slab that has been pulled apart because of land spreading beneath (Beattie); (Right) A reinforced slab that has been pulled apart by land spreading beneath (Beattie)

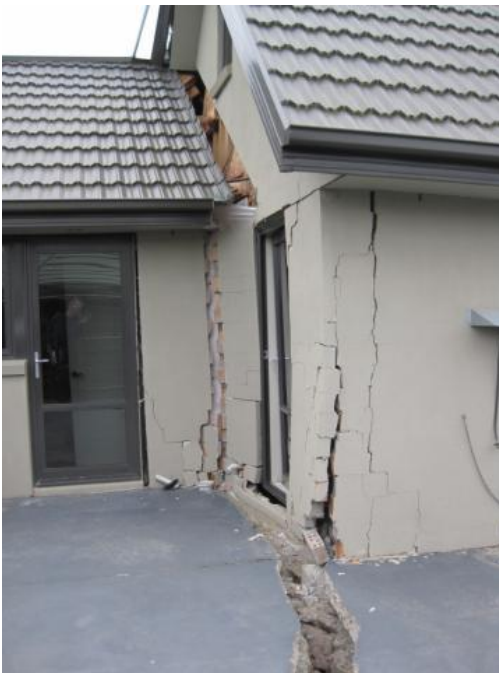
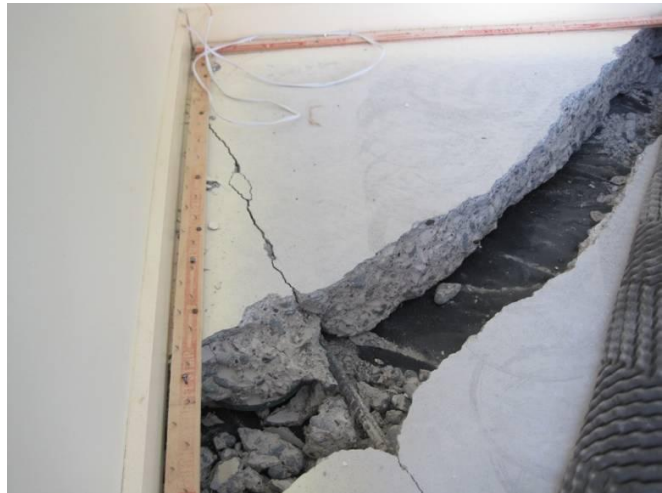
Figure 24: House and reinforced slab damage as a result of ground movement (Buchanan).

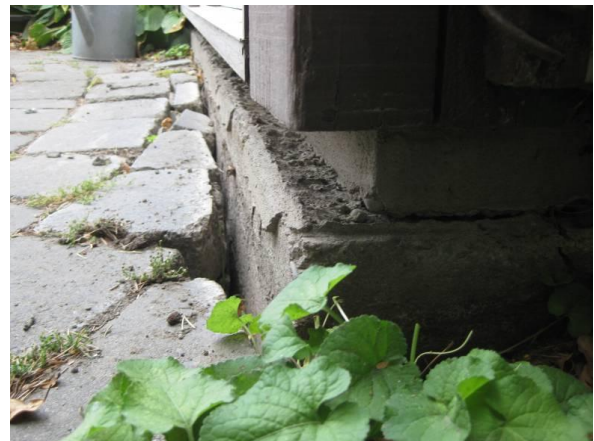
Figure 25: Example of a floor slab that has slipped sideways on the supporting foundation (Beattie).

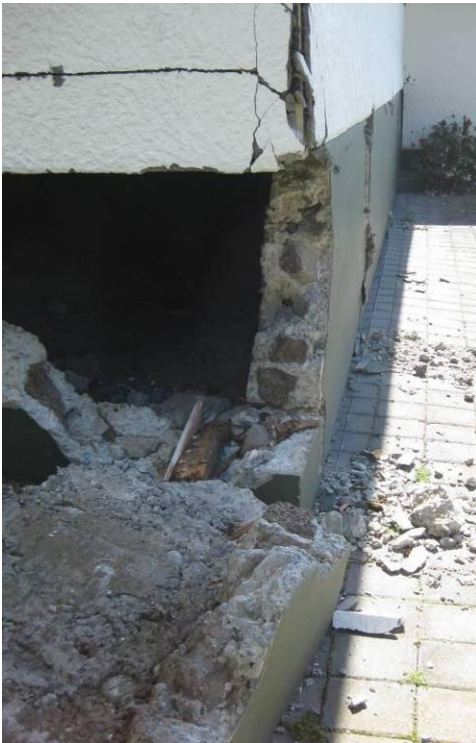
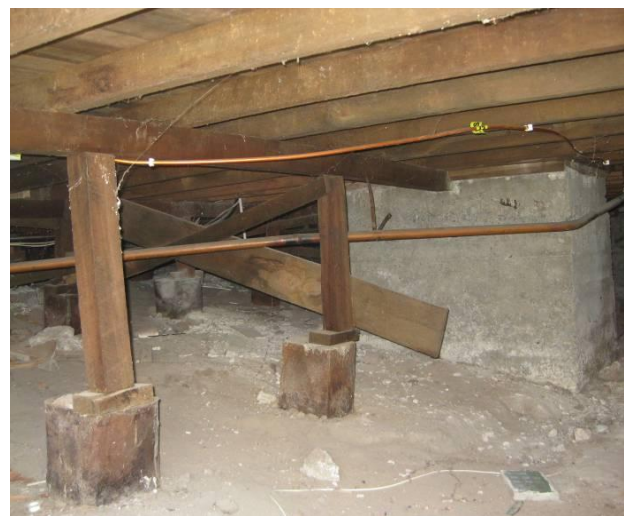
Figure 27: (Left) Failed unreinforced concrete wall foundation and (Right) jack studs (Beattie).

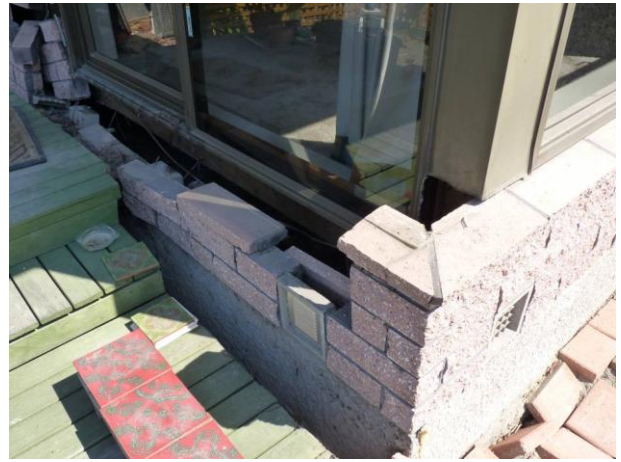
Figure 26: Example of a foundation wall that has pulled clear of the floor framing. Note how the veneer and foundation have pulled away from the framing at the corner (Beattie).

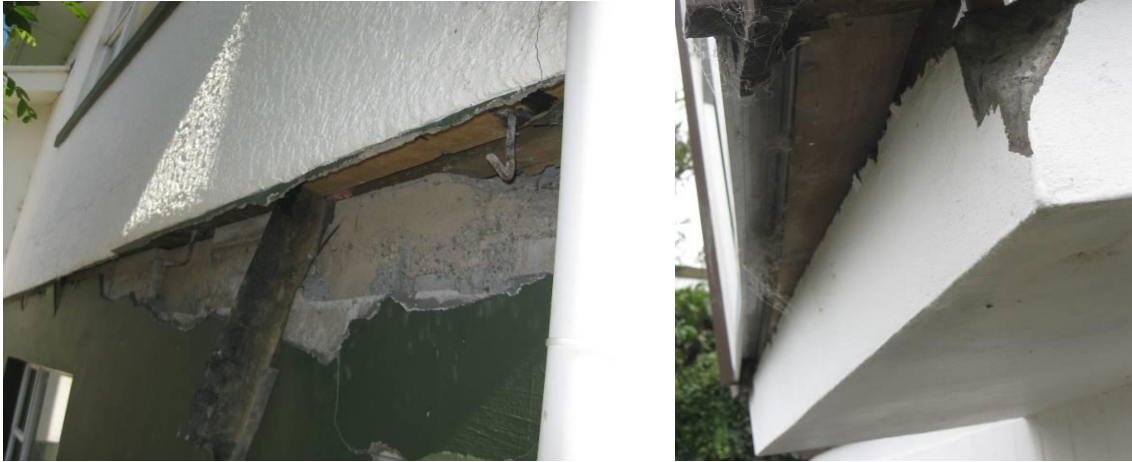
Figure 28: (Left) Bottom plate anchors that have torn out of the unreinforced concrete foundation wall; (Right) No apparent connection between the plate and the concrete slab (Beattie).

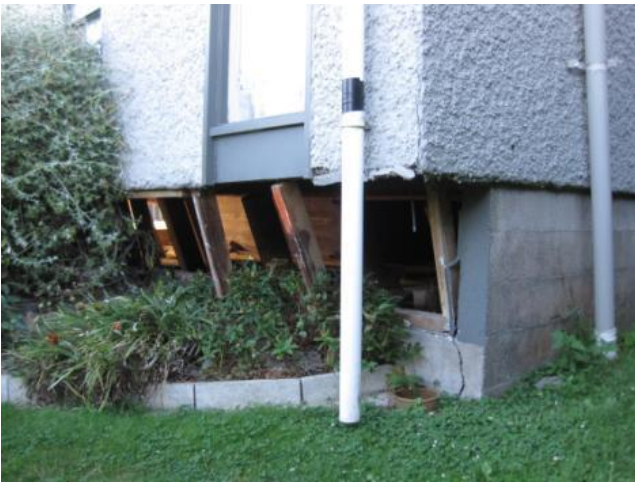
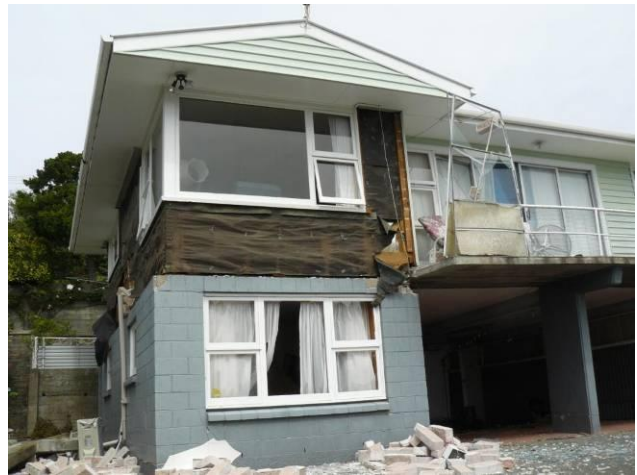
Figure 29: Houses sliding on foundations (Left, Buchanan, Right, Morris).

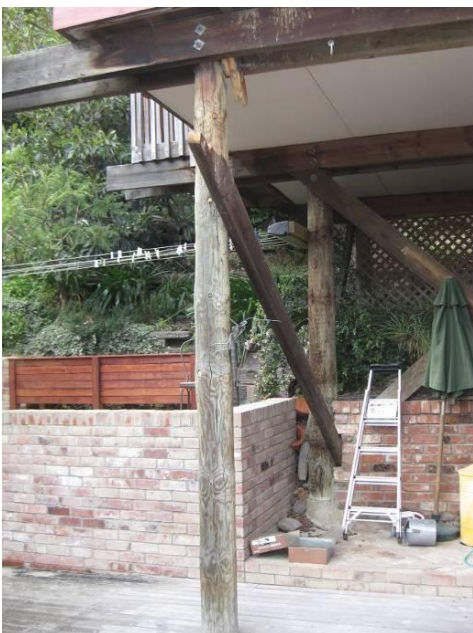
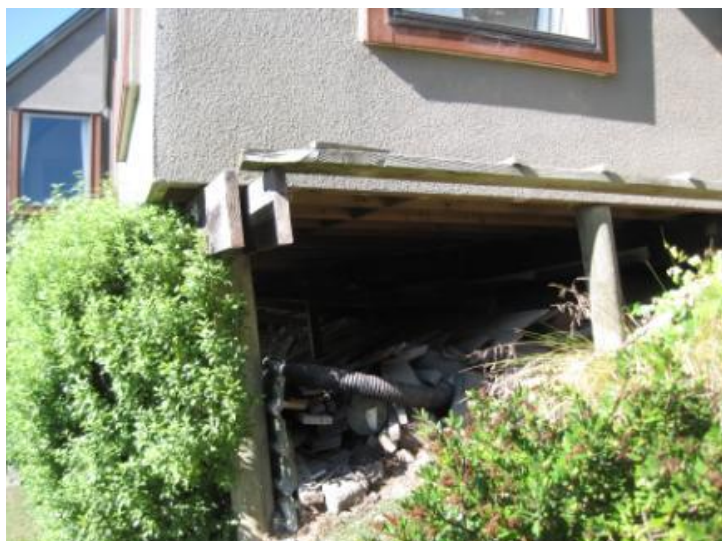
Figure 30: Failed diagonal brace between poles of a pole framed house (Left, Beattie) and lateral movement of house on pole foundations (Right, Buchanan).

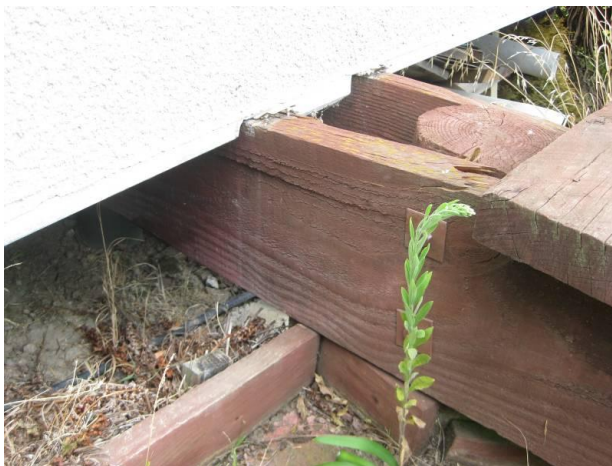
Figure 31: Evidence of impact of the house superstructure on the supporting pole structure (Beattie).

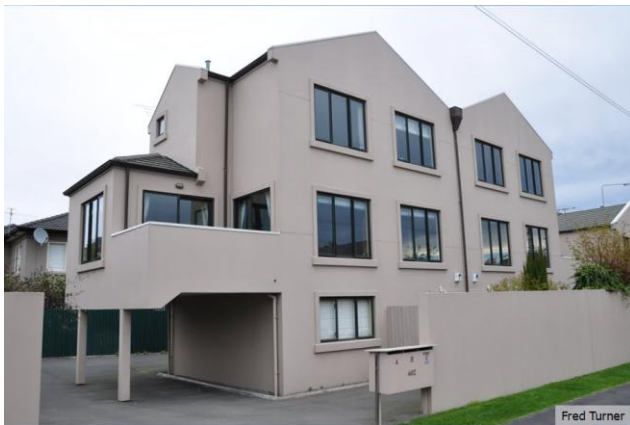
Fresh evidence was observed of vertical impact from a house superstructure on a pole frame foundation, confirming that the vertical component of the earthquake may have been sufficient to lift the superstructure and drop it back onto its supporting structure (Figure 31).

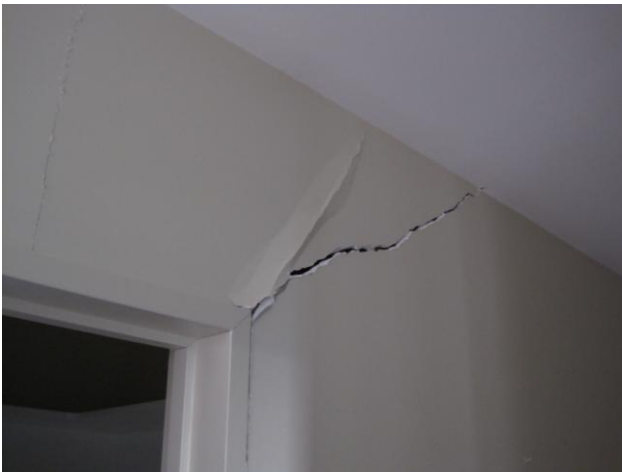
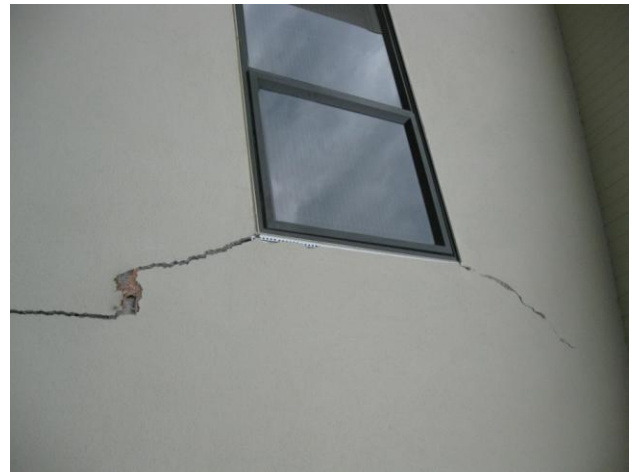
Figure 34: *(Left) Interior lining damage to steel framed house, and (Right) Exterior cladding damage to steel framed house (Carradine).*

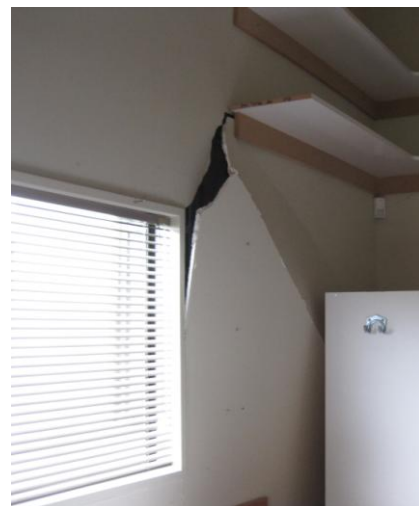
Figure 35: *Damage to plasterboard bracing sheet glued to steel studs with no screws.*

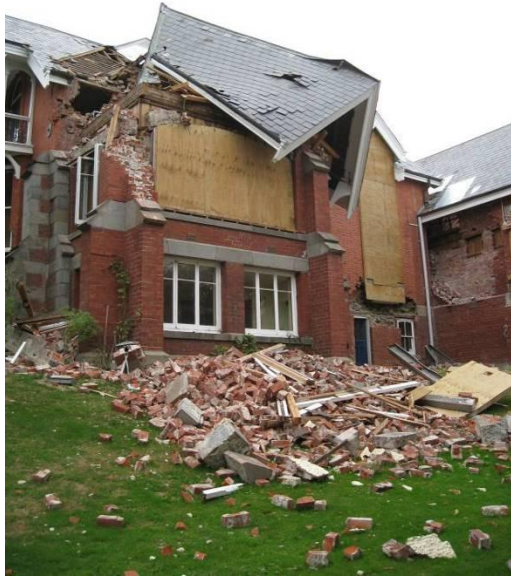
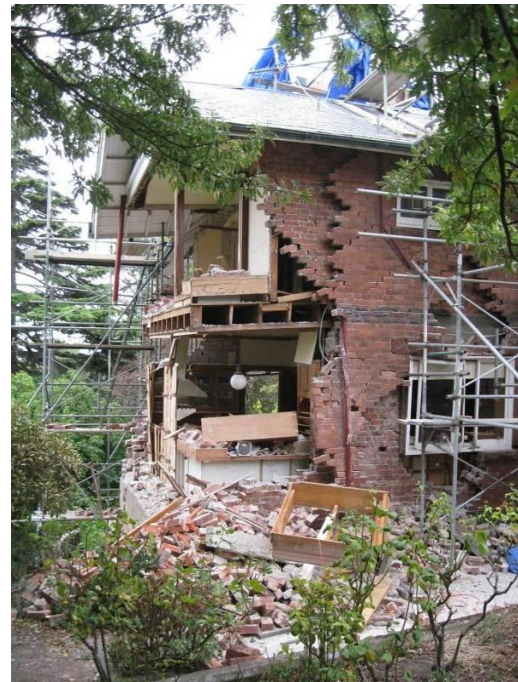
Figure 36: *Examples of partial collapse of double brick houses (Carradine).*

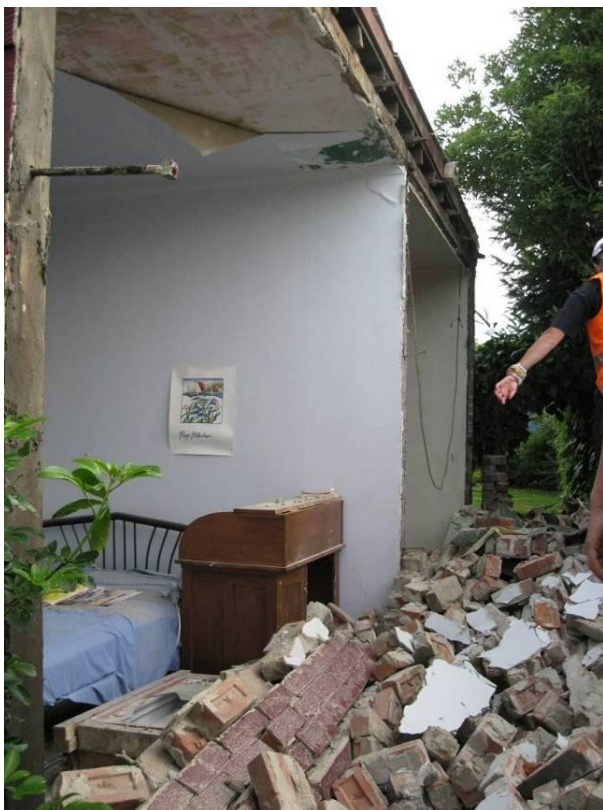
Figure 37: *Failure of brick fire wall near city centre (Carradine).*

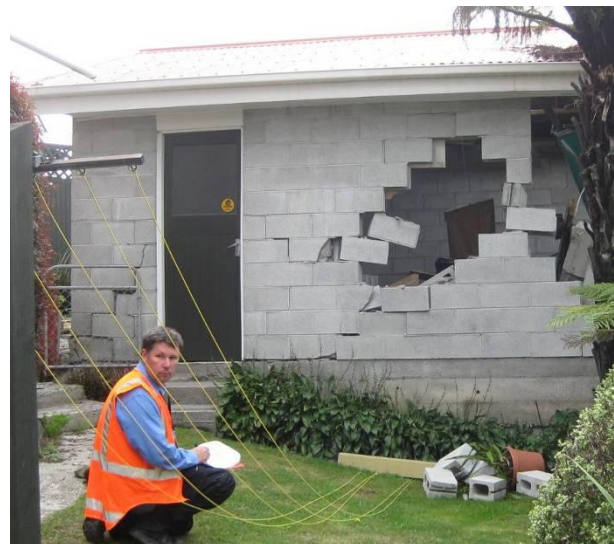
Figure 38: *UngROUTED cells with reinforcing steel in place (Beattie).*

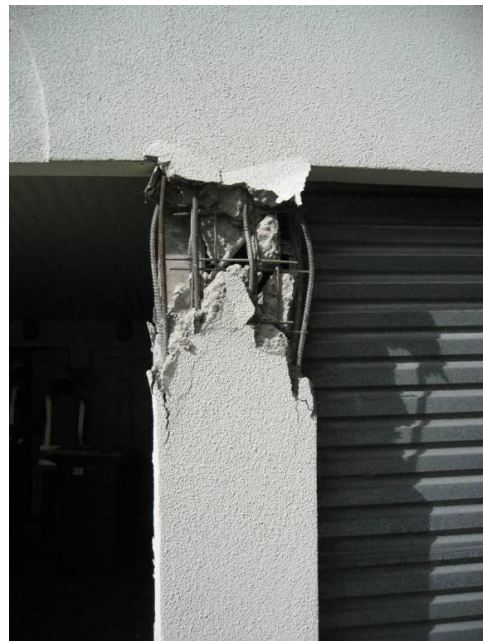
Figure 41: Compression failure of tilt-panel concrete house (Carradine).

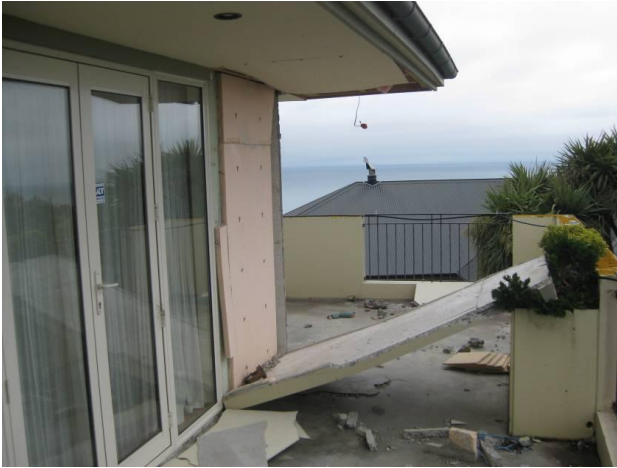
Figure 42: Failure of a concrete sandwich panel wall system (Beattie).

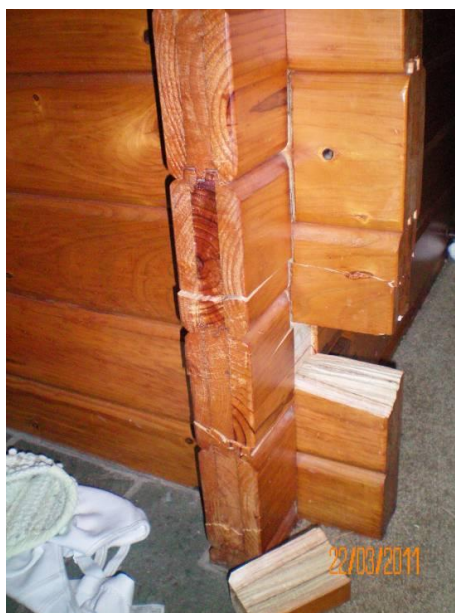
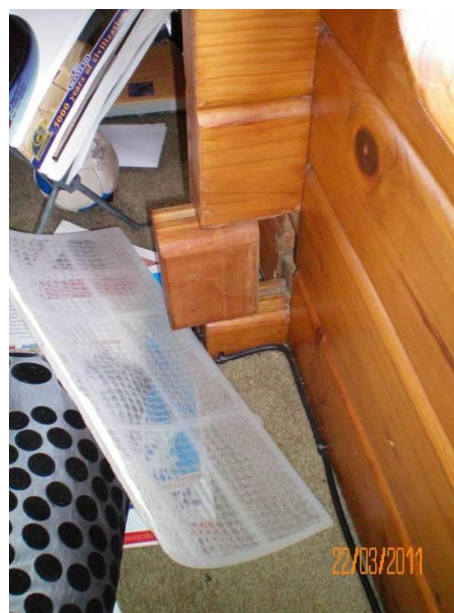
Figure 43: Examples of damage to Fraemohs home located near Dyers pass (Love).

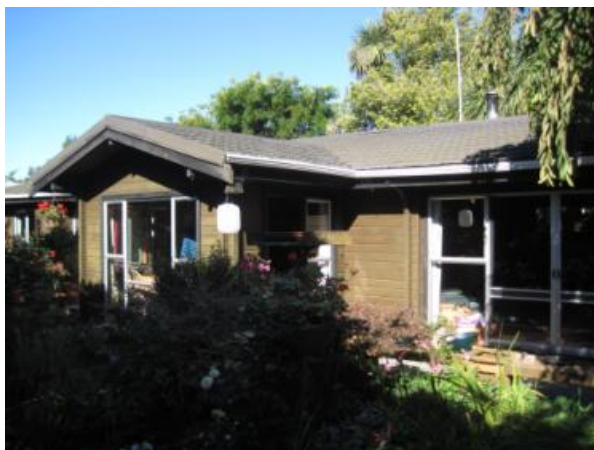
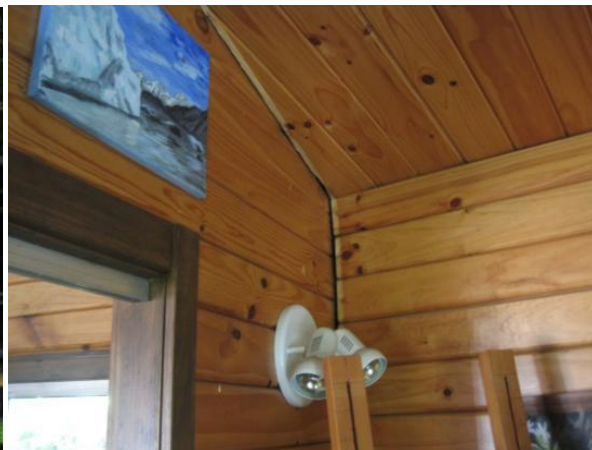
Figure 44: Minor damage to interior of Fraemohs house despite serious liquefaction and differential settlement (Buchanan).
