## THE M8.8 CHILE EARTHQUAKE, 27 FEBRUARY 2010

### SUMMARY

This report summarises the observations of the NZSEE/EQC teams, supplemented by media updates on the Chilean reconstruction experience one year after the earthquake.

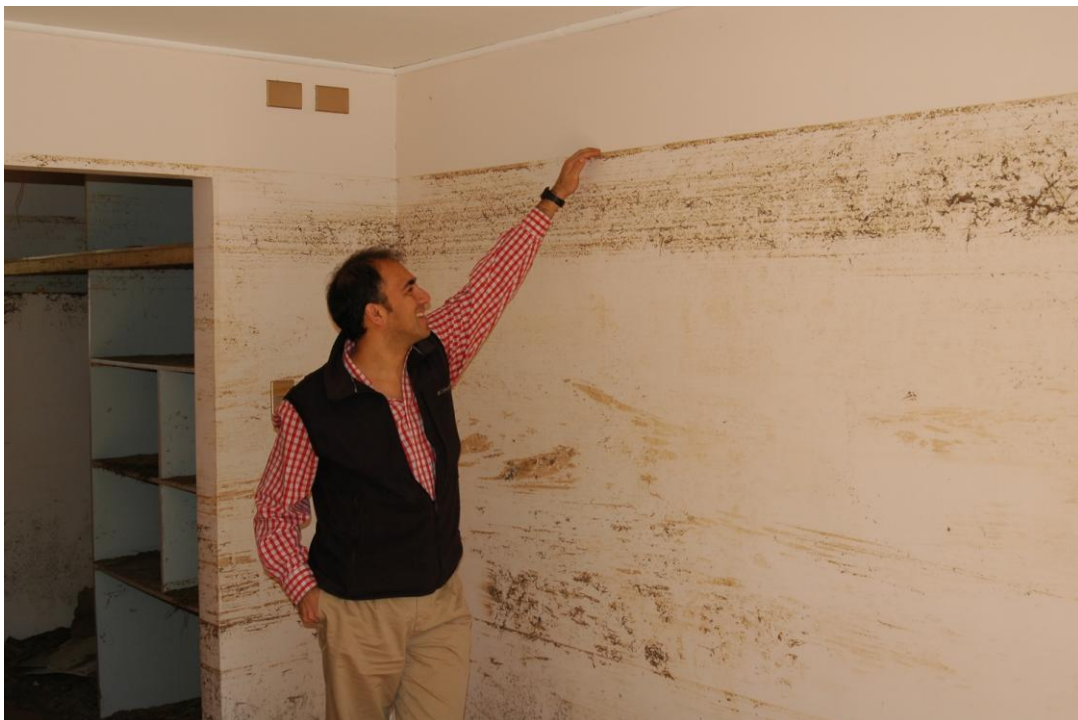
*Figure 2.2b: Tsunami fill-depth of ~2 m in homes at the coastal resort of El Pingueral, north of Concepción. (Photo: Hugh Cowan).*

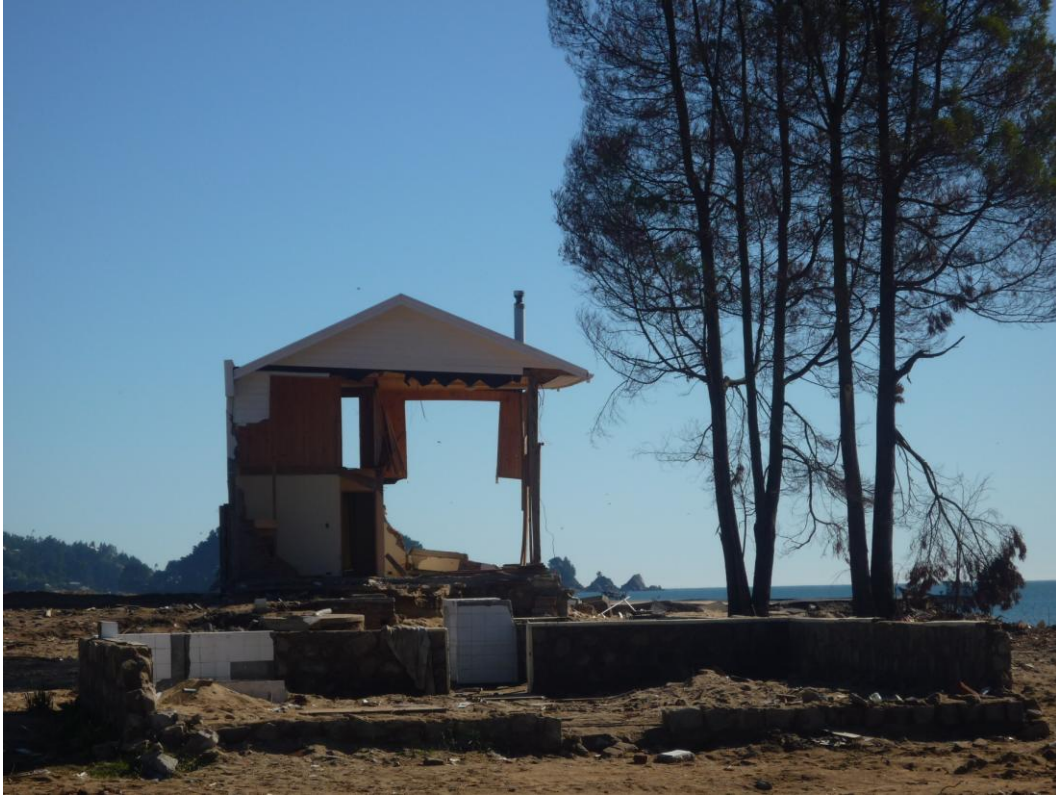
*Figure 2.2c: Complete destruction of coastal dwellings where the tsunami came ashore at Dichato, north of Concepción. (Photo: Katherine Hill).*

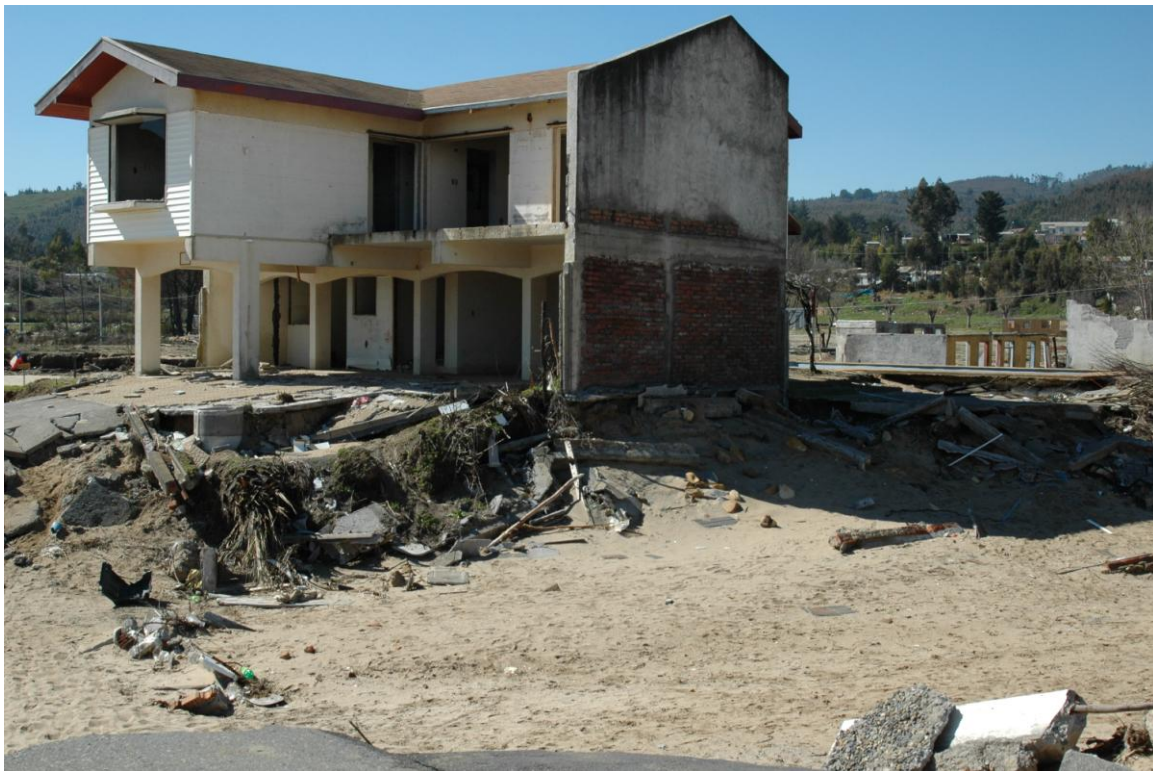
*Figure 2.2d: Receding water caused severe scouring of foundations beneath coastal structures at Dichato. (Photo: Hugh Cowan).*

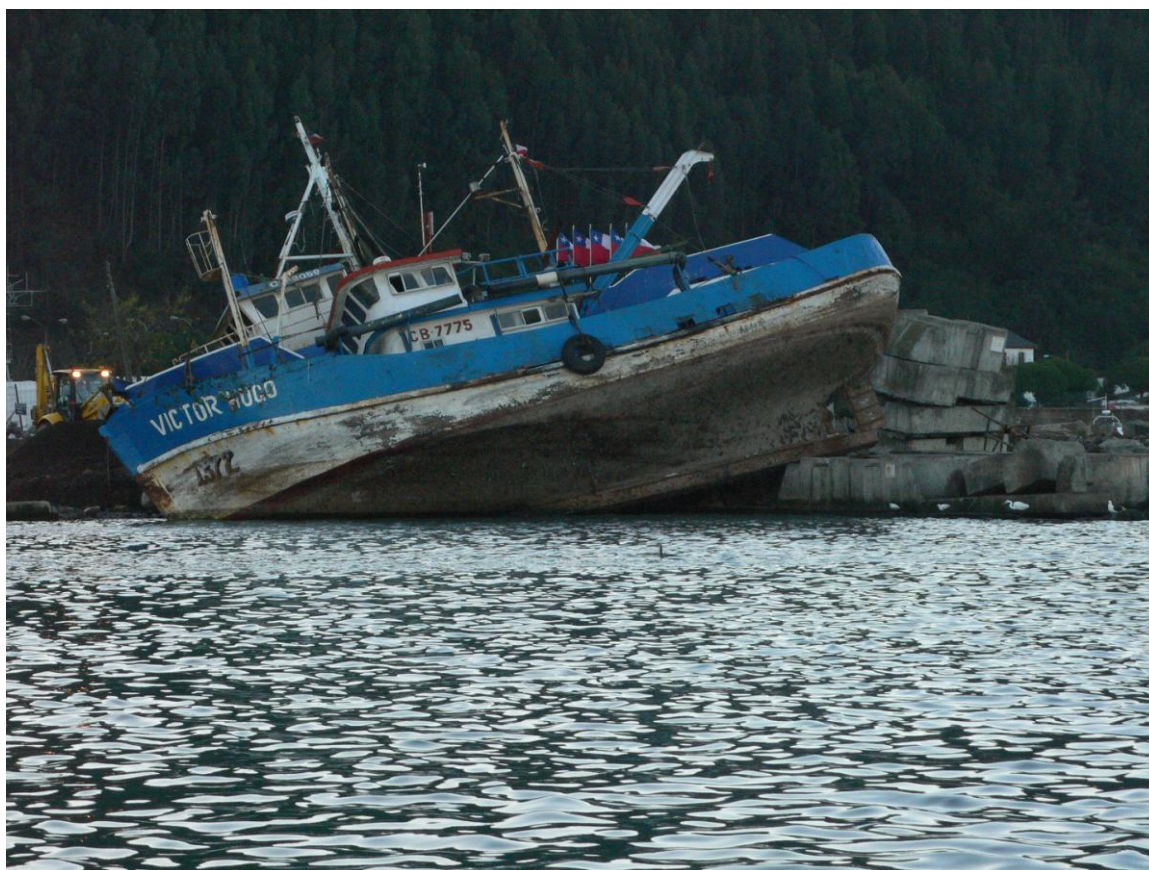
*Figure 2.2e: The tsunami carried many vessels ashore, severely impacting local maritime transport and trade. (Photo: Graeme Beattie).*

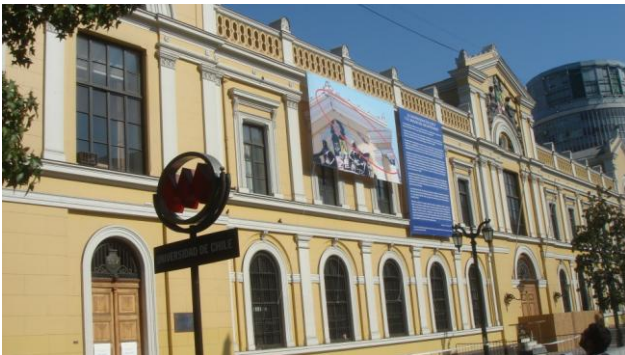
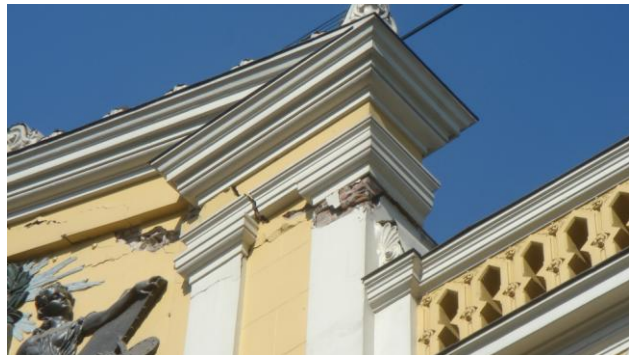
*University of Chile, Santiago.*

*Damaged parapets to above.*

Due to a lack of legislative requirements for securing of what we would classify as earthquake risk buildings, parapets and other appendages were typically still present and were often damaged or failed during the earthquake. Fortunately the earthquake occurred in the early hours of the morning and the failures did not result in any significant loss of life.

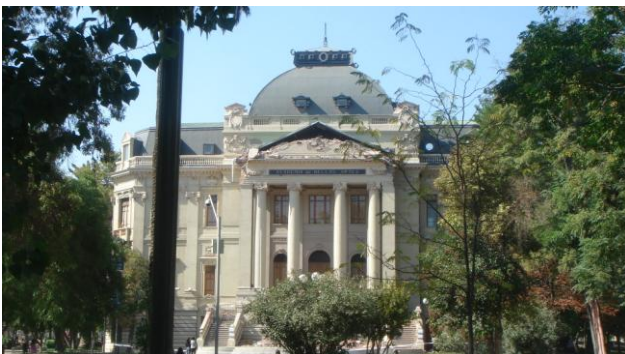
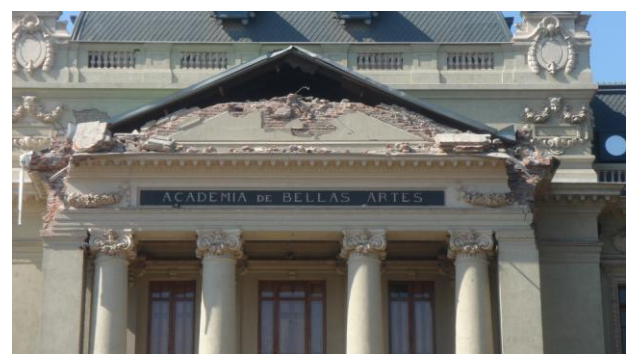
*Academia de Bellas Artes, Santiago.*

*Failed parapet Academia de Bellas Artes, Santiago.*

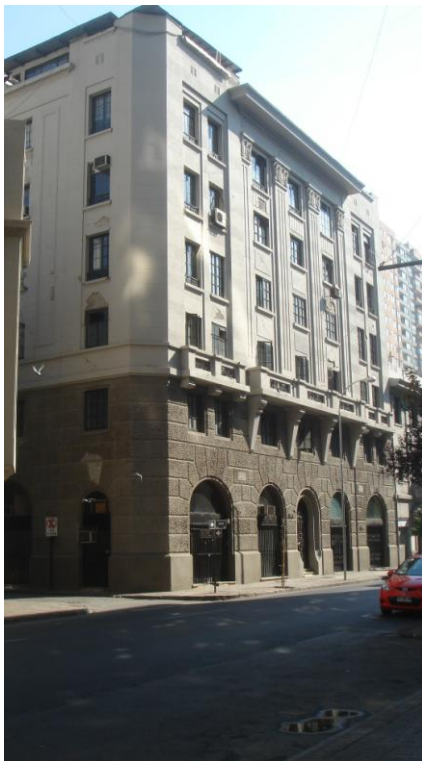
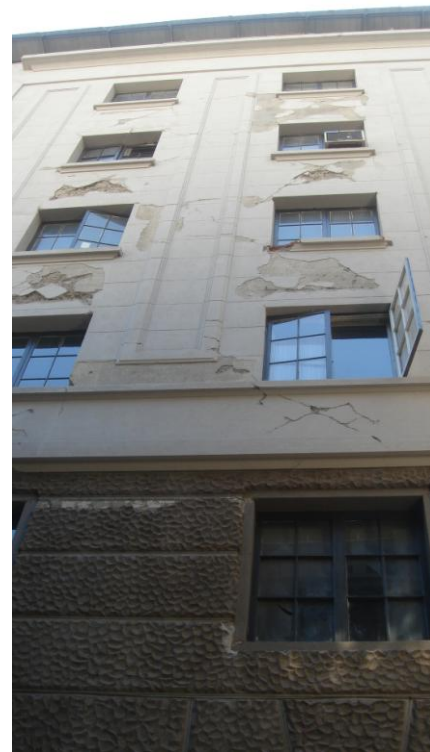
*Damaged spandrels to early reinforced concrete building in central Santiago.*

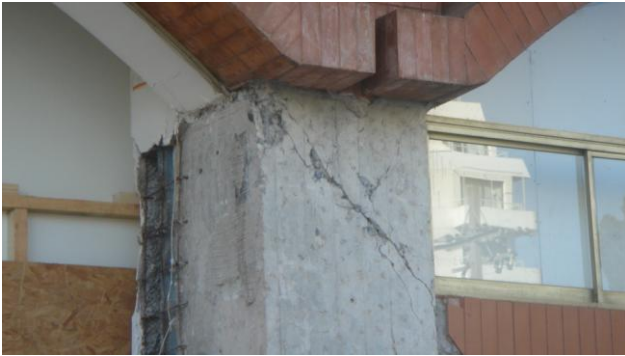
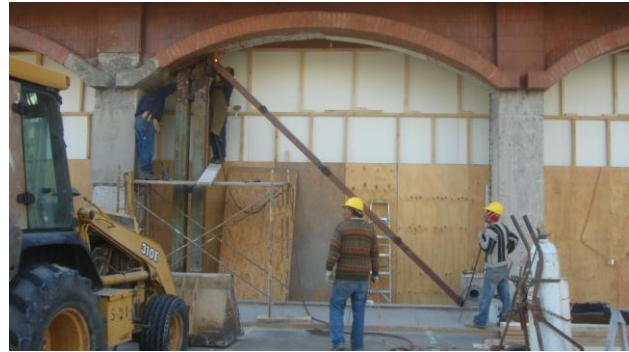
*Low-rise commercial building with shear failure of columns due to non-isolation of infill walls, Valparaíso.*

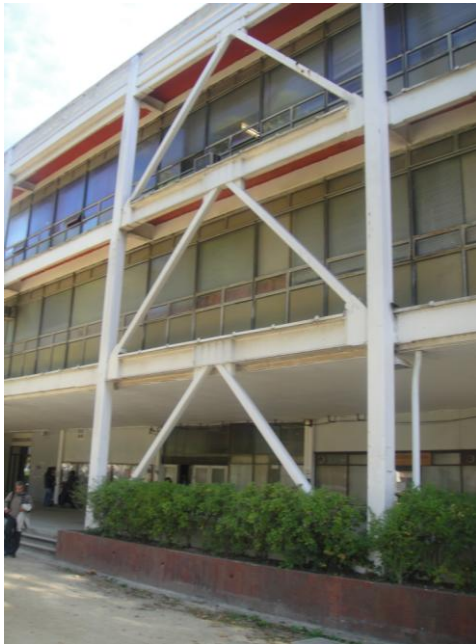
*Steel K braced retrofitted to three-storey building at University of Concepción.*

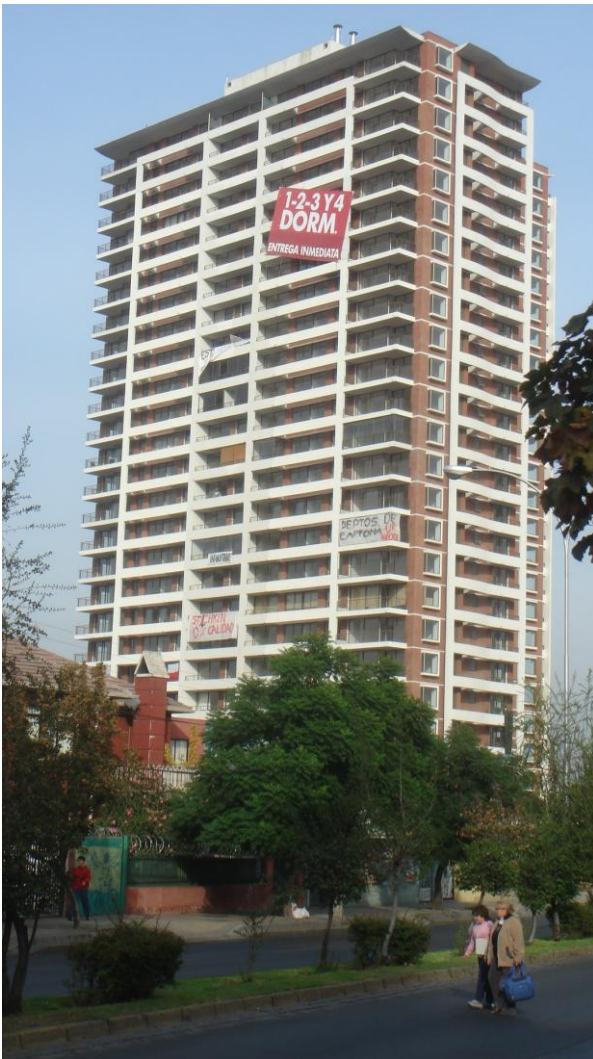
*Los Cerezos Apartment building in Santiago.*

Detailing of these walls is understood to have been in accordance with pre 1995 ACI requirements. Typically the tension and compression reinforcement was inadequately confined and wall thicknesses of 200 mm were used for 16 storey and 250 mm were used for up to 25 storey buildings (Figure 5.3a).

These walls typically failed in flexure with horizontal cracking below first floor level. The failure mechanism demonstrated the potential for buckling of the vertical reinforcement to cause spalling of the cover concrete. With the cover concrete spalled and the compression reinforcement ineffective due to buckling, there was a significant reduction in the area of concrete left to resist the compression load and the concrete core remaining being unconfined, resulted in progressive failure of the remaining concrete core resulted in a vertical failure of the wall. Where the outer edge of transverse walls were supported on lightly reinforced columns, the significant load induced under overturning of the shear wall above resulted in column failure.

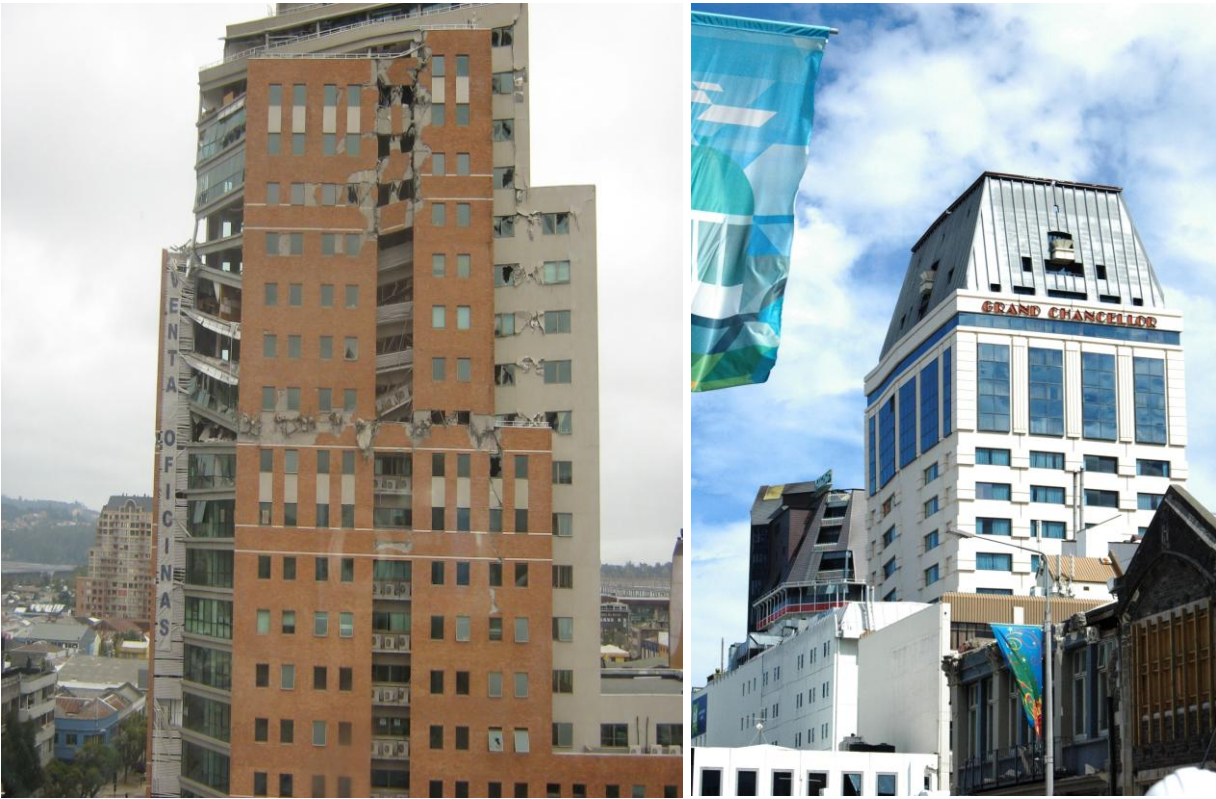
**Figure 5.3b:** *The partial collapse of large commercial buildings, such as the O'Higgins Tower of Concepción, Chile (left) and the Grand Chancellor Hotel of Christchurch, New Zealand (right) highlights the vulnerability of surrounding areas to prolonged denial of access and business interruption. (Photos: Hugh Cowan).*

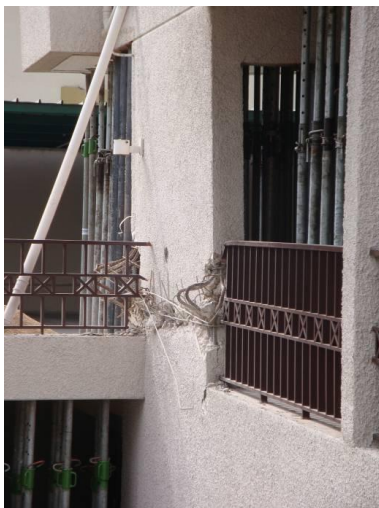
A large number of multi-storey apartment buildings inspected in Chile had thin shear wall elements that suffered significant damage in the lower storeys. Flexural-compressive shear wall damage was commonly observed at the lower levels of multi-storey apartment buildings affected by the earthquake. In one case in Vina del Mar a shear wall had crushed and collapsed completely, leading to the portion of the building supporting it dropping over 600 mm (Figure 5.3c). In another spectacular case the use of columns with a low level of confinement under the outer edge of alternate shear walls led to the total overturning collapse of a 13-level apartment building in Concepción (Figure 5.3e). The principal reasons for the poor performance appeared to be the inadequate confinement of the

**Figure 5.3:** *(c - left) Collapse of a shear wall in a multi-storey apartment block in Viña del Mar. (d - right) Use of temporary props in another damaged apartment block. (Photo: Graeme Beattie).*

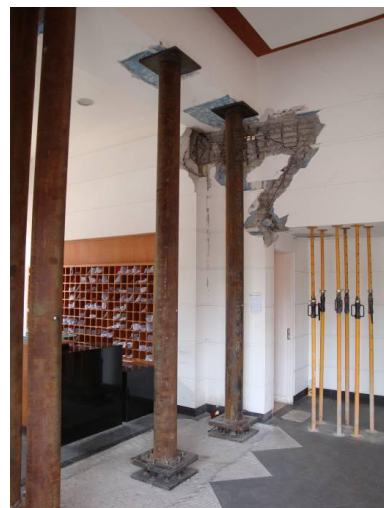
Some effective emergency propping systems had been used to secure damaged buildings and prevent further damage until permanent repairs could be designed and implemented (Figure 5.3d).

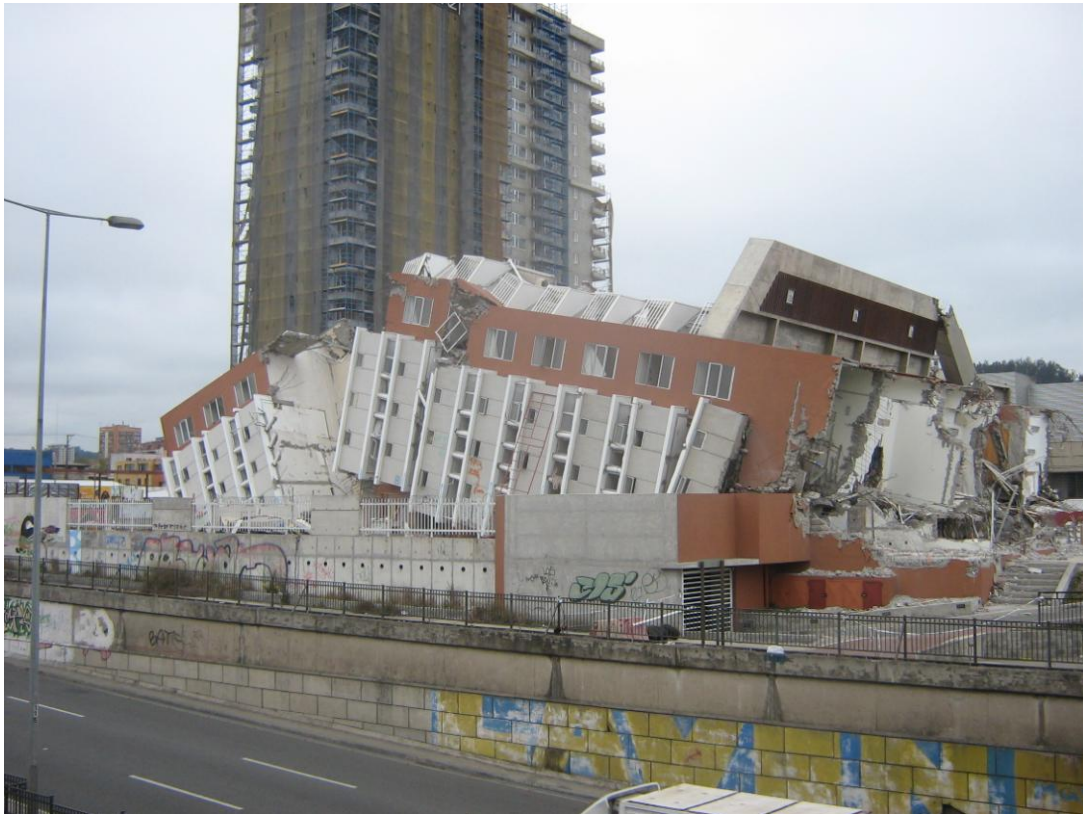
*Figure 5.3e: Catastrophic failure of the multi-storey “Alto Rio” apartment block in Concepción. (Photo: Hugh Cowan).*

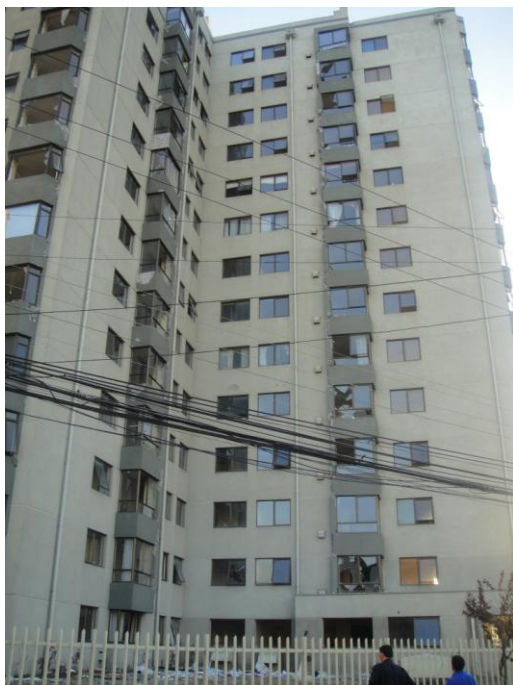
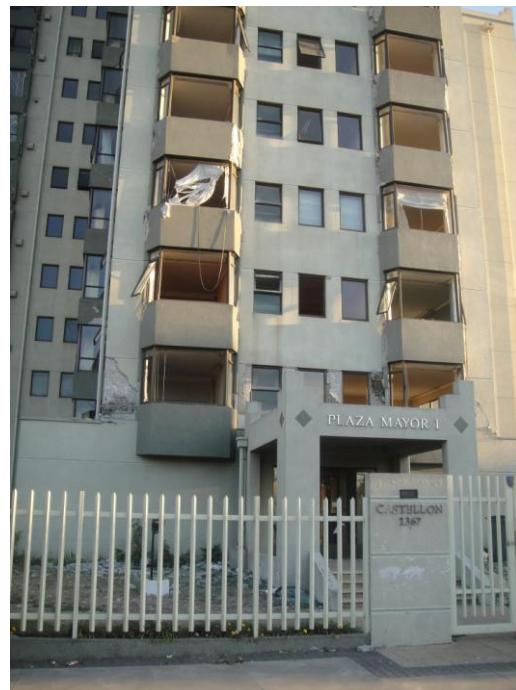
The significance of the direction of the primary earthquake pulse relative to the plan orientation of building was evident in the Plaza Mayor apartment complex where a series of 5 essentially identical apartment buildings with different orientation suffered significantly variable damage (Figure 5.3f).

*Damaged tower to Plaza Mayor building.*

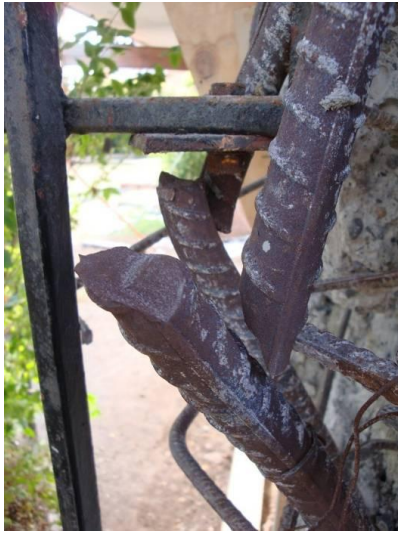
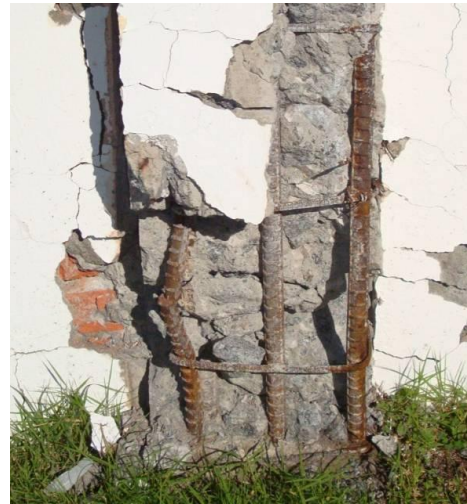
In some locations where shear wall or column failures had occurred, brittle fractures in flexural reinforcing steel were also evident (Figures 5.3g and h). These appeared to be linked to localised cyclic buckling and partial re-straightening of the reinforcing steel. This occurred where confining steel had

failed to fulfil its function of retaining the core concrete in place or where the tie spacing was perhaps too large relative to the diameter of the bar being confined. The long duration of strong cyclic ground motion in this earthquake may have been a factor in causing this mode of damage. With this in mind for

*Figure 5.3g and 5.3h: Fractured reinforcing steel in single storey reinforced concrete frame (left) and damaged shear wall (right). (Photos: Clark Hyland).*

New Zealand application, the standard multi cycle loading regime, using cycles with increasing displacement should be reviewed to ensure that member degradation is being accurately assessed.

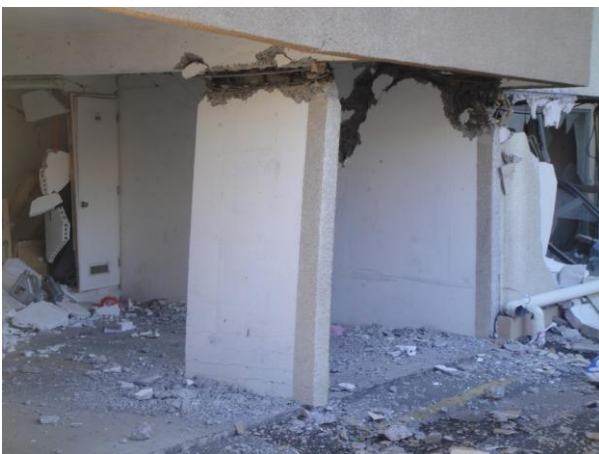
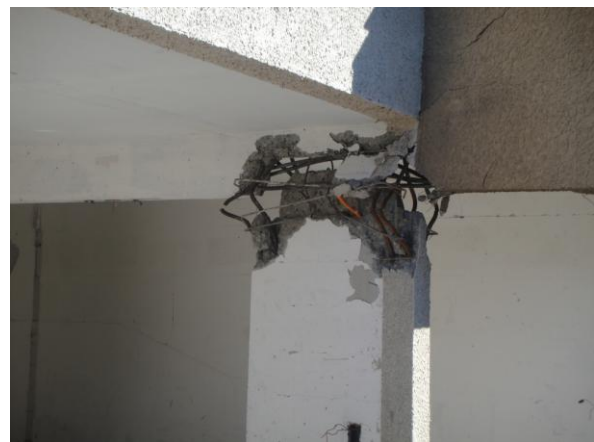
The need for shear walls to be detailed to prevent buckling of tension and compression reinforcement in areas where inelastic deformations are expected and to confine the core concrete that must provide an essential part of the compression resisting structure was amply demonstrated in the structural failures in Chile (Figure 5.3i).

*Figure 5.3i: Shear wall failures, Plaza del Rio, Concepción. (Photos: Peter Smith).*

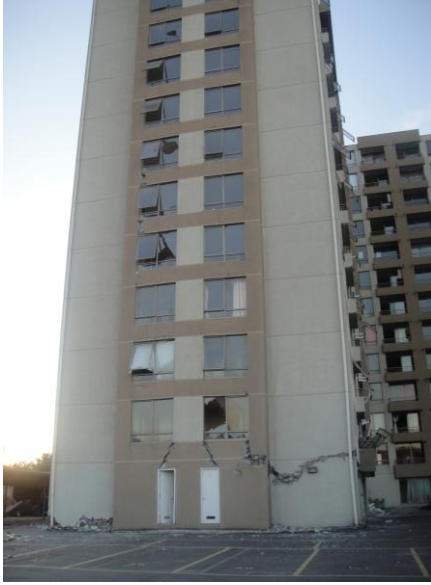
*Shear wall failure, Plaza del Rio, Concepción.*

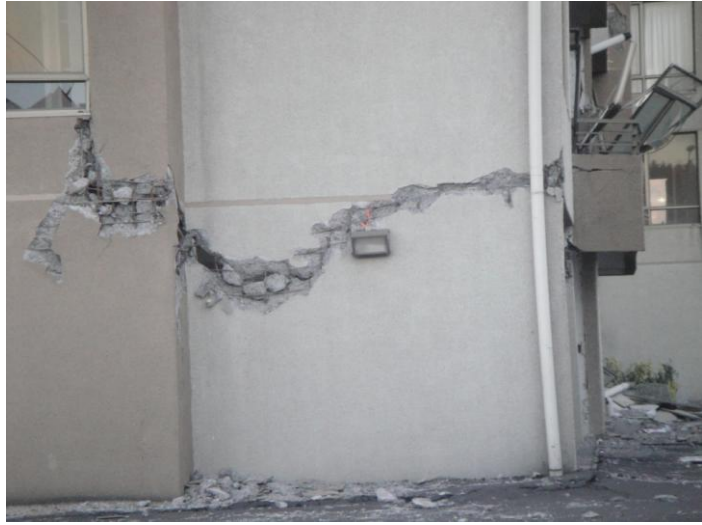
*Shear wall failure, Plaza del Rio Apartments, Concepción.*

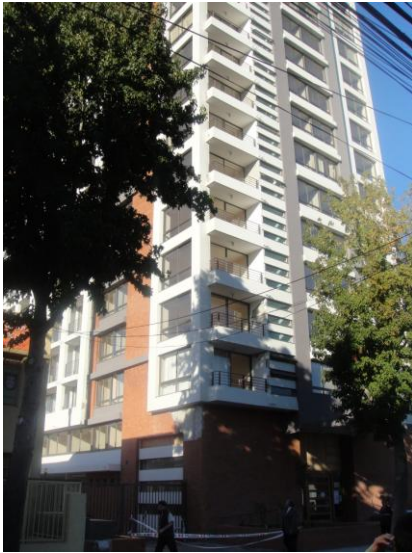
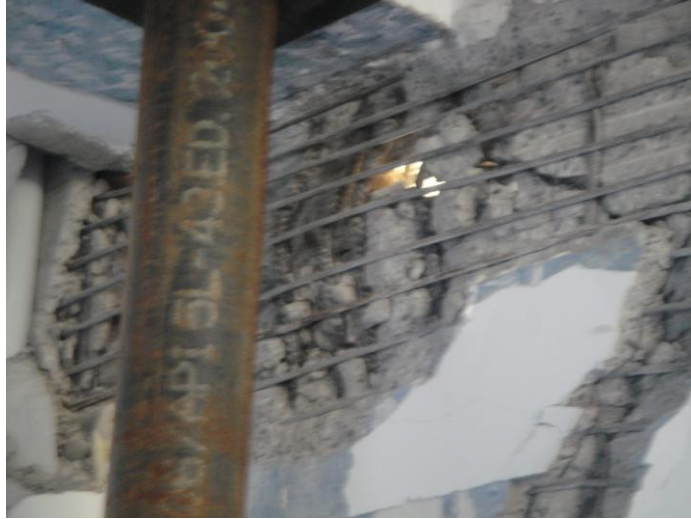
*Apartment building, Santiago.*

*Failed shear wall in apartment building shown to the left, Santiago.*

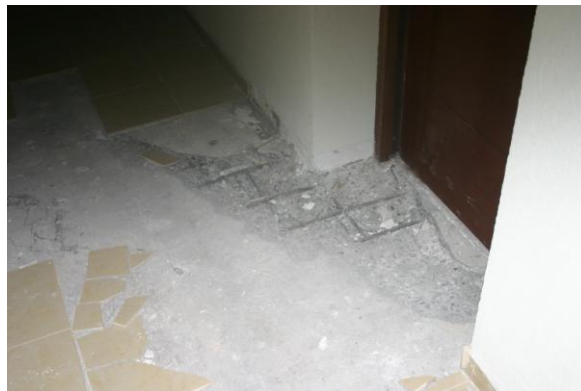
action is thought to have resulted in high compression forces in the in-situ floors between walls, actions, which are not considered in the analysis of the building (Figures 5.3j and 5.3k).

*Figure 5.3k: Floor slab shear damage at end of shear walls in an apartment building in Concepción. (Photo: Clark Hyland).*

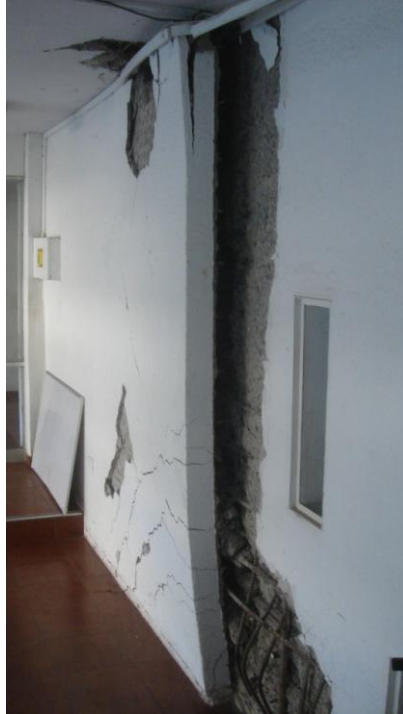
a thickening against damaged walls (Figure 5.4a). Where the construction could be identified the tie to the existing wall was nominal consisting of 6 mm pins at 200 mm c/s around the perimeter. The strengthening was inadequately pinned to the original construction and delaminated.

*Figure 5.4a: Shear wall delamination – Festival Apartment Building.  
(Photo: Peter Smith).*

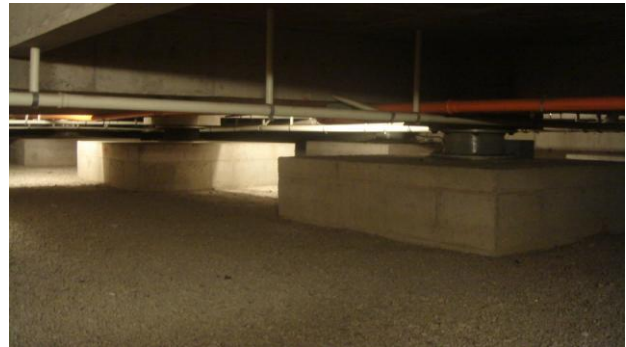
Several important buildings are base isolated. The Catholic University building in Santiago suffered very minor damage and had a permanent deformation in the lead rubber bearings (Figure 5.5b).

*Permanent offset of lead rubber bearing Catholic University of Chile building.*

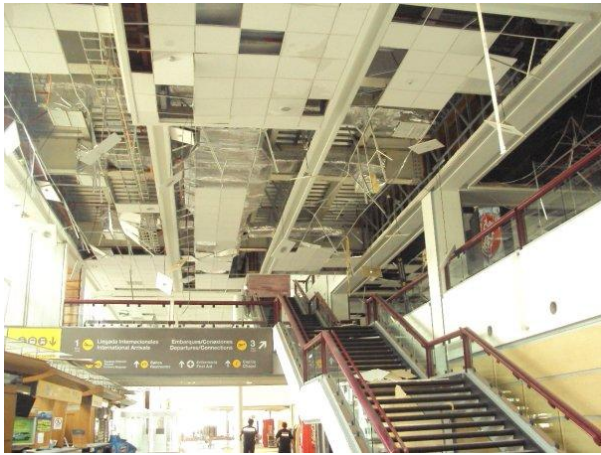
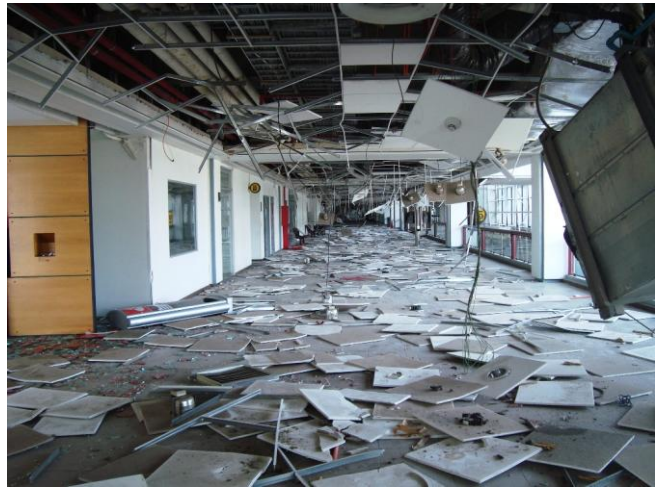
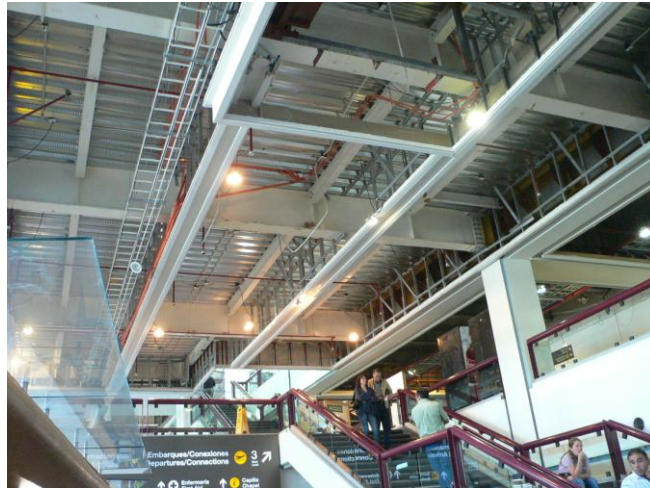
Figure 5.7a, b & c: Loss of ceiling tiles and damage to ceiling mounted equipment at Santiago International Airport.

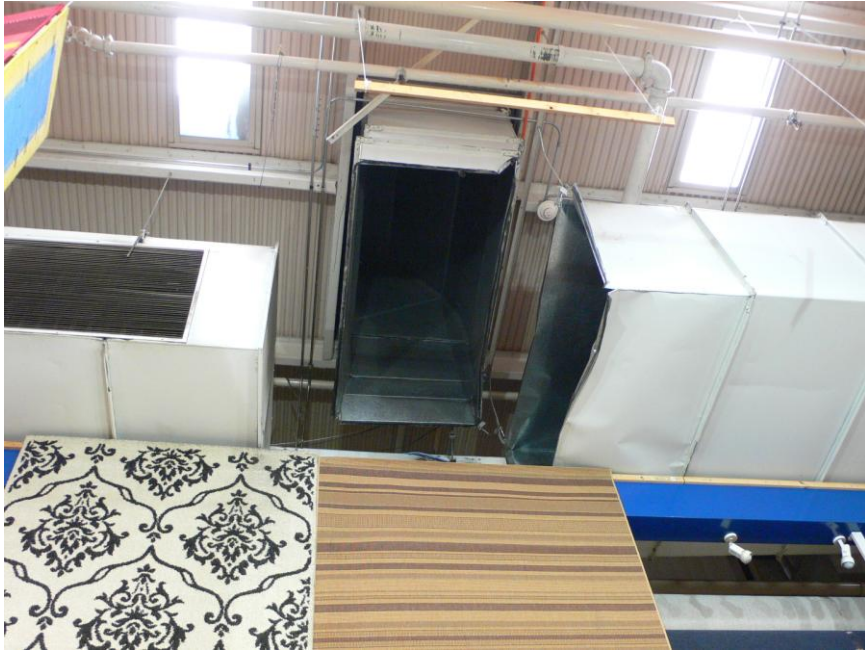
Figure 5.7d: Santiago International Airport - air handling fan missing and damaged ducting. (Photo: Graeme Beattie).

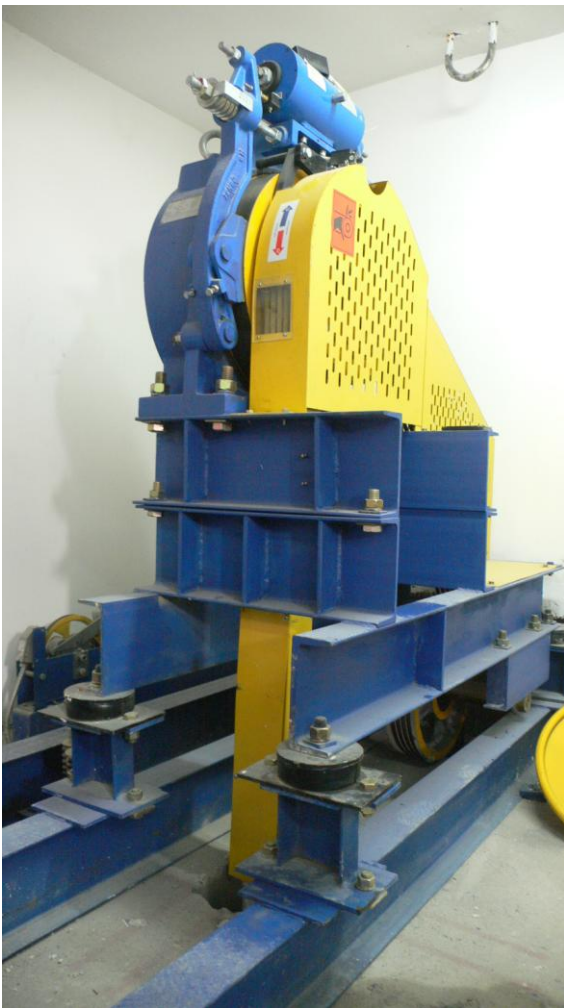
(e) Motor still well restrained.

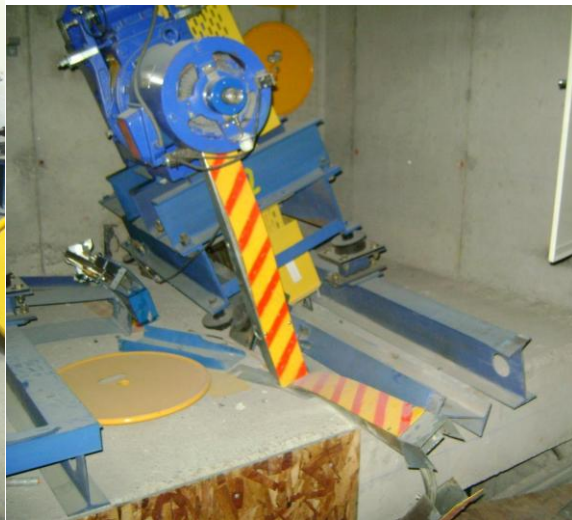
(f) Motor mounting has failed.

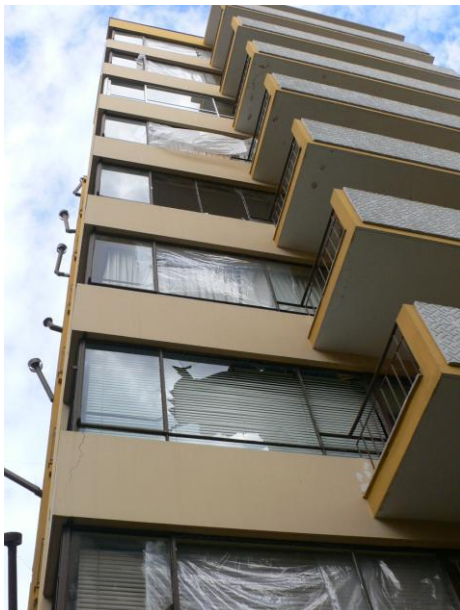
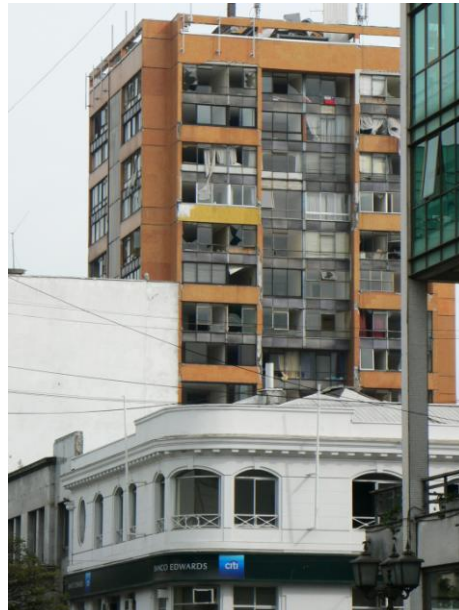
*Figure 5.9a: Examples of buildings in Concepción with broken exterior glazing. (Photos: Graeme Beattie).*

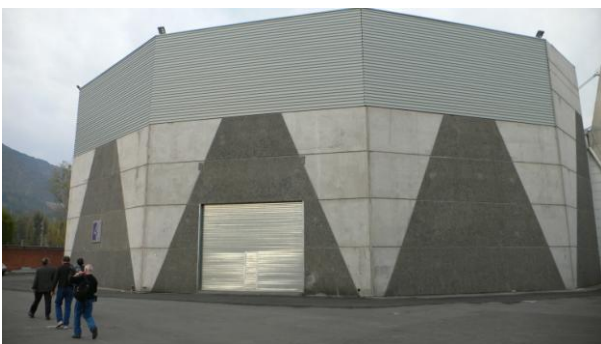
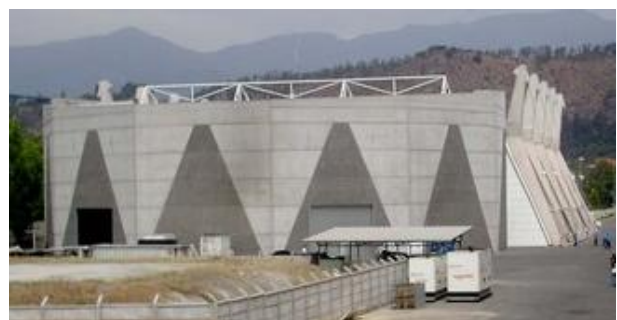
*Figure 5.10: (a) Precast panels with flimsy connections toppled at this convention hall near Santiago; (b) the same building before the earthquake. (Photo: G. Beattie and Juanelo242, Google Earth, respectively).*

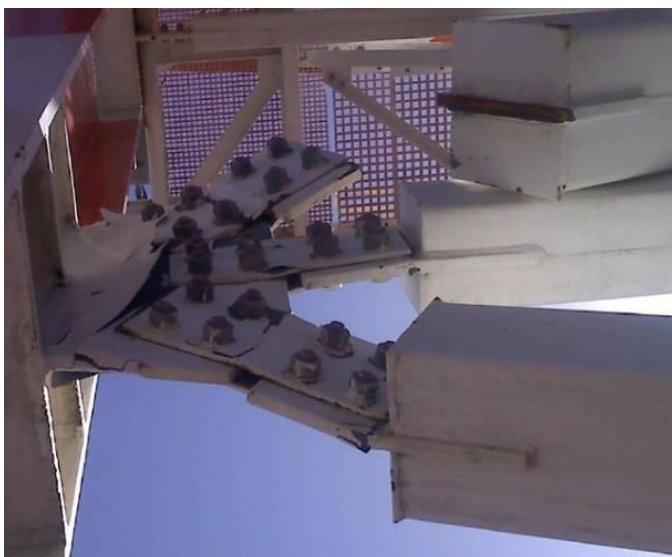
*Figure 5.12a: Fractured steel bracing cleat. (Photo: Carlos Aguirre).*

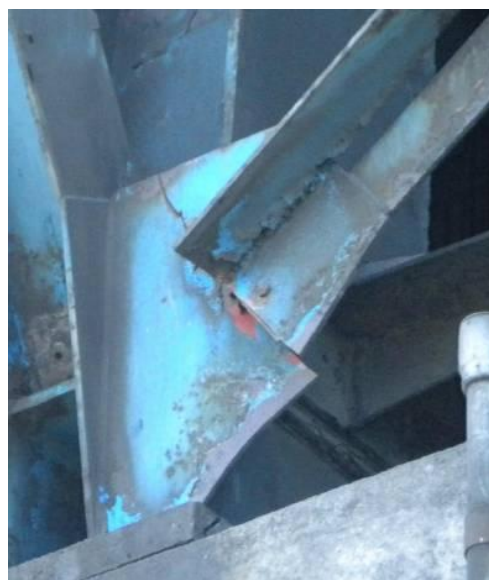
*Figure 5.12b: Fractured steel gusset plate connected to a chevron-braced frame. (Photo: Carlos Aguirre, UTFSM).*

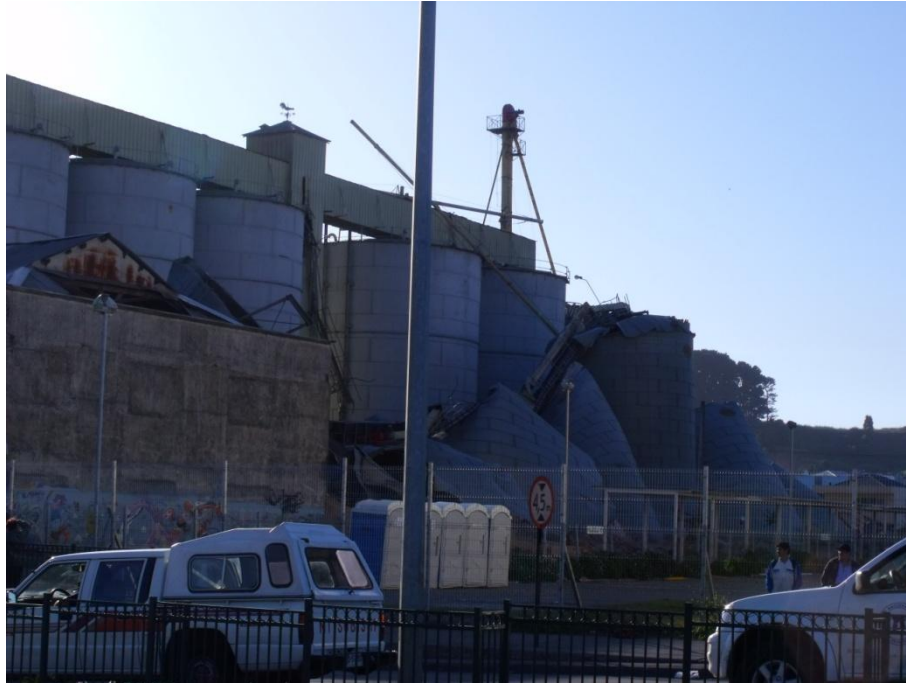
*Figure 5.12c: Collapsed grain Silos in Concepción. (Courtesy of A. García).*

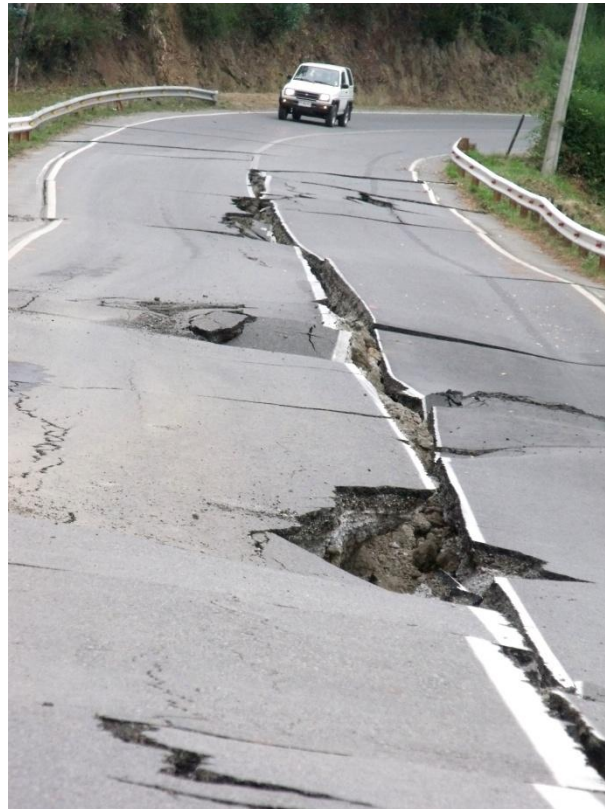
*Figure 8.1: Damaged road near Concepción. (Courtesy of A. García).*

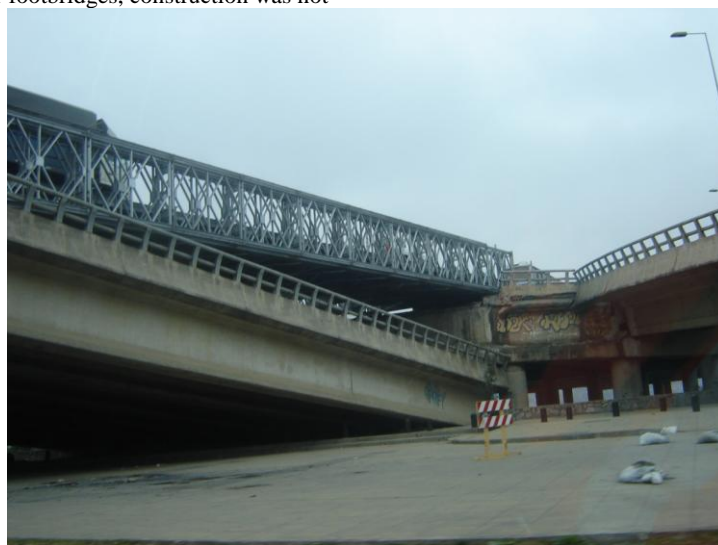
Figure 8.2: Bridge deck collapse and a bailey span repair in Concepción. (Photo: Graeme Lawrence).

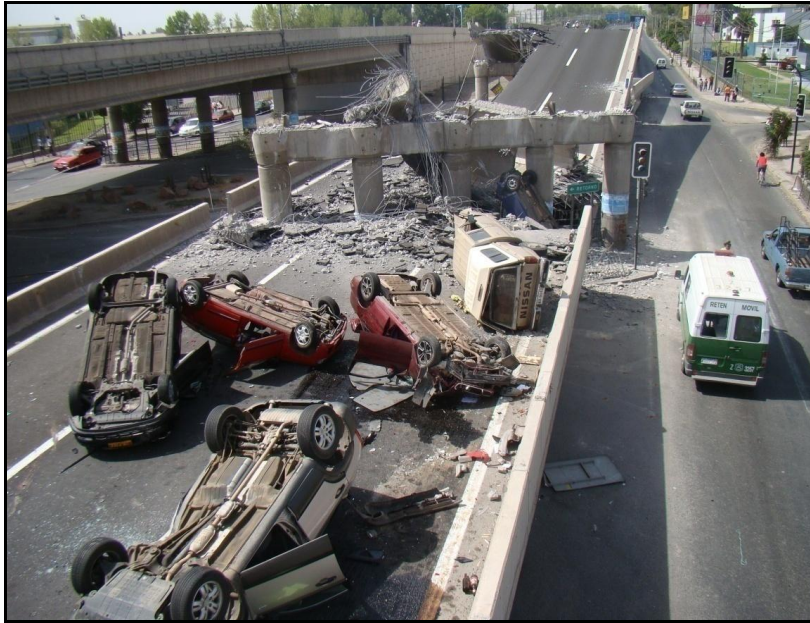
**Figure 8.3:** Collapse of a bridge deck on the Santiago ring-road “Vespucio Norte”, due to lateral rotation of the obliquely-seated deck and absence of diaphragms. (Photo: Ministerio de Obras Públicas).

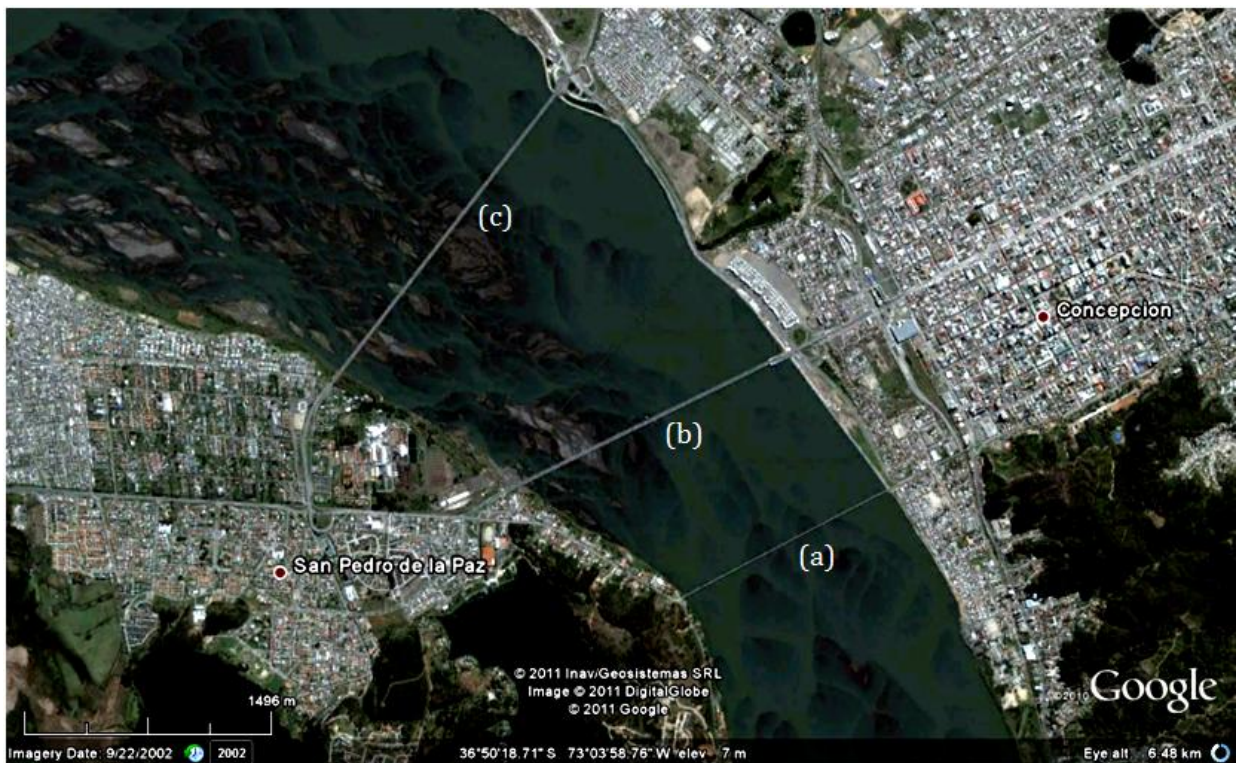
**Figure 8.4:** Damage to the bridges crossings Bio Bio River in Concepción imposed severe constraints on traffic flow, retarding the initial recovery effort. (a) Puente Viejo road bridge, (b) Llacolén road bridge and (c) Juan Pablo II road bridge. (Image: Google Earth).

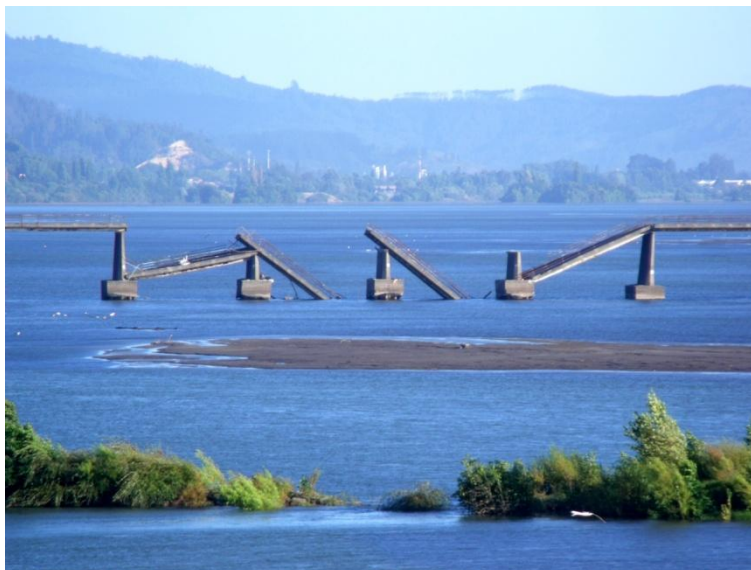
*Figure 8.5: Collapsed bridge across Bio-Bio River. (Courtesy of A. García).*

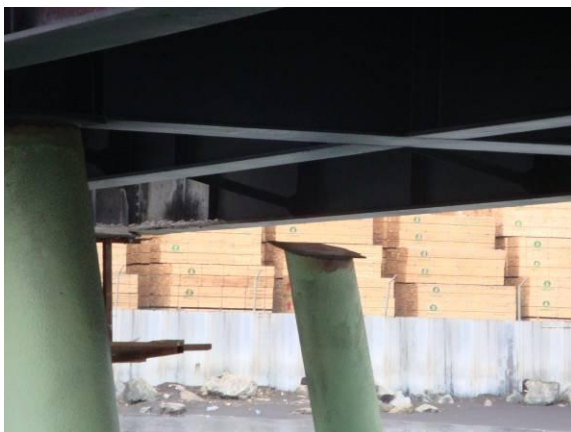
**Figure 8.7a:** *Pile heads broken away from wharf deck steelwork at Puerto Coronel. (Photo: Clark Hyland).*

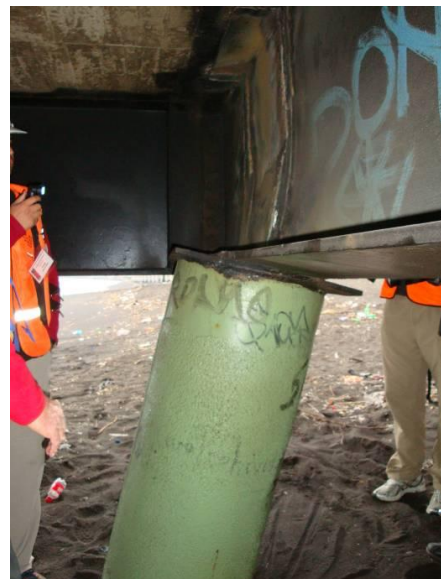
**Figure 8.7b:** *Pile head deformed due to abutment shunting caused by liquefaction. (Photo: Clark Hyland).*
