## THE M8.8 CHILE EARTHQUAKE, 27 FEBRUARY 2010

### SUMMARY

This report summarises the observations of the NZSEE/EQC teams, supplemented by media updates on the Chilean reconstruction experience one year after the earthquake.

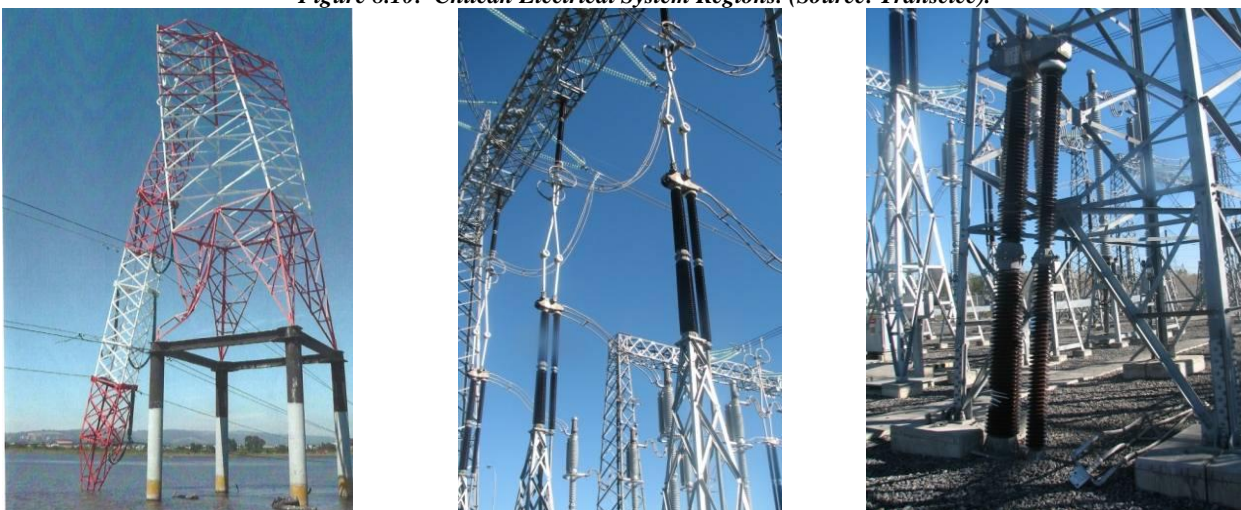
Figure 8.11: Concepción – San Vicente 154 kV pulled over transmission tower (left); Charrua Substation - In service (centre) and failed (right) disconnectors. (Photos: Transelec).
