## GENERAL OBSERVATIONS OF EFFECTS OF THE 30th SEPTEMBER 2009 PADANG EARTHQUAKE, INDONESIA

**Jitendra Bothara<sup>1</sup>, Dick Beetham<sup>2</sup>, Dave Brunson<sup>3</sup>, Mike Stannard<sup>4</sup>, Roger Brown<sup>5</sup>, Clark Hyland<sup>6</sup>, Warren Lewis<sup>7</sup>, Scott Miller<sup>8</sup>, Rebecca Sanders<sup>9</sup> and Yakso Sulistio<sup>10</sup>**

### SUMMARY

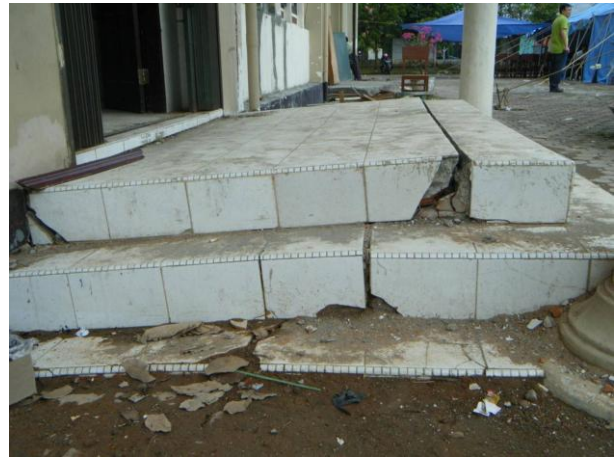
**Figure 3.1:** Settlement damage to building steps.

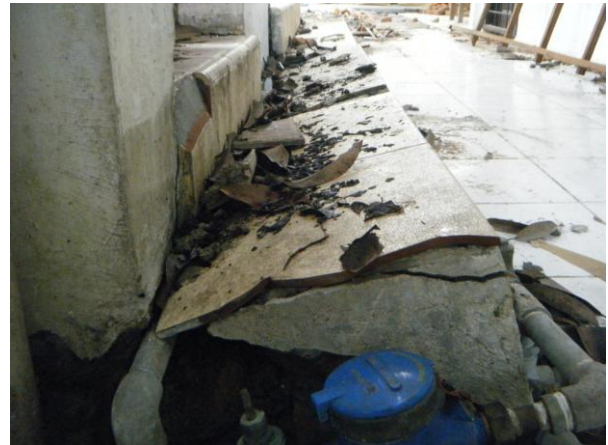
**Figure 3.2:** Settlement damage to a large building due to liquefaction and expulsion of water and fine sand. Buildings on sand strata near drains, creeks and rivers suffered from failure due to lateral spreading of soil. In one case half the length of a classroom building had dropped 800 mm compared to the other half.

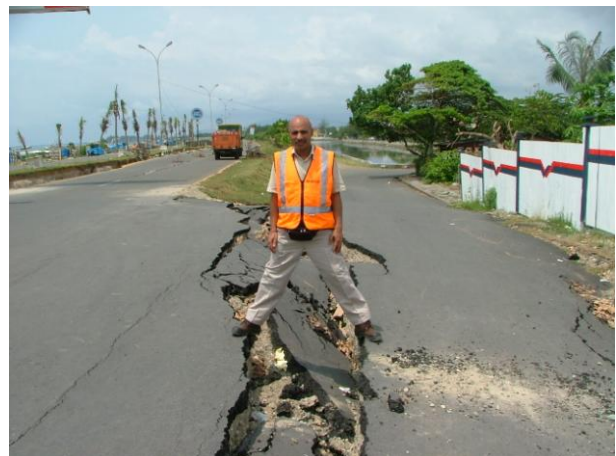
**Figure 3.3:** Lateral spreading and settlement of the present-day beach ridge. The ocean is to the left and a lagoon area to the right.

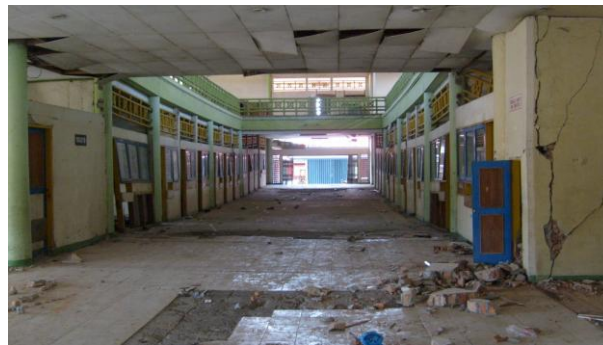
**Figure 3.5:** Differential settlement of foundation and floors of the Padang Bus Terminal has strained and deformed the entire building.

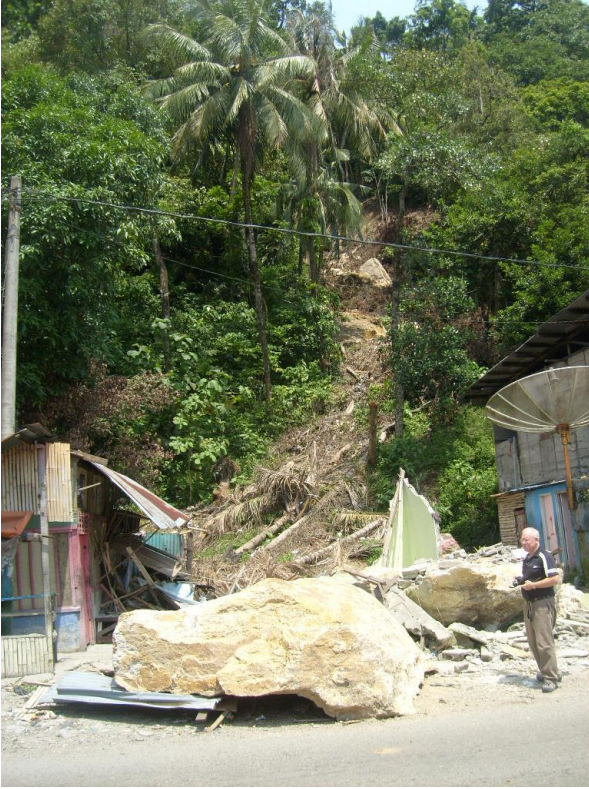
**Figure 3.6:** *Rock fall from steep slopes behind the port of Telukbayur, some 12 km to the south of Padang city. Previous rockfalls were evident along the foot of these slopes.*

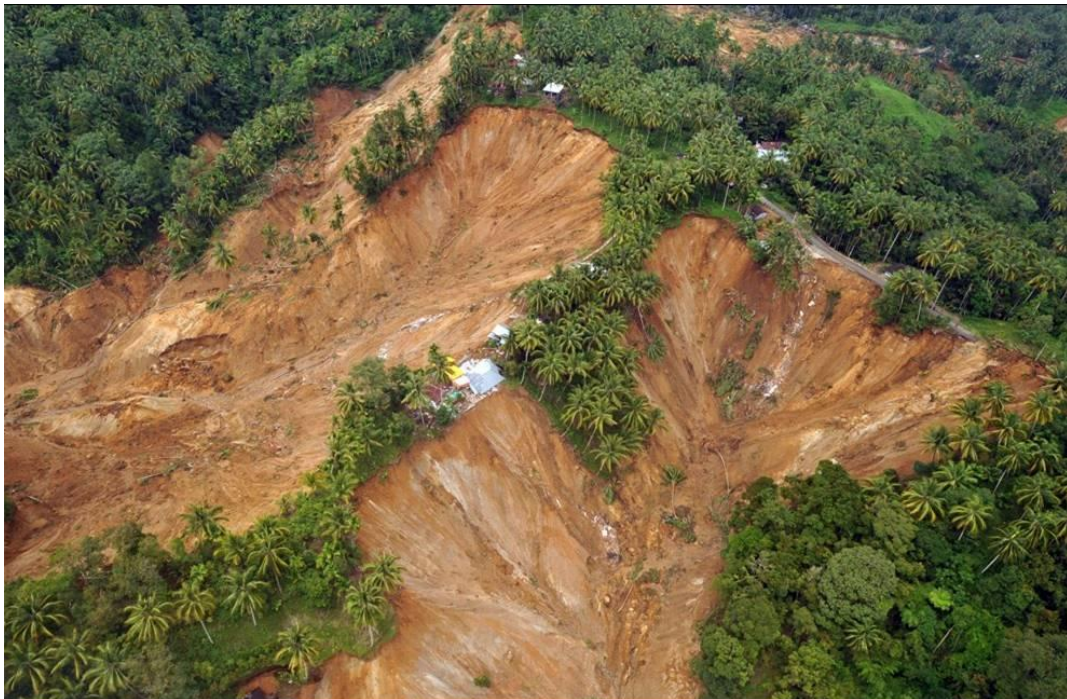
**Figure 3.8:** *Slope failures in volcanic tuffs some 70 m deep triggered by the earthquake. These unexpected earth flows from moderately steep slopes buried several villages and killed more than 600 people.*

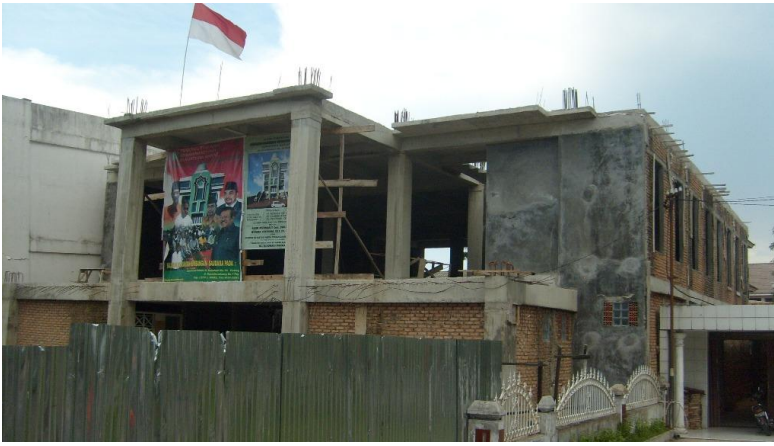
*a) A typical RC frame building under construction with brick masonry infill panels. Note the deficient length of column reinforcement for future extension.*

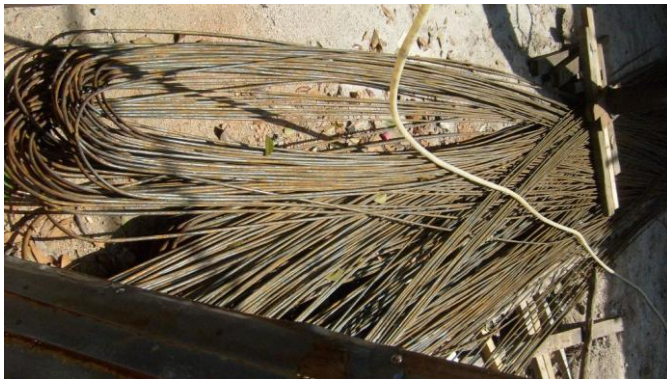
Use of plain bars, even up to 20 mm in diameter, for longitudinal reinforcement in columns and beams is common in the Padang area (Figure 5.3b). Mixing of deformed and plain bars is also common in the area (Figure 5.3c). In a number of cases, the reinforcement in columns (Figure 5.3d) were bent during construction—this led to reduction in tension capacity and often blew the concrete out when the bars tried to straighten, or came into compression during earthquake shaking. In a few cases, reinforcement splicing lengths were found to be about 20 diameters or even less for plain bars. Column bars are invariably lapped at the column base.

*b) Plain reinforcing mild steel bars are commonly used.*

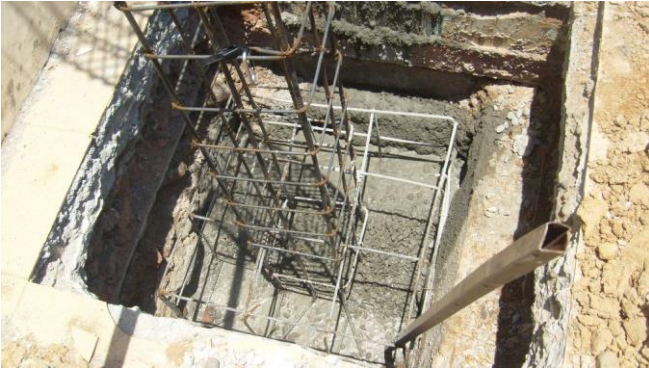
In detailing, stirrups were often observed at greater than 300 mm spacing throughout the column. It is not usual practice to provide stirrups in the beam-column joints (Figure 5.3e) and 90° hooks (Figure 5.4) are very common for stirrups, even in newer construction, although the seismic standard recommends 135° hooks. Ties are not used in columns.

**Figure 5.4:** A typical isolated foundation pad for a RC frame building. Note inferior quality of concrete and the wide spacing of stirrups with 90° hooks.

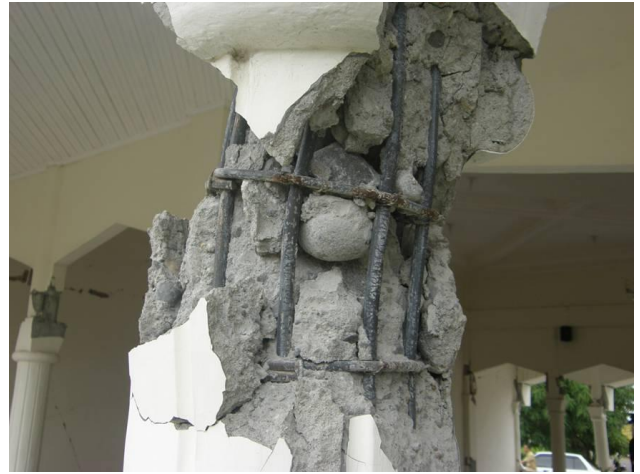
**Figure 5.5:** Segregation of concrete and large pebbles/cobbles in the concrete. Note 90° hooks and wide spacing of stirrups.

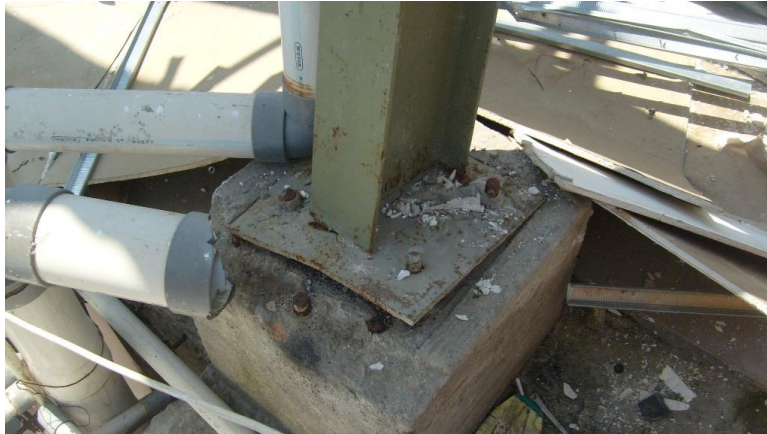
**Figure 5.6:** Missing nuts, bending of base plate resulting in large rotation of the column base.

Figure 5.6 shows a base plate of a steel column where half the nuts were missing and the other half were sluggishly tightened, which led to large rotation of the column leading to partial collapse of the roof. Damaged infill wall panels in a reinforced concrete frame buildings show evidence of thick mortar joints and inferior quality masonry.

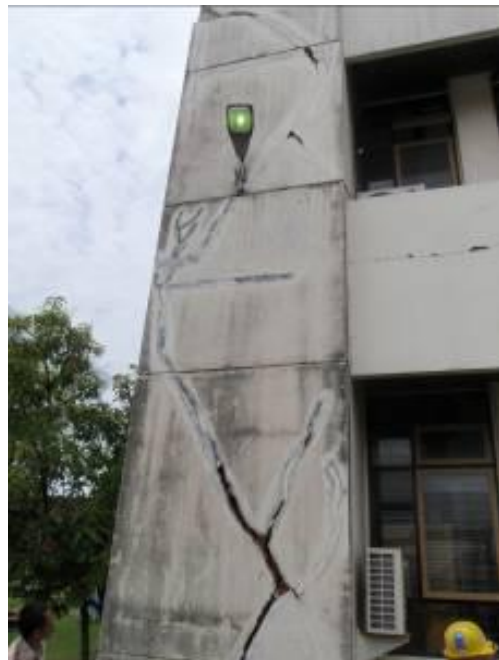
Figure 5.7 shows a wall that was damaged in the 6 March 2007 earthquake. Rather than strengthening the building, the cracks were covered by plaster. These opened again during the 2009 earthquake. Though the building survived, it shows the level of acceptance of poor construction techniques.

**Figure 5.7:** Diagonal cracks in a pier. This building was damaged in the 6 March 2007 M6.4 earthquake, but the building was not strengthened and the cracks were just covered.

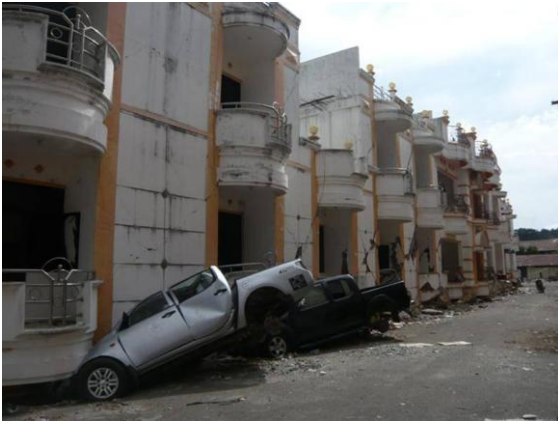
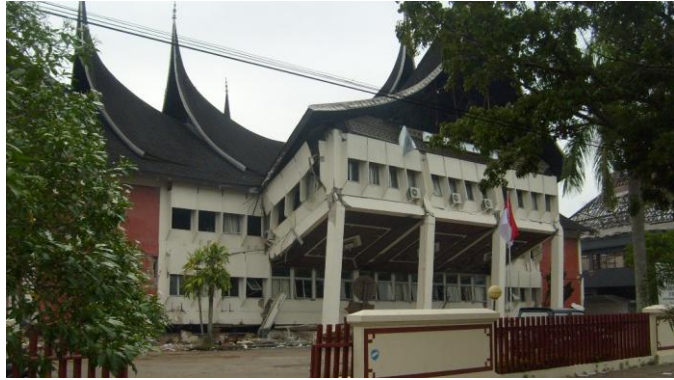
**Figure 6.1:** Several examples of soft storey failure.

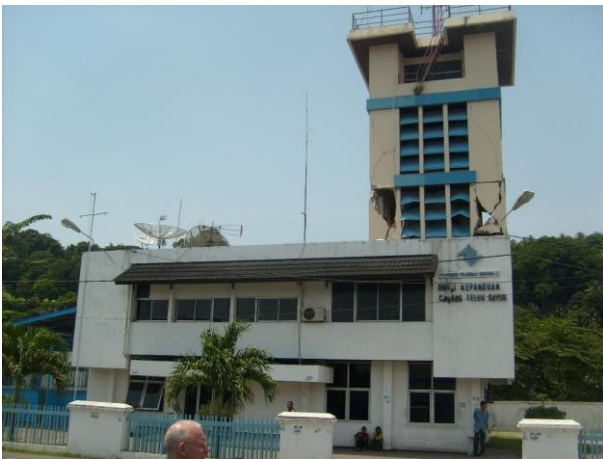
**Figure 6.2:** Damage due to shaking amplification.

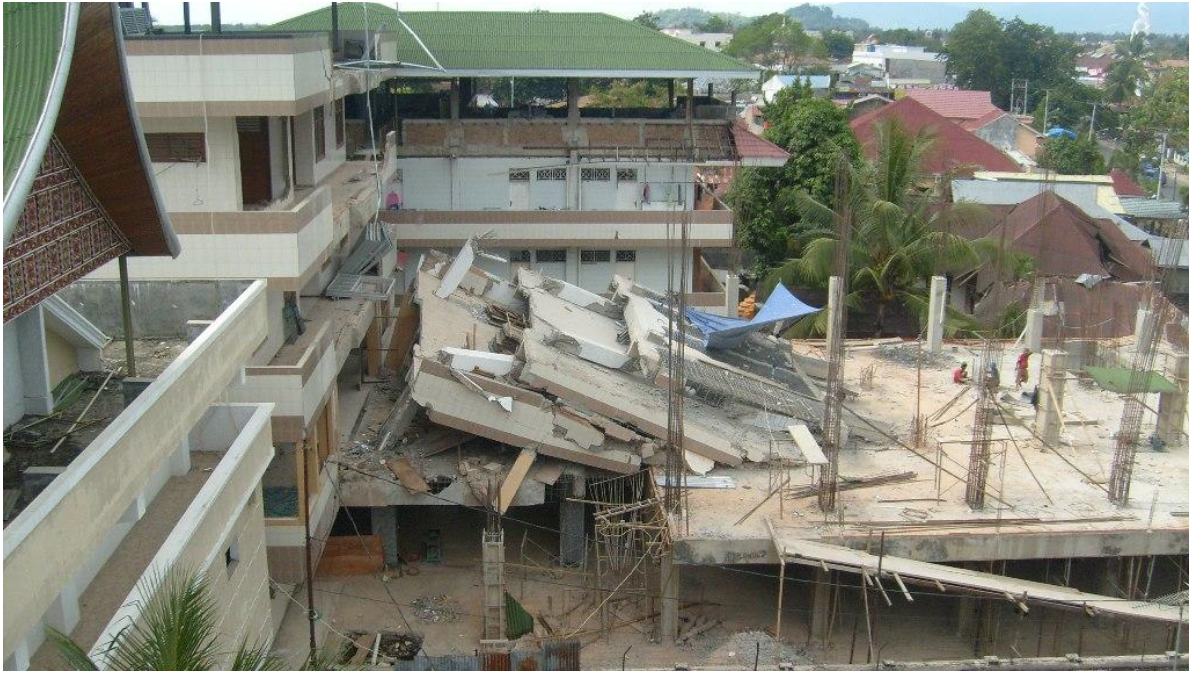
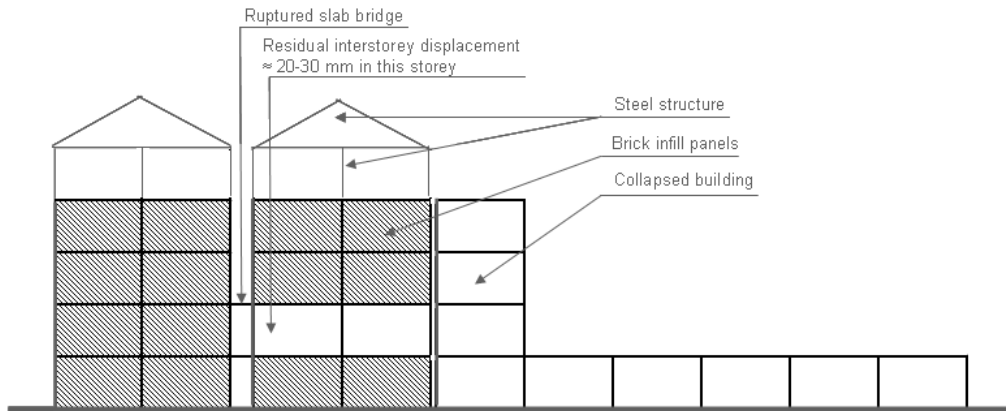
**Figure 6.3:** *View of a building collapse due to pounding and amplification, with the building layout shown below.*

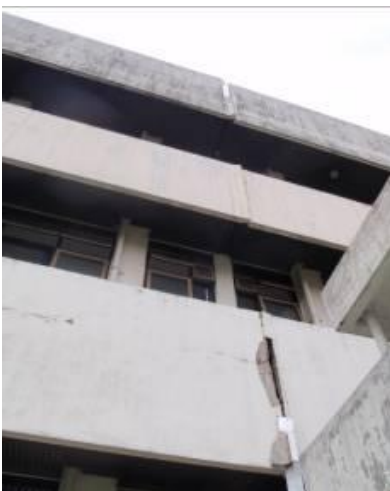
Interaction between adjoining buildings was another problem observed in the area. Pounding between adjoining buildings was observed in row buildings without a seismic gap. Figure 6.4 shows two adjoining institutional buildings where adequate seismic gaps were not provided between the buildings. Signs of pounding can be seen at the interface of parapet walls. The floors slabs of both the building were aligned and both building were of the same height. Although their floors suffered pounding, both the building survived, presumably because of the aligned floors and the similar height of the buildings. In another case, two five storey high RC framed building were connected by a cast in-situ RC bridge slab. The bridge slab which was integral with the floor slabs of both the buildings, was ripped apart by shaking (Figure 6.5), which was presumably out-of-phase.

**Figure 6.4:** *Pounding damage.*

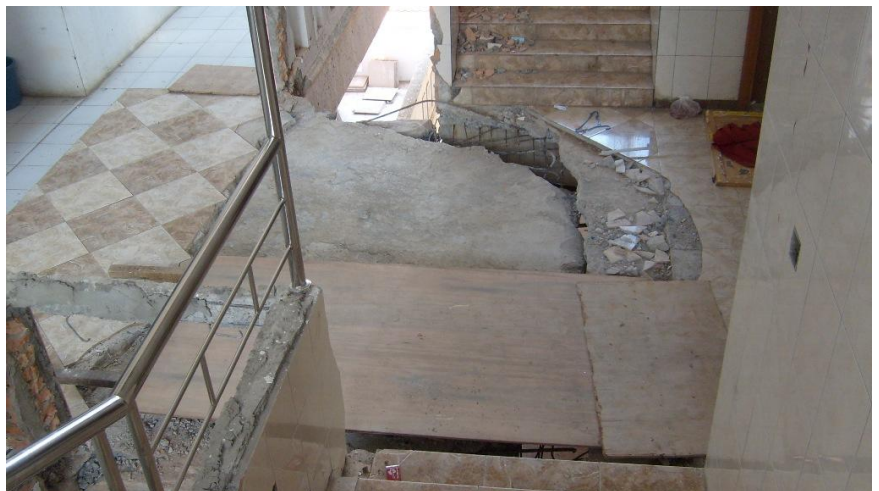
**Figure 6.5:** *Rupture of a slab bridging two buildings (see Figure 6.3 for layout of the buildings).*

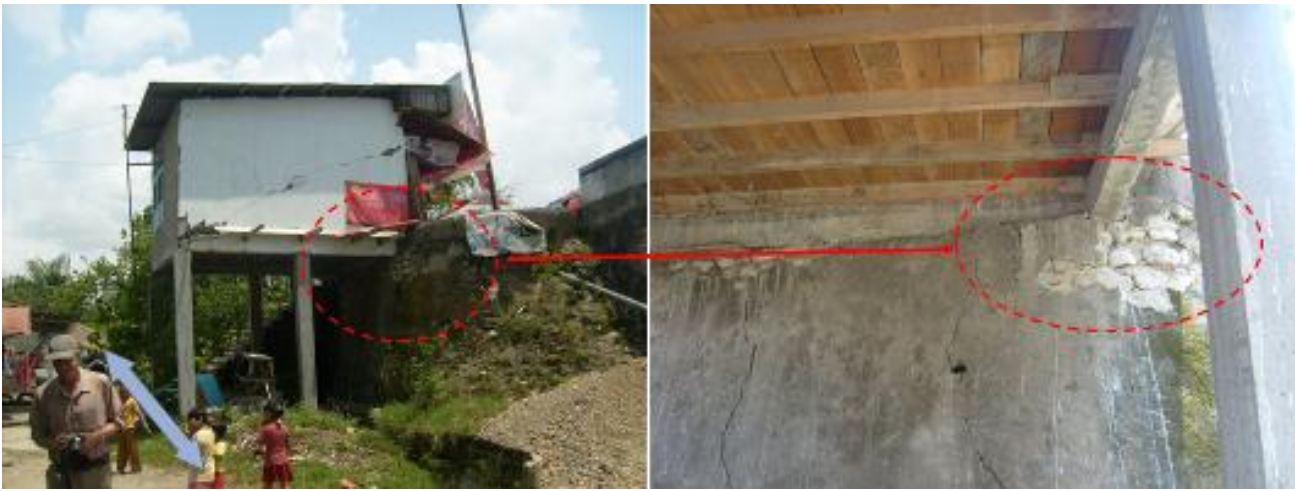
Damage in many buildings was observed due to plan irregularities. Buildings with L- and U-shaped plans and other torsionally active buildings showed evidence of torsion damage. Figure 6.6 (left) shows a small building with the front supported on a retaining wall and the back on slender stilts. Although the building survived, it suffered significant torsion, as evidenced by interaction between the building and the wall (Figure 6.6, right).

**Figure 6.6:** Building on stilts (arrow shows direction of shaking).

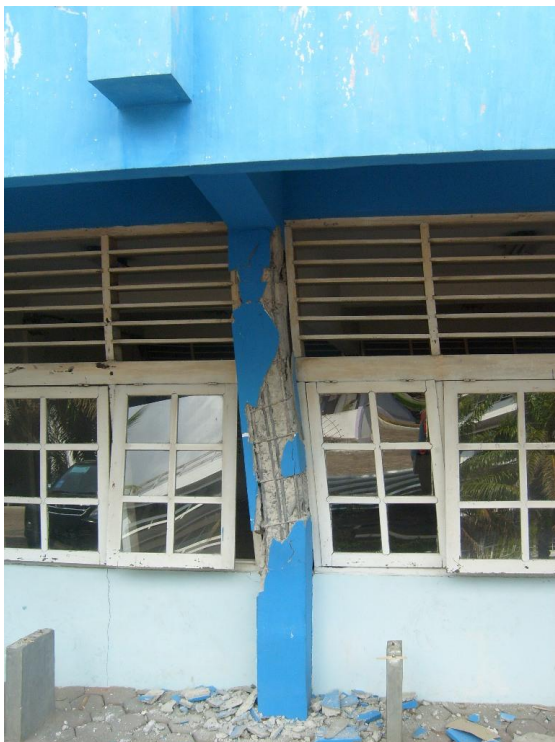
Short column effects were another commonly observed problem in RC framed buildings. In these buildings, the half-height walls restrained the columns and forced them to fail in shear, producing severe diagonal cracks and concrete spalling. This occurred in a number of buildings, particularly school, hospital and university blocks. Contrary to the accepted notion that the timber window frames are non-structural, it was interesting to observe interaction between timber window frames and columns. Figure 6.7 shows a short column in an RC frame building in which the mid-height window horizontal members restrained the column and forced it to fail in shear.

**Figure 6.7:** Short column failure. Note how the timber window frame has influenced the failure.

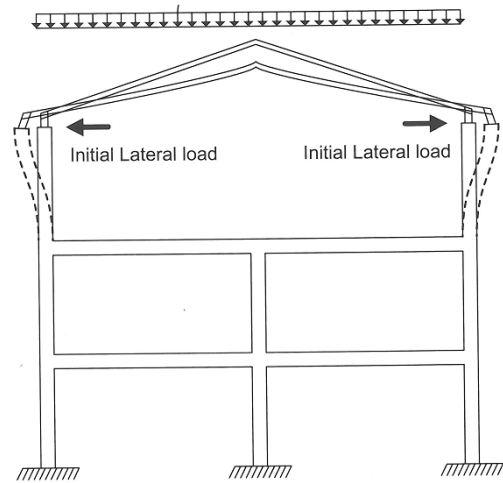
Shakedown spreading was one of the more interesting cases of failure seen. This failure type was encountered in one building where it has caused significant damage and a need for rebuilding. The building had a heavy porcelain tile roof supported on timber purlins and steel frames pitched at a steep angle to the middle. The steel frames did not have a collar tie (or any other tie) and so the cantilevered concrete columns on the perimeter carried the lateral spread loads from gravity loading. When the earthquake hit, the roof frames shook from side to side, imposing additional lateral loads to the top of the cantilevered columns. The columns have suffered significant flexural damage and have not recovered to their original position, allowing the roof to push out and spread around 300 mm out of position (Figure 6.8).

**Figure 6.8:** Column spreading because of a lack of truss ties (Hyland and Wijanto, 2010).

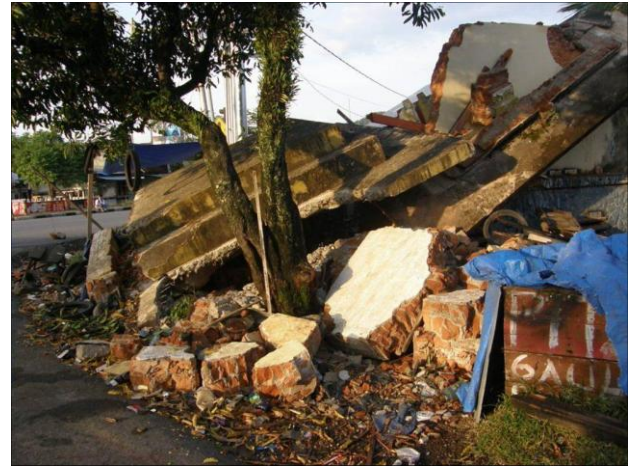
*b) Total collapse of a similar unreinforced masonry building.*

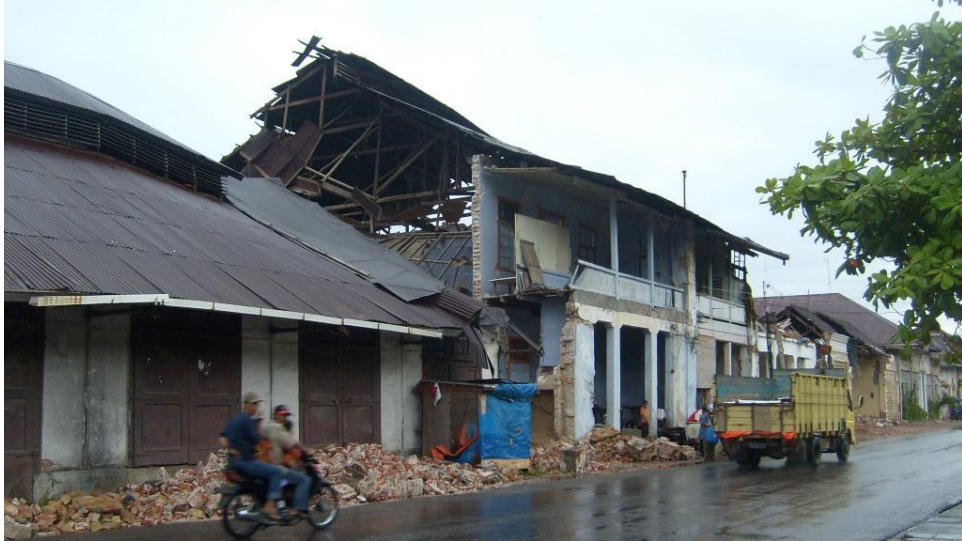
*a) A building with out-of-plane collapse of walls.*

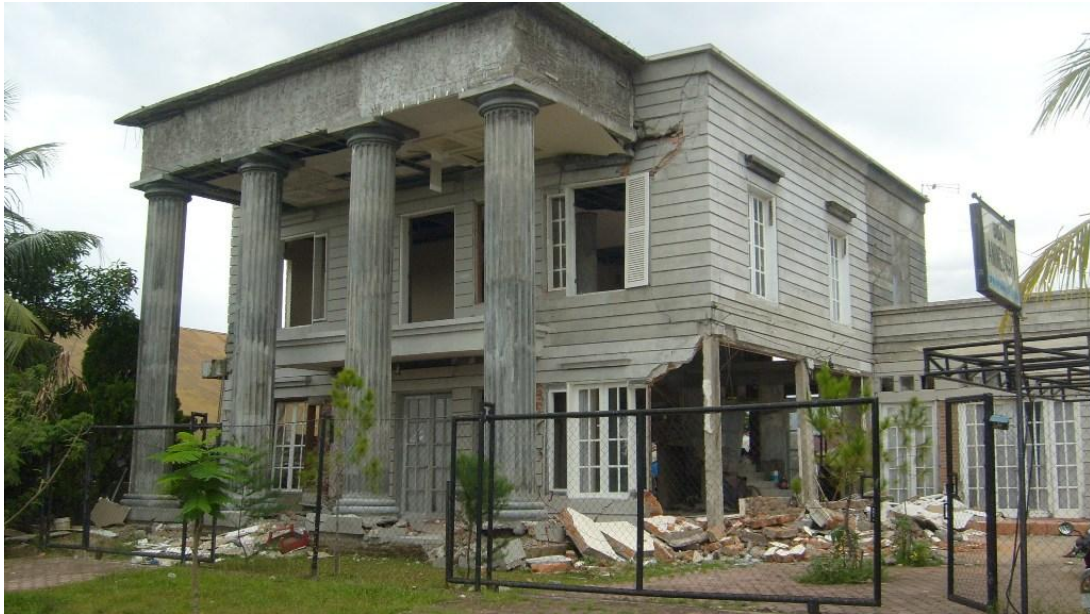
*b) Out-of-plane failure of a brick wall in a building with practical columns and beams.*

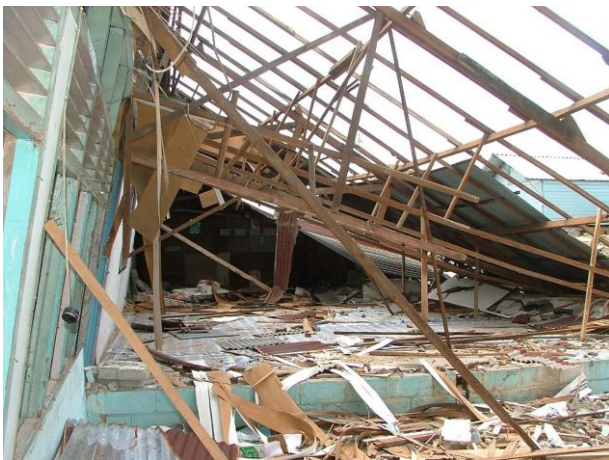
*c) Failure of a poorly connected roof due to loss of support.*

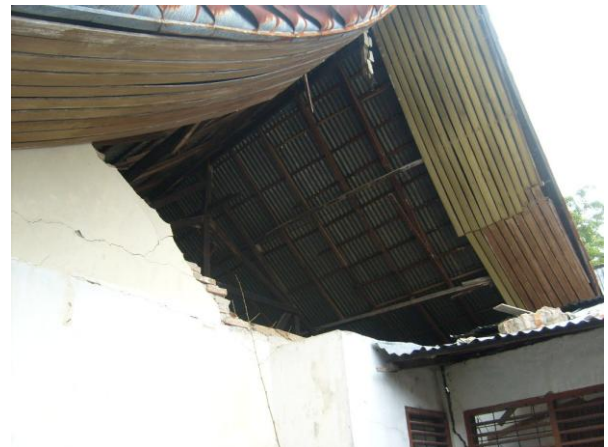
*d) Toppling of a gable wall.*

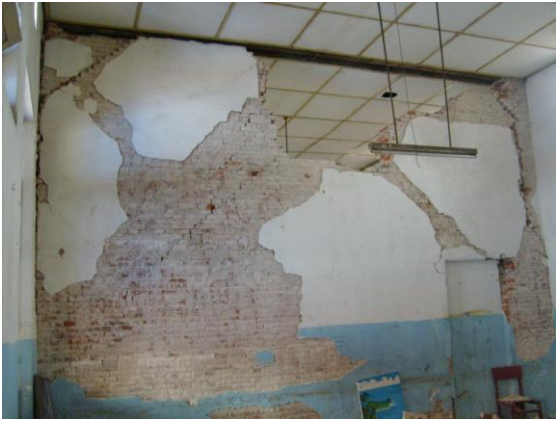
a) Diagonal shear crack combined with out-of-plane failure of an unreinforced brick wall in a school (note separation of in-plane and face loaded walls).

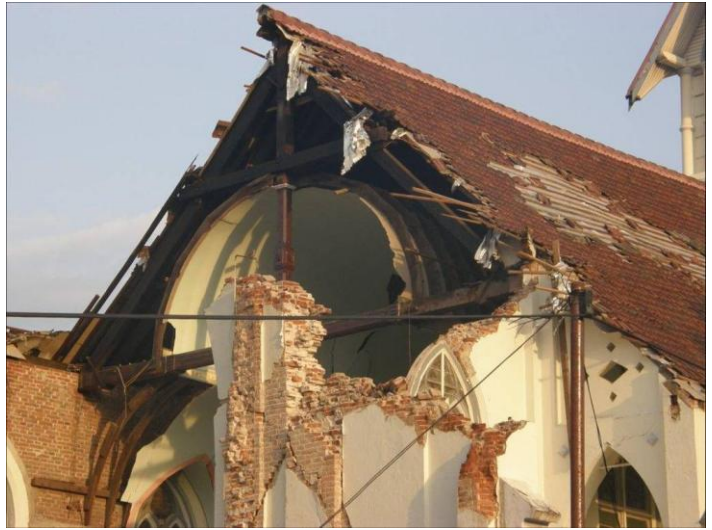
b) An old masonry brick church barely survived the earthquake. The roof survived because of alternative load paths.

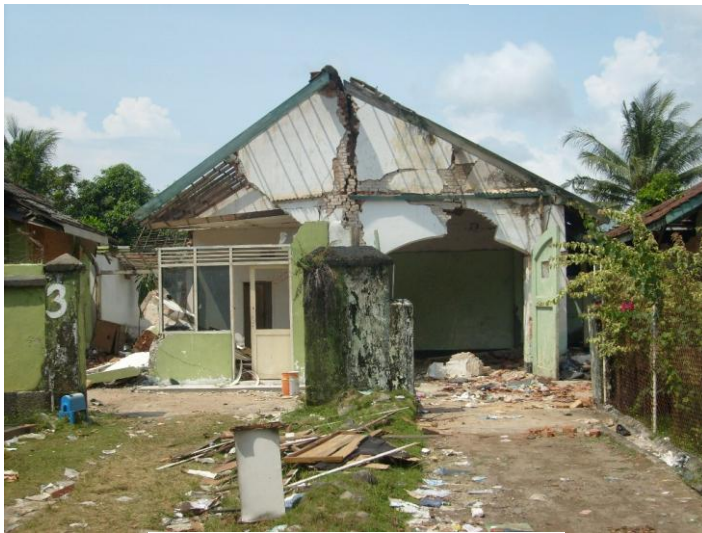
c) Vertical cracking of a house wall.

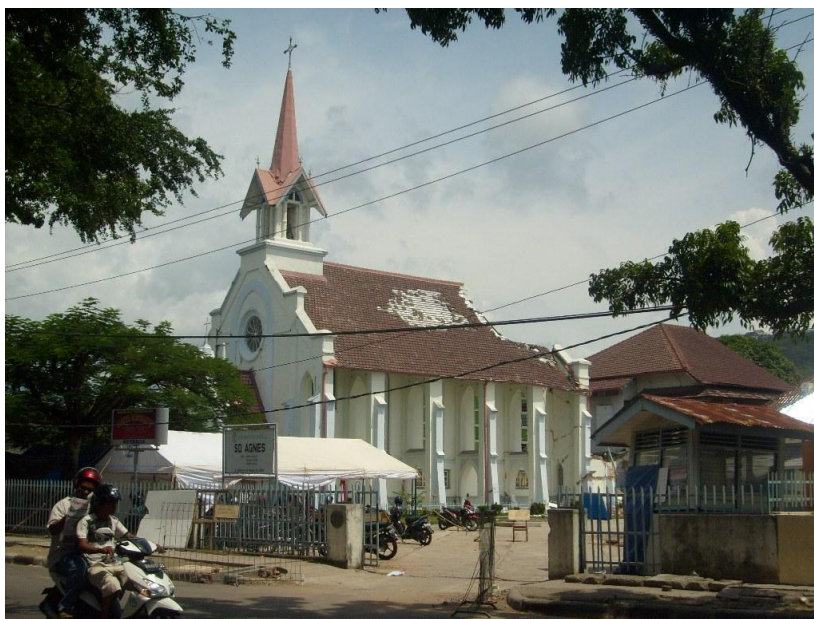
It is interesting to note that an old church which suffered partial collapse due to both out-of-plane and in-plane damage at its back, as well as sliding of roof tiles, did not suffer much

damage in the front, and even the bell tower of the church survived (Figure 6.14).

Figure 6.14: Church with undamaged bell tower.

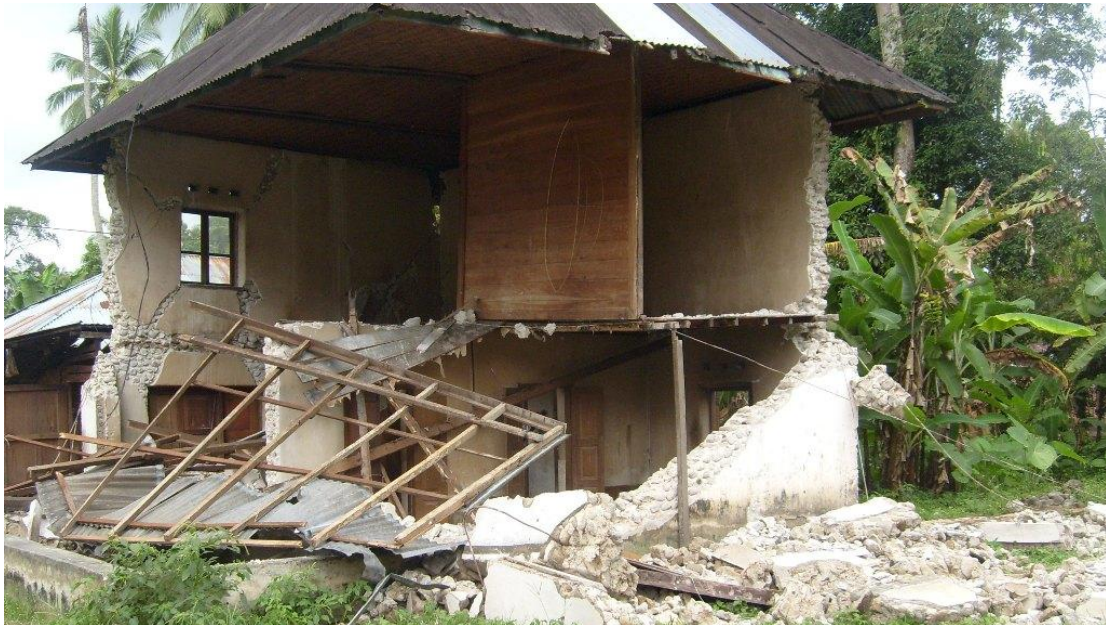
*Figure 6.16: Partial collapse of a stone masonry house building due to out-of-plane toppling of walls (note lack of connection between structural components and shear failure of piers).*

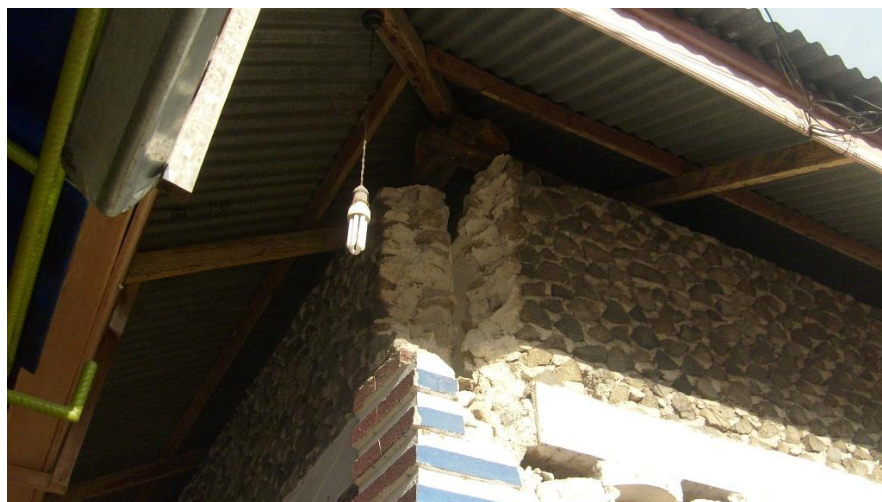
*Figure 6.17: Corner failure (note lack of connection between walls).*

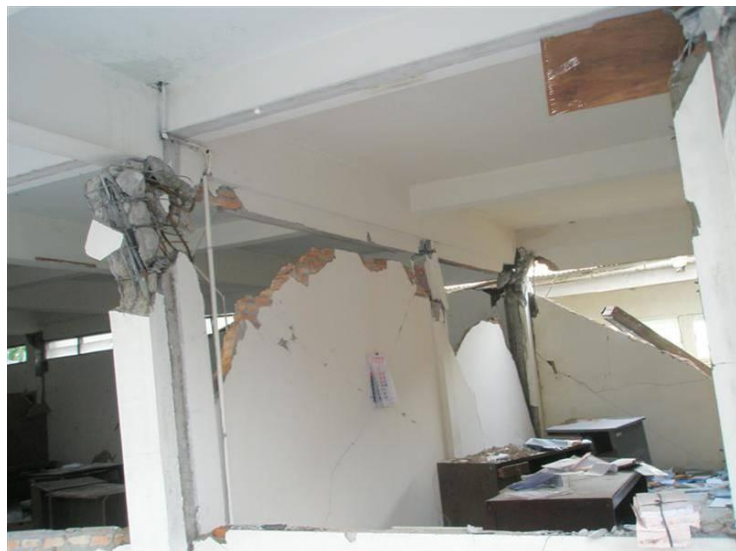
*c) Column failure due to shear imposed by infill wall structure.*

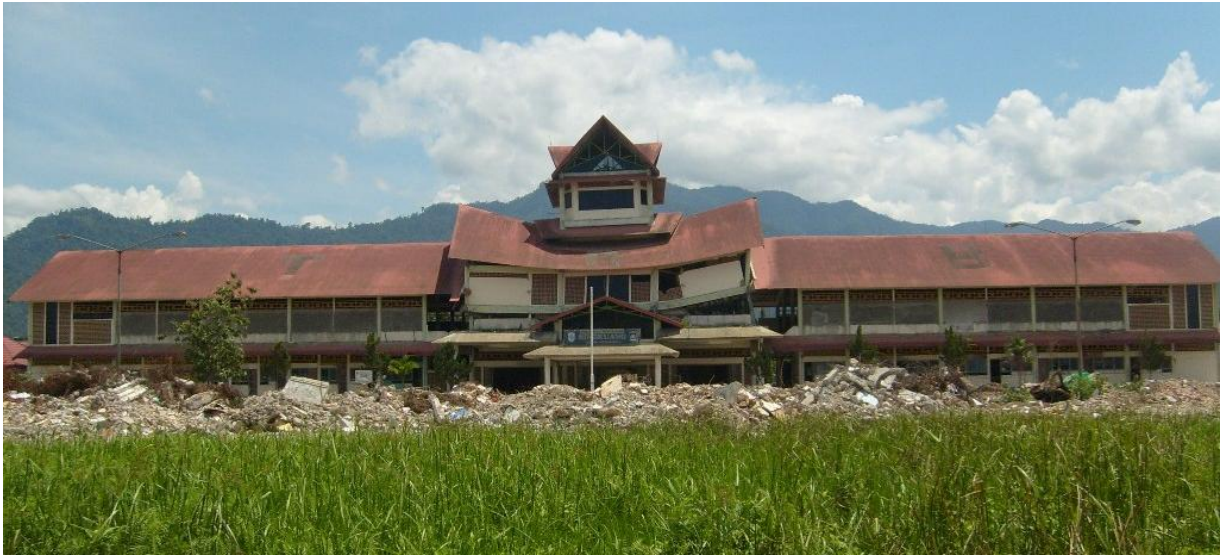
**Figure 6.20:** Padang's bus terminal building suffered extensive damage due to differential ground settlements and soft storey collapse of the central block. Note destruction of the second storey; roof ridge should be horizontal.

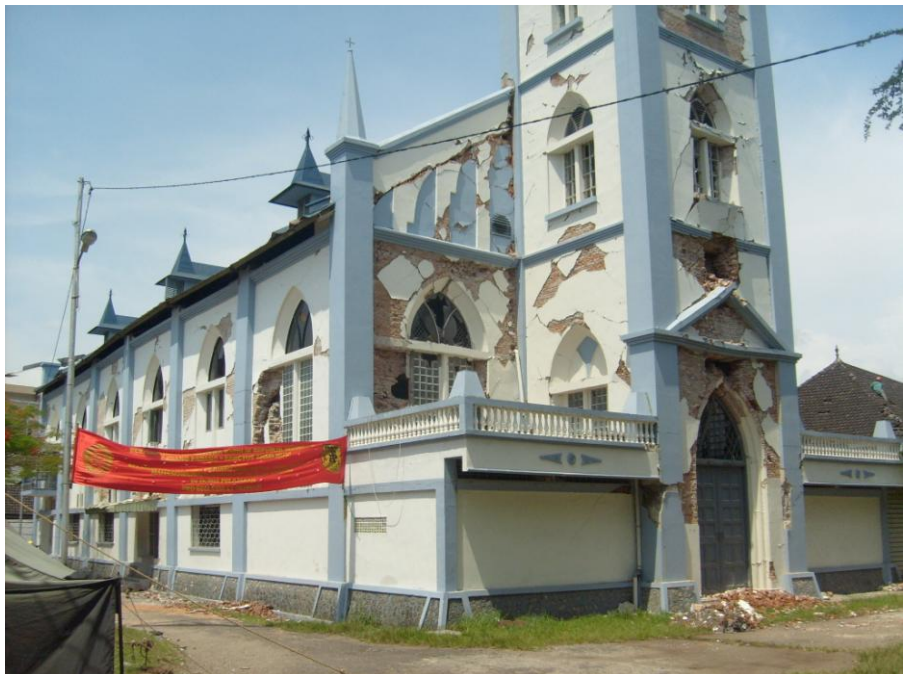
Figure 6.22 shows damage to a church building constructed with a RC frame with masonry infill in the perimeter wall. The church has a large hall with a large-span steel roof structure. It has a mezzanine floor tied to the perimeter frame. The violent shaking is manifested by the severe interaction between the infill walls and frame and significant damage to infill walls, anchor failure between the mezzanine floor and the perimeter frame, and roof support anchor failure (see Figure 6.30).

**Figure 6.22:** A badly damaged Dutch-era masonry brick church building with a recently added internal RC frame and slab mezzanine floor—which probably prevented complete collapse.

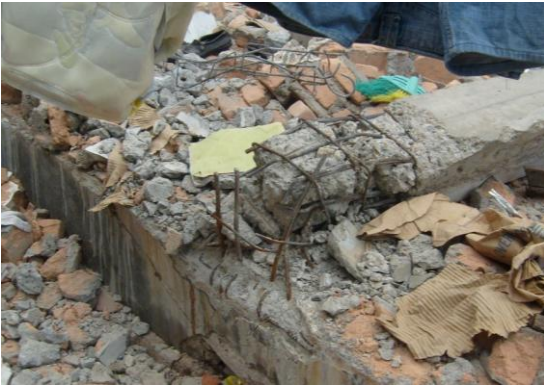
*a) Failure of column bar splicing.*

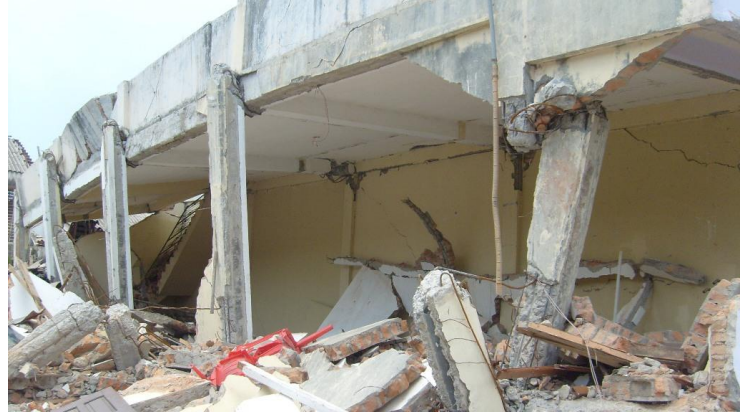
*b) Cold-joint problem.*

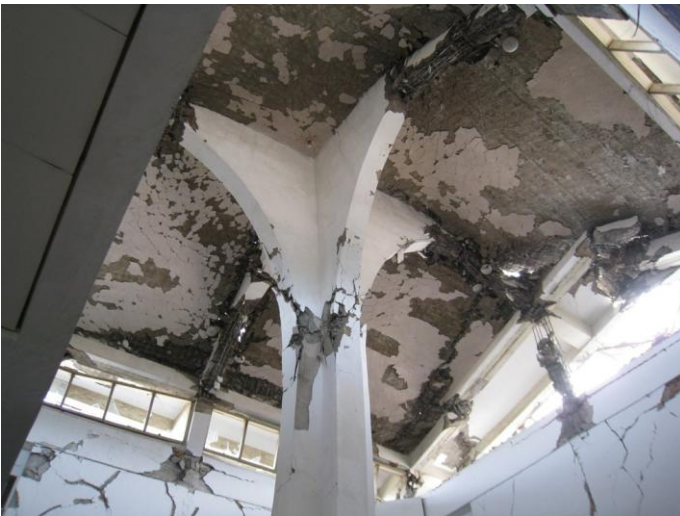
*c) Failure of column due to sudden change of stiffness.*

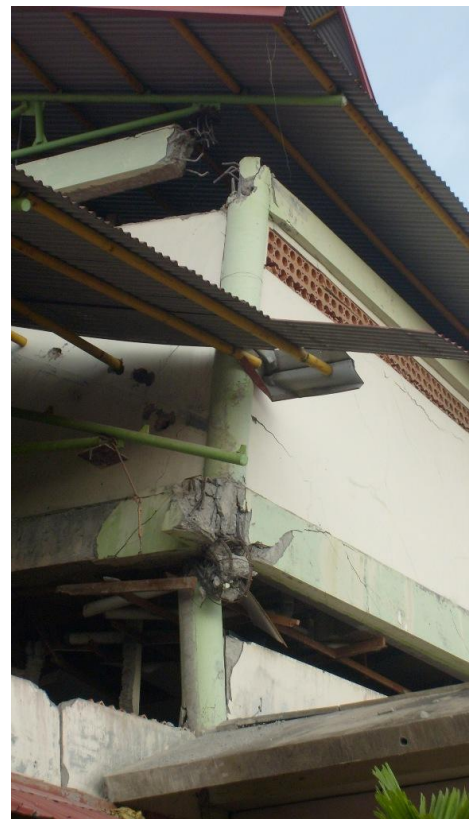
*d) Beam bar anchorage failure (at roof level) and crushing of column in the bus terminal building.*

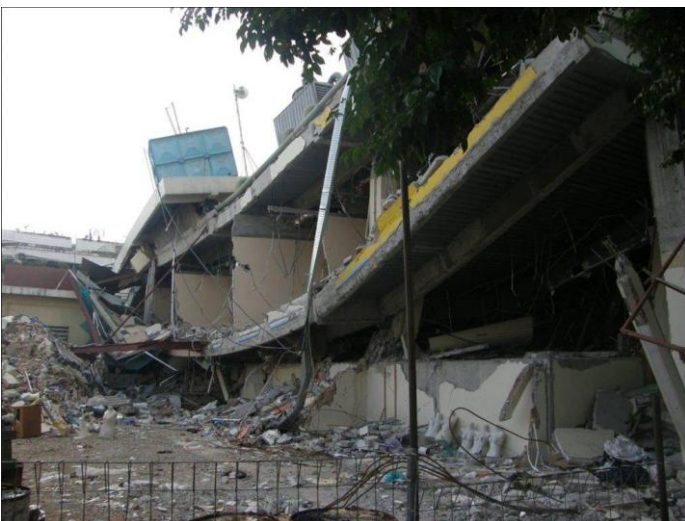
*f) Failure of columns leading to failure of high-bond floor.*

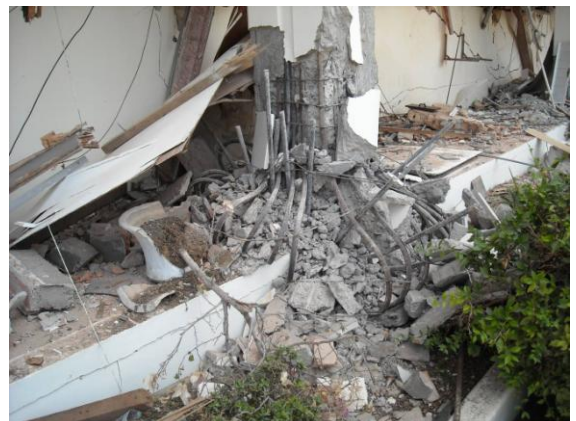
*e) Column base crushing and buckling of reinforcement due to opening of stirrups.*

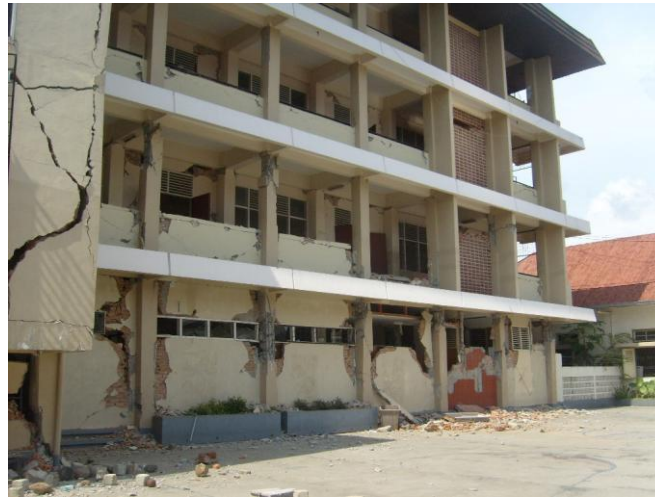
*a) Plastic hinges distributed along the height of the building, presumably due to the similar strength and stiffness of each level.*

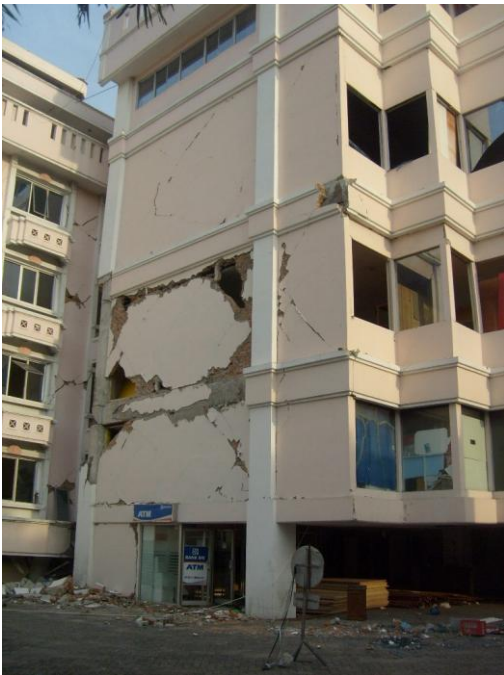
*a) Wall panel is stable, even after severe damage.*

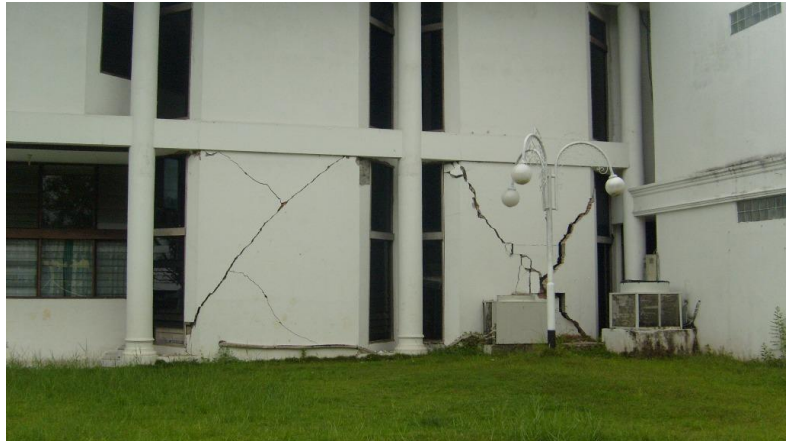
*b) Diagonal failure of infill walls separated from columns.*

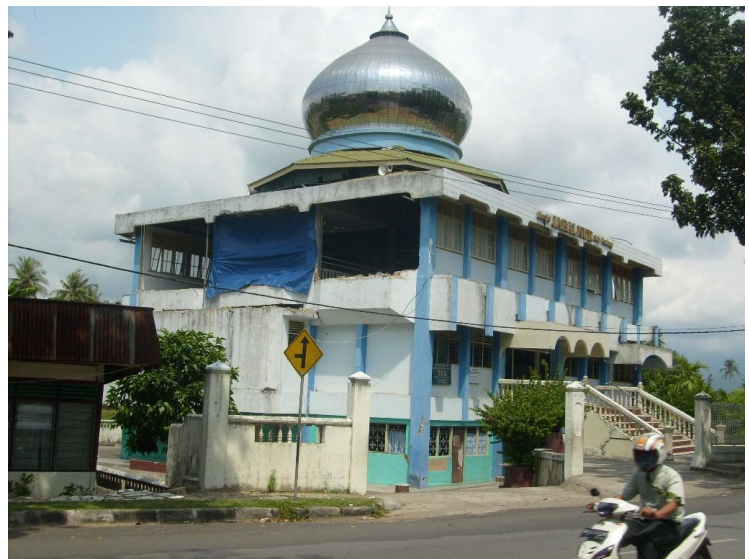
*c) Out-of-plane failure of infill walls.*

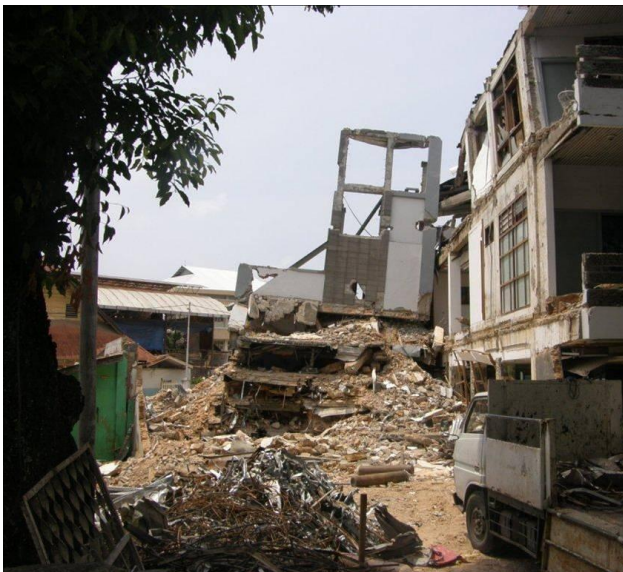
Steel columns in one two-way moment-resisting frame that performed well were concrete encased. During this earthquake, a five-storey two-way steel frame with metal decking collapsed in a pancaking manner (Figure 6.28a), with

*a) Pancaking after weak axis column bending failure.*

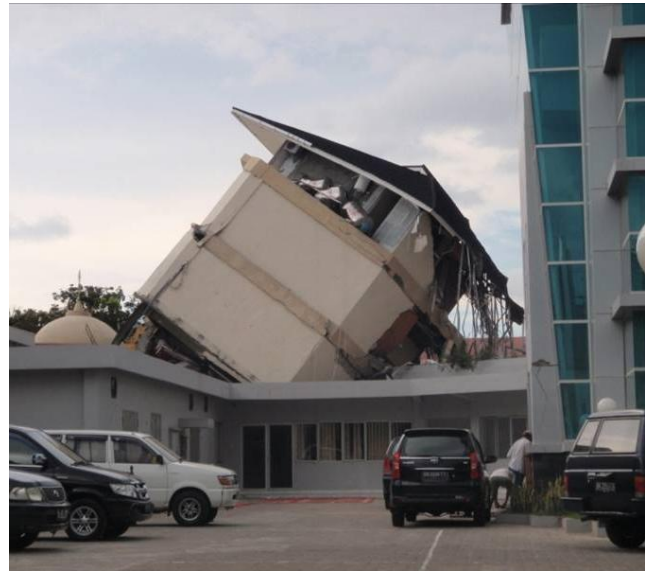
*b) Building collapse due to column failure.*

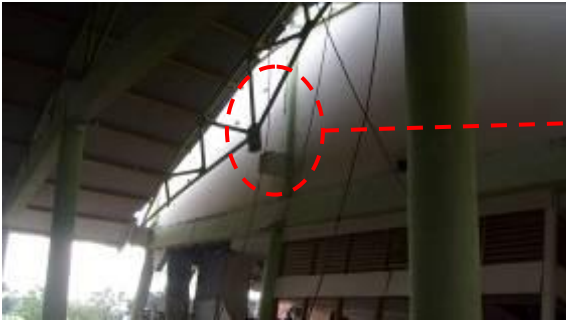
*a) Anchor and roof bracing ties failure.*

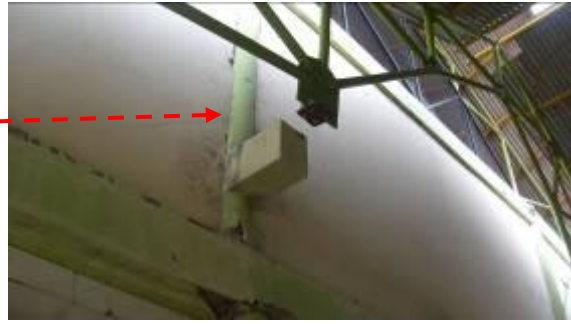
*b) Anchor plate failure (note the plate was anchored to an adjoining building).*

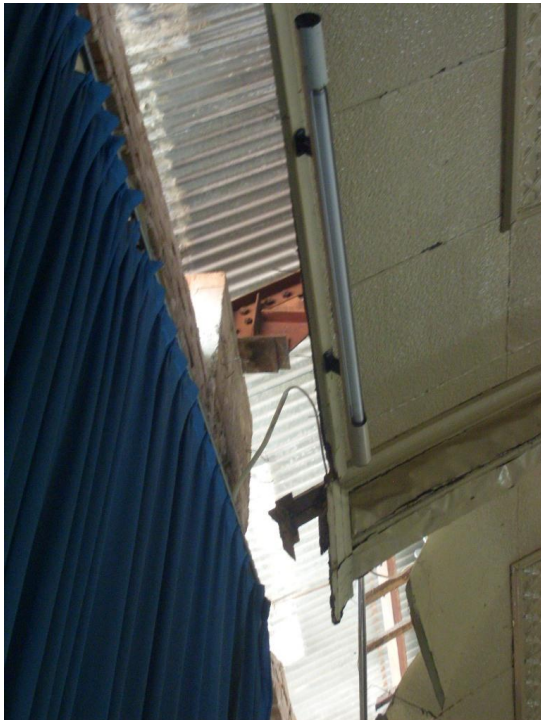
**Figure 6.30: Failure of anchors between a steel roof truss and concrete column in an old church.**

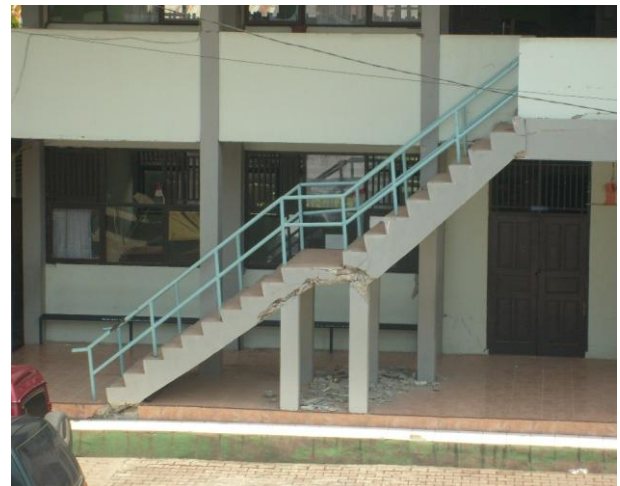
*a) Interaction between structure and waist slab.*

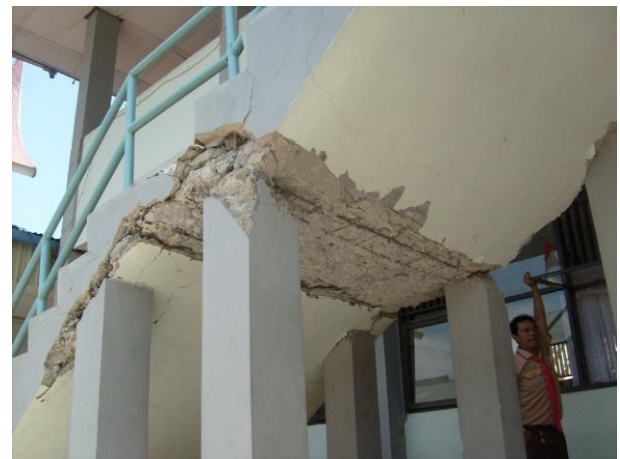
*b) Close-up view of staircase in (a).*

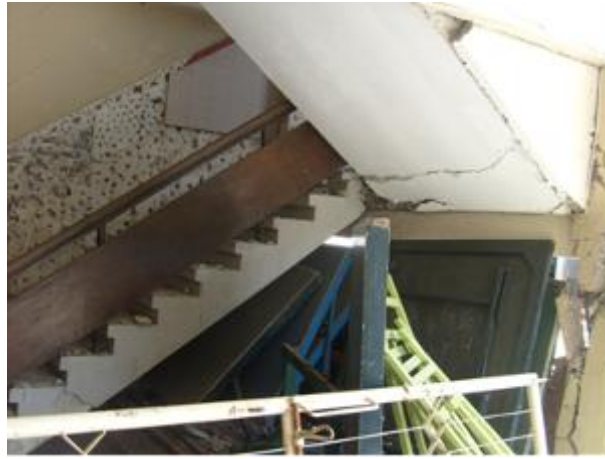
**Figure 6.32:** *Compression-flexural crack between waist slab and supporting beam.*
