## GENERAL OBSERVATIONS OF EFFECTS OF THE 30th SEPTEMBER 2009 PADANG EARTHQUAKE, INDONESIA

**Jitendra Bothara<sup>1</sup>, Dick Beetham<sup>2</sup>, Dave Brunson<sup>3</sup>, Mike Stannard<sup>4</sup>, Roger Brown<sup>5</sup>, Clark Hyland<sup>6</sup>, Warren Lewis<sup>7</sup>, Scott Miller<sup>8</sup>, Rebecca Sanders<sup>9</sup> and Yakso Sulistio<sup>10</sup>**

### SUMMARY

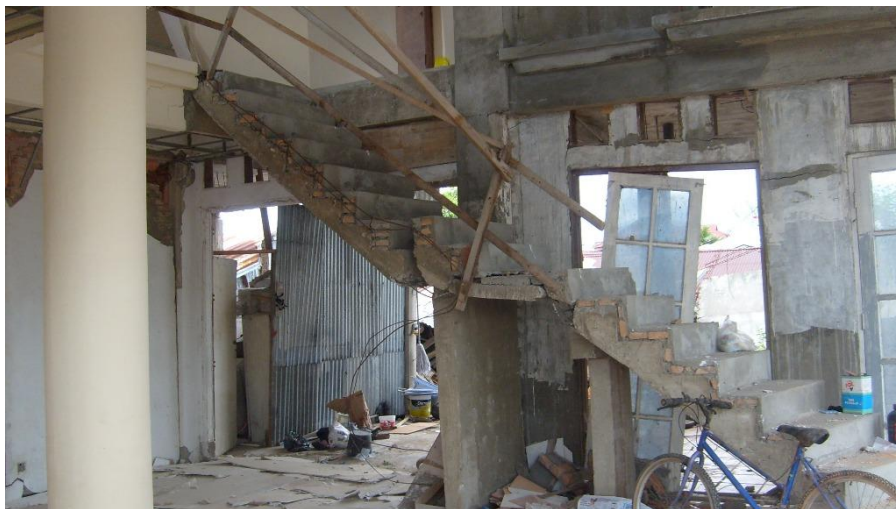
**Figure 6.33:** *Compression failure of a waist slab.*

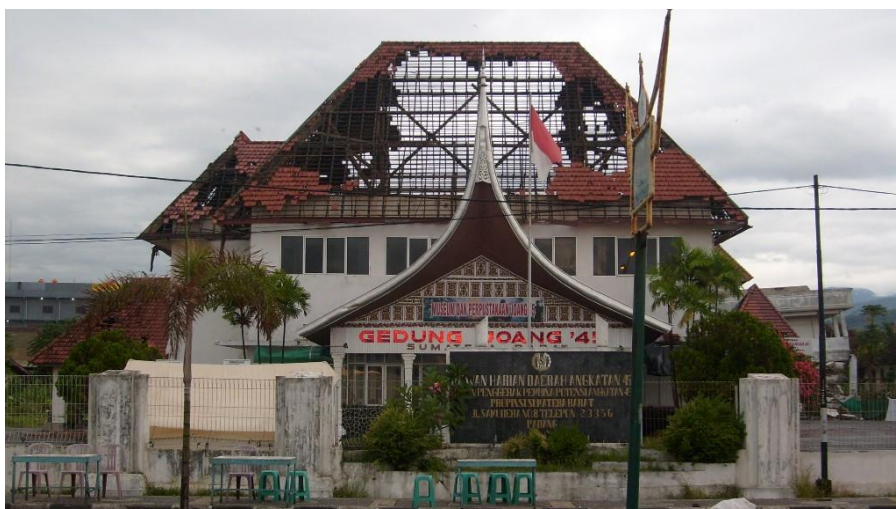
**Figure 7.1:** *Shedding of untied tiles.*

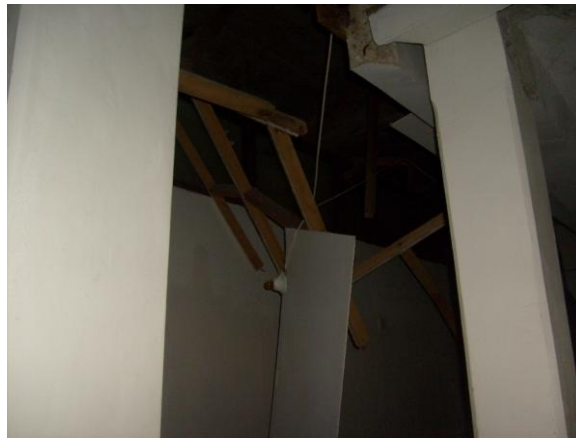
**Figure 7.3:** *Damage to false ceilings was common.*

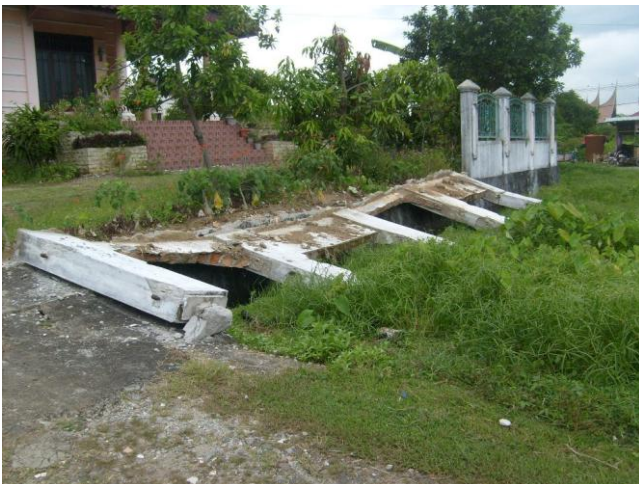
**a) Toppled boundary walls were common.**
