# THE Ms 8.0 WENCHUAN EARTHQUAKE OF 12 May 2008 RECONNAISSANCE REPORT

Jiashun Yu<sup>1</sup>, Philip Yong<sup>2</sup>, Stuart Read<sup>3</sup>  
P. Brabhakaran<sup>4</sup> and Meng Foon<sup>5</sup>

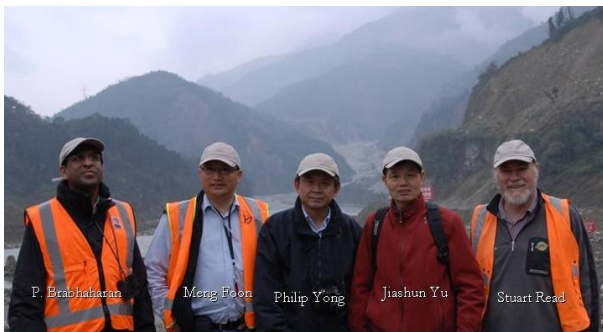
**Figure 2:** The team in Yingxiu, the epicentre, 4 November 2008.

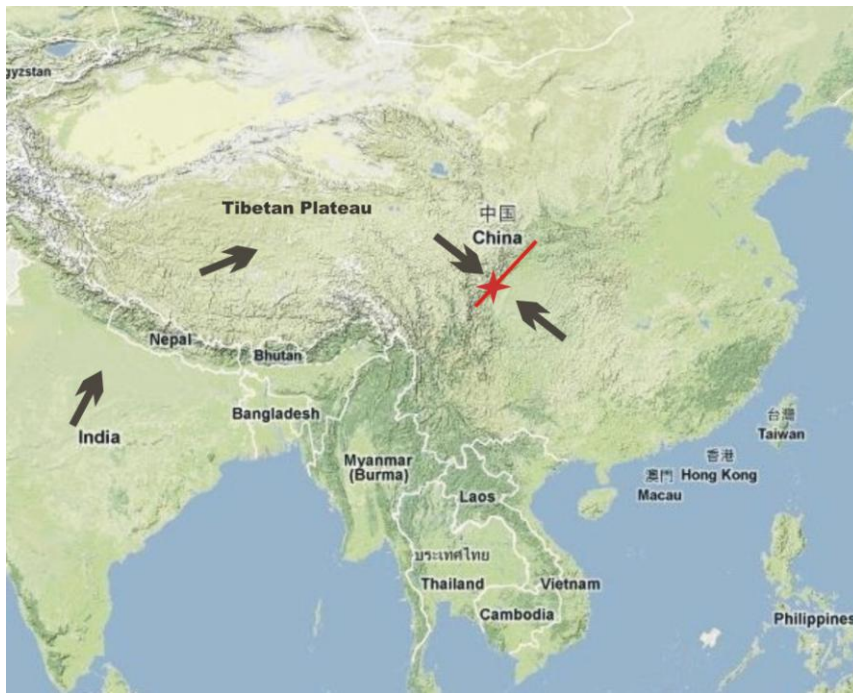
Figure 5: Location of the Wenchuan Earthquake (star), the Longmenshan Fault (red line), and the indicative movement of the plate tectonic blocks.

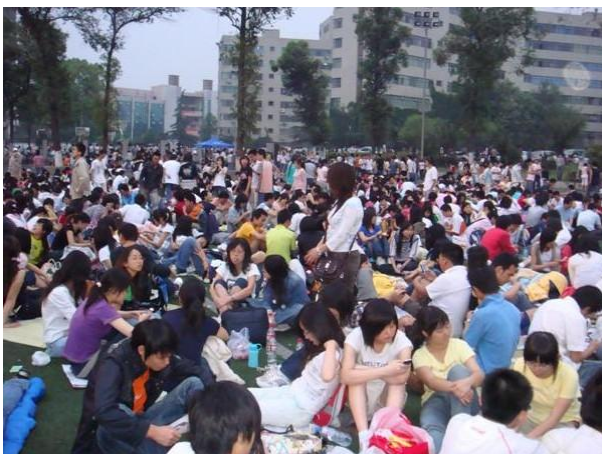
**Figure 11:** 12 May 2008. Sports ground track field, CDUT. Students who had escaped from the earthquake.

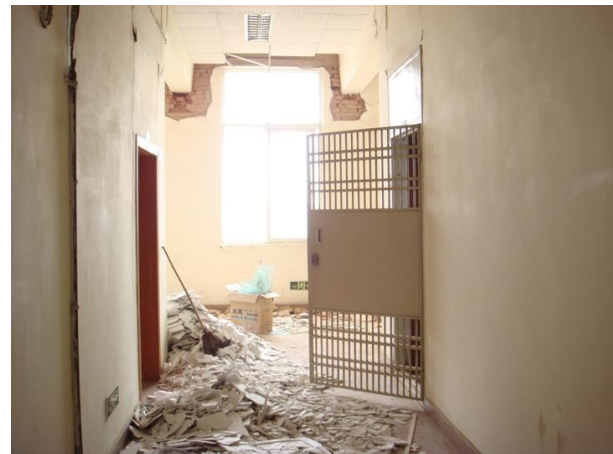
**Figure 13:** 13 May 2008. CDUT. The Museum Building badly damaged.

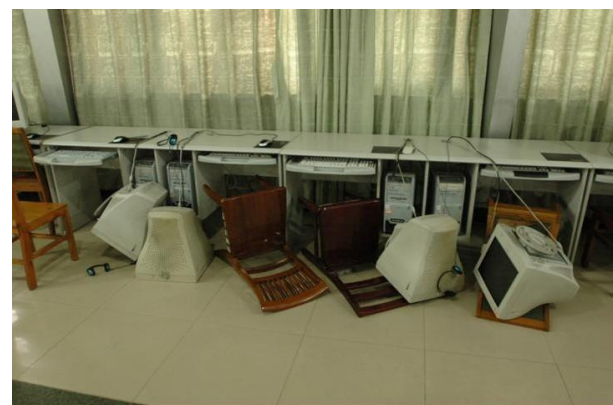
**Figure 14:** 12 May 2008. Library, CDUT. Fallen computer terminals and chairs.

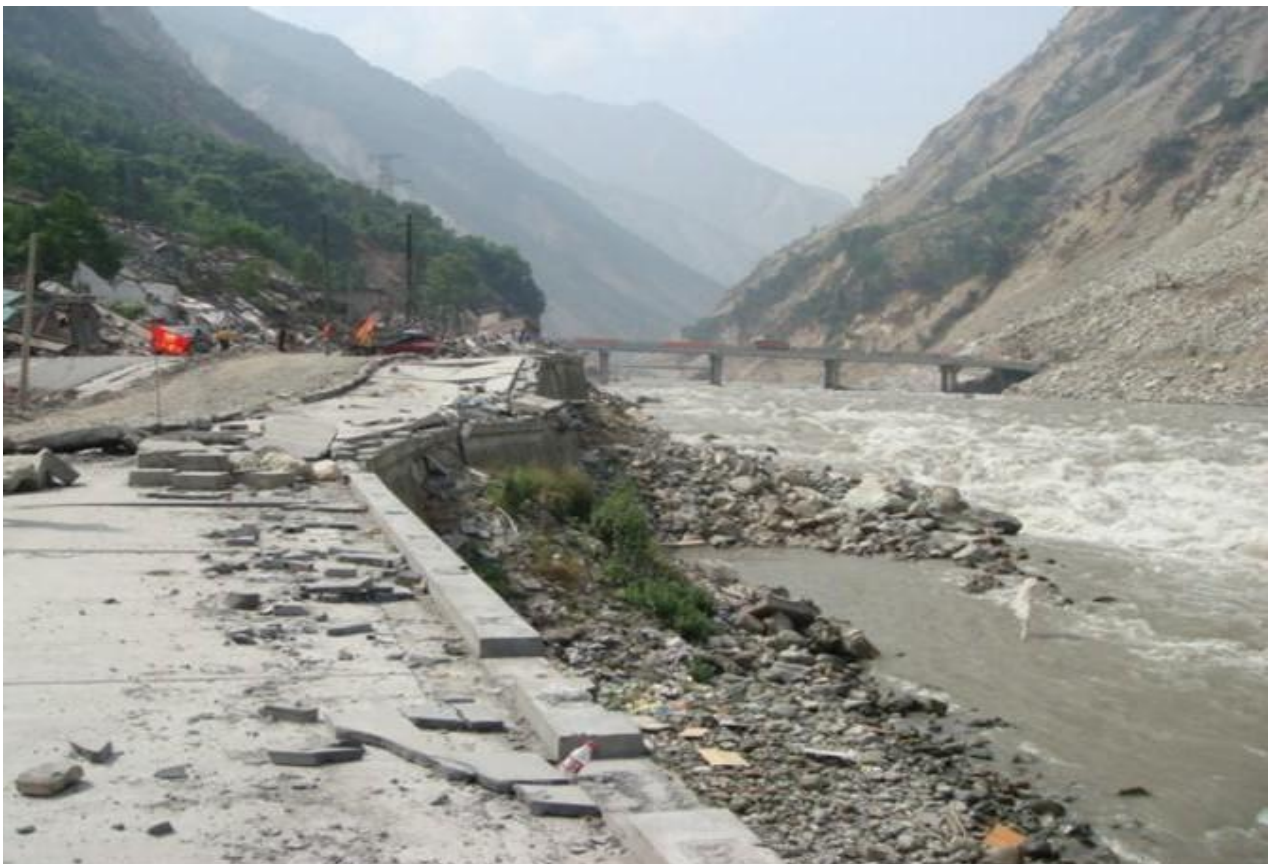
**Figure 15:** *The Yingxiu-Beichuan fault cut through the river bank road north of the Yingxiu Township. The earthquake caused vertical and horizontal displacements of 2 m and 1.7 m, respectively, across the fault. (From Chen Yuntai, Chinese Academy of Sciences.)*

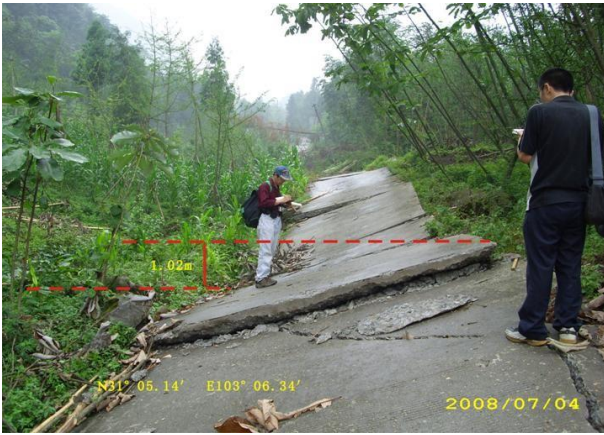
**Figure 16:** Land deformation due to the underground rupture of the Yingxiu-Beichuan fault in Shenxigou.

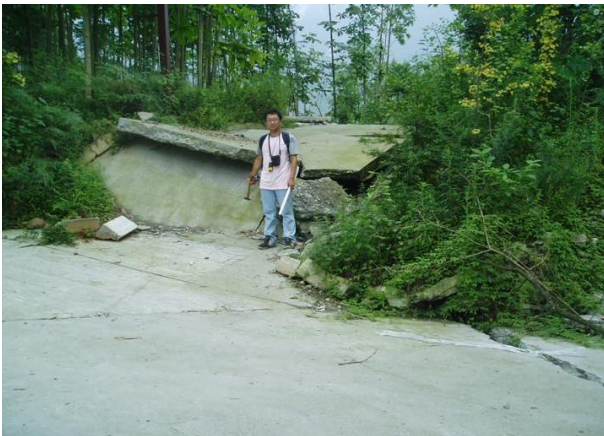
**Figure 17:** The Yingxiu-Beichuan fault rupture created a sudden uplifting of the road in Gaoyuan. The vertical displacement is ~1.5 m. No significant oblique movement was observed at this site.

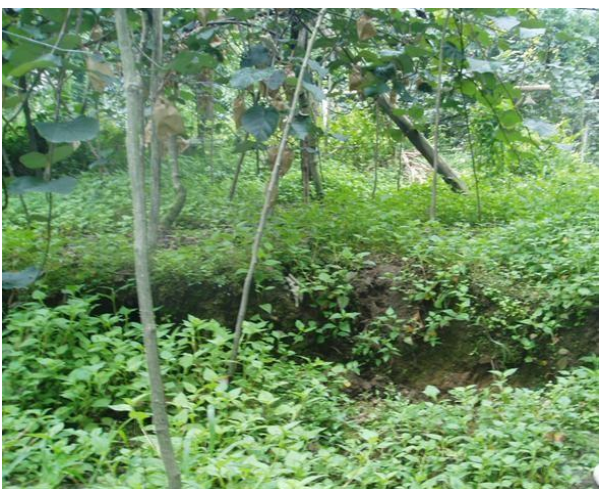
**Figure 18:** Cracks of ~0.8 m wide caused by the earthquake in the Kiwi fruit farm in Gaoyuan.

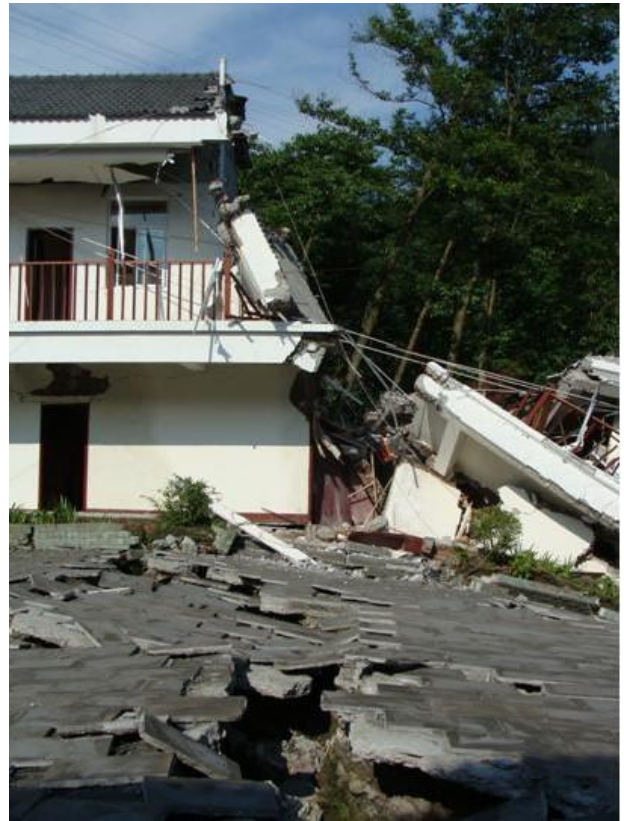
**Figure 19:** In Bajiaomiao, a two story building sitting on top of the Yingxiu-Beichuan fault line was cut in half. The south-east wing of the building, on the right hand side of the picture, was brought down in the earthquake.

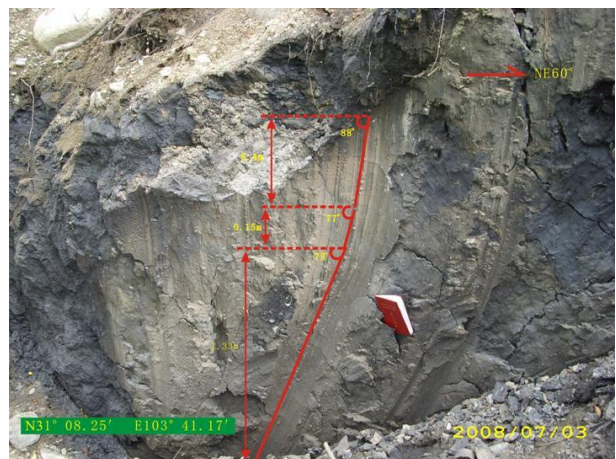
**Figure 20:** A rupture plane of the Yingxiu-Beichuan fault in Bajiaomiao. Striations on the fault plane in mudstone indicate a right-lateral oblique reverse offset.

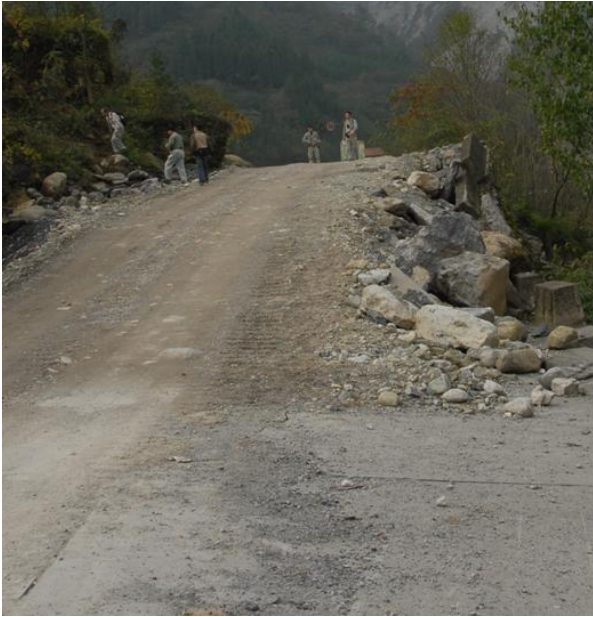
**Figure 21:** *The displacement of the Yingxiu-Beichuan fault near Qingping Village. The vertical displacement is of ~4 m.*

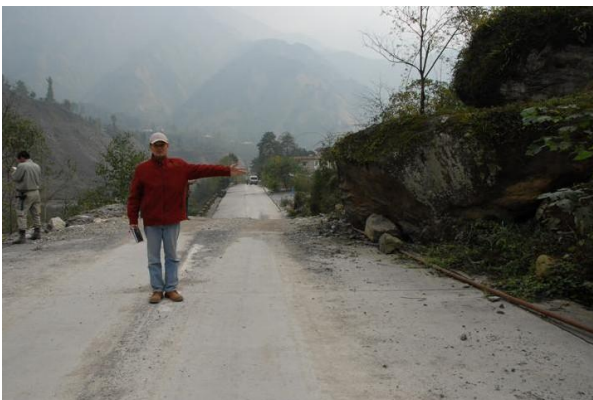
**Figure 22:** *Horizontal displacement of the surface rupture of the Yingxiu-Beichuan fault near Qingping Village. Jiashun Yu is indicating the right lateral offset based on the road centre line.*

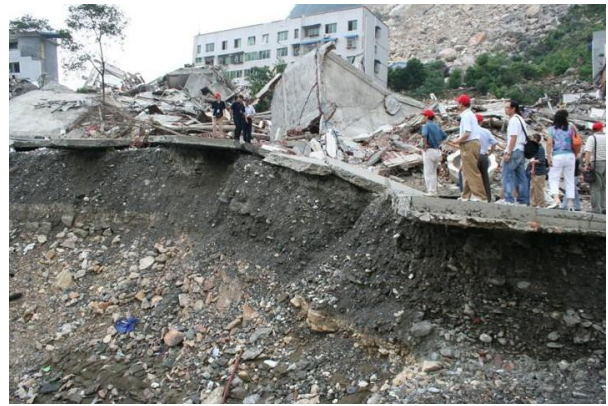
**Figure 23:** *The Yingxiu-Beichuan fault surface rupture in Beichuan city. A dip-slip reverse displacement can be seen.*

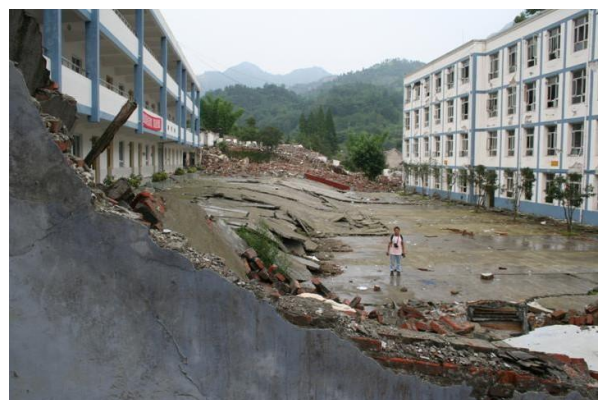
**Figure 24:** *The Peng-Guan fault rupture in the Bailu School campus. The vertical displacement was ~2 m. Two buildings used to sit on top of the fault line were brought down by fault rupturing and only ruins were visible in the frontal and distal parts of the photo.*

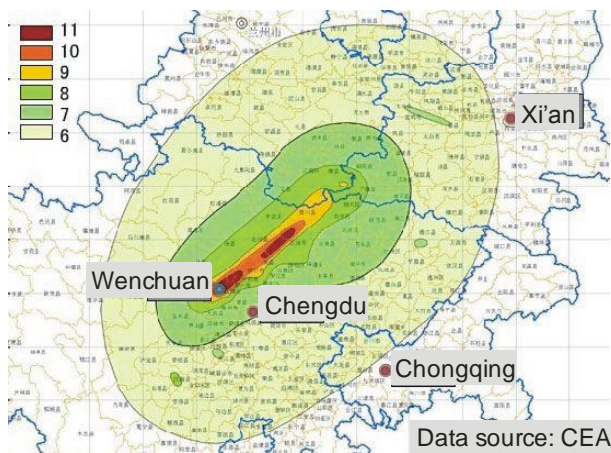
**Figure 29:** MM Intensity of the Wenchuan Earthquake published by the Chinese Earthquake Administration (CEA).

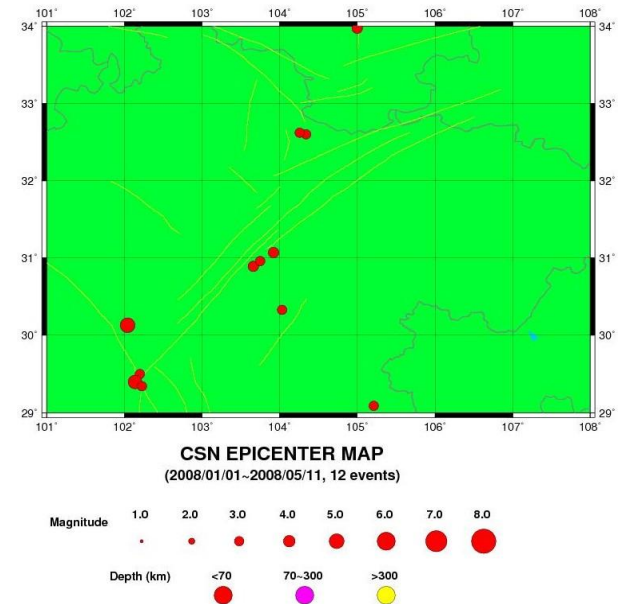
Figure 32: There were 3 earthquakes of, or slightly greater than, magnitude 3.0 along the Longmenshan fault zone in 2008 before the Wenchuan Earthquake.

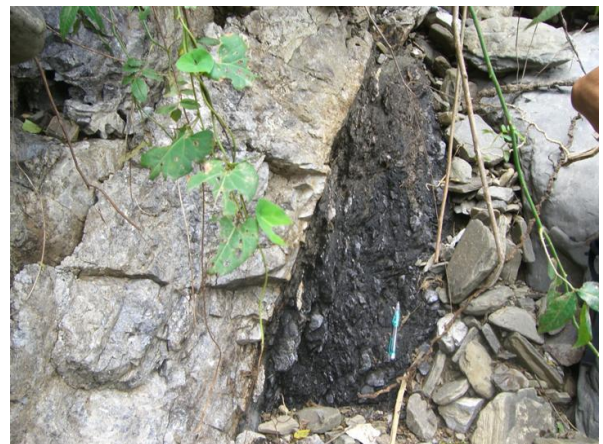
Figure 33: A lenticle in the Yingxiu-Beichuan fault zone in Leigu. The large dip and the compressive structure of the coal fragment in the lenticle suggest a high angle reverse rupture of the fault in the past.

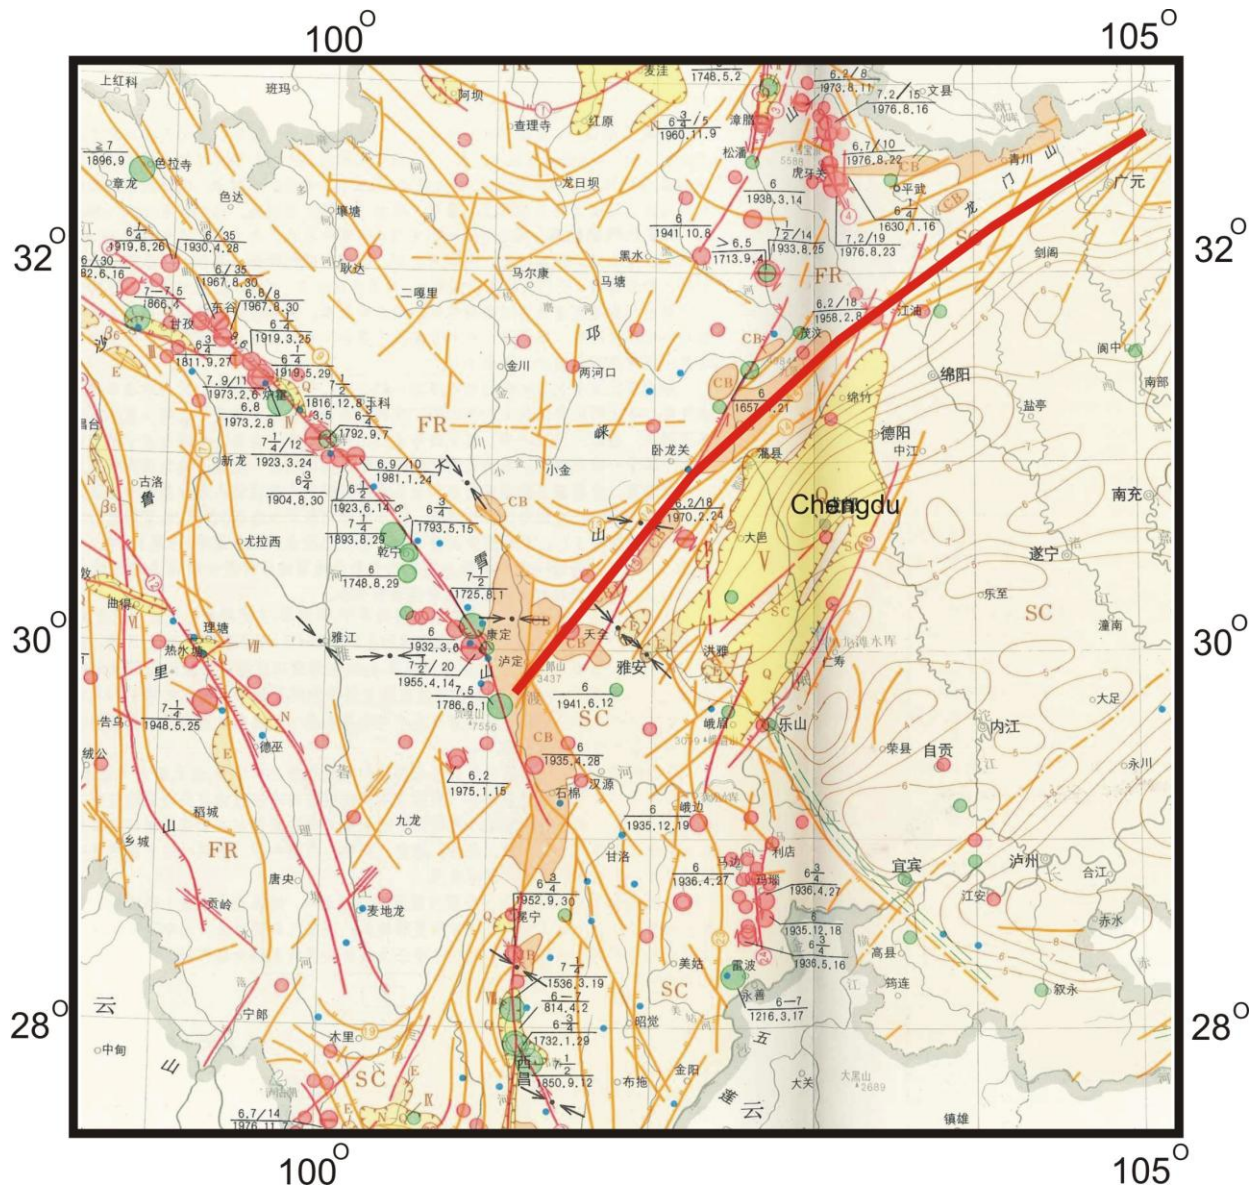
Figure 34: Historic earthquakes in the West-Sichuan area (Ma et al. 1989). A Y-shaped fault system dominates the tectonics in the area. The thick red line represents the Longman Mountain fault Belt. To its left, the top left branch of the Y is the Xuanshui River Fault Belt. The footing section of the Y is the Anninghe Fault Belt. Marked by red solid circles are historic earthquakes of magnitude  $\geq 6$ .

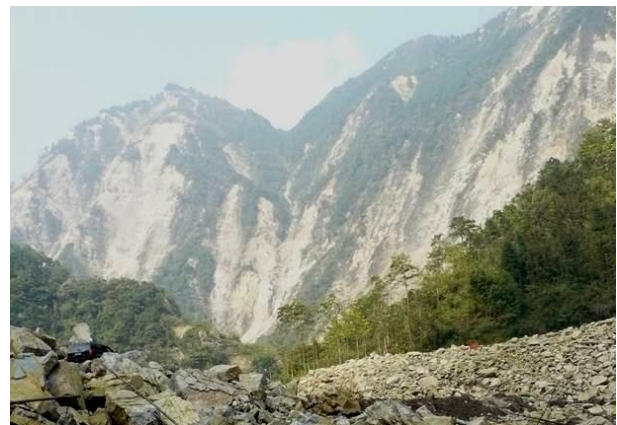
**Figure 39:** *Extensive damage to slopes northwest of Hanwang. Steep slopes almost stripped by landslide debris trails.*

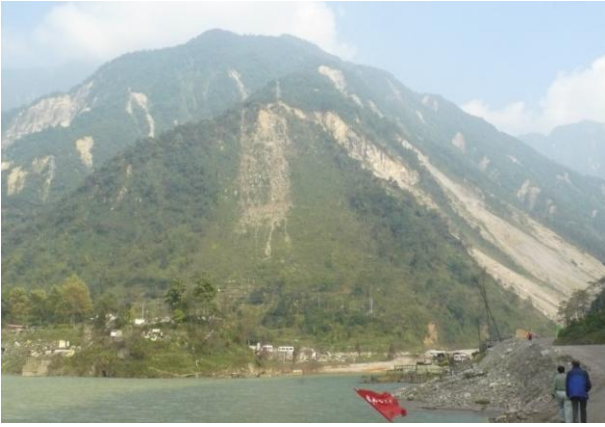
**Figure 40:** *Less intense landslide damage with partial reactivation of previous shallow landslide. Location closer to Hanwang than Figure 39.*

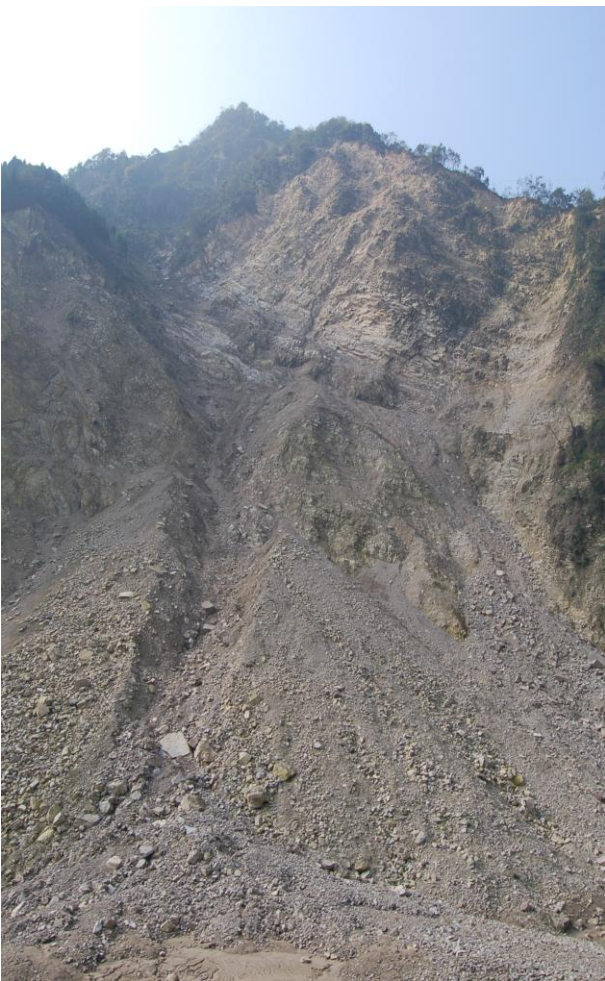
**Figure 41:** *Ridge failure in bedded sandstones beside the Mianyuan River with landslide debris covering lower part of the slope.*

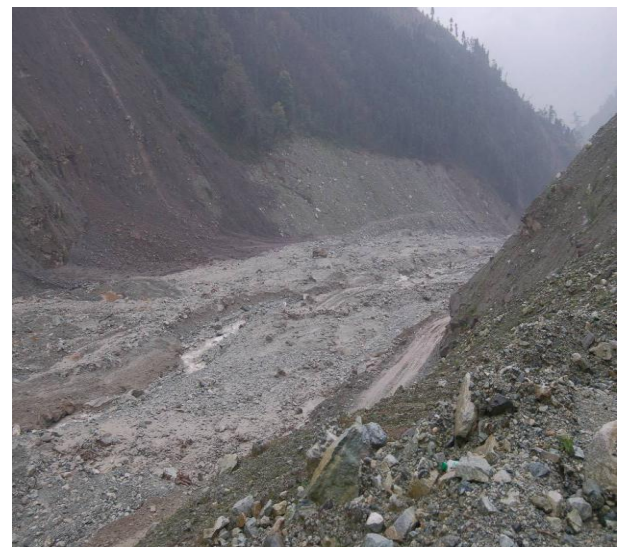
**Figure 42:** *Super-elevation along the path of Niujuangou debris flow avalanche near Yingxiu.*

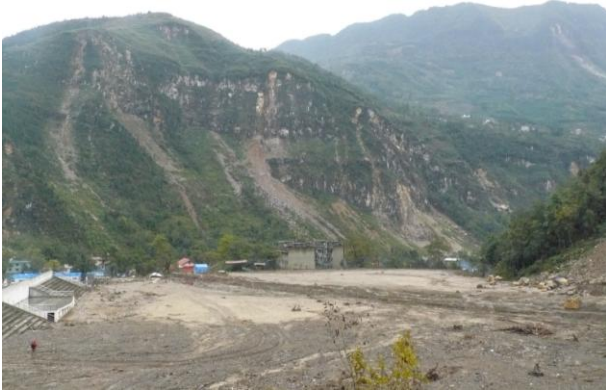
**Figure 47:** *Debris flow in September 2008 in gate entry village to Qushan Town. Steep dolomite scarp slopes on opposite side of the valley.*

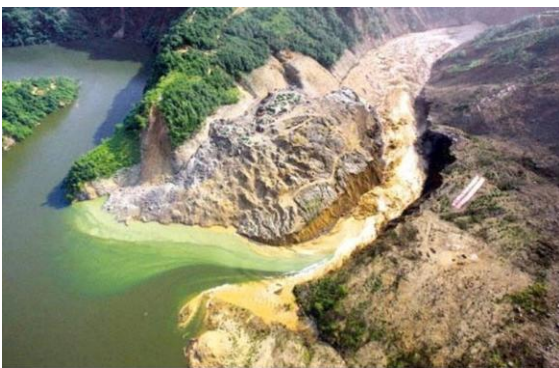
**Figure 48:** *Breach of 150 m high Tangjiashan landslide dam formed in mudstone dominated lithologies (after Chen *et al.*, 2009).*

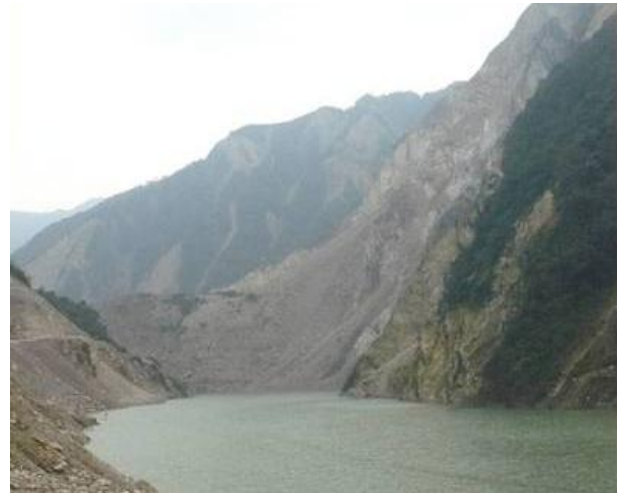
**Figure 49:** *Yi Ba Dao landslide dammed lake between Hanwang and Qingping. The landslide was a rock block slide from the right bank and the 60 m deep lake has been lowered by 30 m.*

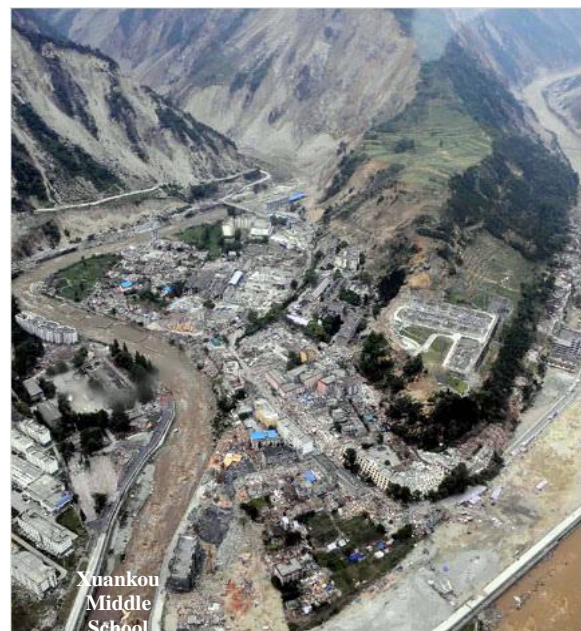
**Figure 50:** *Yingxiu Township, totally devastated after the earthquake. Xuankou Middle School is located at the left bottom corner.*

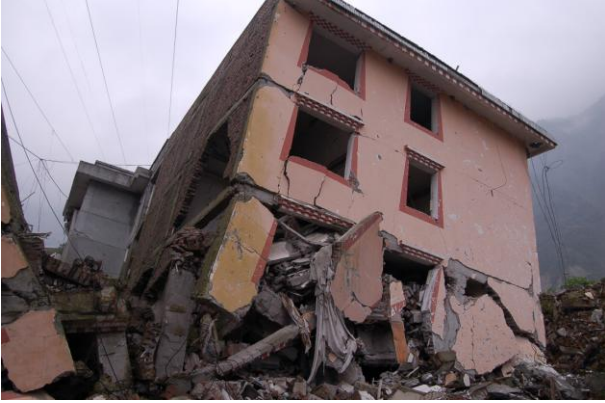
**Figure 51:** *Type 1 Masonry Construction in Yingxiu, complete collapse.*

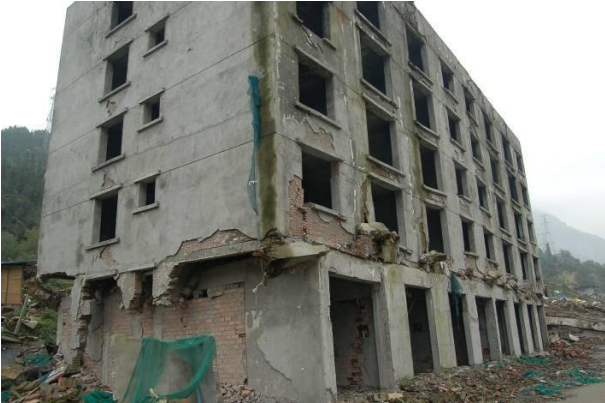
**Figure 52:** *Type 2 Masonry Structure: Hybrid with reinforced concrete structure at the bottom level and URM above. Note the complete failure of the URM floor.*

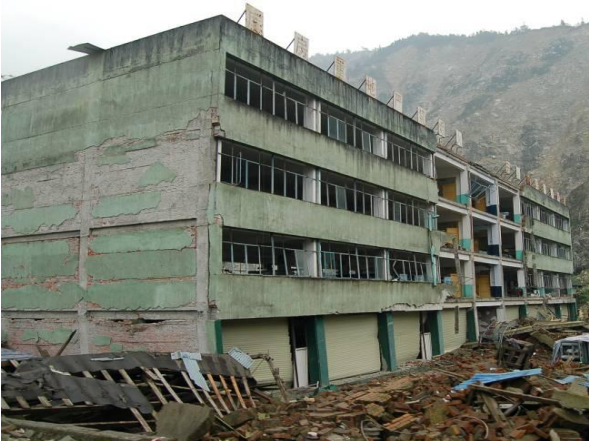
**Figure 53:** *Reinforced concrete framed structure with masonry in fill with soft story failure at the bottom level.*

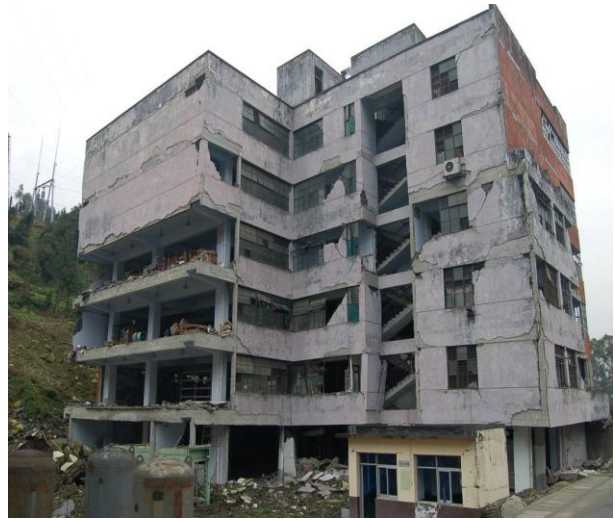
**Figure 54:** *Shear wall building in Yingxiu; good performance observed.*

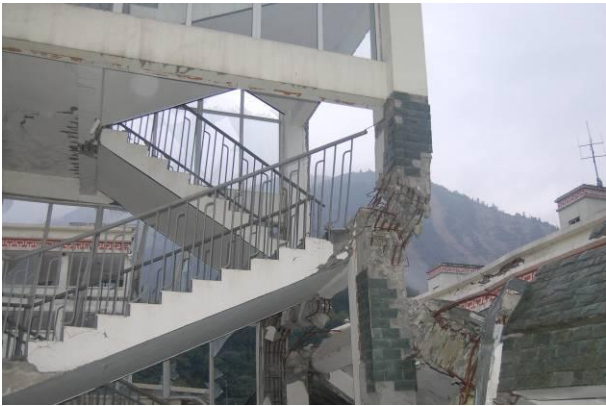
**Figure 56:** Link structure - bracing effect of stair.

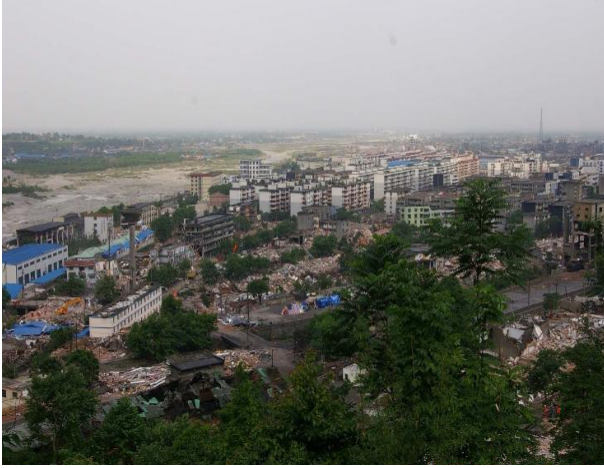
**Figure 63:** *Hanwang township - note the collapse of the buildings.*

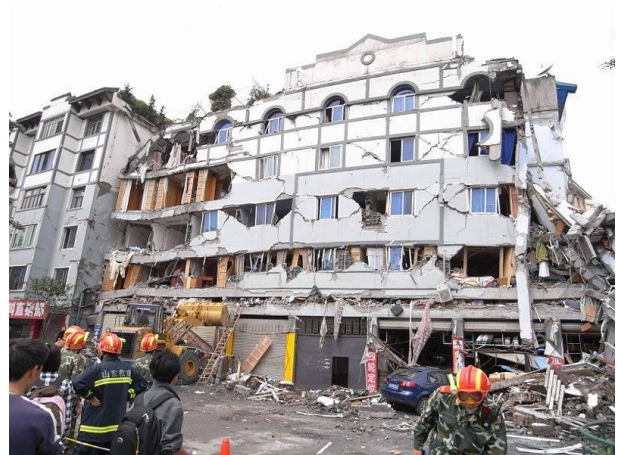
**Figure 67:** *Collapse of an entire floor in Dujiangyan (MM X), Type 2 Masonry Construction.*

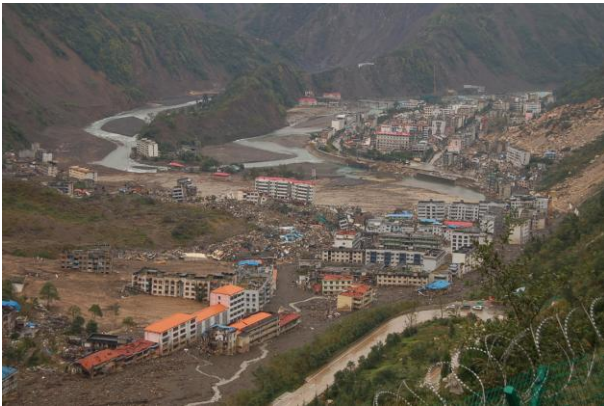
**Figure 69:** *Beichuan old township, totally abandoned.*

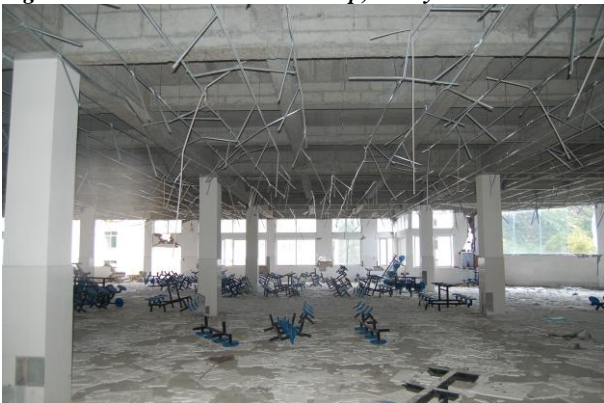
**Figure 70:** *The school dining hall, minor structural damage but severe damage to the architectural fixtures.*

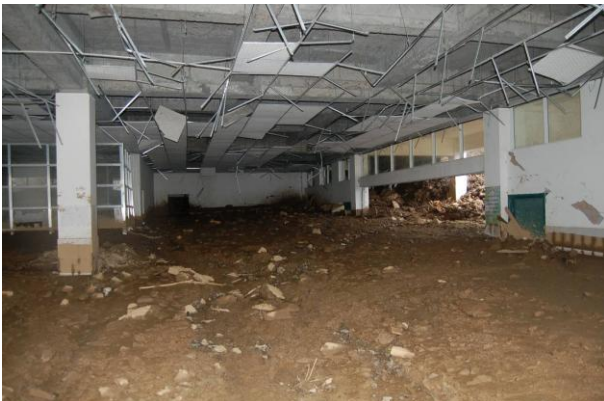
**Figure 71:** *Debris flow inside the school dining hall.*

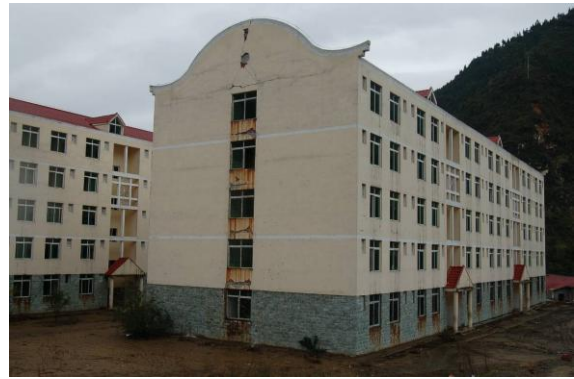
**Figure 73:** *Classroom Block of the school Beichuan, regular structure, minor damage.*

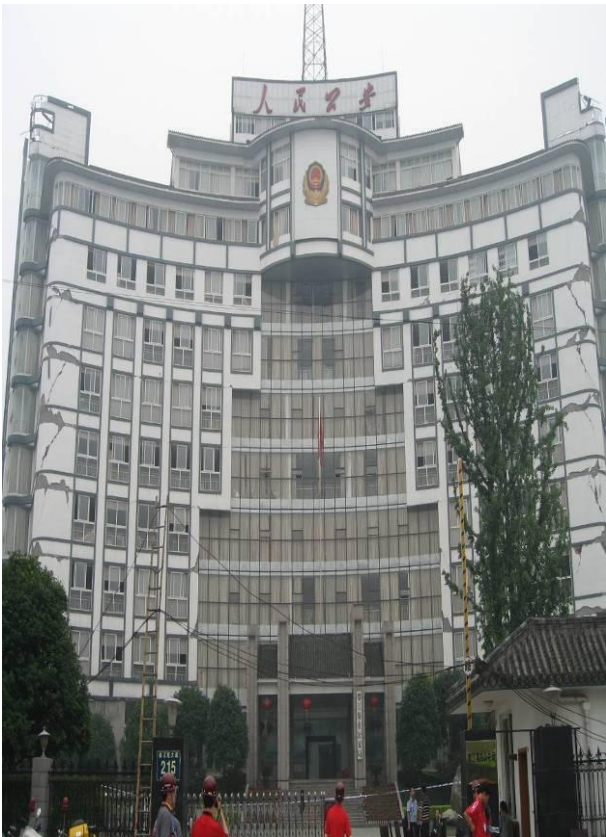
**Figure 74:** Public Security Bureau in Dujiangyan (MMX), some structural damage but intact, reinforced concrete frame - shear wall structure.

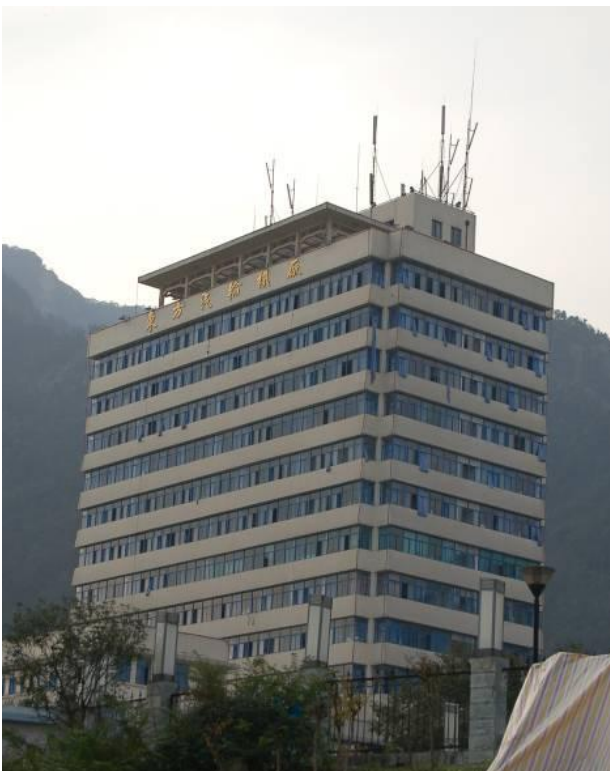
**Figure 75:** Dong Fang Steam Turbine Factory in Hanwang (MMX), basically intact with minor damage, shear wall structure.

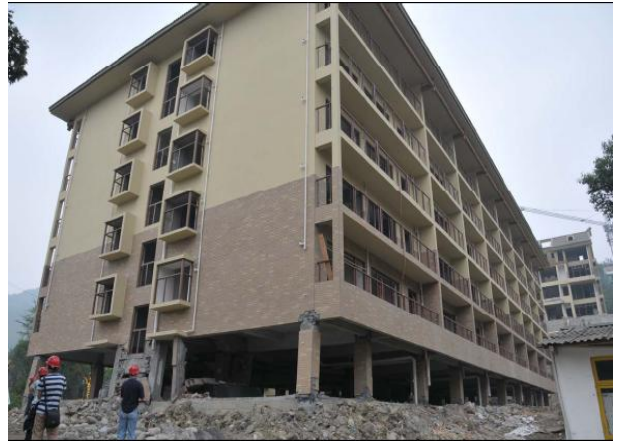
**Figure 76:** Soft story at the bottom, large change in structural stiffness vertically.

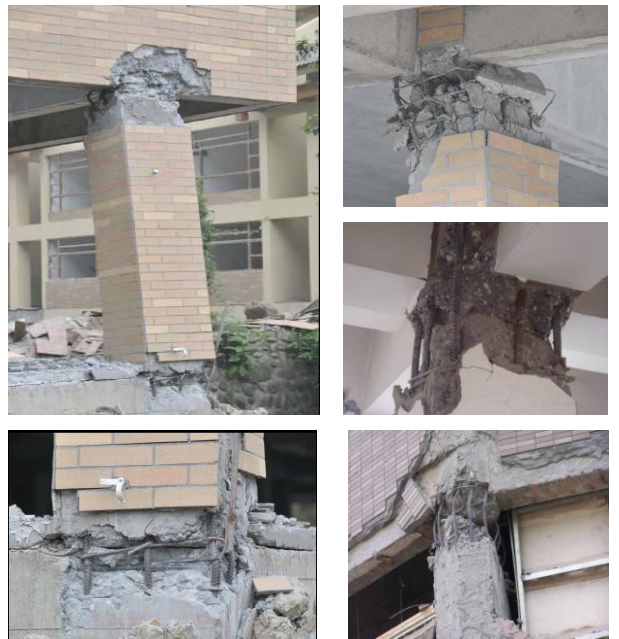
**Figure 77:** Inadequate transverse reinforcement in the columns.

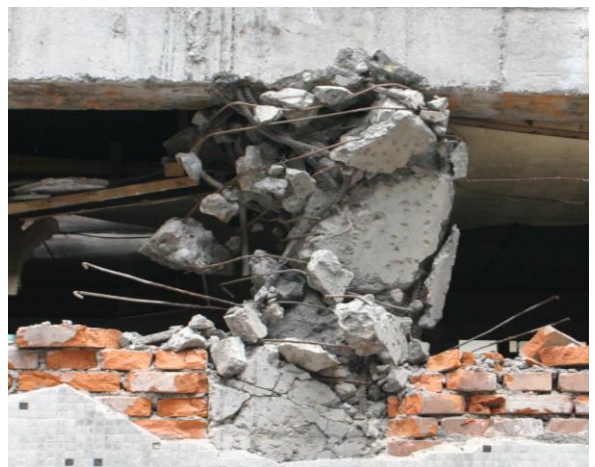
**Figure 78:** Short column effect.

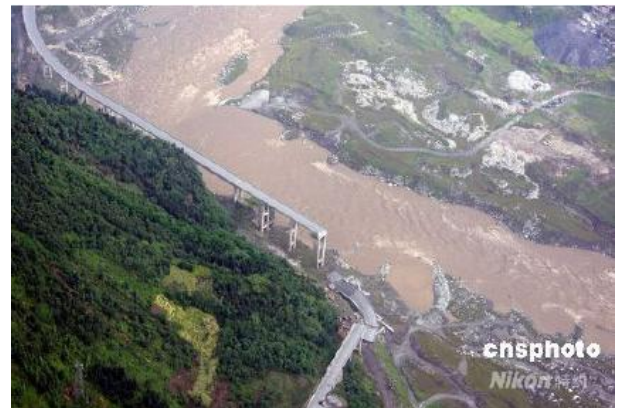
**Figure 79: Baihua Bridge after the earthquake.**

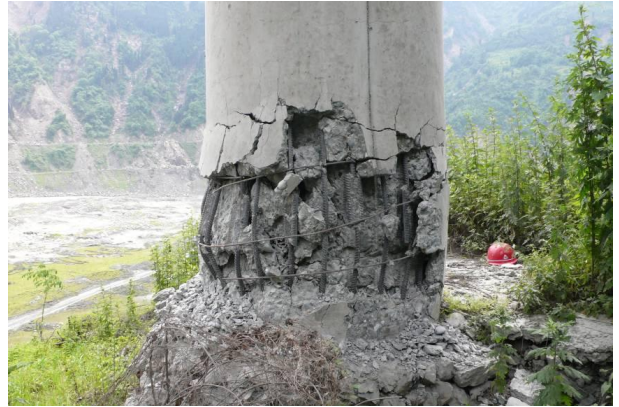
**Figure 84:** Shear failure, buckling of main reinforcing bars, spacing of stirrups in excess of 400 mm.

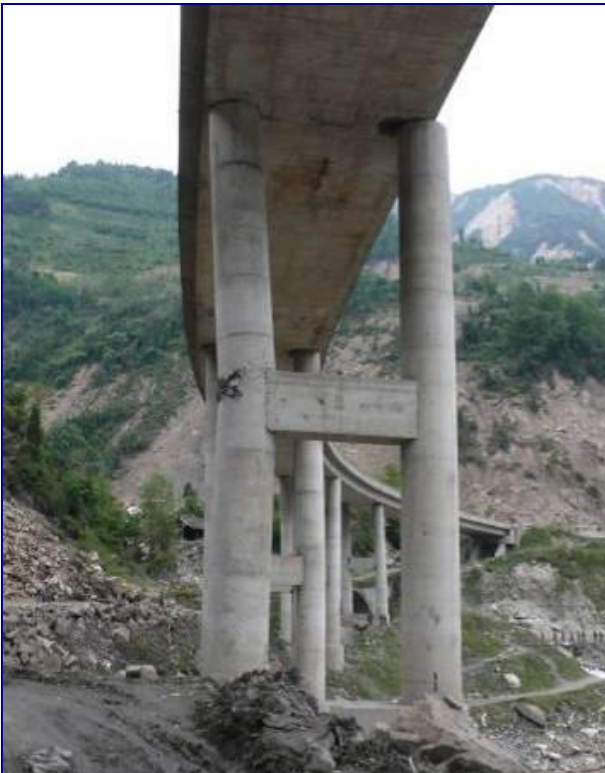
**Figure 82:** Large lateral displacement (800 mm) of the bridge deck and damage to bridge pier.

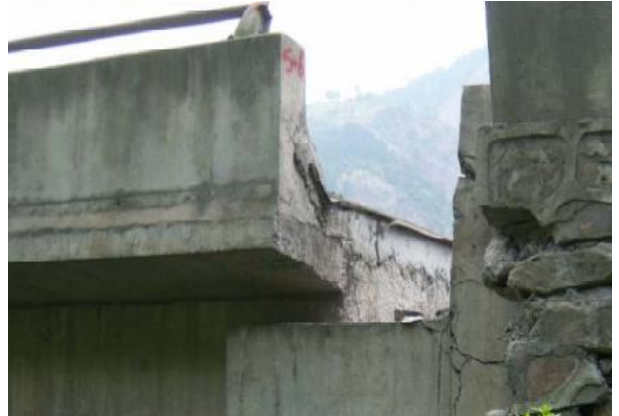
**Figure 85:** Longitudinal movement at abutment in excess of 600 mm.

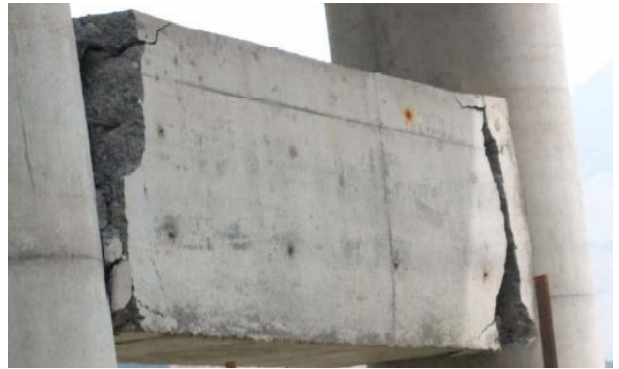
**Figure 86:** Fracture of main bars in the cross beam, large cracks and ineffective portal action.

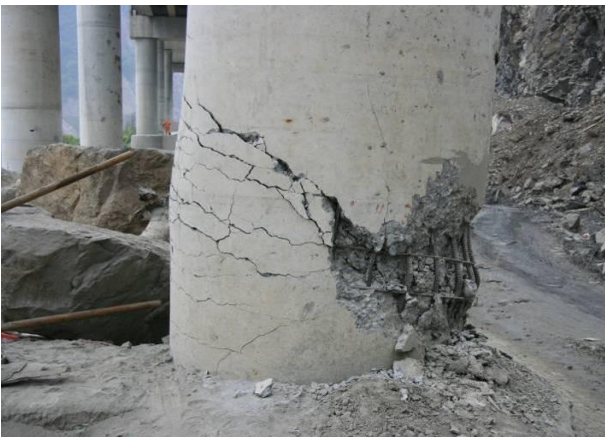
**Figure 83:** Buckling of main reinforcing bars, spacing of stirrups well in excess of 300 mm.

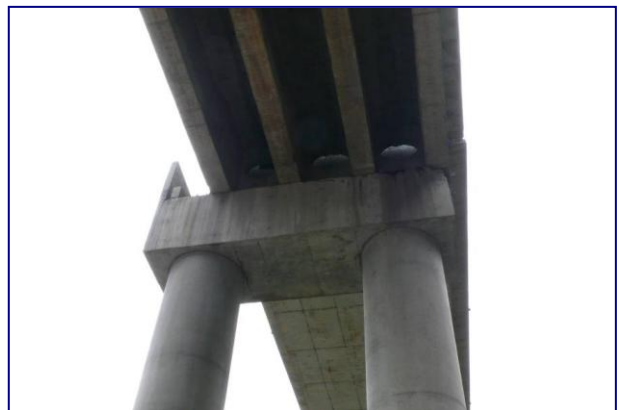
**Figure 87:** Lateral displacement of bridge deck at bridge Section 3.

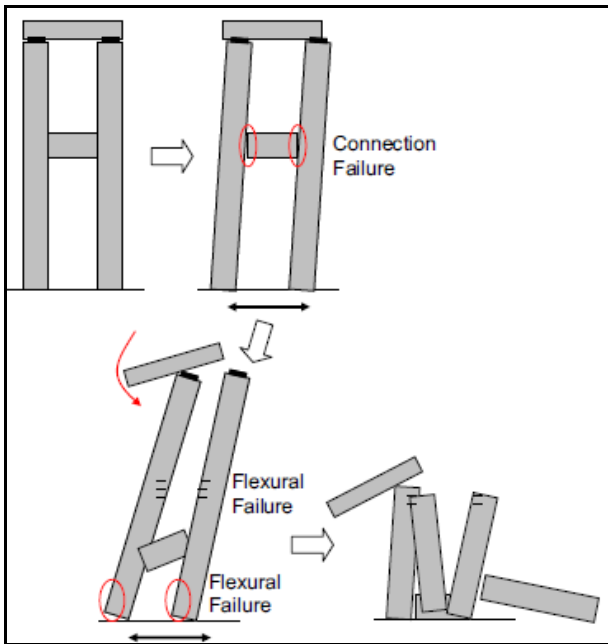
Figure 88: Baihua Bridge – Possible failure mechanism.

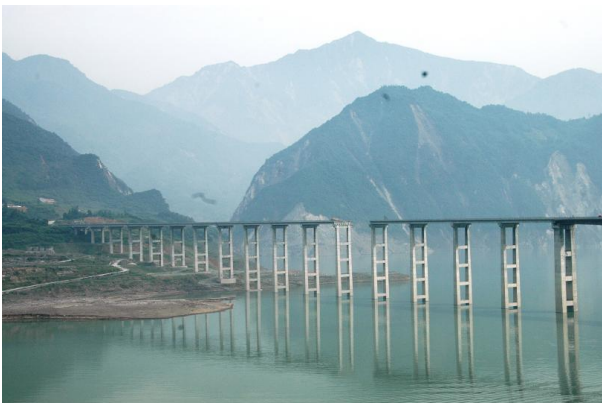
Figure 89: Loss of seating at span no. 10.

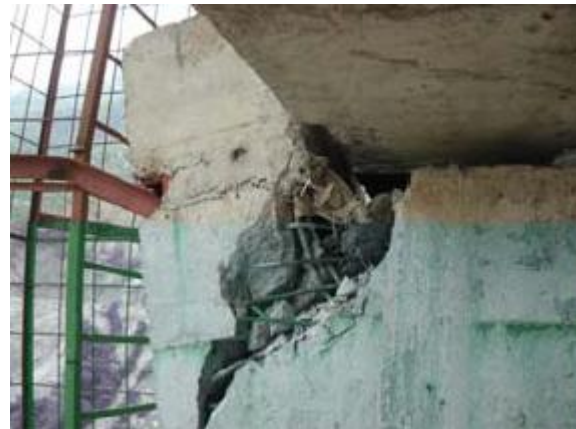
Figure 91: Impact damage of external shear key.

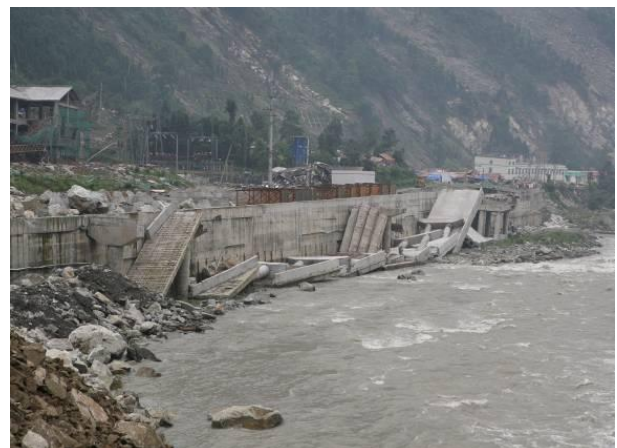
Figure 92: Complete collapse of a bridge across the fault rupture at Yingxiu near the epicentre.

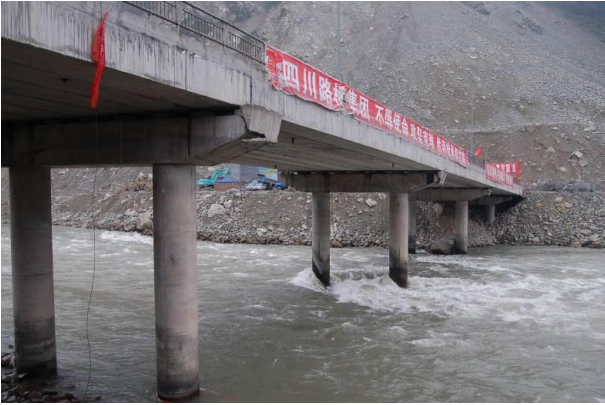
**Figure 93:** A bridge that runs parallel to the fault rupture near the Epicentre, suffered considerably less damage, large movement of the deck, up to 1 m horizontally .

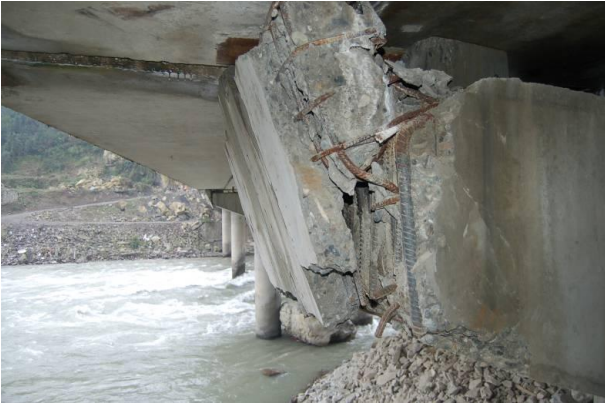
**Figure 94:** Damage to shear key due to the horizontal inertia force from the deck.

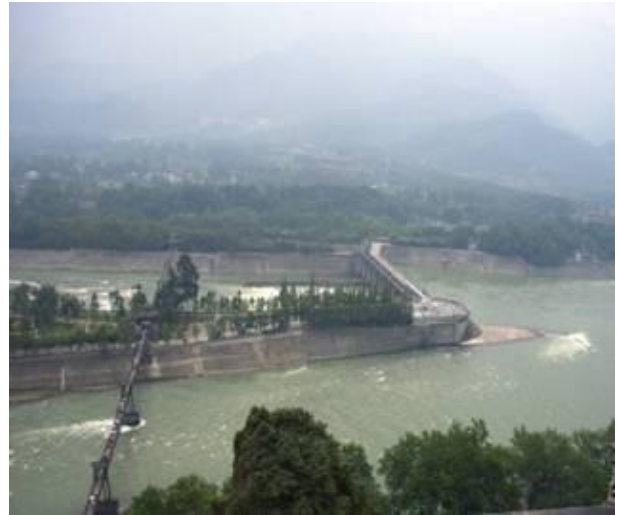
**Figure 96:** *Dujiangyan irrigation system headworks. Original scheme used the central levee to divert the river into the channel in the foreground with the race intake.*

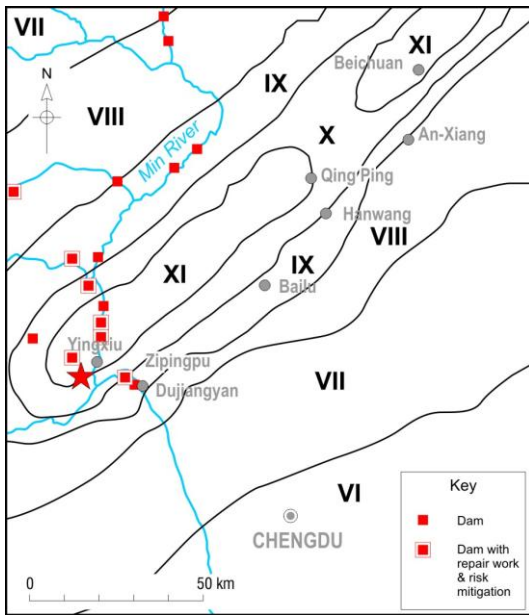
Figure 97: Major dams on Minjiang or Min River and tributaries (after Wang et al., 2009).

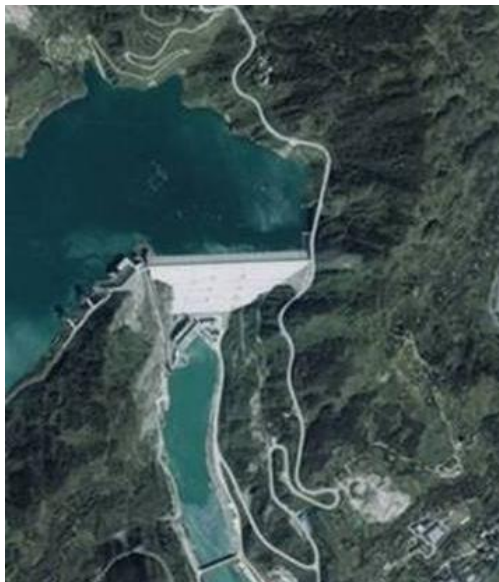
Figure 98: Google image of the Zipingpu dam.

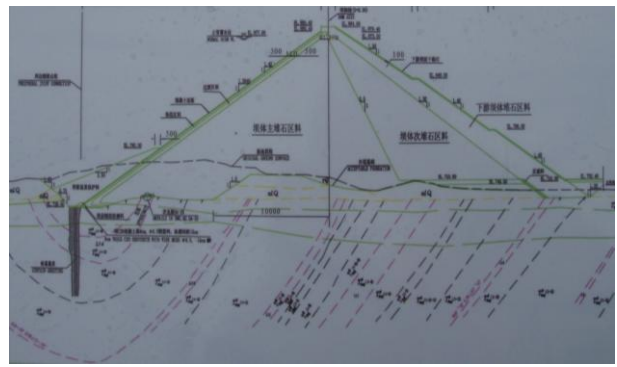
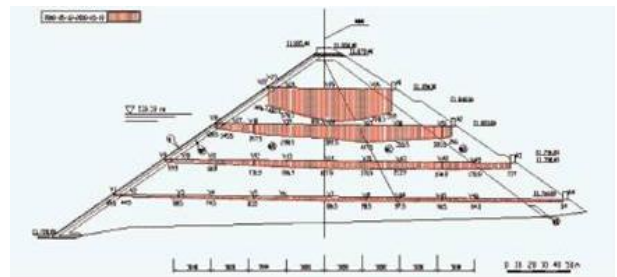
Figure 99: Cross section of 156 m high Zipingpu dam showing foundation geology and settlement (max. 730 mm - Wang et al., 2009) as a result of the earthquake.

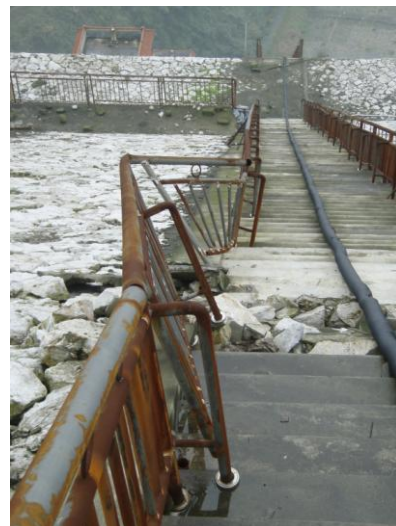
Figure 100: Deformation of Zipingpu dam downstream face reflecting settlement during earthquake.

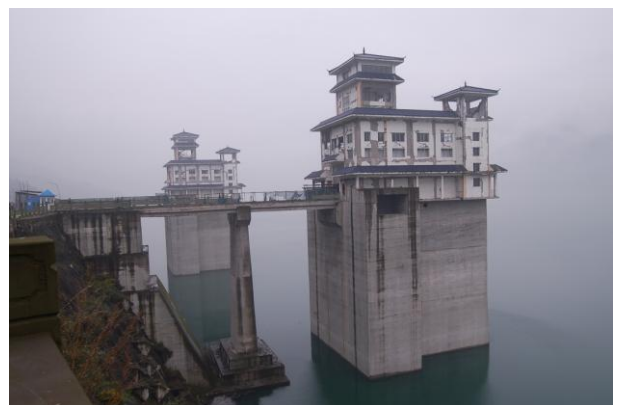
Figure 101: Intake structures low level outlet tunnels. Some damage to tower superstructures is apparent, but tunnels operated after earthquake.

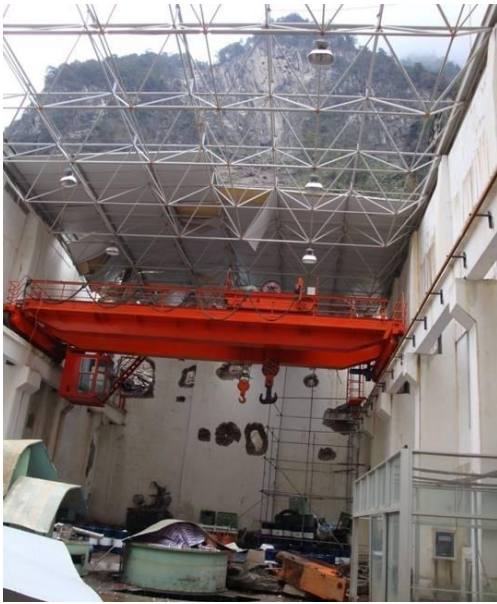
**Figure 102:** *Shapai powerhouse showing damage from ‘evil dancing rock’ impacts (photo from Charlewood et al., 2009).*
