# THE Ms 8.0 WENCHUAN EARTHQUAKE OF 12 May 2008 RECONNAISSANCE REPORT

Jiashun Yu<sup>1</sup>, Philip Yong<sup>2</sup>, Stuart Read<sup>3</sup>  
P. Brabhakaran<sup>4</sup> and Meng Foon<sup>5</sup>

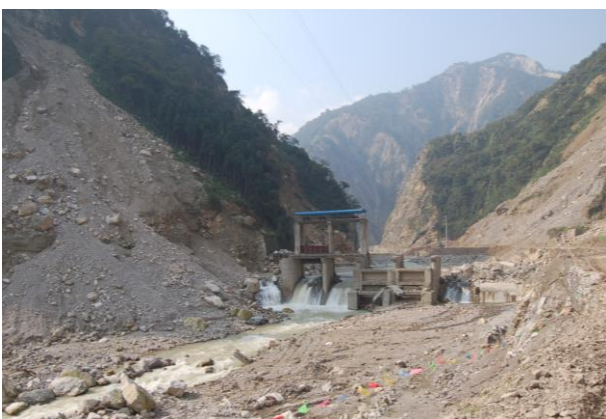
**Figure 103:** *Irrigation control structure on Mianyu River upstream of Hanwang. Much of damage believed to be from partial breach of Yi Ba Dao landslide-dammed lake.*

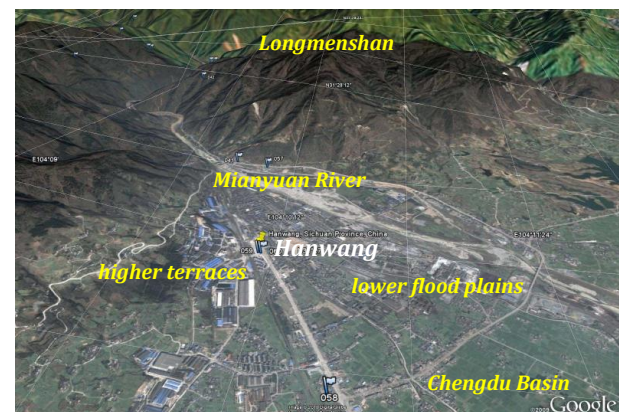
**Figure 104:** *Hanwang on alluvial fan of Mianyu River.*

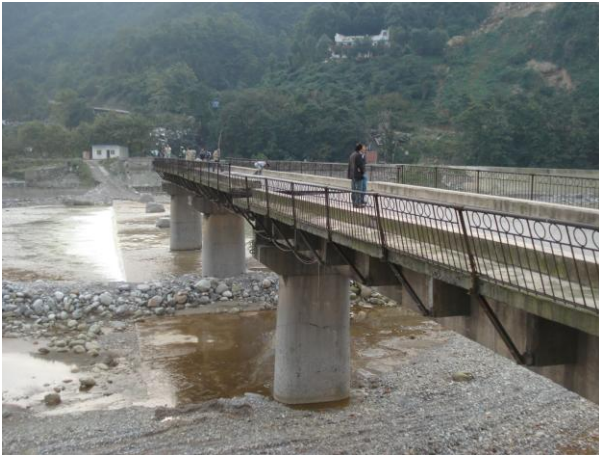
**Figure 105:** Bridge collapse due to fault rupture.

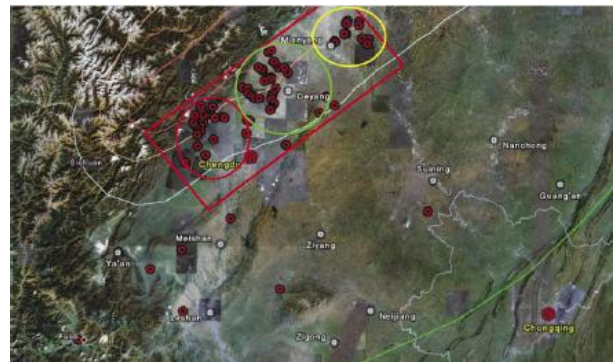
**Figure 106:** Locations of liquefaction (red circles)- Wenchuan Earthquake (after Longwei *et al*, 2009).

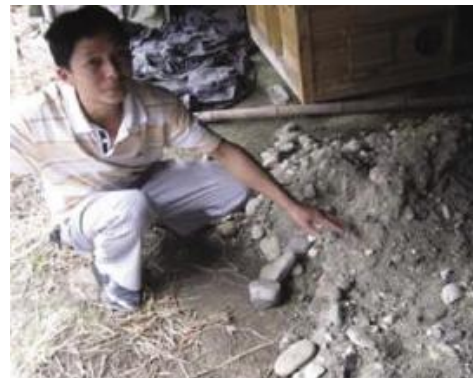
**Figure 107:** Gravel ejected into well in Baihutou village of Mianzhu City (after Longwei *et al*, 2009).

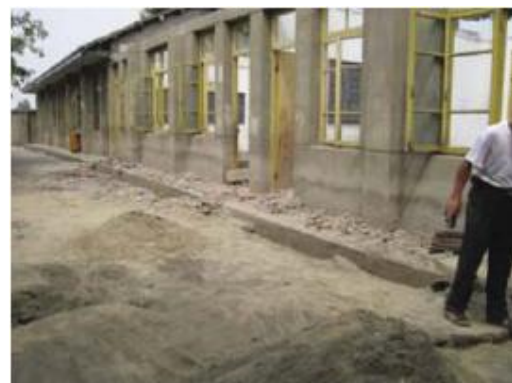
**Figure 108:** Liquefaction at Zhongxing Middle School in Dujiangyan City (after Longwei *et al*, 2009).

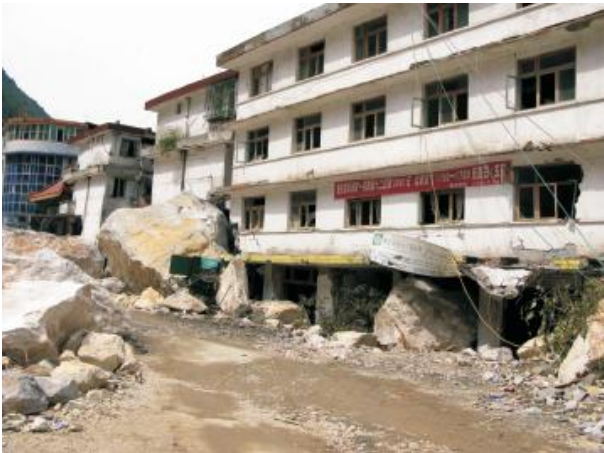
**Figure 109:** Buildings damaged by large rock boulders.

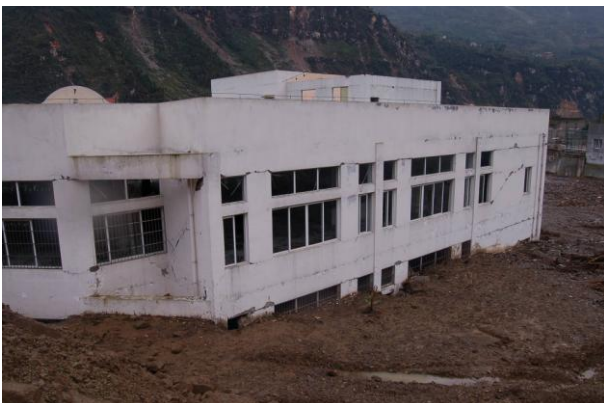
**Figure 110:** School building partially buried by debris flow in Beichuan.

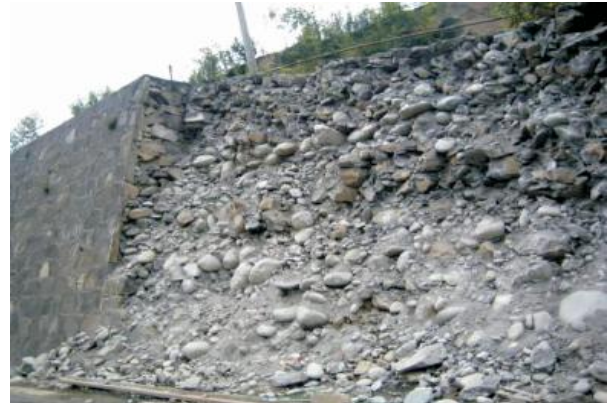
**Figure 111:** Collapsed section of gravity retaining wall.

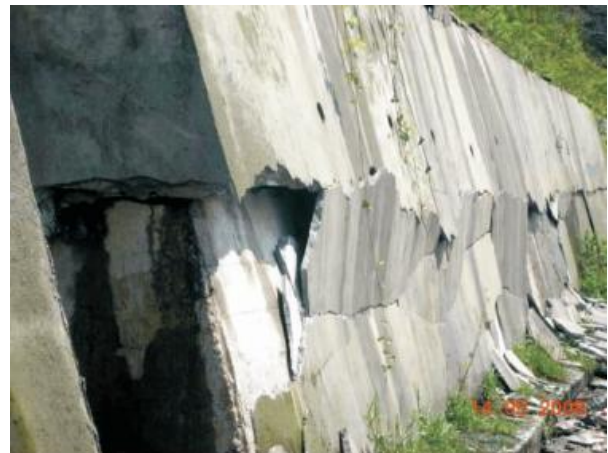
**Figure 112:** Cracked concrete retaining wall.

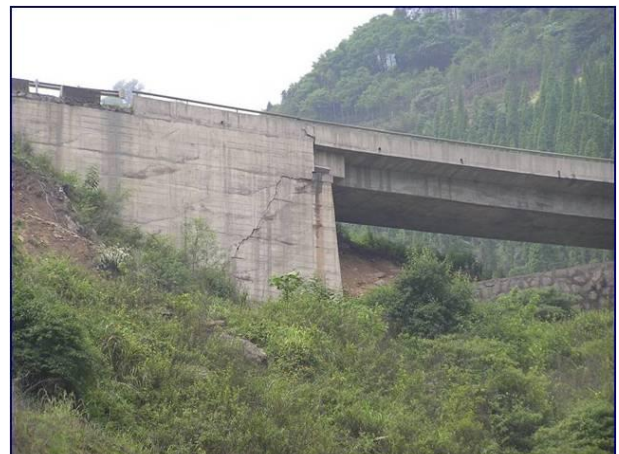
**Figure 113:** Cracked bridge abutment wall.

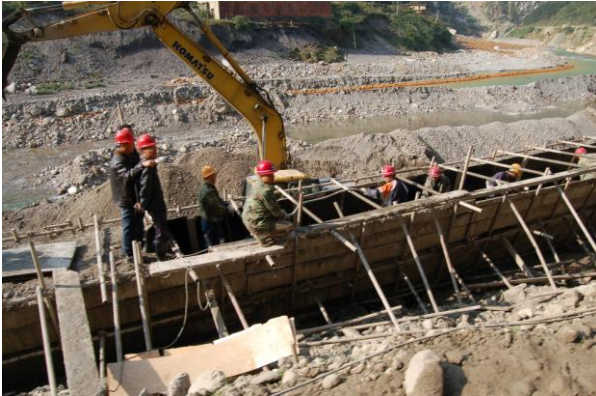
**Figure 114:** Reconstruction of gravity retaining wall to replace walls that had collapsed.

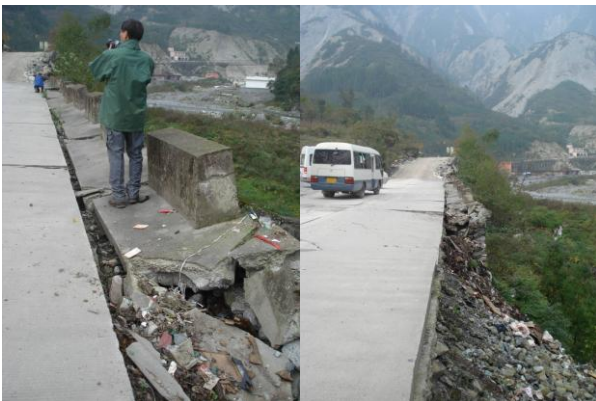
**Figure 115:** Section of retaining wall that has displaced up to ~200 mm, and section that collapsed adjacent to fault rupture near Qing Ping.

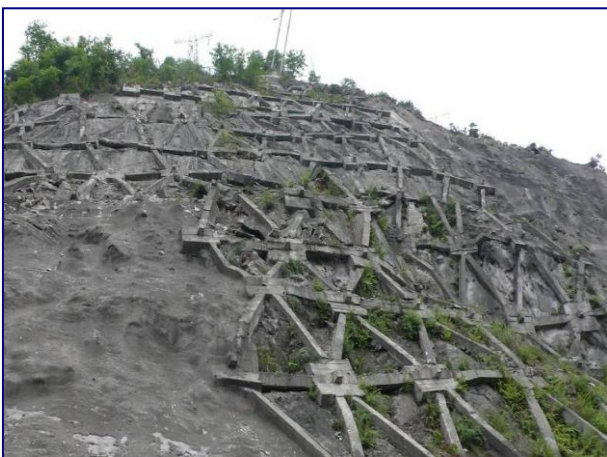
**Figure 116:** Anchored wall generally performed well.

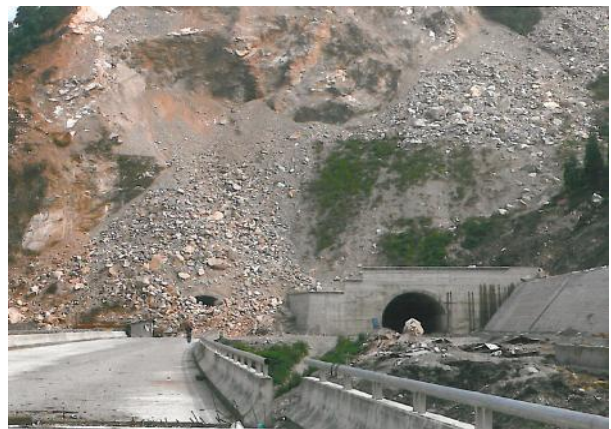
**Figure 117:** Tunnel portal blocked by rock slides.

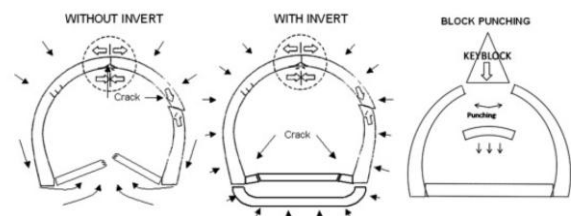
**Figure 118:** Types of damage observed in tunnels (after Aydan *et al.* 2009).

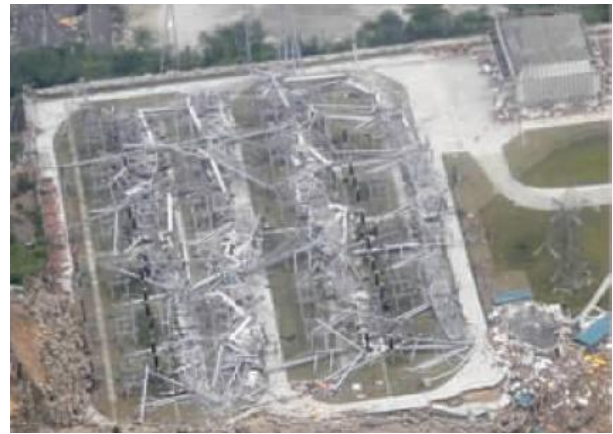
**Figure 119:** Destruction of substation in earthquake.

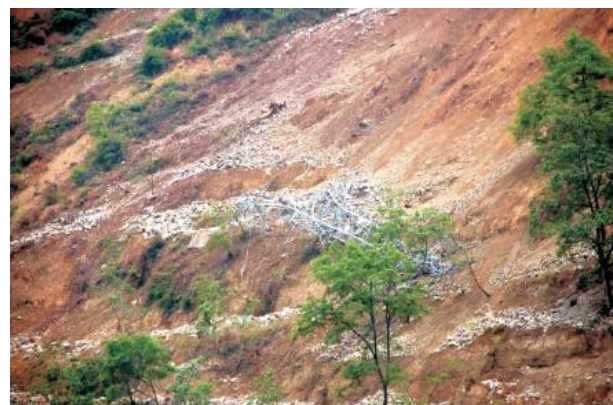
**Figure 120:** Transmission tower destroyed by landslide.

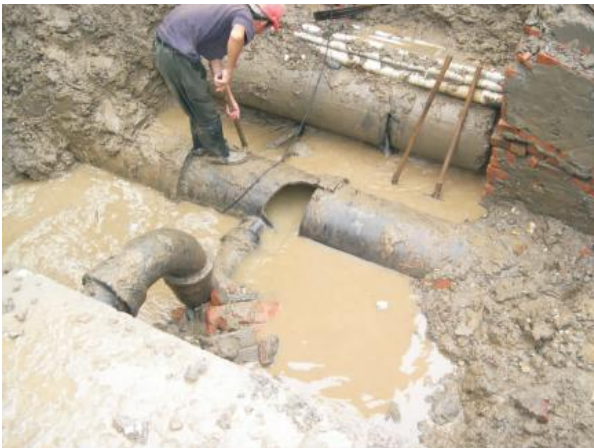
**Figure 121:** *Damage and repair to water supply pipeline.*

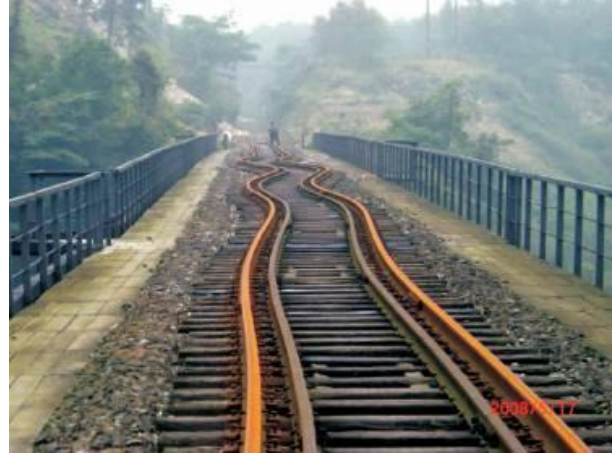
**Figure 122:** *Damaged railway line.*

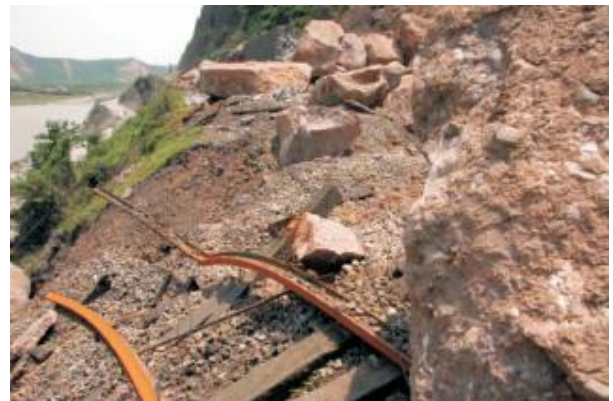
**Figure 123:** *Railway line destroyed by landslide.*

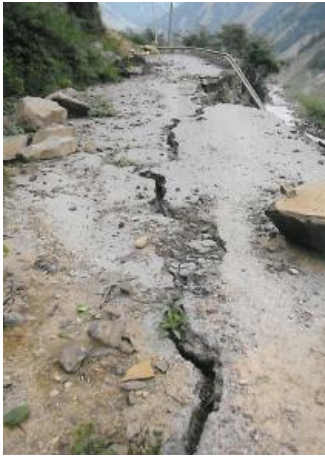
**Figure 125:** Loss of road platform due to underslips.

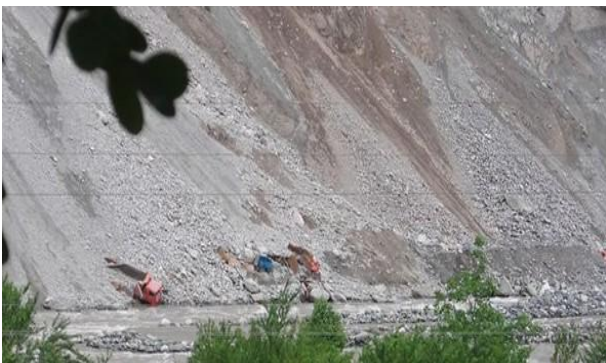
**Figure 126:** Highway completely removed by landslides.

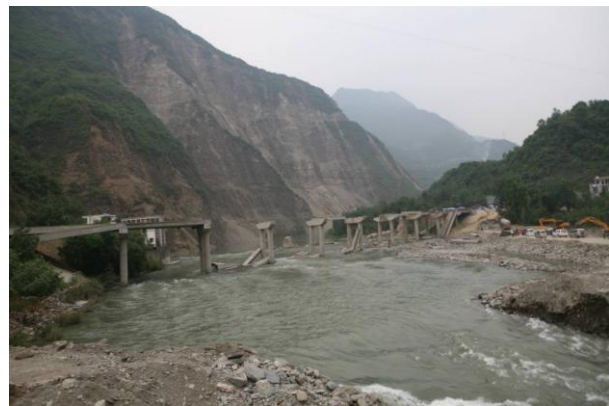
**Figure 128:** Loss of access from collapse of river bridge.

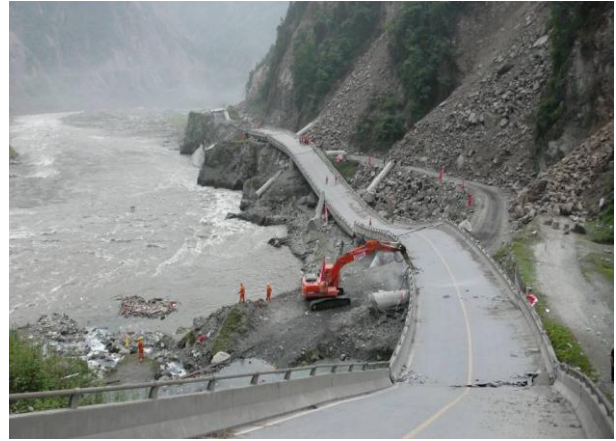
**Figure 132:** Partially collapsed Baihua bridge blasted down with explosives to make access along Highway 213.

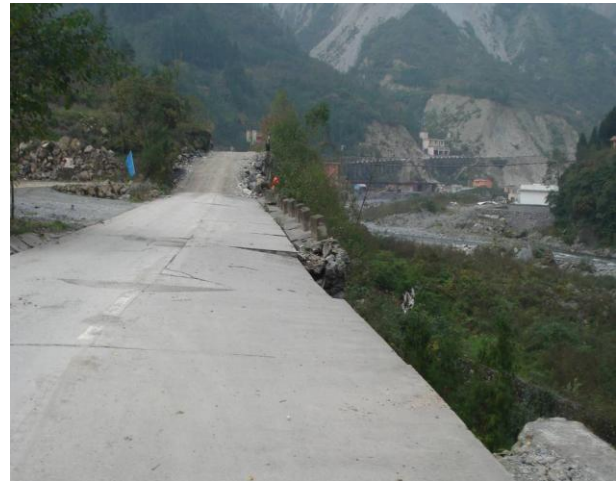
**Figure 133:** Ramping up road across fault rupture, near Qingping.

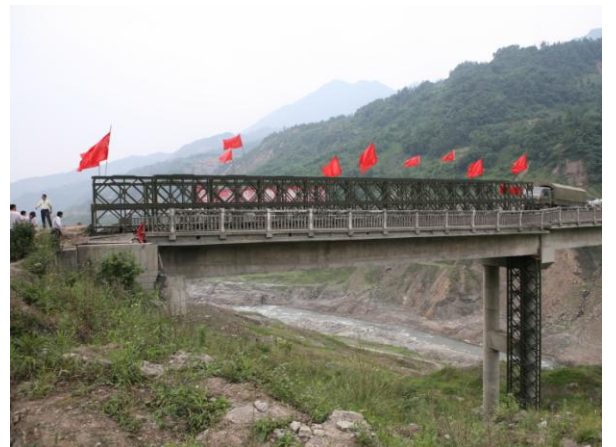
**Figure 134:** Reinstating temporary access across damaged bridges using truss structures.

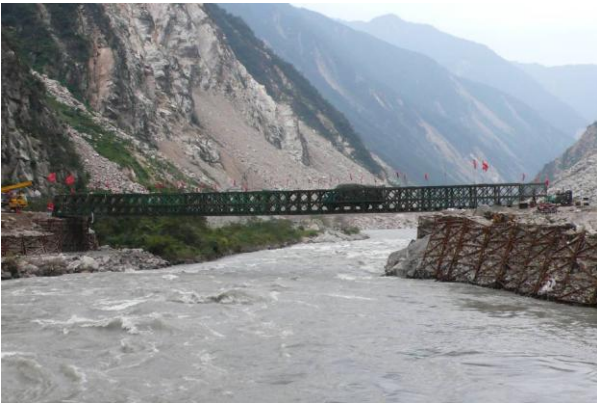
**Figure 135:** Reinstating temporary access across rivers using truss bridges.

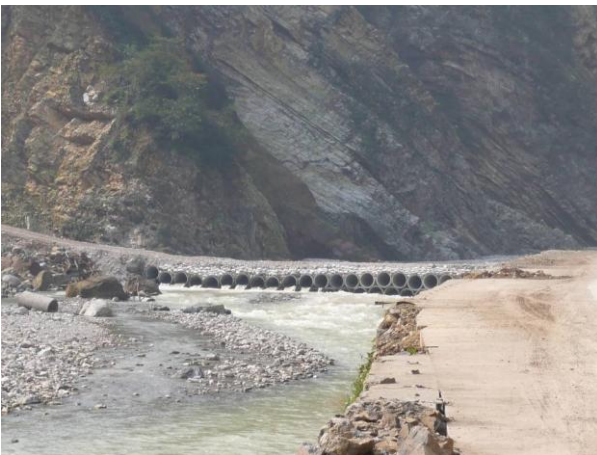
**Figure 136:** Reinstating temporary access across rivers using culverts and fords.
