# THE $M_w$ 6.3 ABRUZZO (ITALY) EARTHQUAKE OF APRIL 6<sup>TH</sup>, 2009: ON SITE OBSERVATIONS

Claudio Oyarzo-Vera<sup>1</sup> and Michael C. Griffith<sup>2</sup>

The authors visited the disaster zone one month after the earthquake. The most badly affected areas in L'Aquila historical centre and three other villages – San Gregorio, Pagánica and Onna – were inspected.

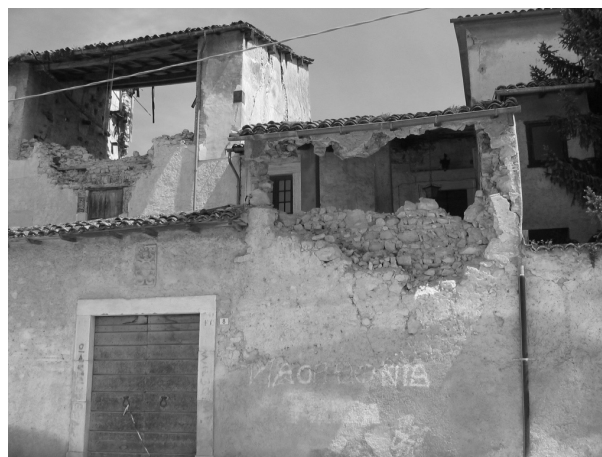
Hence, the most common failure modes observed were associated with out-of-plane failures of parapets, gable-ends and in some cases entire walls (Figures 5 and 6). In-plane failure modes, such as shear cracking and failure of panels adjacent to door or window openings (Figure 7) and shear failure of spandrel beam sections above openings (Figure 8), were also observed, but in most cases did not lead to complete building collapse.

**Figure 5:** Out-of-plane failure of walls (San Gregorio).

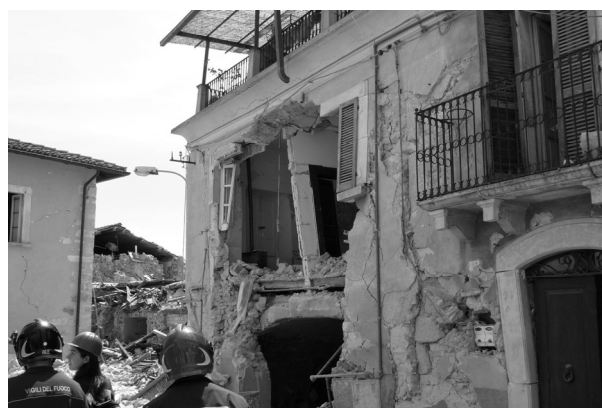
**Figure 6:** Out-of-plane failure of walls (Onna).

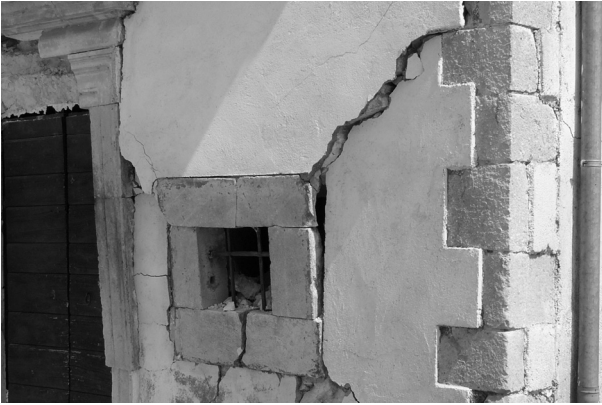
**Figure 7:** *Damage adjacent to openings (San Gregorio).*

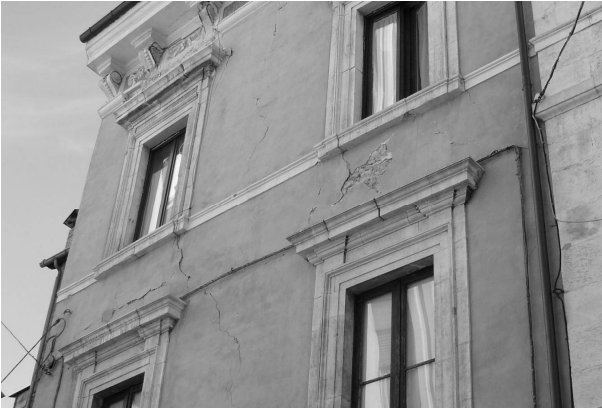
**Figure 8:** *Damage in spandrel (San Gregorio).*

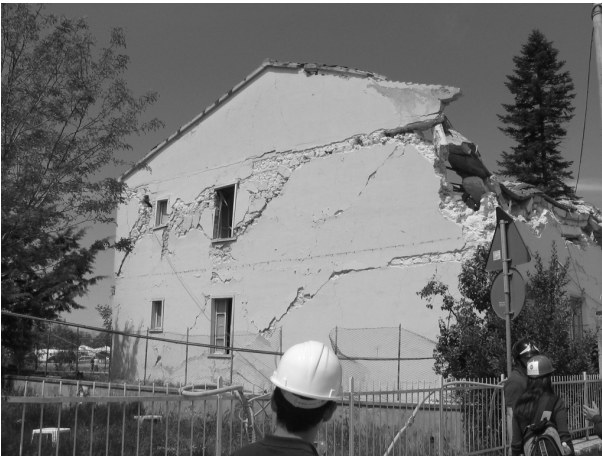
It was particularly interesting to note that in some cases, URM buildings with good horizontal diaphragm action performed poorly (Figure 9). This was thought to be due to the large concentration of inertia force at the floor/roof levels exceeding the capacity of the connections to the vertical in-plane wall elements, resulting in large deformations being imposed on the out-of-plane walls. This damage concentration at diaphragm level was also observed in some buildings that had concrete ring beams (Figure 10) at floor and roof levels installed to 'tie the building together'.

**Figure 9:** *Damage concentration at diaphragm level (Onna).*

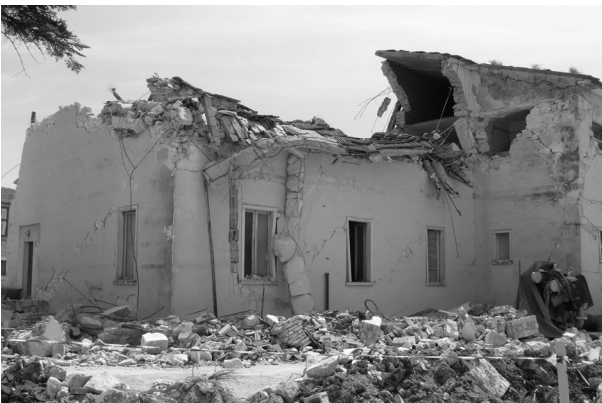
**Figure 10:** *Collapse of walls with R/C ring beam at roof level (Onna).*

Some buildings, having reinforced concrete ring beams or stiff floor diaphragms, were observed to fail and it was noted that this was most likely due to inadequate strength of the connection between the in-plane walls and floor diaphragms. However, it appeared that the failure mode was still much improved over the many out-of-plane wall failures where little connection or diaphragm action was present. Hence, it was concluded that masonry buildings which were well connected (at wall intersections and between walls and horizontal elements such as floors and roof) performed much better than those having poor connections between structural elements.

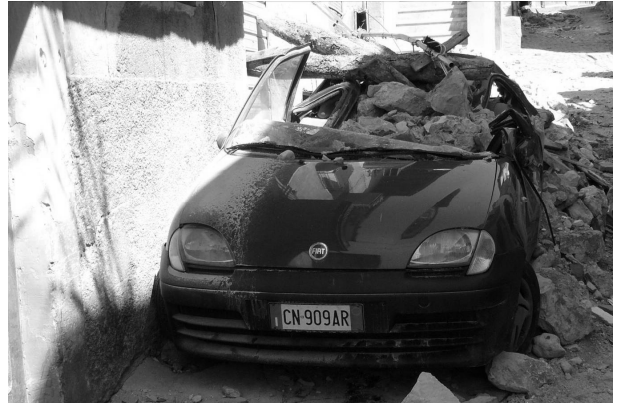
There were also many examples of damage to neighbouring buildings and vehicles parked in streets due to falling masonry (Figure 11), owing to the lack of good cross-ties between the inner and outer faces of stone masonry walls.

**Figure 11:** *Damage to vehicles because of bricks falling (Pagánica).*

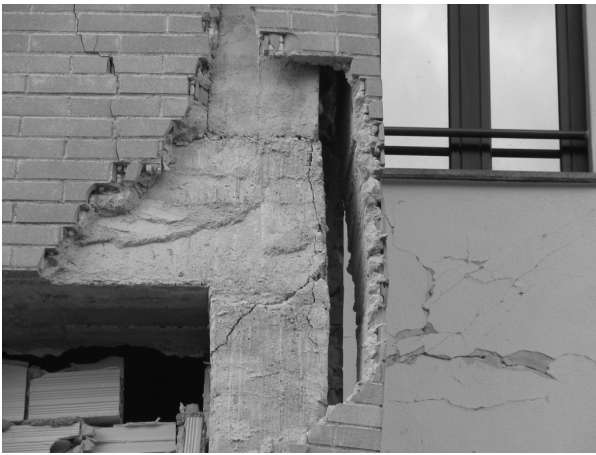
Masonry cladding was typically a thin veneer clay masonry brickwork with no positive, mechanical fasteners to the structure. The veneer brickwork simply sat on the floor slabs and was poorly 'fastened' to the structure through some adhesion to the columns. Many examples of the veneer failing out-of-plane were seen (Figure 12). Less common, but still sufficient to cause concern, was the out-of-plane and/or in-plane failure of masonry infill walls (Figure 13). These walls were commonly constructed with perforated clay block units with the perforations running horizontally, where the masonry infill was not supporting any vertical gravity load.

**Figure 12:** *Veneer out-of-plane failure (L'Aquila).*

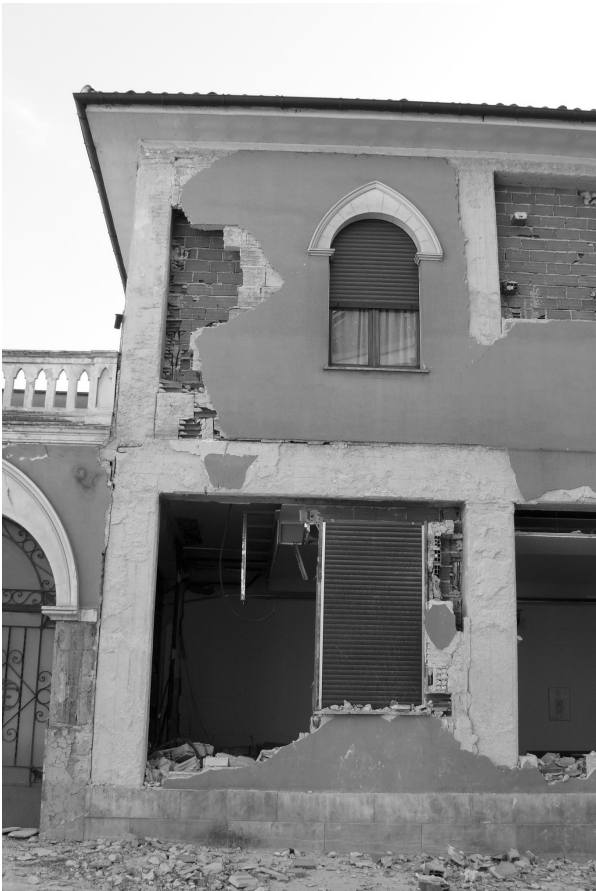
**Figure 13:** *Masonry infill out-of-plane failure (L'Aquila).*

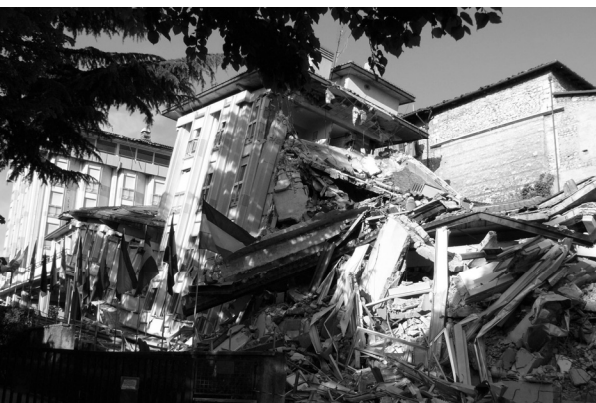
There were several examples of complete collapse in L'Aquila, such as the building shown in Figure 14. Many of these collapses appear to be due to failure of the columns in lower storeys, either due to shear or flexure. Plain round reinforcement bars were found in most of the collapsed concrete frames and failed concrete columns (Figure 15). It was common to observe a lack of confinement, such as transversal reinforcement spaced in excess of 250 mm, and poor cross-section detailing, e.g. 90 degree hooks in the shear ligatures.

**Figure 14:** *Collapsed R/C frame building (L'Aquila).*

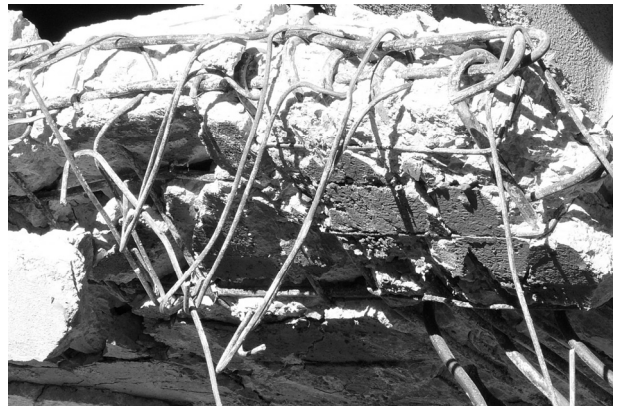
**Figure 15:** *Plain round reinforcement bars found in collapsed building (L'Aquila).*

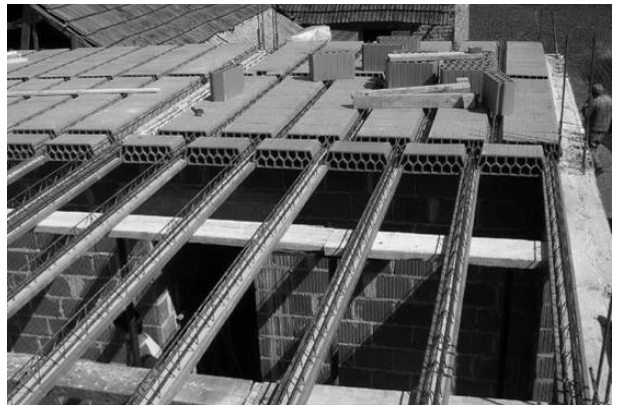
Another observation in many of the collapsed or partially collapsed buildings was the use of perforated masonry diaphragm systems. These systems continue to be used in modern construction in Italy and feature perforated masonry units (clay bricks or concrete blocks) which are supported by inverted concrete T-beams that span between the primary concrete or steel girders (refer Figure 16 for typical details). The perforated clay units are topped with concrete but do not appear to have any mechanical connectors with the topping concrete to ensure good monolithic diaphragm behaviour and hence have limited structural benefit when subjected to seismic loading (Figure 17).

**Figure 16:** *Photo of perforated masonry diaphragm system (courtesy of Sanja Hak).*

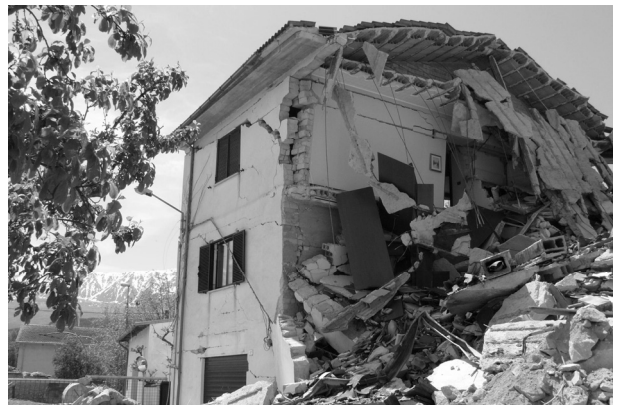
**Figure 17:** *Damage due to deficient performance of perforated masonry diaphragm system (Onna).*

Perforated masonry diaphragm systems performed poorly, primarily because of both deficient monolithic diaphragm behaviour and the inadequate diaphragm-to-wall connection, which generated an important mass concentration at floor/roof level, but not necessarily a structural benefit. However, this form of construction (see Figures 16 and 17) is not common in New Zealand or Australia.

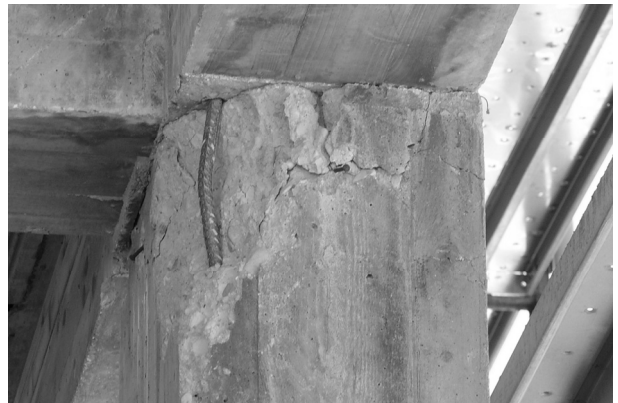
It was interesting to see column hinges in one new concrete frame building under construction in Onna, even though the masonry infill was not yet in place. Figure 18 shows damage at the top of one column in the bottom (not basement) storey, where it can be seen that a horizontal failure plane has occurred at the top of the column where it meets the bottom of the beams (i.e. at a construction joint). It appears that at this location the concrete cover has spalled and the compression reinforcement has buckled.

**Figure 18:** *Plastic hinging and reinforcement buckling at the top of a column (Onna).*
