**THE PISCO (PERU) EARTHQUAKE OF 15 AUGUST 2007**  
**NZSEE Reconnaissance Report, June 2008**

**David Hopkins, Darrin Bell, Rafael Benites, James Burr,  
 Craig Hamilton and Rudolph Kotze**

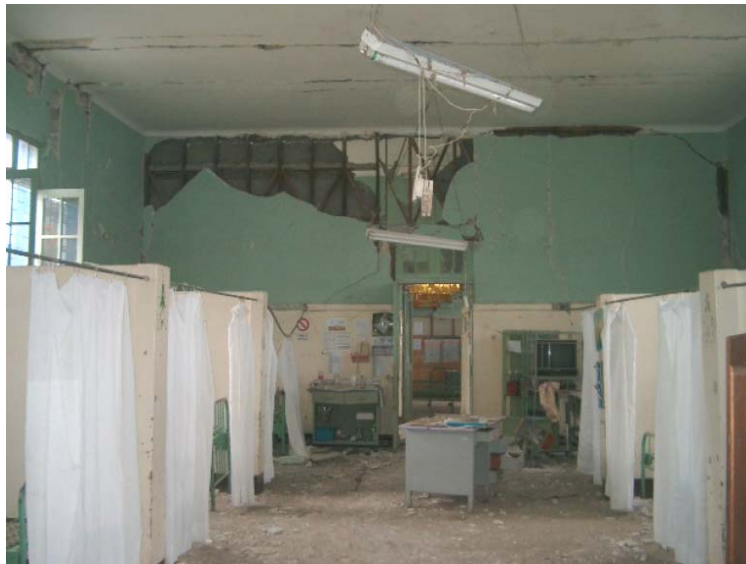
existing patients, but also in their ability to provide treatment to those injured in the earthquake. Figure 13 shows damage to a hospital treatment room which has rendered it unusable to treat the injured.

*Figure 13. Damage to hospital treatment room in Ica Regional Hospital*

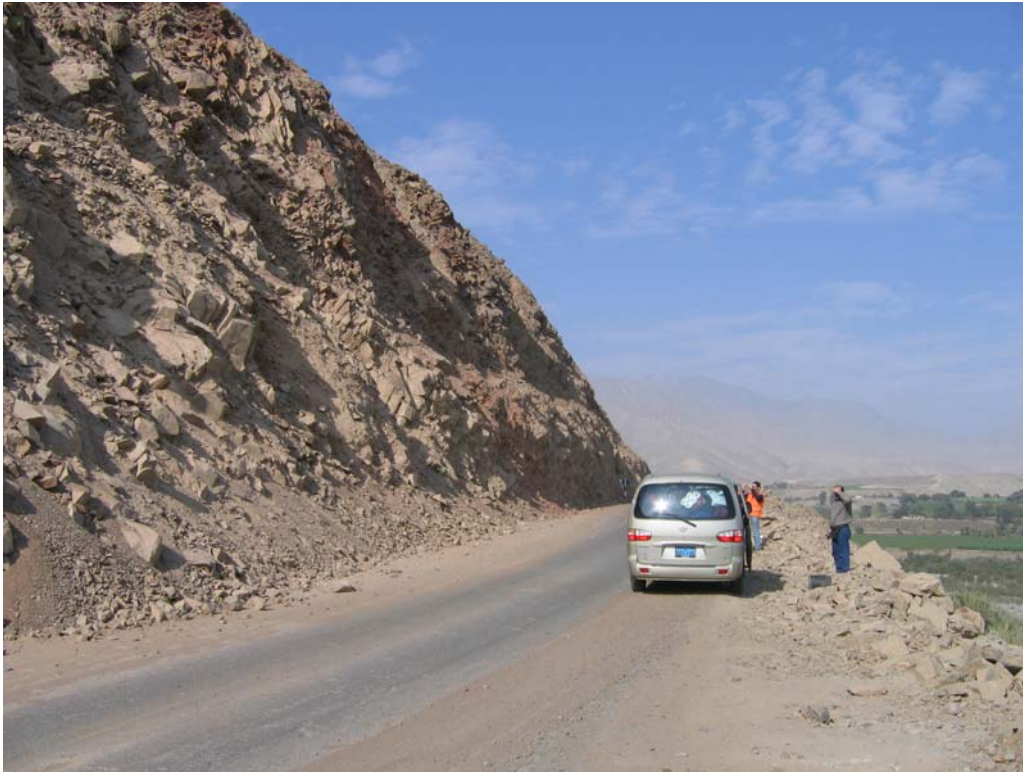
*Figure 18. Rock slide above road in Andes foothill*

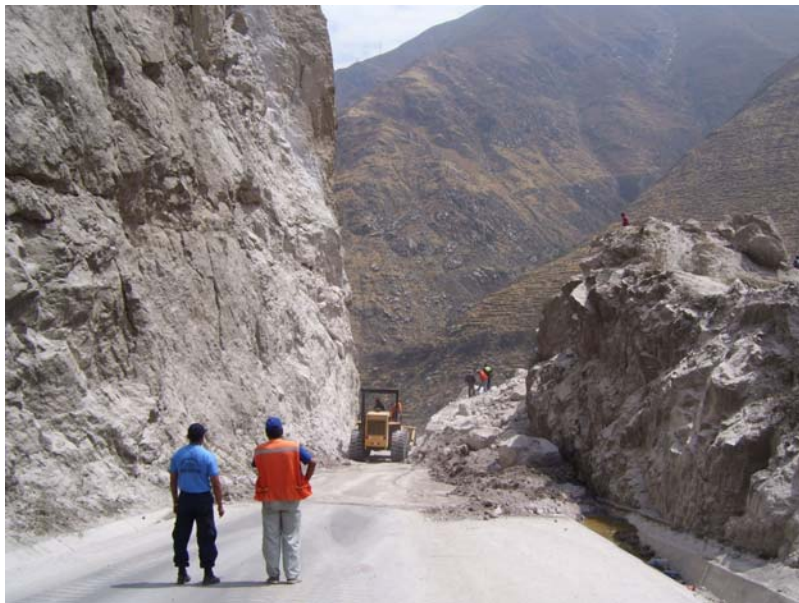
*Figure 19. Failure of cut slope*  
*Photo – Ministry of Transport and Communications*

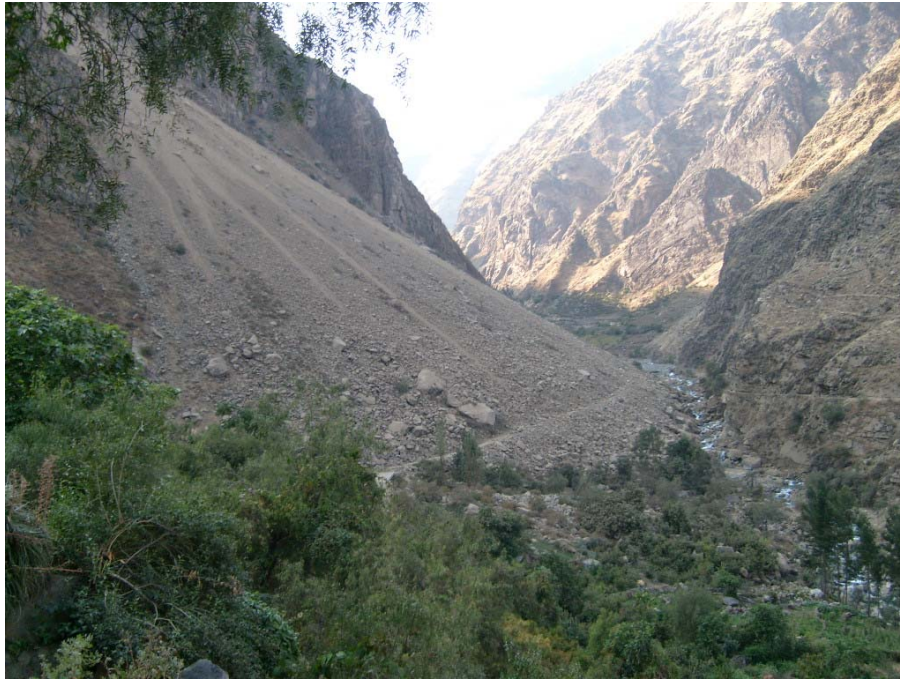
**Figure 20. Reactivation of scree slope**  
Photo – Ministry of Transport and Communications

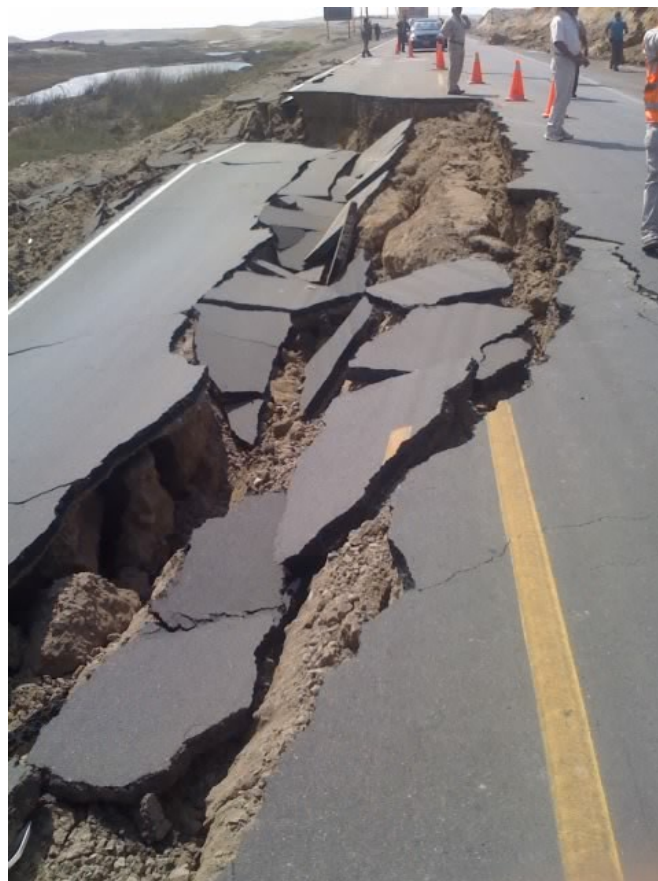
We observed numerous small road embankment failures on the Pan American Highway between Cerro Azul and Pisco. These failures were caused by liquefaction of the underlying soils and were typically located where the road was carried by a low embankment crossing a shallow valley with higher groundwater levels. The embankments were less than 3 m high and the slips generally appeared to extend back to no further than the centreline. Figure 21 shows one such typical embankment failure. Power poles running along the sides of the embankments were also damaged by the slips and many poles were leaning or had been replaced. In one location we noted a laterally extensive and several meter high failure in the adjacent natural sandy slope.

**Figure 21. Typical embankment failure as a result of liquefaction**  
Photo – Ministry of Transport and Communications

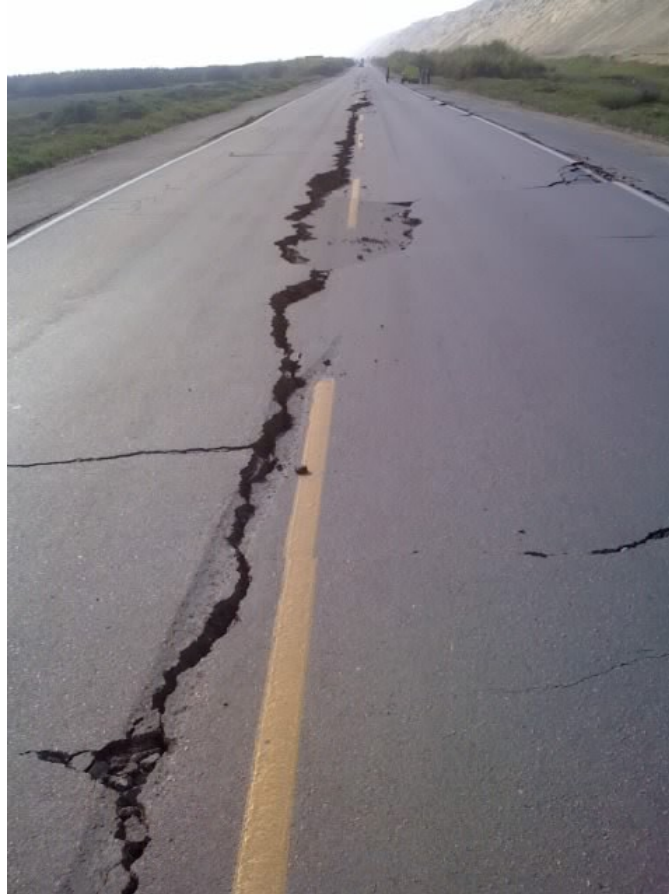
Alta is founded on recent marine deposits and has a high groundwater level due to its proximity to the sea. These embankments were less than one metre high but were still affected with lateral spreading and some vertical displacement, typically along the centreline as shown in Figure 22. The steeper sandy slopes above the road had numerous very shallow failures. These appeared to be restricted to the crust at the ground surface.

**Figure 22. Low embankment failure**  
Photo – Ministry of Transport and Communications

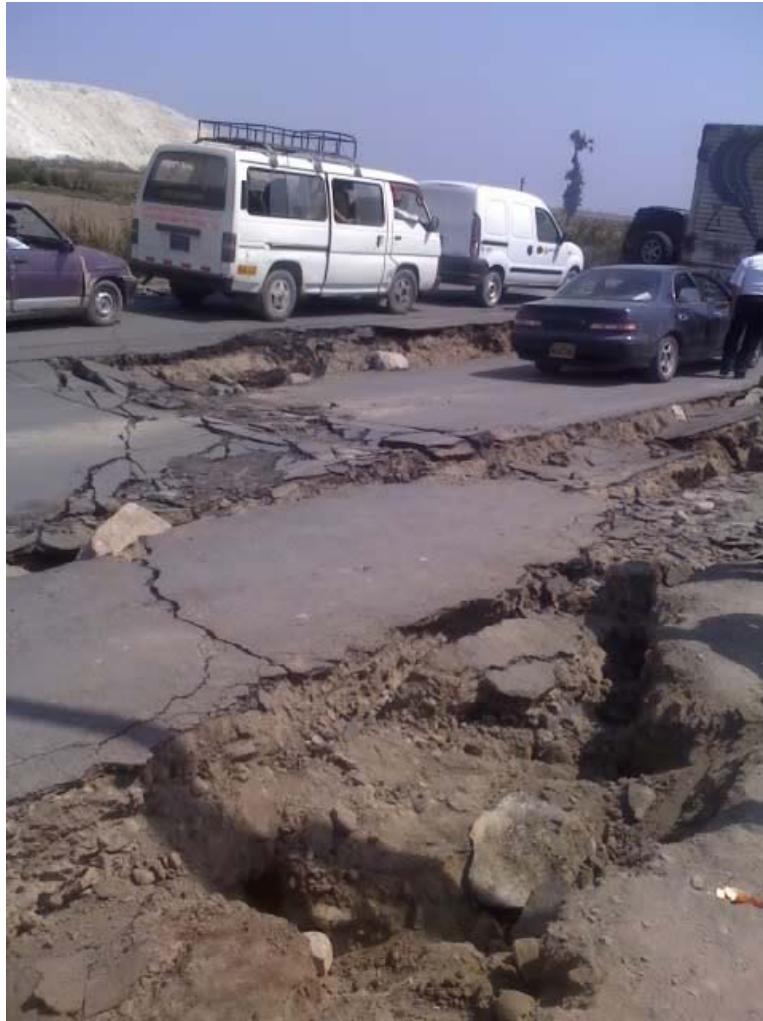
passive resistance may have been responsible for the damage to the upper part of the bridge's southern abutment wall. The toe of that southern abutment wall shows signs of movement out towards the river with the riprap at the base having clearly recently moved.

**Figure 23. Damage to the Huamani Bridge southern embankment**  
 Photo – Ministry of Transport and Communications

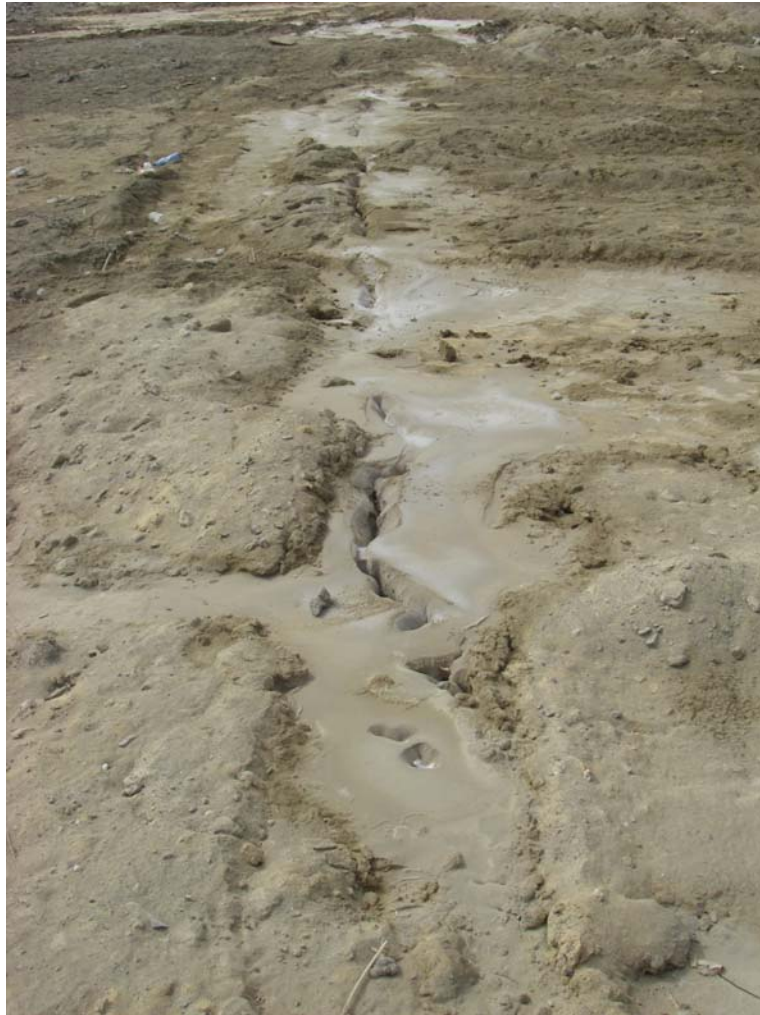
*Figure 25. Sand ejecta beside Pan American Highway*

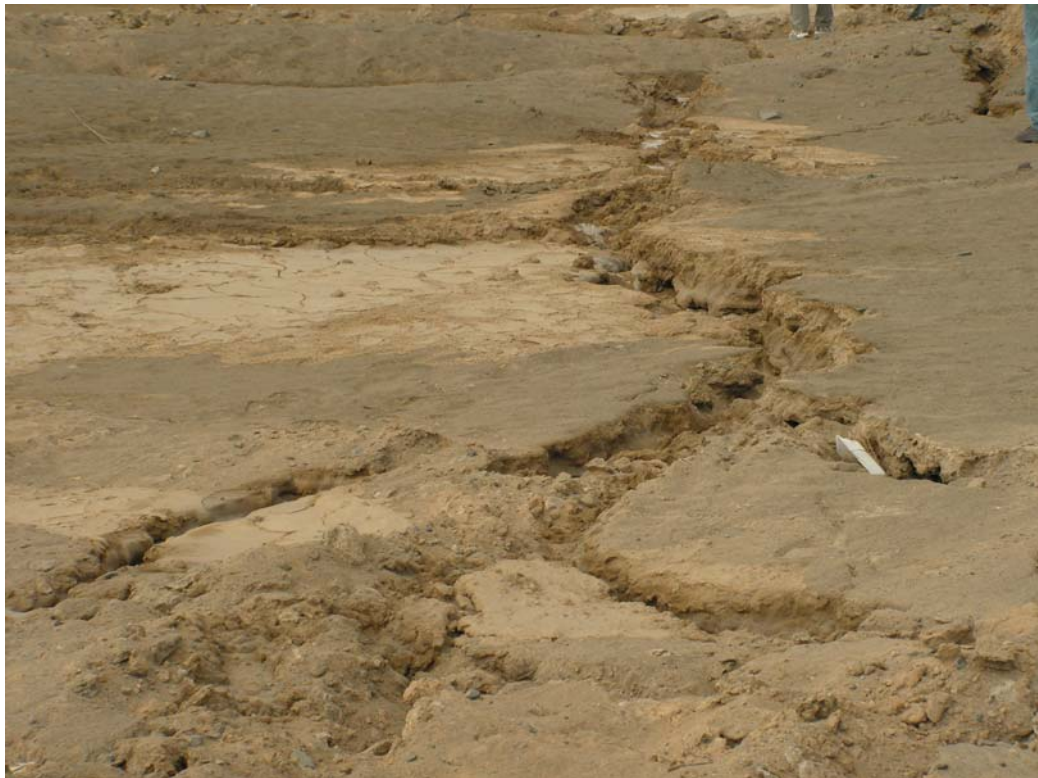
*Figure 26. Surface cracking from liquefaction*

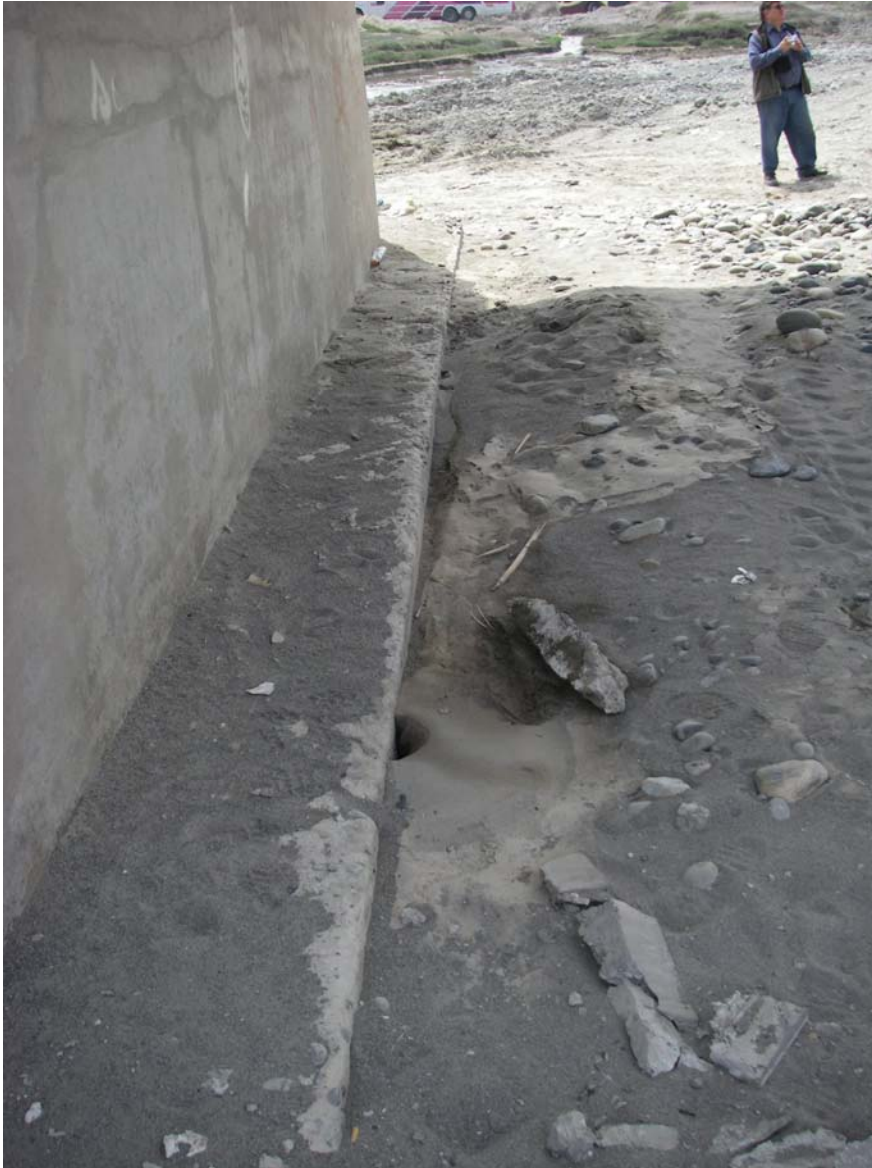
described above, but in addition some sand boils were observed around two of the foundations as shown in Figure 27. The most damaged pier had several sand boils around it and the next pier north had two boils. The ejecta consisted of clean fine to medium sand. No vertical displacement was observed in the bridge and no sand boils were seen in the open areas between the piers or upstream and downstream of the bridge. The sand boils around the piers are therefore considered to be the result of the lateral movement of the bridge foundations forcing the sand up through the surface.

*Figure 27. Ejecta around bridge abutments*

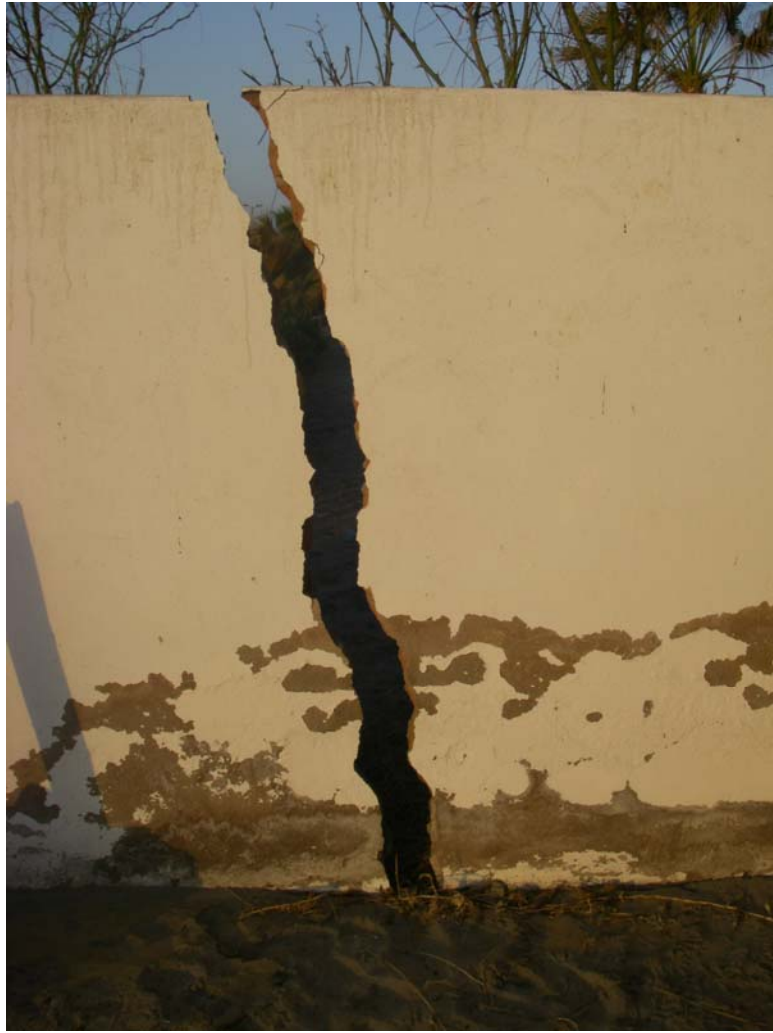
and small seawall along waterfront. The team observed settlement and lateral spreading damage to several roads and houses close to the coast including a 300 mm longitudinal offset to a wall running perpendicular to the coast (see Figure 28 ). Two wharves were damaged in Paracas with structural failure at the pile heads, probably due to reduced resistance to lateral loads caused by liquefaction of the underlying soils.

*Figure 28. Liquefaction-induced offset to wall in Paracas*

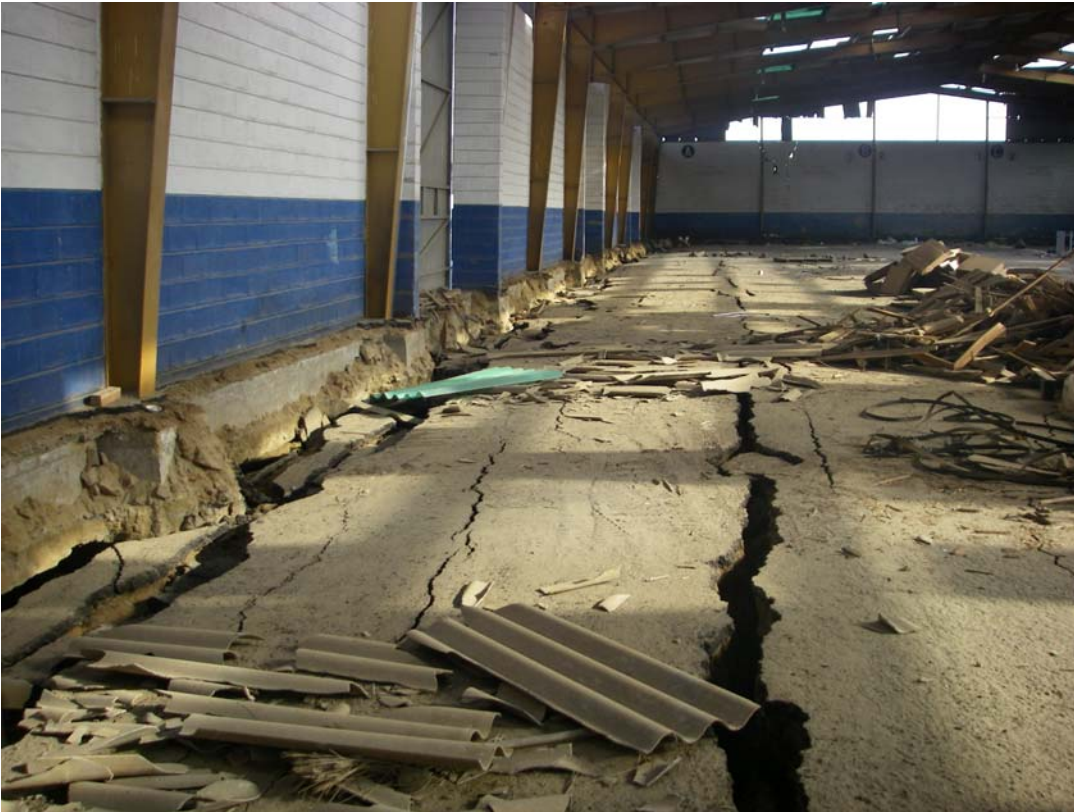
Wharf storage sheds are located on the liquefied fill areas of the port. These are steel portal structures supported on concrete filled steel piles, presumably founded below the fill. One of these buildings was located near the wharf in the area of greatest ground movement and the adjacent ground settled by up to 500 mm as well as suffering significant horizontal displacement. Refer Figure 29. Figure 29 Some gapping was observed in the soils around the top of these piles indicating that the piles had moved laterally in relation to the ground. However, the piles and their connections to the concrete ground beam appeared to be in good condition as did the sheds themselves, indicating that the earthquake ground motions and the liquefied soil movements had little detrimental effect on these pile foundations.

*Figure 29. Ground subsidence in wharf shed at Port San Martin*

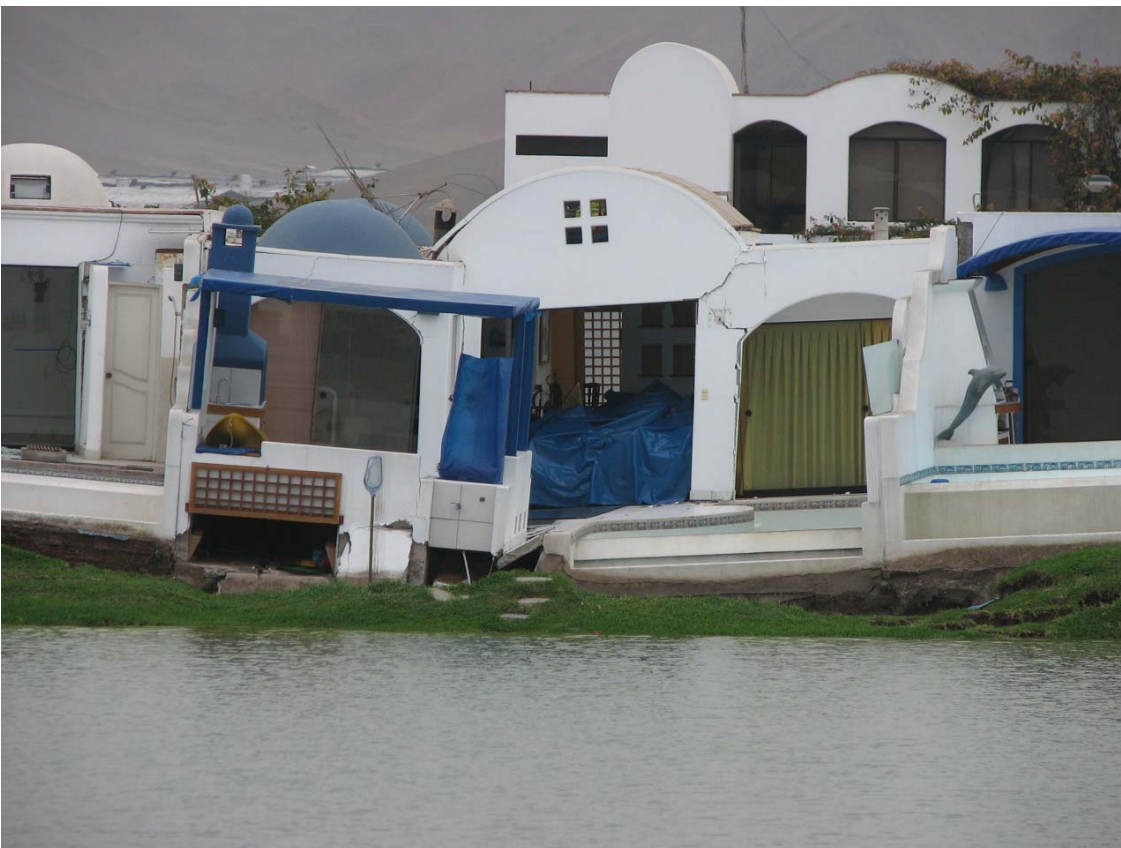
*Figure 30. Liquefaction damage at Las Lagunas*  
*Photo courtesy Alfonso Rey*

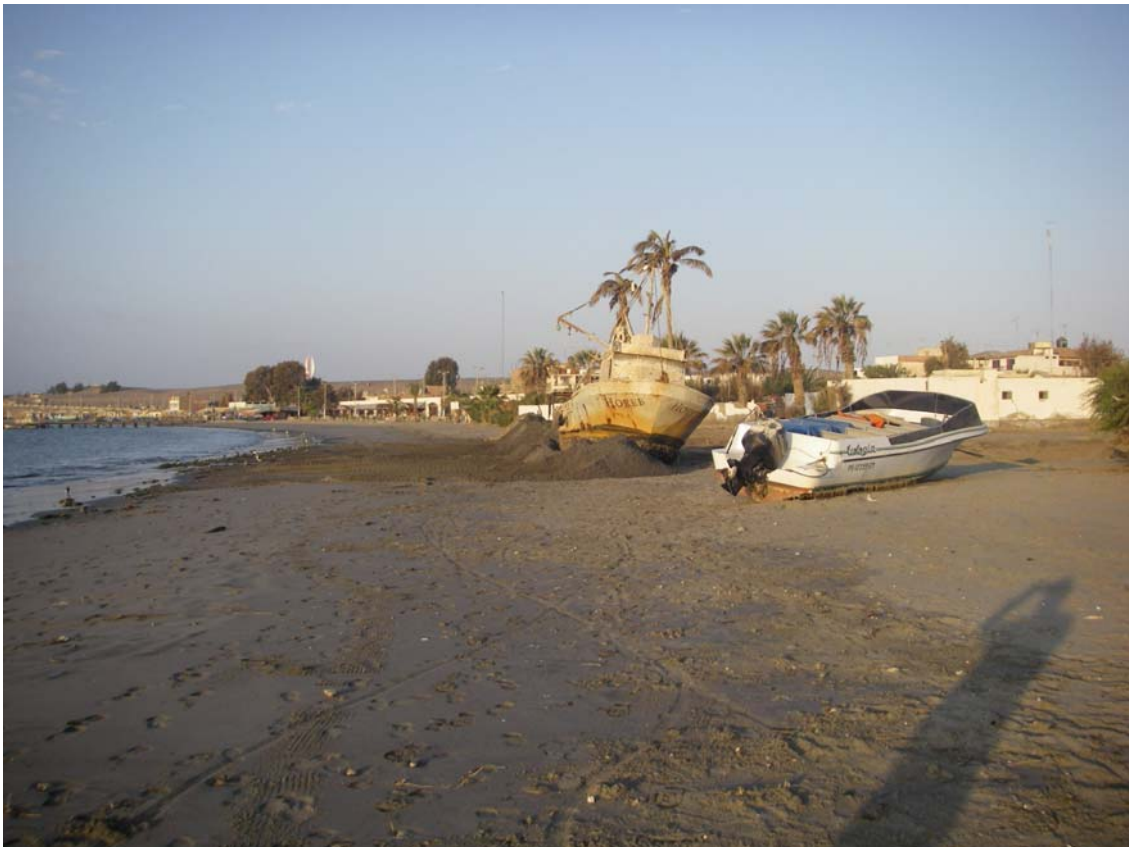
The tsunami was significantly larger to the south of the peninsula, with run-up heights of up to 10 m recorded around the bay formed by the southern part of the peninsula. In Lagunillas a 5 to 6 m high wave destroyed buildings on a small narrow point and three deaths were reported. In Laguna Grande some 30 km south of the peninsula no damage was reported to the fishing village which sits on a sandspit around 1 m above sea level. However, in Chucho around 1.7 km away, a 3.4 m run-up was recorded. This significant difference may be due to the large lagoon adjacent to Laguna Grande.

*Figure 34. Boats washed up by tsunami in Paracas*

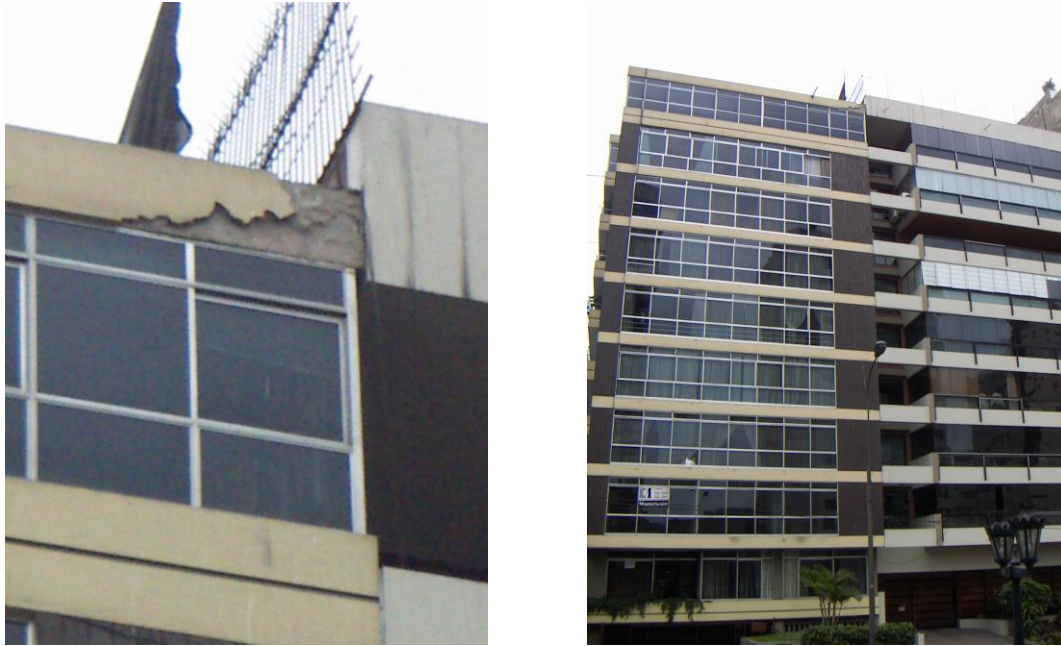
Two multi-storey buildings in these streets were observed to have a few missing window panes.

**Figure 47. Building Impact – Miraflores**

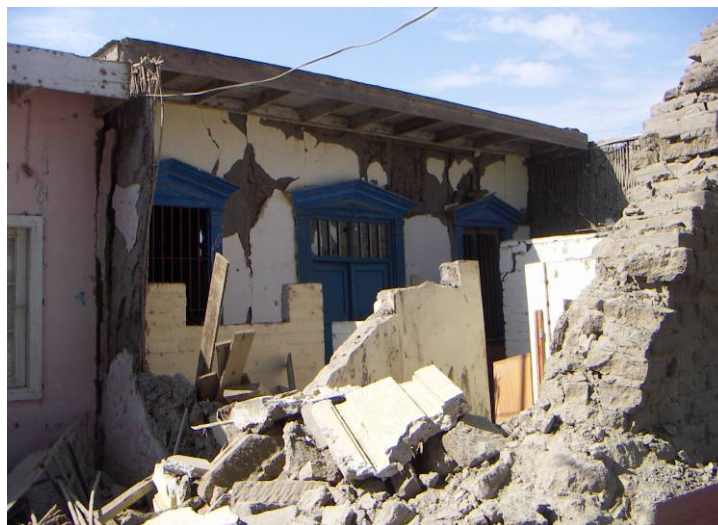
*Figure 57. Collapsed Adobe House - Pisco*

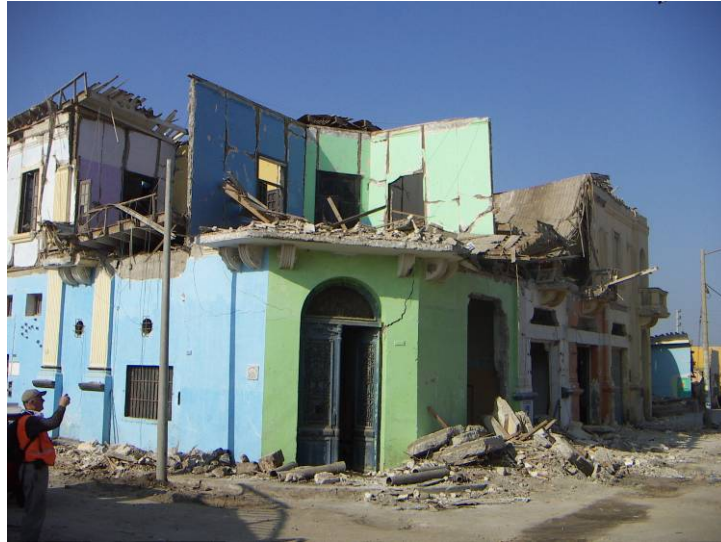
*Figure 58. Damaged Two Storey Adobe Buildings - Pisco*

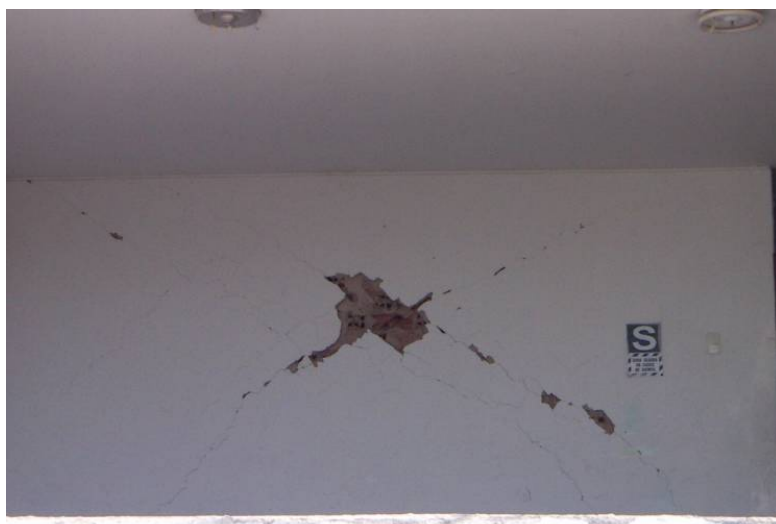
*Figure 65. Diagonal cracking of infill masonry panel*

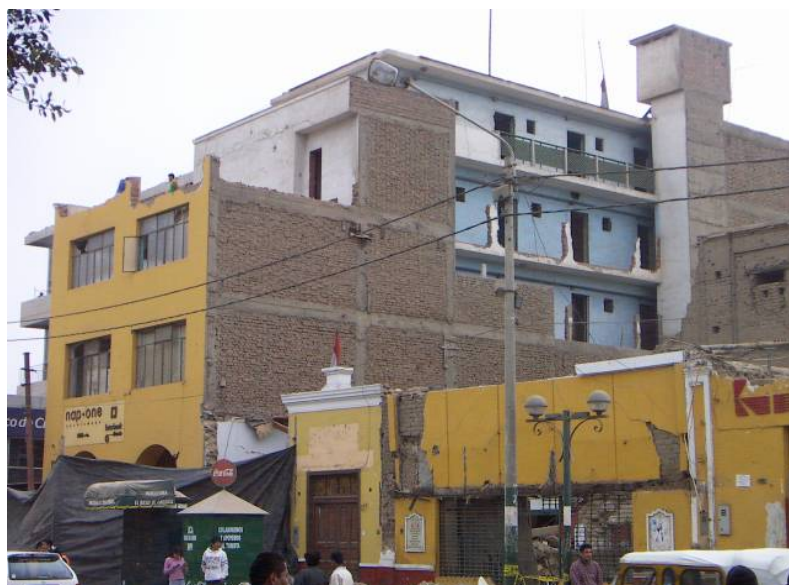
*Figure 66. Brick panel damage - Ica*

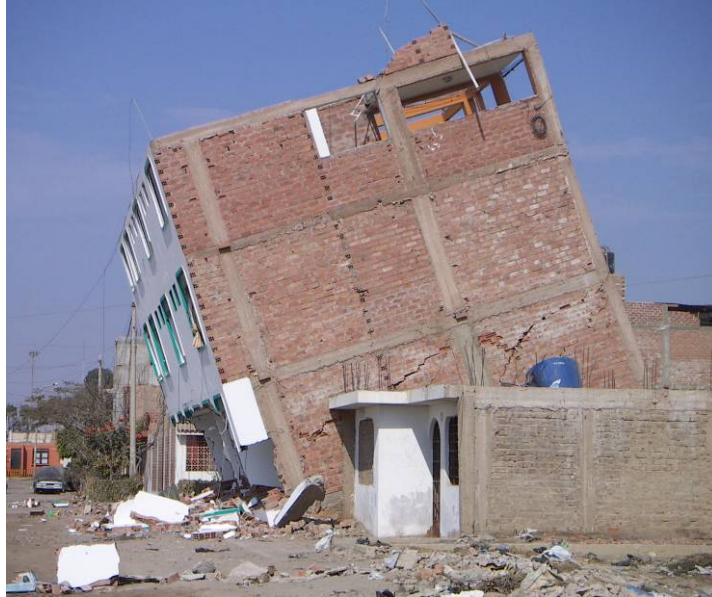
**Figure 67. First Floor Collapse - Pisco Residential Buildings**

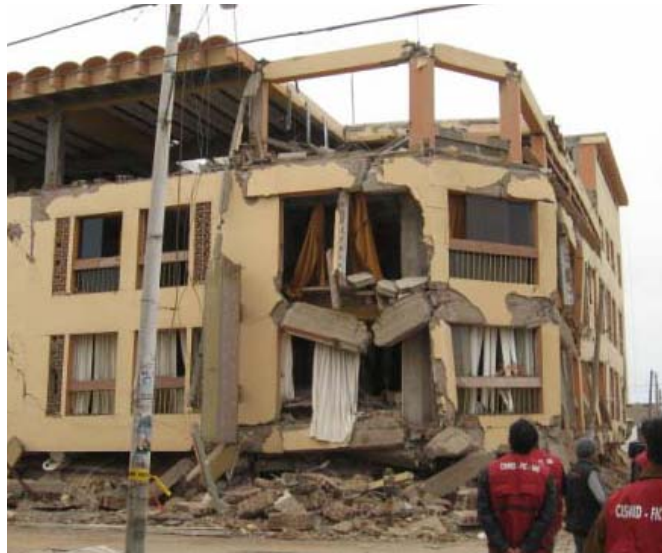
The 5-storey Embassy Hotel building collapsed and had been demolished. It was reported that 15 fatalities in this buildings. The building behind it, which appeared to be of similar structural form, had significant damage to brick walls

**Figure 69. Embassy Hotel Damage - Pisco**  
(Source: Taiki Saito Building Research Institute)

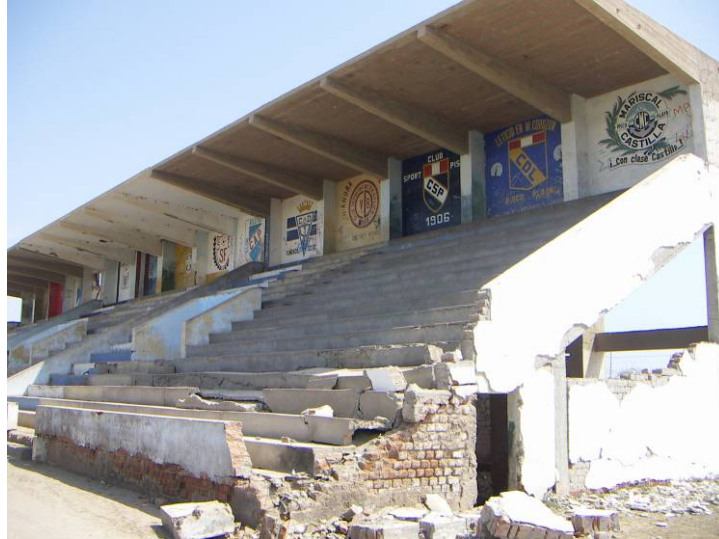
cracking of infill masonry panels. Damage of the Ica grandstand was limited to cracking at the base (due to differential movement) and minor infill panel cracking. There was no damage to the reinforced concrete columns and beams - not even a crack.

*Figure 73. Pisco Grandstand*

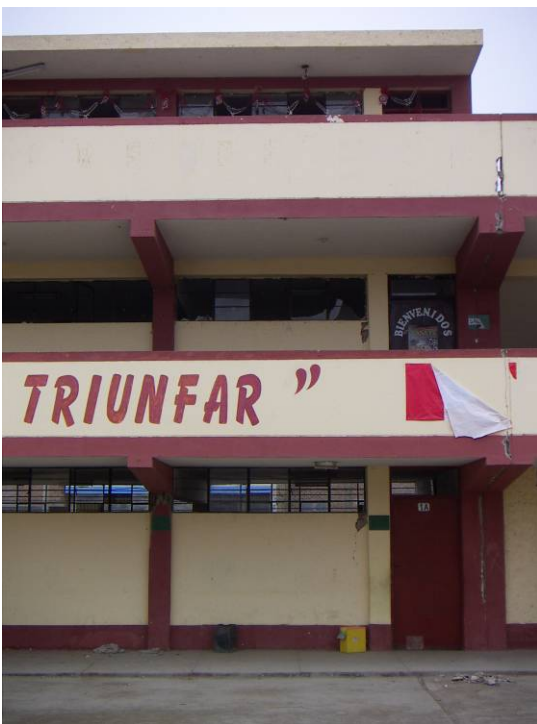
*Figure 77. Damaged School - Canete*

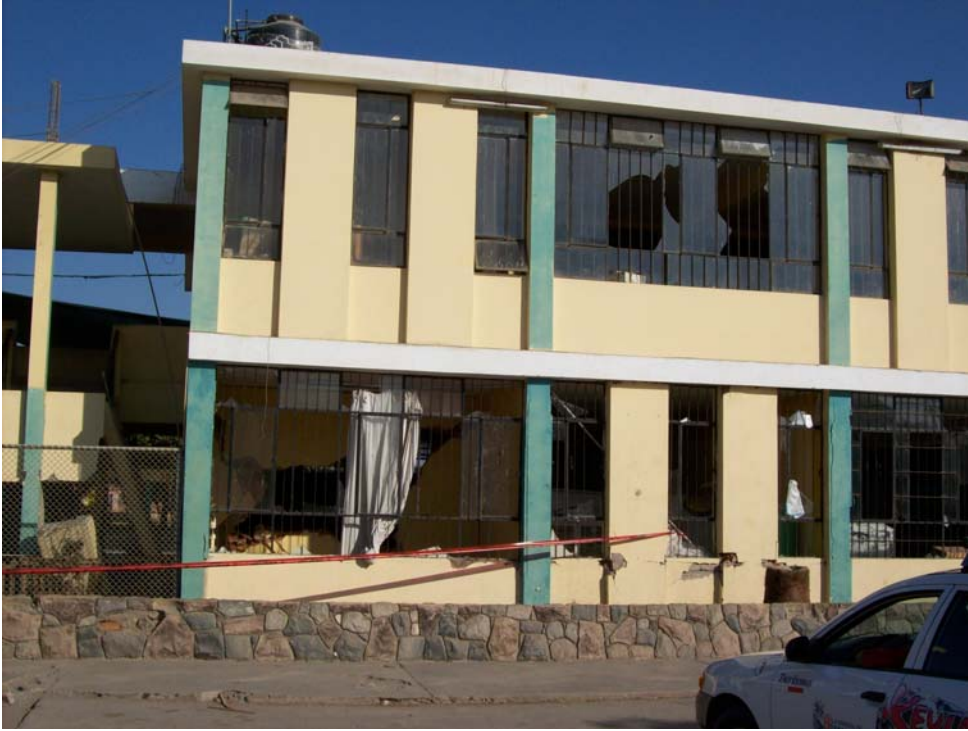
*Figure 84. Glass damage at an Ica school*

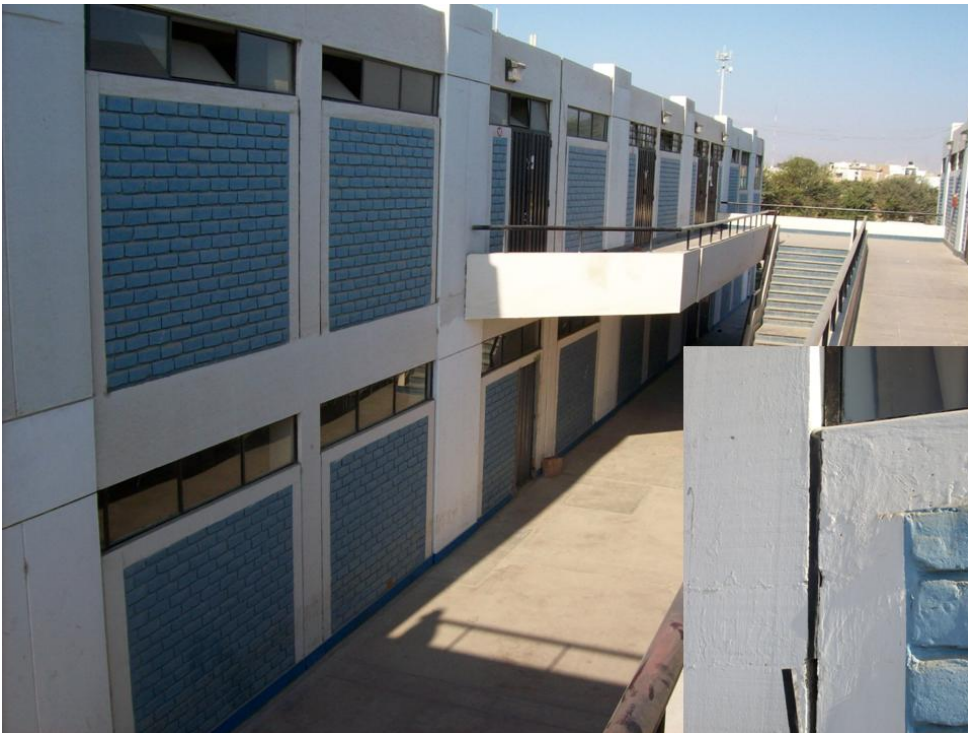
*Figure 85. Spandrel separation at an Ica school*

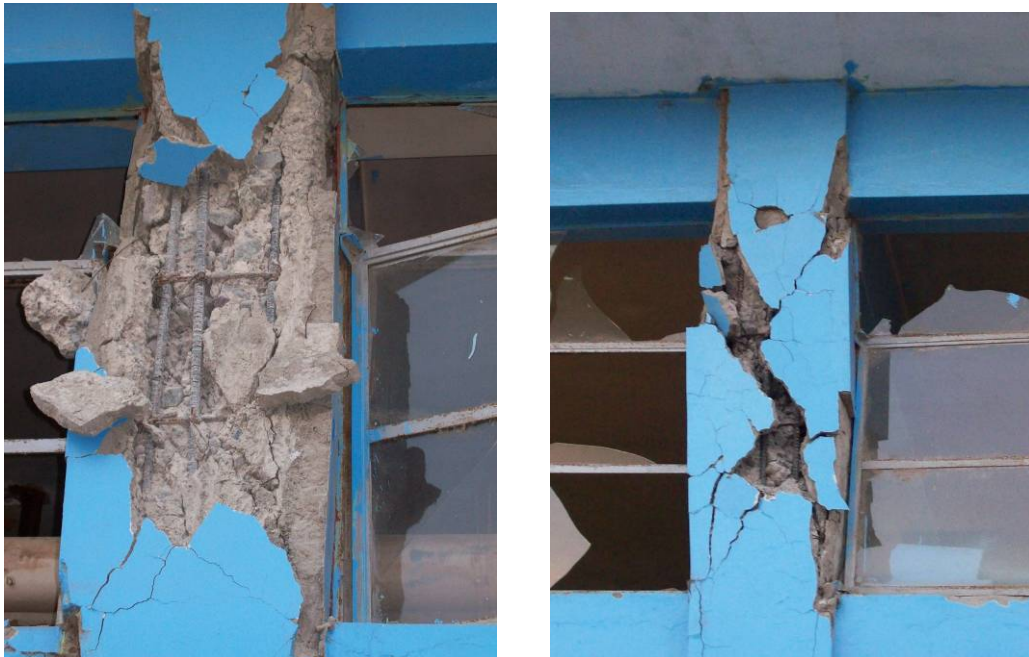
*Figure 89. Short Column Failure - Ica Regional Hospital*

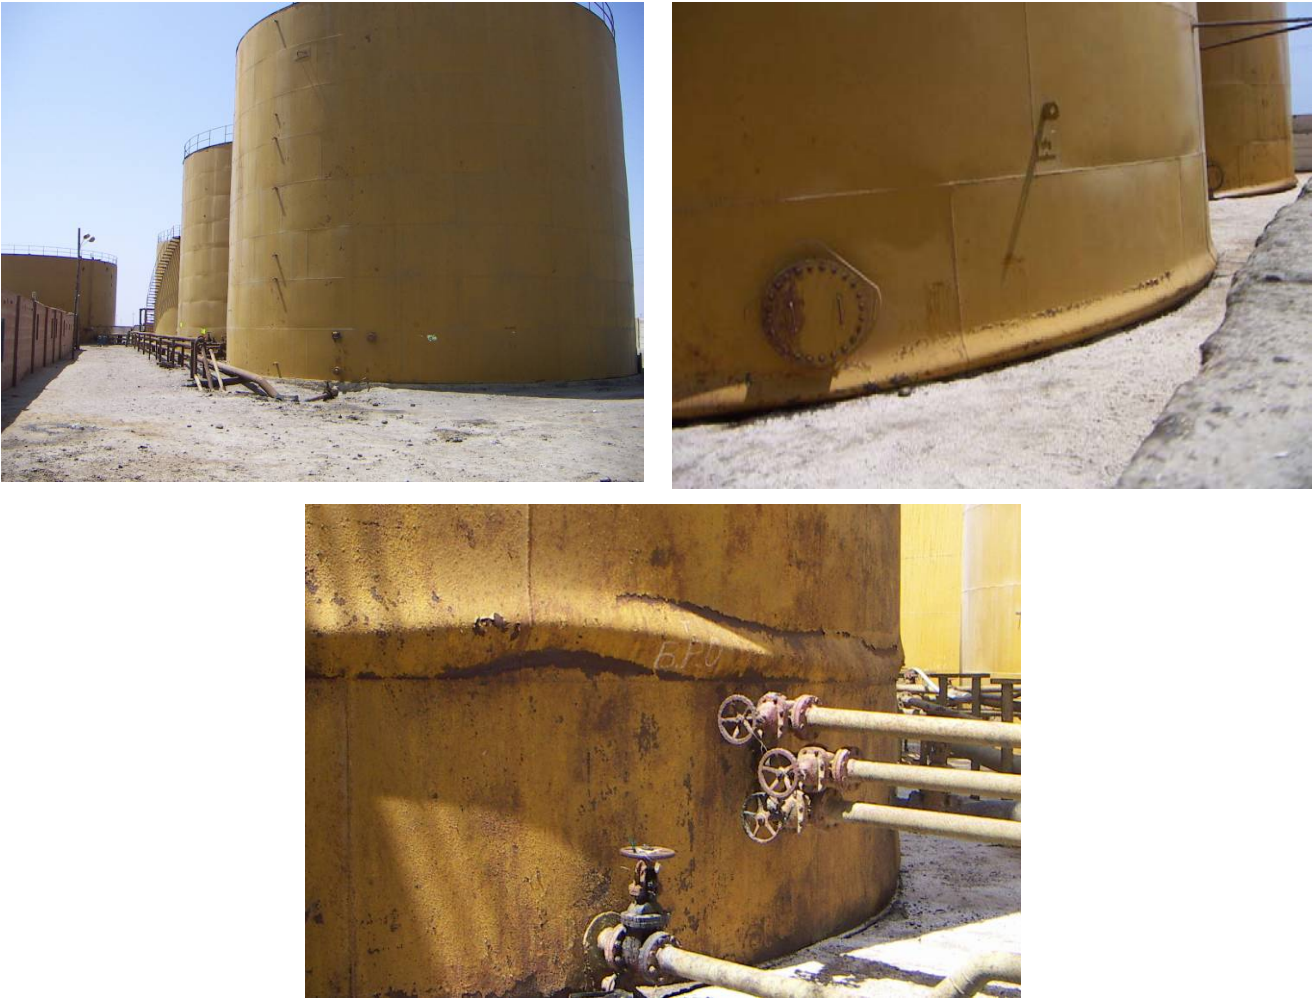
**Figure 101. Tank Damage - Blue Pacific Oil**

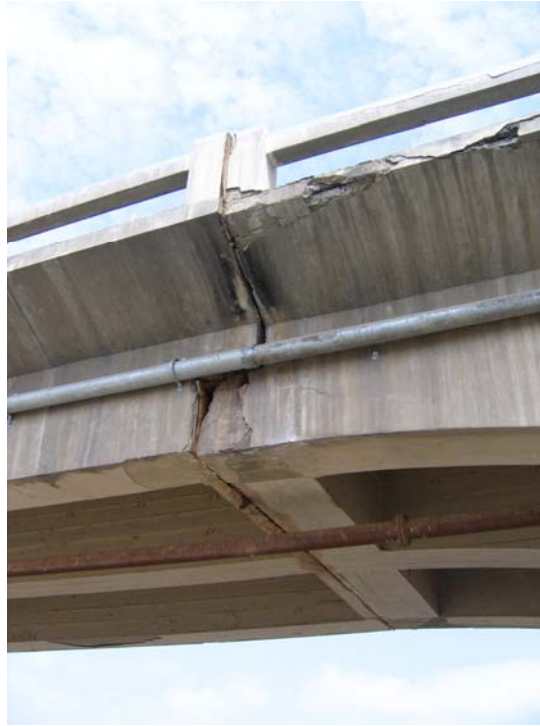
**Figure 105. Superstructure damage**

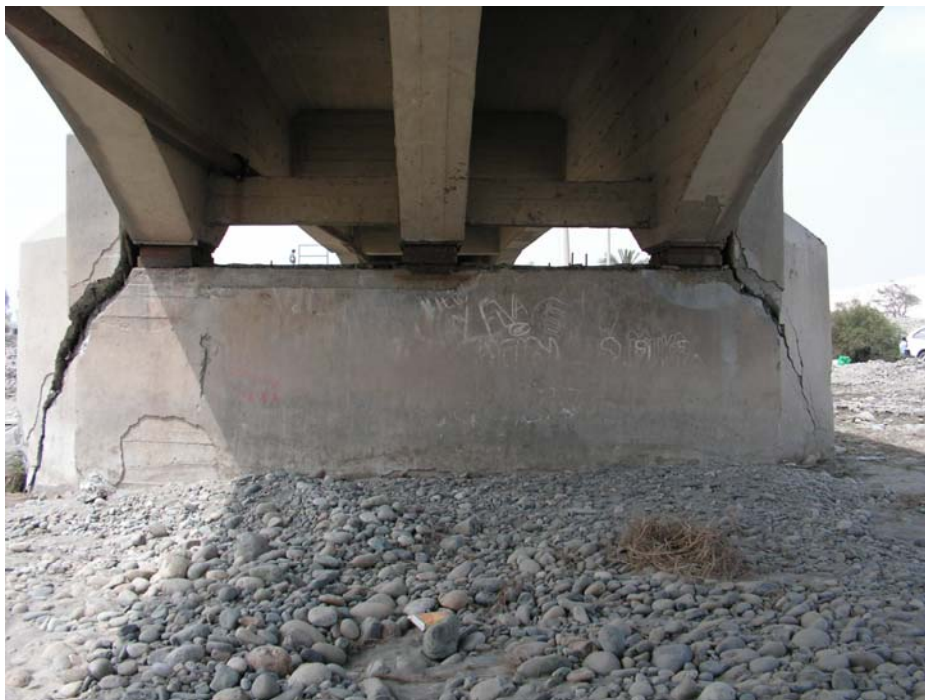
**Figure 106. Damage to restraining walls**

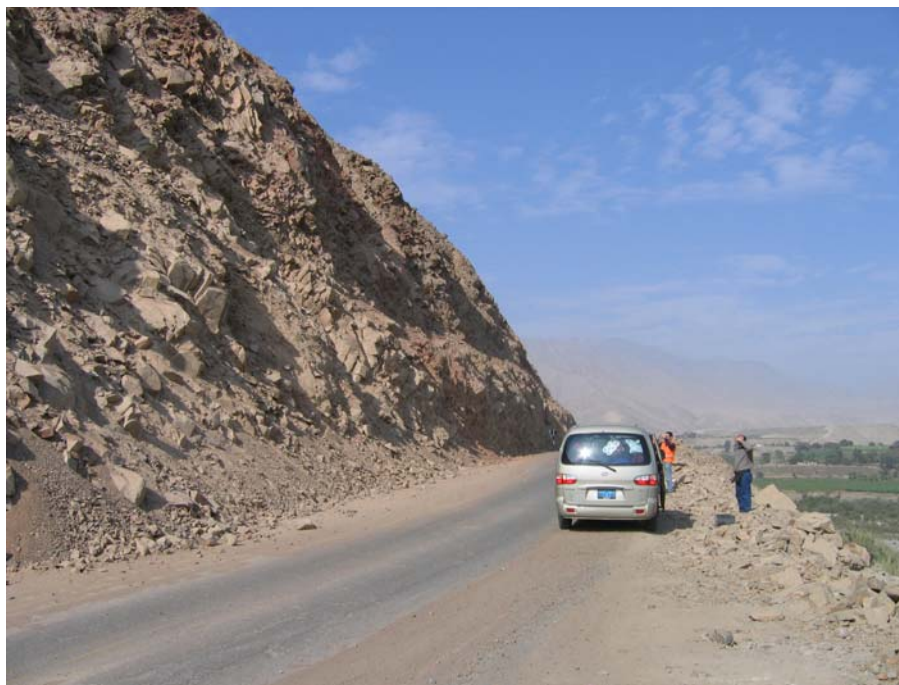
**Figure 107. Rock falls on Route 24a**

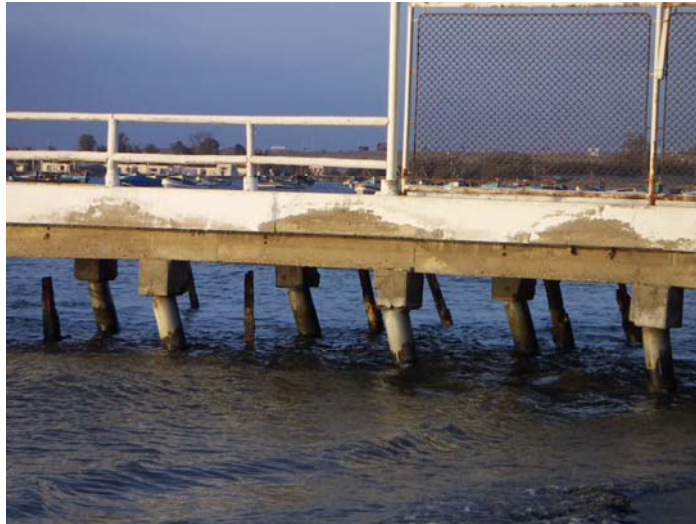
**Figure 109. Structural damage to pier**  
Photo courtesy Alfonso Rey

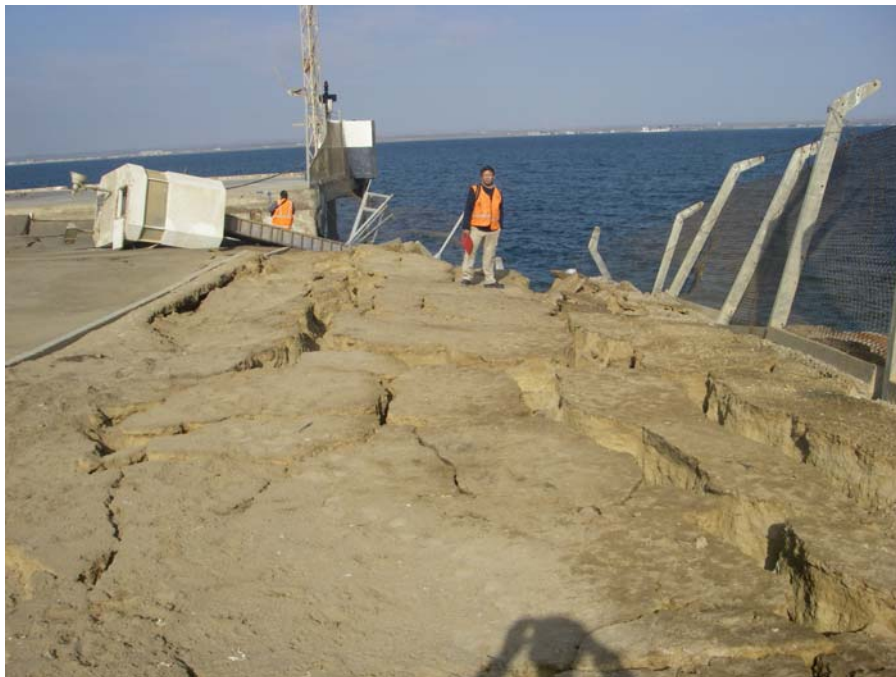
**Figure 110. Wharf damage - Port San Martin**

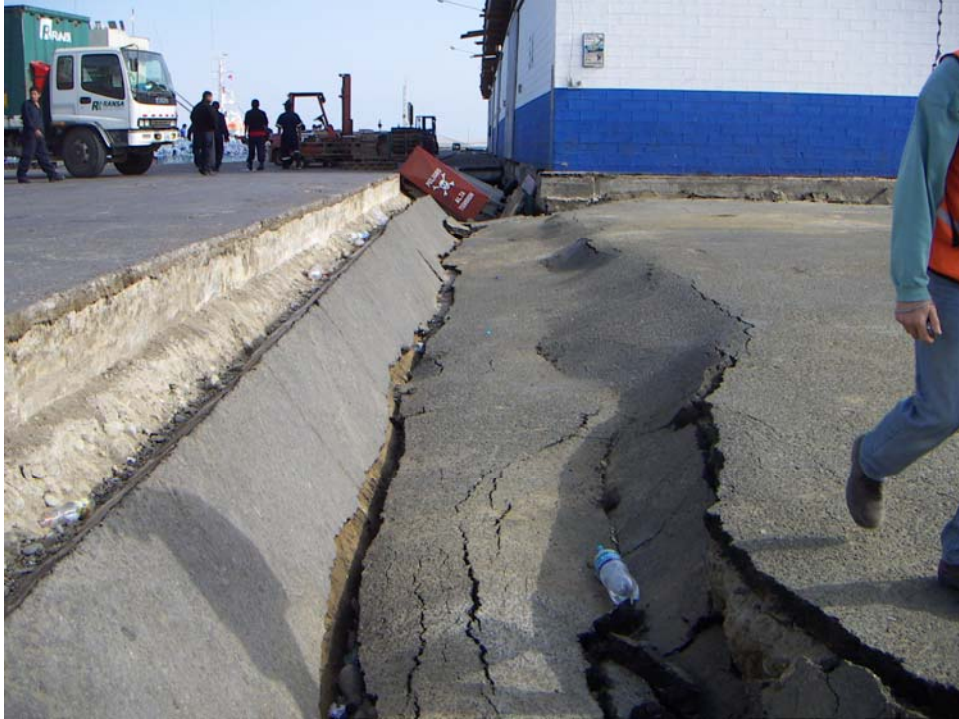
**Figure 111. Settlement behind wharf**
