**THE PISCO (PERU) EARTHQUAKE OF 15 AUGUST 2007**  
**NZSEE Reconnaissance Report, June 2008**

**David Hopkins, Darrin Bell, Rafael Benites, James Burr,  
 Craig Hamilton and Rudolph Kotze**

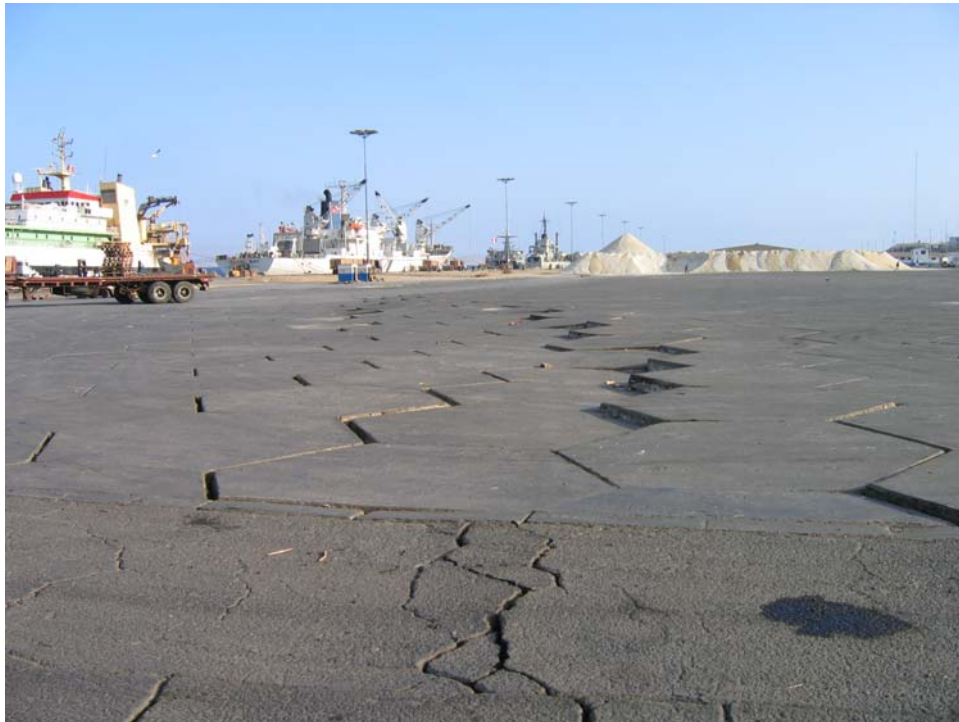
**Figure 112. Settlement of backfilled areas behind wharf**
