THE OCTOBER 1, 1987 WHITTIER NARROWS EARTHQUAKE

R. Shepherd*

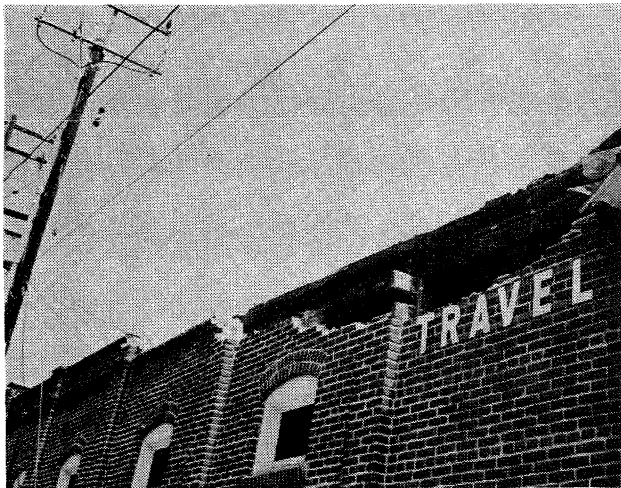
One problem which clearly persists is that of weak parapets in position not covered by the earlier parapet ordinance. Such parapets on walls adjoining other buildings are liable to collapse and to thereby cause damage to other property (Fig. 2). A second ongoing problem is that of inadequate bond between layers of bricks in the vertical plane resulting in peeling off of outer wites (Fig. 3).

FIG. 2 - Collapsed parapet, to left, and upper part of bearing wall, to right

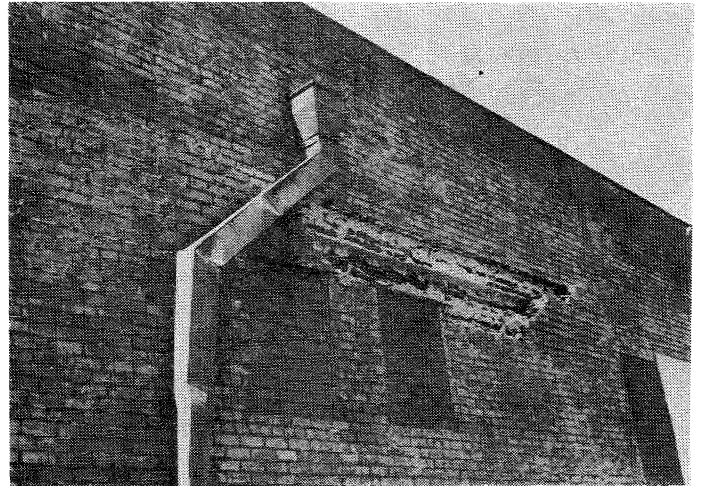
FIG. 3 - Loss of outer wites of bricks

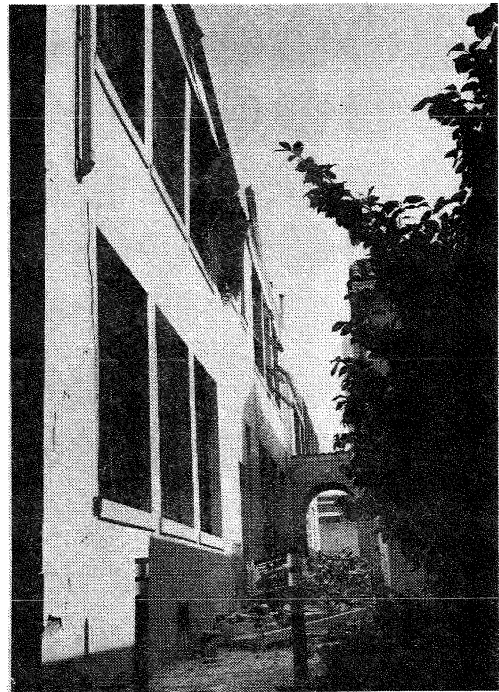
Some walls are susceptible to out-of-plane bulging, again indicating deficient lateral restraint (Fig. 4).

FIG. 4 - Bulging and collapse as a result of inadequate lateral restraint

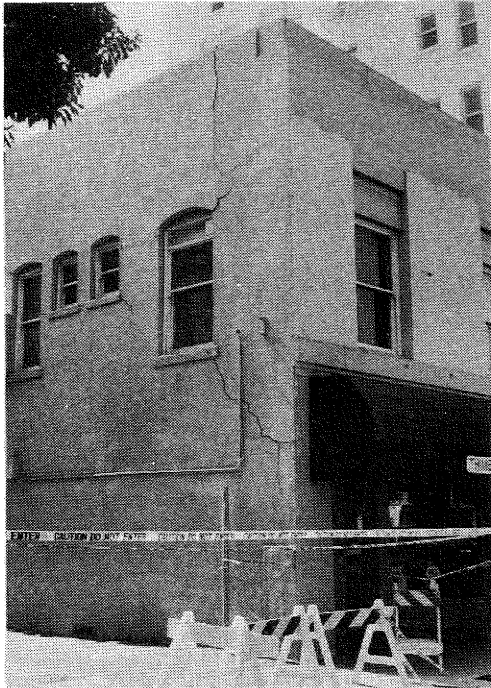
A recurrent problem with strengthened buildings is manifested by cracks occurring in the masonry at the corners of the building consistent with the floor and ceiling diaphragm having exerted horizontal force to push the wall outwards (Fig. 5). This can be ascribed to flexibility in the shear connectors with consequent inability to transfer the diaphragm inertia forces to inplane wall loads without significant slipping.

FIG. 5 - Front wall pushed outwards by diaphragm inertia forces

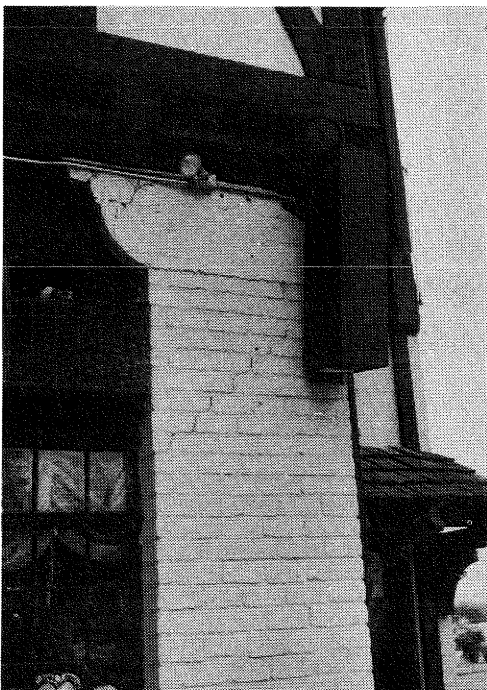
Unanticipated distress in brick piers

and brick spandrel beam zones was recorded (Fig. 6) Causes for these problems have yet to be agreed and, consequently, remedies are yet to be found.

FIG. 6 - Failed brick pier

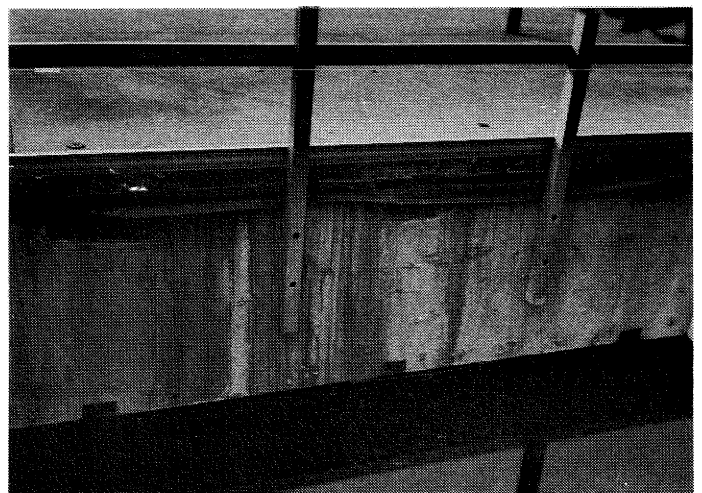
One student was killed when a 3.65 x 2.3 x 0.15m precast lightweight concrete panel fell on her after failure of the connections to the supporting car park structure (Fig. 7). The surviving 334

FIG. 7 - Position from which panel fell, killing student. Railing added after accident.

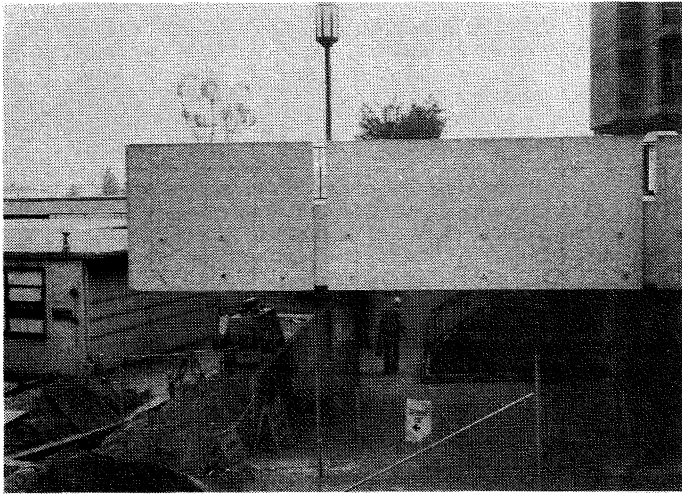
FIG. 8 - Panel connection strengthened by addition of bolts

similar panels have had their fastening reinforced by the addition of 2.54 cm diameter bolts (Fig. 8).

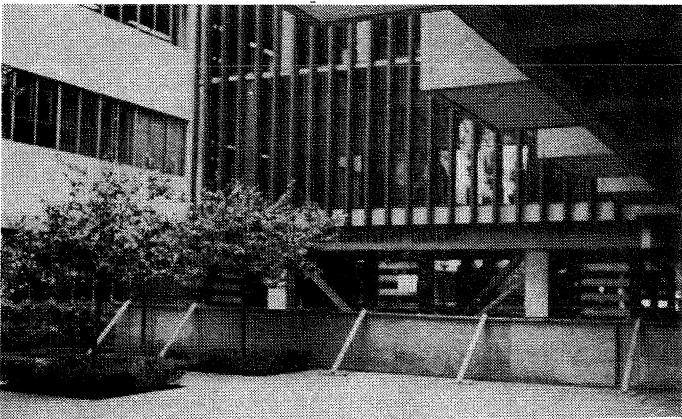
FIG. 9 - California State University, Los Angeles, Library Bridge

A somewhat unusual structure, the Library Bridge (Fig. 9), connecting the main buildings, suffered extensive damage. Weighing some 4450 kN and of plan dimensions 18 x 7.6 m the bridge has a centre span of almost 8 m. It is supported on four columns each 0.61 m square and having 4 #18 (56 mm diameter) bars as main reinforcement. The ties are #3 (10 mm diameter) bars at 0.46 m pitch and, as might have been expected, extensive shear cracking occurred (Figs. 10 and 11). The columns extend downwards different distances, the shortest being 3 m and the longest 7.3 m. This may well explain the indication of torsional excitation exhibited by one of the columns.

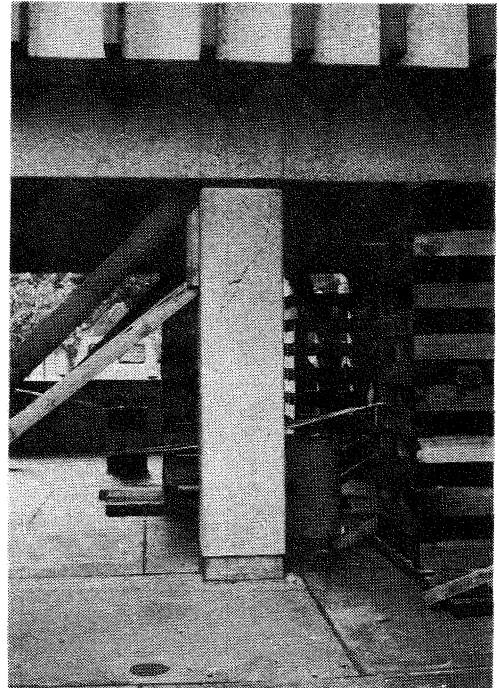
FIG. 10 - Cracked column in Library Bridge

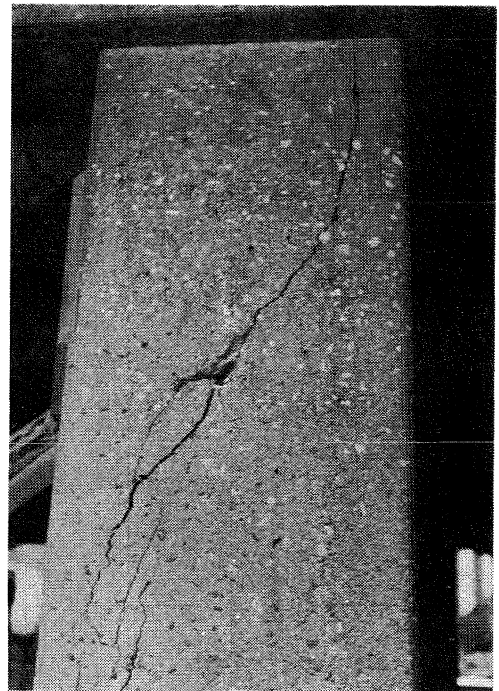
FIG. 11 - Close-up of cracked column shown in Fig. 10

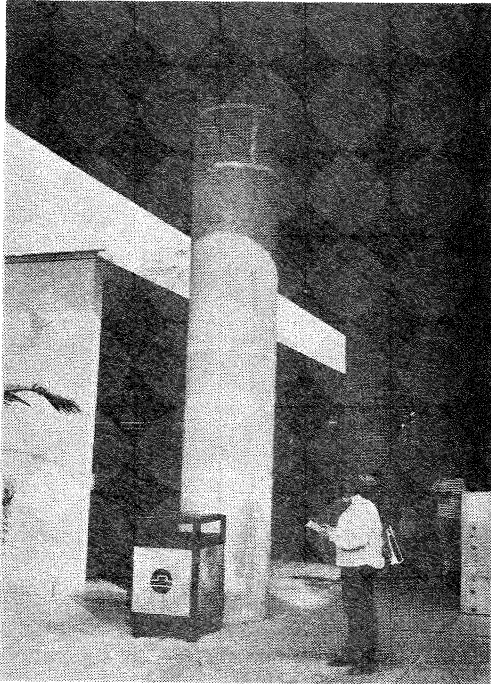
and worst case acceleration peaks of 39% g (E-W) at the base, 48% g (N-S) at the roof, and 53% g (vertical) at the second level were recorded. One support column was badly cracked (Fig. 12) and promptly

FIG. 12 - Epoxy repaired column at base of Administration Building

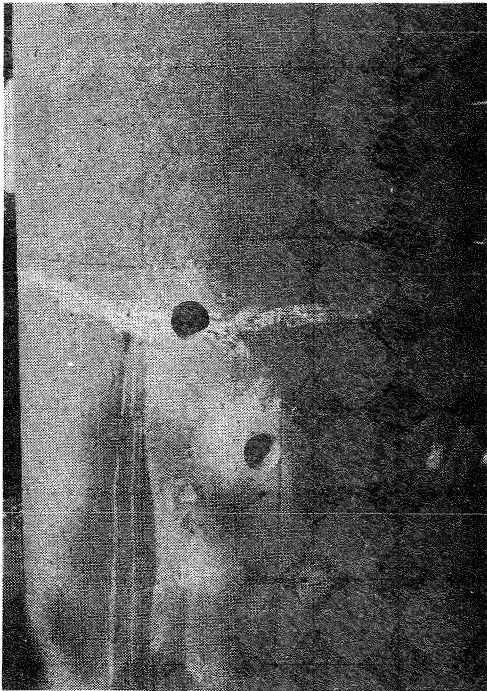
FIG. 13 - Cores taken to check effectiveness of epoxy repair

repaired using epoxy (Fig. 13). Similar repairs were undertaken on shear cracks which formed in beams in the adjoining parking structure.

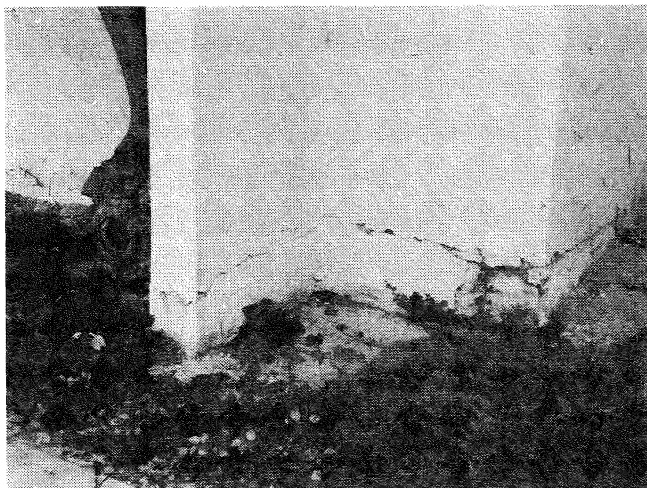
FIG. 14 - Cracked stucco at base of wall of Whittier apartment building

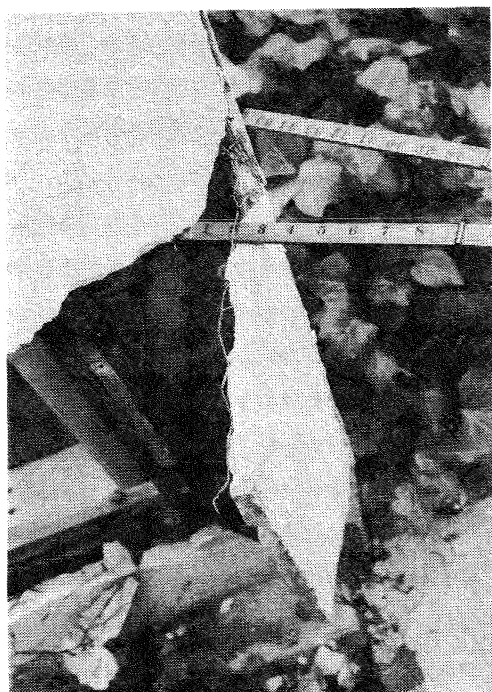
FIG. 15 - Fractured stucco where air-conditioning unit had broken loose from wall of Whittier apartment building

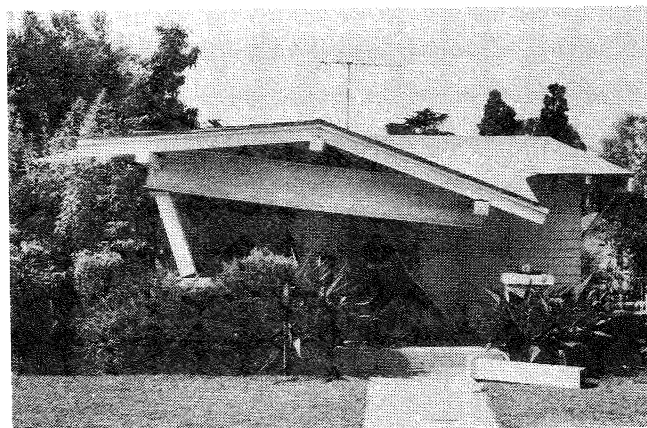
FIG. 16 - Collapsed verandah, Whittier home

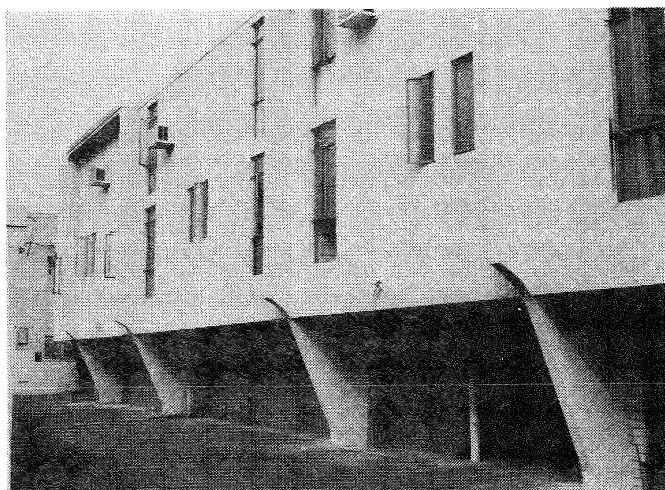
The common practice of providing parking underneath living quarters frequently results in a building being severely torsionally unbalanced as well as having a

flexible bottom storey (Fig. 17). This resulted in some buildings being damaged to the extent they were judged unsafe for occupation (Fig. 18).

FIG. 17 - Parking bays under apartment building (Plywood panels added to avoid collapse of damaged support walls)

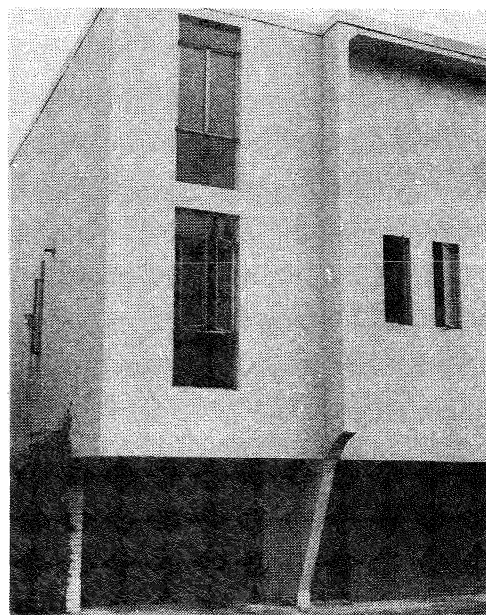
FIG. 18 - Fractured support wall at ground level, left hand end of building shown in Fig. 17.

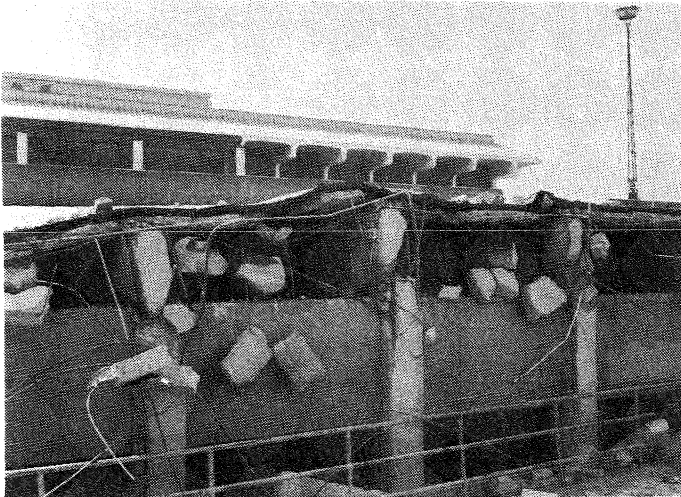
Car park buildings having large spans and relative few load carrying walls tend to be vulnerable to earthquake loading. A four storey structure of this type in Whittier lost its top floor in the October 1 earthquake and then collapsed completely in the October 4 shake (Fig. 19). It is notable that a nearby similar structure with spiral wound columns survived both events.

FIG. 19 - Collapsed car parking building in Whittier
