## EDGECOMBE EARTHQUAKE: RECONNAISSANCE REPORT

**M. J. Pender and T. W. Robertson\***

### SUMMARY

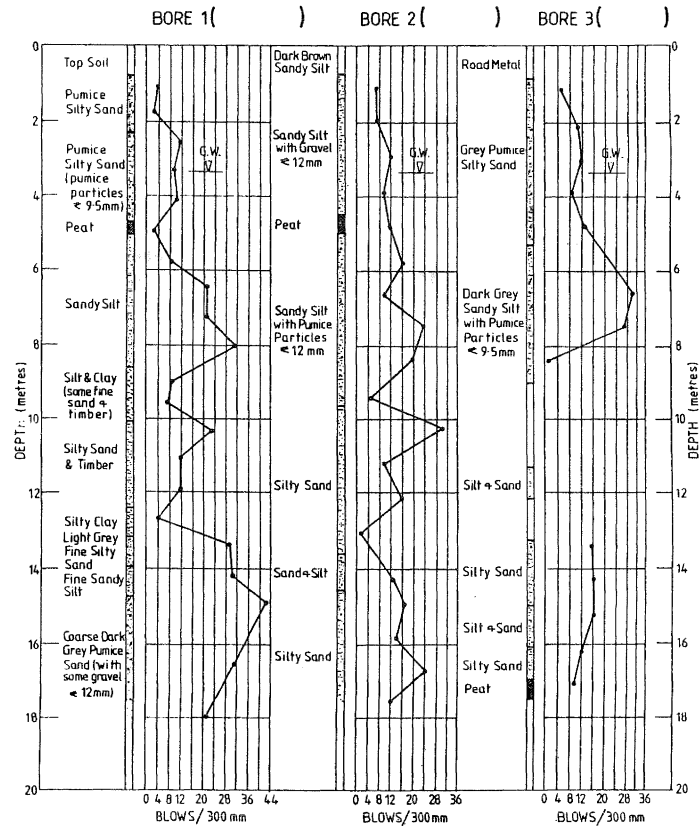
Fig. 1.4 : The soil profile at the Edgcombe Substation

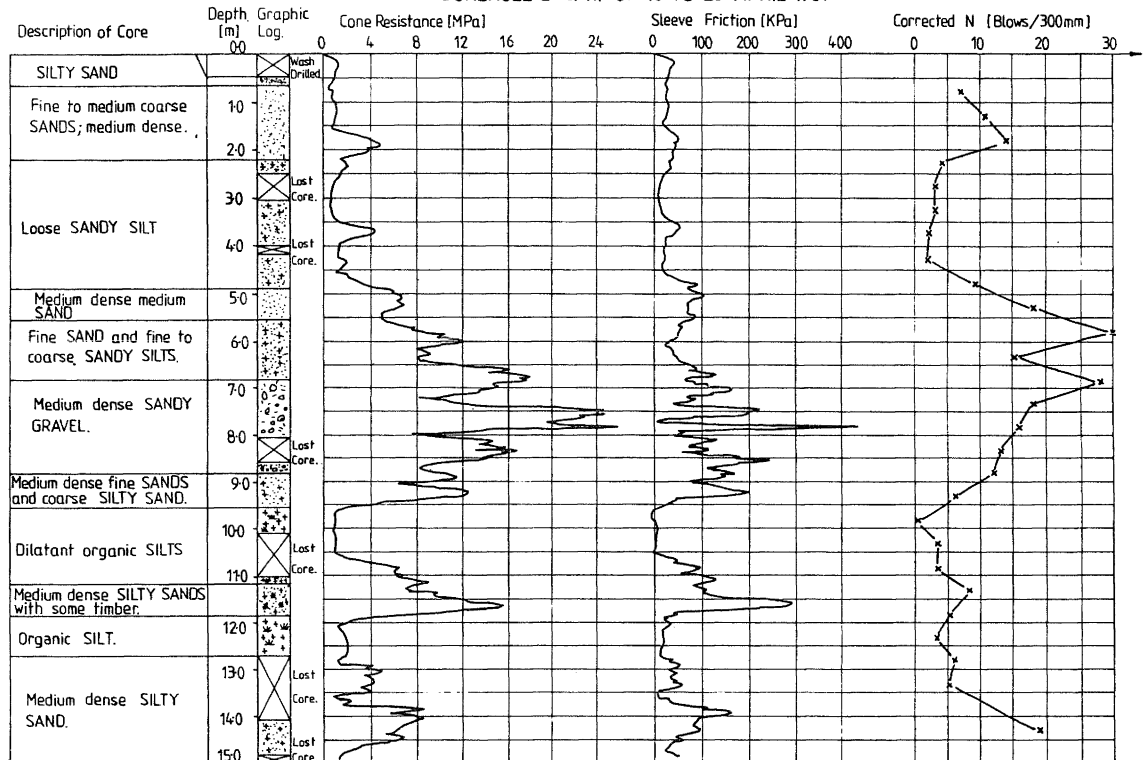
Fig. 1.5 : The soil profile at the Te Teko School

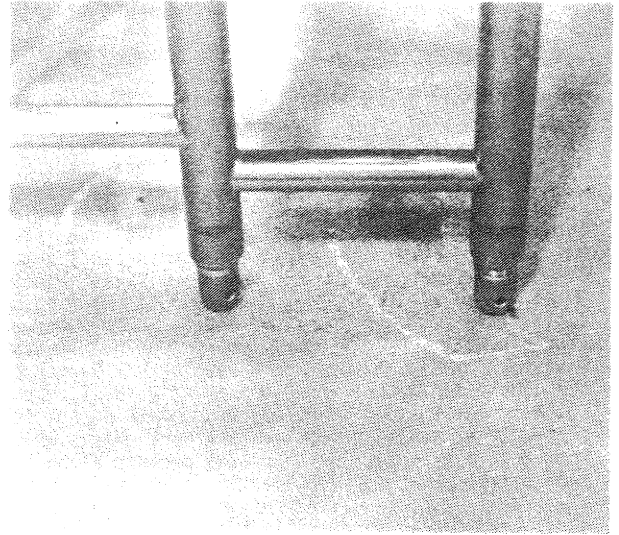
Fig. 2.8 : Scratch marks made on the Dairy factory floor by the legs of a tank stand

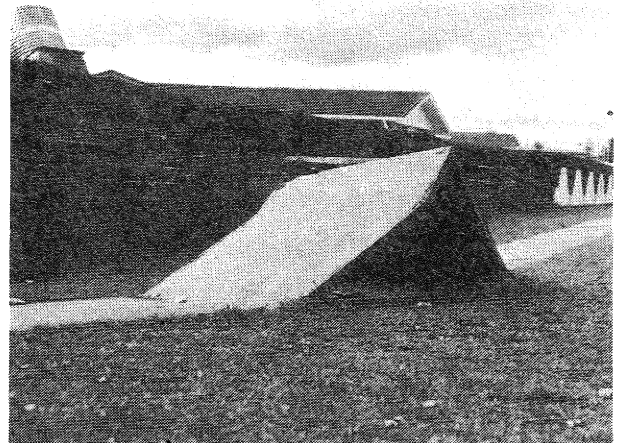
(vi) Railway lines suffered numerous instances of compression buckling and sometimes fracture, Fig. 2.9. A similar effect was apparent in the streets in Edgumbe with the compression of the pavement and buckling of the footpath, Fig. 2.10. Both of these features suggest ground compression in the Edgumbe area.

Fig. 2.10 : Compression of the footpath in Edgcumbe

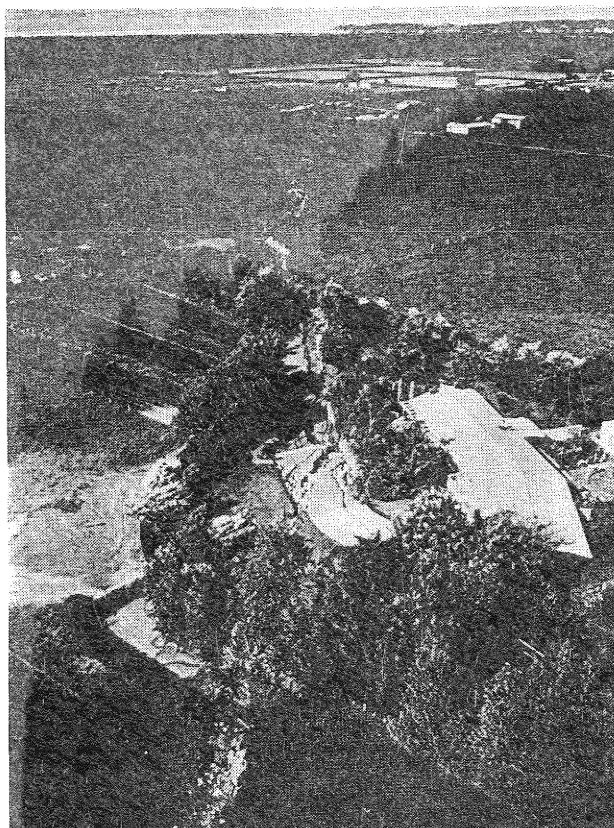
Fig. 3.2 : Aerial view of the main fault trace

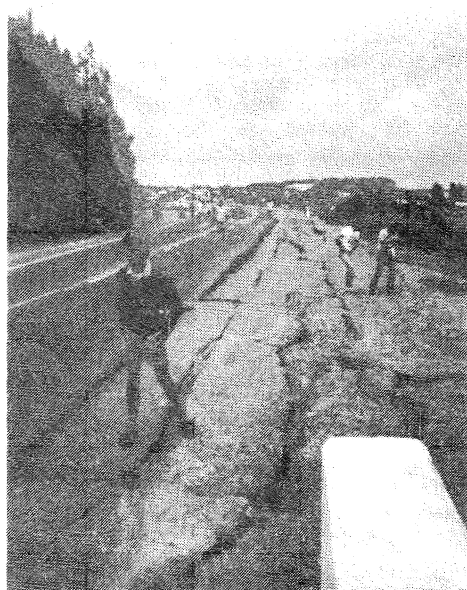
Fig. 3.6 : Cracks in the approaches to the Landing Rd. bridge over the Whakatane River.

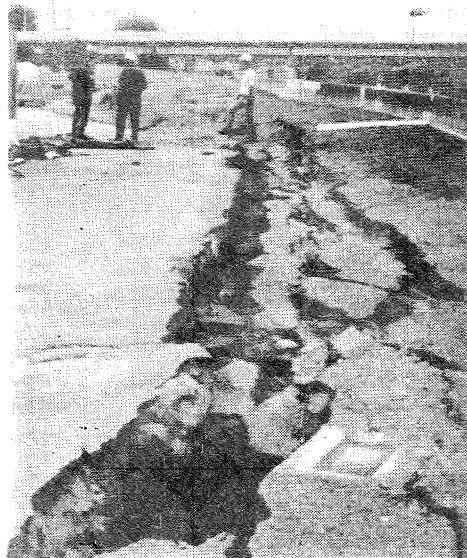
Fig. 3.7 : The condition of the true right stopbank of the Rangitaiki River in Edgcumbe after the earthquake.

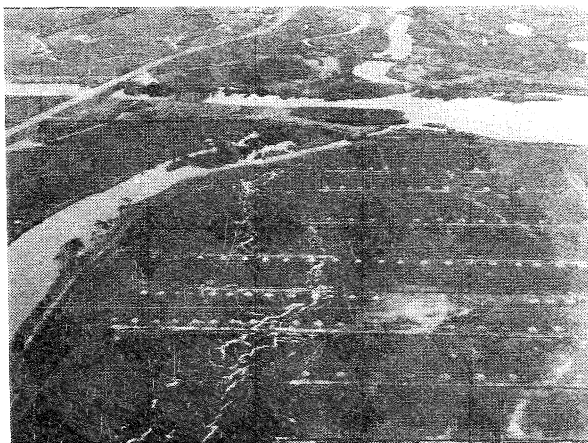
Fig. 3.5 : Ejected sand near the mouth of the Tarawera River. (The elongated white traces are the result of the earthquake. There is also a regular pre-earthquake pattern due to drainage works of the farmer.)

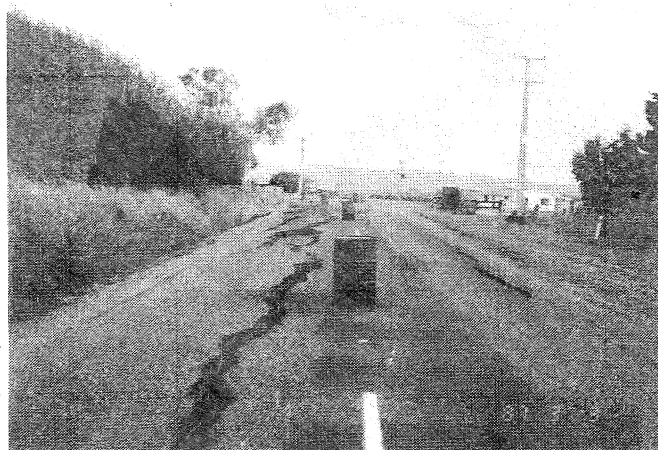
Fig. 3.8 : Cracking in Thompson Rd. which, at this location, is on the crest of the stopbank along the Rangitaiki River

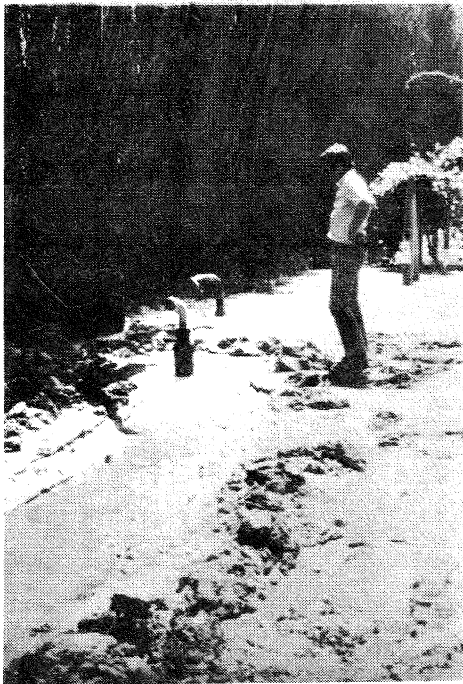
Fig. 3.14 : A well head surrounded by ejected sand

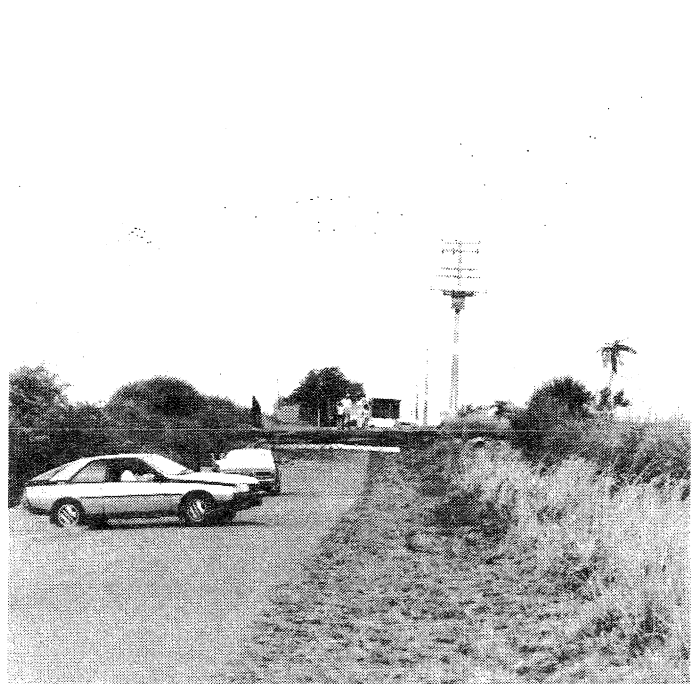
Spectacular damage to roads was observed where the main fault trace crossed the Edgecumbe-Awakeri Rd., McCracken Rd. and the Edgecumbe-Te Teko Rd. Figure 3.15 shows the abrupt change in level across McCracken Rd.

Fig. 3.15 : Damage to McCracken Rd. where it intersects the main fault trace

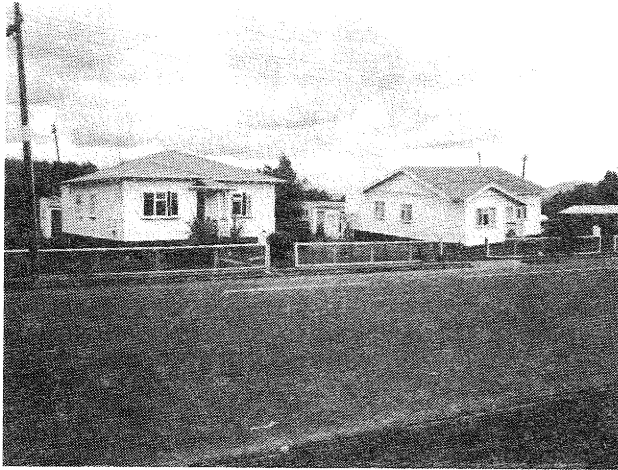
Fig. 4.1.1 : Two near identical houses on lightly braced jackstuds and concrete piles. The house on the right has toppled off, the one on the left is laterally displaced at floor level.

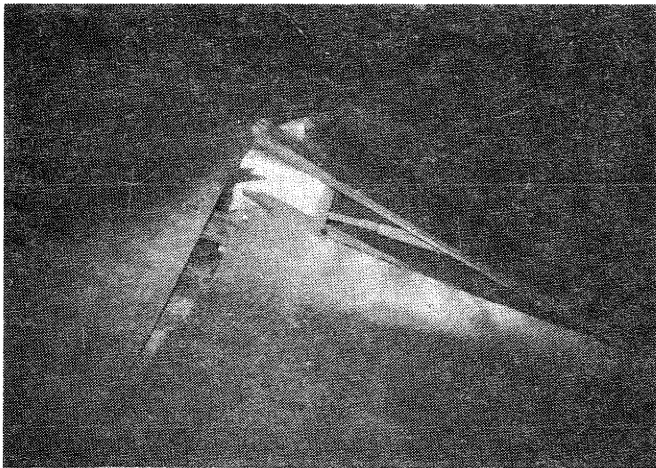
Figure 4.1.3 : Houses which fell off their piles badly damaged the floor, apart from other damage

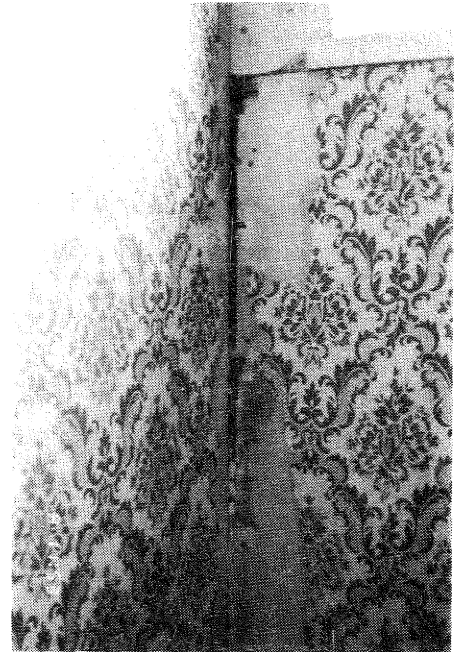
Figure 4.1.4 : Typical damage to joints between sheets of wall linings

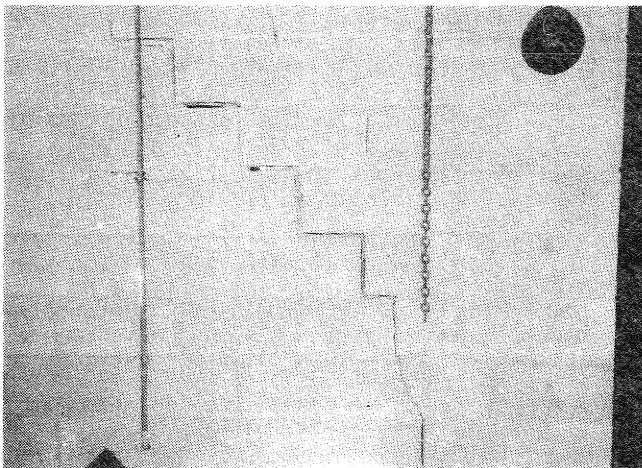
Figure 4.1.5 : Damaged unreinforced concrete block walls

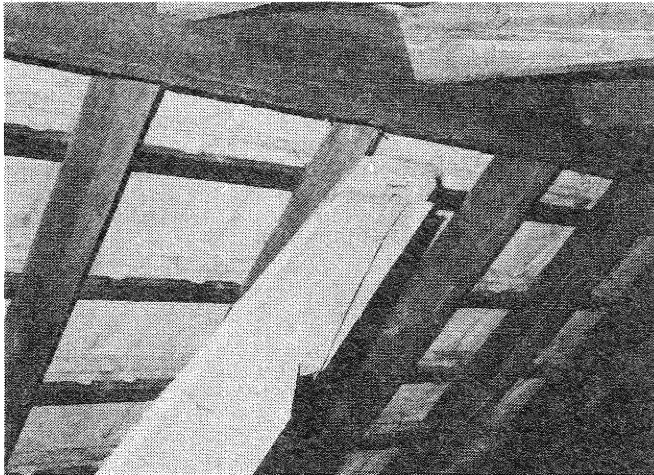
Figure 4.1.6 : A failed connection of a diagonal timber roof brace to the ridge board of a concrete tiled roof

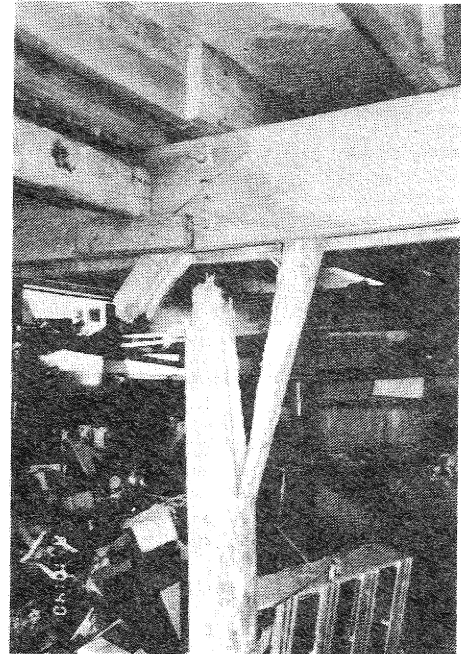
Figure 4.1.8 : A broken pole of the house in Figure 7

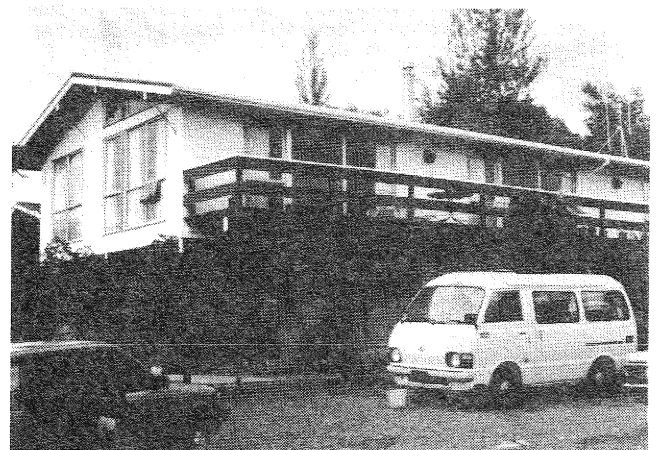
Figure 4.1.9 : An irregular lower storey, half on concrete block and half on cantilevered posts and beams. Failure occurred at the connections of the beams to the block walls.

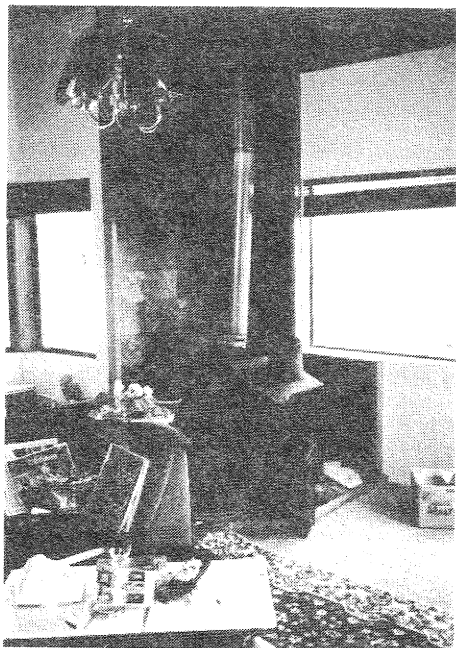
Fig. 4.1.11 : A dislodged free-standing solid fuel stove

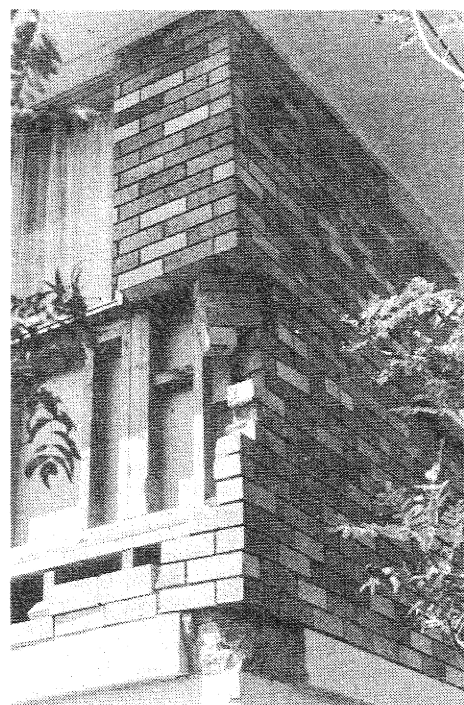
Fig. 4.1.15 : Corner damage of brick veneer

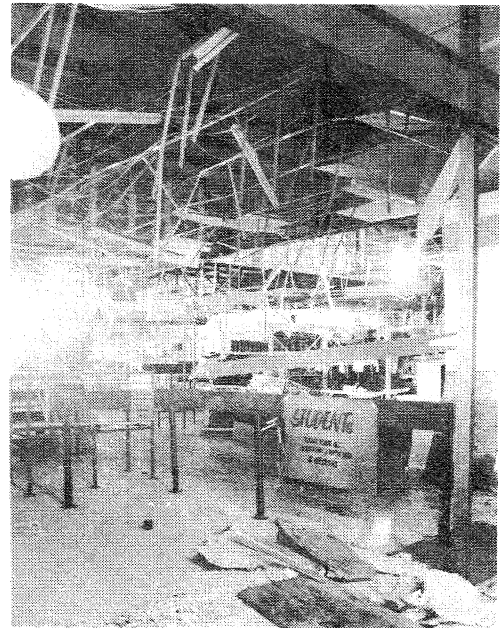
Figure 4.2.1 : Riverslea Shopping Centre suspended ceiling collapse

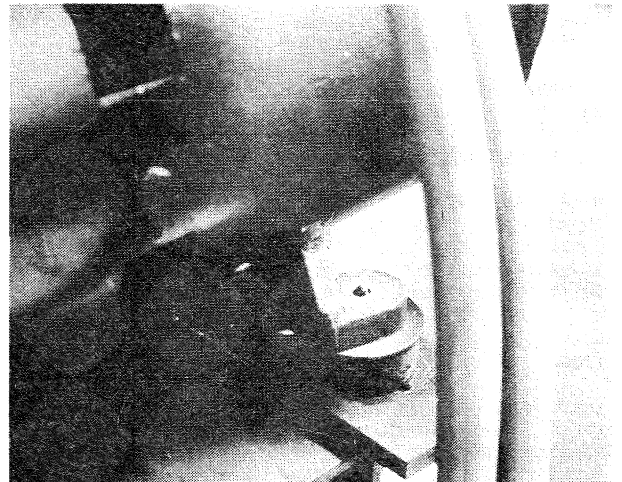
(v) Evidence of vertical acceleration has been suggested in the apparent vertical motion of liquids in storage vessels and the way in which tops were pushed off these vessels. In addition the lift motor in the Power Board Building in Whakatane seemed to have jumped clear of 12 mm retaining pins without damage to the pins (cf. section 4.2.2.4).

Figure 4.2.2 : BoP Power Board Building lift motor foot showing lack of holding down

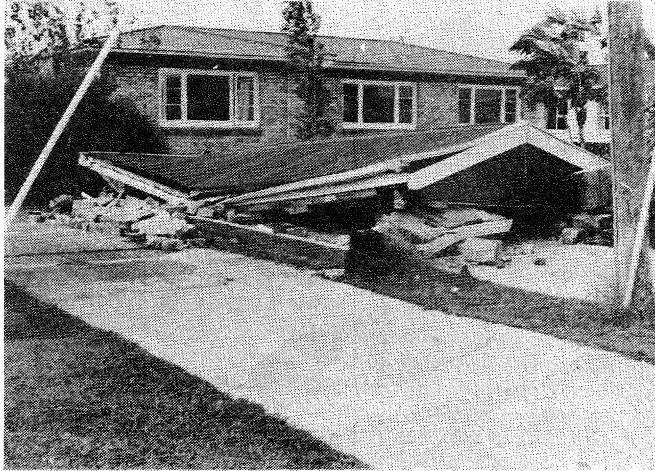
Two such buildings are illustrated, Figs. 4.2.4 and 4.2.5, and need very little comment, except that corner reinforcement prevented overall collapse of a concrete block garage even though starter bars from the foundation into the reinforced cavities were not provided. Basking reinforcement could have

Fig. 4.2.4 : Unreinforced masonry garage

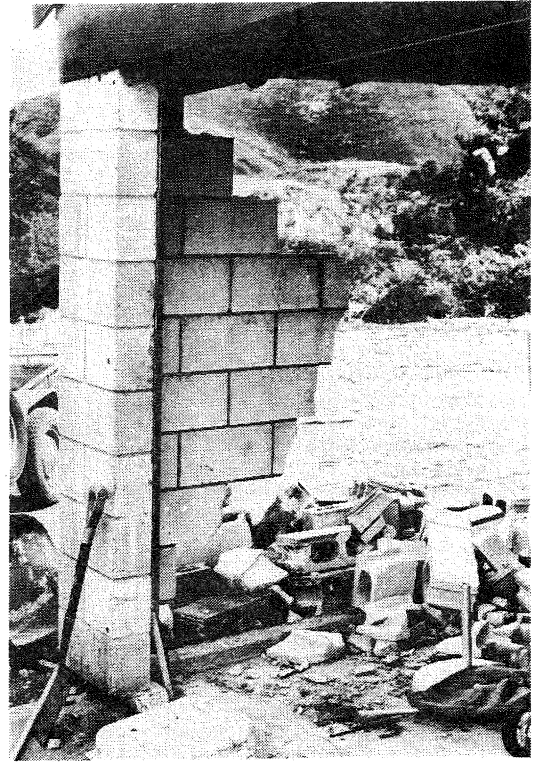
Fig. 4.2.5 : Unreinforced concrete masonry shed

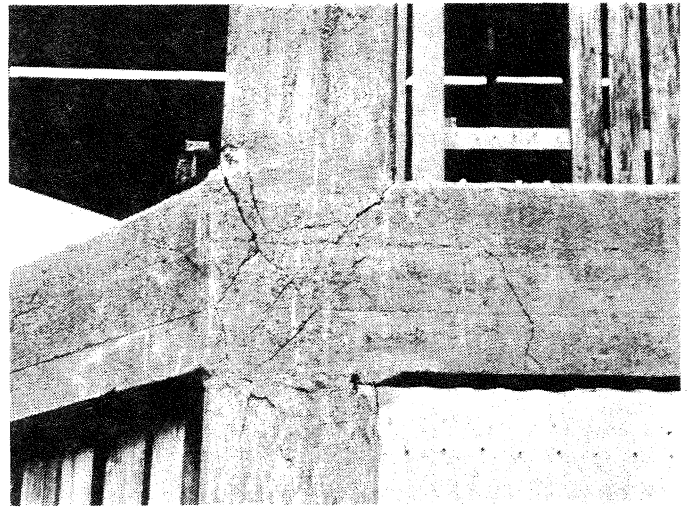
Fig. 4.2.8 : Water tower beam/column joint hinging

joint showed signs of beam hinging in both directions, with minor spalling of beam cover concrete. The structure remained stable but is expected to be demolished.

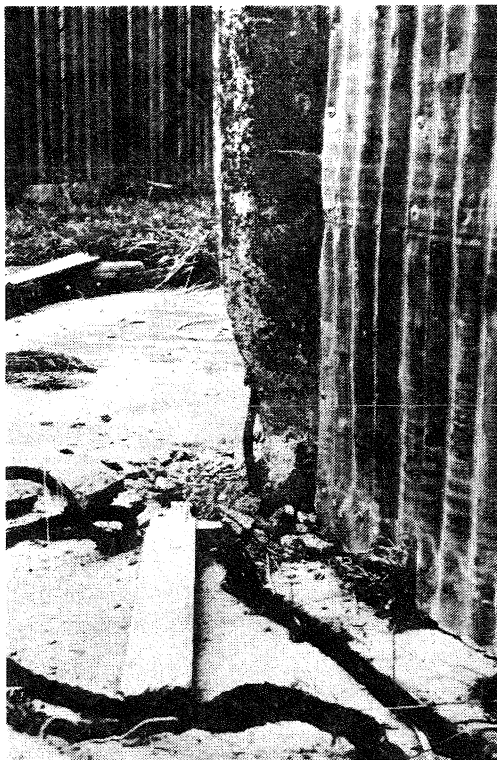
The support structure had behaved in almost textbook fashion, i.e. the inadequate, out of date details had behaved as theory would have predicted. Most columns showed column base hinging with significant spalling of cover concrete, Fig. 4.2.7. The plain steel reinforcing was not confined with consequential buckling of the column bars after yielding in tension. Several beam/column joints had failed in joint shear with reversal creating diagonal corner to corner cracking, Fig. 4.2.8. The amount of joint steel is unknown but judging from the age of the structure it is likely to be light to non-existent. One external beam had hinged considerably with large loss of concrete due to lack of confining stirrups. An internal beam column

Fig. 4.2.7 : Water tower column base hinge

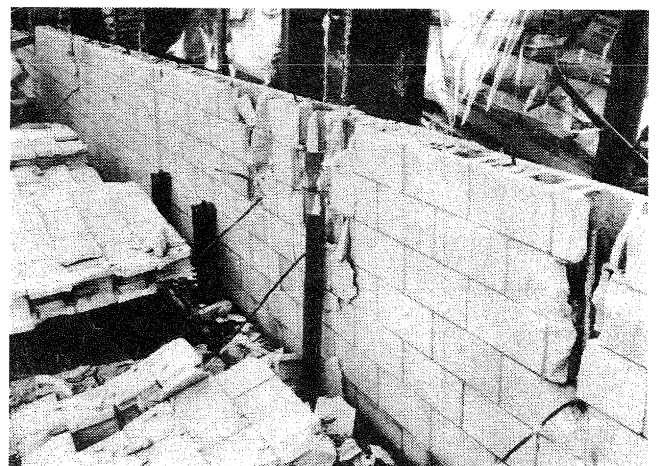
Fig. 4.2.11 : Collapsed fire wall. Note spacing of reinforcing and incomplete grouting of reinforced cells.

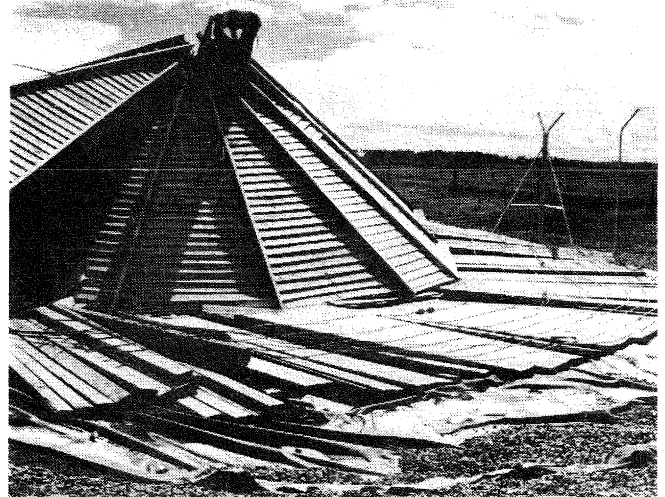
However, there were many other timber tanks in the area (reported to be over 30) only three of which sustained any damage and only the Edgcombe one with extensive damage. There were several examples of timber tanks having slid back and forth by about 90 mm.

Fig. 4.3.1 : Edgcombe timber tank

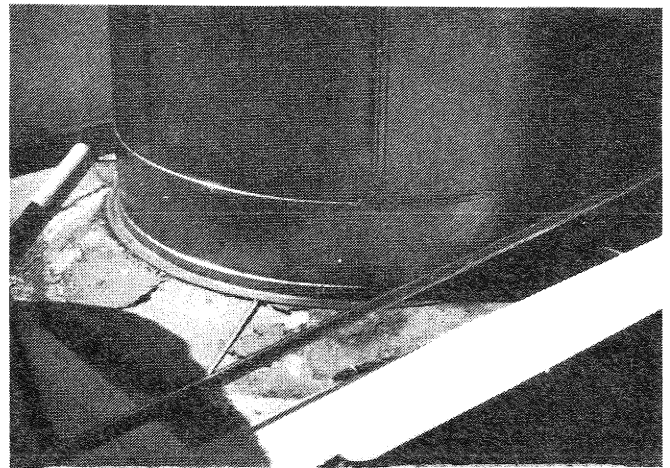
Fig. 4.4.4 : Horizontal tank slippage

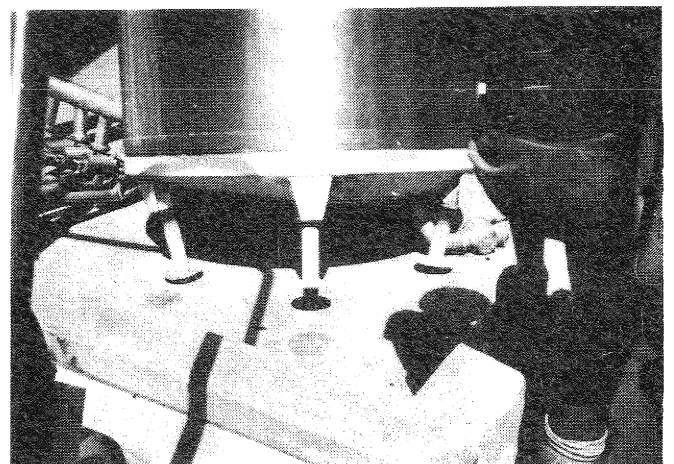
Fig. 4.4.5 : Damage to tank on legs

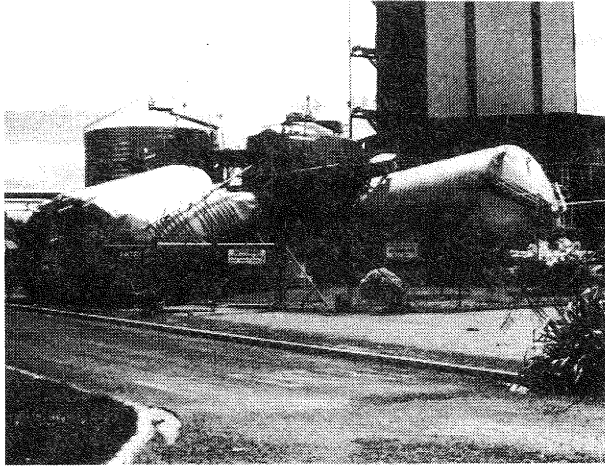
Fig. 4.4.6 : Bay Milk Products - overturned tanks

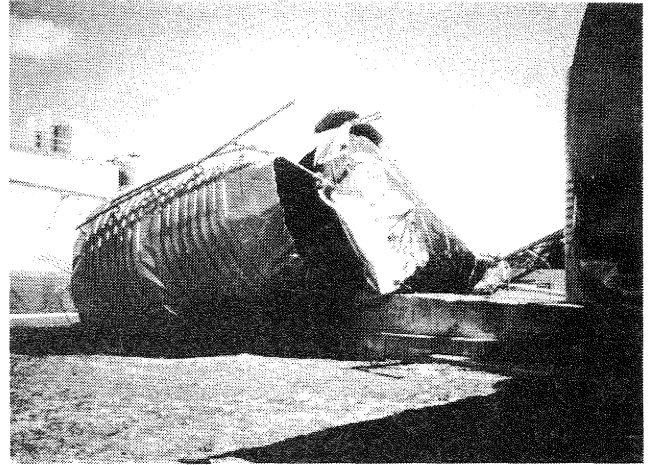
Fig. 4.4.7 : Bay Milk Products - overturned tanks

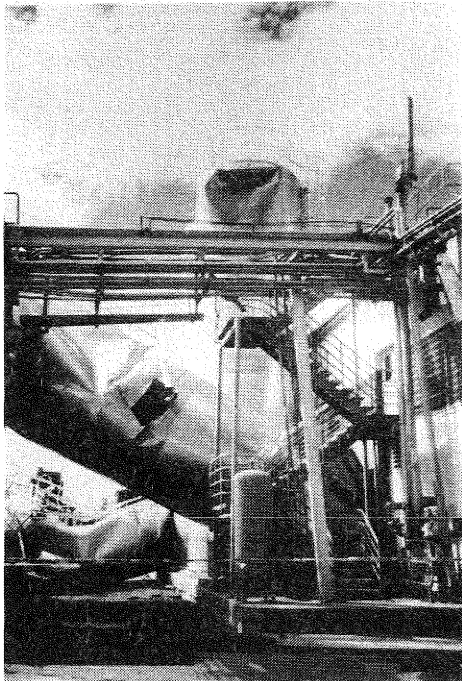
Fig. 4.4.8 : Bay Milk Products - overturned tanks

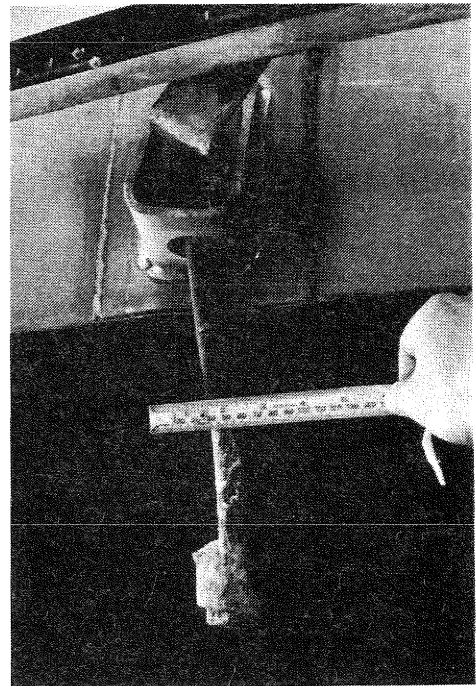
Fig. 4.4.9 : Holding down bolt, pull out failure

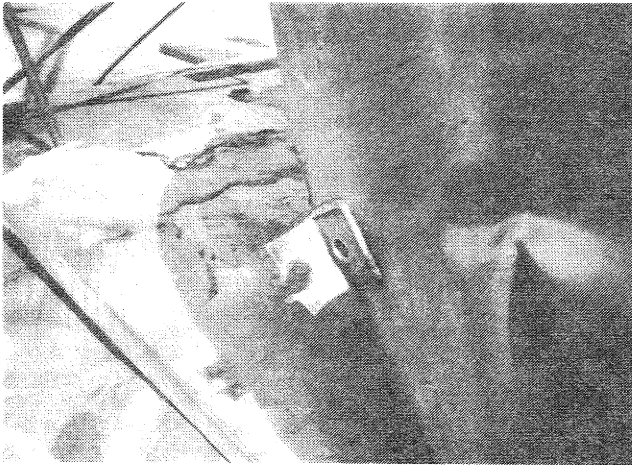
Fig. 4.4.10 : Holding down lug, ripped

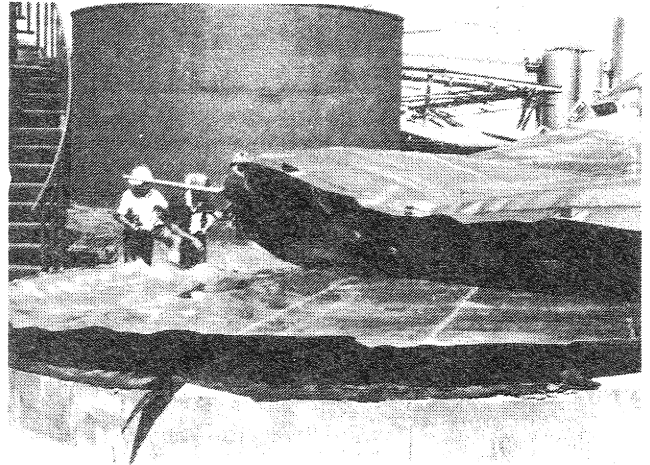
Fig. 4.4.11 : Shell of tank torn from base

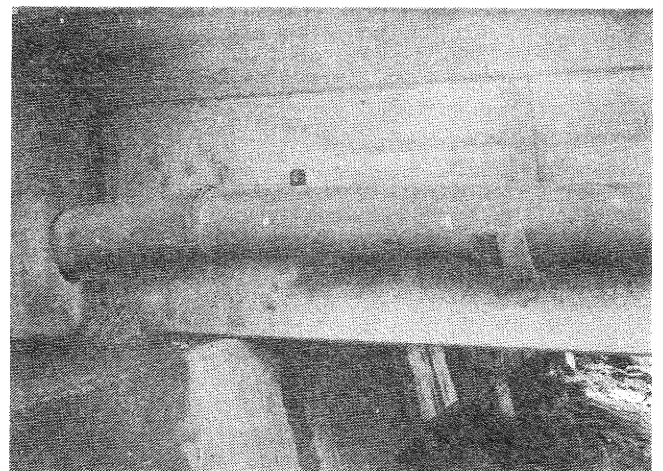
At the Landing Road bridge at Whakatane, a 250 mm diameter steel rubber ring jointed pipe which was supported from the bridge deck without upwards restraint fixings passed through an open sleeve in the abutment. Settlement of the approach to the bridge has forced the pipe downwards, causing it to pivot about the abutment and consequently rotating the first rubber ring joint under the bridge. This joint has been rotated by about 15 degrees without leaking. The abutment of this bridge appears to have moved both longitudinally and laterally during the earthquake, Fig. 6.2.4.

Fig. 6.2.4 : Pipeline under Landing Road Bridge

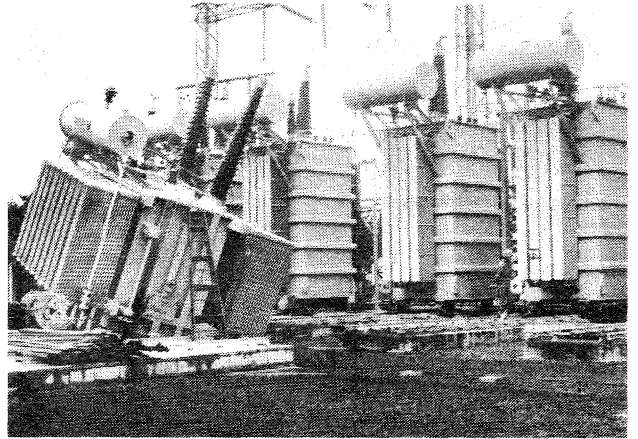
Fig. 7.1.1 : Damaged Savigliano 220 kV 16667 MVA Transformer

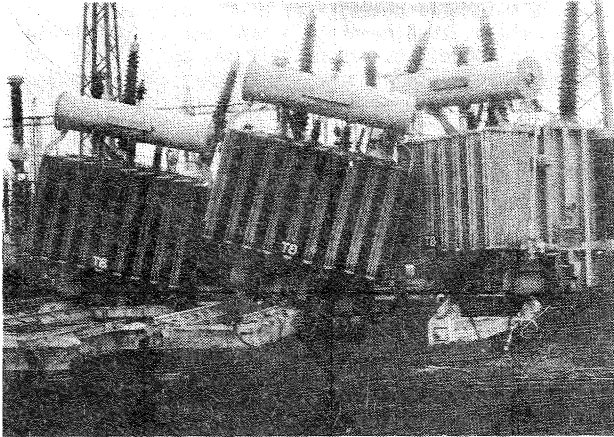
All three Savigliano transformers plus the spare came off the rails when the holding down arrangements failed completely. All of the 3/4" Whitworth studs securing the holding down brackets to the wheels failed in shear as shown in Fig. 7.1.3. The studs would have been subjected to very high shear loads under horizontal earthquake load in the direction of the rails because of the lever action of the relatively long bracket on the narrowly spaced studs, Fig. 7.1.4.

Fig. 7.1.2 : T8 Bank of Savigliano 220 kV transformers

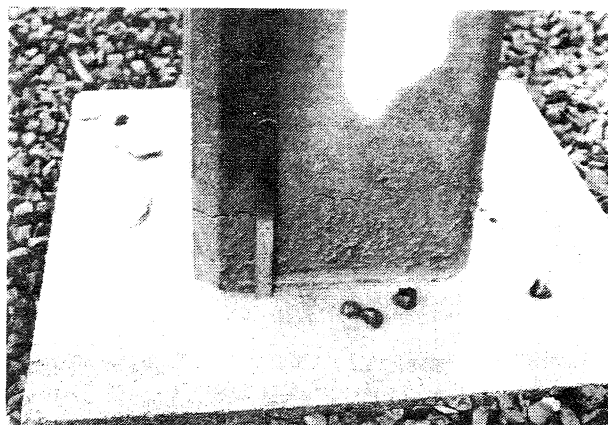
Fig. 7.3.1 : The base of a concrete pillar supporting an airbreak switch. This crack is smaller than a major crack and is typical of an intermediate crack.
