Seismic Retrofitting of Low Strength Unreinforced Masonry Non-engineered School Buildings

J. K. Bothara¹, B. Pandey² and R. Guragain²

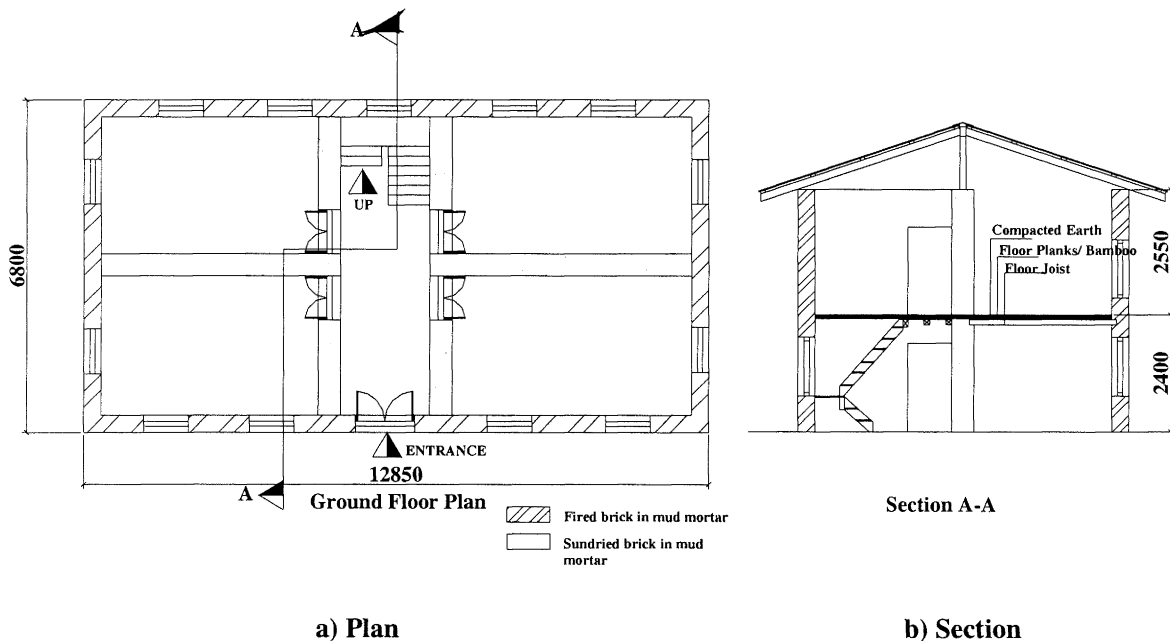
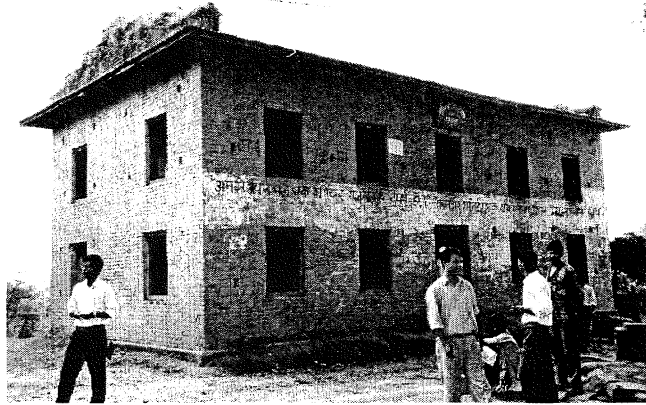
Figure 1 continued: Typical layout of existing school buildings (before intervention)

The retrofitted buildings were two-storey buildings of load bearing type with 350 mm thick walls in brick in mud mortar sitting on strip foundations. Due to multi-phase construction, some of the retrofitted buildings had 230 mm thick walls made of bricks in cement mortar in the upper storey. In some buildings, external walls of fired brick and internal walls of adobe, both in mud mortar, were also observed. Storey height of these buildings ranged between 2.4 m (8 feet) and 2.7 m (9 feet). Most of the school buildings were symmetrical in plan and elevation. The windows were small and away from the wall junctions. The rooms were small and walls covered more than 15% of the plinth area (foot-print of the building). One of the retrofitted two-storey school buildings is shown in Figure 1.

Figure 1: Typical layout of existing school buildings (before intervention)

c) A general photographic view

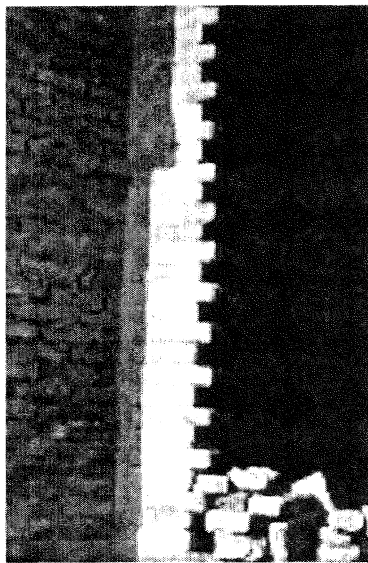
The major problem with those retrofitted URM buildings was lack of connections between different structural components. The orthogonal walls were connected either by vertical joints or the orthogonal walls were not constructed simultaneously resulting in a poor anchorage (Figure 2). The bricks were laid in mud mortar, which has a low shear strength and almost no tensile strength. Flexible floors were mostly constructed of soil laid on timber planks or bamboo strips supported on timber joists. The depth of the soil topping on floors was typically 75 mm. The floor joists were also not tied up to the walls. Planks were just placed on the joists without any nailing. The roofs were typically constructed of timber with corrugated iron sheets. As in the floors, the components of the timber structure supporting the roofing material may not be firmly tied with each other and with the walls. The gable walls were not tied to the roof structure. Hence, the buildings were more like stacked materials without interconnections.

Figure 2: Toothing for wall construction

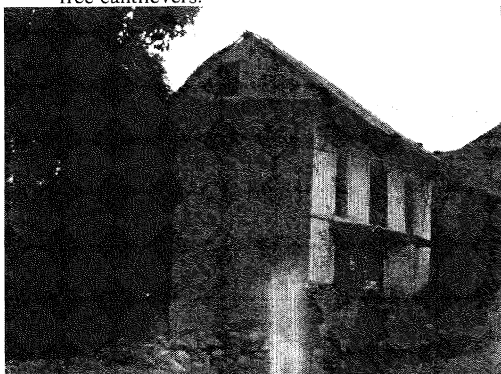
- After a few initial shocks, the out-of-plane walls separate from the in-plane walls forming continuous vertical cracks (Lizundia, 1997, NSET, 1998). Then the isolated walls start to behave as vertical cantilevers (Figure 3). Note that this mode of failure is very rapid (Bruneau, 1994).

Figure 3: Shear and vertical cracking

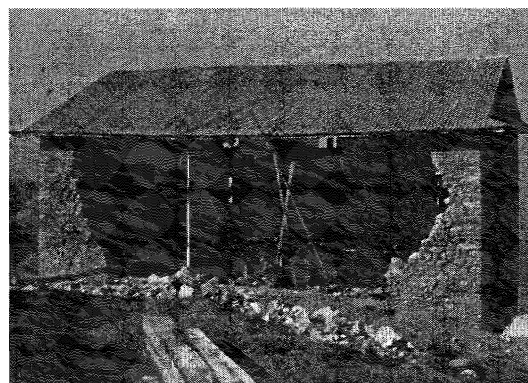
Figure 4: Out-of-plane failure of wall.

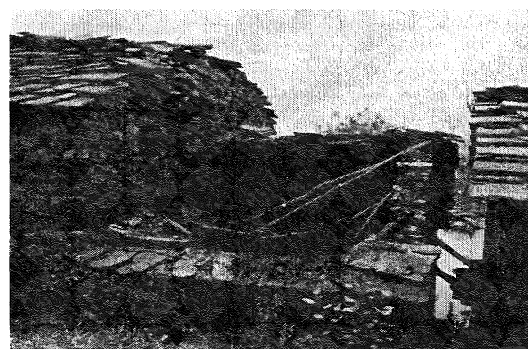
- Floor/roof may fall down due to the lack of integrity and anchorage with the walls, (Figure 6).
- Compressive failure of piers is rare especially in rectangular block masonry building of this class.
- Building failures from excessive foundation loading are very seldom in URM. It is because the superstructure is too weak and fails long before overstressing of the foundation (NSET, 1998) in general.

Figure 6: Collapse of roof due to lack of integrity and anchorage

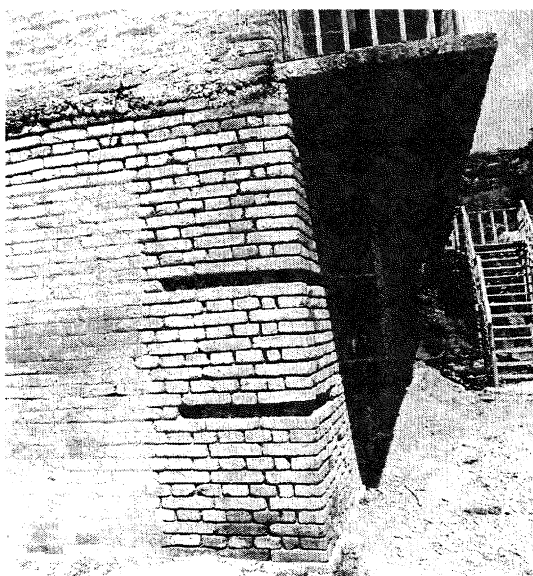
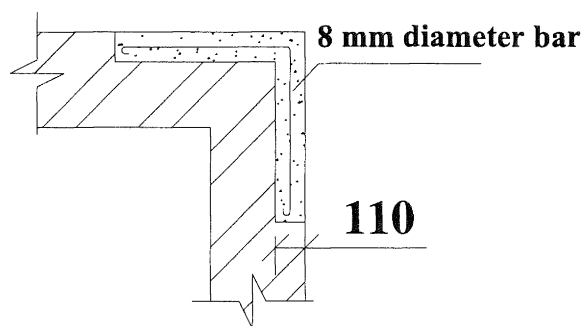
Figure 9: Stitching of walls

a) Before placing stitch

b) Stitch

The basic focus of retrofitting was to enhance the integrity of the building so the building would act as a box. Site specific details were developed to enhance integrity of walls, floors, and roof structures and connections between them. The weak connections between orthogonal walls were improved at corners and T-junctions, either by widening splints (discussed later) or by providing stitching. The stitches were provided at a spacing of about 600 mm (generally three stitches between floor and lintel). The stitches were placed by drilling holes in the walls first, filling the drill hole with cement grout and then forcefully inserting the steel bar. Alternately, bricks were taken out and then filled with reinforced concrete as shown in Figure 9).

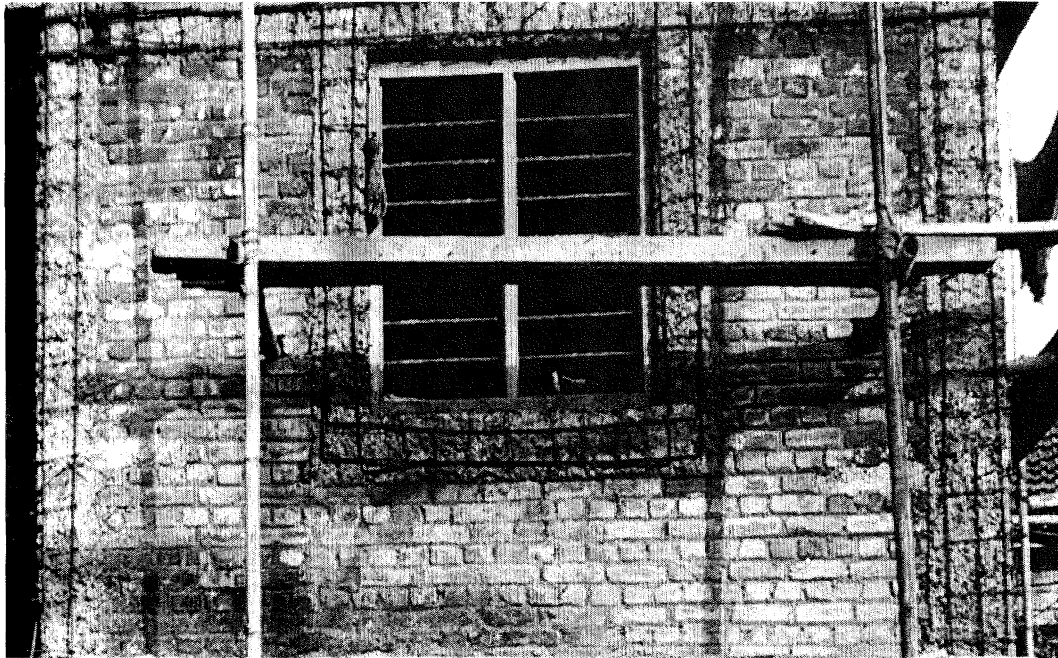
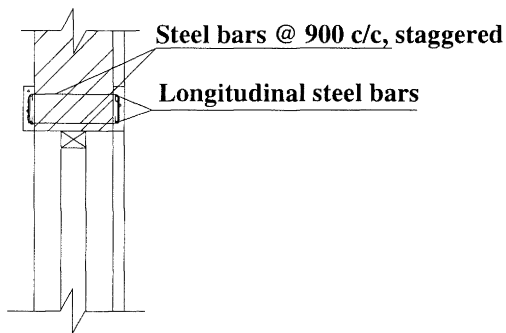
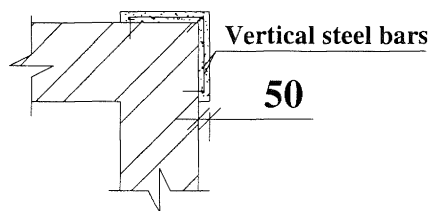
Figure 10: Construction of Splint, Bandage and Window Encasement

a) Splint and bandage under implementation

b) Bandage

c) Splint

The Splint and bandage system can be considered as an economic version of shotcrete jacketing where reinforcing bars are provided at most critical locations; i.e. wherever tensile stress can develop. Splints are vertical elements provided along the wall junction. In addition, openings were also surrounded by splints and bandages to prevent initiation of cracks from their corners (Figure 10). These were provided in the external

face only (Figure 10). The goal was to supplement tensile strength in the vertical direction. Furthermore, the splints would also prevent the masonry being dislodged due to cracking. It is expected that the piers might suffer diagonal cracks but these cracks will be restrained from widening by vertical steel provided in the splints at the ends of the piers.

The splints and bandages are the thin sections around 50 mm in thickness (Figure 10). To improve the bond with the walls, a 20

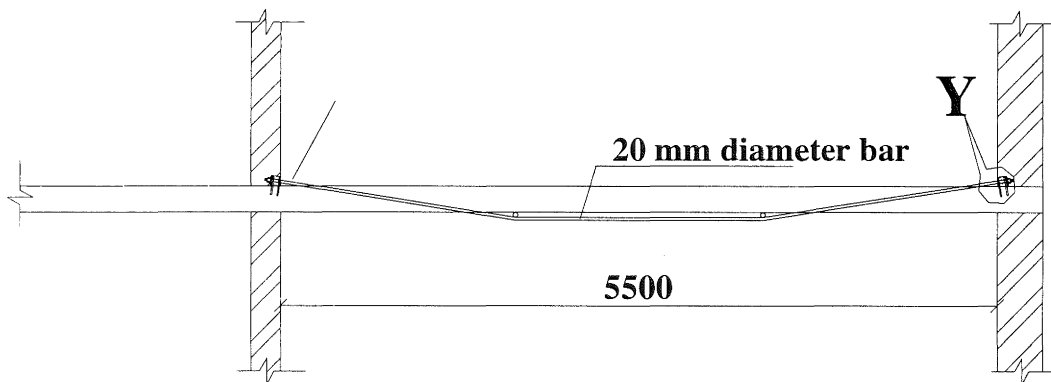
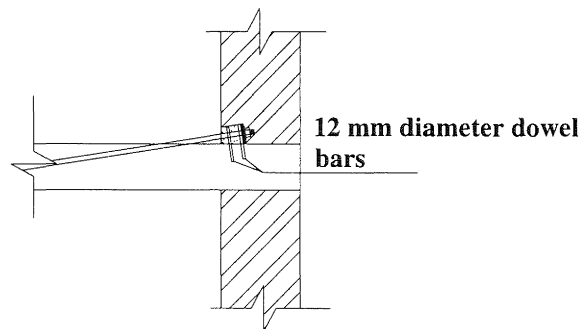
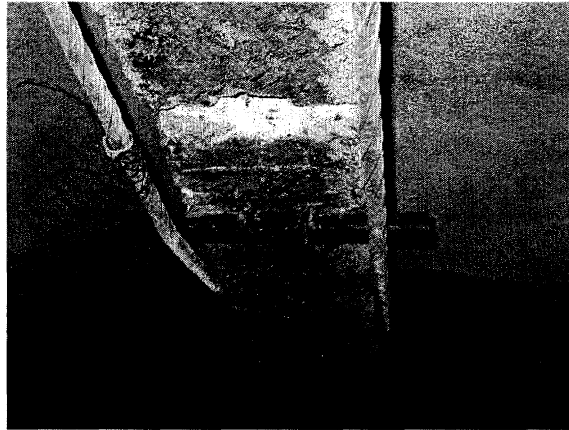
Figure 12: Post stressing of beam

Beam strengthening: The floor slab of one of the end rooms (size 5x5.5 m) of one of the retrofitted school building was sagging. Significant vibration could be felt even under normal walking. It was because of a very thin slab (about 75 mm) being supported by a shallow beam (200 mm including slab). The beam was severely cracked at different locations. The quality of concrete was rather inferior, and the beam was not uniform in shape. Concrete cover was not consistently maintained, and brick fill was used in the beam and slab to save concrete.

a) Longitudinal Section of Beam

b) Detail-Y

c) System after implementation

In order to strengthen the beam, jacketing, propping it at the centre and post-stressing of the beam were considered as different options. Based on economic consideration, effectiveness and opportunity to develop the system, the beam was post-tensioned with two 20 mm diameter steel bars. Site-

specific end anchorages were designed and simple jacks were developed for post-tensioning. The bars were anchored at the top of the beam at the ends (Figure 12). During post-stressing approximately 5 to 6 mm sag was recovered. After the implementation, no significant vibration was felt even when about 6-7 adults jumped on it. This low-cost method turned out to be very effective as no relaxation has been observed even after three years of service.
