# THE MAGNITUDE 8.3 JUNE 23 2001 SOUTHERN PERU EARTHQUAKE AND TSUNAMI: RECONNAISSANCE TEAM REPORT

Mark Stirling<sup>1</sup>, Robert Langridge<sup>2</sup>, Rafael Benites<sup>2</sup> and Hector Aleman<sup>3</sup>

## SUMMARY

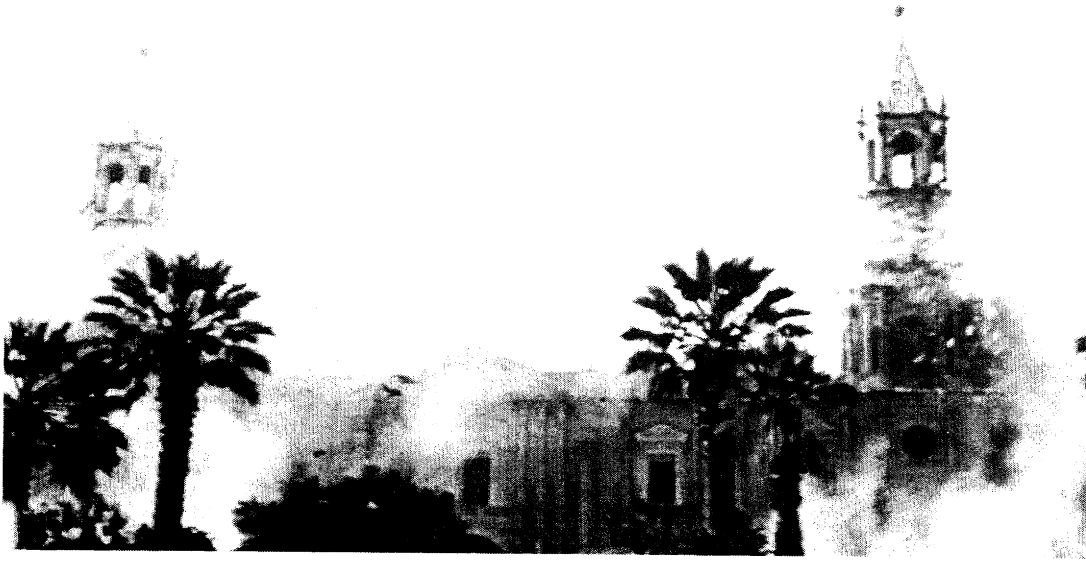
Figure 5. The Arequipa cathedral during the actual earthquake shaking, moments before the left-hand spire fell through the cathedral ceiling (the picture is from the tourist brochure "Terremoto" which was being sold on the streets of Arequipa at the time of our visit).

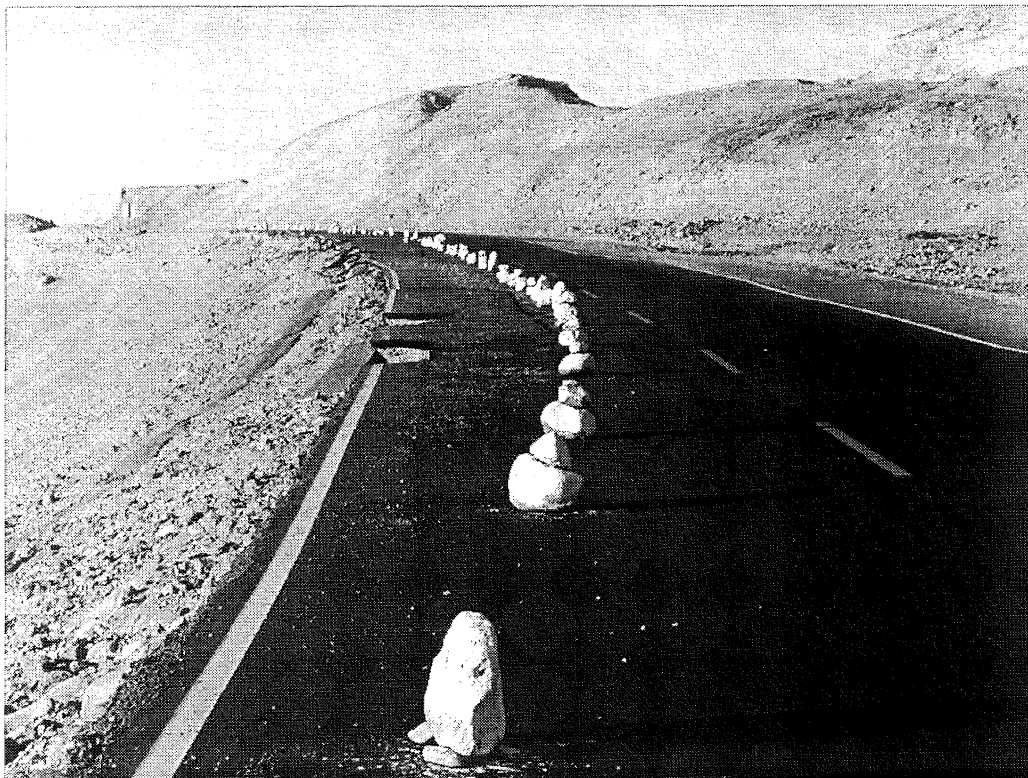
Hill slope subsidence and slope failure damaged the Pan American highway and other main highways within the 300 km long earthquake zone. We show typical damage to a highway in Figure 8.

*Figure 8. Damage to the Pan American highway from failure of the slopes beneath the highway. Damage like this was widespread on the highways along the 300km long earthquake rupture zone, creating some considerable traffic hazards.*

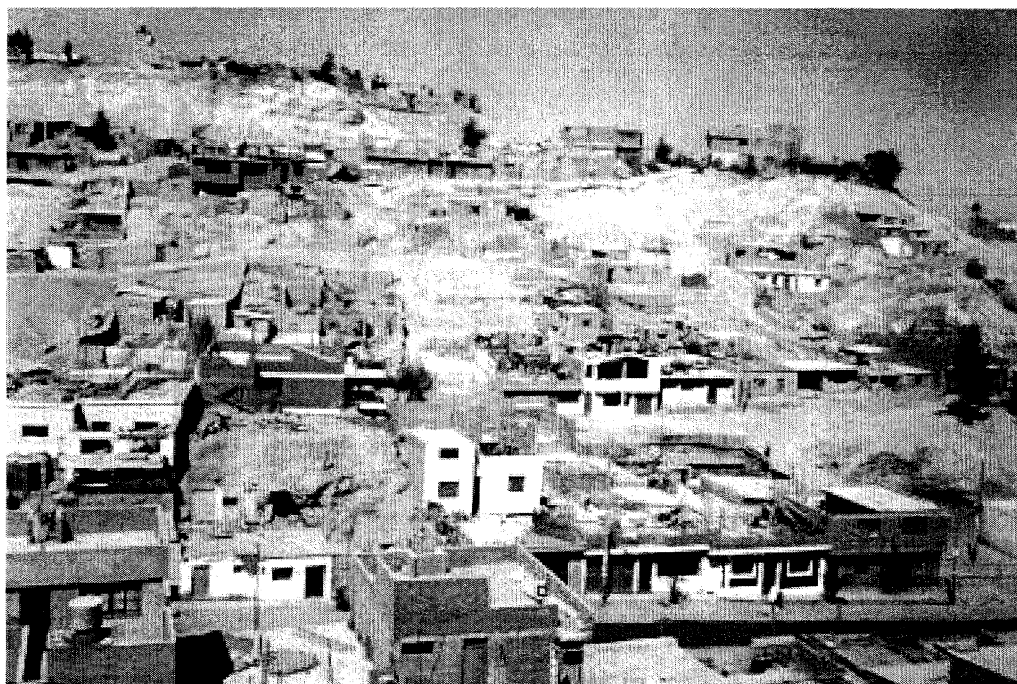
The only strong motion accelerograph record of the southern Peru earthquake came from the city of Moquegua (Fig. 3). This city sustained the most significant earthquake shaking damage of all the cities we saw because of the widespread "soft soil" (gravel alluvium) beneath the city. The accelerograph showed that a peak ground acceleration (PGA) of 0.3g had occurred in the city (Fig. 2), which we consider to be compatible with the level of damage observed in the city. The measured PGA of 0.3g is therefore likely to represent the maximum PGA produced by the earthquake, based on the fact that we did not see any other damage as extensive along the whole 300 km extent of the earthquake zone. This includes the epicentral area, where the strongest MM Intensity (8) was felt (Fig. 2a). A large proportion of the buildings were of adobe construction, and so the damage to the city was extensive (Fig. 9). Damage to younger and better constructed buildings was also significant, such as to the school building shown in Figure 10. This building appeared to be constructed to a similar standard to some buildings in New Zealand. Incidentally, our visit to Moquegua coincided with a visit by President Toledo to observe the earthquake damage. We were fortunate enough to meet the President during the course of our survey of the city.

*Figure 9. Severe damage to buildings on the steep hillslopes of Moquegua. These hillslopes, along with the valley bottoms, are underlain by alluvial sediments which would have amplified the shaking from the earthquake. In this photograph nearly all adobe buildings have been destroyed, with considerably less damage to the more substantially constructed buildings.*

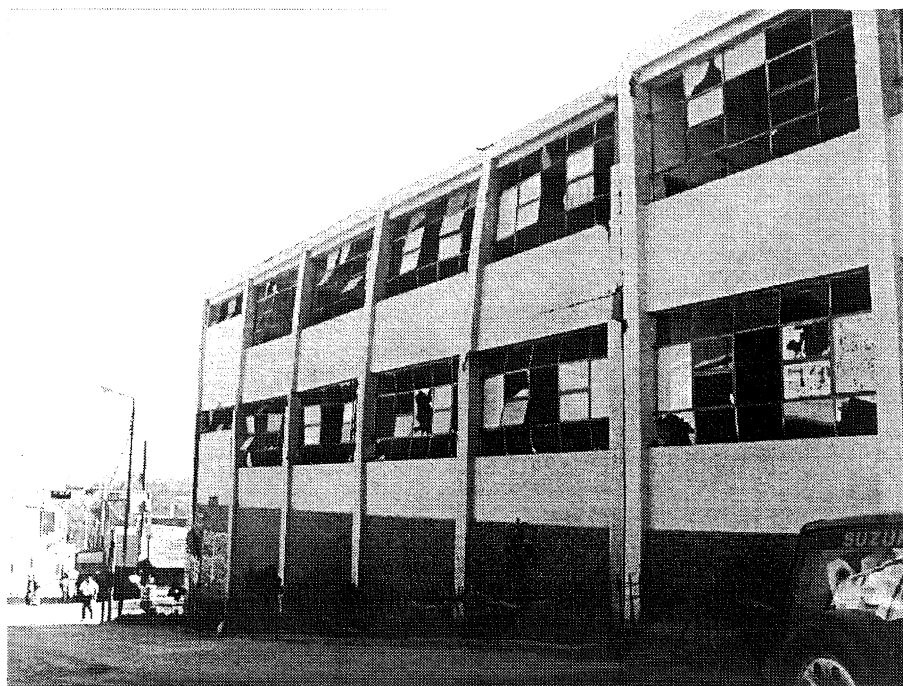
*Figure 10. Damage to the Moquegua College, a building probably of similar age to the Arequipa military mess building in Figure 7.*

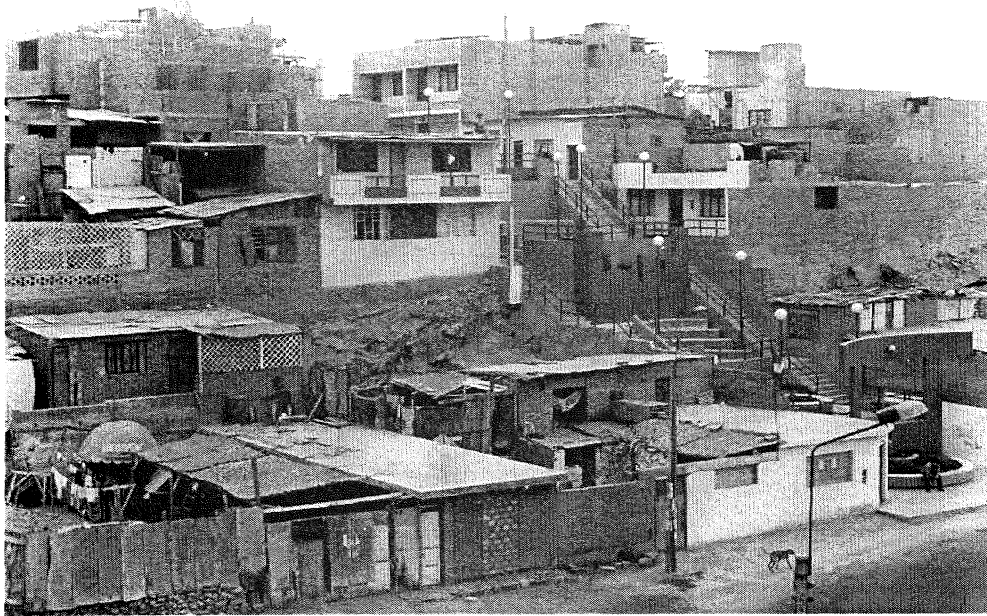
In contrast to Moquegua, the city of Mollendo showed very little earthquake damage, despite being closer to the ruptured subduction interface. This city is on granite, or "hard rock" in engineering terms. This site condition was such that shaking damage was light. Few buildings including those of adobe construction were damaged (Fig. 11).

*Figure 11. Undamaged buildings on granite rock in Mollendo. No damage was observed in the city, even in the case of adobe buildings (as can be seen in the lower centre of the photograph).*

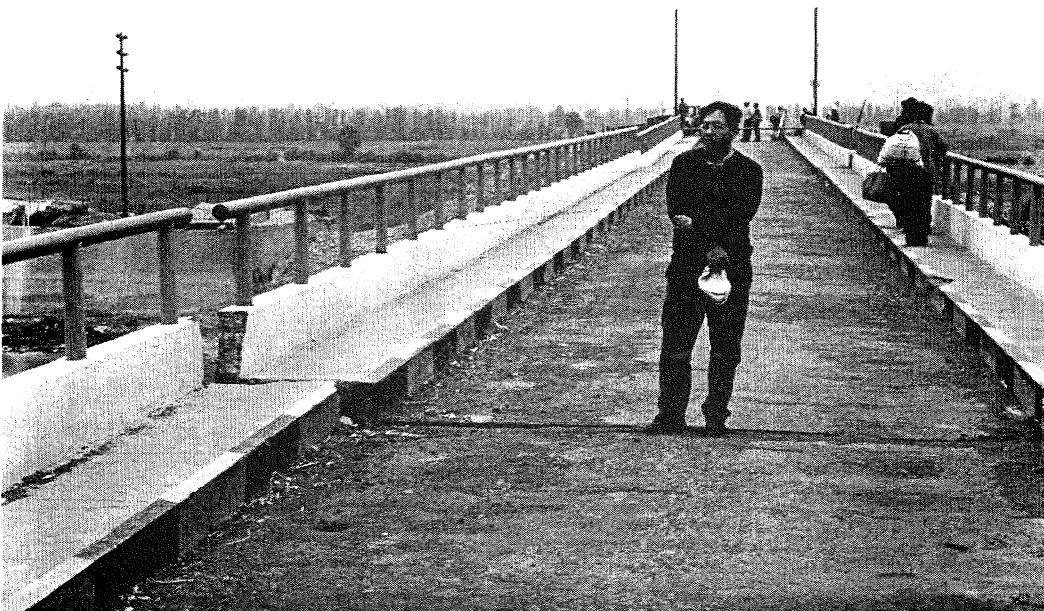
There were several places in the earthquake zone where seemingly well-constructed bridges were damaged. We show the one bridge we visited near Punta De Bom Bon in Figure 12, which shows the bridge broken in several places where the foundations have failed significantly. The bridge appeared to be of similar construction to many New Zealand bridges.

*Figure 12. Damage to the bridge serving the township of Punta De Bom Bon.*

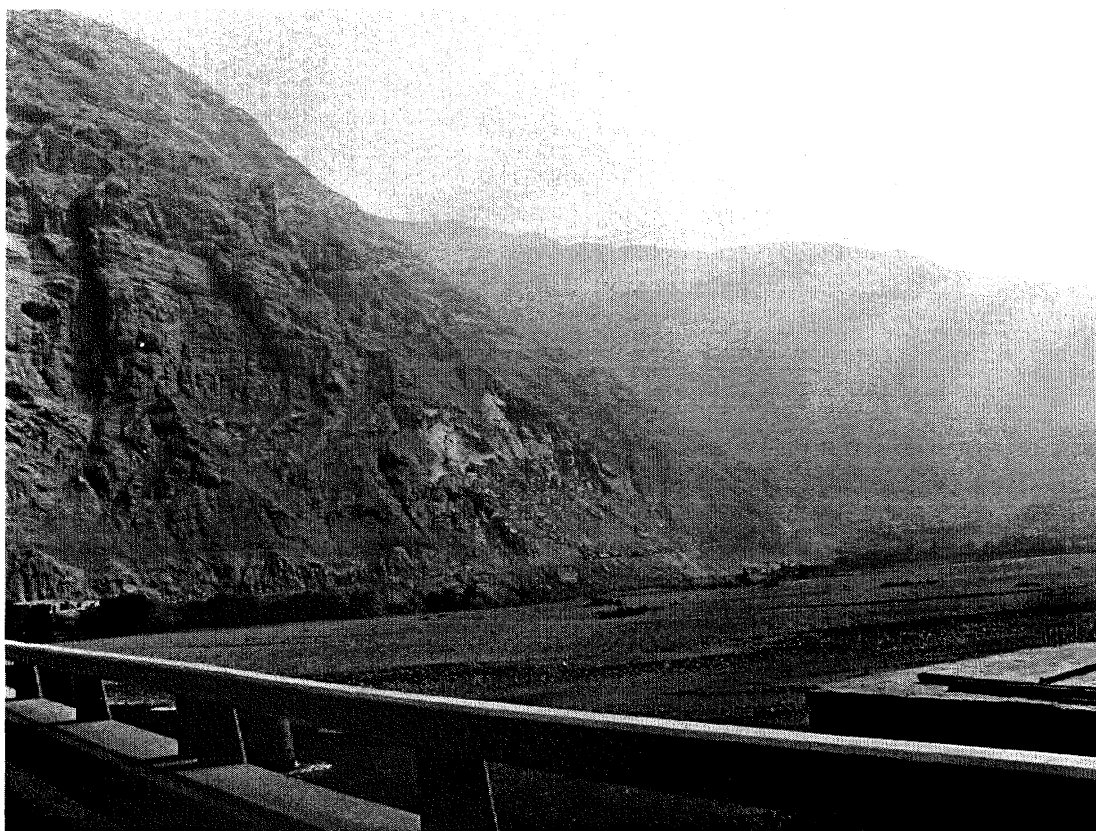
There was very little earthquake-induced landsliding from the southern Peru earthquake. We saw one 100m high rock slide near the epicentre of the earthquake (Fig. 13). This was also where we saw one of only two areas of liquefaction. The other area of liquefaction was near the southern end of the earthquake zone, in a farm paddock near Punta de Bom Bon. Surprisingly these were the only areas of liquefaction seen, despite the great size of the earthquake and abundance of suitable conditions for liquefaction (coastal plains with sandy sediments and a high water table). It is possible that tsunami inundation in the Camana area destroyed liquefaction features, but the overall impression based on our survey of the 300 km long earthquake zone is that liquefaction was minor during the earthquake.

*Figure 13. Rockfall of c.100 m height in Ocona area.*

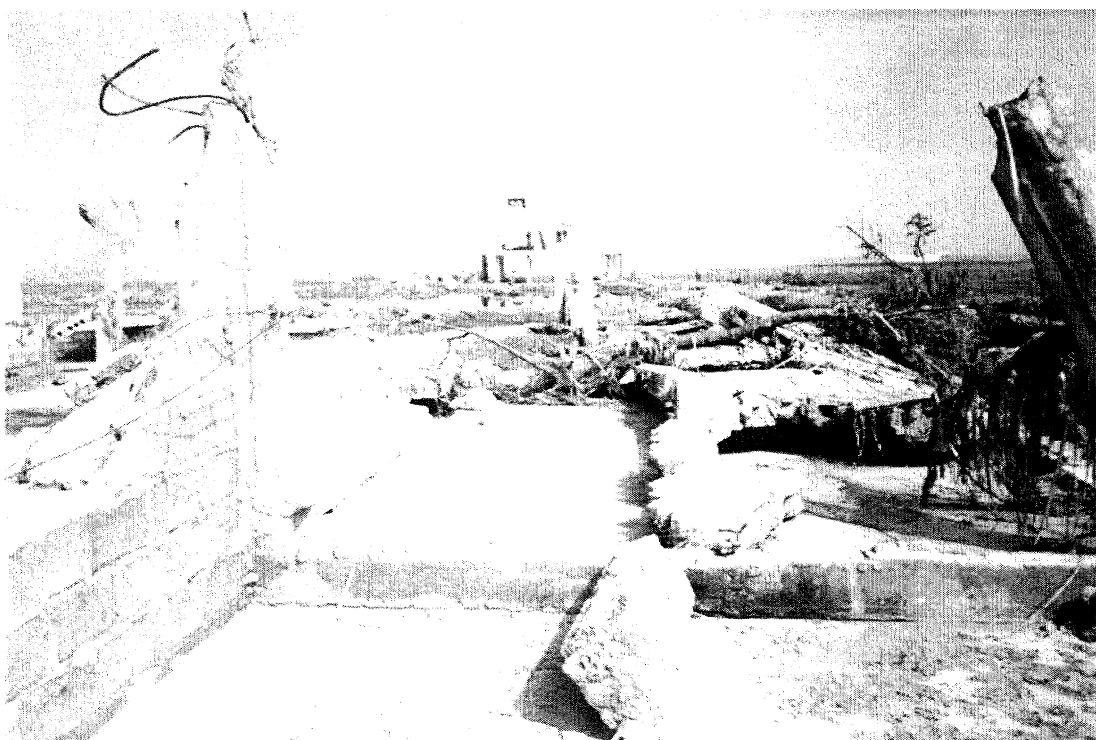
and moved about as if they presented no barrier to the waves. Much sand was deposited by the seawater. The ponded seawater lasted for days on the streets of the ruined settlements after the tsunami (Fig 14).

*Figure 14. Devastation in the coastal resort town of Camana due to the tsunami.*

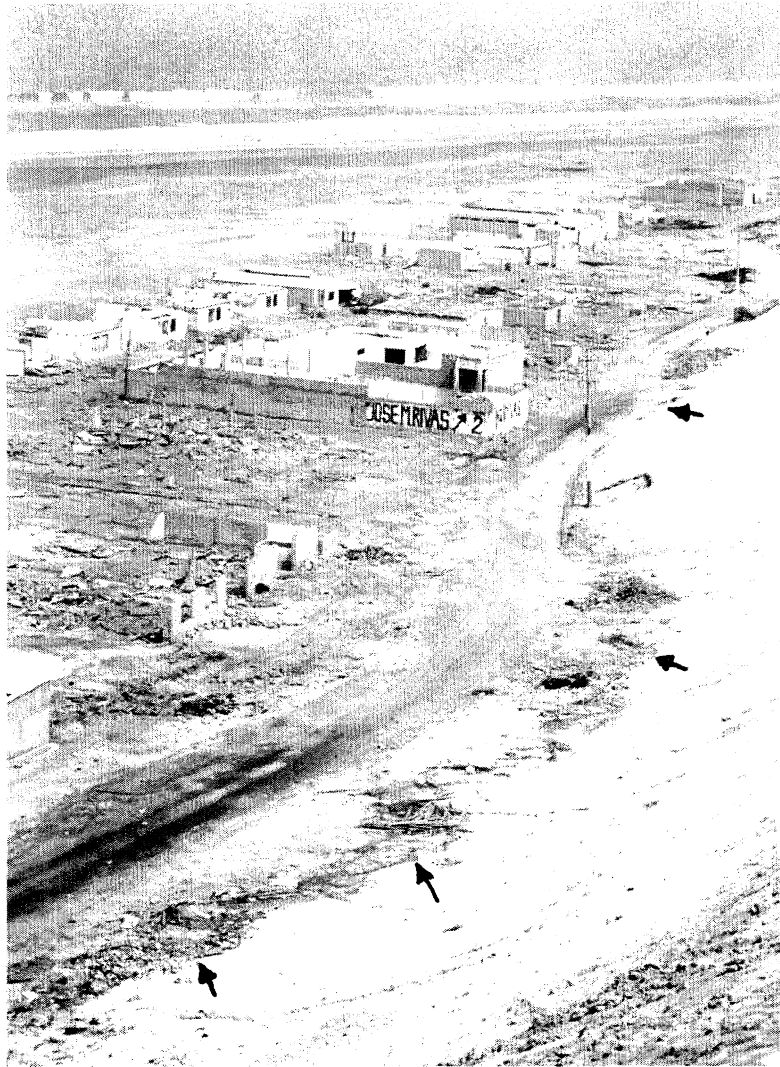
On our first arriving at Las Cuevas, we found it hard to imagine that the near total devastation of the coastal town was due to tsunami (Fig. 15). Instead, our impressions of the damage were that it was due to earthquake shaking. However, it was clear from the line of water-transported debris at the edge of the cliff (Fig. 15) and the distribution of debris throughout the ruins that the tsunami had violently impacted on the area. The tsunami swept several hundred metres in from the sea to the base of the cliff, smashing buildings and walls above high tide level, and depositing a layer of sand (up to 100 mm thick) and debris across the entire area.

Figure 15. The settlement of Las Cuevas (southeastern continuation of Camana) as we saw it some five weeks after it was destroyed by the tsunami. Arrow points to a darkish line of water-washed debris at the base of the hill, which marks the maximum inland extent of the tsunami.

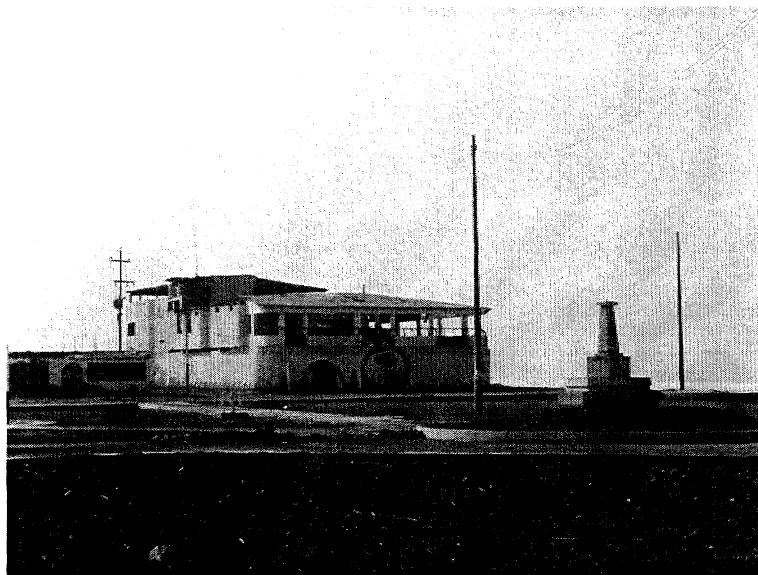
In the Las Cuevas-south Camana area, eye-witness accounts of the tsunami impact allowed us to differentiate between earthquake versus tsunami damage. People felt the earthquake shaking but report no damage associated with the earthquake. It was the impact of the black wall of water that produced the near-total damage to the coastal part of the town. For example, the tsunami was observed to have come over the top of a two-storey discotheque, smashing through the roof and blowing out the windows (Fig. 16).

Figure 16. Witness accounts reported that the tsunami wave smashed through the roof of this disco and blew out the windows. The wave would therefore have been at least 7 m high, a height confirmed by the damage to the lamps of some tall lamp posts in the same area.

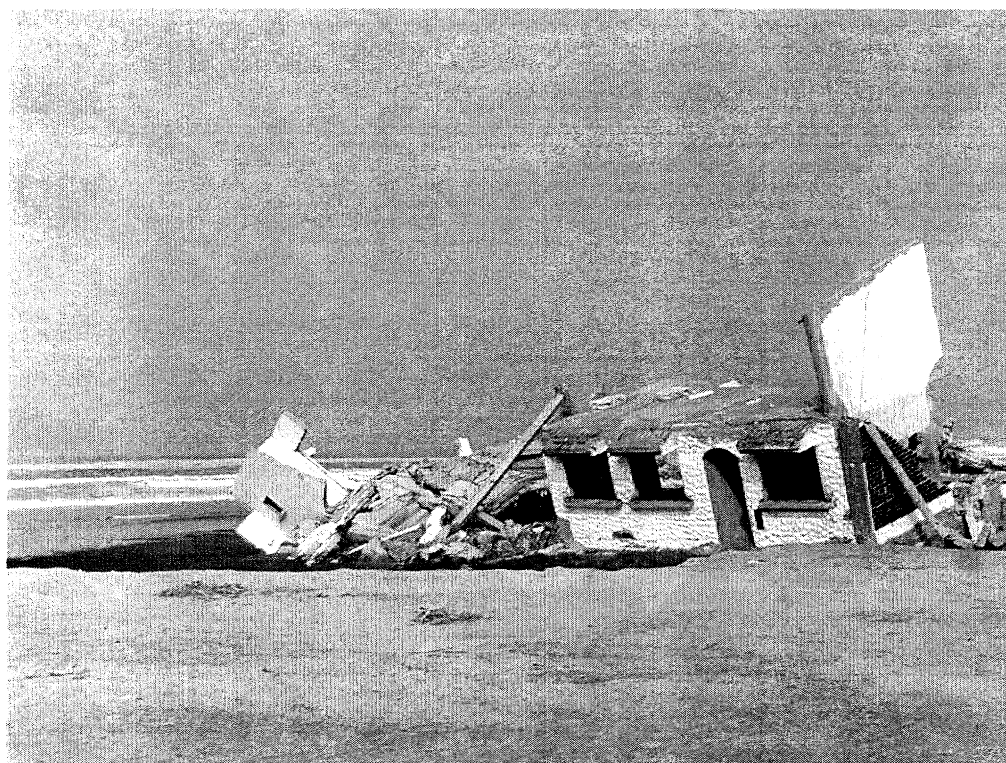
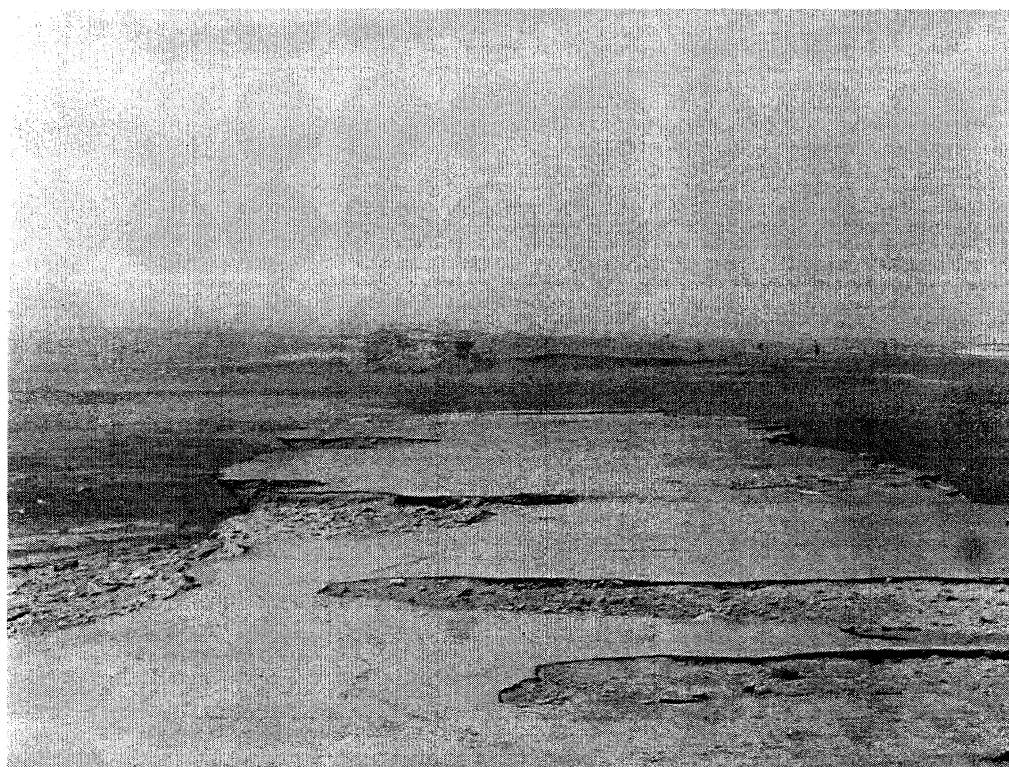
**Figure 17.** Possible evidence for coastal subsidence in Camana. The active beachfront was once 100 m seaward of the ruined building shown in this photograph (a) but is now adjacent to the building. This could be due to subsidence and the erosion of sand by the tsunami. The severe damage and southward lean to the building is likely to be due to scouring of the sand around the building and the severity and obliquity of tsunami impact. The coastal promenade in (b) was once well back from the active beach front, but is now at the active beachfront. In the 5 weeks following the earthquake it has been eroded and breached by the sea. This change in position of the active beachfront may be the result of coastal subsidence, and sand removal by the advance and retreat of the tsunami.

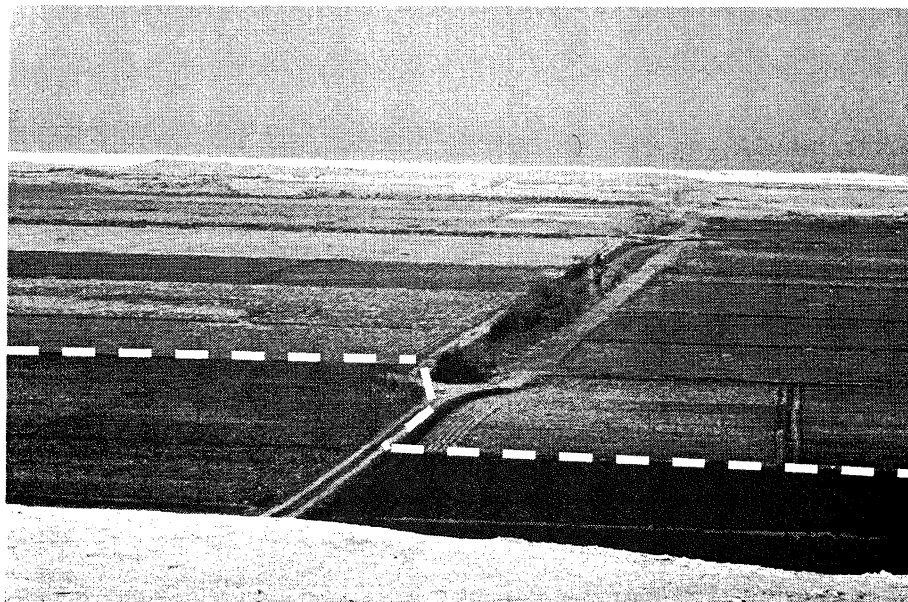
Considerable damage to farmland occurred in the Pucchun area just north of Camana (Fig. 3). Pucchun is a 2km wide irrigated coastal strip of flat land. The up-to-1km inland extent of the tsunami can be clearly seen as a colour contrast in Figure 19. The light gray fields are covered in sand (10 to 200 mm thick; Fig. 19) from the tsunami inundation, whereas the darker fields escaped tsunami inundation. Localised earthquake shaking-related ground damage was also seen at a pumping station in the middle of the farmland (the vegetated drainage channel can be seen to the right of centre of Fig. 19). A high gravel bar was breached in several places along the coast, and coarse gravels were deposited in a large tongue inland from the breach (Fig. 20). Witnesses described the tsunami as a large black wave ("una ola negra") overtopping and breaching the bar. The witnesses were lucky to escape the tsunami alive on foot, whereas many others perished. Bodies were still being recovered from the farmlands at the time of our visit.

*Figure 19. The Pucchun croplands showing the up-to-1km inland extent of tsunami inundation. The light gray farmlands in the photograph are covered with tsunami sand and lack vegetation, whereas the dark (crop-covered) fields escaped inundation. This boundary is marked by a dashed line.*

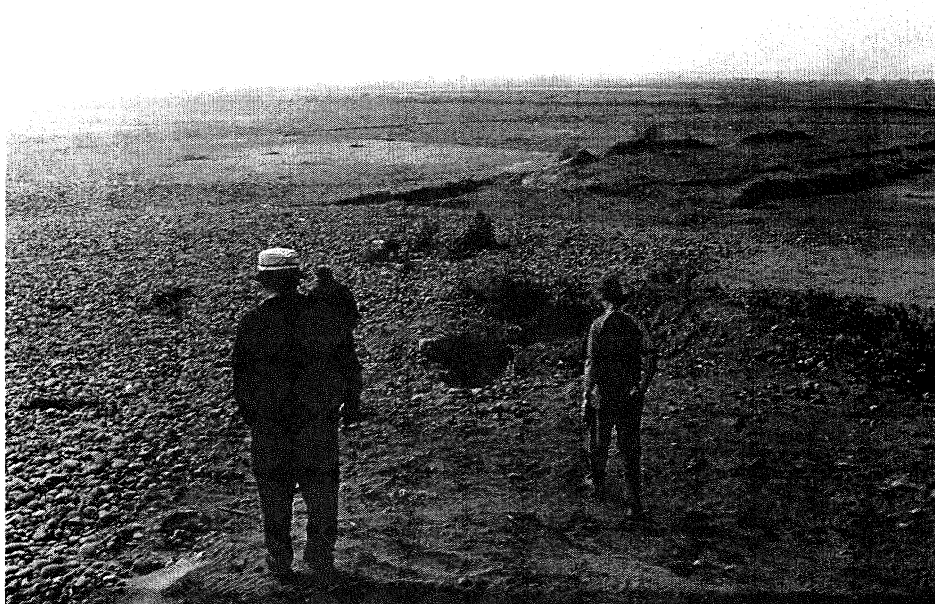
*Figure 20. Cobble gravel deposit formed by breaching of the natural beachfront bar during the tsunami inundation. Note also the extensive deposits of sand in the background.*

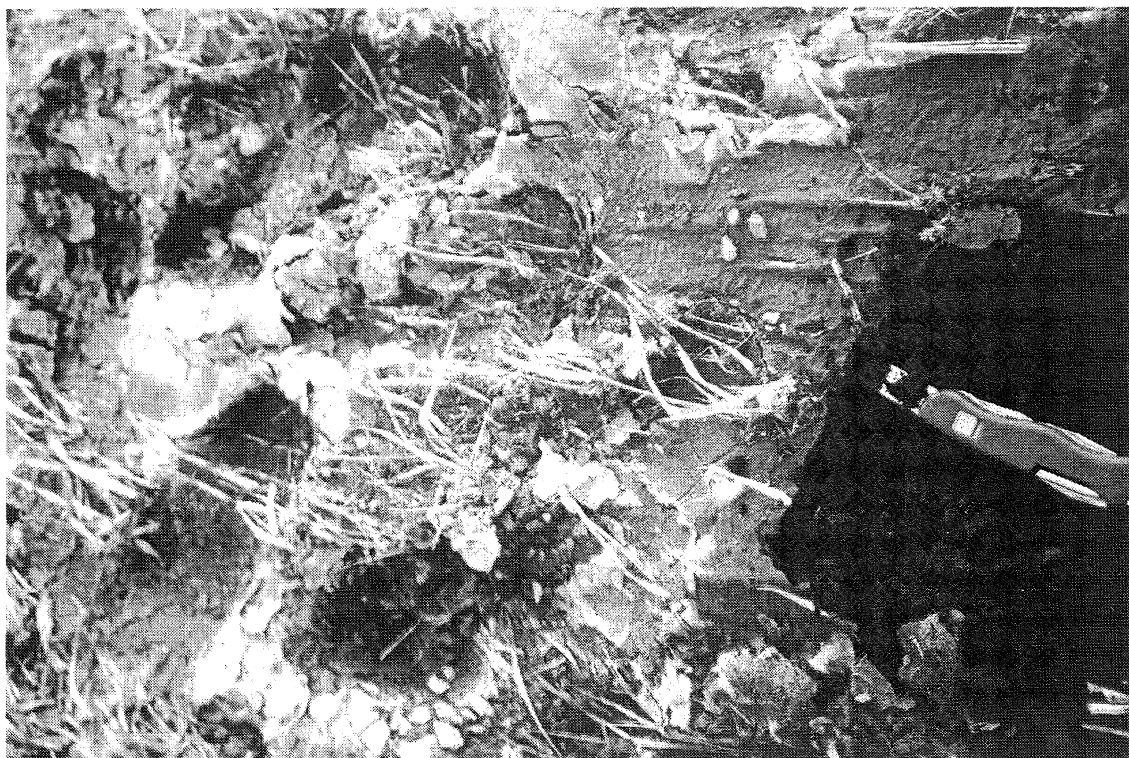
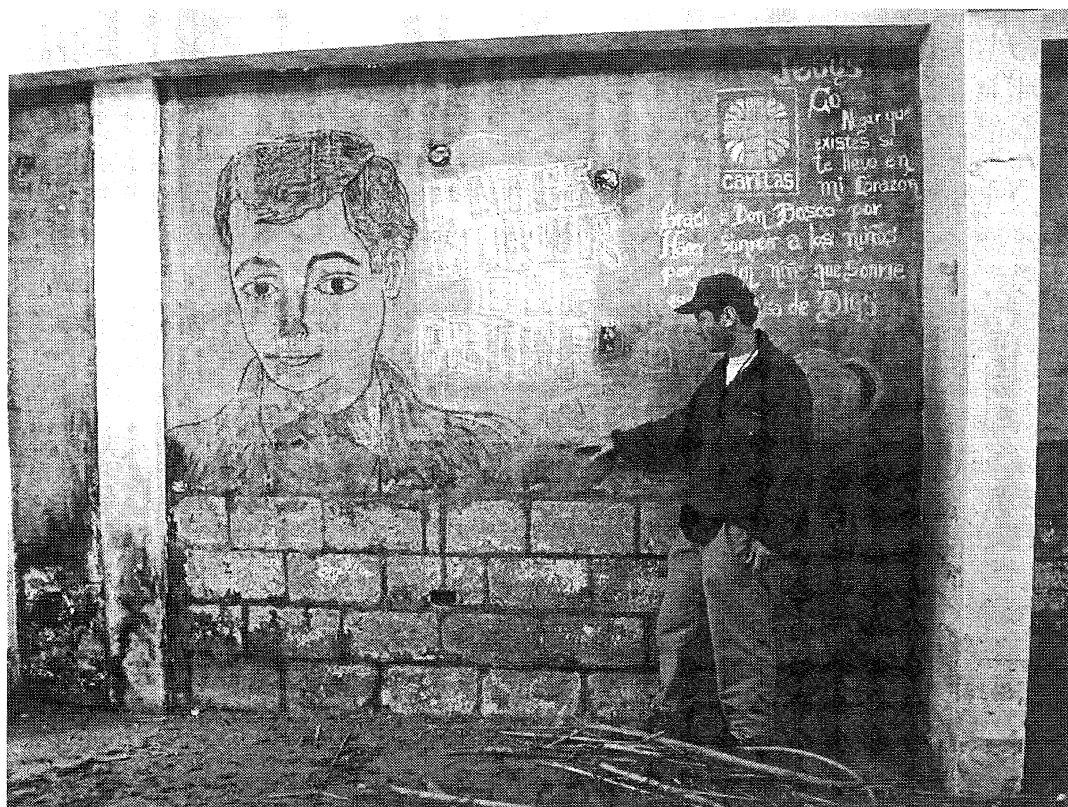
the soil occurred over the zone of inundation, and a layer of sand was deposited over the rich topsoil (Figs. 21 and 22). Sand was also laid down inside many buildings in the area, with the added problem of being highly erosive before deposition. In a church in Las Cuevas the sand-laden waters eroded the cement-veneered walls of the church enough to expose the underlying bricks (Fig. 21b).

**Figure 21. Tsunami deposits.** In (a), vegetation has flattened in the direction of wave motion (i.e. left to right) and buried by about 2cm of sand (see pocket-knife excavation to the right of the photograph) and the light colour on the surface of the deposit is a salt crust left behind after evaporation of the seawater. Tsunami deposits were left inside many buildings in the Las Cuevas-Camana area. The sand-laden water was also highly erosive. In this church building in Las Cuevas (b) the sand-laden waters eroded the cement-veneered walls of the church enough to expose the underlying bricks.

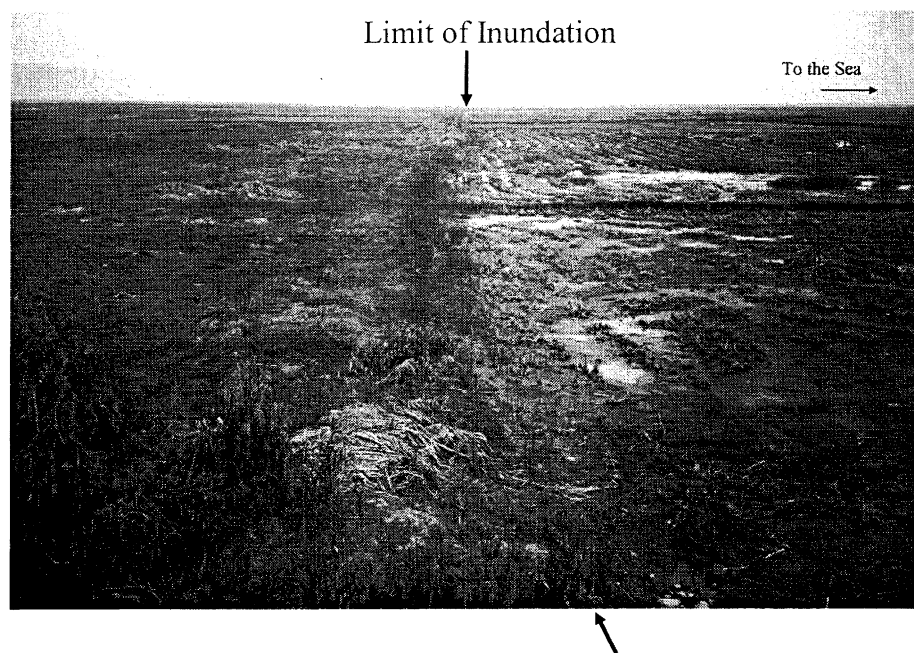
**Figure 22.** Distal edge of the tsunami inundation at Puccun, about 1km inland. The inundation zone experienced crop loss, sand and gravel deposition, ponded seawater and salinisation.
