REINFORCED CONCRETE BUILDING PERFORMANCE IN THE M_w 7.8 1931 HAWKE'S BAY, NEW ZEALAND, EARTHQUAKE

G. van de Vorstenbosch¹, A.W. Charleson² and D.J. Dowrick³

SUMMARY

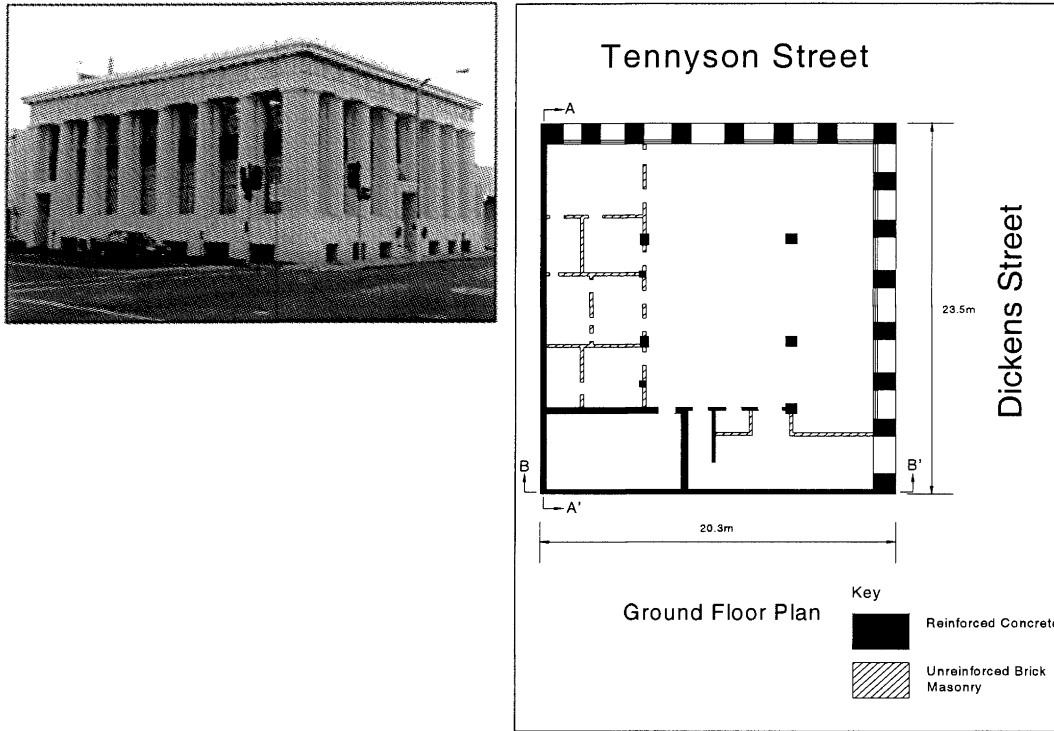
(Figure 1) are classed as corner buildings. The Napier Public Trust Office was much the most heavily damaged building in the data set, despite its two street frontages appearing outwardly to be undamaged.

The damage ratio for the worst damaged building, the Napier Public Trust Office, is based on actual costs and value, while the remaining damage ratios were assessed on the basis of building damage reports.

Figure 1. Public Trust Office, Napier, with perimeter walls on two adjacent facades, making it an asymmetric “corner” building.

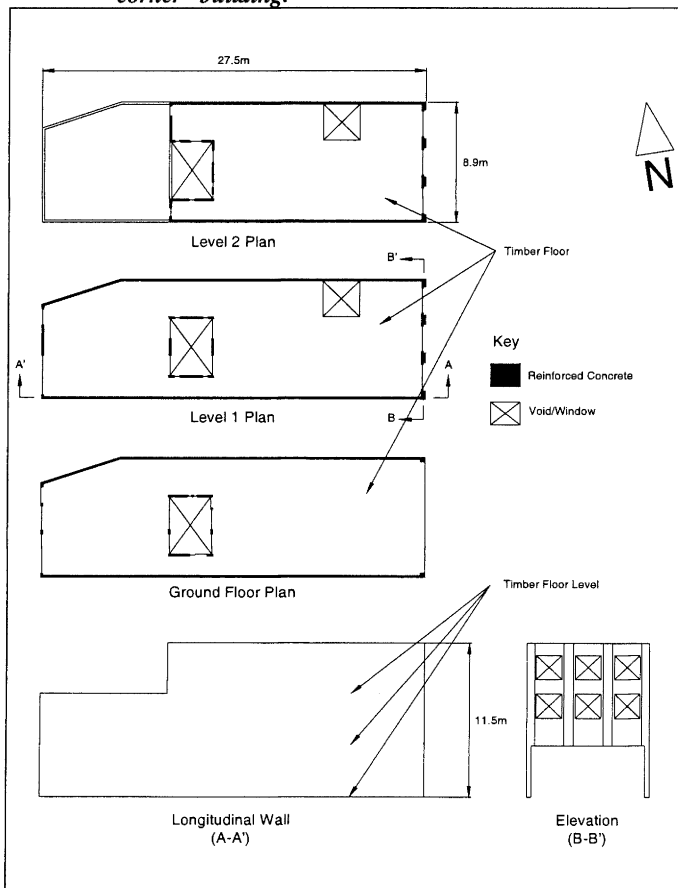
Four buildings exhibit soft-storey reinforced concrete construction. Of them, the three-storey Bennett building (Figure 2) is most notable due to its ground floor "columns" in the transverse direction consisting of concrete walls swaying out of plane. Poppelwell's and Villa d'Este have stiffer first floor construction than the ground floor (in one direction), but the upper floor vertical structure is entirely of unreinforced masonry.

Figure 2. Plans and elevation of the Bennett Building, Napier, showing soft-storey construction.

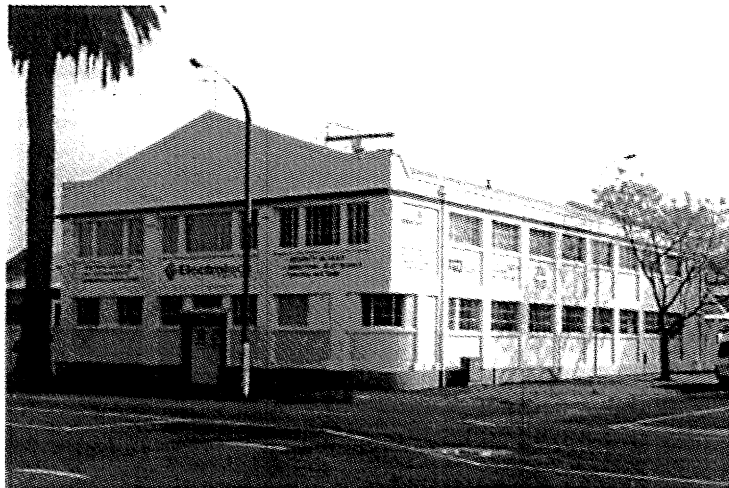
Building Name: Gilberd & Co
Address: 47 Kennedy Rd, Napier
Date of construction: 1927

Recorded notes on damage: No visible damage (Dowrick notes, 1998).

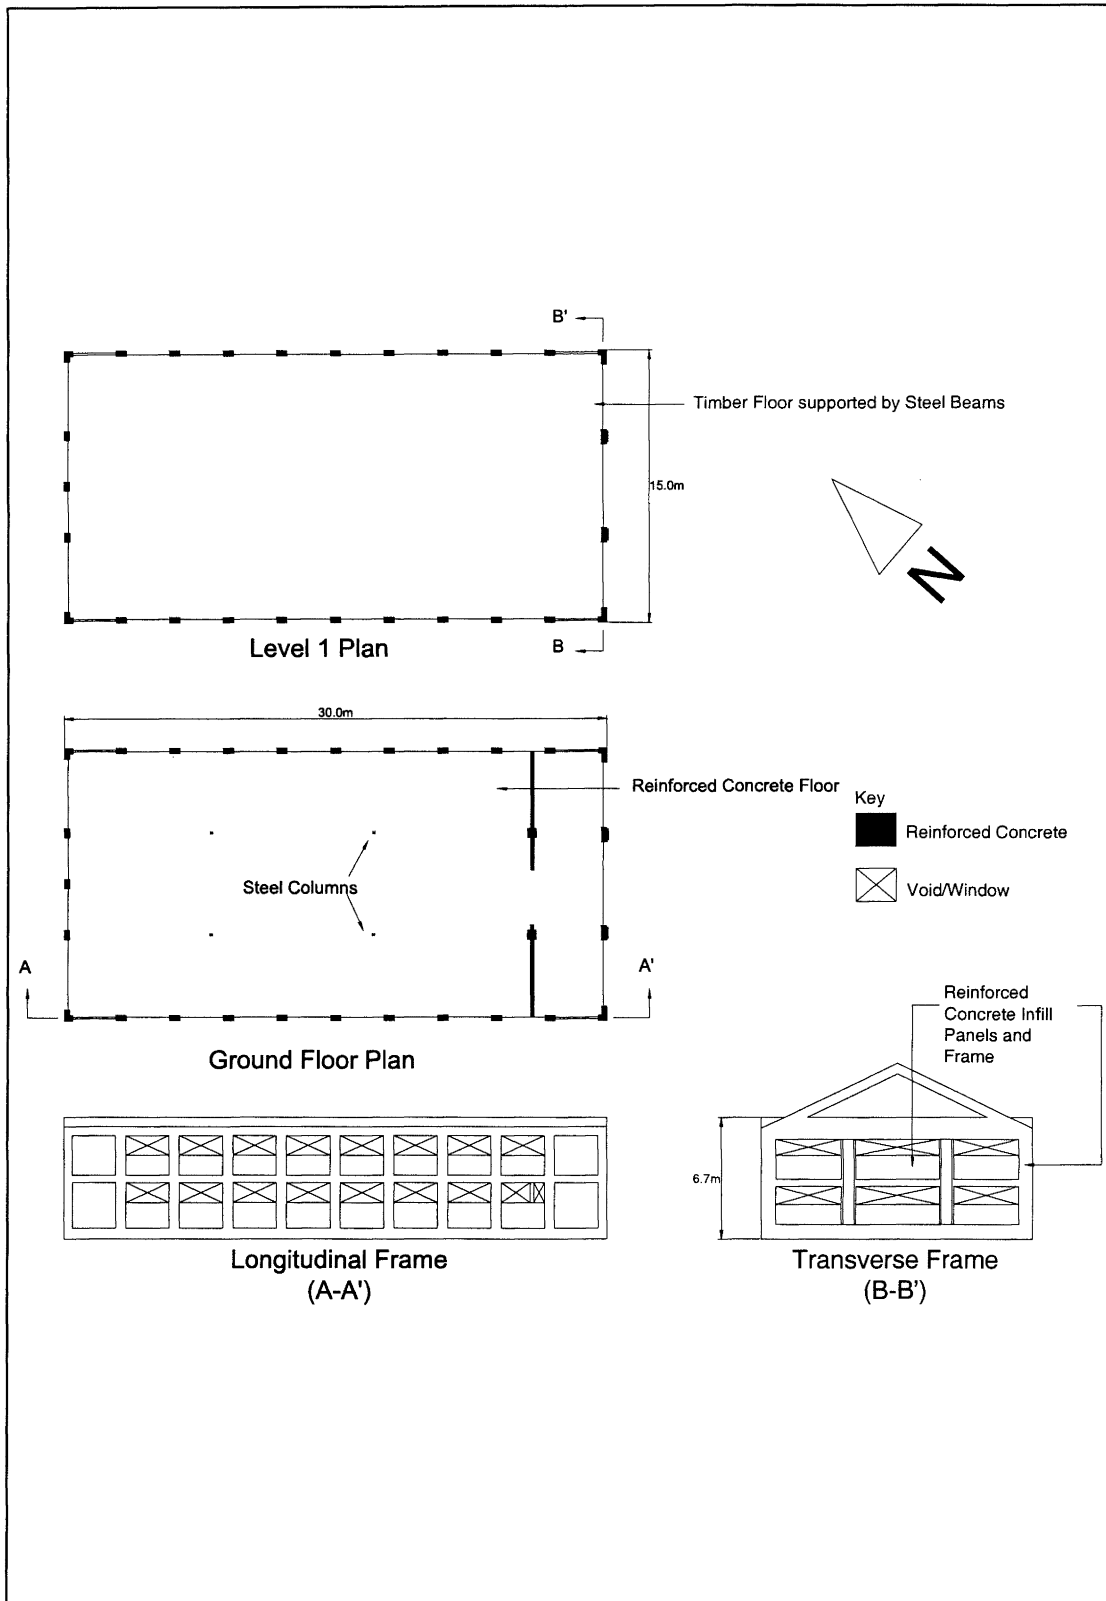
Gilberd & Co.

Level 1 may have suffered some shear cracking though again there is no recorded evidence to support this.
