THE 1942 WAIRARAPA, NEW ZEALAND, EARTHQUAKES: ANALYSIS OF OBSERVATIONAL AND INSTRUMENTAL DATA

G.L. Downes¹, D.J. Dowrick¹, R.J. Van Dissen¹, J.J. Taber²,
G.T. Hancox¹ and E.G.C. Smith²

ABSTRACT

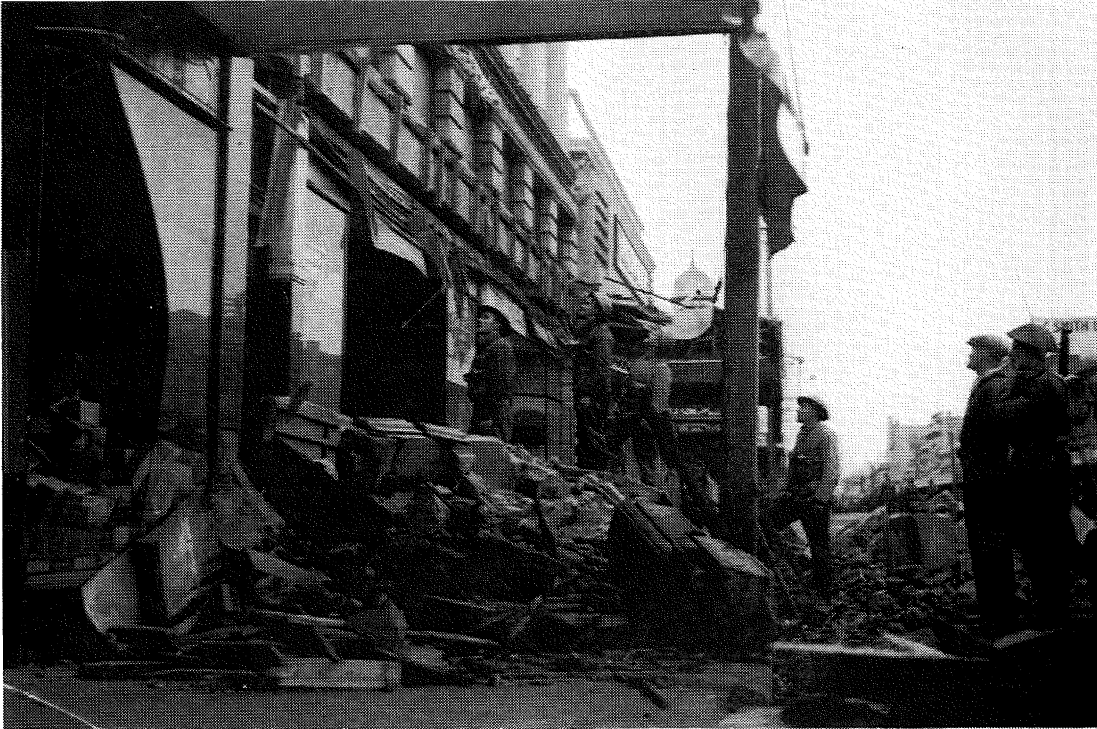
- 24 brick buildings were seriously damaged, and required partial or complete demolition (for example, Figure 6)
- 43 brick buildings were cracked only, or parapets and gable ends collapsed, and capable of reconstruction to earthquake standards
- 18 brick buildings suffered only minor damage.

Figure 6: A view of Queen Street, Masterton on June 25 1942. The debris is from the second storey of Gray's brick building housing Hannah & Co., and Bullick & Blackmore. The undamaged parapet of Woolworth's single storey 1937 reinforced concrete building may be seen just beyond Gray's. (Reference No. G-123912-1/2, "Evening Post" Collection, Alexander Turnbull Library, Wellington, New Zealand).

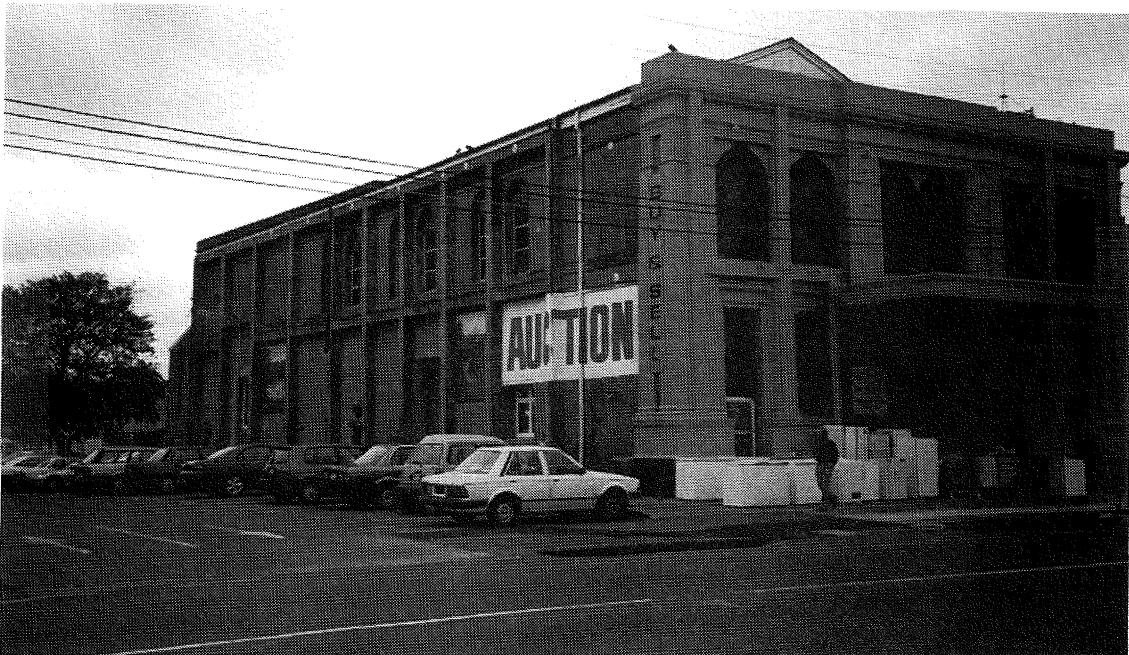
Figure 7: Present day view of the former Opera House, Masterton, showing reinforced concrete beams and columns attached to brickwalls in retrofitting mostly after 1934. (Photograph by D.J. Dowrick, 1998).

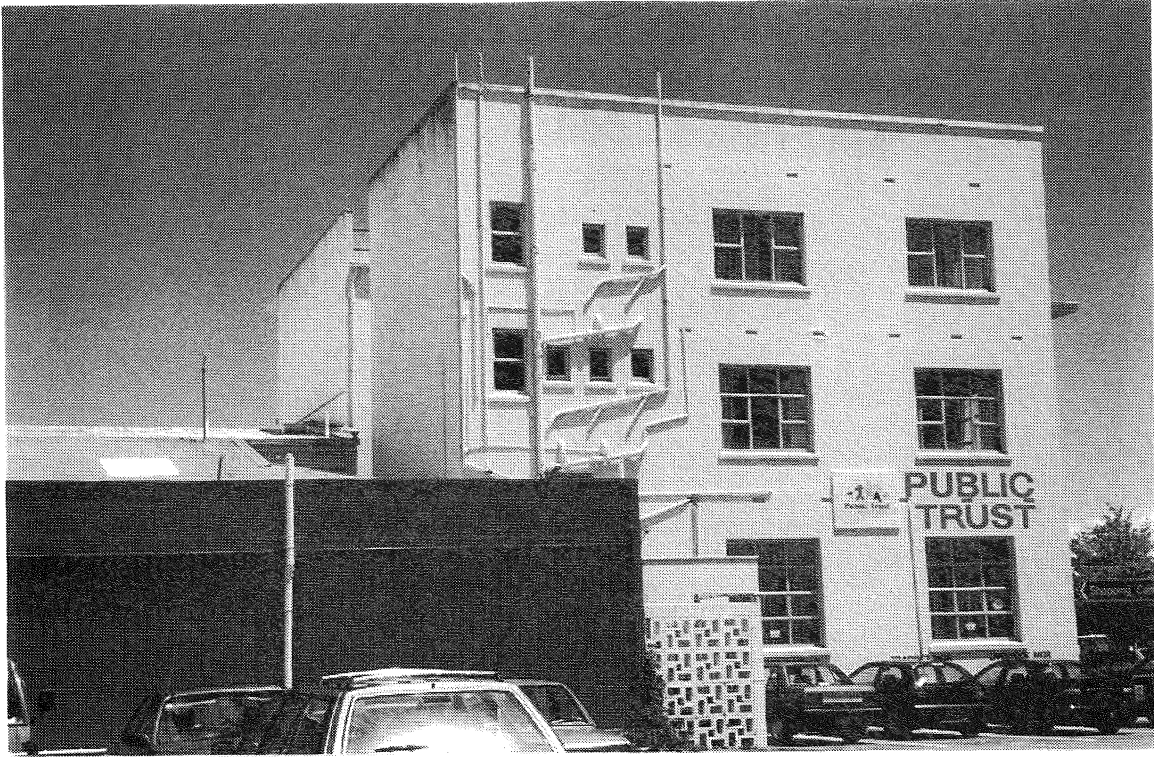
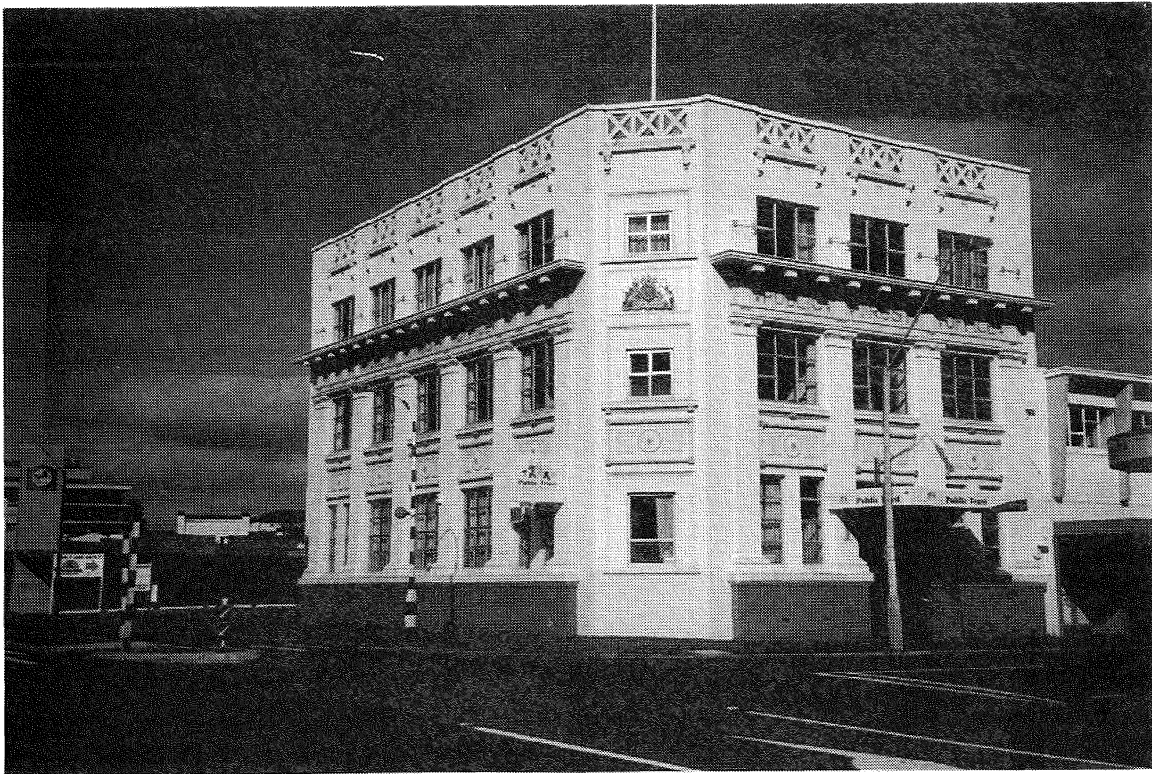
Of the 64 or so original reinforced concrete buildings in Masterton, some had brick infill, and only two (State Theatre and Woolworth’s shop) had been designed to resist earthquakes. Eight other buildings that had originally been of purely brick construction had been substantially retrofitted after the 1934 M_s7.6 Pahiatua earthquake [24], for example, the Masterton Opera House illustrated in Figure 7. Most concrete buildings were undamaged. Three suffered moderate cracking, and a further ten or so were slightly cracked. Ironically, Woolworth’s shop was badly damaged when its roof was destroyed by falling brickwork from a brick building next door. One of the three-storey and one of the two-storey buildings are shown in Figures 8 and 9 respectively.

Figure 8: Present day views of 3-storey 1922 wholly reinforced concrete Public Trust building in Masterton, which “suffered no structural damage whatsoever” during the 1942 earthquakes (PGA=0.3-0.6g). (Photograph by D.J. Dowrick, 1998).

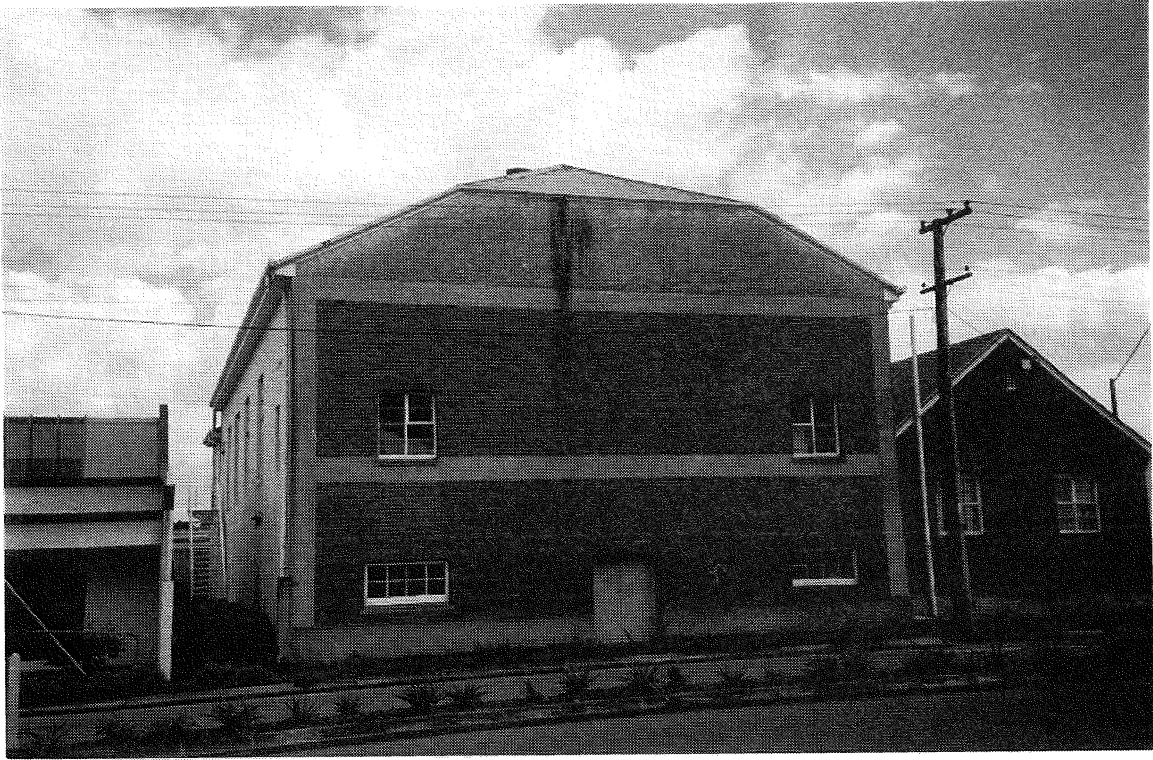
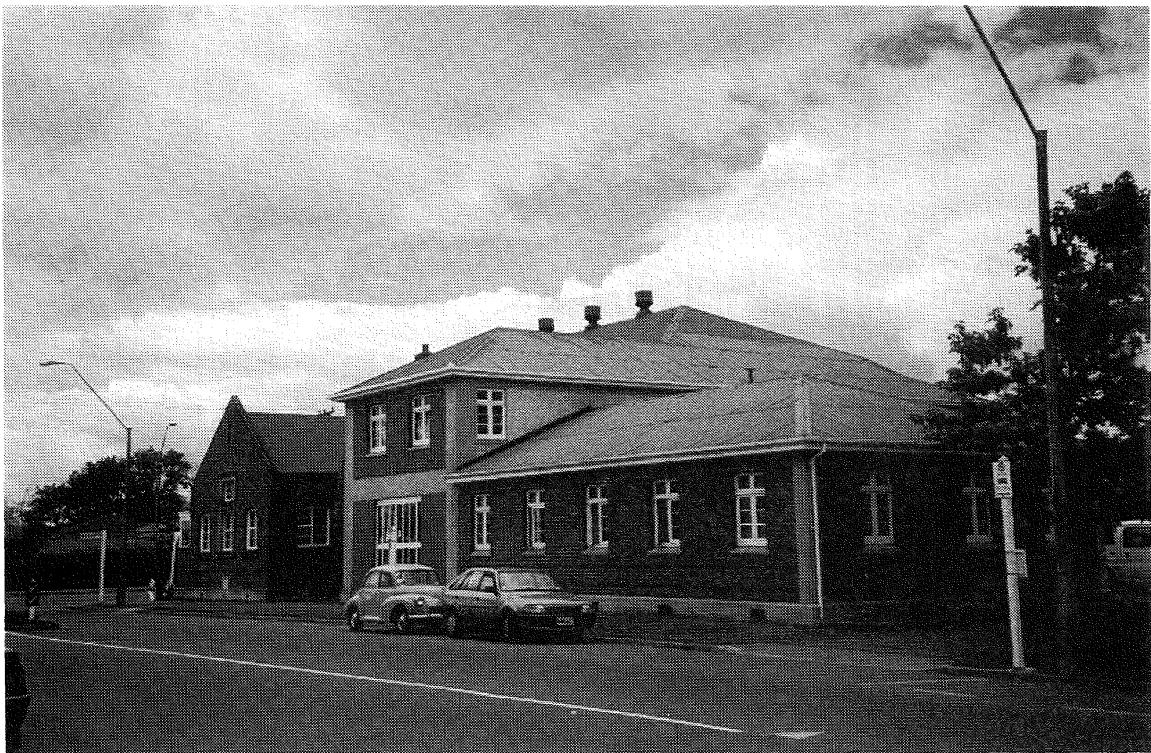
Figure 9: Present day views of 2-storey 1938 Knox Church Hall in Masterton, with a reinforced concrete frame and brick infill, which suffered little or no damage during the 1942 earthquakes. (Photograph by D.J. Dowrick, 1998).

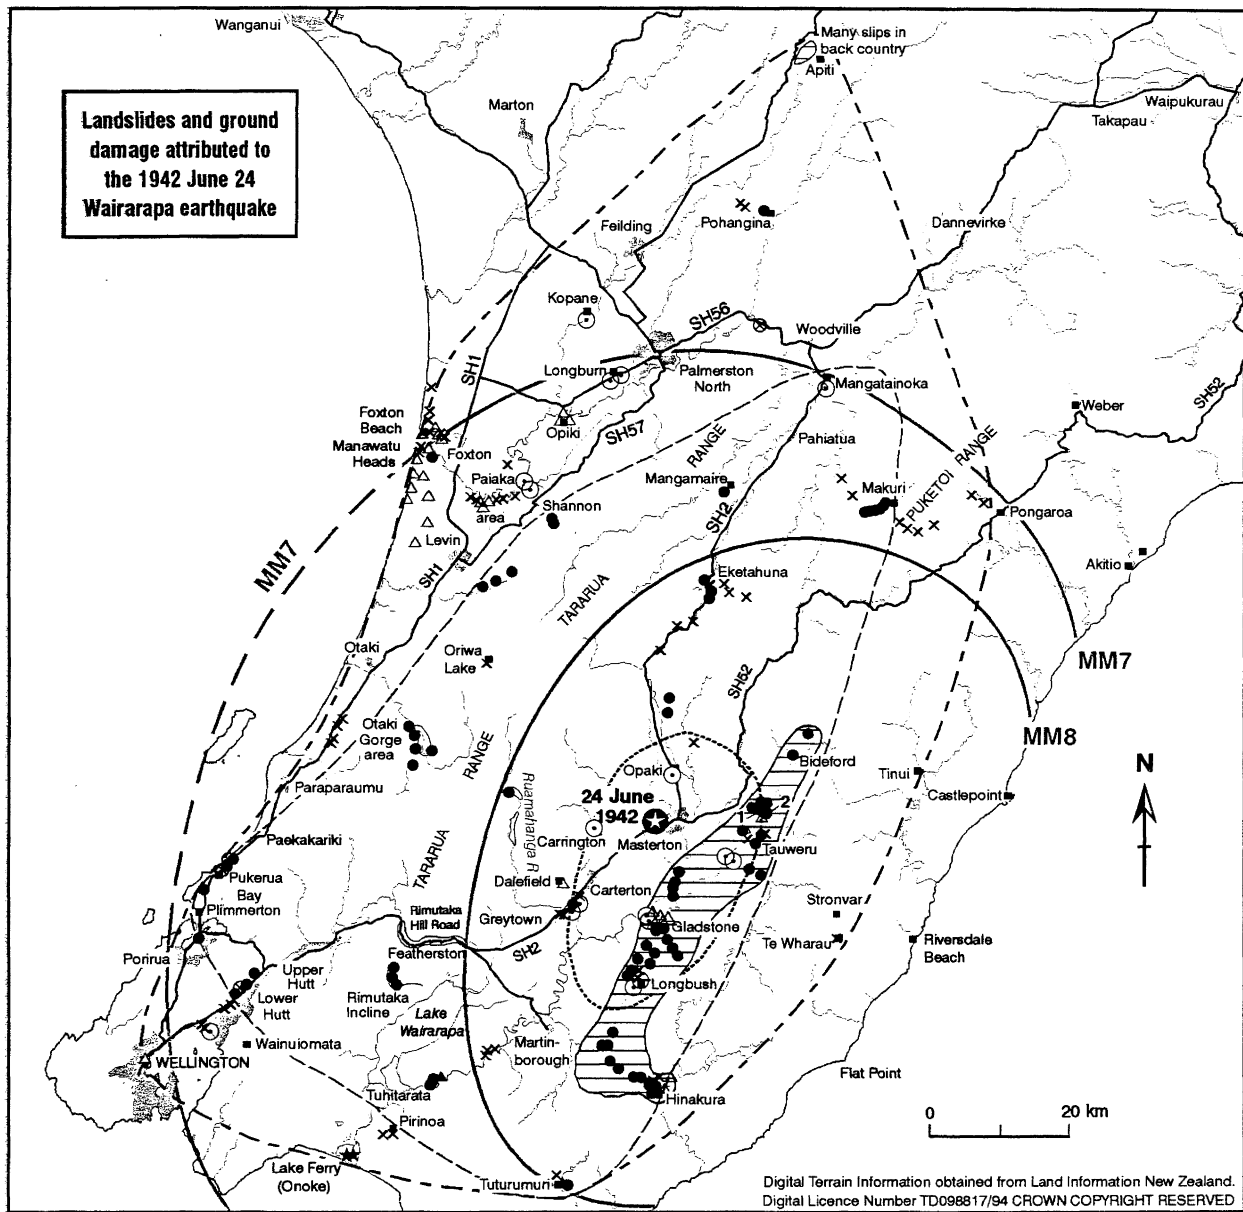
For several days after the main shock the newspapers reported many instances of damage to roads within the MM8 isoseismal (Figures 3, 10). This damage took the form of subsidence of fills, cracking and blockage or undermining by landslides. Landsliding was widespread in the steep hillcountry that dominates much of the MM8 zone (see following section). The larger landslides were documented by Ongley [6], but many more small slides occurred that were sufficient to block some country roads for many days. Subsidences of about a metre occurred on approach fills to two bridges, one on the Tauweru River (Masterton-Stronvar Road) and one on the Ruamahanga River near Kahutara. Just north of Greytown on the main road to Masterton, the approach to the bridge over the Waiohine River subsided about half a metre forcing a temporary road closure. On a side road nearby, the timber structure of the Matarawa bridge was reported to have developed waves, suggesting differential settlement of its piers. About 15 km east of Greytown ground damage was reported to be heavy with cracks in roads.

Figure 10: Geographic distribution of landslides and ground damage attributed to the June 24 1942 Wairarapa earthquake. Isoseismal lines are from Figure 3.

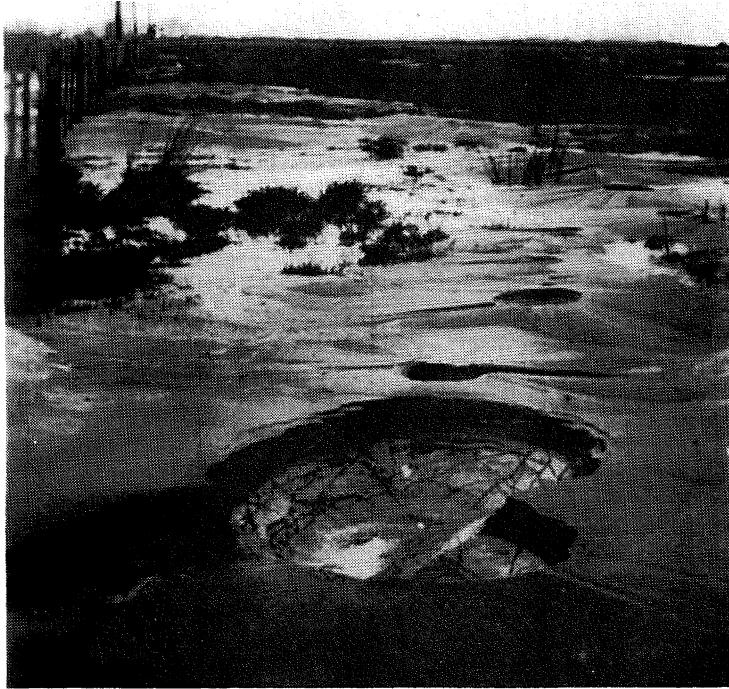
Figure 11: Sand boils at Paiaka, near the Manawatu River, caused by the 1942 June 24 Wairarapa earthquake. Note patches in the background that also appear to be affected.

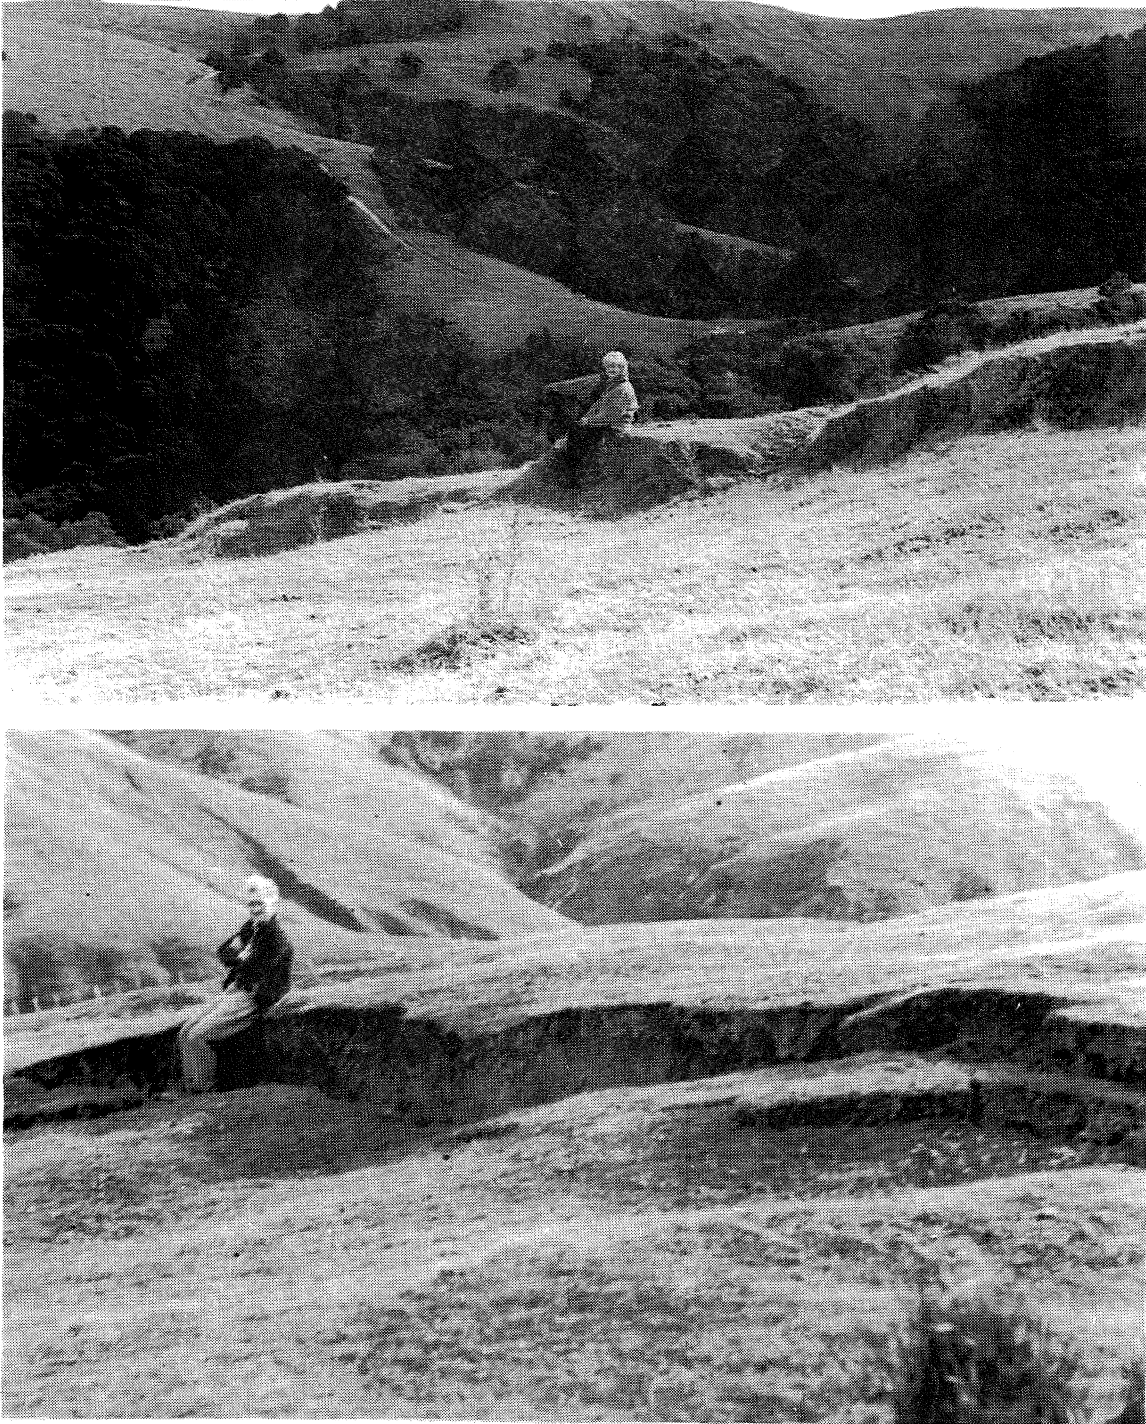
doubt triggered by the strong ground shaking generated from the 1942 earthquake. Ongley [6] describes the maximum vertical displacement across the freshly formed scarp as approximately 3 feet, and notes that the freshly formed scarp comprises only a part of a larger scarp of about 10 feet. Ongley proposed that the larger scarp height was the result of additional, older, fault

movements. The authors agree with Ongley that the larger scarp height documents repeated, older, movement, but the authors ascribe the movement not to tectonic fault rupture, but rather to landslide failure.

Figure 12: Photographs of the scarp near Tauweru (Landslide 1 in Figure 10) that Ongley attributed to surface fault rupture, now recognised as the western side of the head scarp of a large landslide. The upper photograph was taken in June 1999 at approximately the same location as Ongley's [6] Figure 4 shown below.

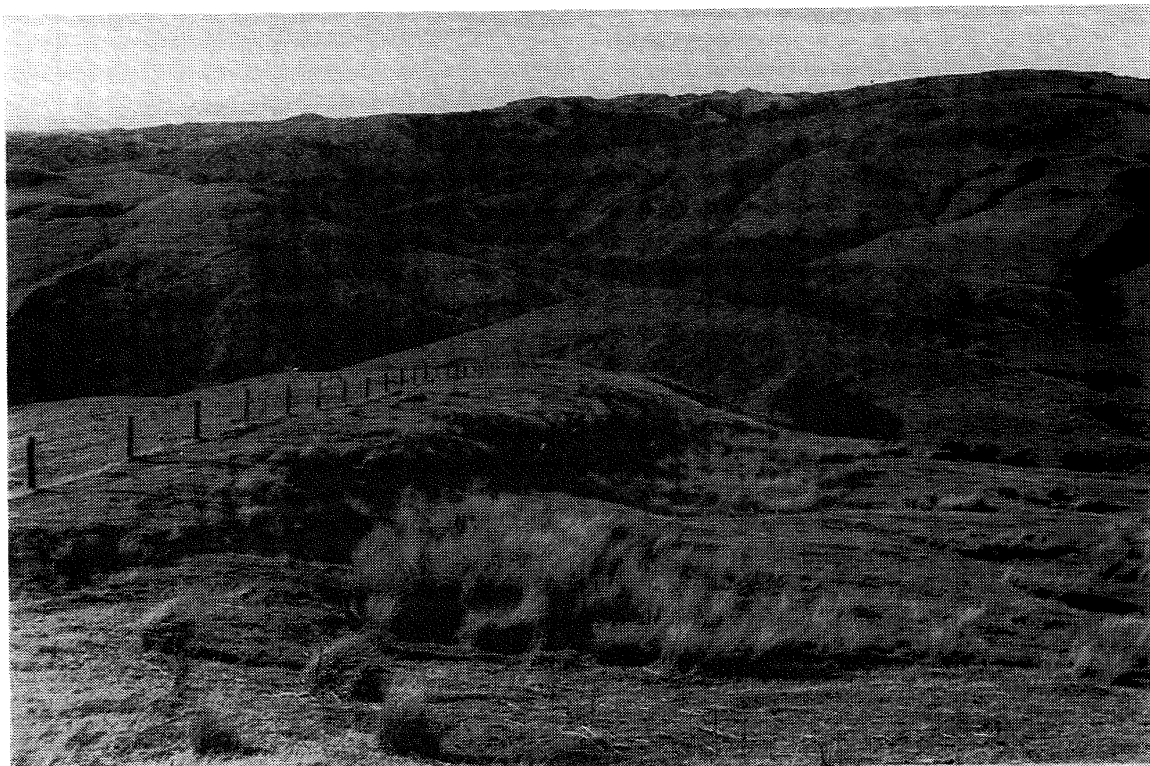
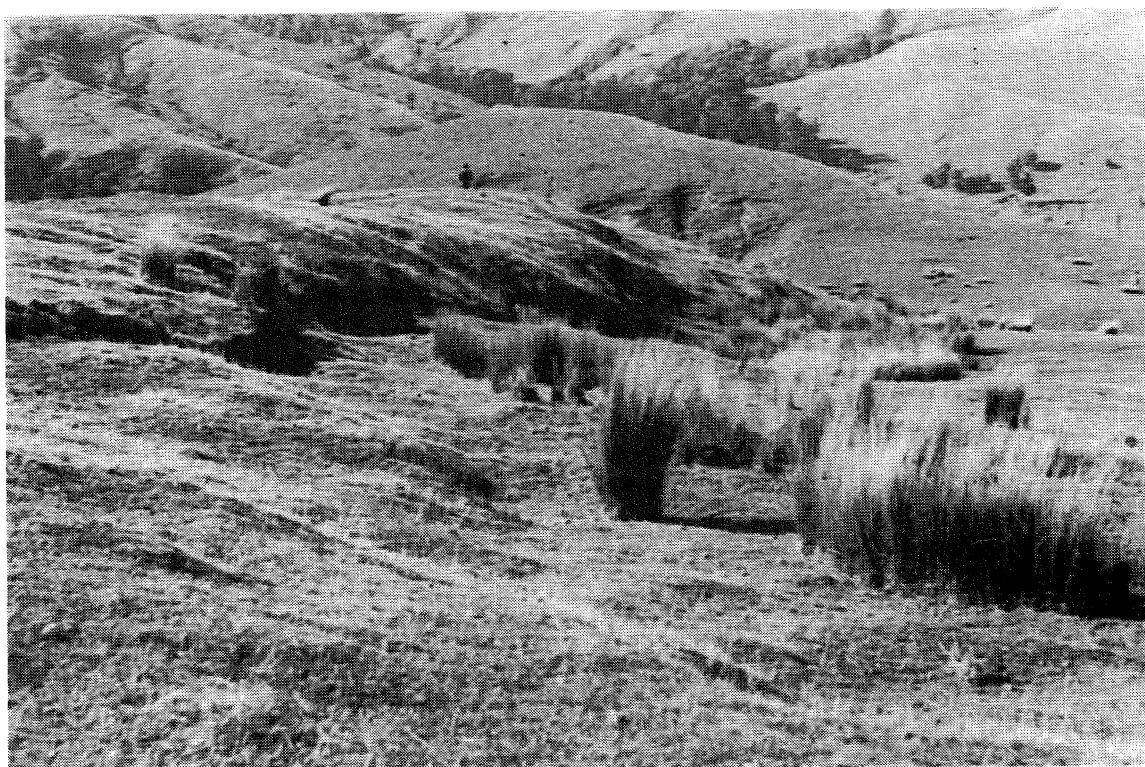
Figure 13. Photographs of the scarp near Tauweru that Ongley attributed to surface fault rupture, now recognised as the eastern side of the head scarp of a large landslide. The upper photograph was taken in June 1999 at approximately the same location as Ongley's [6] Figure 6 shown below.

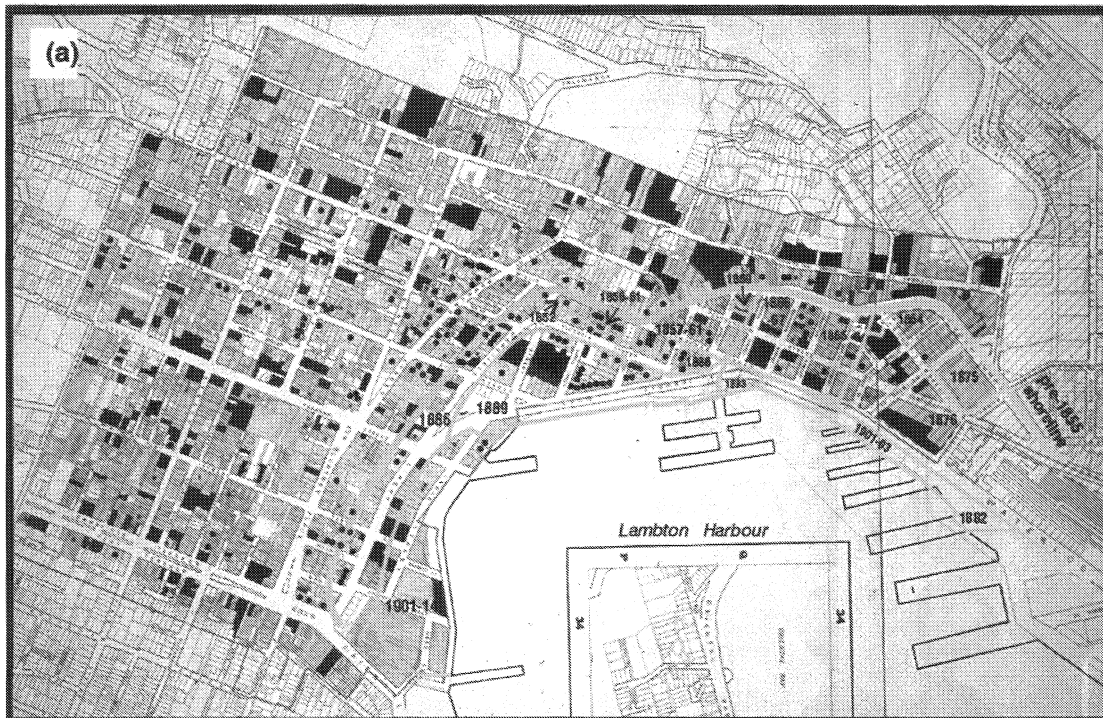
Figure 15. (a) Map (of unknown origin) of damage to commercial structures in the Wellington CBD. Black circles show damaged structures. Structures are separated into three categories: pre-1914 (red), 1914-1934 (blue), and post 1934 (black). Non-commercial structures are shown on map but are not classified as to damage
