# MARMARA SEA EARTHQUAKE RECONNAISSANCE REPORT

## Report of the NZSEE Reconnaissance Team on the 17 August 1999 Marmara Sea, Turkey Earthquake

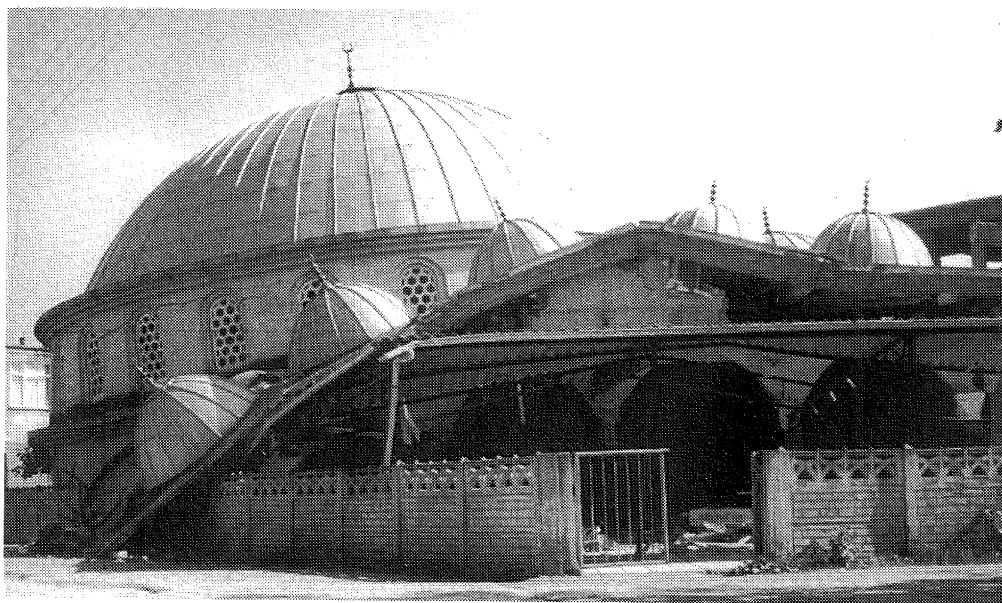
*Figure 1: Collapsed Mosque near Golcuk.*

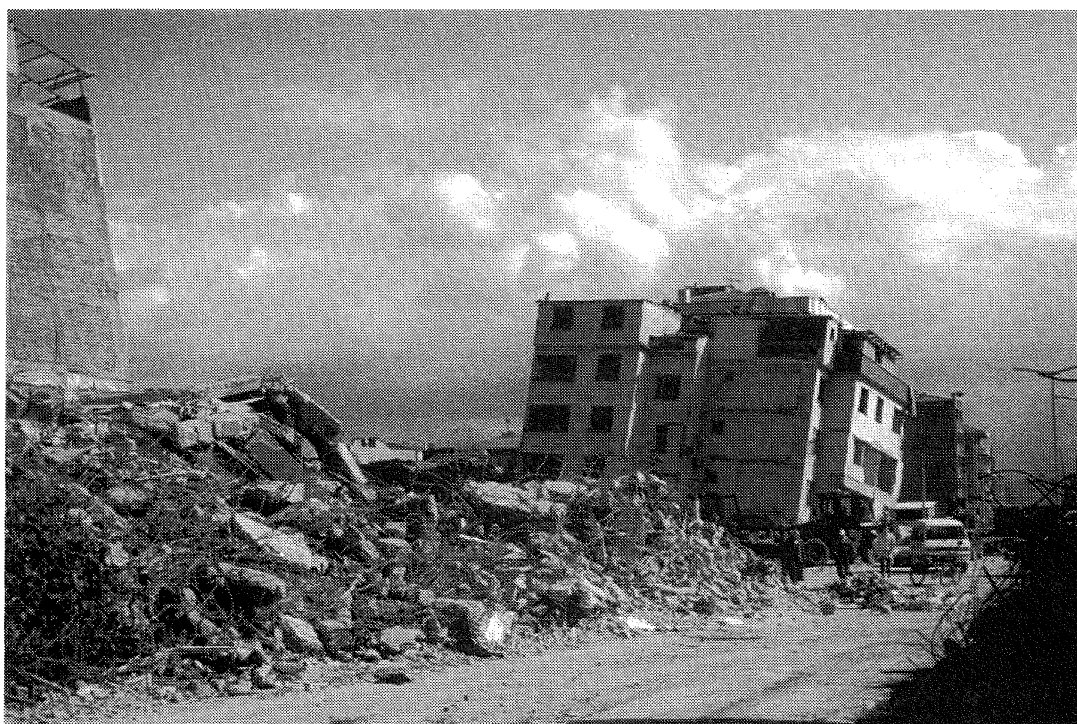
Figure 3: Typical street scene showing devastation of Adapazari.

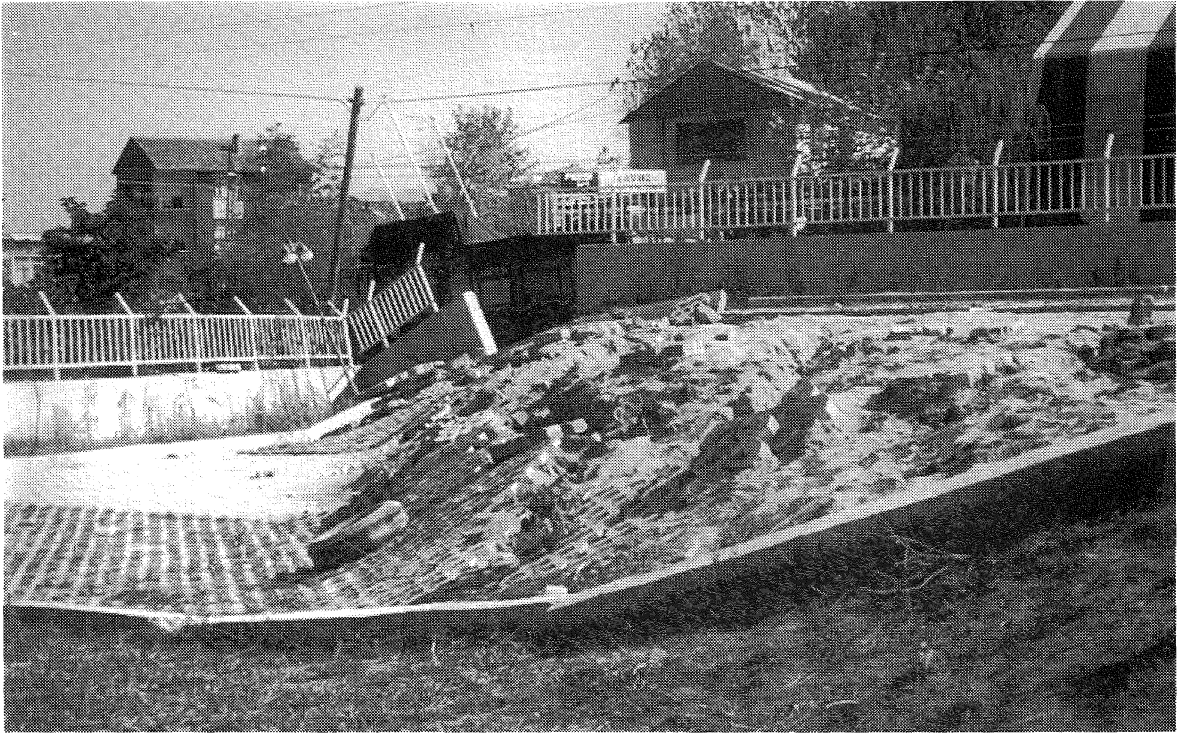
*Figure 6: In the Golcuk area, a right-step, or releasing bend, in the fault trace resulted in tectonic subsidence, instead of lateral displacement, across the fault. The tectonic down-drop is expressed in this photo as a normal fault scarp (1-2 m high) in cobblestone pavement.*

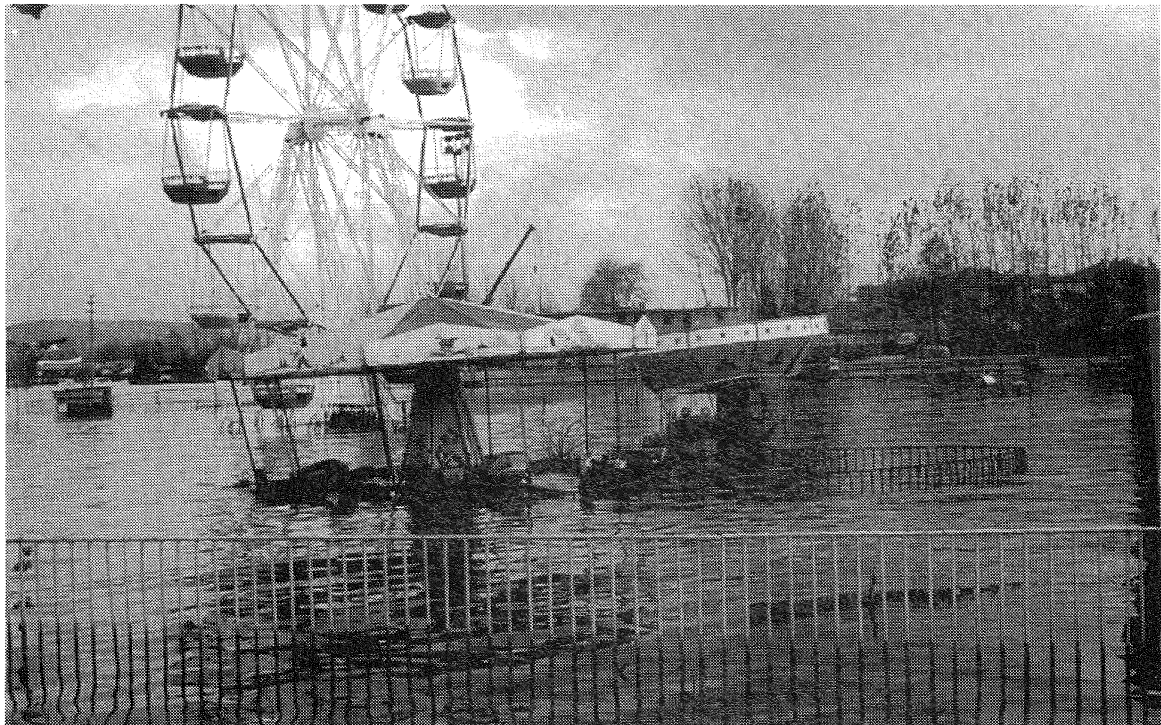
*Figure 7: Tectonic subsidence near Golcuk (up to 2 m) resulted in the permanent inundation of a 4 km length of coast line including this amusement park.*

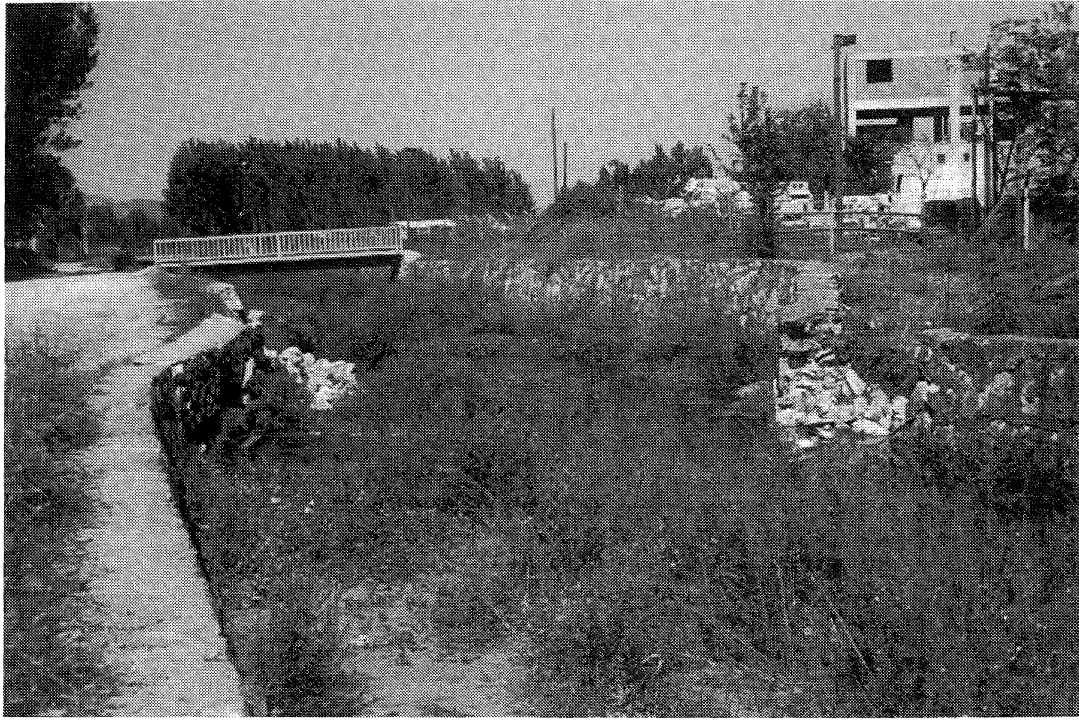
*Figure 8: Right-lateral offset (ca 1.5 m) of a canal near Izmit. This photo shows just one or two fault traces at this locality; the total lateral displacement exceeding 2.5 m.*

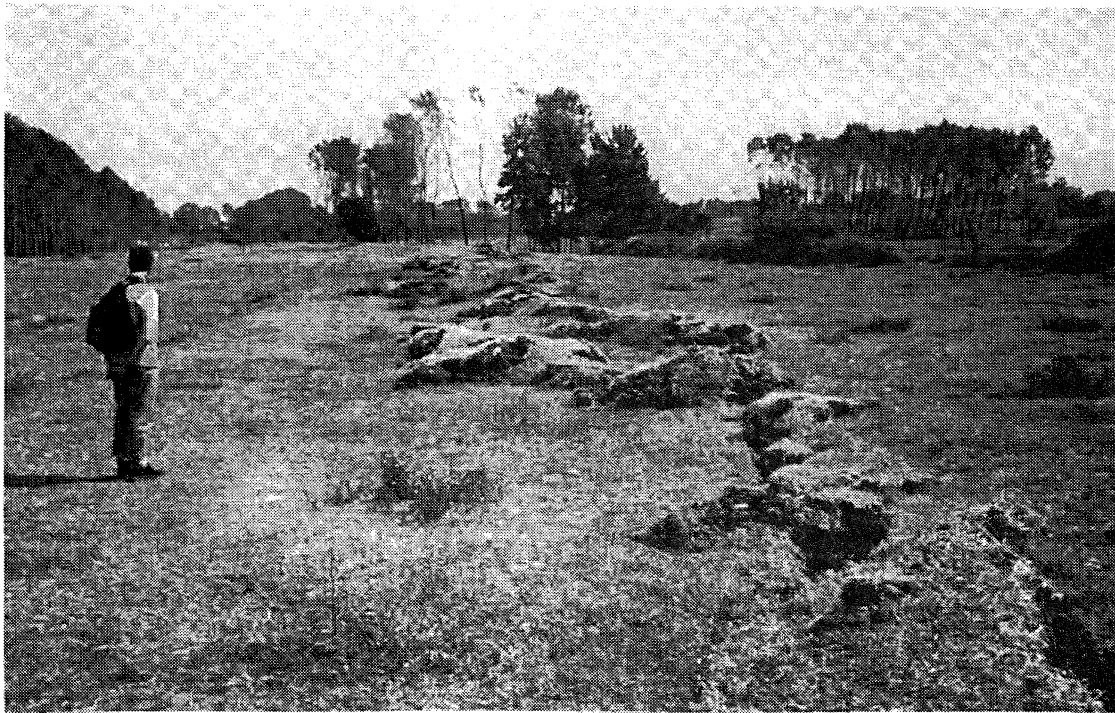
*Figure 9: Complex surface rupture pattern from the 17 August 1999 earthquake. At this location, right-lateral strike-slip displacement was in the order of several metres. Despite the small-scale complexity of the surface rupture pattern at this site, the rupture in general was well defined and usually contained within a 5-25 m wide zone of cracking.*

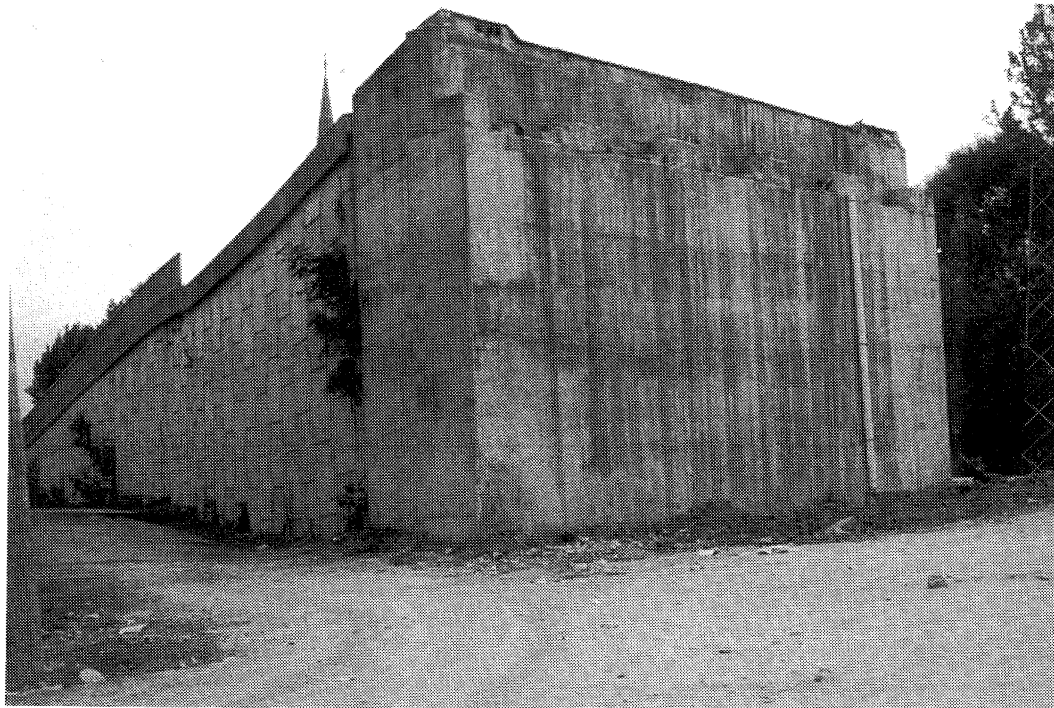
A reinforced earth approach ramp to a motorway overbridge crossing the TEM near Arifre was observed. The overbridge had been destroyed because the fault trace had offset the abutments. However, the reinforced earth retaining structure was in excellent condition apart from one section which had been wrenched by the fault trace offset, as shown in Figure 13.

**Figure 13:** Reinforced earth approach to collapsed motorway overpass near Arifre. Fault trace passes underneath structure at dip in road.

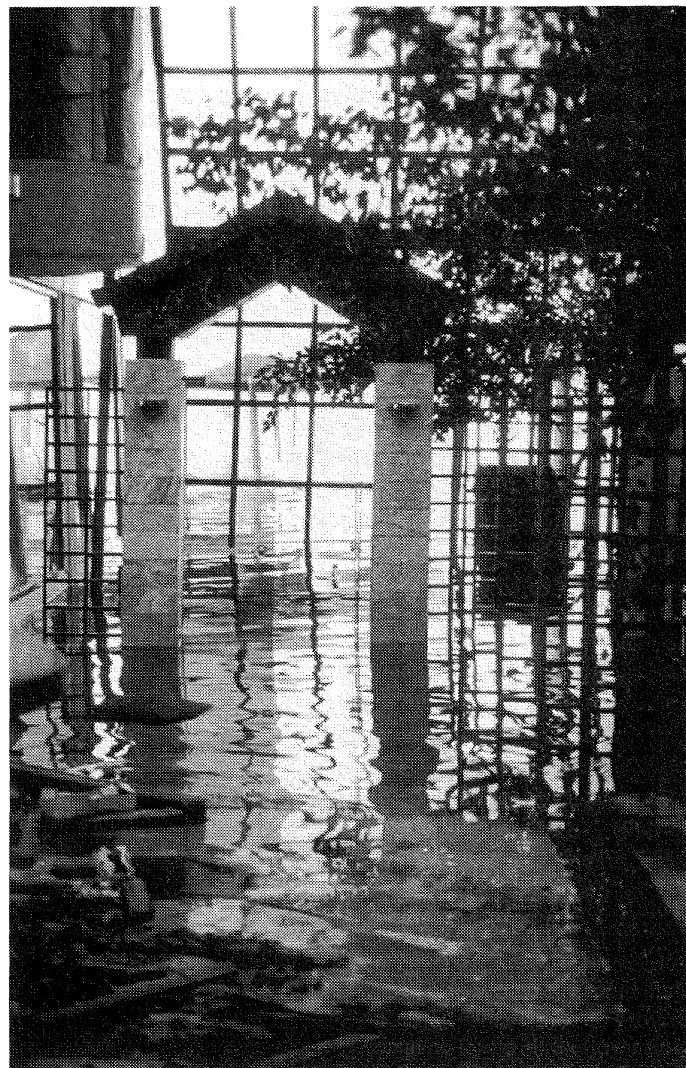
The lakefront at Sapanca has been severely affected by liquefaction and lateral spreading towards the lake. The associated subsidence has caused minor inundation of the waterfront. Unfortunately, a resort hotel recently constructed on the waterfront had subsided by at least 1 metre and probably also moved laterally towards the lake. The hotel appeared to have been founded on two separate concrete rafts which had settled differentially causing major disruption to an atrium area connecting the two halves. The hotel is a complete loss with the foyer now below lake level, as shown in Figure 14.

*Figure 14: Flooded atrium of hotel at Lake Sapanca caused by soil liquefaction and lateral spreading. The building has settled and moved out into the Lake.*

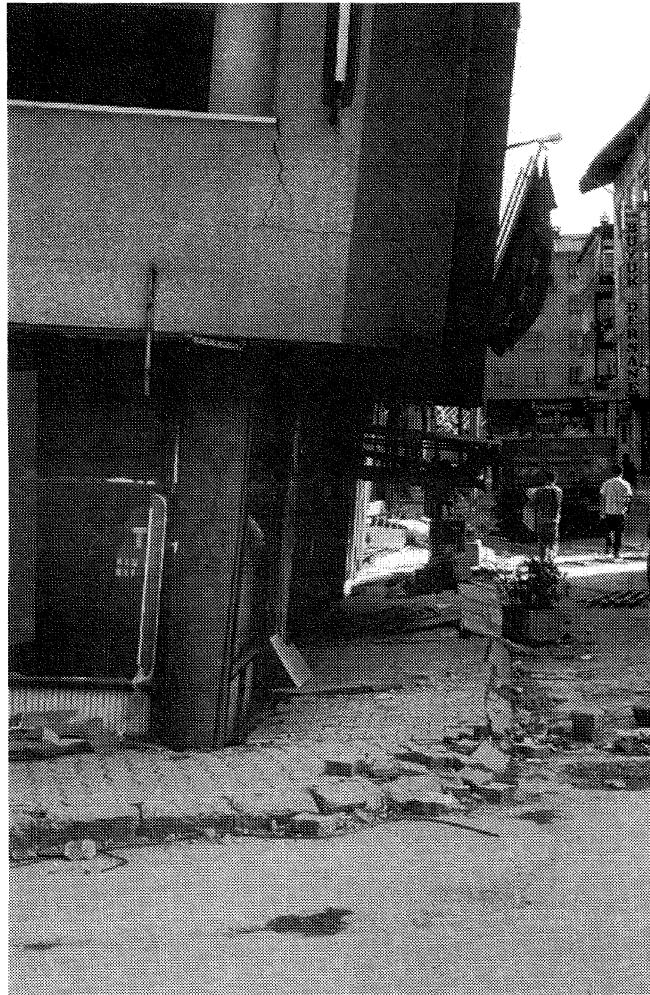
**Figure 15:** Settlement of approximately 1 metre was typical for buildings in Central Adapazzari where soil liquefaction occurred.

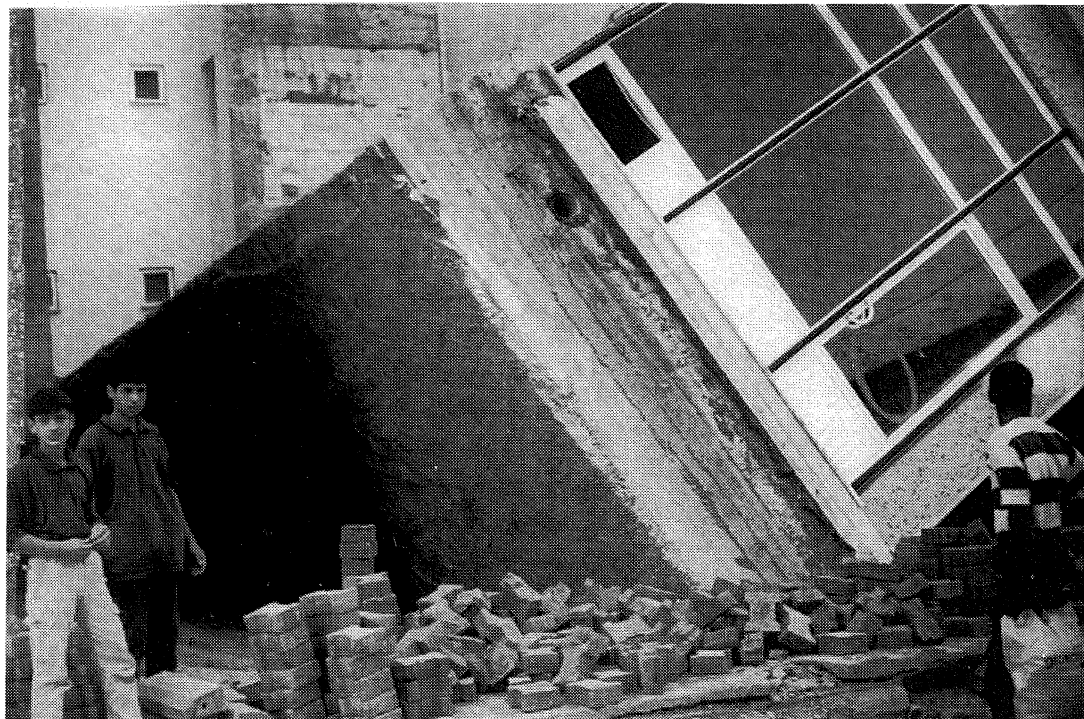
It was possible to observe the underside of two foundations where the building had completely overturned, such as Figure 16. Apparently, the sites had been excavated to approximately 1 metre depth to a brown sand/silt/clay, a small depth of gravel was placed, and the bottom slab of the foundation raft was poured directly onto the gravel. The original condition of the subgrade was impossible to determine because of subsequent dessication.

**Figure 16:** *Overturned building near Central Adapazzari exposing a typical foundation system of a 1 metre thick hollow raft. One corner has sunk because of soil liquefaction. Note the lack of structural damage.*

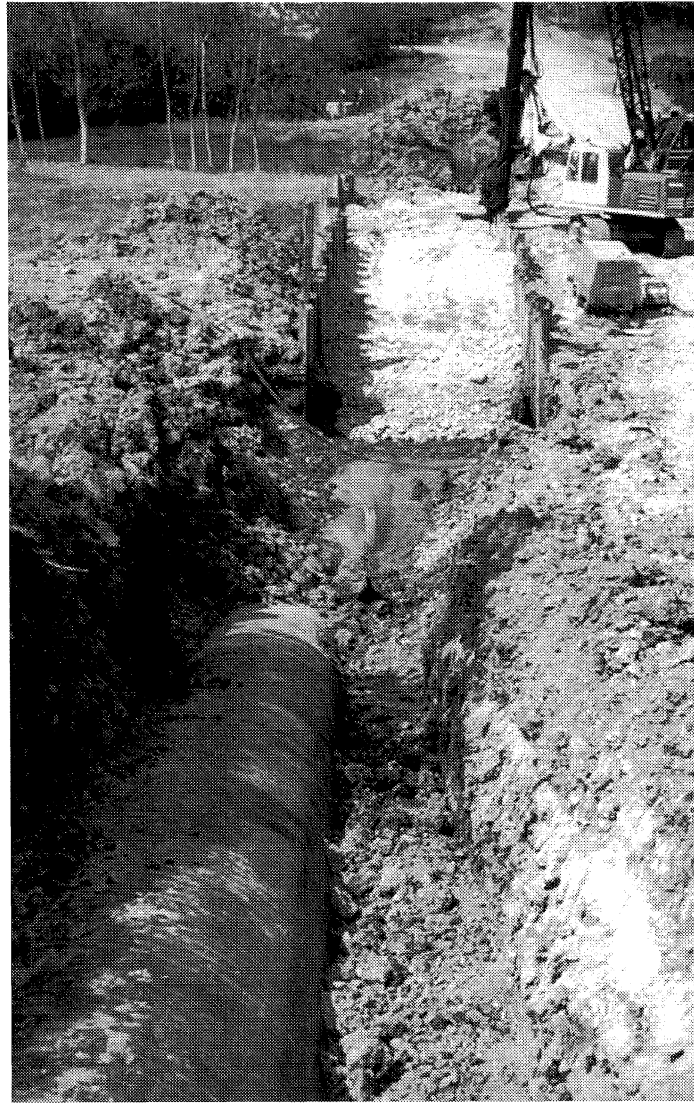
**Figure 17:** *Main water pipeline supplying Izmit after repair. Note the right lateral offset where the pipe crosses the fault trace.*

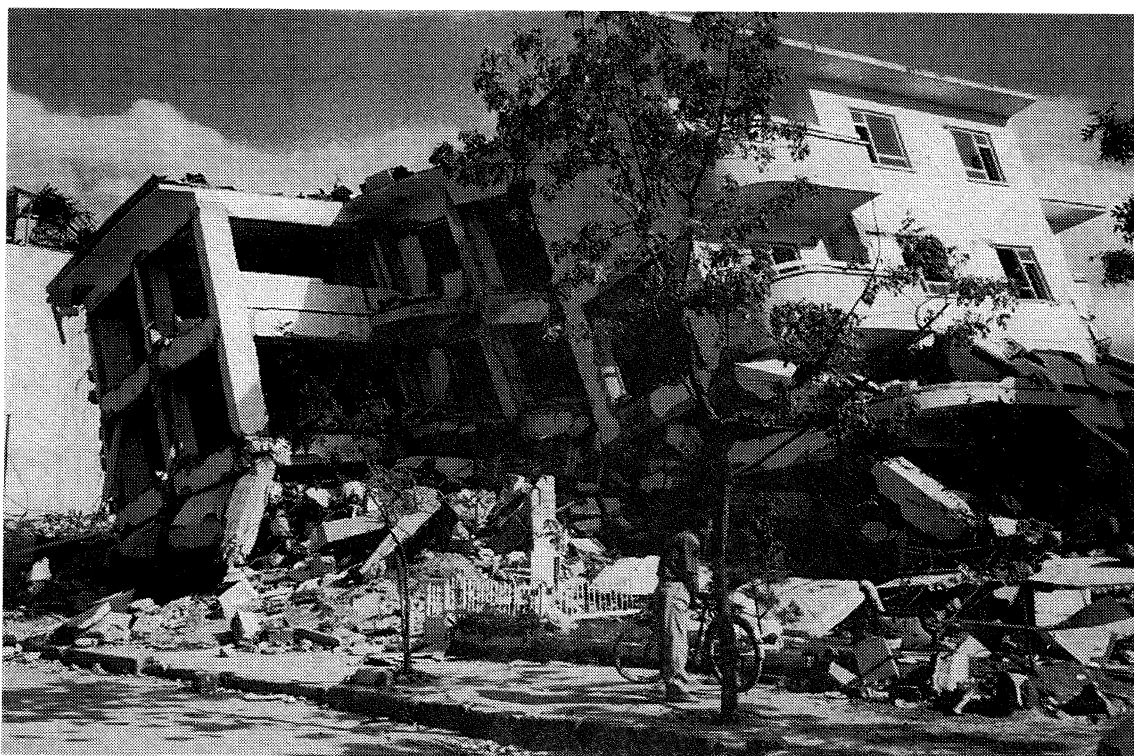
*Figure 18: Typical collapsed masonry infill, reinforced concrete frame apartment block.*

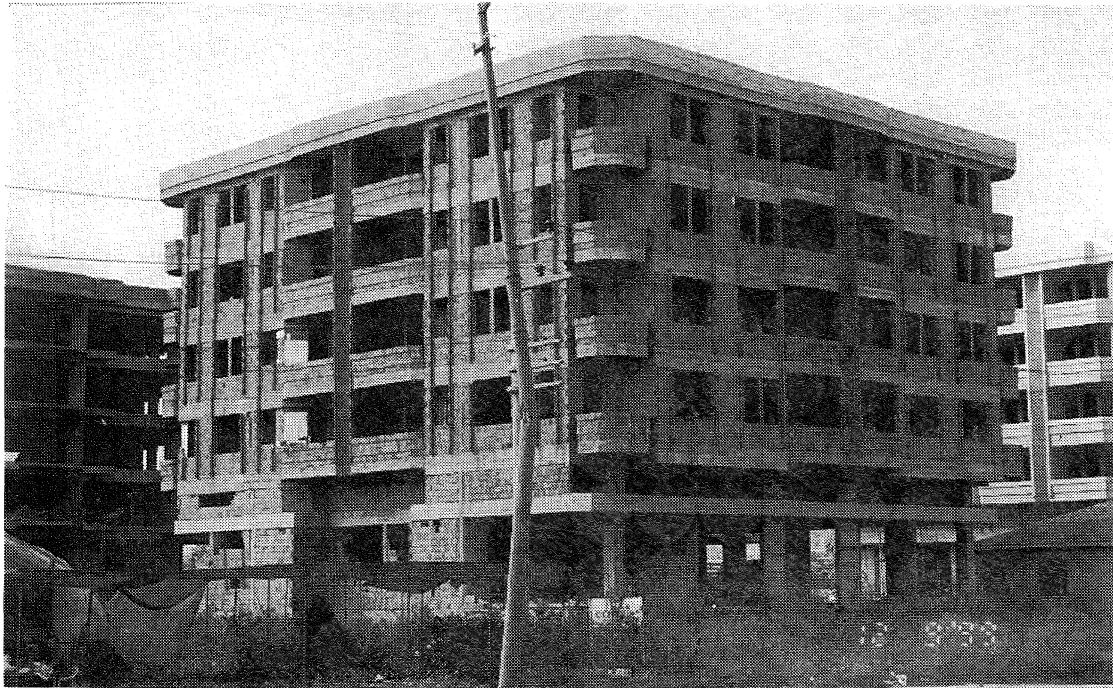
*Figure 19: Typical apartment building under construction showing setback concrete columns, hollow brick infill in progress and soft storey ground floor.*

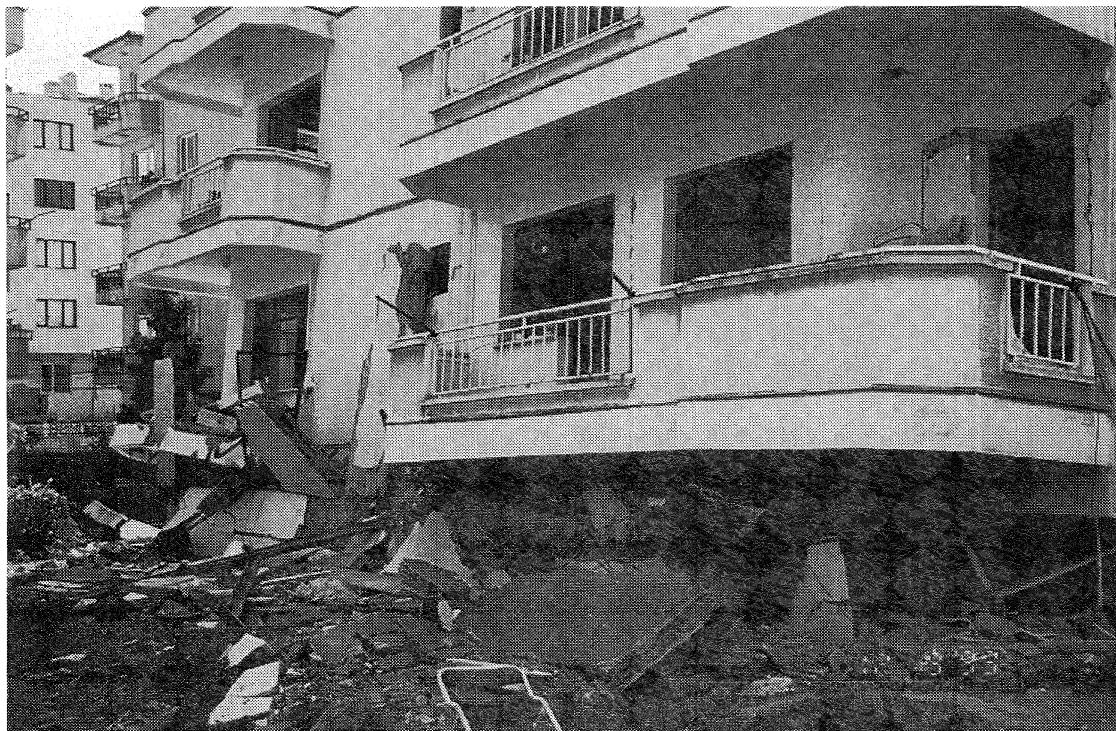
*Figure 20: Near new apartment building with collapsed ground floor.*

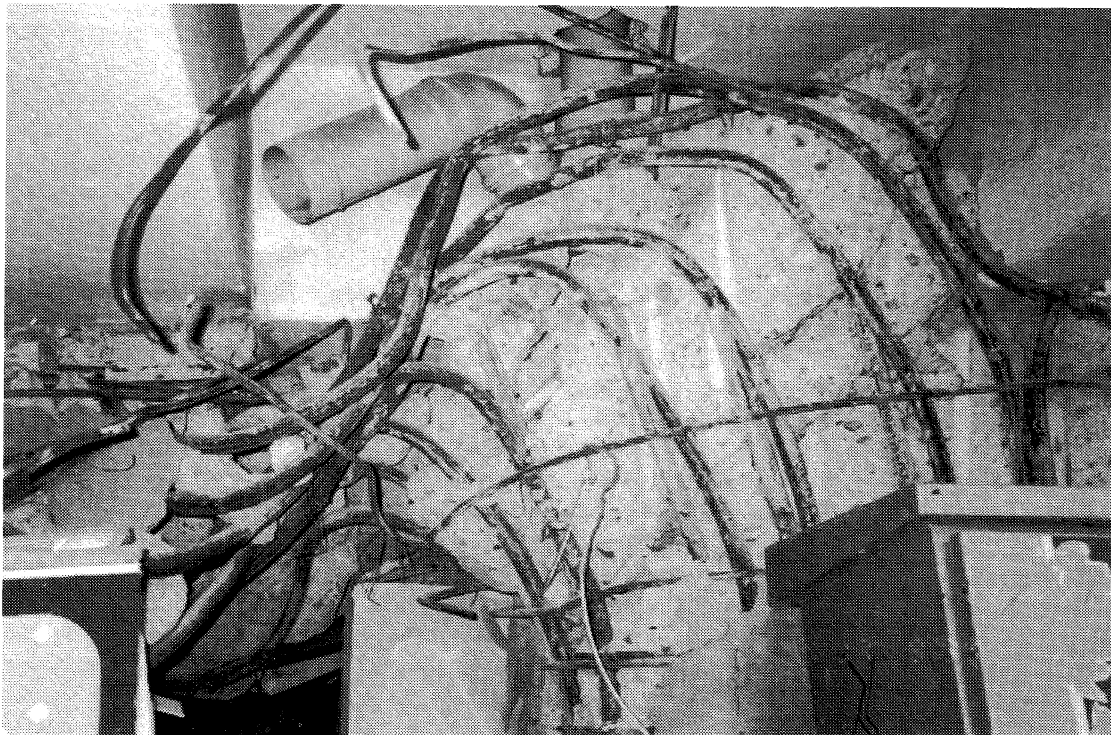
*Figure 21: Typical failed column showing R16 longitudinal bars and single R8 hoops.*

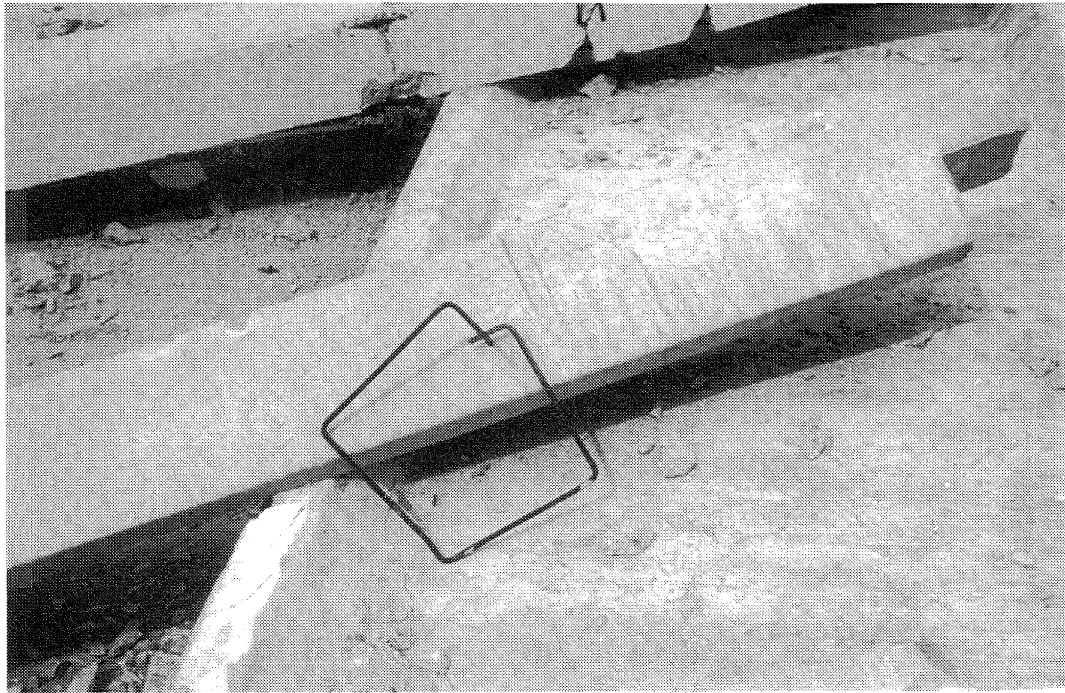
*Figure 22: Typical column tie showing poor detailing with 90 degree hook and short extensions.*

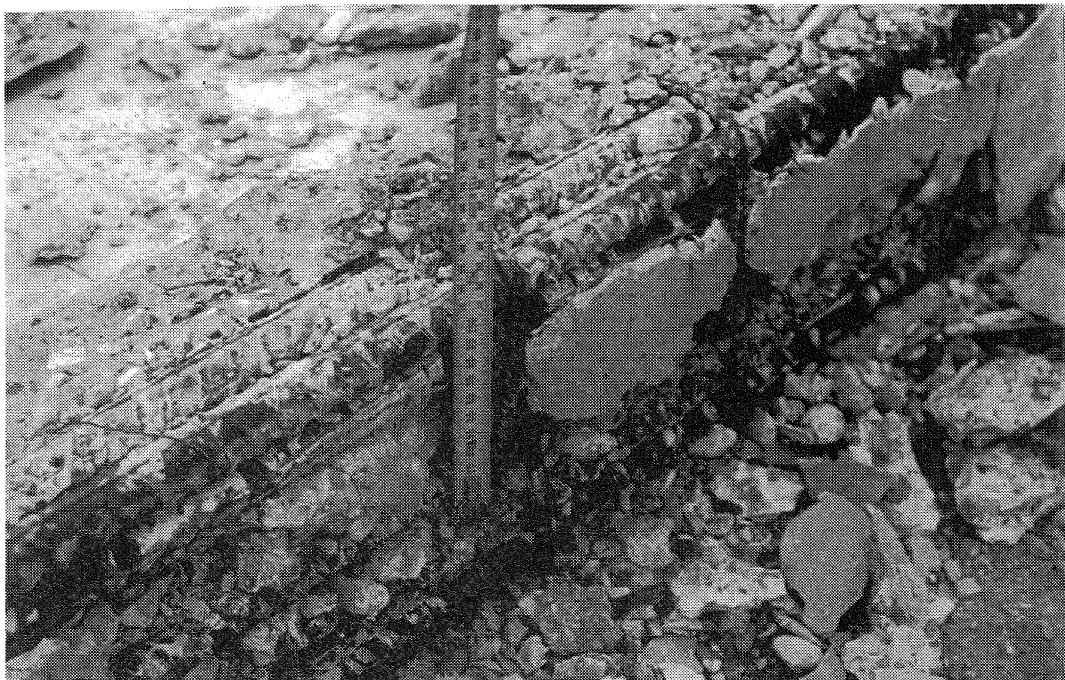
*Figure 23: Inadequate concrete cover in a precast concrete purlin.*

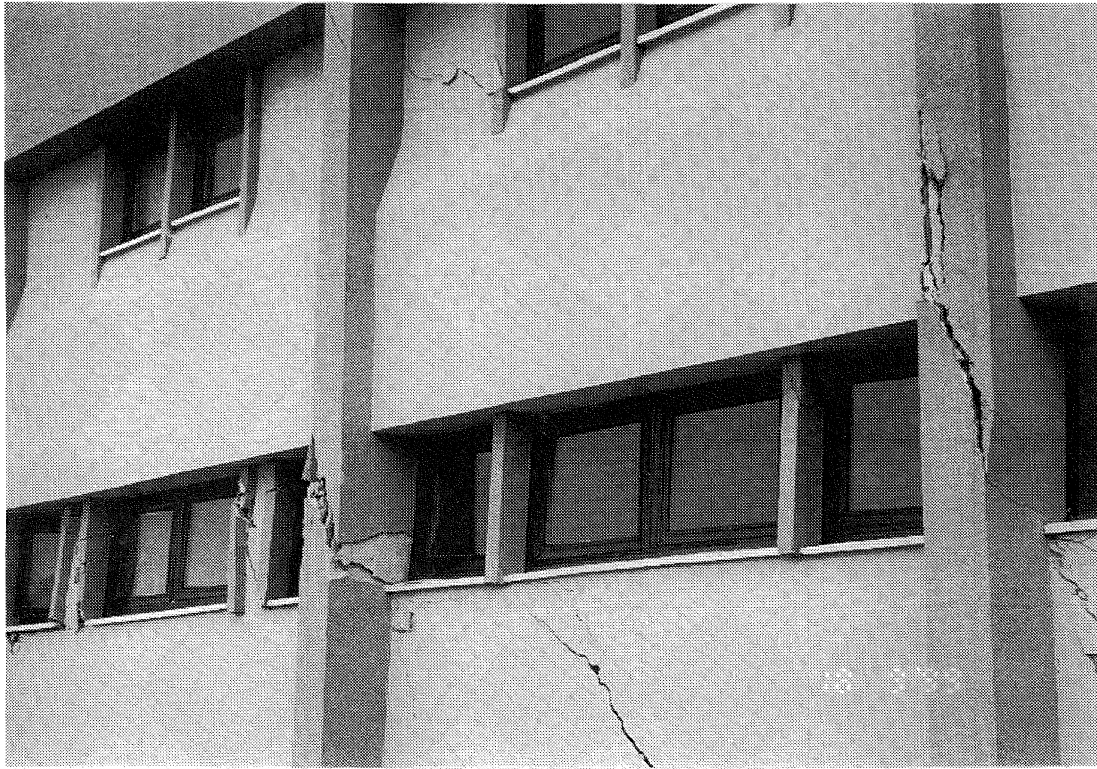
Shear failure had occurred to several ground floor columns to the north exterior side wall at window level due to a short column effect resulting from the presence of masonry brick infill below, as seen in Figure 27.

*Figure 27: Ataturk Stadium, Golcuk, showing short column shear failure.*

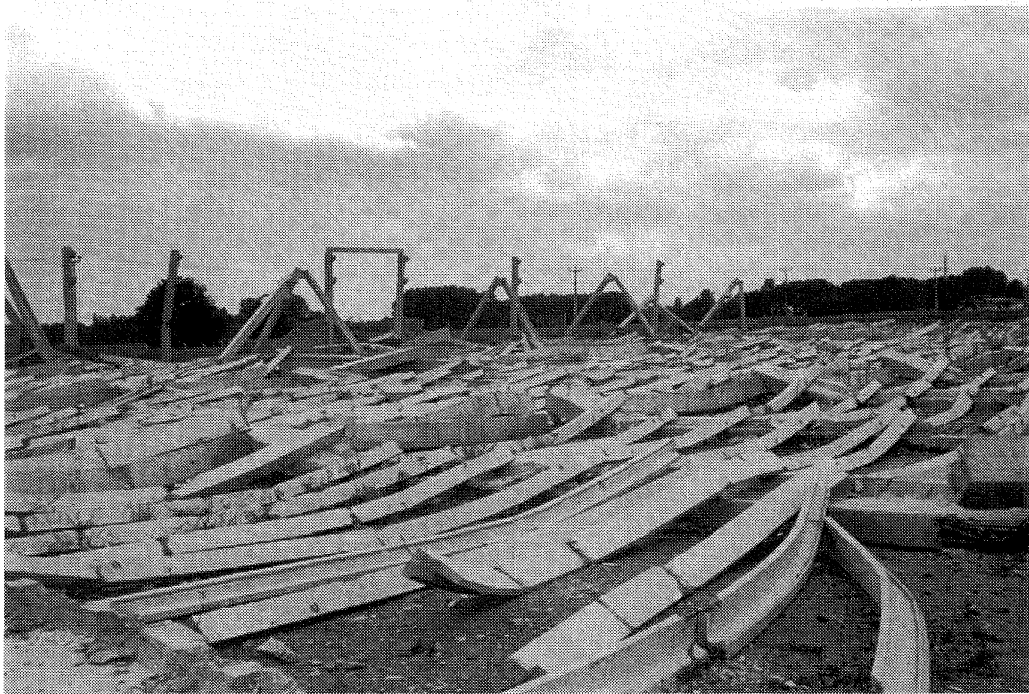
The longitudinal load system was not evident, unless either the roof sheeting was intended to act as a diaphragm or a bracing system was to be installed. In either of these cases the building side wall infill panels must have been intended to carry the longitudinal forces to ground. Since many of these fell over from face loading only, even had the building been completed with a roof diaphragm the side walls may have failed to carry the load and thus caused the building to collapse.

**Figure 28:** *Collapsed precast concrete building near TEM Adapazzari exit.*

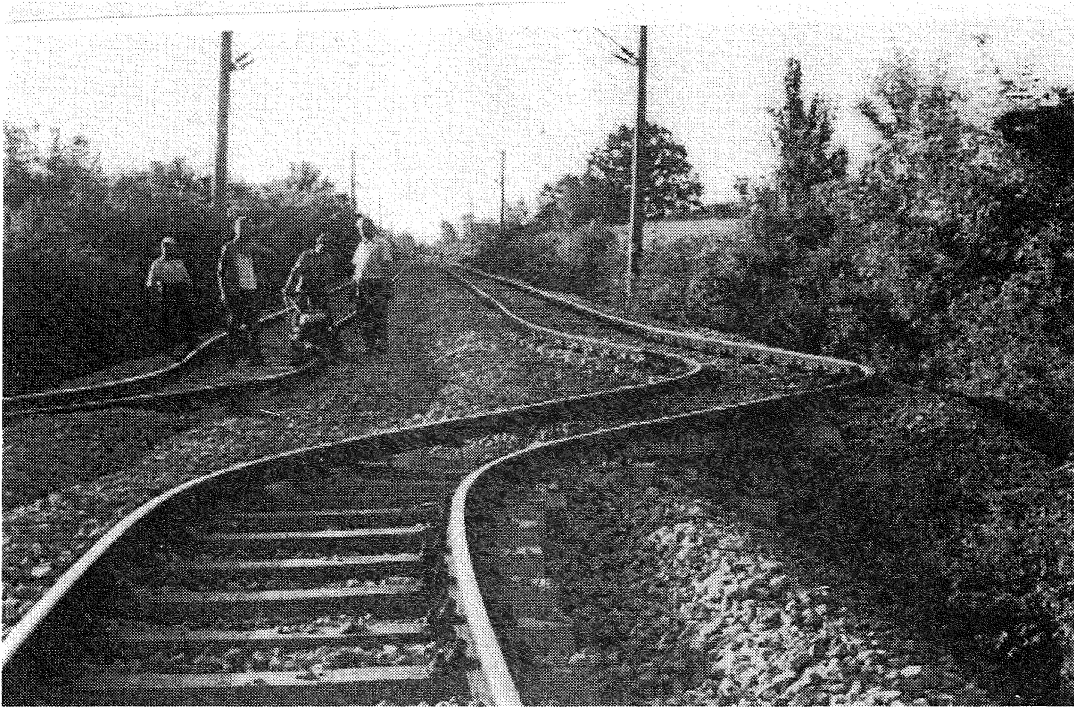
*Figure 29: Damage to rail track near Sapance, showing right lateral offset caused by fault trace.*

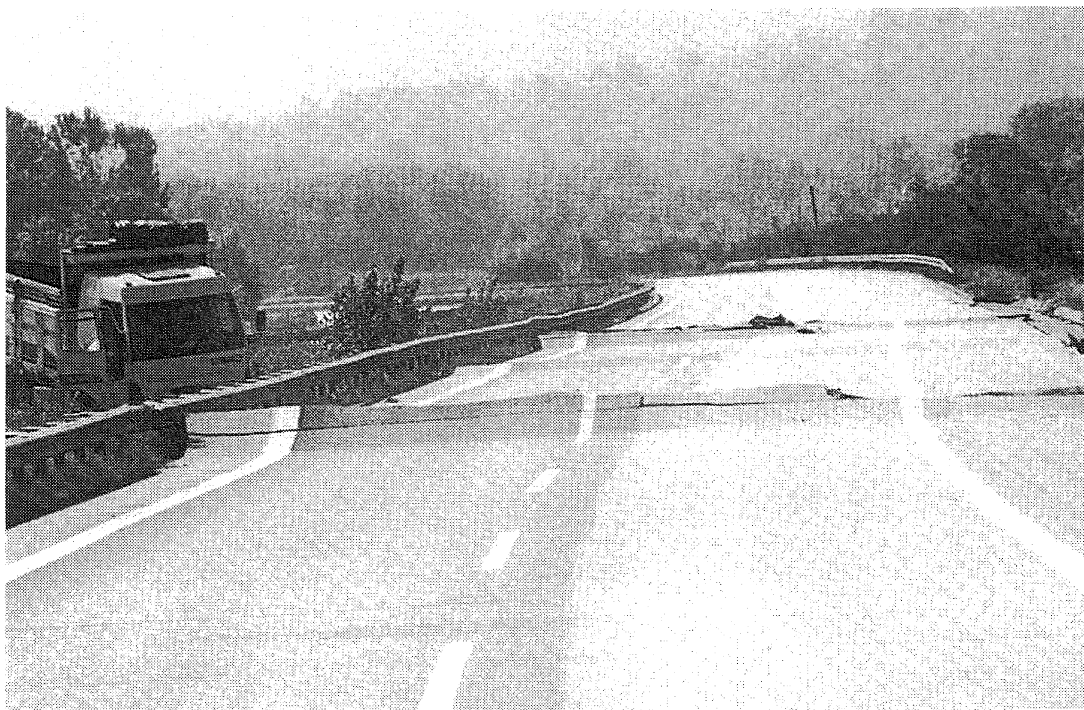
*Figure 30: Damage to E80 motorway carriageway caused by fault trace.*

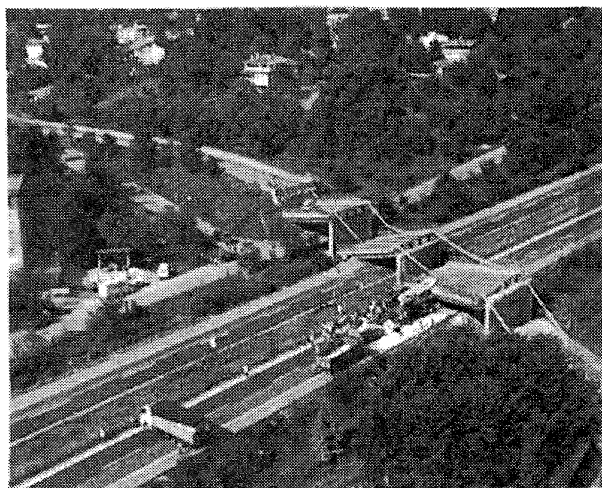
Figure 31: Collapsed four span overpass, E80 near Arifre.

Collapsed Four Span Overpass Over the E80 Motorway at Arifre, Figure 31: The form of this bridge was that of a type 1 described above. This bridge comprised four simply supported, 26.0 m spans of precast, prestressed concrete trough girders with a 200 mm thick, continuous, in situ concrete deck. It was supported on wall piers and cantilever retaining wall abutments skewed at 23 degrees. Foundations comprised 1.2 m diameter cast in place reinforced concrete piles, 8 per pier and 4 per abutment.

At the abutments, the sill supporting the girders was 600 mm wide with the girders being placed with 75 mm clearance from the backwall. Shear keys between each pair of girders restrained the superstructure against transverse movement. The piers were 1.0 m thick, with the beams placed with 50 mm clearance between adjacent spans.

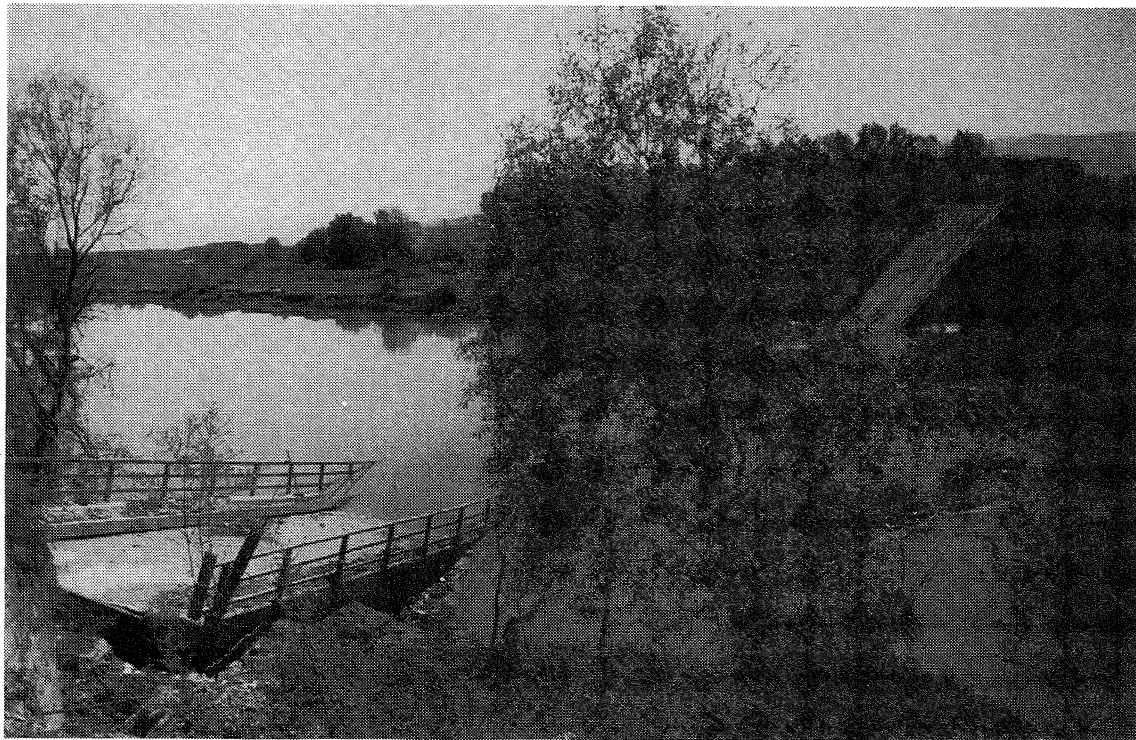
*Figure 32: Sakarya River Bridge.*

These all exhibited significant settlement of their approach fills adjacent to their abutments requiring major ramping up to enable passage over the bridges. In more than one case, the depth of this ramping up extended to the top of the guardrail.

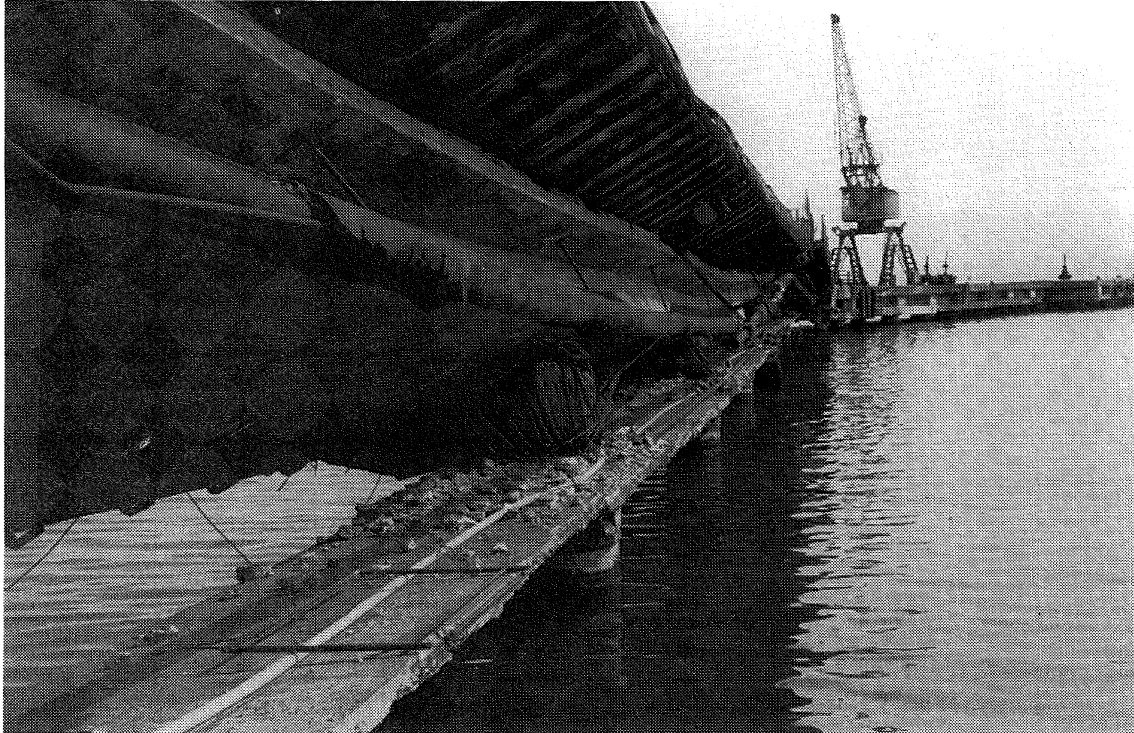
Many industries around the Marmara sea coast operate their own private jetties, some of which were observed to be severely damaged. Figure 33 illustrates one example of these, the SEKA Paper Mill jetty located at the west end of Izmit. The supporting single column piers appear to have moved out from the shore, presumably as a result of mass outward movement of the harbour bed material in which they are embedded. This had resulted in unseating of the abutment end span, with the columns failing in shear / flexure between the upper and lower decks. There was also signs of the first pier having displaced and rotated over transversely, separating from the adjacent sea wall.

*Figure 33: Collapsed SEKA paper mill jetty.*

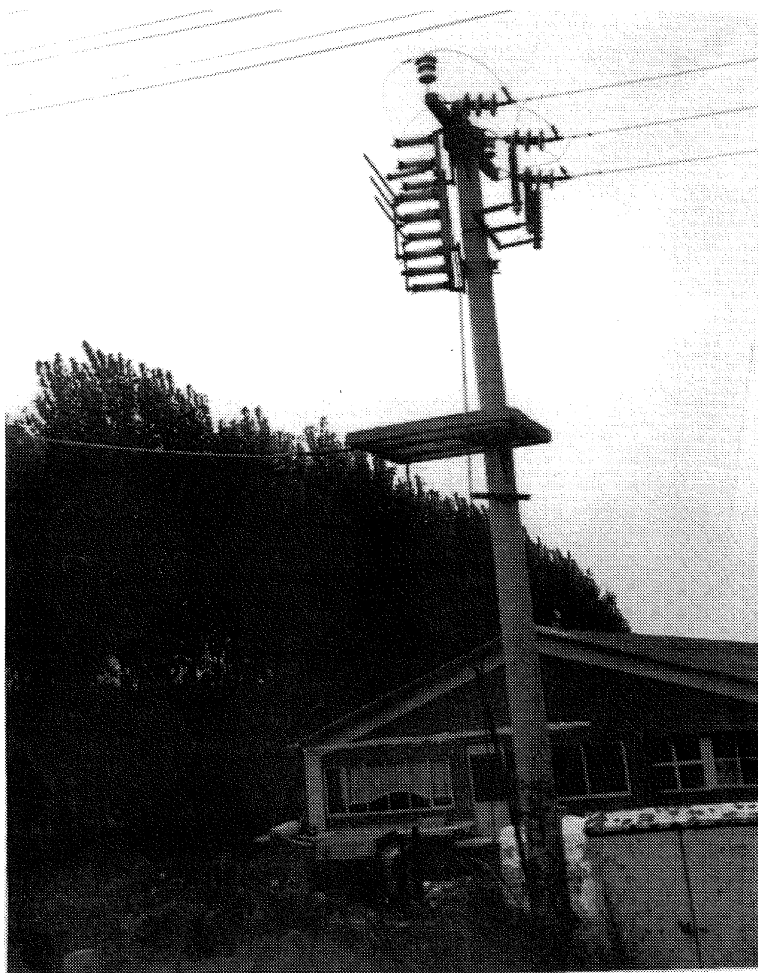
*Figure 35: Transformer fallen from pole near Izmit.*

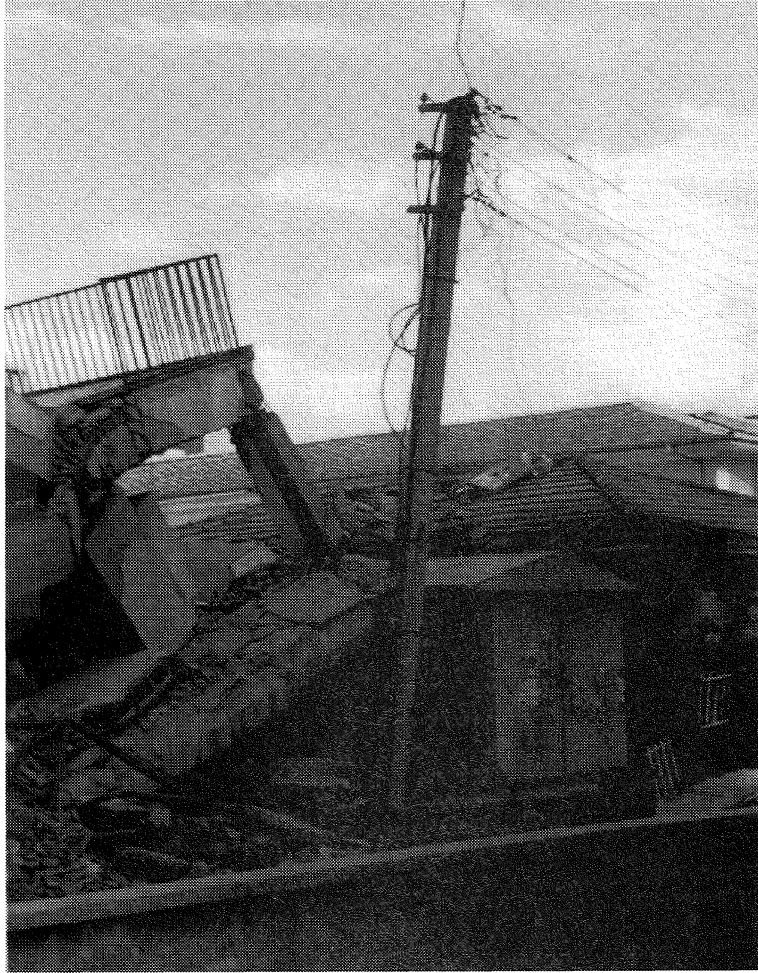
*Figure 36: Power pole damaged by collapsing adjacent building.*

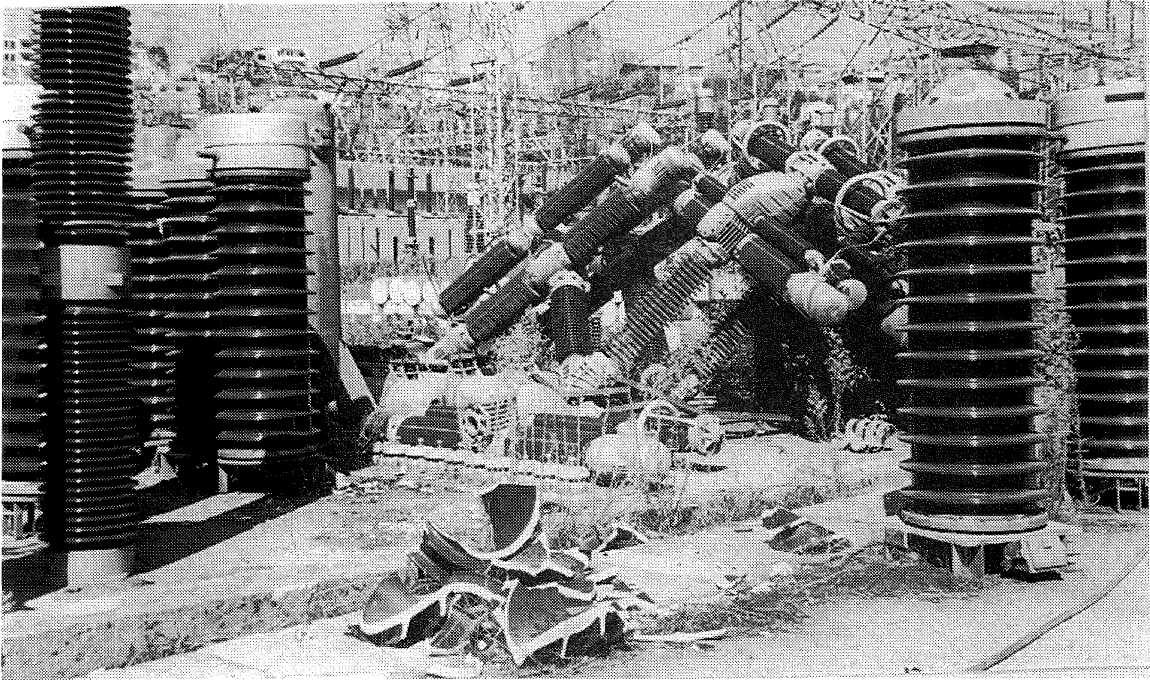
*Figure 37: Damaged 380 kV circuit breakers.*
