THE CHI-CHI, TAIWAN EARTHQUAKE OF 21 SEPTEMBER 1999

Report of the NZSEE Reconnaissance Team

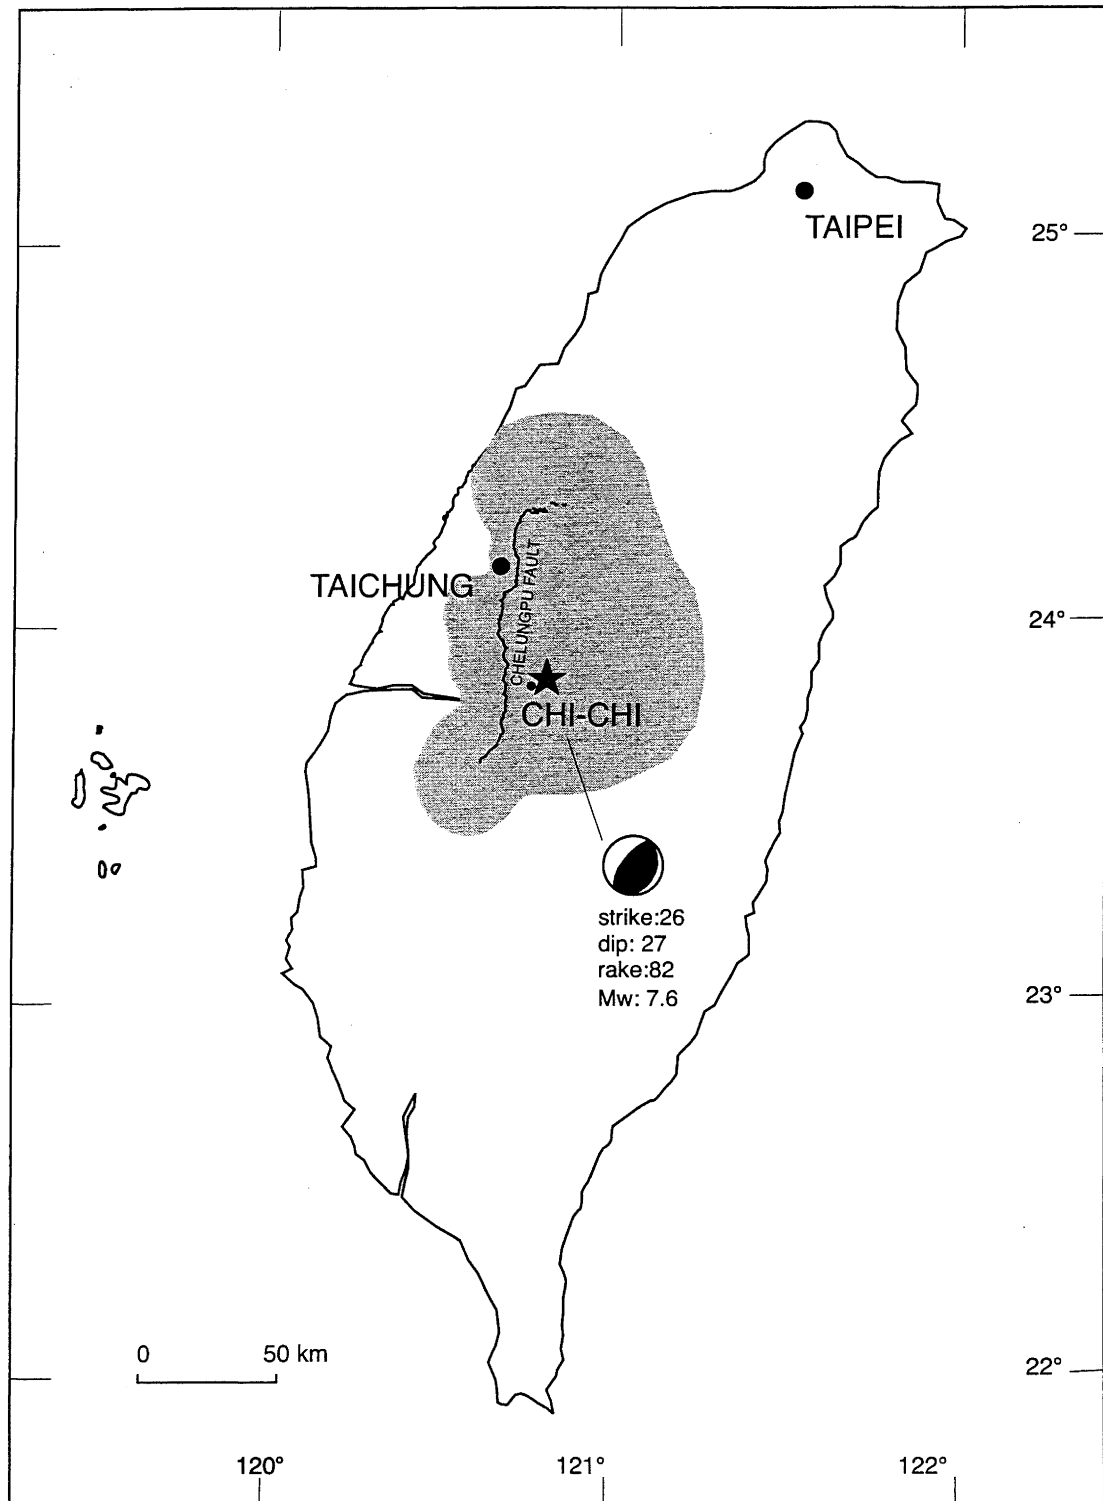
Figure 1.1: Map of Taiwan showing damaged region (shading denotes $PGA > 0.25g$), fault rupture and epicentre (data provided by National Taiwan University and the Central Geological Survey of Taiwan)

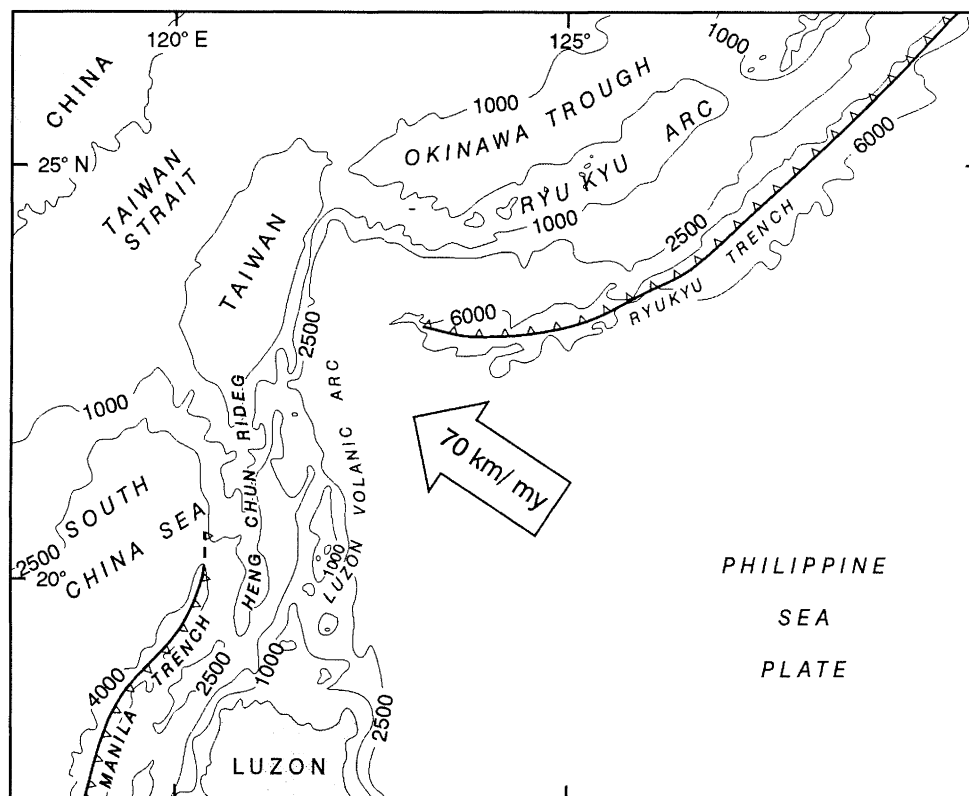
Figure 2.1: Tectonic setting of Taiwan (modified from Seno et al 1993).

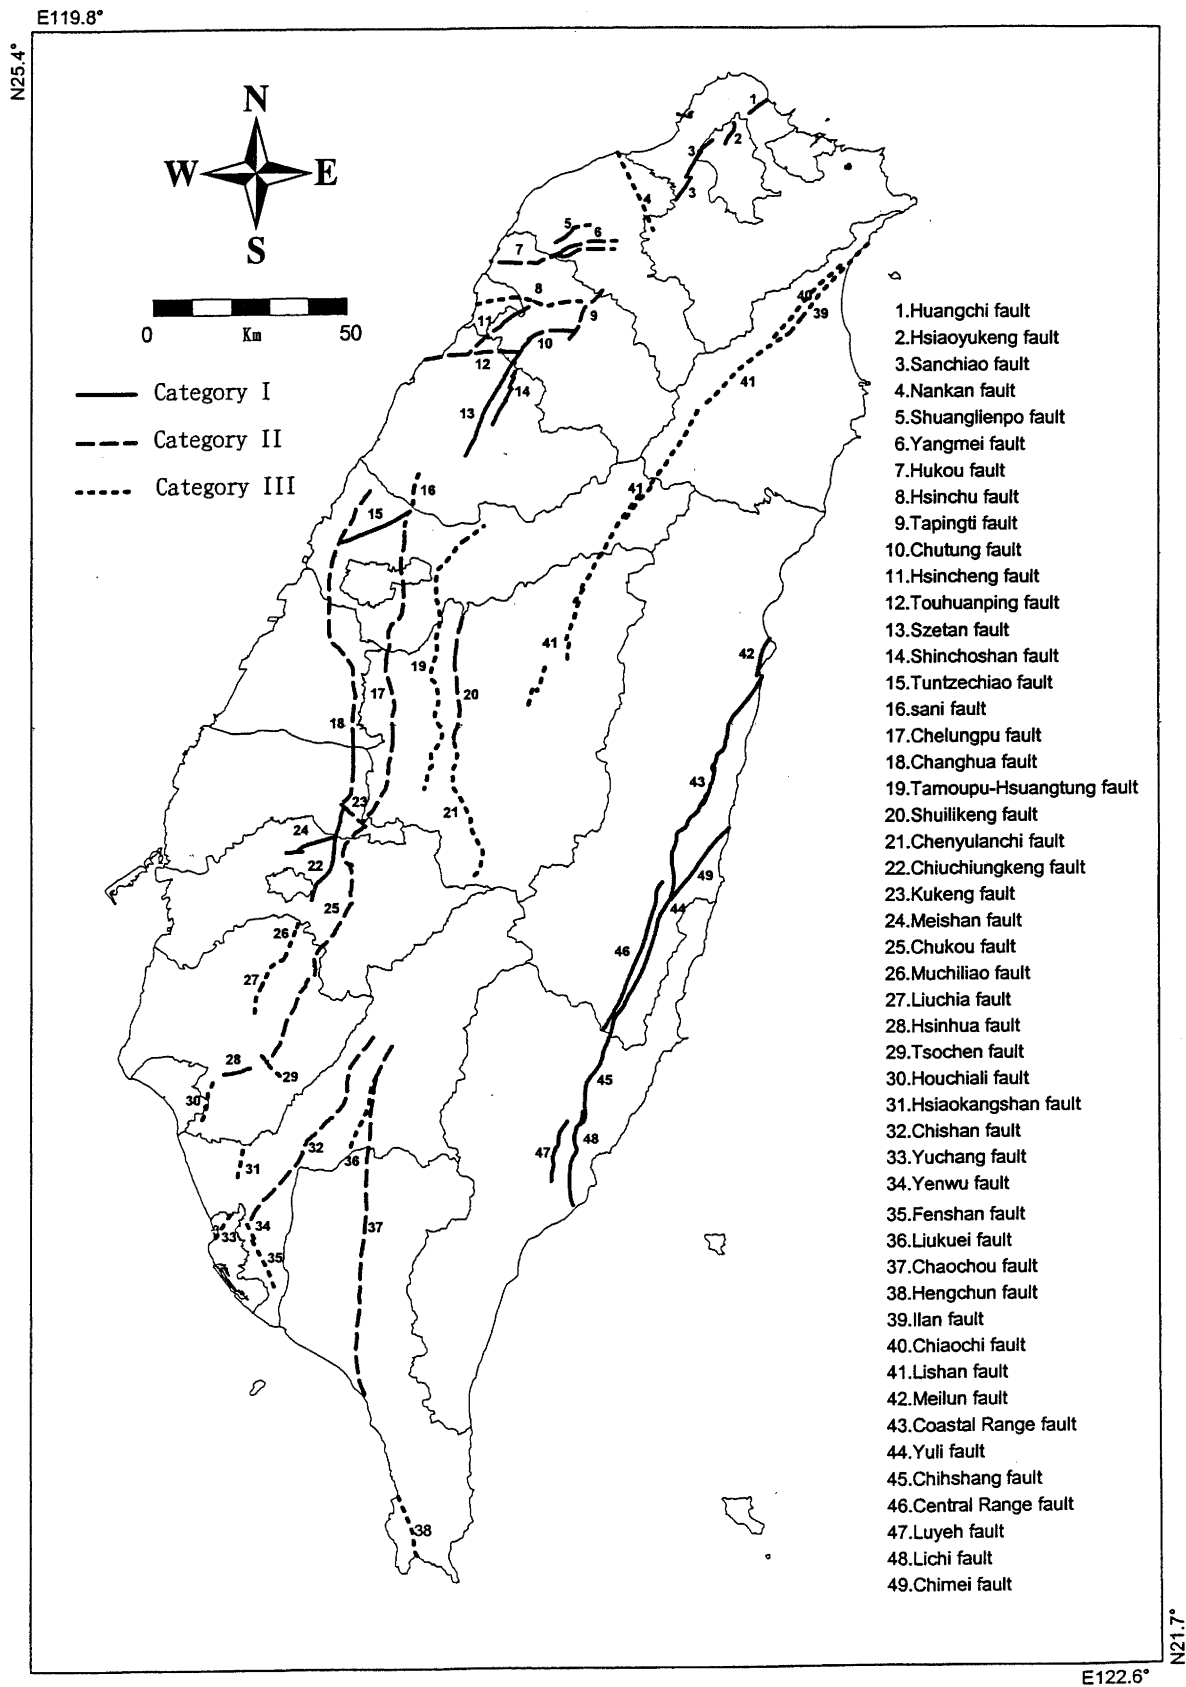
Figure 2.5: Active faults in Taiwan (provided by the Institute of Applied Geophysics of the National Central University of Taiwan).

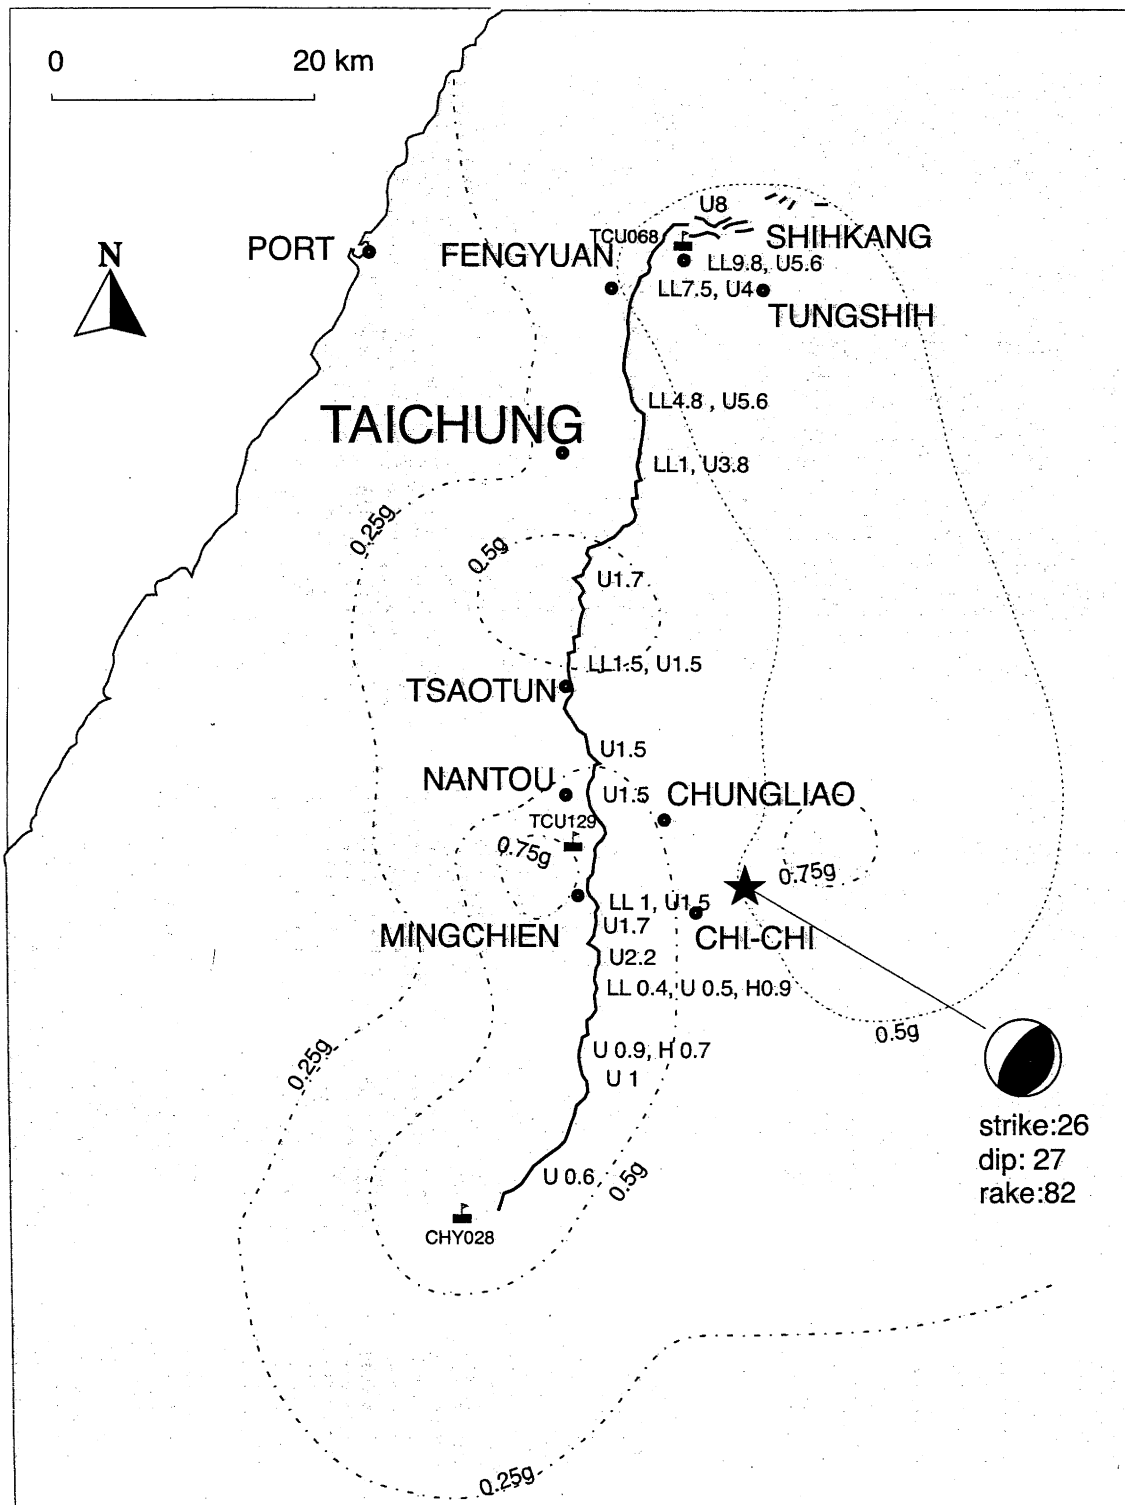
Figure 3.1: 1999 Chelungpu fault surface rupture (solid black line); fault displacement (U, uplift; H, horizontal; LL, left lateral; in metres); peak ground acceleration (dashed lines are pga contours and epicentre location (star), aftershocks and strong motion data (provided by the Institute of Applied Geophysics of the National Central University of Taiwan).

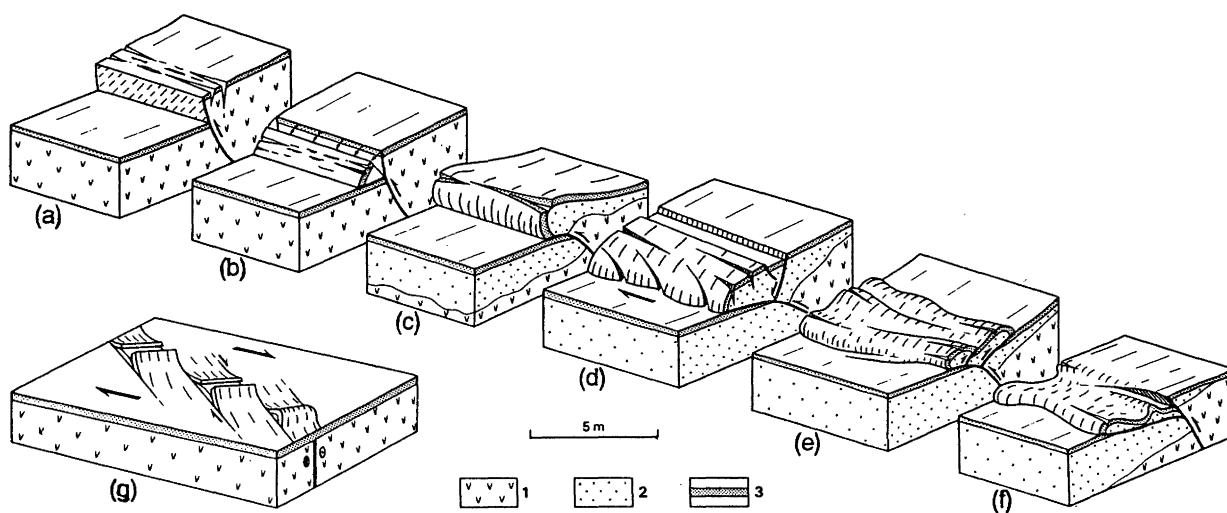
Figure 3.2: *Fault-scarp morphology along the Spitak fault, 7 December 1988 El Asnam earthquake, Armenia (from Philip et al. 1992).*

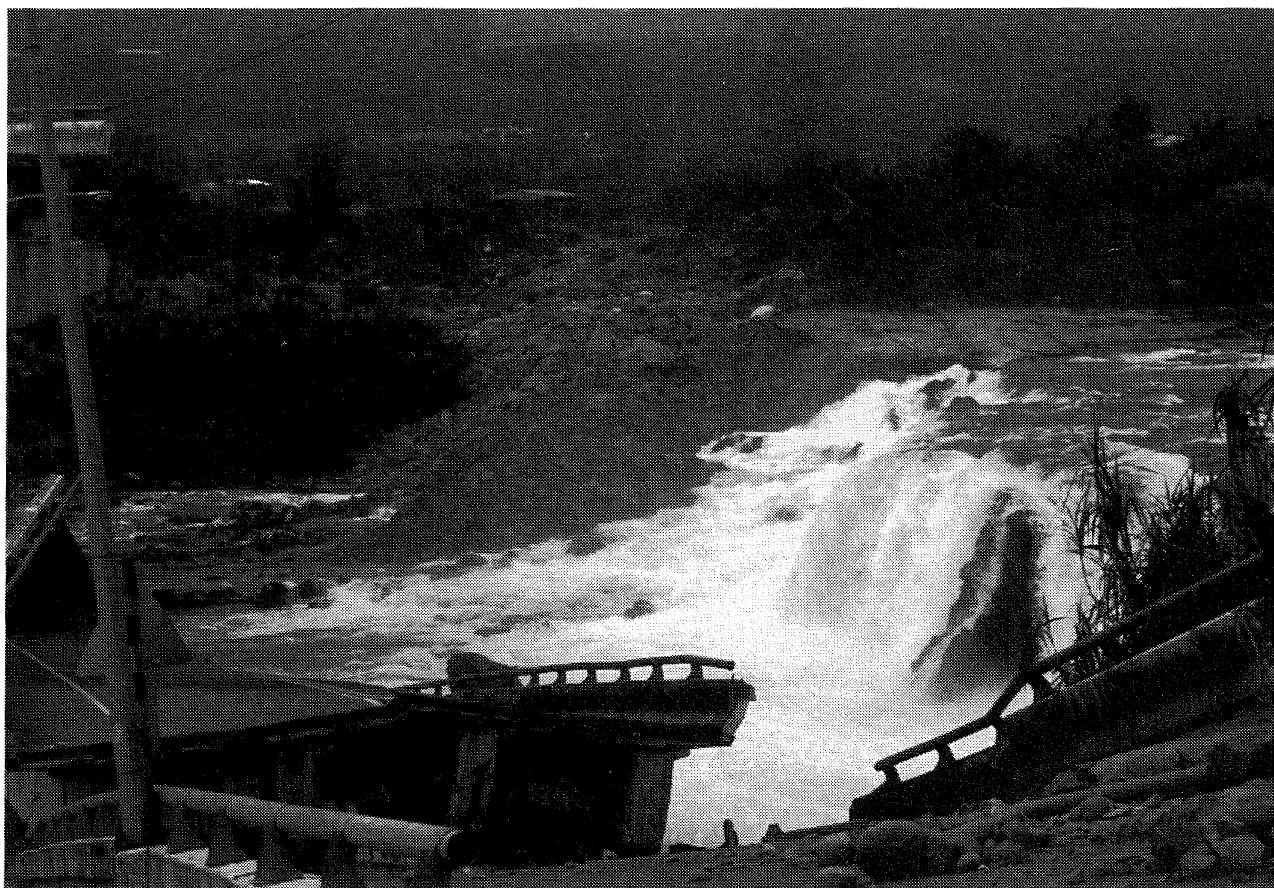
Figure 3.3: *New waterfall formed due to the Chelungpu fault surface rupture, Tachia River. Fault scarp height is 7 m.*

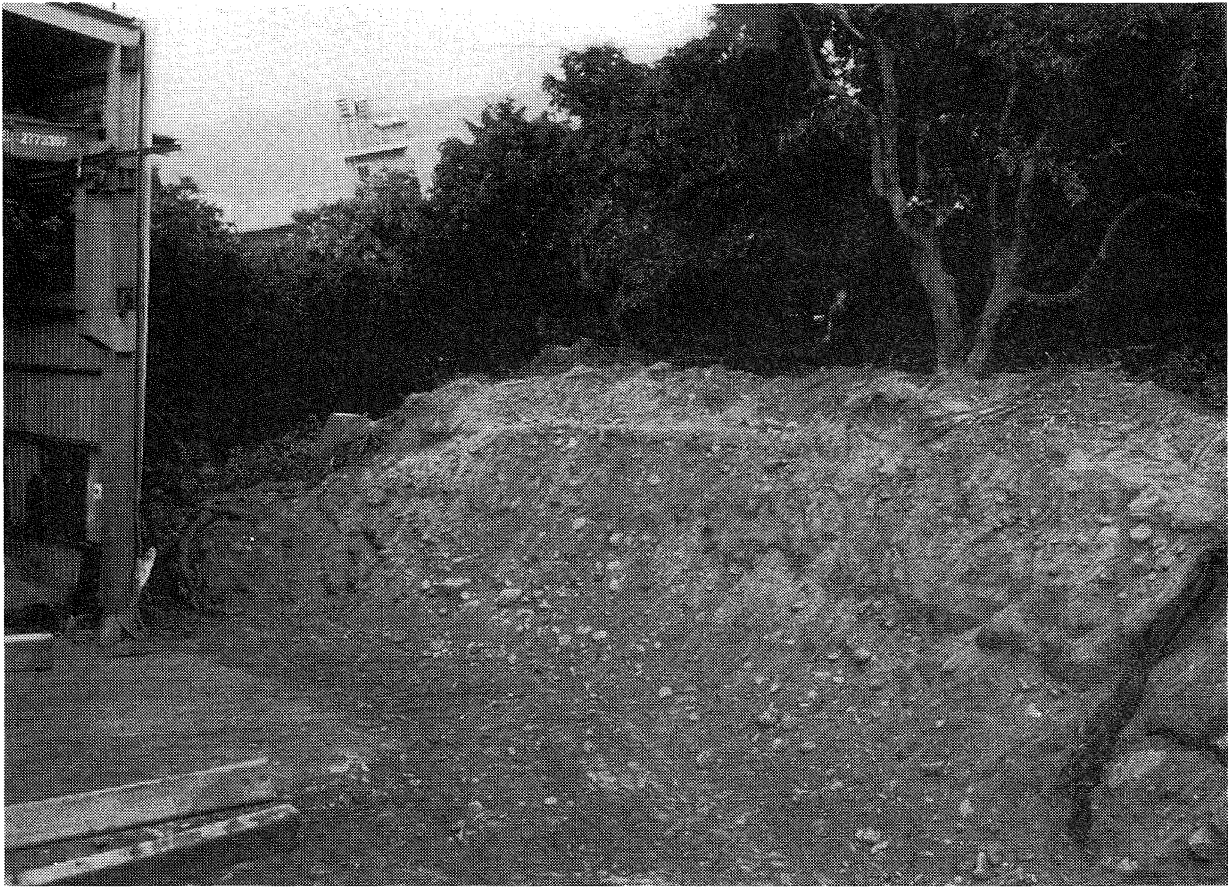
Figure 3.4: Fault scarp at Yijiang Bridge, Tsaotun. Note drag fold.

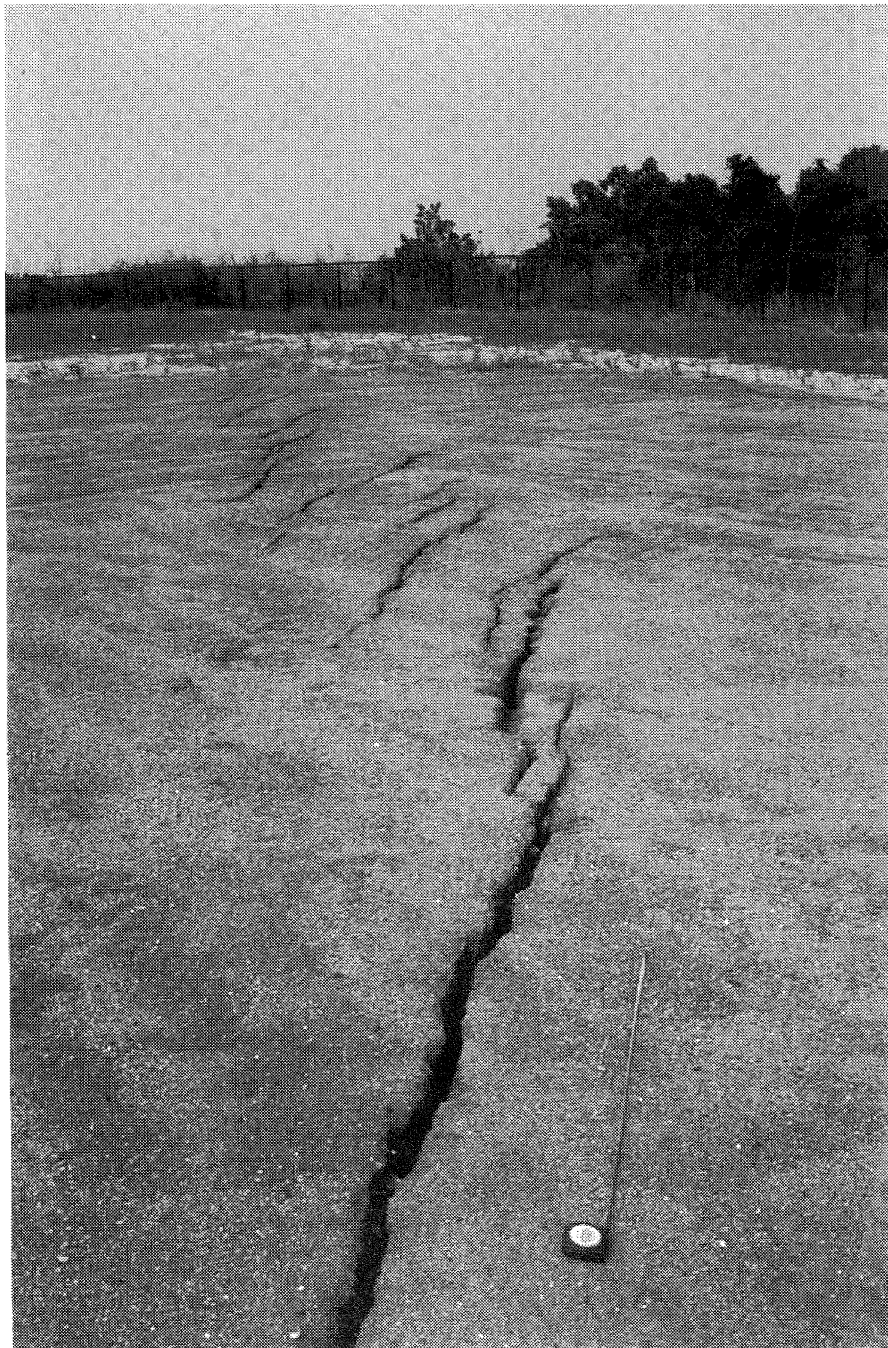
Figure 3.6: Tension cracks on the hanging wall of the Chelungpu fault at Tsaotun.

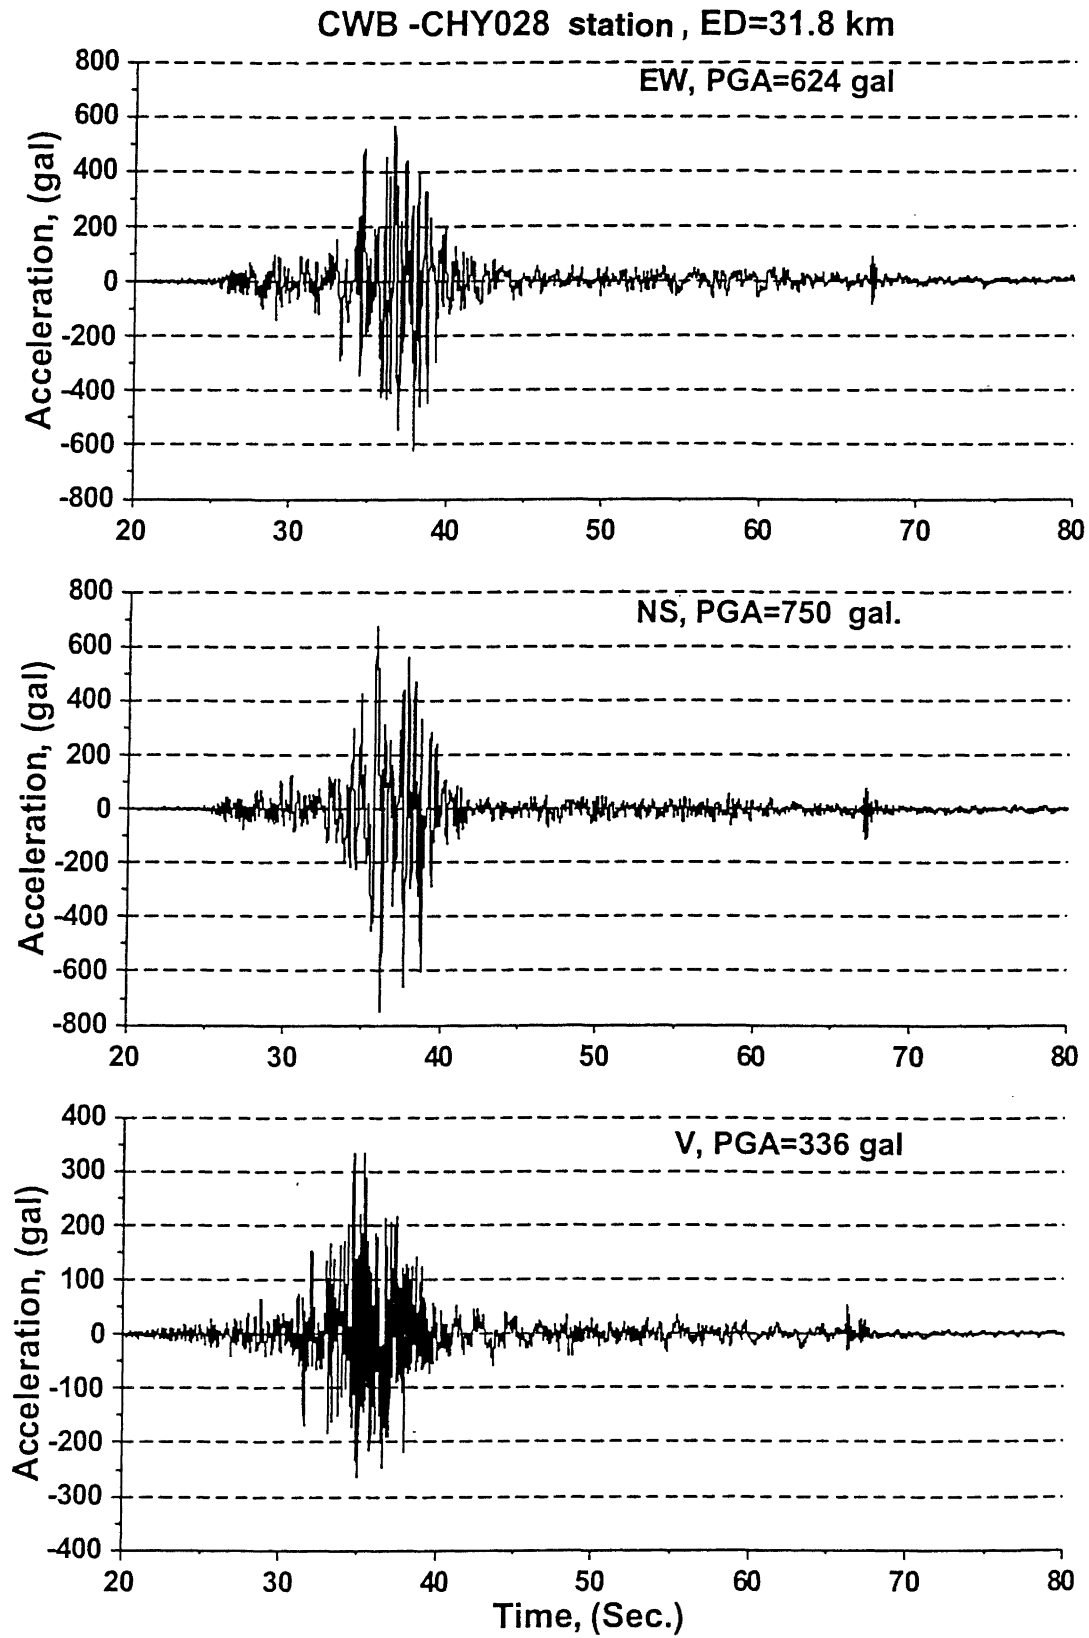
Figure 3.7: Acceleration time history for the record obtained at station CHY028, at the southern end of the surface fault rupture.

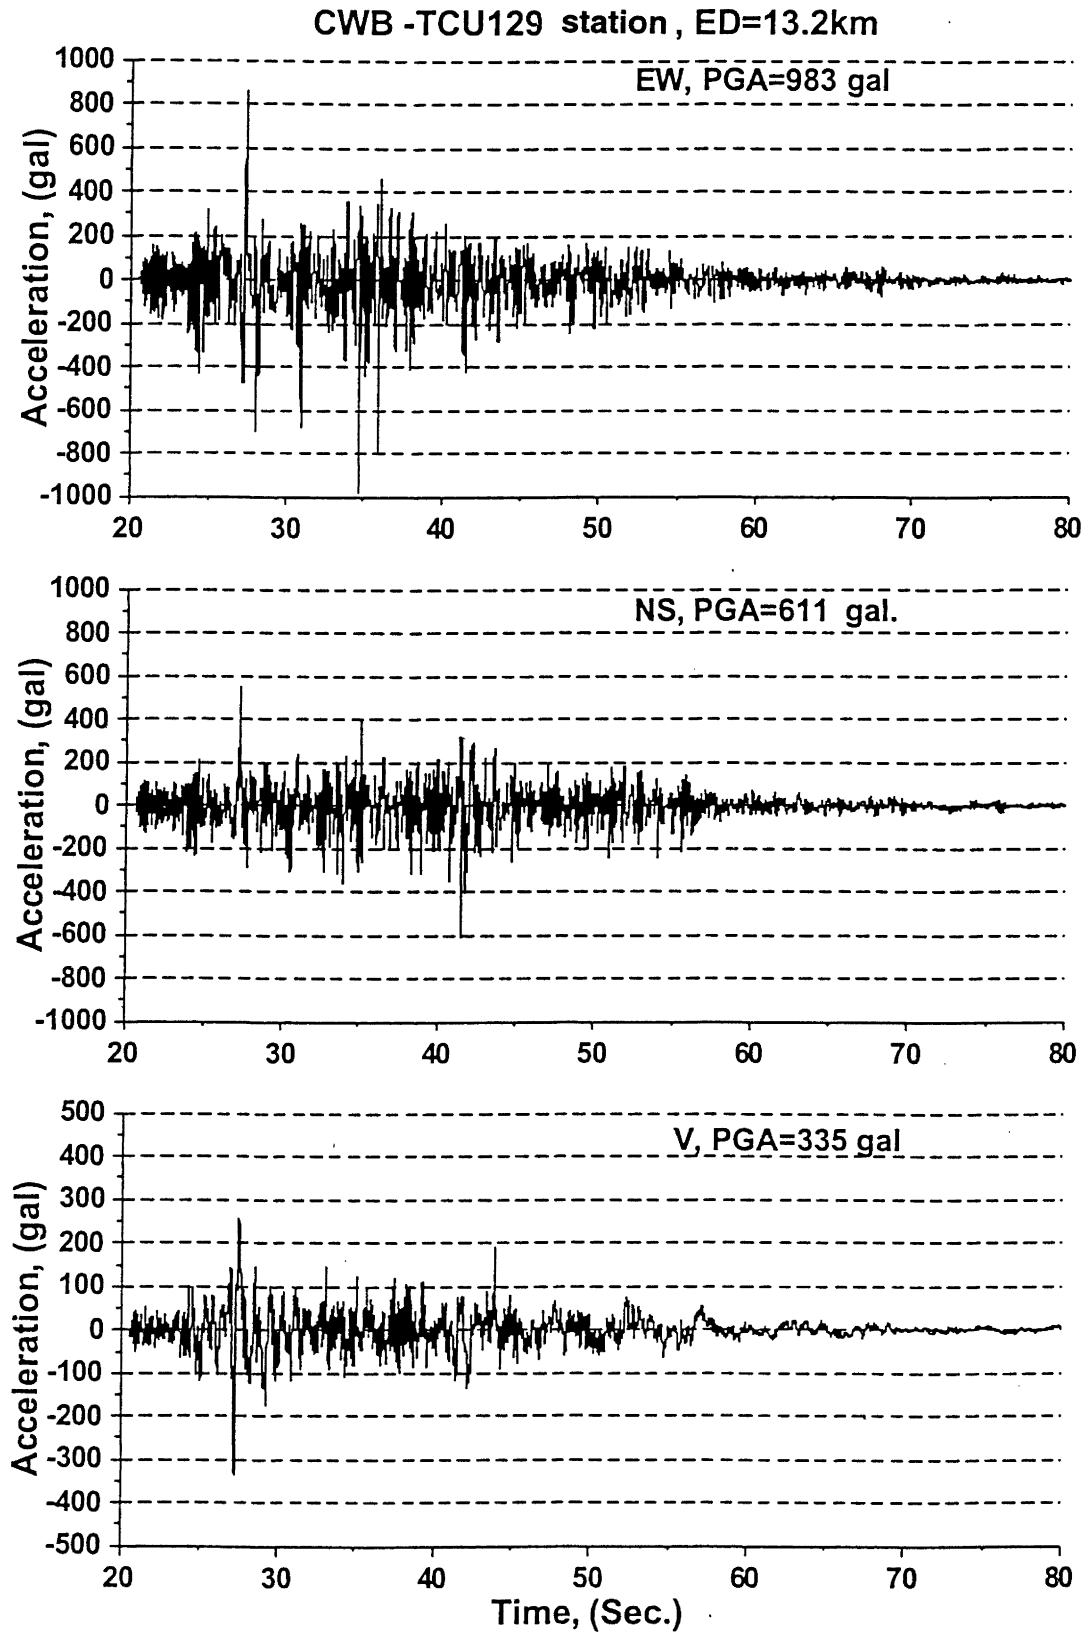
Figure 3.8: Acceleration time history for the record obtained at station TCU129, at the lower middle part of the surface fault rupture.

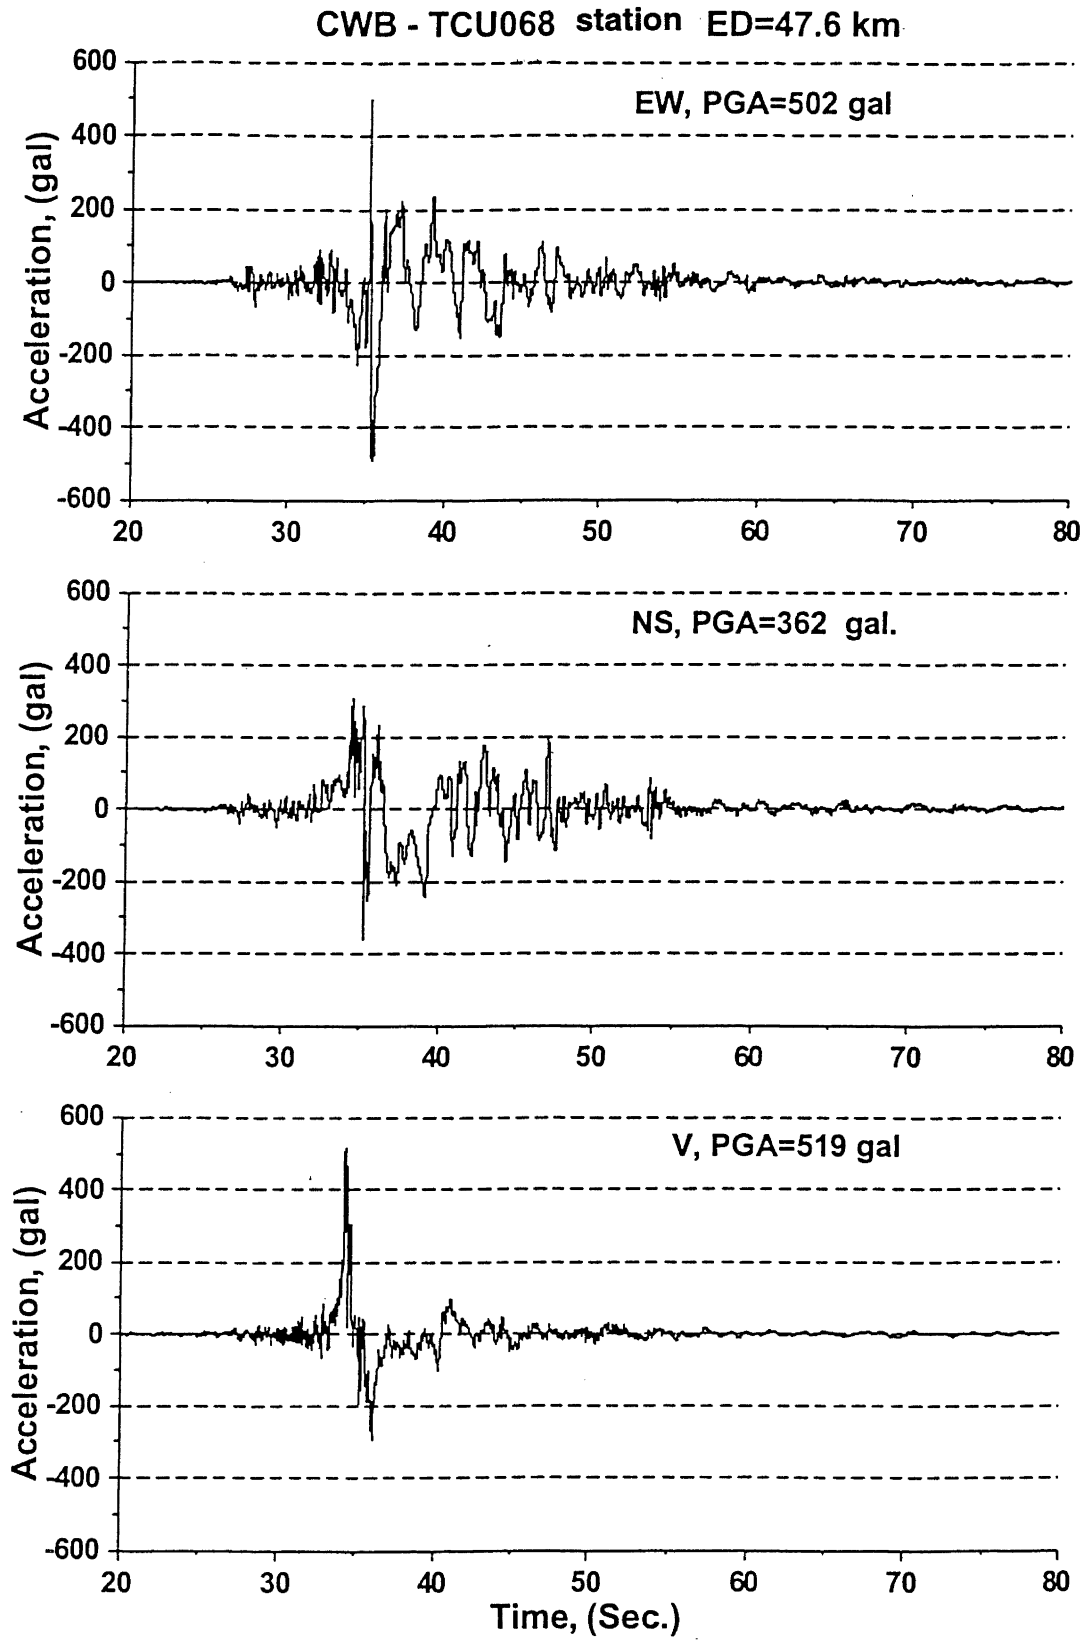
Figure 3.9: Acceleration time history for the record obtained at station TCU068, at the northern end of the surface fault rupture.

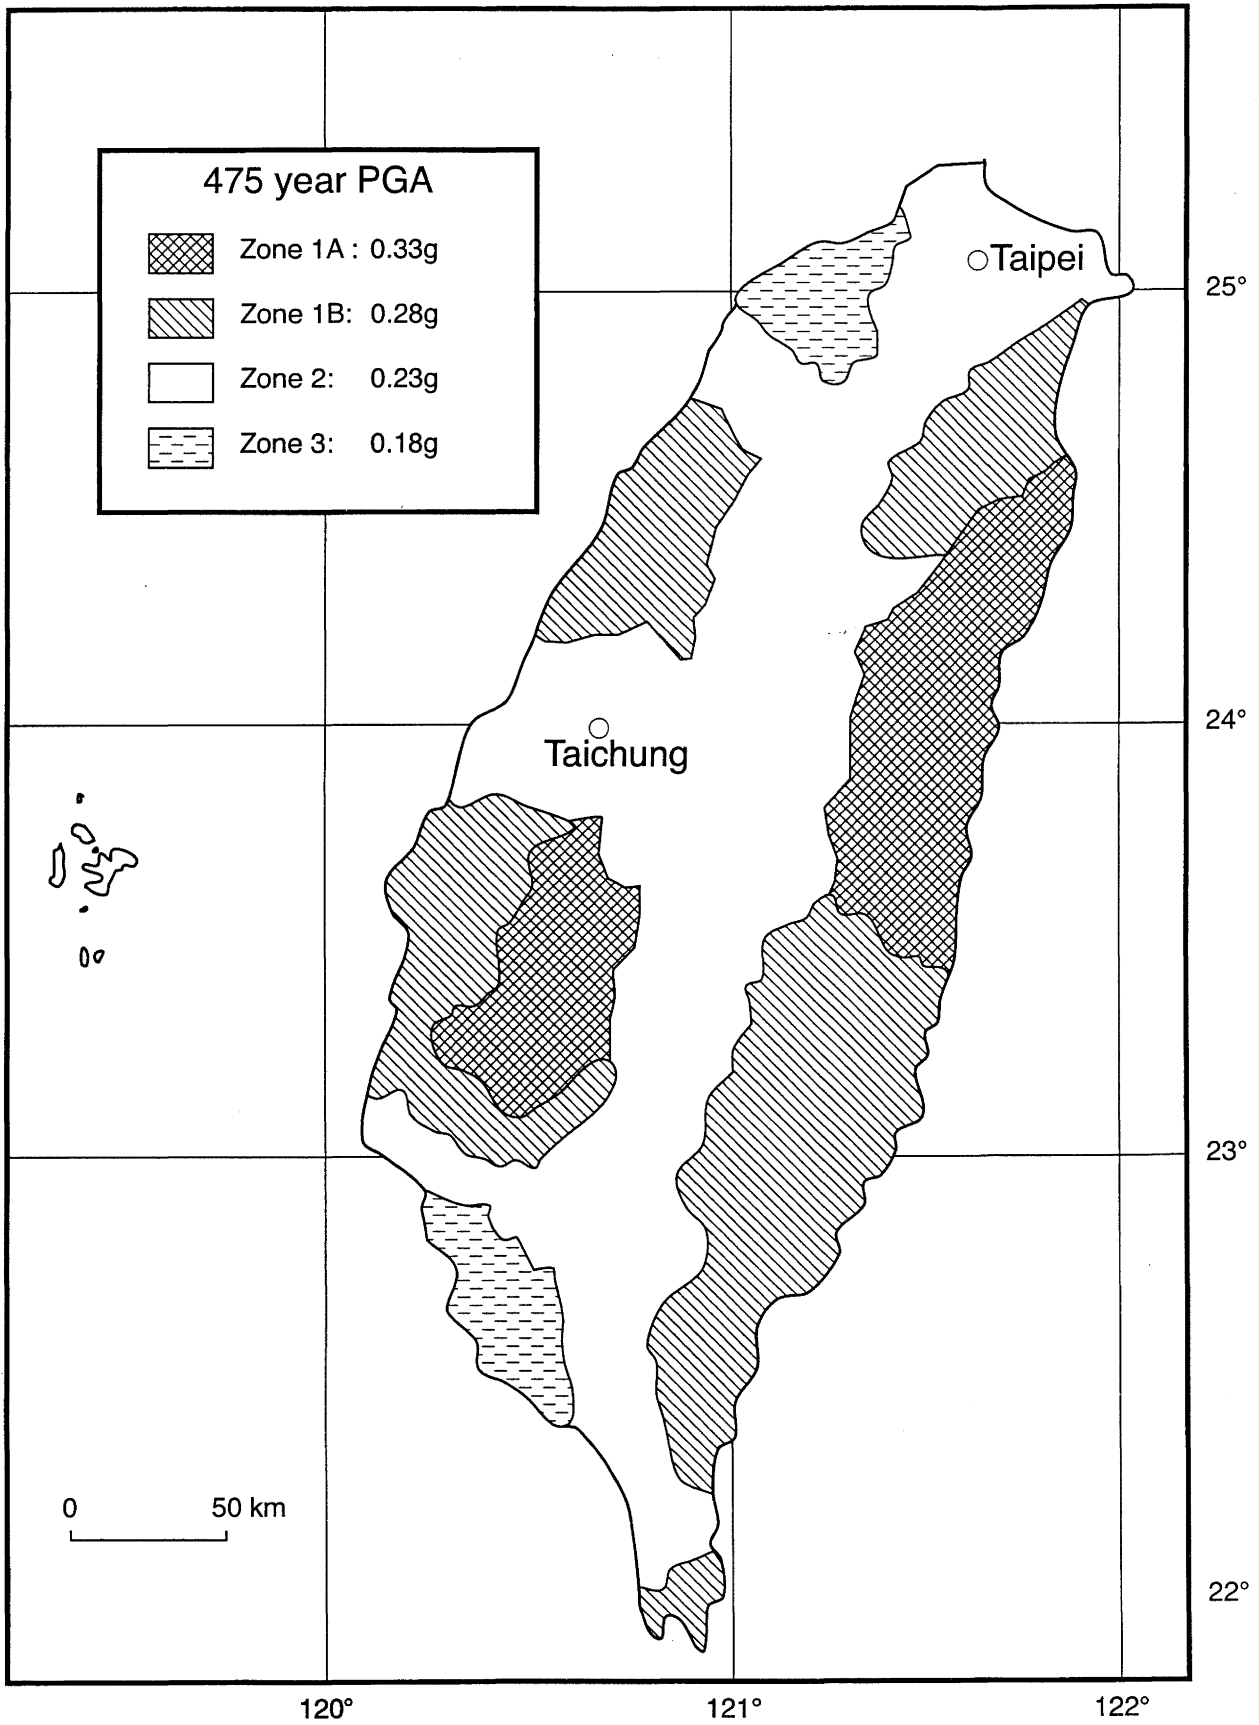
Figure 3.10: Zoning map for the design spectrum for the 1997 Taiwan design code. The white area is Zone 2, which includes most of the severely damaged areas.

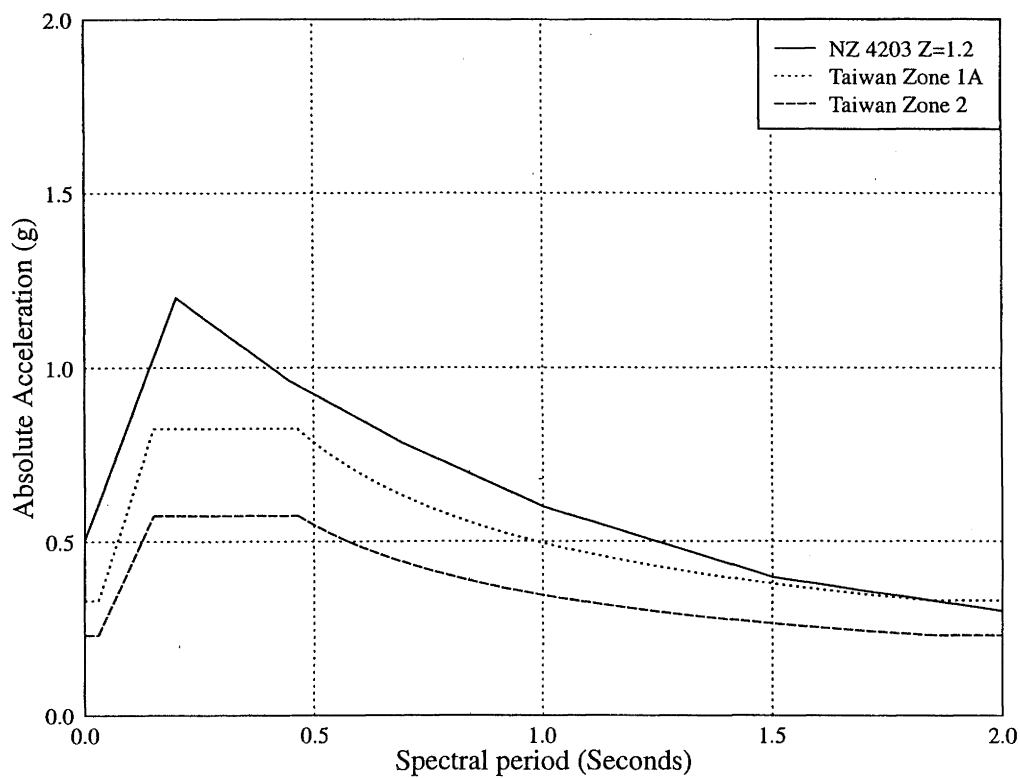
Figure 3.11: Comparison of design spectrum for Zone 1A and Zone 2 in Taiwan with that for New Zealand with a zone factor of 1.2.

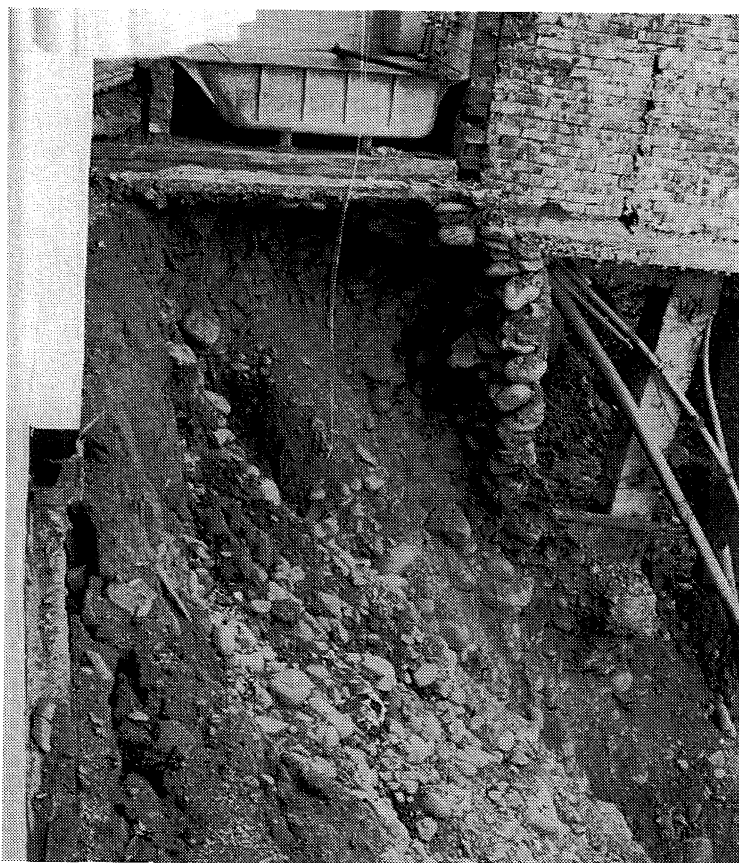
Figure 3.15: Landslide in an elevated quaternary terrace, Chongsing Village.

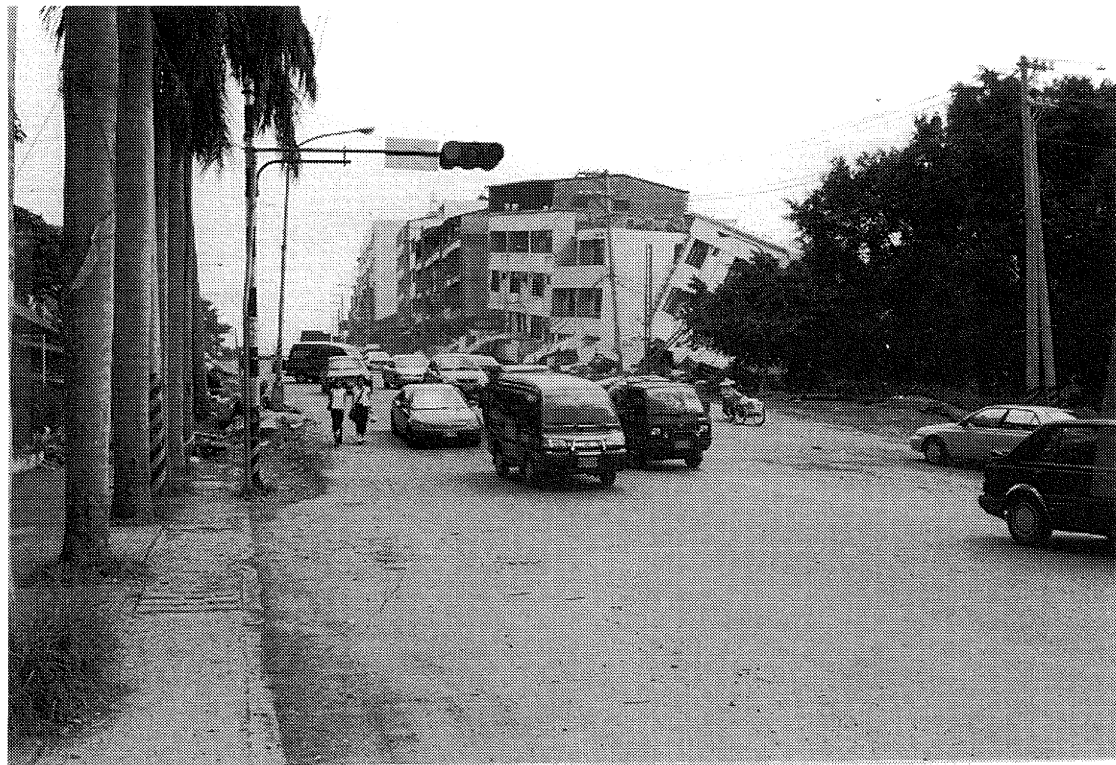
Figure 3.19: The fault scarp near Tsaotun. The scarp deformation shows clearly in the road and in the building damage.

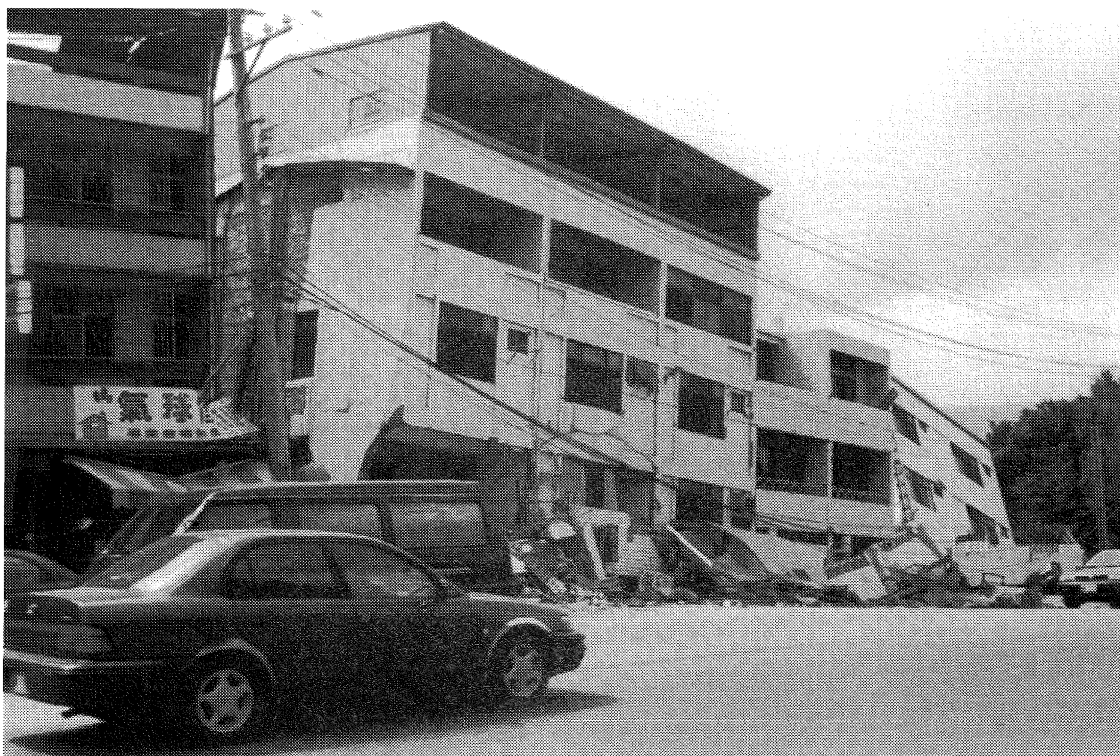
Figure 3.20: The fault scarp near Tsaotun. The scarp location and shape is reflected in the building damage.

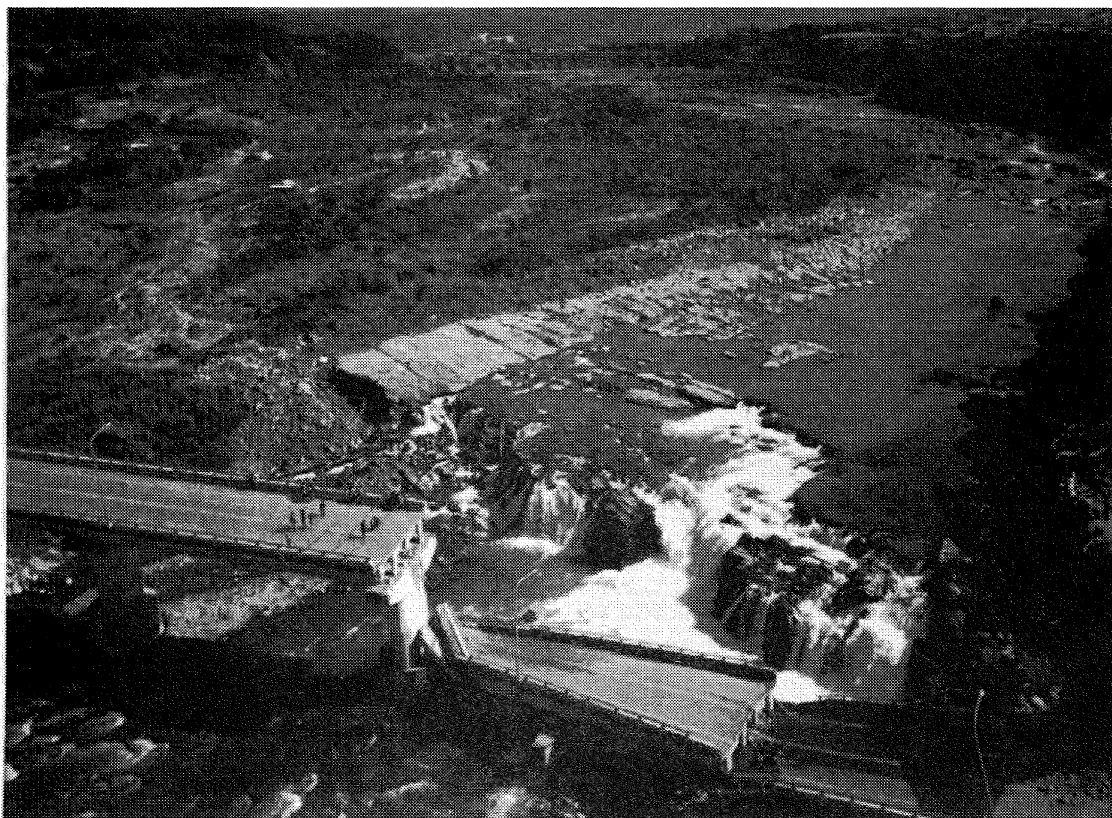
Figure 3.21: Fault rupture passes through the bridge and dam (background) near Shihkang.

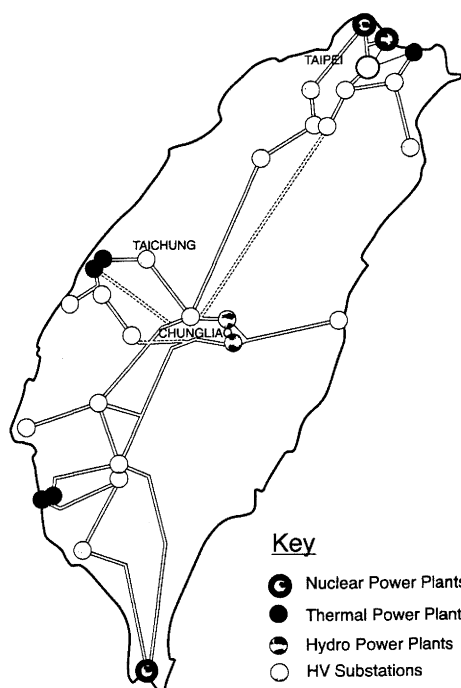
Figure 4.1: Overview of Taiwan's Electricity Network (disrupted main routes shown dotted).
